# REHABILITATION STUDY REPORT

State Project No. 137-164  
Bridge No. 03906 in Stonington  
Alpha Avenue over Amtrak and Local Roads

State of Connecticut  
Department of Transportation  
Newington, Connecticut

*Submitted:* April 2022

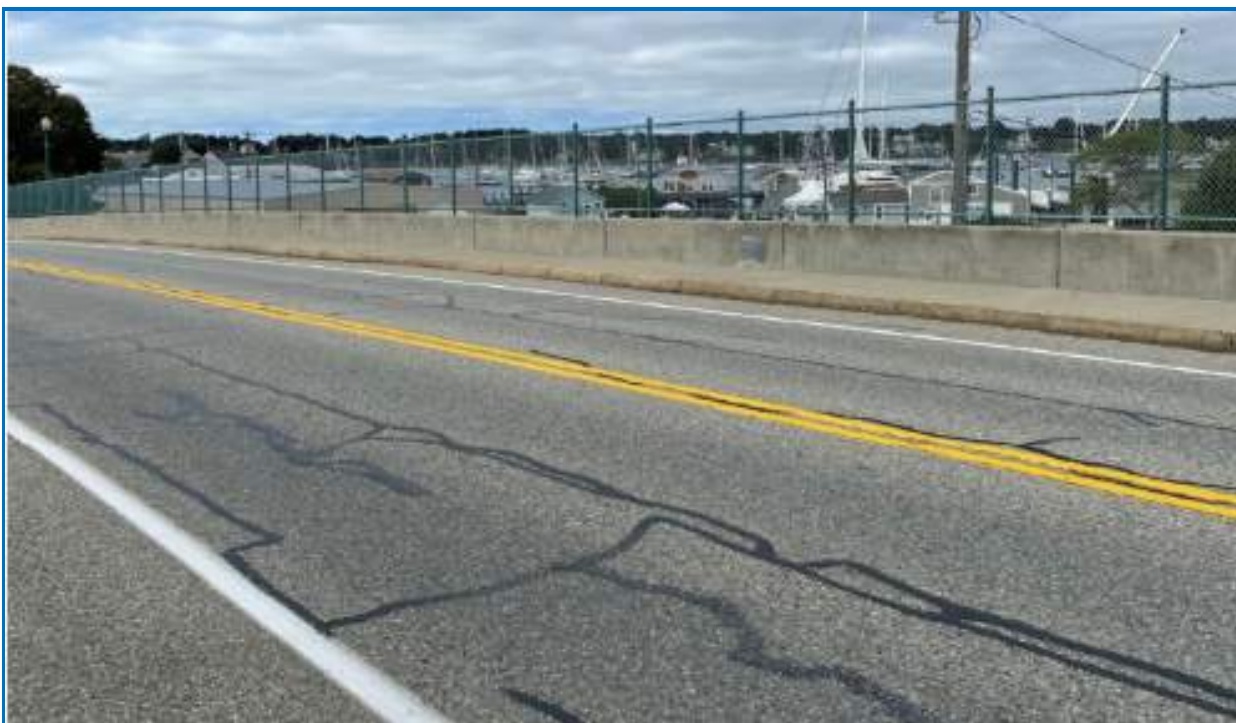
*Photo 5: Condition of deck overlay showing transverse and longitudinal cracks (typical).*

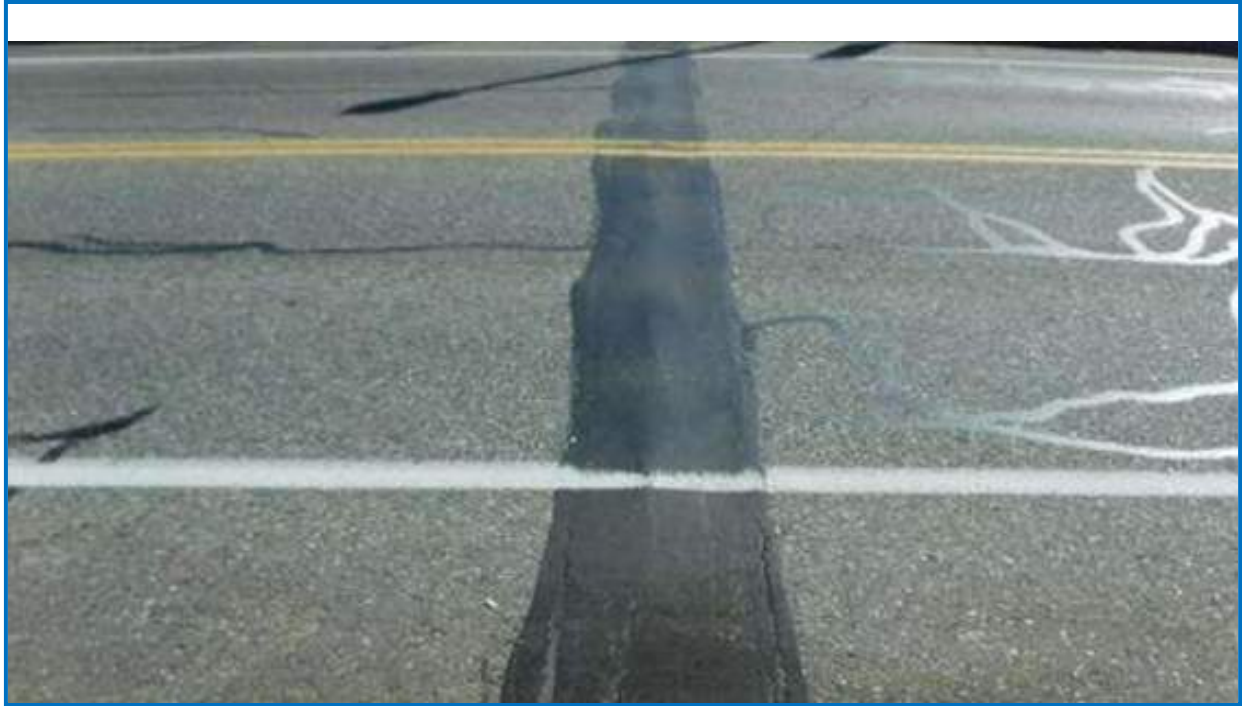
*Photo 7: Condition of asphaltic plug joints over abutments. Note adhesion crack and settlement of joints (typical).*

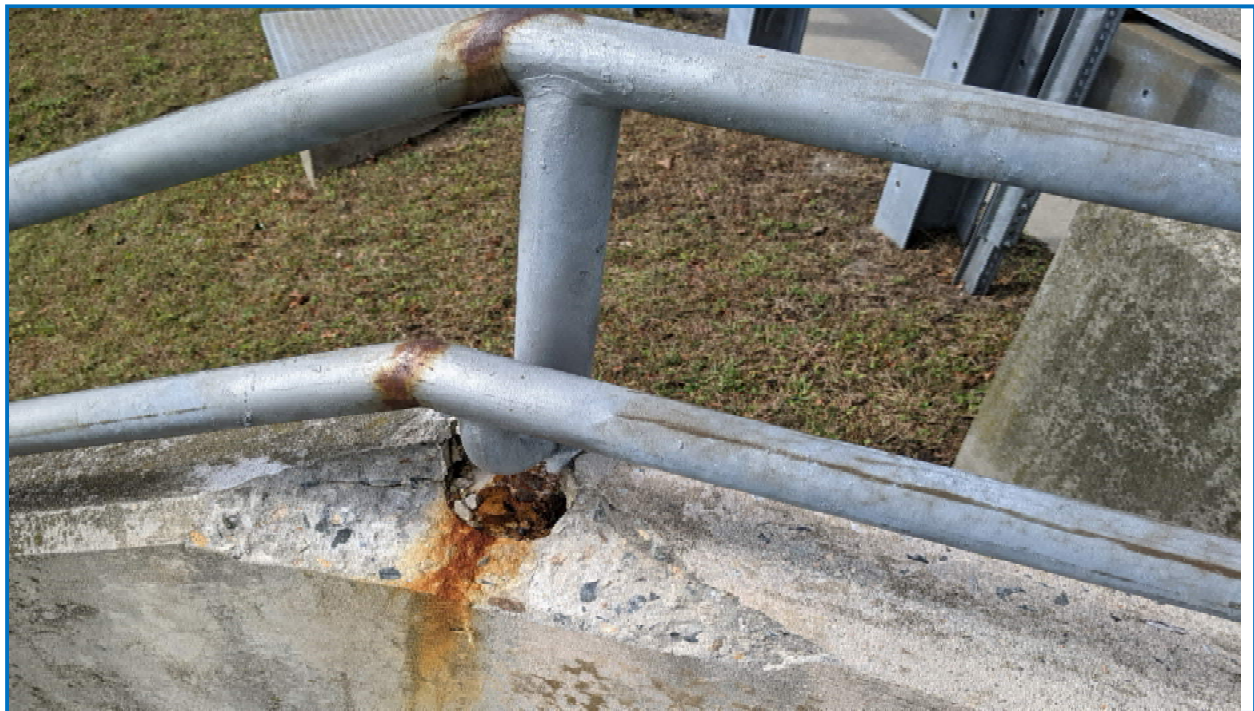
*Photo 8: Condition of southeast stairwell showing spalled concrete and missing hand rail post.*

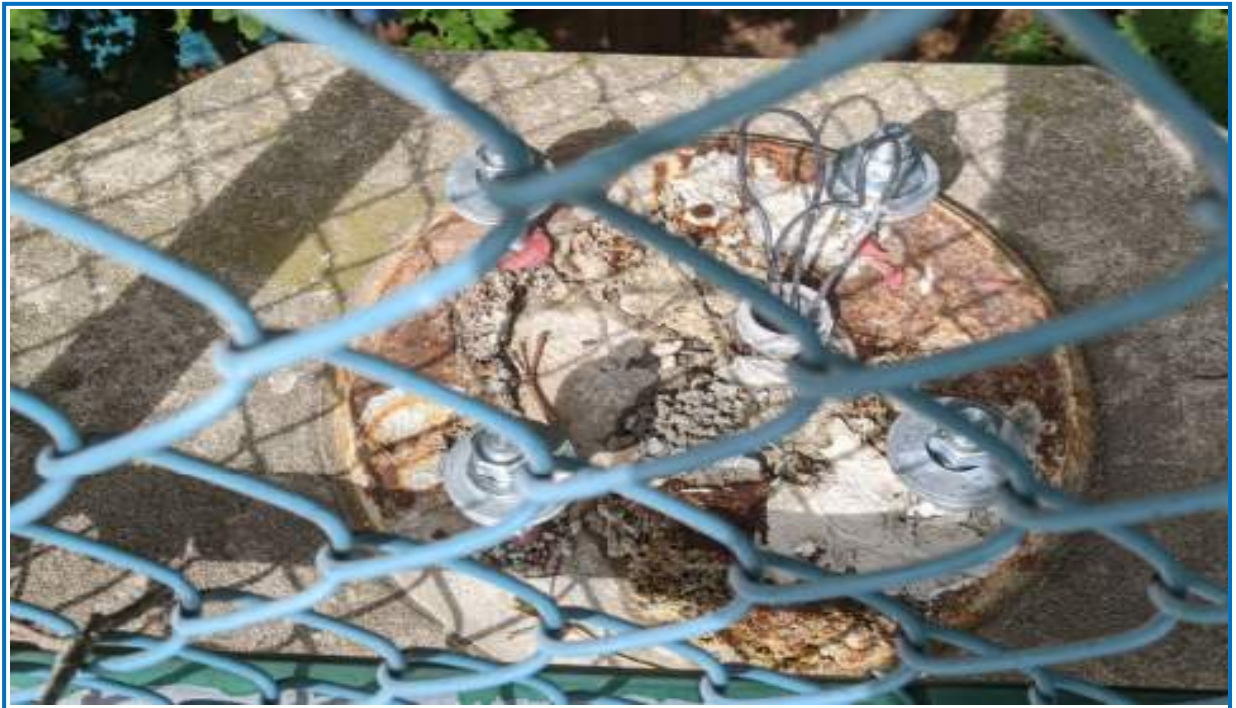
*Photo 10: Close up of missing lighting standard at Span 3 west parapet.*

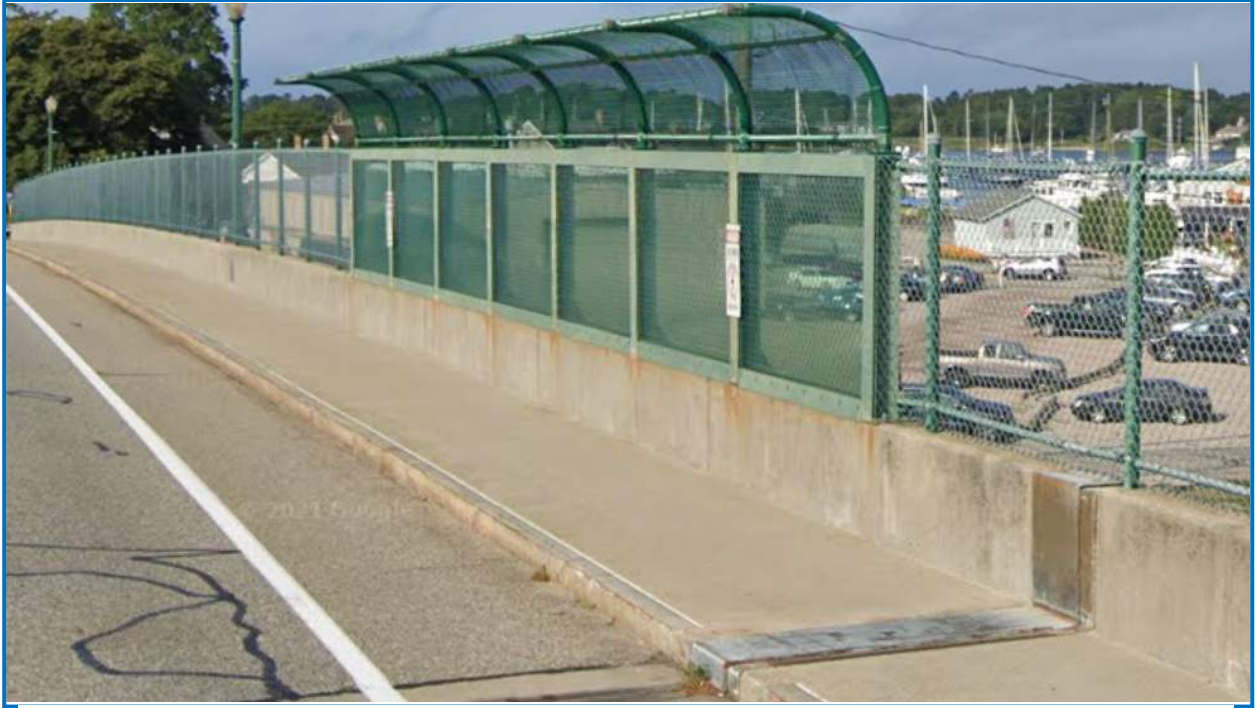
*Photo 11: Condition of bridge parapets and vinyl coated chain link fencing.*

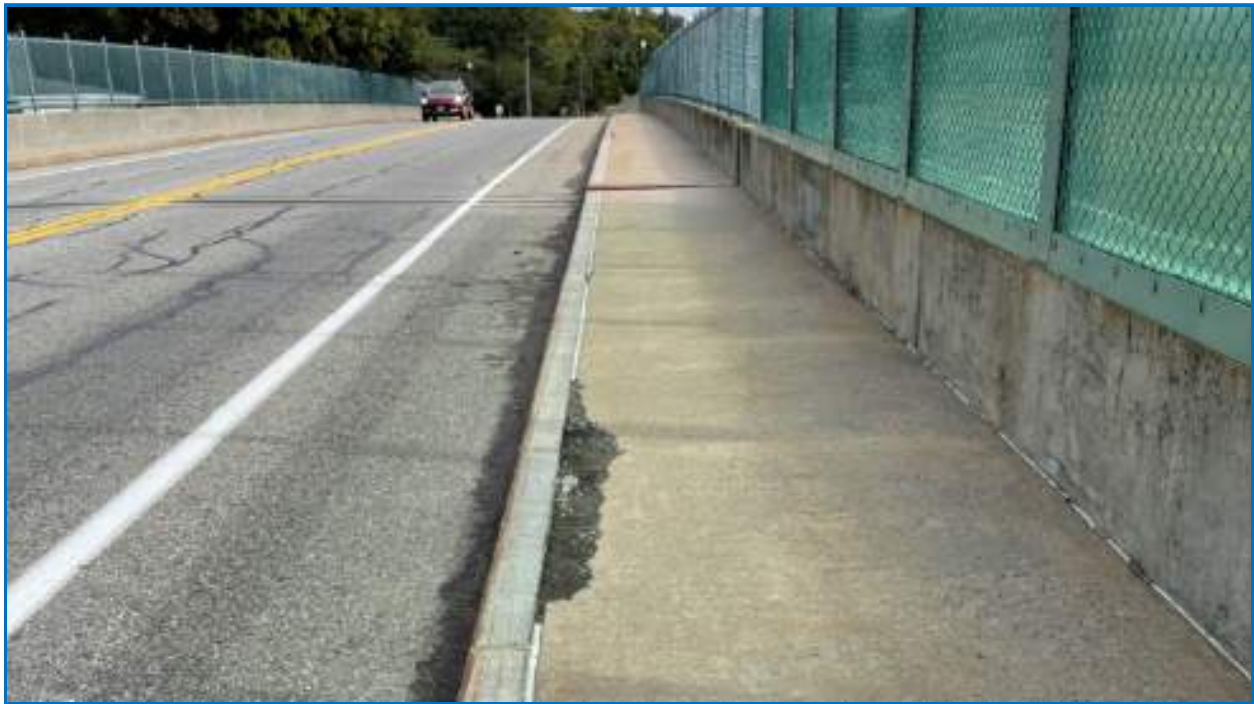
*Photo 12: Sidewalk located on south side of bridge (looking North). Isolated areas on sealant and concrete missing behind the granite curbing (typical).*

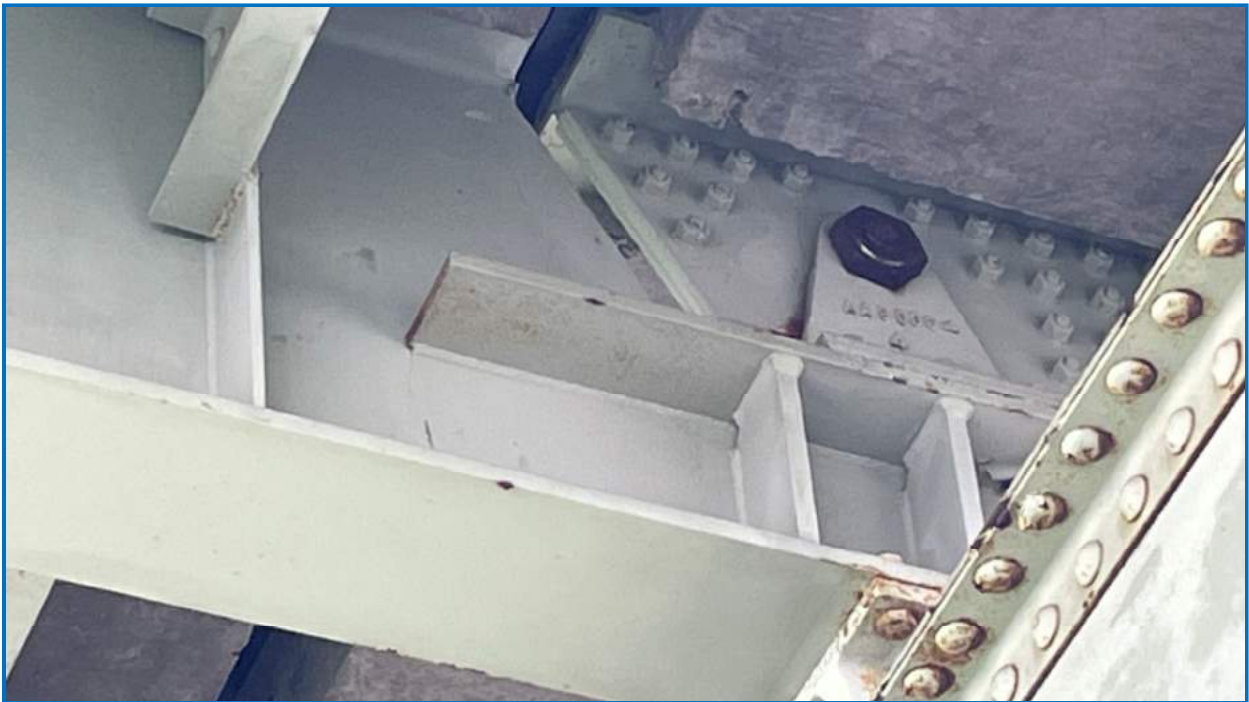
*Photo 14: Expansion bearings over pier bent 4. No paint over the nuts or bearing pins (typical).*

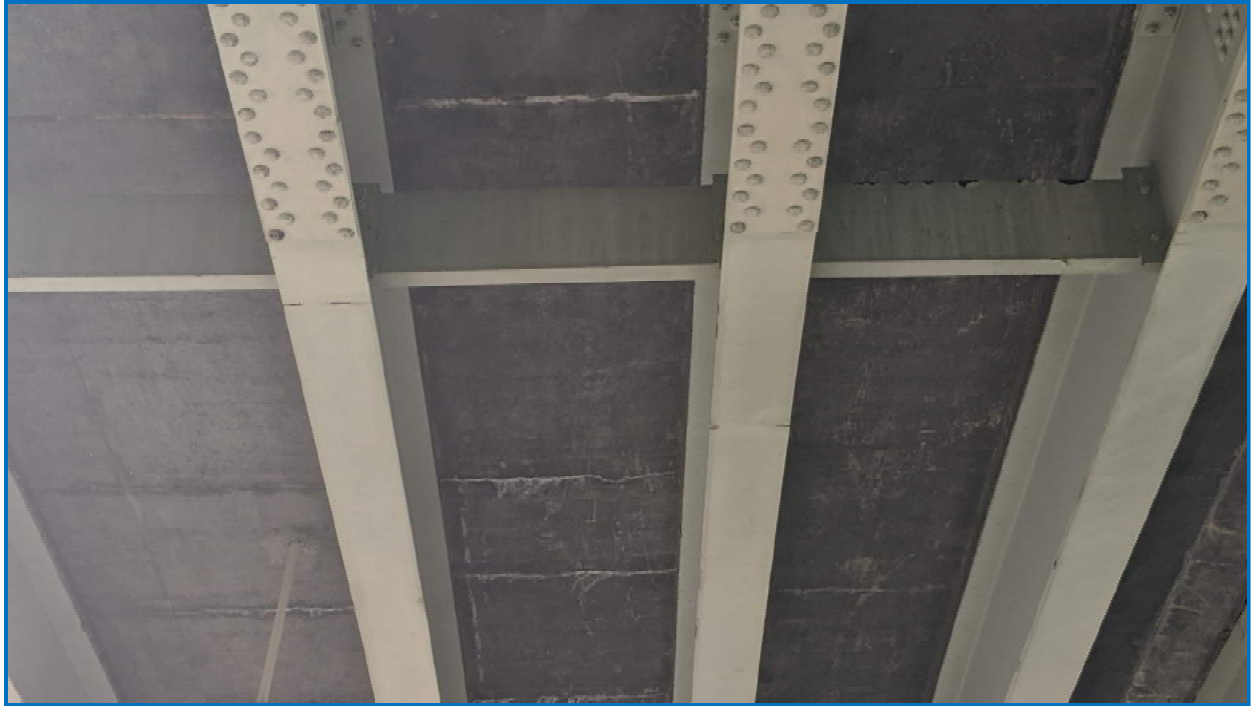
*Photo 17: Underside of concrete deck. Random transverse cracks, active efflorescence, and isolated spalling. (Span 6 Girders 8 and 9 in photo).*

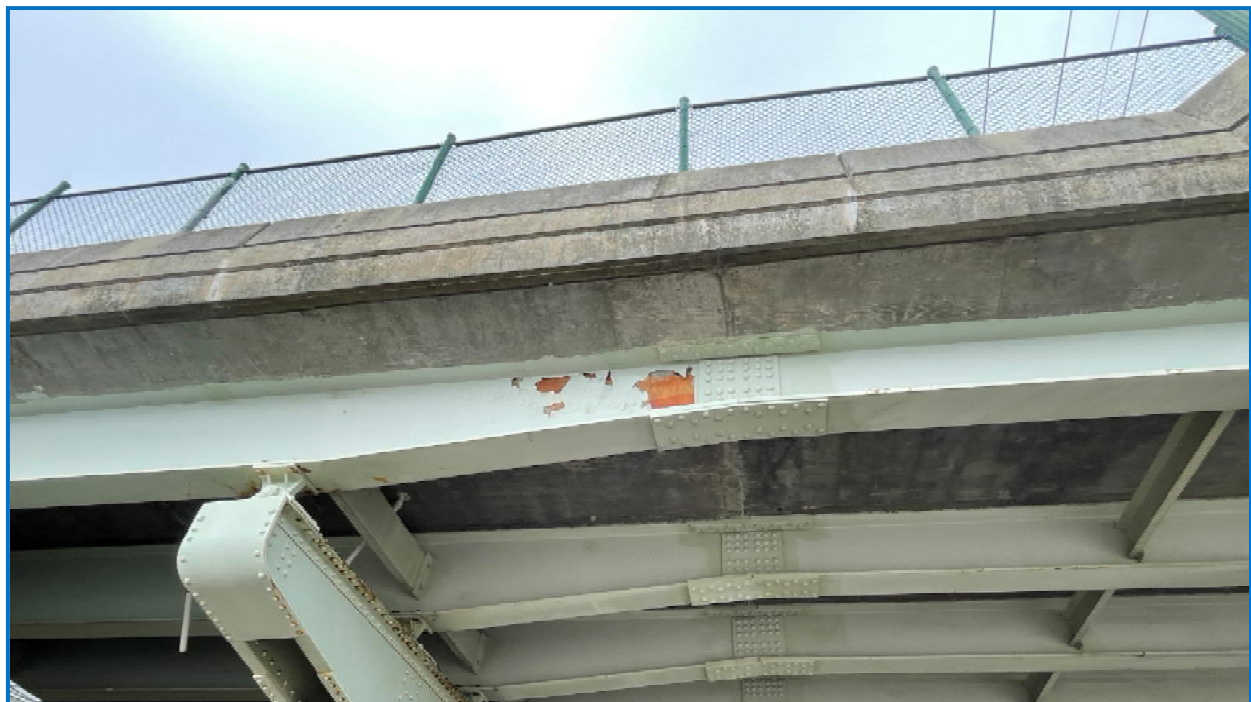
*Photo 22: Facia of Girder G9 in Span 8 showing areas of peeling paint and surface rust near field splice.*

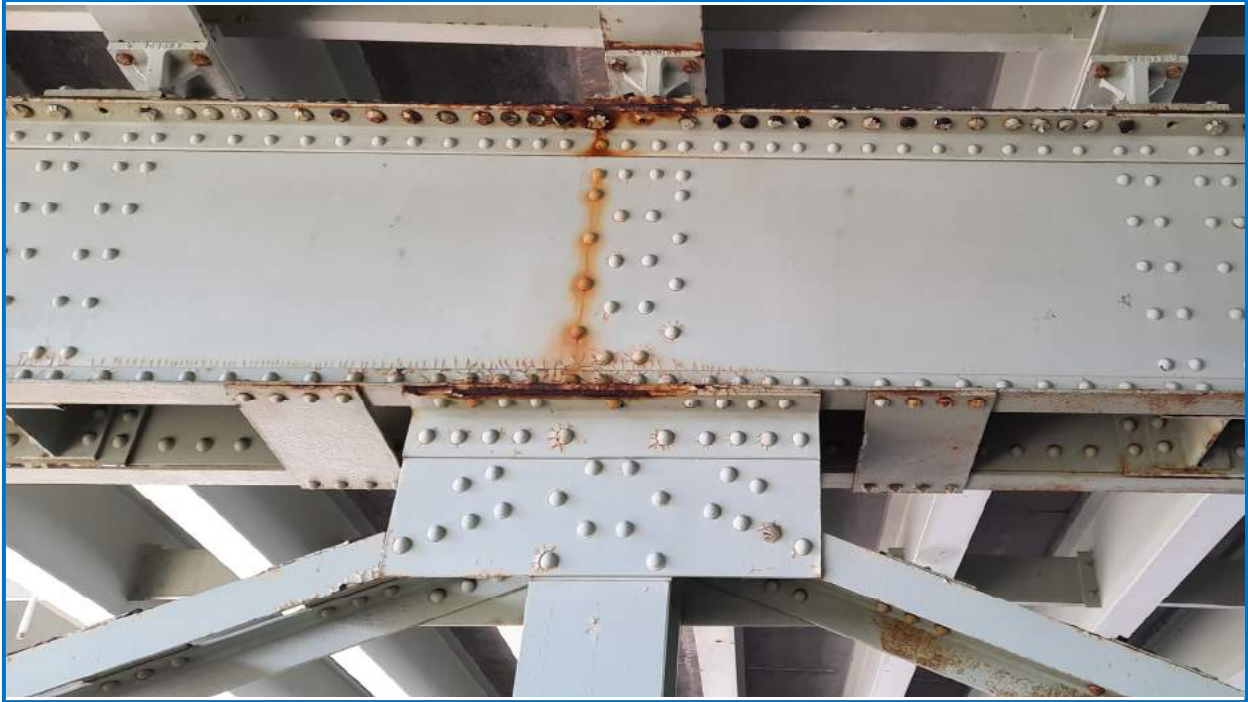
*Photo 25: Pier Cap 6 from North side showing top and bottom section losses and random missing rivets..*

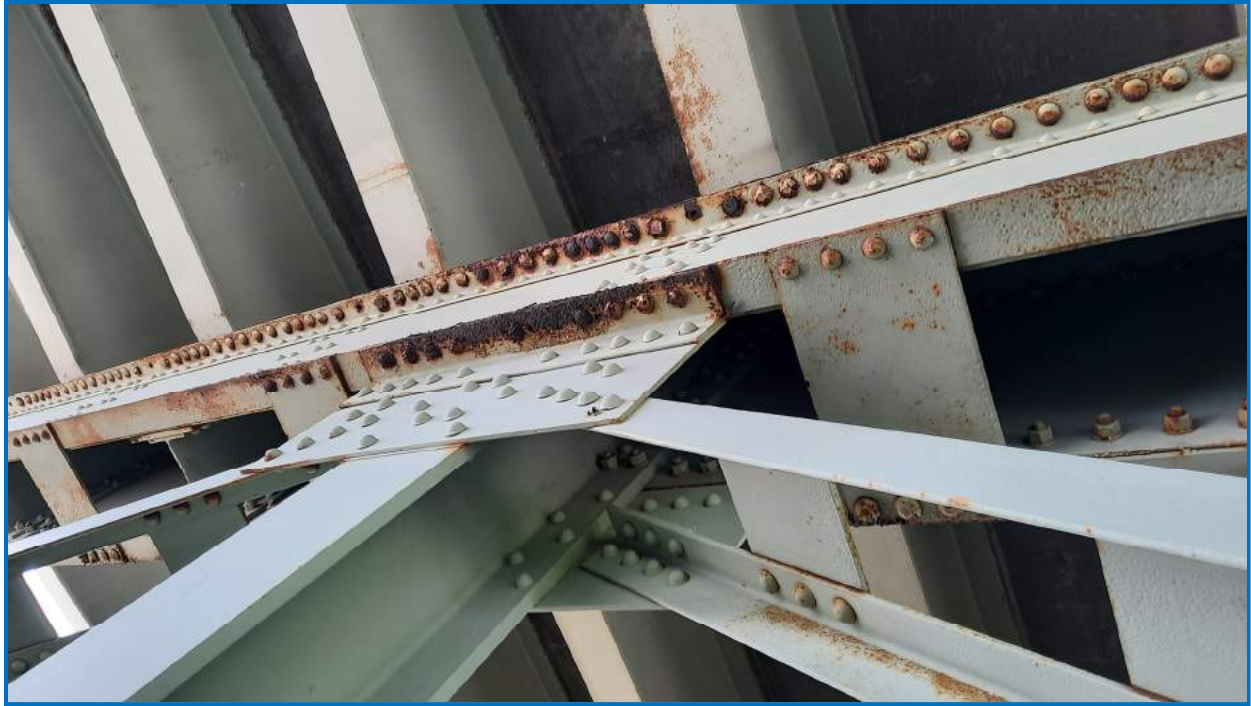
*Photo 27: Pier Cap 6 top and bottom flange deterioration over center column. Photo taken from South side of pier.*

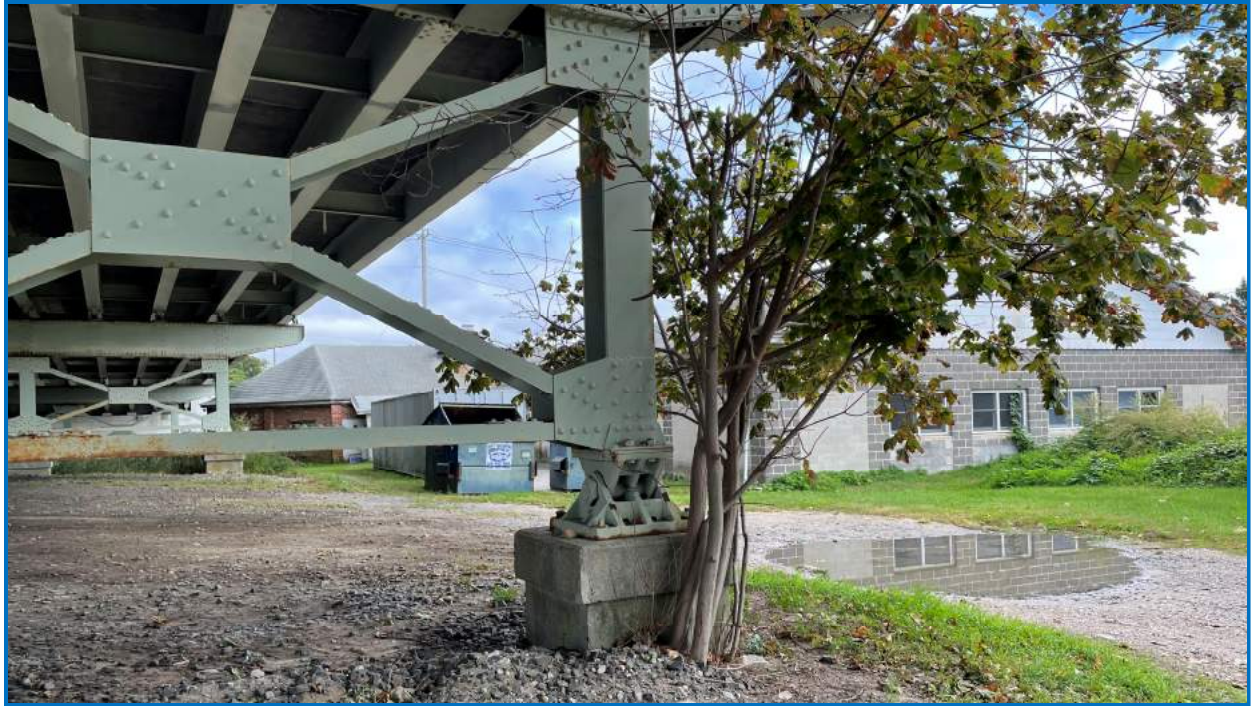
*Photo 29: Tree growing beside bearing pedestal under Pier 5.*

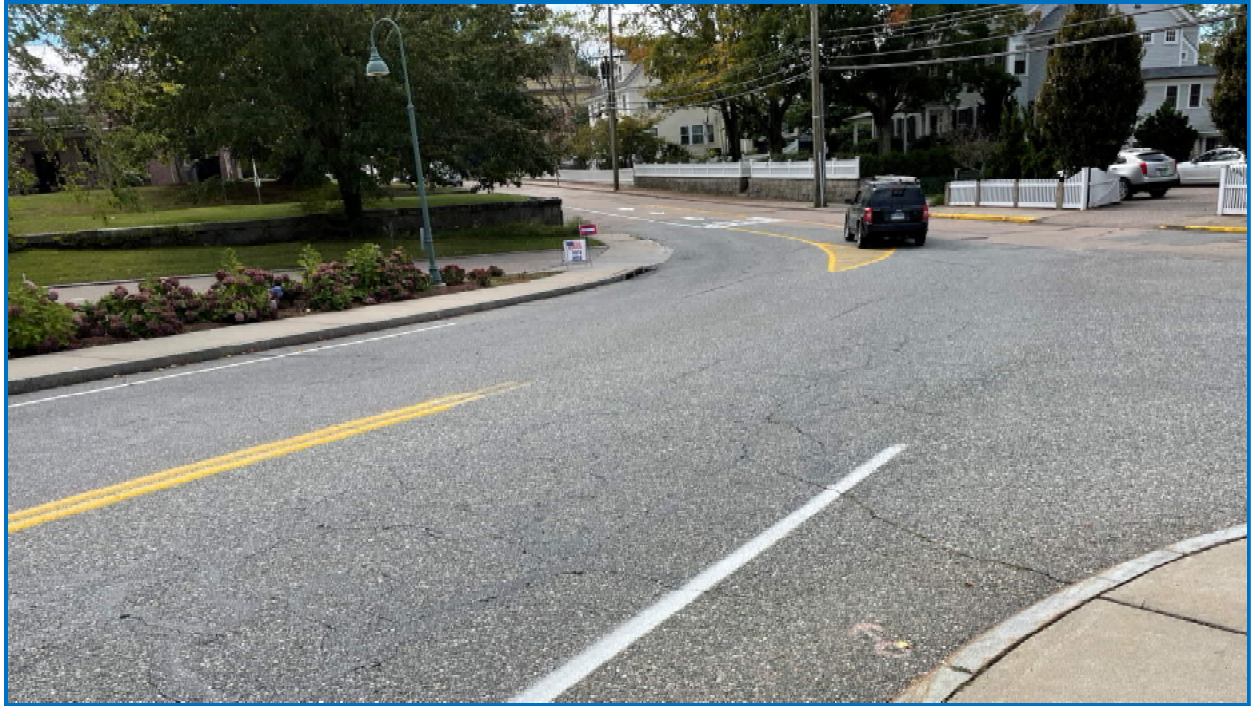
*Photo 31: South bridge approach at intersection with Water Street (looking South).*

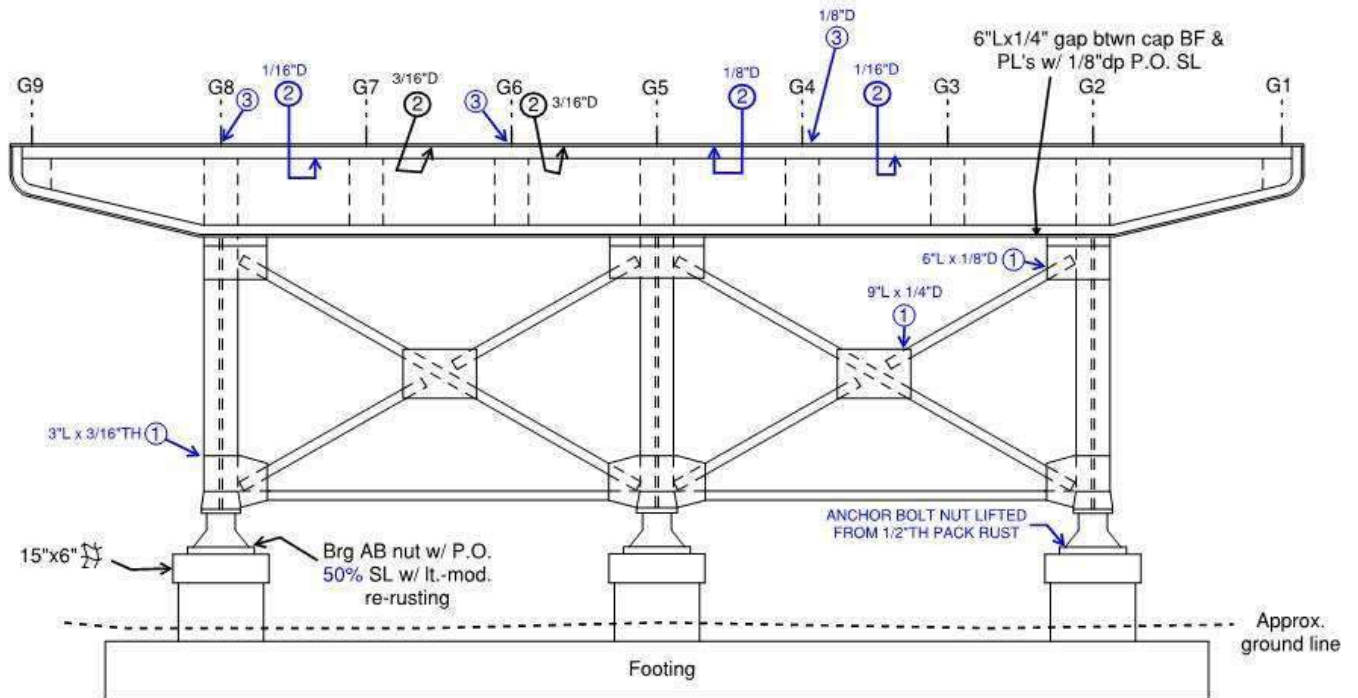
- ① Pack rust btwn gusset plate and member.
- ② HORIZONTAL LEG TOP FLANGE ANGLE w/ FW x 1/8" D (PO) PITTING (UP TO 3/16" D AT ISOLATED LOCATIONS)
- ③ 9" L x 3/16" TH PACK RUST BETWEEN HORIZONTAL ANGLE AND TOP PLATE

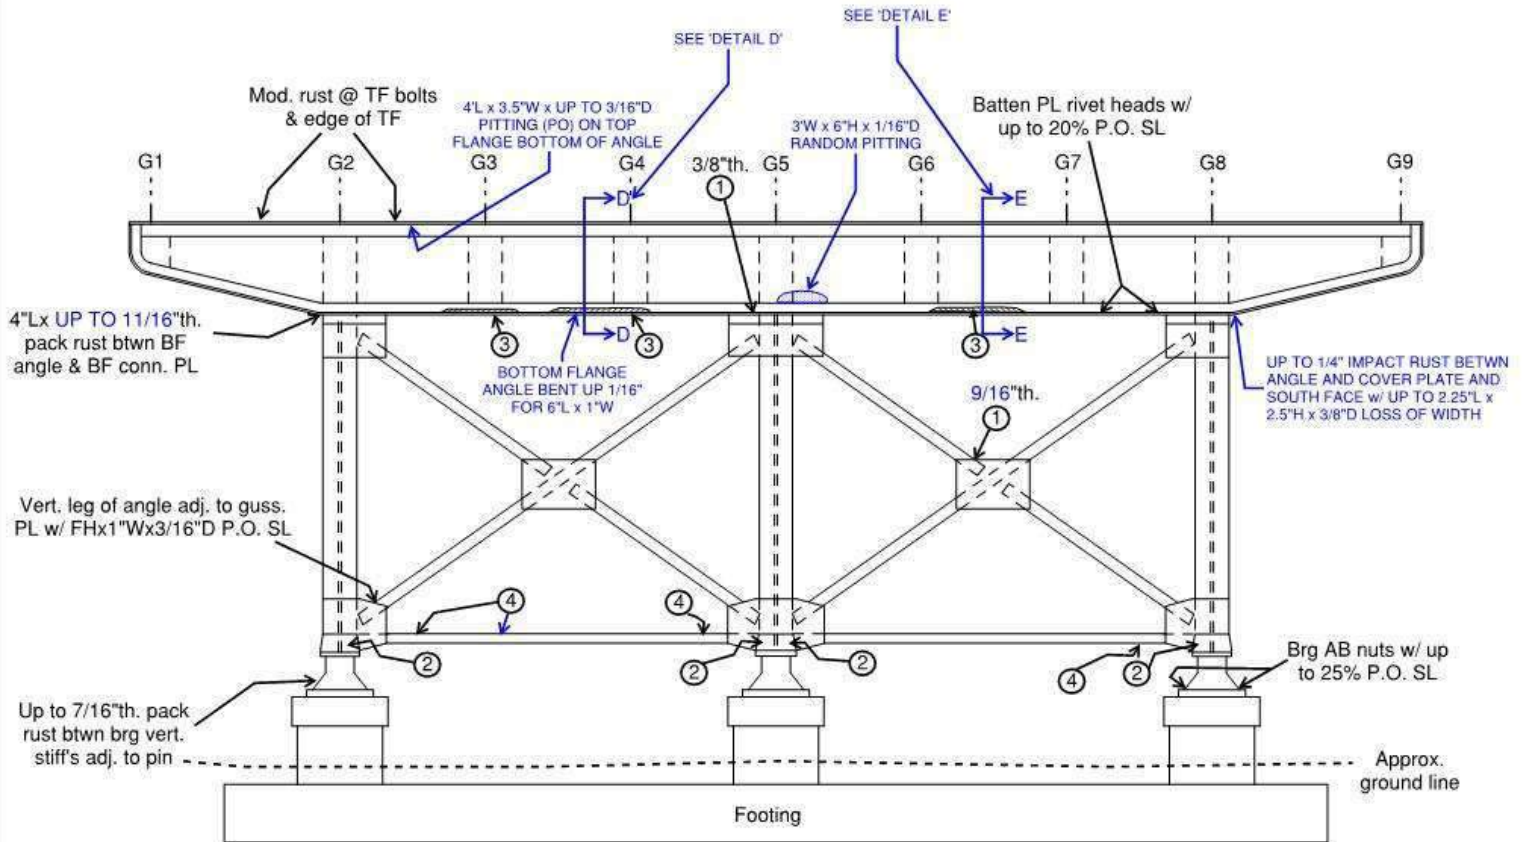
- Pier column bearings have areas of peeling paint w/ spotty light-moderate rust w/ up to 3/16"D P.O. SL.
- Steel has random areas of peeling paint w/ light to moderate rust.
- Steel has random areas of painted over pitting up to 1/16"D (not full sections; worst areas noted on sketch).

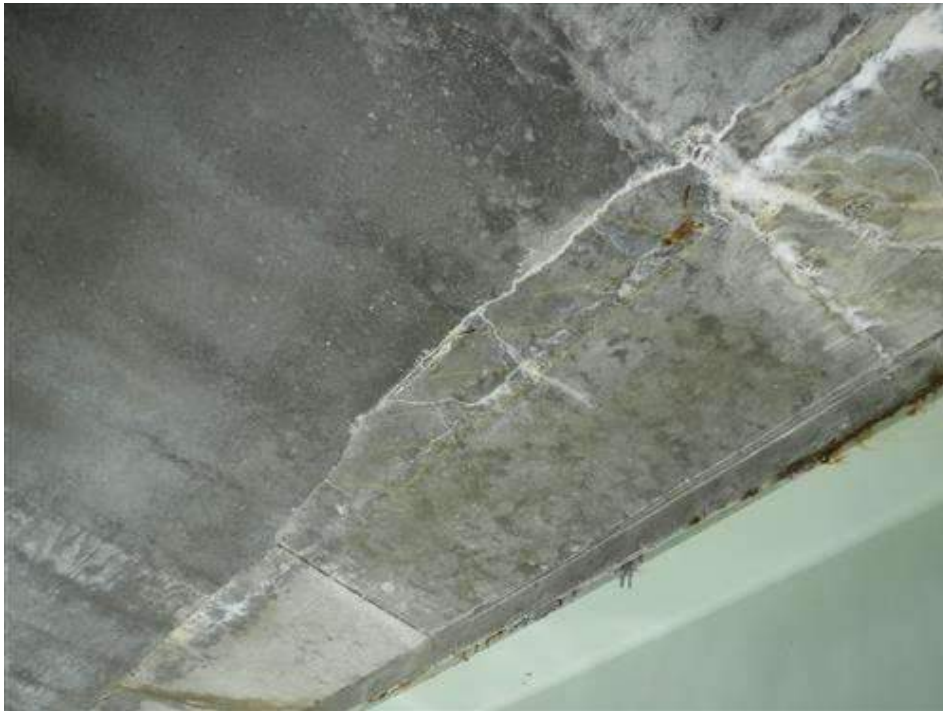
Photo Number: 12

Span 6, Bay 3 underside of deck between Diaphragms D2 & D3 near Diaphragm D3 has a spall with an adjacent hollow area over the parking lot below.

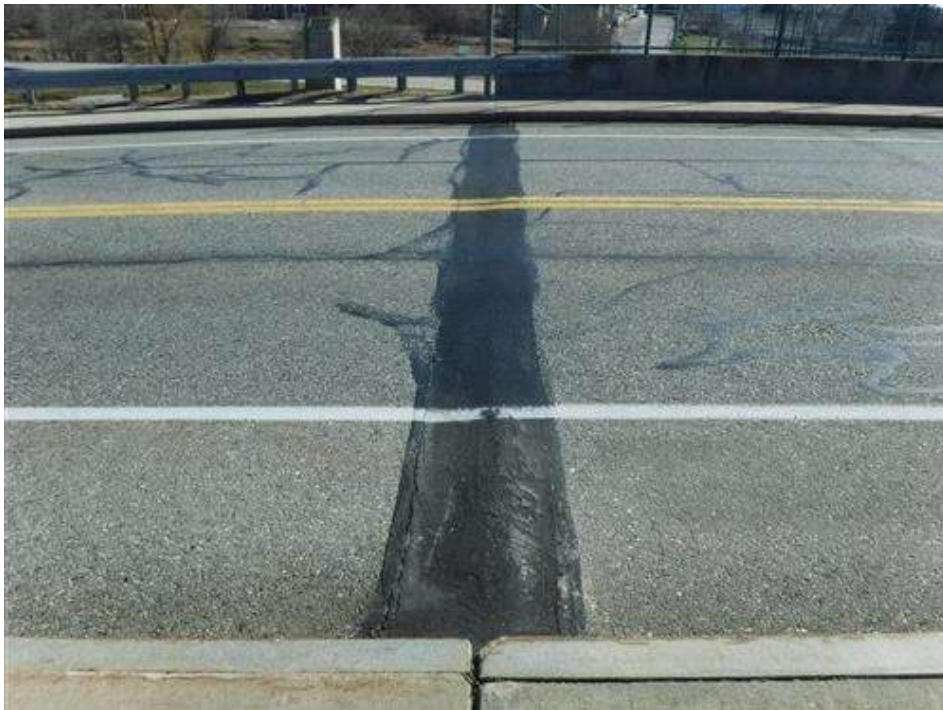
Photo Number: 24

Abutment 1 plug joint has multiple adhesion cracks with full length settlement/depressions, looking east.

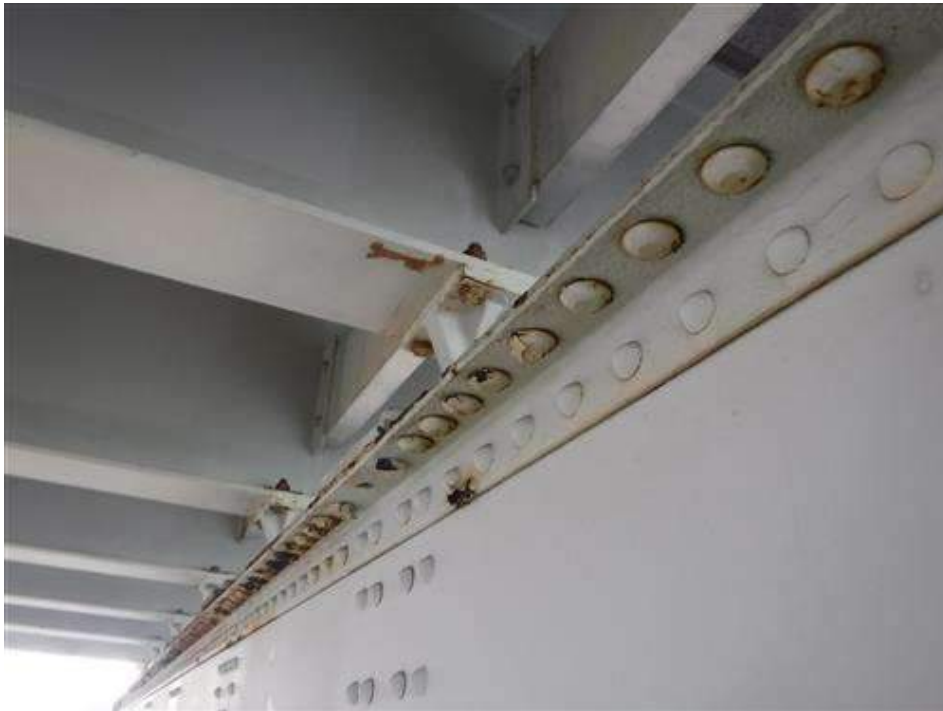
Photo Number: 50

Pier 2 cap, south elevation at Girder G7 has pack rust between the top flange angle and cover plate. Note: One (1) missing rivet in web.

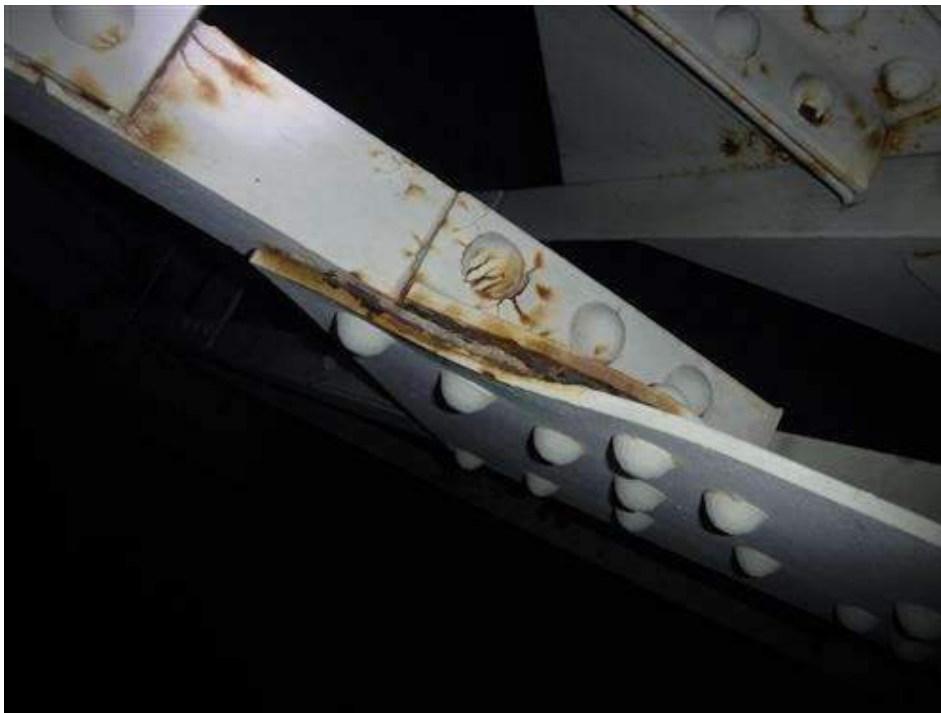
Photo Number: 58

Pier 4, Column C3 west elevation at the base has laminated rust with section loss and areas of painted over section loss on the interior column legs.

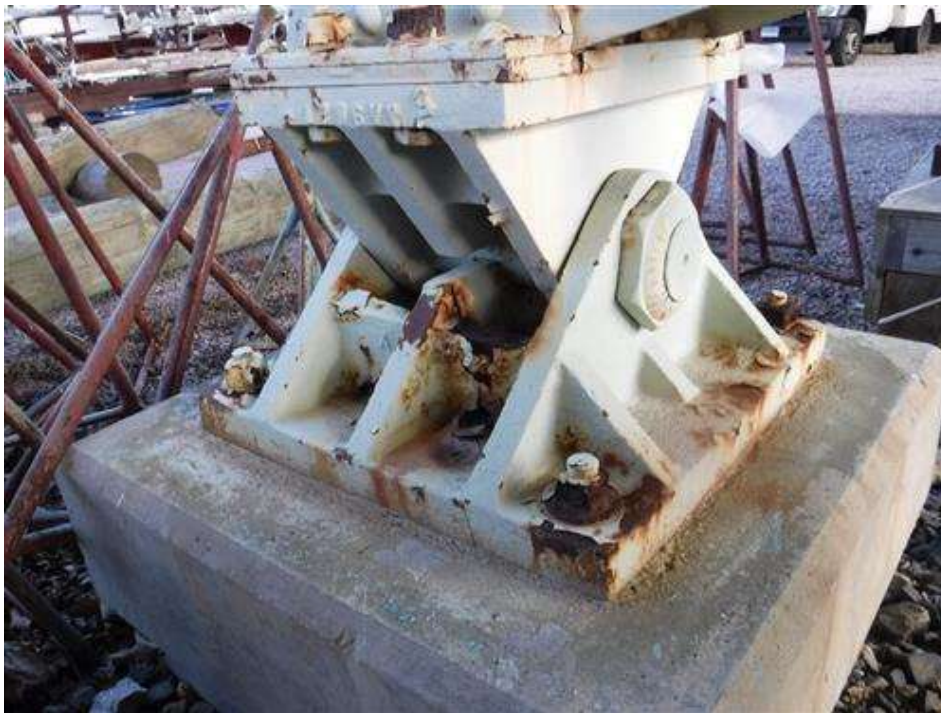
Photo Number: 60

Pier 4, north elevation of Column C1 bearing has laminated rust with section loss on the bearing plates and pack rust between the vertical plates.
