## Appendix A

### Mystic Area CCTV Inspection Logs

## NWMCC INSPECTION REPORT

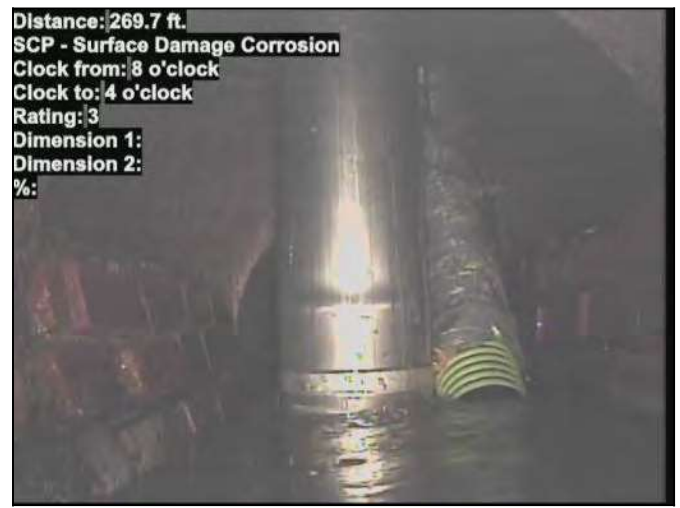
Photo: MH 1-40A-MH 1-40-20220822-121204.JPG

At: 269.7 ft. 8/4 SCP - Surface Damage Corrosion

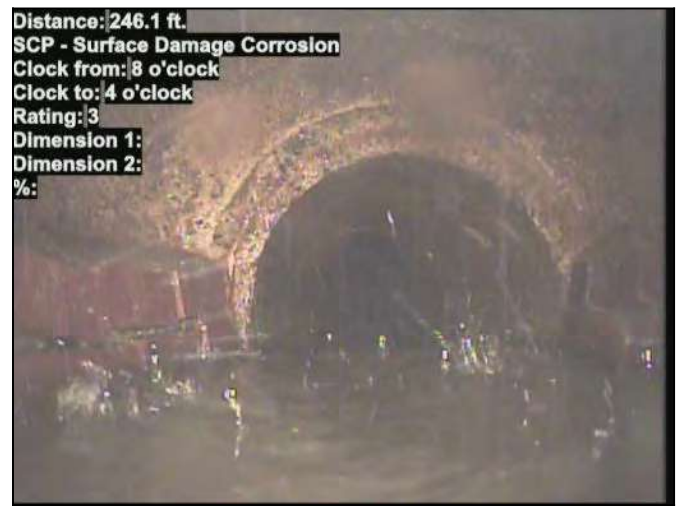
Distance: 246.1 ft.  
 SCP - Surface Damage Corrosion  
 Clock from: 8 o'clock  
 Clock to: 4 o'clock  
 Rating: 3  
 Dimension 1:  
 Dimension 2:  
 %:

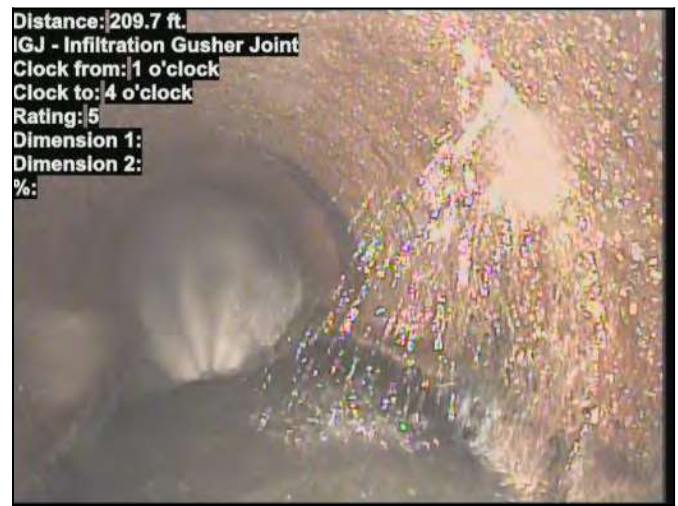
Photo: MH 1-25-MH 1-24-20220825-131617.JPG

At: 209.7 ft. 1/4 IGJ - Infiltration Gusher Joint

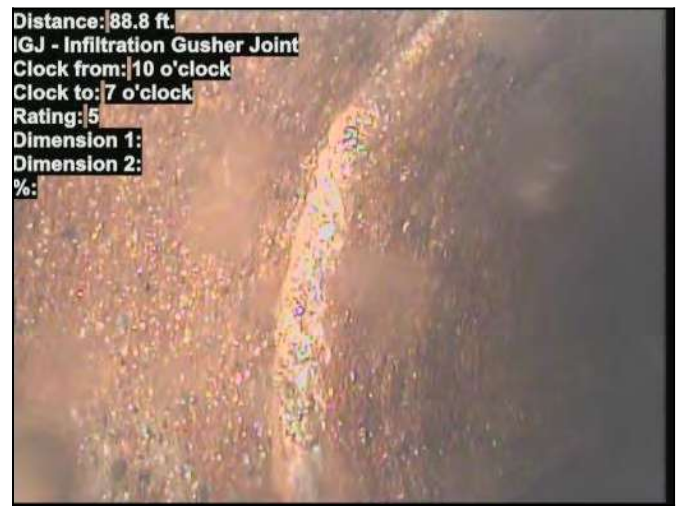
Distance: 88.8 ft.  
IGJ - Infiltration Gusher Joint  
Clock from: 10 o'clock  
Clock to: 7 o'clock  
Rating: 5  
Dimension 1:  
Dimension 2:  
%:

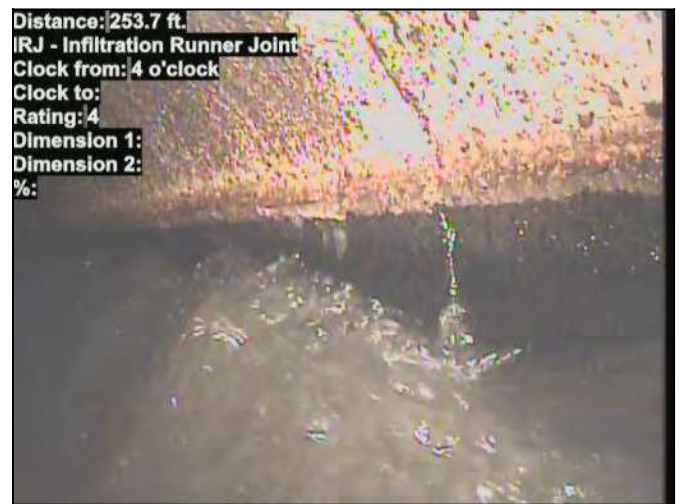
Distance: 253.7 ft.  
IRJ - Infiltration Runner Joint  
Clock from: 4 o'clock  
Clock to:  
Rating: 4  
Dimension 1:  
Dimension 2:  
%:

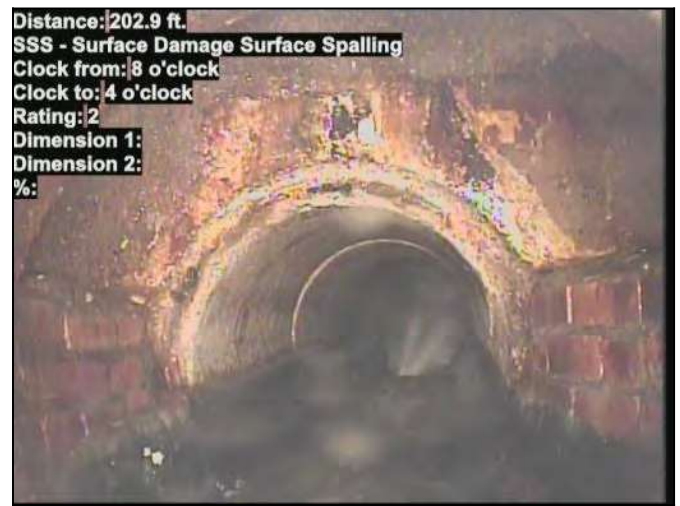
Distance: 202.9 ft.  
 SSS - Surface Damage Surface Spalling  
 Clock from: 8 o'clock  
 Clock to: 4 o'clock  
 Rating: 2  
 Dimension 1:  
 Dimension 2:  
 %:

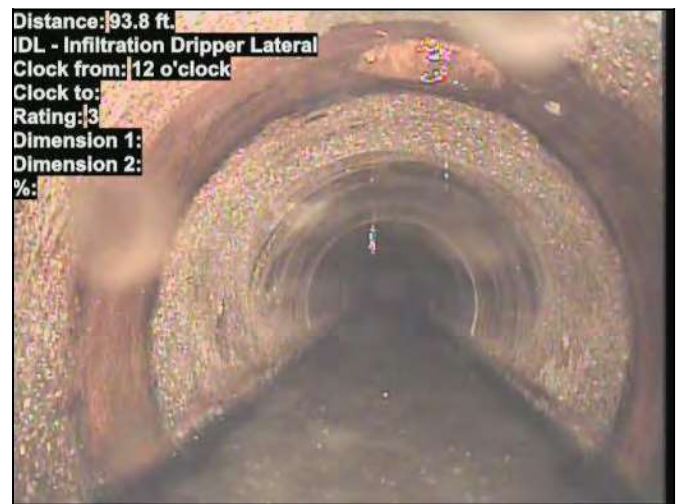
Distance: 93.8 ft.  
IDL - Infiltration Dripper Lateral  
Clock from: 12 o'clock  
Clock to:  
Rating: 3  
Dimension 1:  
Dimension 2:  
%:  
Photo: MH 1-07-MH 1-06-20220831-125750.JPG  
At: 93.8 ft. 12/. IDL - Infiltration Dripper Lateral  
Joint: Yes

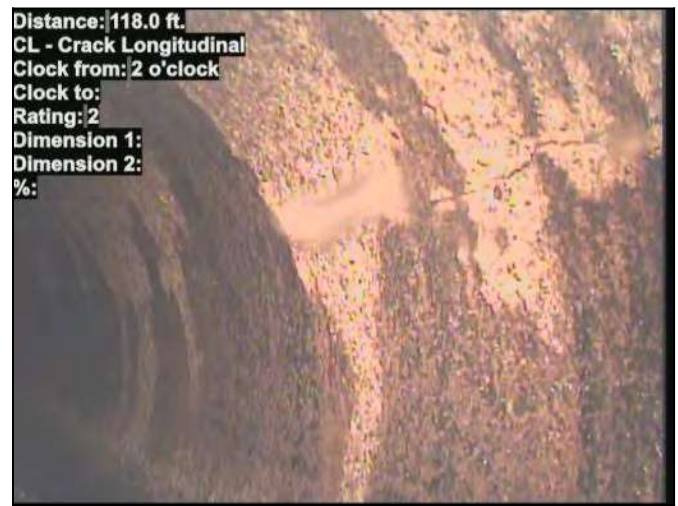
Distance: 118.0 ft.  
CL - Crack Longitudinal  
Clock from: 2 o'clock  
Clock to:  
Rating: 2  
Dimension 1:  
Dimension 2:  
%:

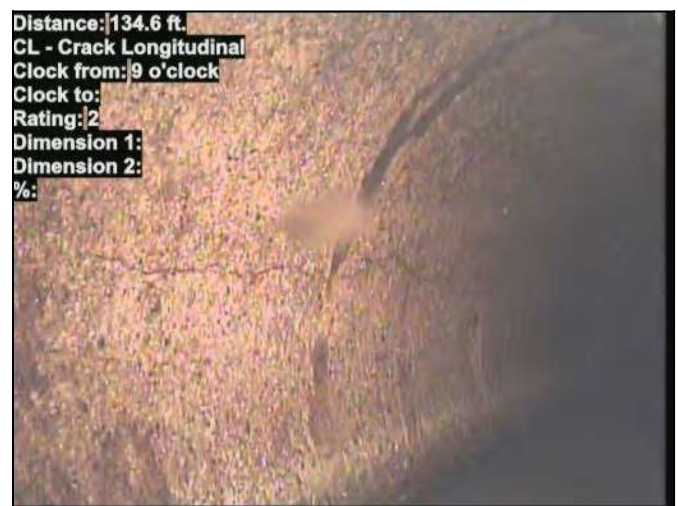
Distance: 134.6 ft.  
CL - Crack Longitudinal  
Clock from: 9 o'clock  
Clock to:  
Rating: 2  
Dimension 1:  
Dimension 2:  
%:

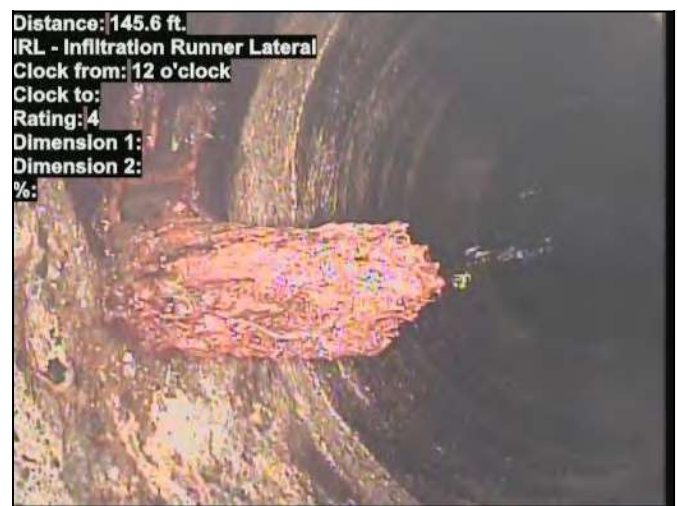
Distance: 145.6 ft.  
IRL - Infiltration Runner Lateral  
Clock from: 12 o'clock  
Clock to:  
Rating: 4  
Dimension 1:  
Dimension 2:  
%:

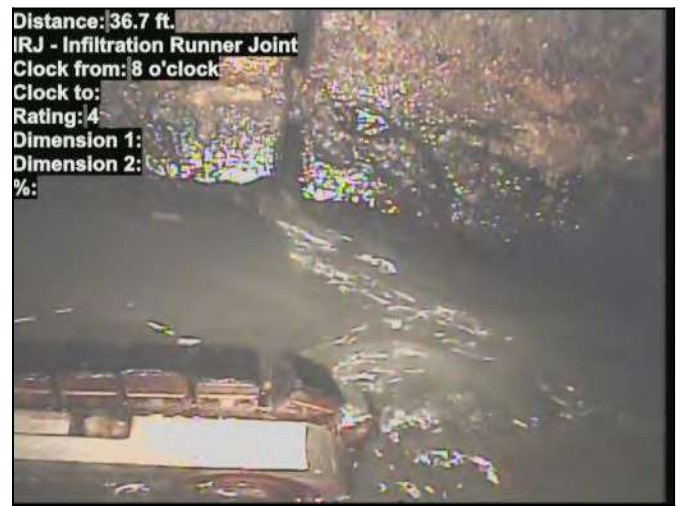
Distance: 36.7 ft.  
IRJ - Infiltration Runner Joint  
Clock from: 8 o'clock  
Clock to:  
Rating: 4  
Dimension 1:  
Dimension 2:  
%:

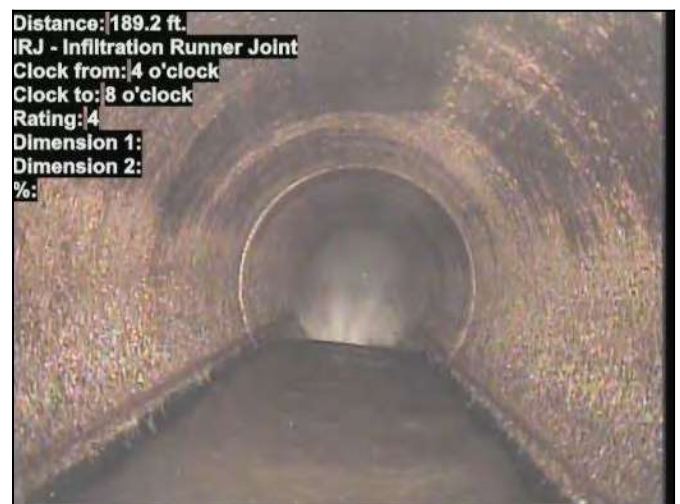
Distance: 189.2 ft.  
IRJ - Infiltration Runner Joint  
Clock from: 4 o'clock  
Clock to: 8 o'clock  
Rating: 4  
Dimension 1:  
Dimension 2:  
%:
