Appendix B

Mystic Area Manhole Inspection Reports and Photos

Town of Stonington, Connecticut

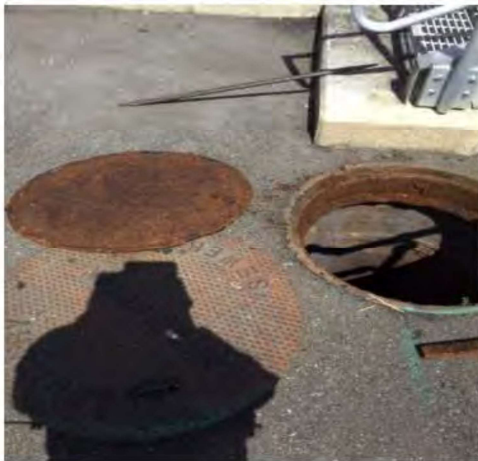
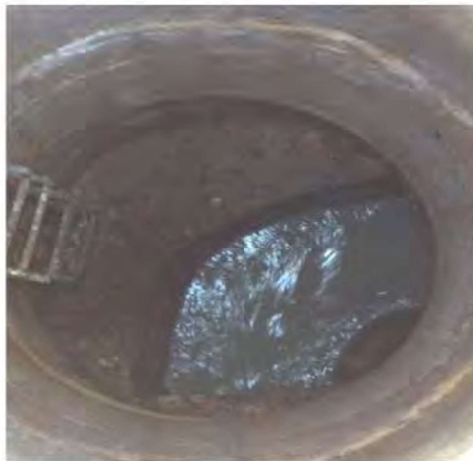
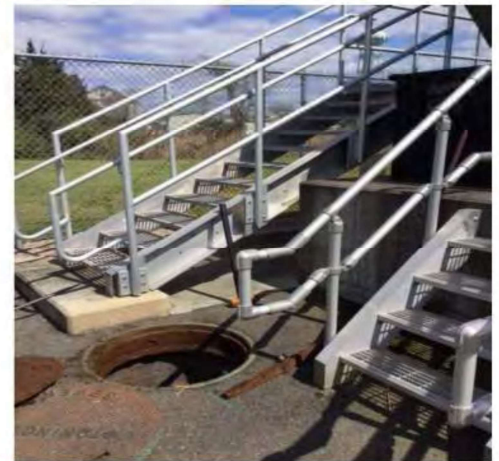
GIS MH No: 1-0

Location in MH	Mtrl. Code	Infil. Code	Cond. Code	Repair Codes	Comments
Frame/Cover	CAST IRON	NONE	CORRODED	REPLACE FRAME AND COVER	
Chimney	CONCRETE (PRECAST)	NONE	SOUND	NONE	
Cone	CONCRETE (PRECAST)	NONE	SOUND	NONE	
Wall	CONCRETE (PRECAST)	NONE	SOUND	NONE	
Bench	BRICK	NONE	SOUND	NONE	
Invert/Channel	BRICK	NONE	SOUND	NONE

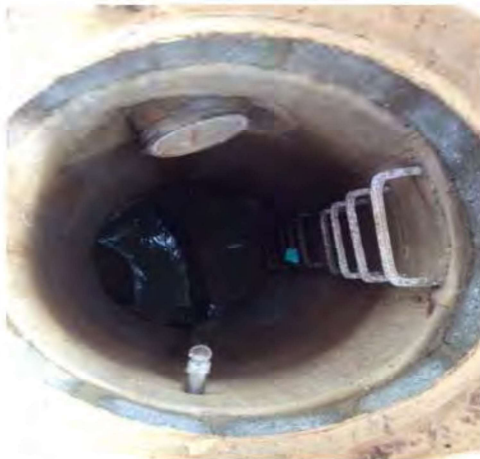
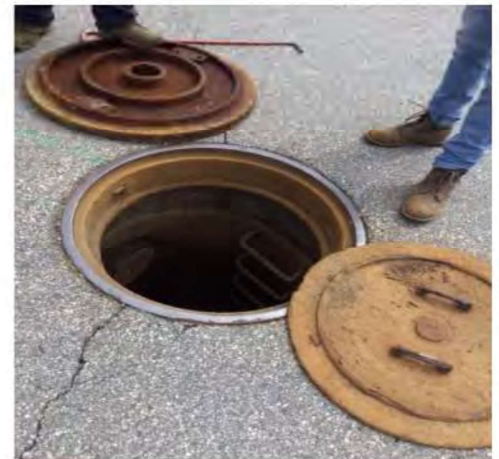
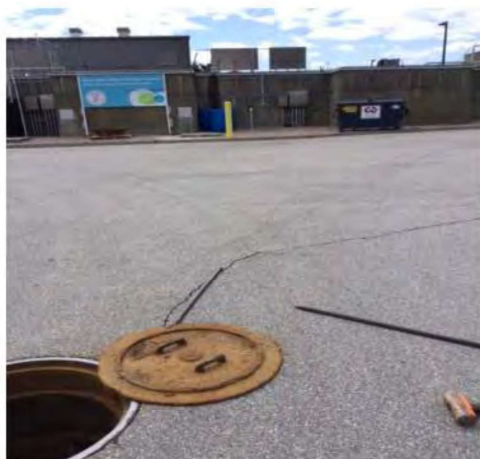
GIS MH No: 1-1

Location in MH	Mtrl. Code	Infil. Code	Cond. Code	Repair Codes	Comments
Frame/Cover	CAST IRON	NONE	CORRODED	REPLACE FRAME AND COVER	
Chimney	CONCRETE BLOCK	NONE	SOUND	NONE	
Cone	CONCRETE (PRECAST)	NONE	SOUND	NONE	
Wall	CONCRETE (PRECAST)	NONE	SOUND	NONE	
Bench	BRICK	NONE	SOUND	NONE	
Invert/Channel	BRICK	NONE	SOUND	NONE

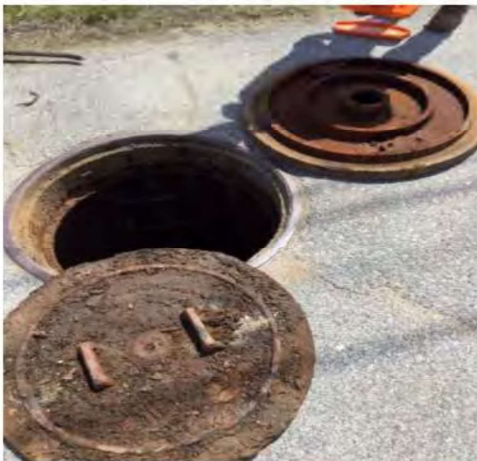
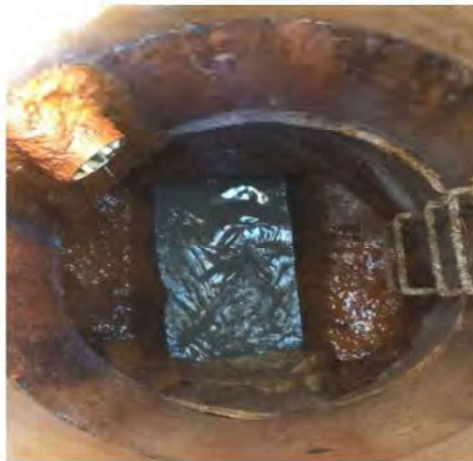
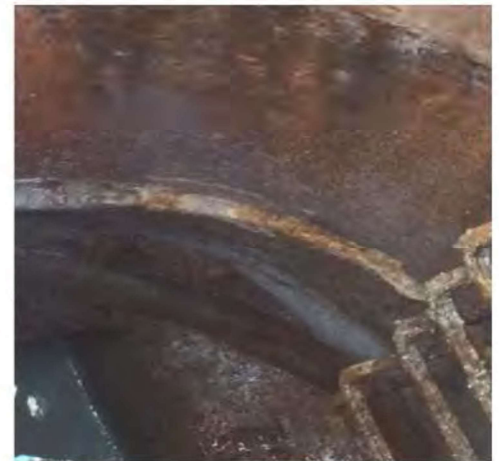
GIS MH No: 1-2

Location in MH	Mtrl. Code	Infil. Code	Cond. Code	Repair Codes	Comments
Frame/Cover	CAST IRON	NONE	CORRODED	REPLACE FRAME AND COVER	
Chimney	OTHER (DESCRIBE IN DETAILS)	NONE	NOT KNOWN	NONE	NO CHIMNEY
Cone	OTHER (DESCRIBE IN DETAILS)	NONE	SOUND	NONE	NO CHIMNEY
Wall	CONCRETE (PRECAST)	WEEPER	SOUND	LINE_MANHOLE	
Bench	BRICK	NONE	SOUND	NONE	
Invert/Channel	BRICK	NONE	SOUND	NONE

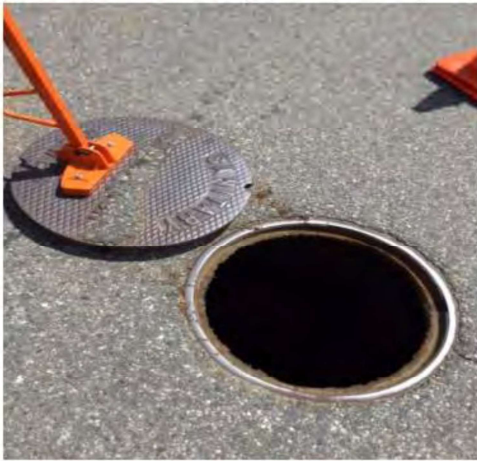
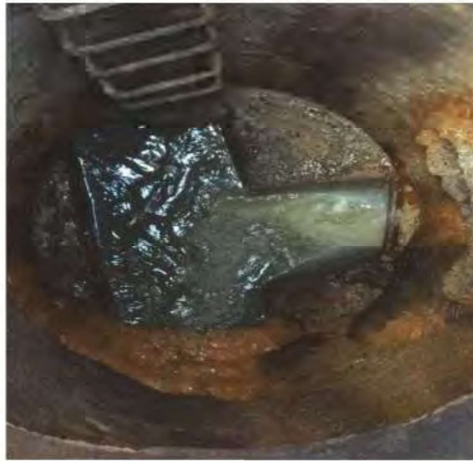
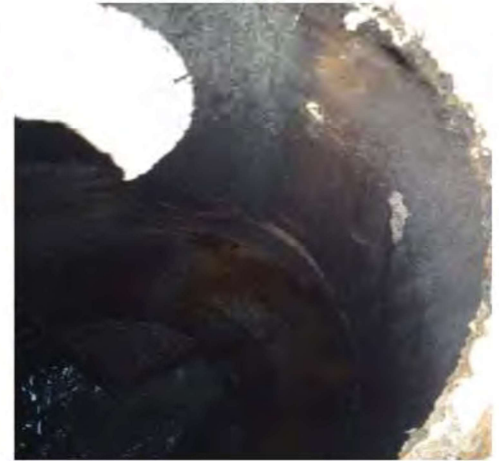
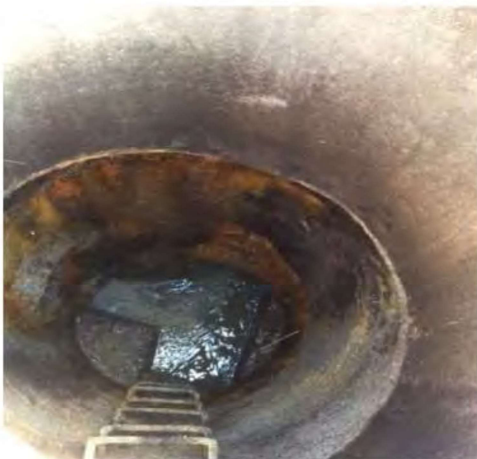
GIS MH No: 1-5

Location in MH	Mtrl. Code	Infil. Code	Cond. Code	Repair Codes	Comments
Frame/Cover	CAST IRON	NONE	CORRODED	REPLACE FRAME AND COVER	
Chimney	BRICK	NONE	SOUND	NONE	
Cone	OTHER (DESCRIBE IN DETAILS)	NONE	SOUND	NONE	NO CONE
Wall	CONCRETE (PRECAST)	WEEPER	DEFECTIVE	LINE_MANHOLE	TONS OF CORROSION
Bench	BRICK	NONE	SOUND	NONE	
Invert/Channel	BRICK	NONE	SOUND	NONE

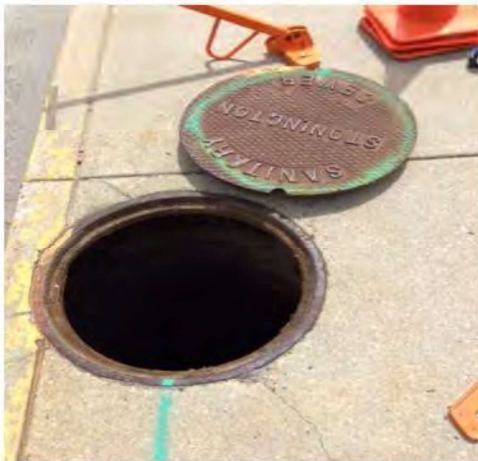
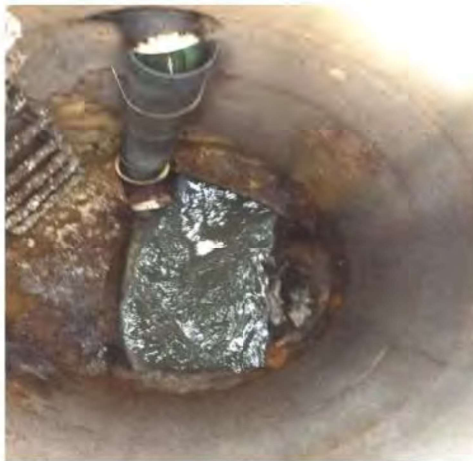
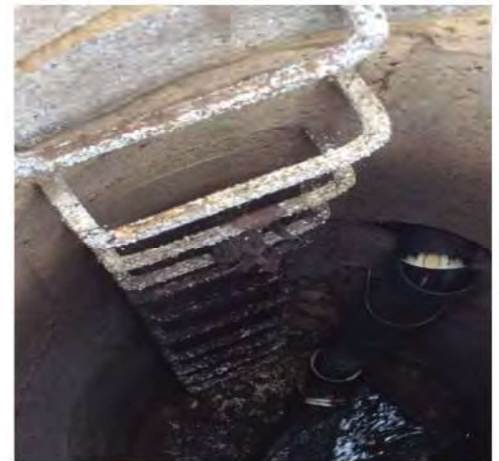
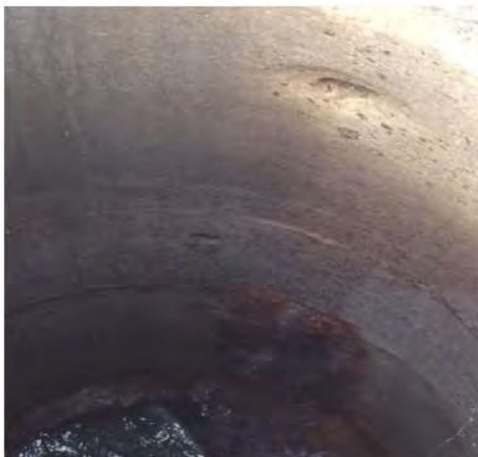
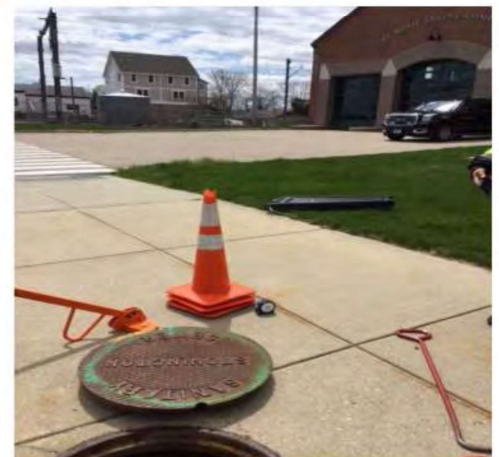
GIS MH No: 1-6

Location in MH	Mtrl. Code	Infil. Code	Cond. Code	Repair Codes	Comments
Frame/Cover	CAST IRON	NONE	SOUND	NONE	
Chimney	BRICK	STAINS	DEFECTIVE	REBUILD TOP, REPLACE FRAME AND CHIMNEY	
Cone	OTHER (DESCRIBE IN DETAILS)	NONE	SOUND	NONE	NO CONE.
Wall	CONCRETE (PRECAST)	STAINS	SOUND	NONE	
Bench	BRICK	NONE	SOUND	NONE	
Invert/Channel	BRICK	NONE	SOUND	NONE

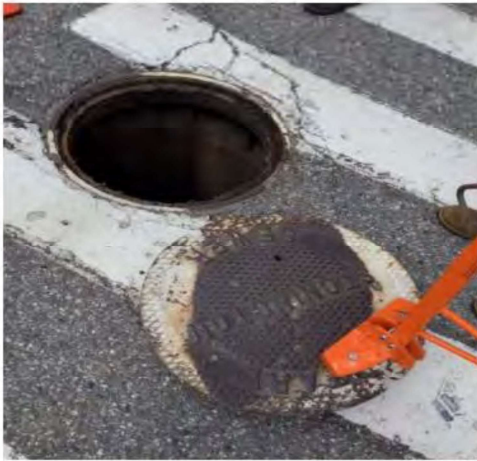
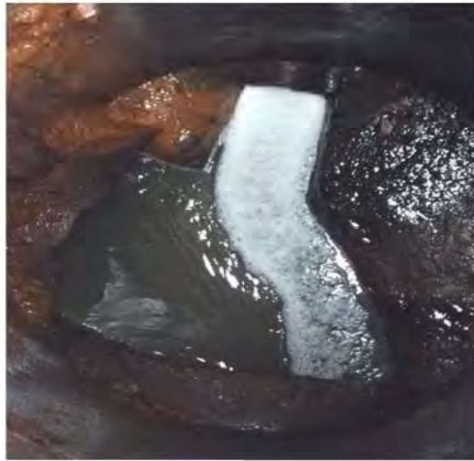
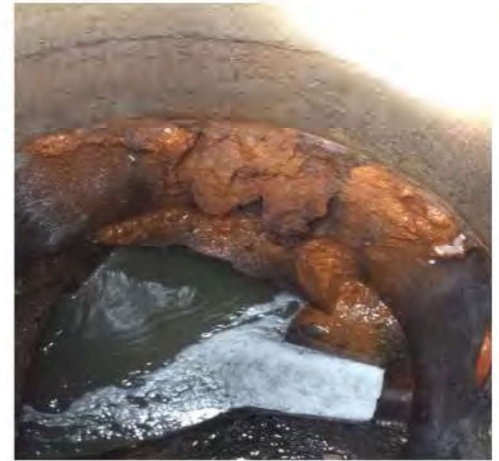
GIS MH No: 1-8

Location in MH	Mtrl. Code	Infil. Code	Cond. Code	Repair Codes	Comments
Frame/Cover	CAST IRON	NONE	BROKEN	REPLACE FRAME AND COVER	
Chimney	CONCRETE BLOCK	NONE	SOUND	NONE	
Cone	OTHER (DESCRIBE IN DETAILS)	NONE	SOUND	OTHER	NO CONE.
Wall	CONCRETE (PRECAST)	RUNNER	DEFECTIVE	LINE_MANHOLE	SEDIMENT ALSO ON WALL AROUND NINE O CLOCK PIPE. RUNNER AROUND 2 O CLOCK.
Bench	BRICK	NONE	SOUND	NONE	
Invert/Channel	BRICK	NONE	SOUND	NONE

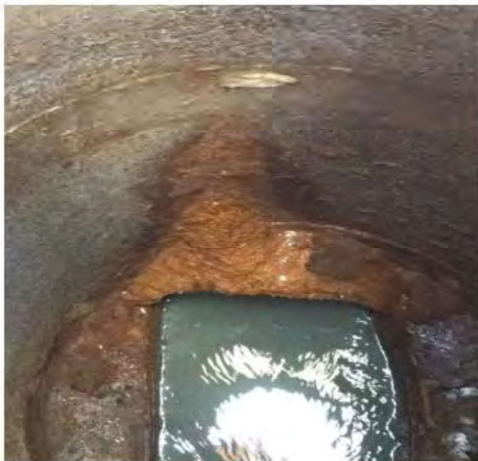
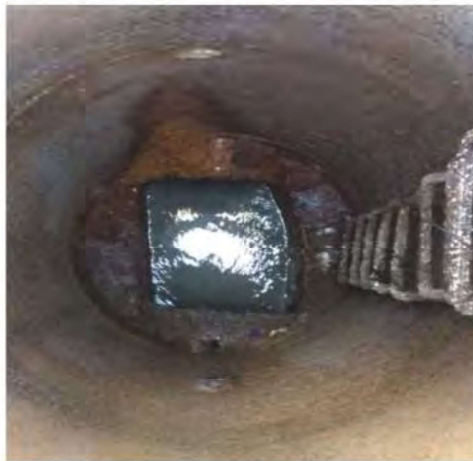
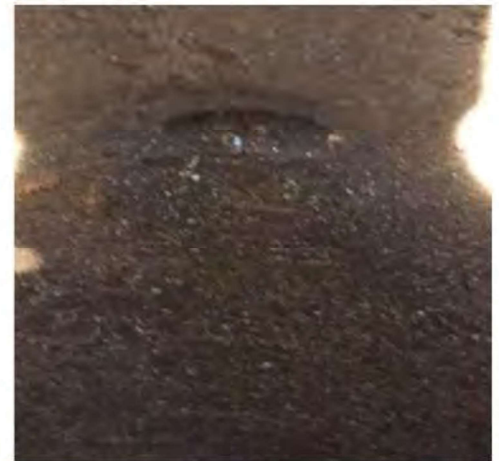
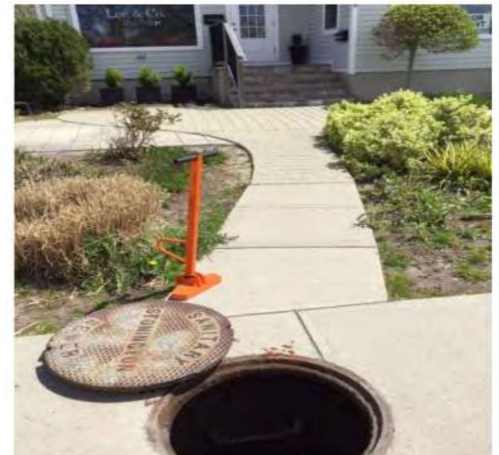
GIS MH No: 1-9

Location in MH	Mtrl. Code	Infil. Code	Cond. Code	Repair Codes	Comments
Frame/Cover	CAST IRON	NONE	SOUND	NONE	
Chimney	BRICK	NONE	DEFECTIVE	LINE MANHOLE	
Cone	OTHER (DESCRIBE IN DETAILS)	NONE	NOT KNOWN	NONE	
Wall	CONCRETE (PRECAST)	WEEPER	DEFECTIVE	LINE_MANHOLE	WEEPER WHERE HOLE FOR CARING WAS. MINERALS AND INFILTRATION ABOVE 12 O'CLOCK PIPE.
Bench	BRICK	NONE	SOUND	NONE	
Invert/Channel	BRICK	NONE	SOUND	NONE

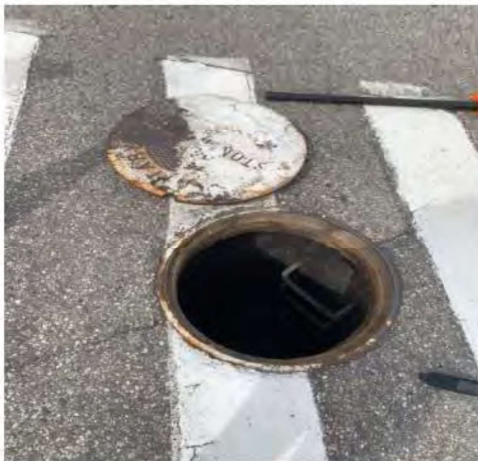
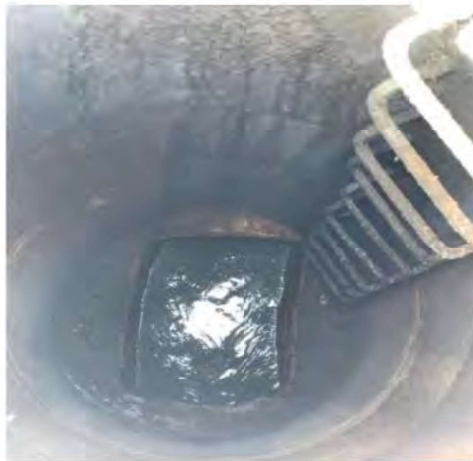
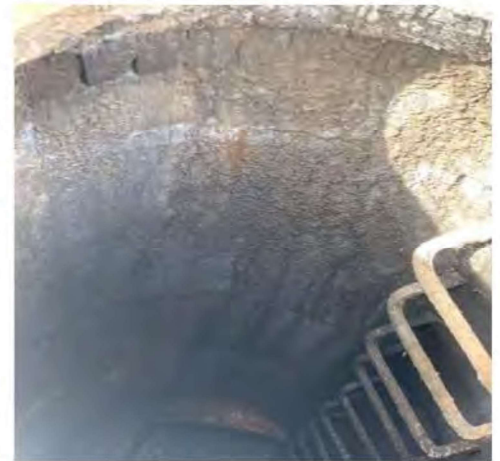
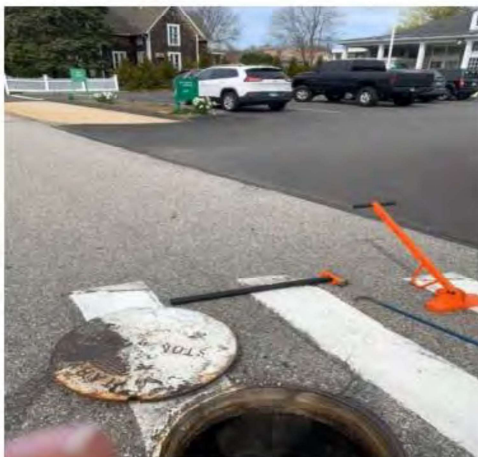
GIS MH No: 1-11

Location in MH	Mtrl. Code	Infil. Code	Cond. Code	Repair Codes	Comments
Frame/Cover	CAST IRON	STAINS	SOUND	REPLACE FRAME AND COVER	
Chimney	BRICK	NONE	SOUND	NONE	
Cone	OTHER (DESCRIBE IN DETAILS)	NONE	SOUND	NONE	NO CONE
Wall	CONCRETE (PRECAST)	NONE	SOUND	NONE	
Bench	BRICK	NONE	SOUND	NONE	
Invert/Channel	BRICK	NONE	SOUND	NONE

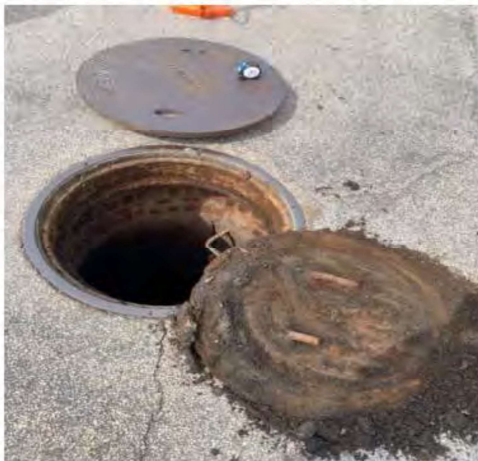
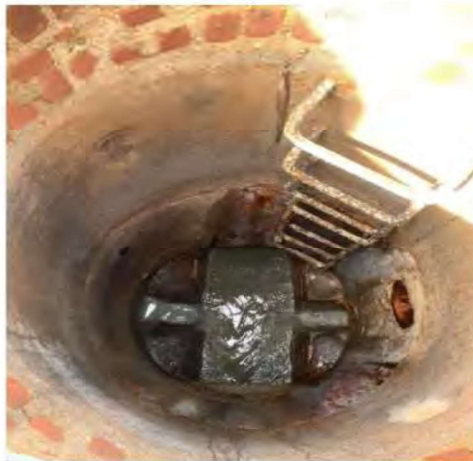
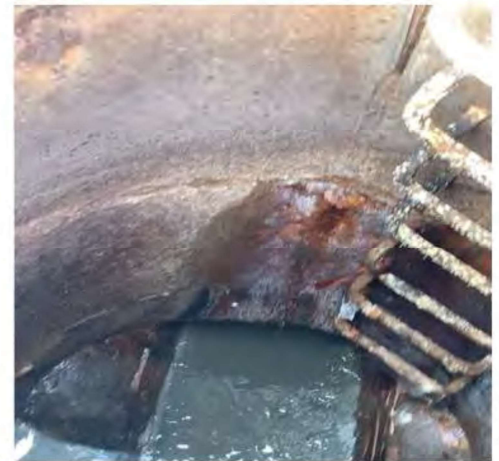
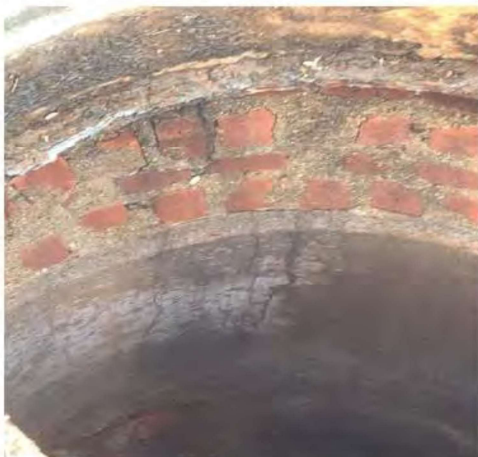
GIS MH No: 1-12

Location in MH	Mtrl. Code	Infil. Code	Cond. Code	Repair Codes	Comments
Frame/Cover	CAST IRON	NONE	SOUND	NONE	
Chimney	BRICK	STAINS	DEFECTIVE	LINE MANHOLE	
Cone	OTHER (DESCRIBE IN DETAILS)	NONE	SOUND	NONE	NO CONE
Wall	CONCRETE (PRECAST)	STAINS	DEFECTIVE	LINE_MANHOLE	
Bench	BRICK	NONE	SOUND	NONE	
Invert/Channel	BRICK	NONE	SOUND	NONE

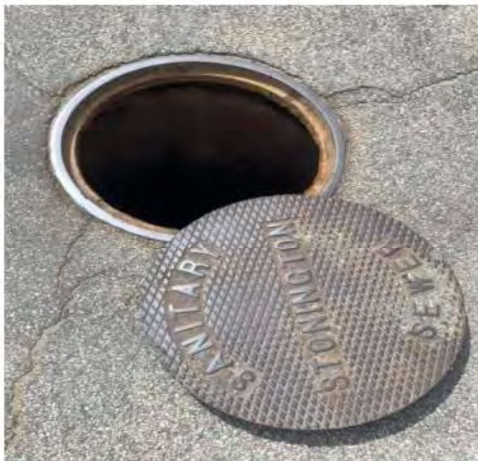
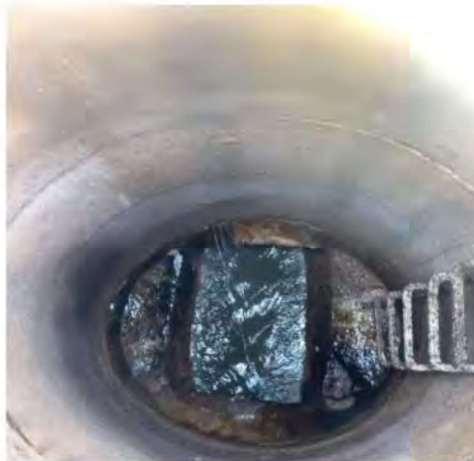
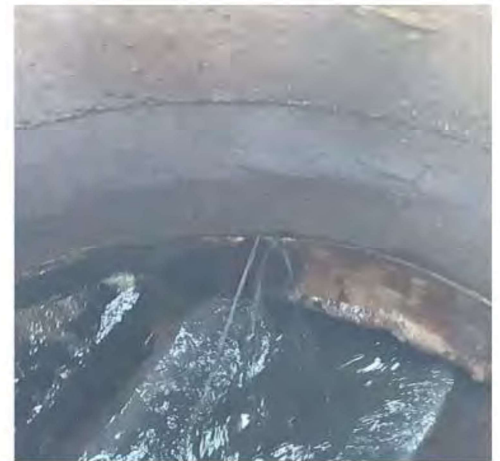
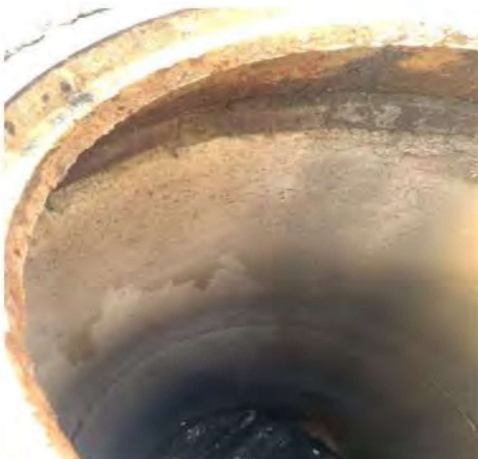
Location in MH	Mtrl. Code	Infil. Code	Cond. Code	Repair Codes	Comments
Frame/Cover	CAST IRON	NONE	SOUND	NONE	
Chimney	BRICK	STAINS	DEFECTIVE	LINE MANHOLE	
Cone	NOT KNOWN	NONE	SOUND	NONE	NO CONE
Wall	CONCRETE (PRECAST)	GUSHER	DEFECTIVE	LINE_MANHOLE	
Bench	BRICK	NONE	SOUND	NONE	
Invert/Channel	BRICK	NONE	SOUND	NONE

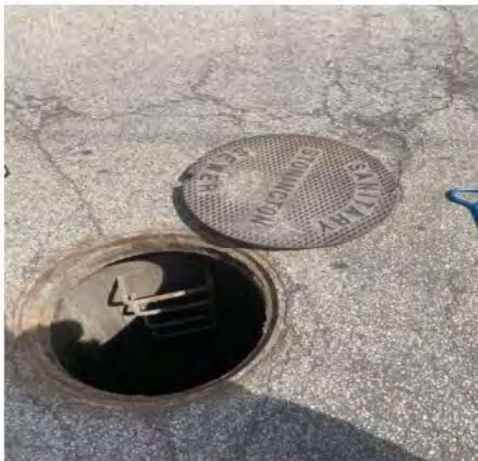
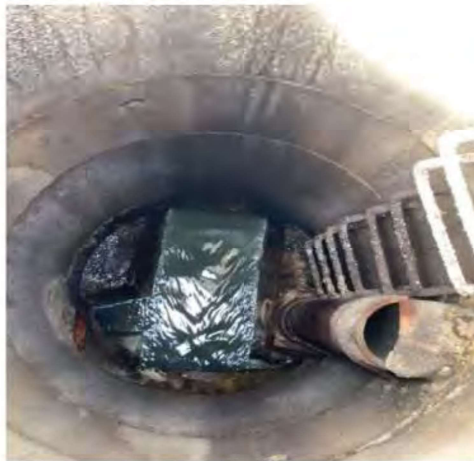
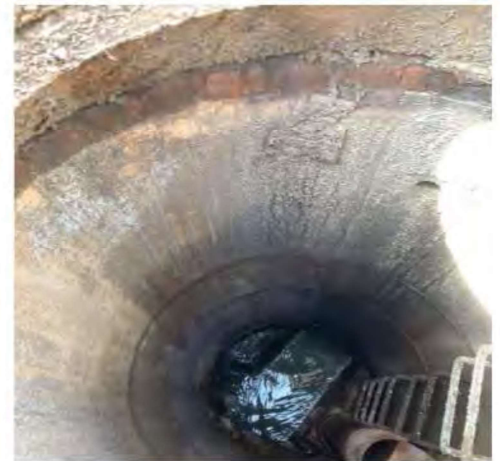
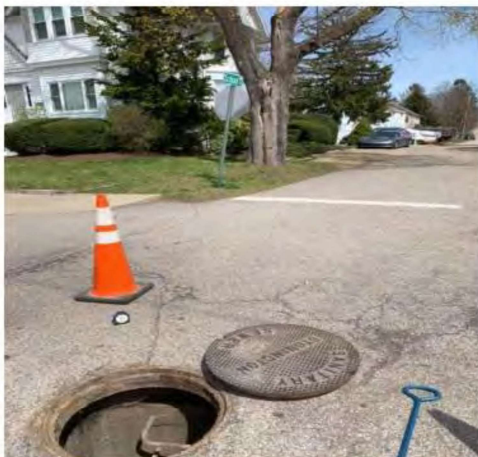
Location in MH	Mtrl. Code	Infil. Code	Cond. Code	Repair Codes	Comments
Frame/Cover	CAST IRON	STAINS	CORRODED	LINE MANHOLE	
Chimney	BRICK	NONE	DEFECTIVE	LINE MANHOLE	CORRODED
Cone	OTHER (DESCRIBE IN DETAILS)	NONE	SOUND	NONE	NO CONE
Wall	CONCRETE (PRECAST)	NONE	DEFECTIVE	LINE_MANHOLE	CORRODED
Bench	BRICK	NONE	SOUND	NONE	
Invert/Channel	BRICK	NONE	SOUND	NONE

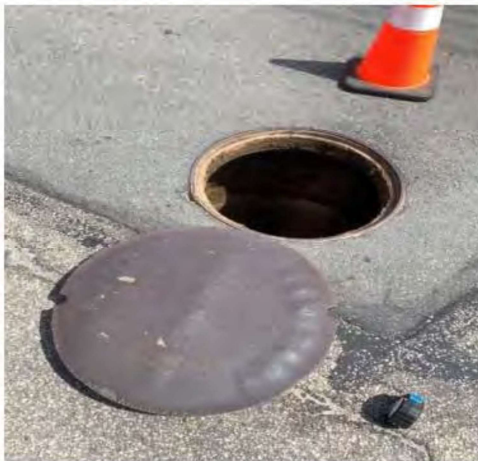
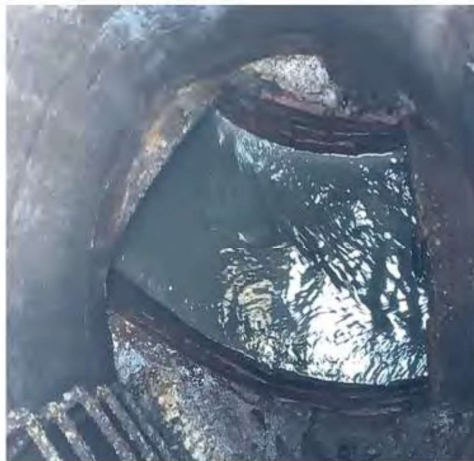
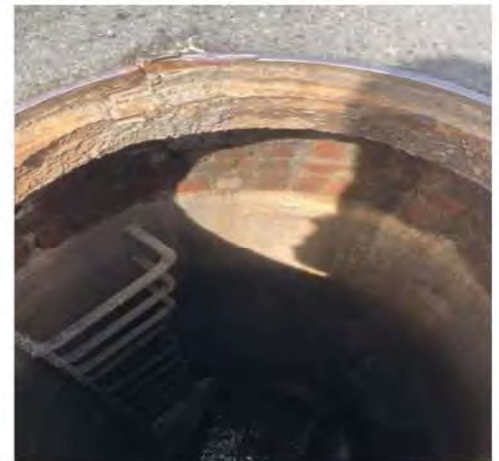
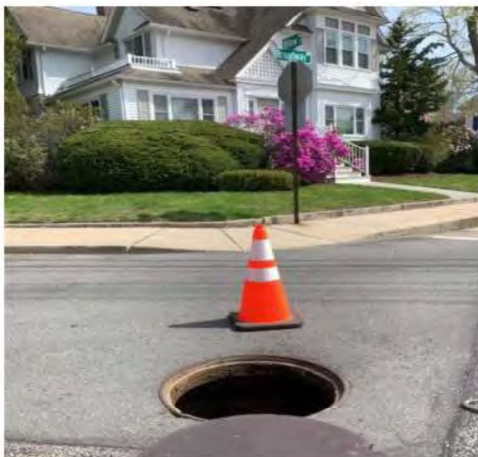
Location in MH	Mtrl. Code	Infil. Code	Cond. Code	Repair Codes	Comments
Frame/Cover	CAST IRON	STAINS	BROKEN	REPLACE FRAME AND COVER	
Chimney	BRICK	NONE	SOUND	NONE	
Cone	NOT KNOWN	NONE	SOUND	NONE	
Wall	CONCRETE (PRECAST)	NONE	SOUND	NONE	
Bench	BRICK	NONE	SOUND	NONE	
Invert/Channel	BRICK	NONE	SOUND	NONE

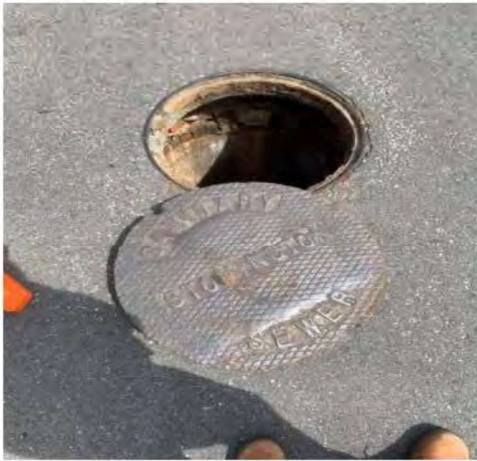
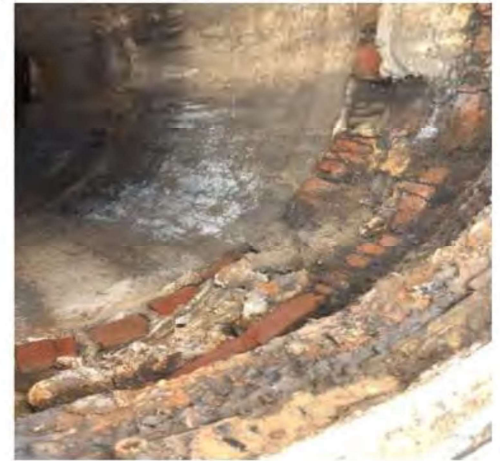
Location in MH	Mtrl. Code	Infil. Code	Cond. Code	Repair Codes	Comments
Frame/Cover	CAST IRON	STAINS	SOUND	REPLACE FRAME AND COVER	
Chimney	BRICK	NONE	DEFECTIVE	RESET EXISTING FRAME AND CHIMNEY	
Cone	OTHER (DESCRIBE IN DETAILS)	NONE	SOUND	NONE	NO CONE
Wall	CONCRETE (PRECAST)	NONE	SOUND	NONE	
Bench	BRICK	NONE	SOUND	NONE	
Invert/Channel	BRICK	NONE	SOUND	NONE

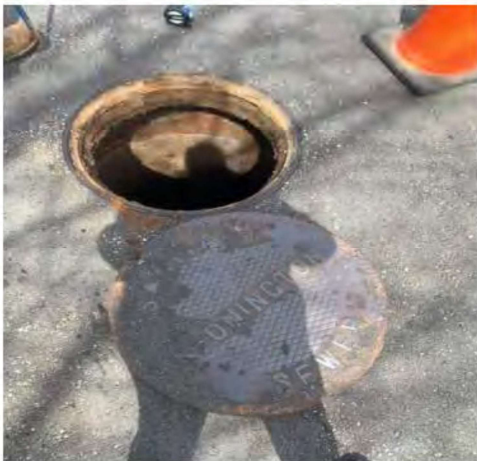
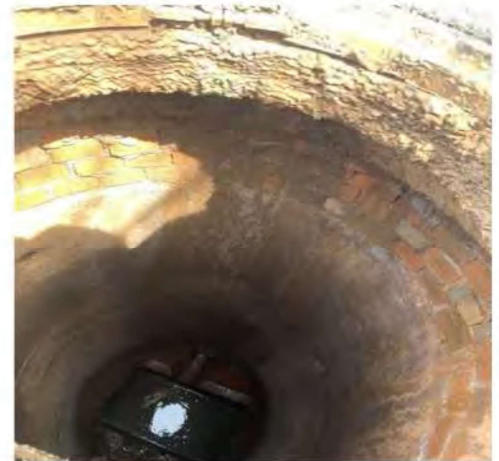
Location in MH	Mtrl. Code	Infil. Code	Cond. Code	Repair Codes	Comments
Frame/Cover	CAST IRON	STAINS	BROKEN	REPLACE FRAME AND COVER	
Chimney	BRICK	NONE	SOUND	NONE	
Cone	NOT KNOWN	NONE	SOUND	NONE	NO CONE
Wall	CONCRETE (PRECAST)	NONE	SOUND	NONE	
Bench	BRICK	NONE	SOUND	NONE	
Invert/Channel	BRICK	NONE	SOUND	NONE

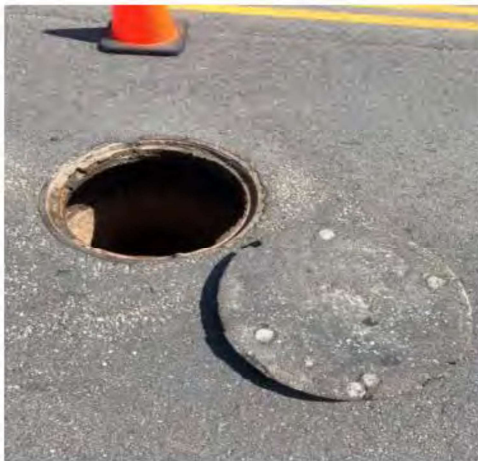
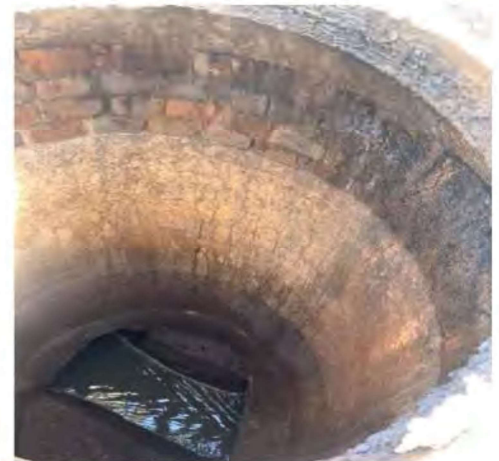
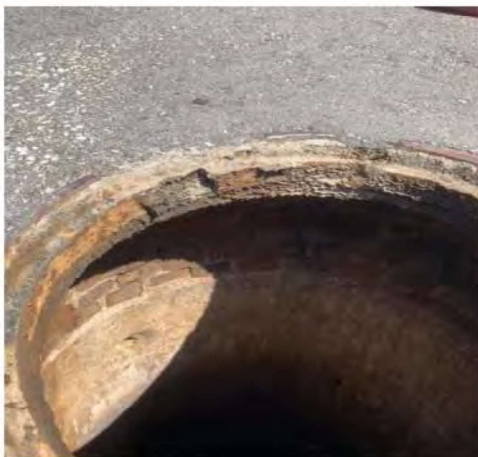
Location in MH	Mtrl. Code	Infil. Code	Cond. Code	Repair Codes	Comments
Frame/Cover	CAST IRON	NONE	BROKEN	REPLACE FRAME AND COVER	
Chimney	BRICK	STAINS	SOUND	LINE MANHOLE	
Cone	OTHER (DESCRIBE IN DETAILS)	NONE	SOUND	NONE	NO CONE
Wall	CONCRETE (PRECAST)	STAINS	SOUND	LINE_MANHOLE	
Bench	BRICK	NONE	SOUND	NONE	
Invert/Channel	BRICK	NONE	SOUND	NONE
