CDM
Smith

Town of Stonington, Connecticut

Manhole Inspection Form

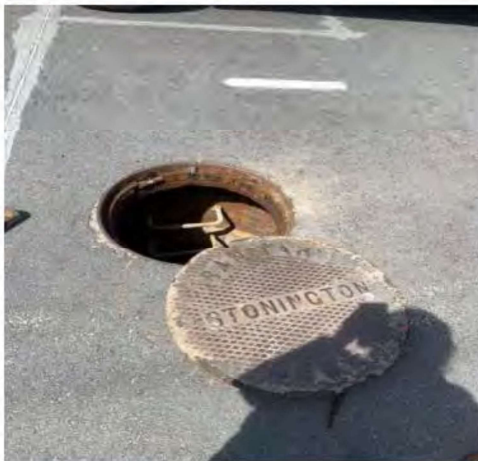
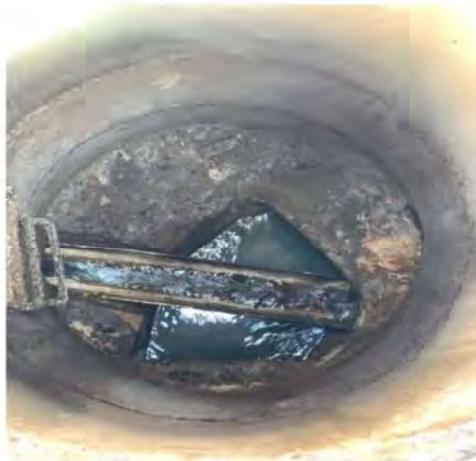
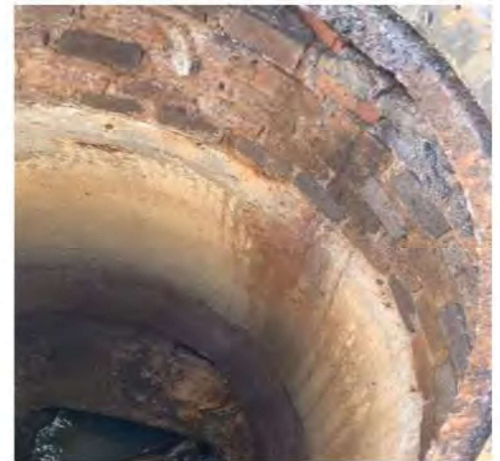
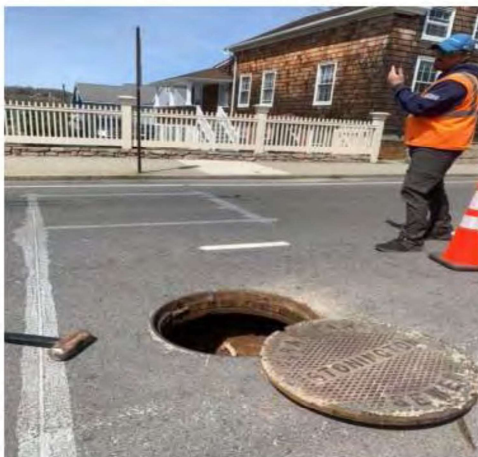
GIS MH No: 1-23

Location in MH	Mtrl. Code	Infil. Code	Cond. Code	Repair Codes	Comments
Frame/Cover	CAST IRON	NONE	SOUND	NONE	
Chimney	BRICK	WEEPER	DEFECTIVE	LINE MANHOLE	
Cone	OTHER (DESCRIBE IN DETAILS)	NONE	SOUND	NONE	NO CONE
Wall	CONCRETE (PRECAST)	NONE	SOUND	NONE	
Bench	BRICK	NONE	SOUND	NONE	
Invert/Channel	BRICK	NONE	SOUND	NONE

Pipe	Direction	Rim to Invert	Pipe Dia. (in)	Pipe Mtrl. Code	Clock Position*	Comments
Pipe 1	OUT	10.5	24	REINFORCED CONCRETE PIPE	06:00	
Pipe 2		10	6	REINFORCED CONCRETE PIPE	08:00	PIPE GOES FROM 08:00 TO 05:00 THROUGH MANHOLE. DOES NOT DROP INTO MANHOLE, PIPE FLOW
Pipe 3	IN	10.5	24	REINFORCED CONCRETE PIPE	02:00	
Pipe 4						
Pipe 5

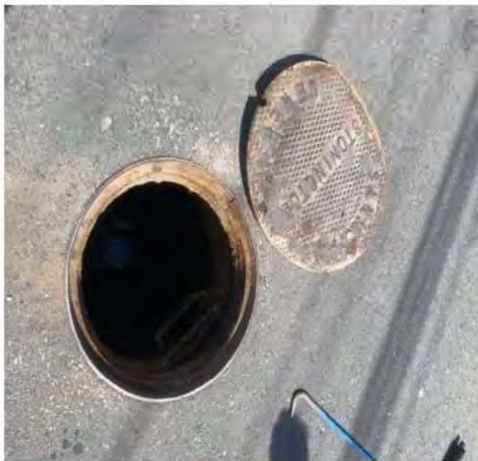
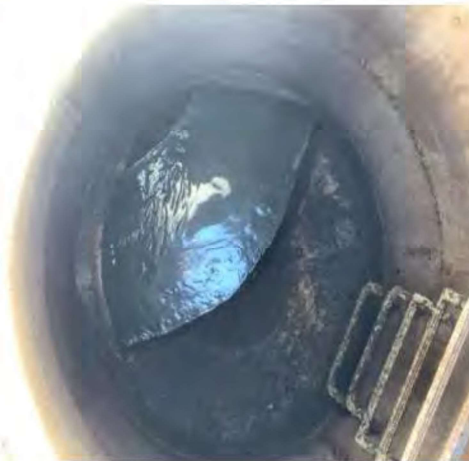
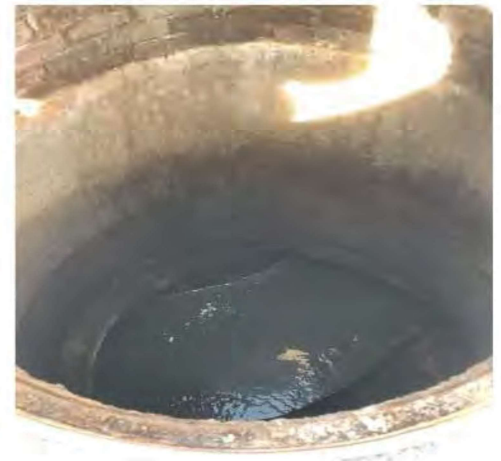
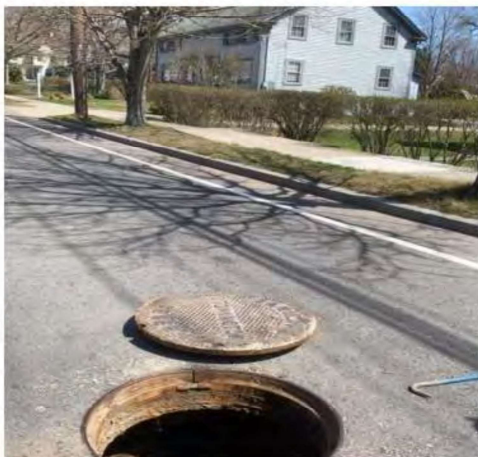
GIS MH No: 1-23A

Location in MH	Mtrl. Code	Infil. Code	Cond. Code	Repair Codes	Comments
Frame/Cover	CAST IRON	NONE	SOUND	REPLACE FRAME AND COVER	REPLACE COVER
Chimney	BRICK	STAINS	SOUND	NONE	
Cone	OTHER (DESCRIBE IN DETAILS)	NONE	SOUND	NONE	NO CONE.
Wall	CONCRETE (PRECAST)	NONE	SOUND	NONE	
Bench	BRICK	NONE	SOUND	NONE	
Invert/Channel	BRICK	NONE	SOUND	NONE

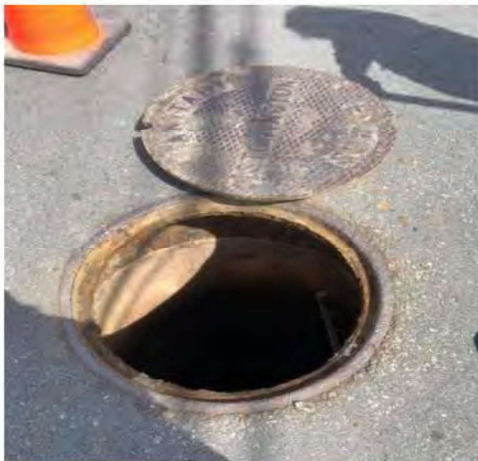
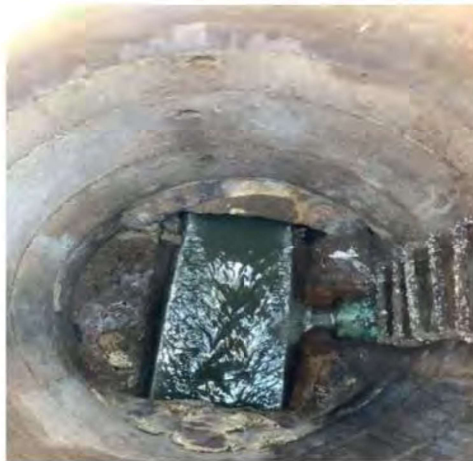
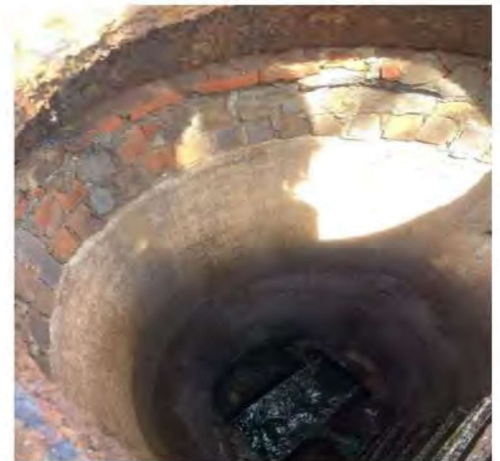
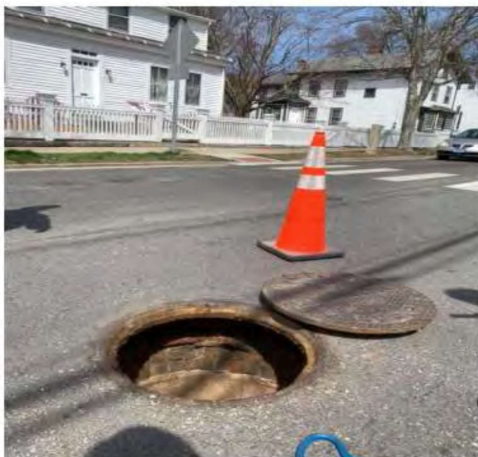
GIS MH No: 1-24

Location in MH	Mtrl. Code	Infil. Code	Cond. Code	Repair Codes	Comments
Frame/Cover	CAST IRON	NONE	SOUND	NONE	
Chimney	BRICK	WEEPER	DEFECTIVE	LINE MANHOLE	
Cone	NOT KNOWN	NONE	SOUND	NONE	NO CONE
Wall	CONCRETE (PRECAST)	NONE	SOUND	NONE	
Bench	BRICK	STAINS	SOUND	NONE	
Invert/Channel	BRICK	NONE	SOUND	NONE

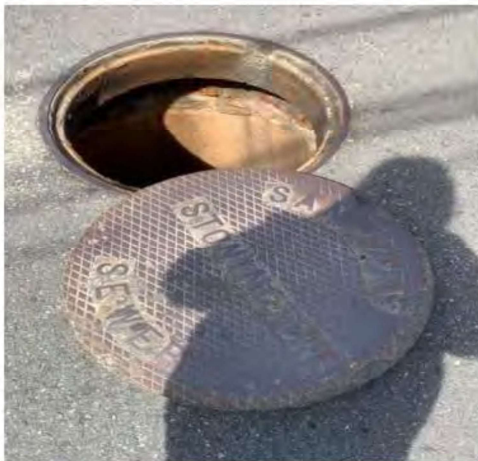
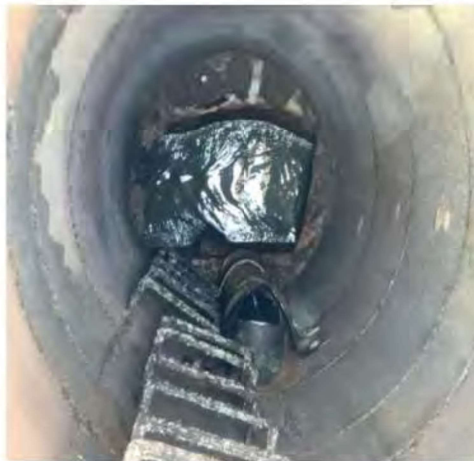
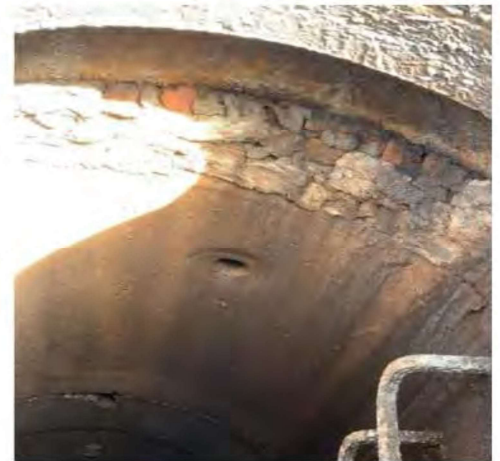
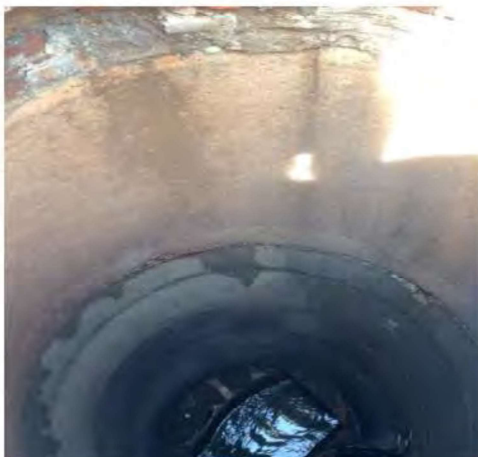
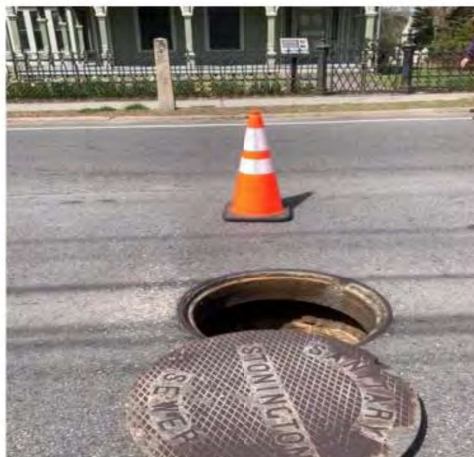
GIS MH No: 1-25

Location in MH	Mtrl. Code	Infil. Code	Cond. Code	Repair Codes	Comments
Frame/Cover	CAST IRON	NONE	SOUND	NONE	
Chimney	BRICK	STAINS	DEFECTIVE	LINE MANHOLE	
Cone	OTHER (DESCRIBE IN DETAILS)	NONE	SOUND	NONE	NO CONE
Wall	CONCRETE (PRECAST)	STAINS	DEFECTIVE	LINE_MANHOLE	
Bench	BRICK	NONE	SOUND	NONE	
Invert/Channel	BRICK	NONE	SOUND	NONE

Pipe	Direction	Rim to Invert	Pipe Dia. (in)	Pipe Mtrl. Code	Clock Position*	Comments
Pipe 1	OUT	17	24	REINFORCED CONCRETE PIPE	06:00	
Pipe 2	IN	17	24	REINFORCED CONCRETE PIPE	11:00	
Pipe 3	IN	10.5	6	REINFORCED CONCRETE PIPE	04:00	DROP LINE
Pipe 4						
Pipe 5

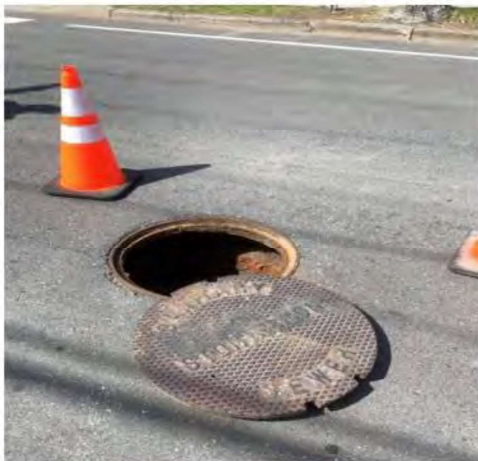
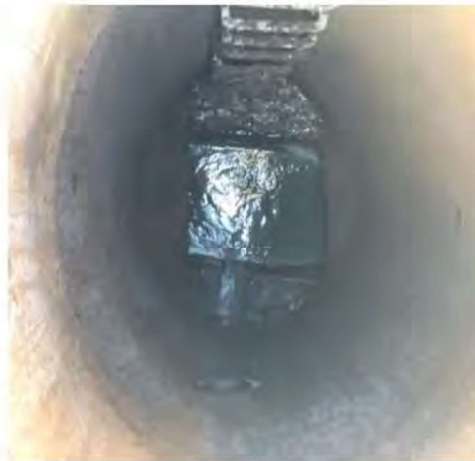
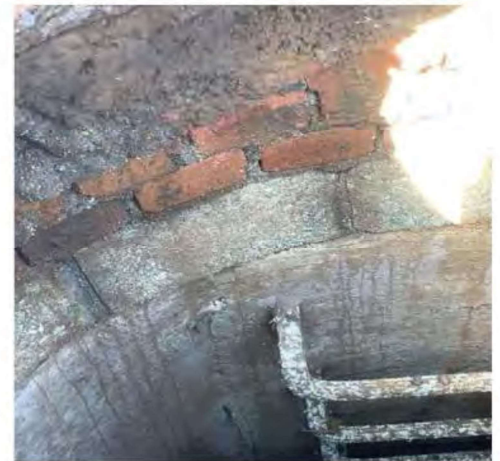
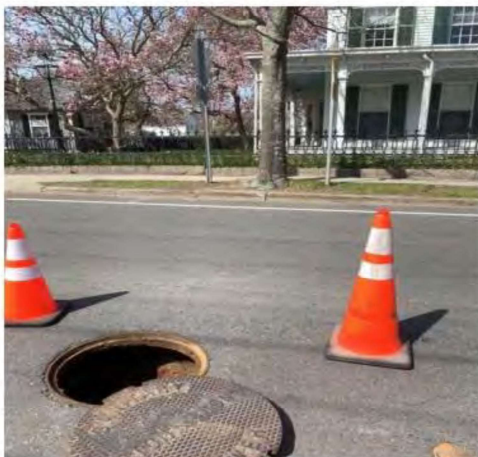
GIS MH No: 1-26

Location in MH	Mtrl. Code	Infil. Code	Cond. Code	Repair Codes	Comments
Frame/Cover	CAST IRON	NONE	SOUND	NONE	
Chimney	BRICK	WEEPER	DEFECTIVE	LINE MANHOLE	BRICK AND CONCRETE BLOCK. INFILTRATION RIGHT BELOW
Cone	OTHER (DESCRIBE IN DETAILS)	NONE	SOUND	NONE	CONCRETE BLOCKS NO CONE
Wall	CONCRETE (PRECAST)	NONE	SOUND	NONE	
Bench	BRICK	NONE	SOUND	NONE	
Invert/Channel	BRICK	NONE	SOUND	NONE

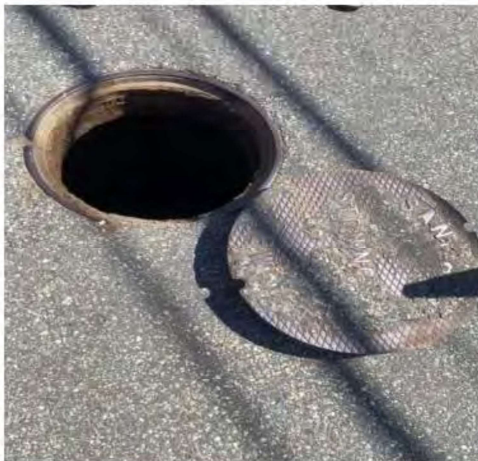
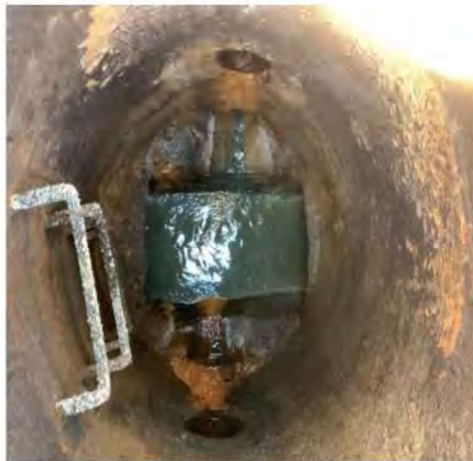
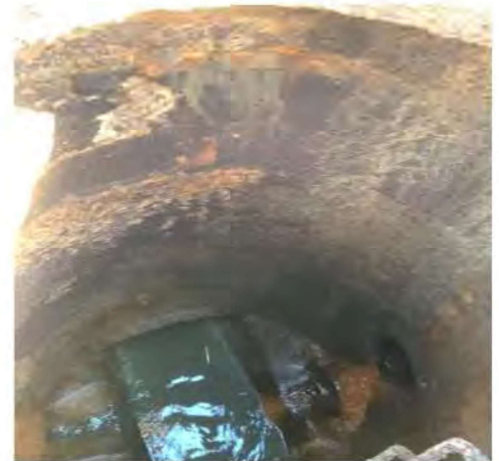
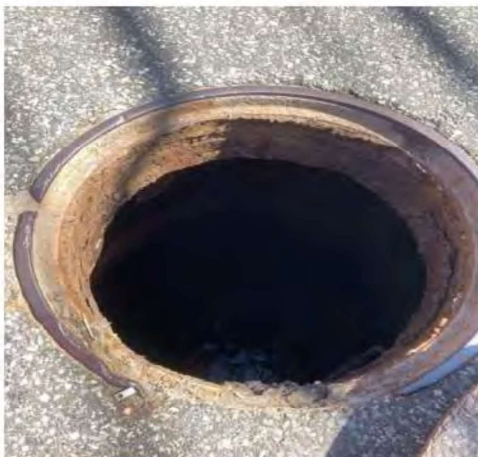
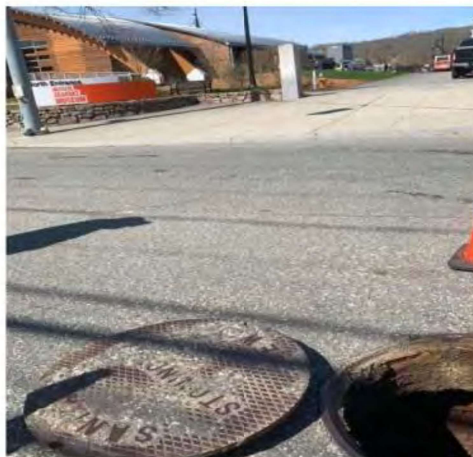
GIS MH No: 1-28

Location in MH	Mtrl. Code	Infil. Code	Cond. Code	Repair Codes	Comments
Frame/Cover	CAST IRON	NONE	BROKEN	REPLACE FRAME AND COVER	
Chimney	BRICK	NONE	DEFECTIVE	LINE MANHOLE	CORROSION
Cone	OTHER (DESCRIBE IN DETAILS)	NONE	SOUND	NONE	NO CONE
Wall	CONCRETE (PRECAST)	NONE	DEFECTIVE	LINE_MANHOLE	CORROSION
Bench	BRICK	NONE	SOUND	NONE	
Invert/Channel	BRICK	NONE	SOUND	NONE

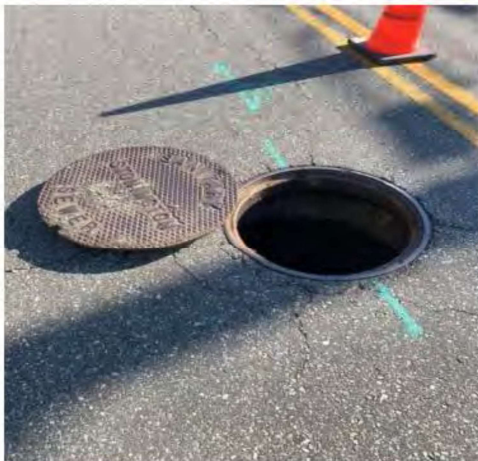
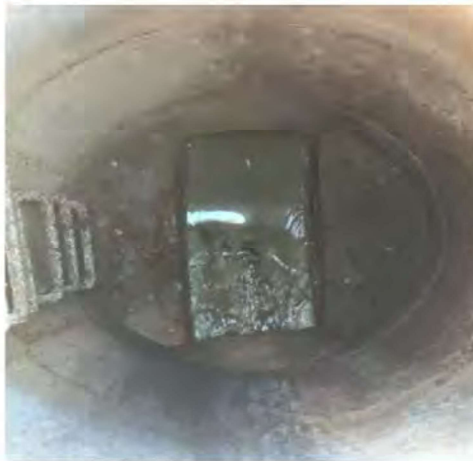
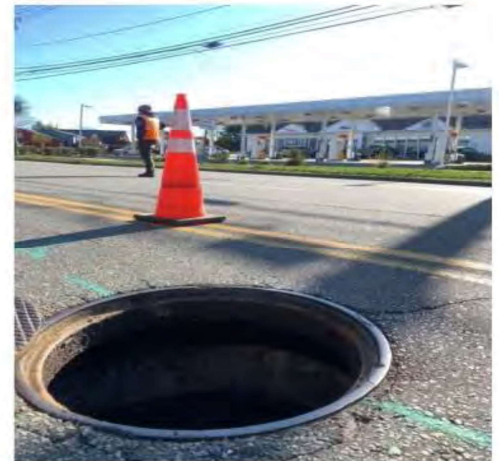
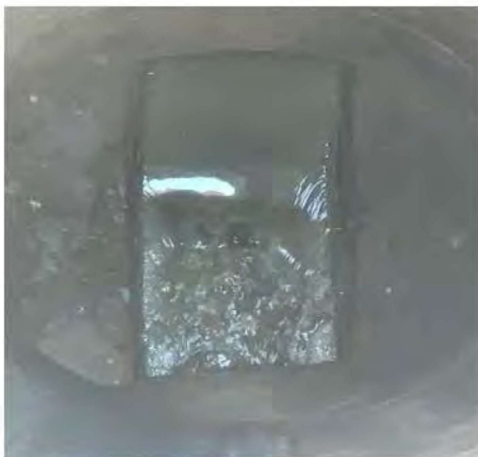
Location in MH	Mtrl. Code	Infil. Code	Cond. Code	Repair Codes	Comments
Frame/Cover	CAST IRON	NONE	SOUND	NONE	
Chimney	CONCRETE BLOCK	NONE	SOUND	NONE	CONCRETE BLOCK AND BRICK
Cone	CONCRETE (PRECAST)	NONE	SOUND	NONE,SEAL_REPOINT	NO CONE
Wall	CONCRETE (PRECAST)	NONE	SOUND	NONE	
Bench	BRICK	NONE	SOUND	NONE	
Invert/Channel	BRICK	NONE	DEFECTIVE	CLEAN	DEBRIS IN CHANNEL

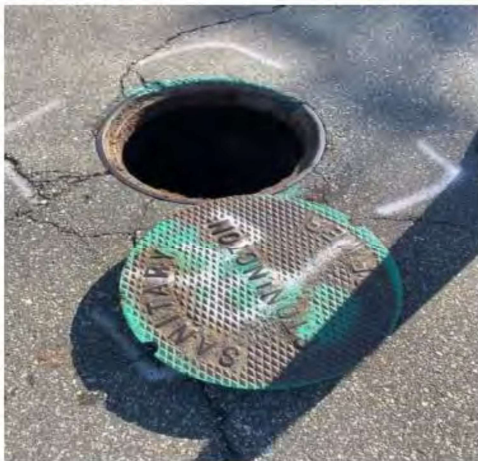
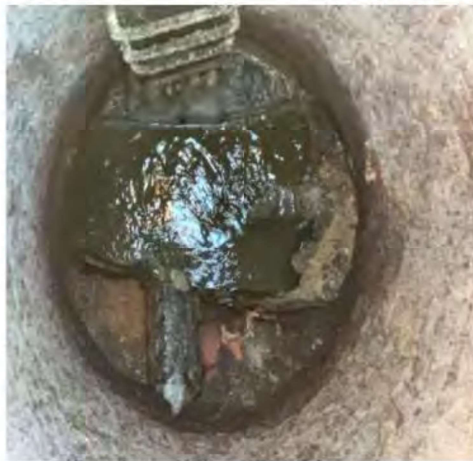
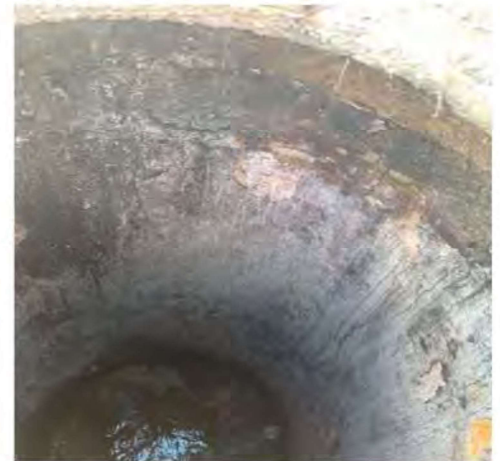
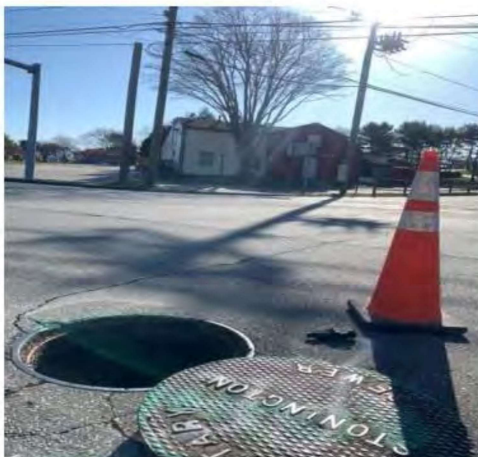
Location in MH	Mtrl. Code	Infil. Code	Cond. Code	Repair Codes	Comments
Frame/Cover	CAST IRON	NONE	BROKEN	REBUILD TOP, REPLACE FRAME AND CHIMNEY	
Chimney	BRICK	NONE	SOUND	NONE	
Cone	CONCRETE (PRECAST)	NONE	SOUND	NONE	NO CONE
Wall	CONCRETE (PRECAST)	NONE	DEFECTIVE	LINE_MANHOLE	CORROSION
Bench	BRICK	NONE	SOUND	NONE	
Invert/Channel	BRICK	NONE	SOUND	NONE

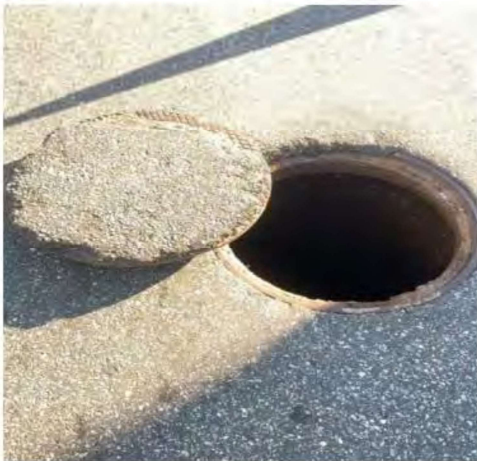
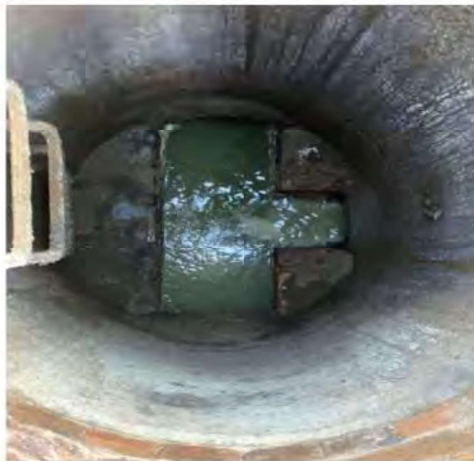
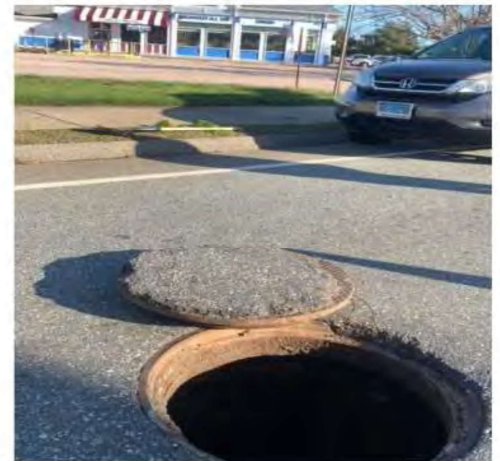
Location in MH	Mtrl. Code	Infil. Code	Cond. Code	Repair Codes	Comments
Frame/Cover	CAST IRON	NONE	SOUND	REPLACE FRAME AND COVER	COVER IS CHIPPED A LITTLE, COVERED IN PAVEMENT. NEEDS TO BE REPLACED.
Chimney	BRICK	NONE	SOUND	NONE	
Cone	OTHER (DESCRIBE IN DETAILS)	NONE	SOUND	NONE	NO CONE
Wall	CONCRETE (PRECAST)	NONE	SOUND	NONE	
Bench	BRICK	NONE	SOUND	NONE	
Invert/Channel	BRICK	NONE	SOUND	NONE
