Manhole Inspection Form

Town of Stonington, Connecticut

CDM
Smith

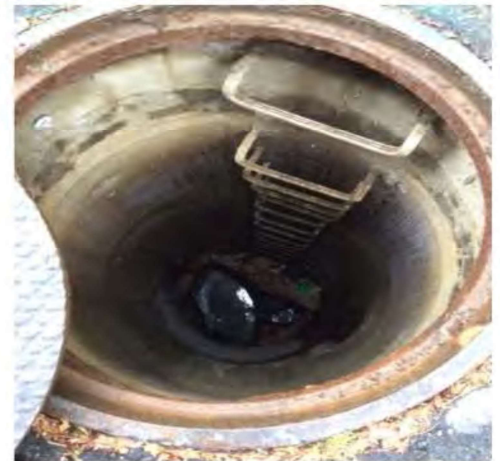
Location in MH	Mtrl. Code	Infil. Code	Cond. Code	Repair Codes	Comments
Frame/Cover	CAST IRON	NONE	SOUND	NONE	
Chimney	BRICK	NONE	SOUND	NONE	BRICK AND CONCRETE BLOCK
Cone	CONCRETE (PRECAST)	NONE	SOUND	NONE	
Wall	CONCRETE (PRECAST)	WEEPER	DEFECTIVE	LINE_MANHOLE	
Bench	BRICK	NONE	SOUND	NONE	
Invert/Channel	BRICK	NONE	SOUND	NONE

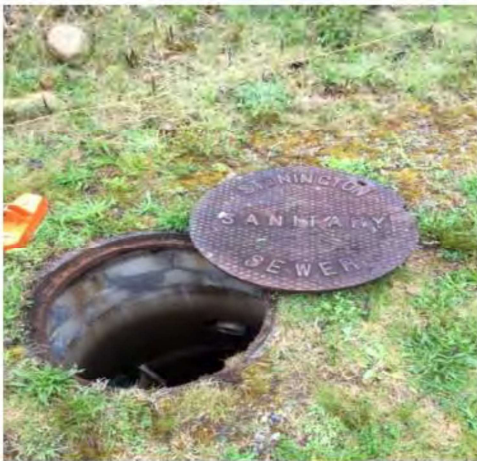
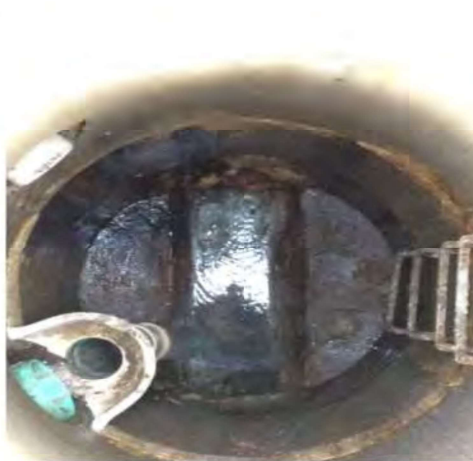
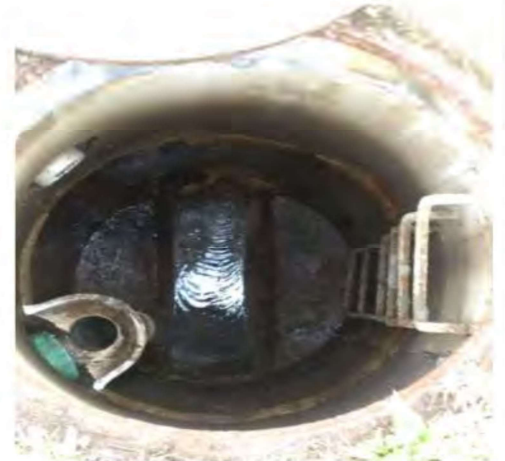
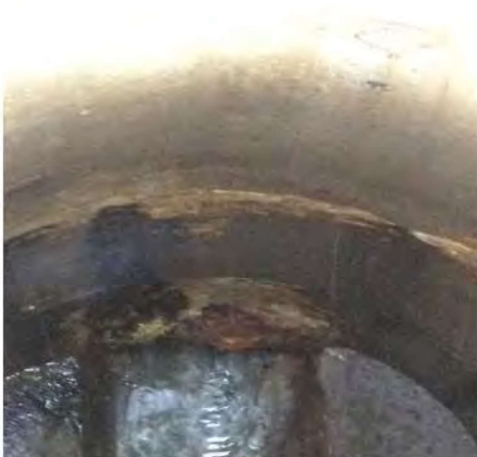
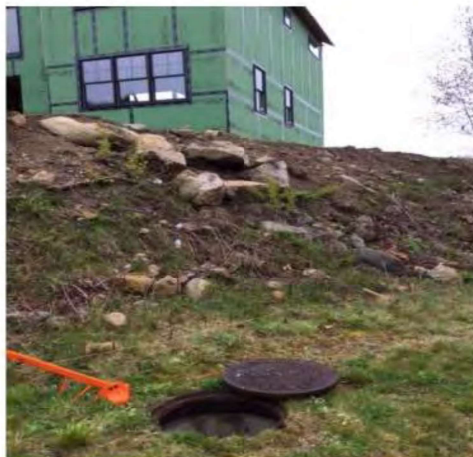
Location in MH	Mtrl. Code	Infil. Code	Cond. Code	Repair Codes	Comments
Frame/Cover	CAST IRON	NONE	SOUND	NONE	
Chimney	CONCRETE BLOCK	NONE	SOUND	NONE	
Cone	CONCRETE (PRECAST)	NONE	SOUND	NONE	
Wall	CONCRETE (PRECAST)	DRIPPER	DEFECTIVE	LINE_MANHOLE	
Bench	BRICK	NONE	SOUND	NONE	
Invert/Channel	BRICK	NONE	SOUND	NONE

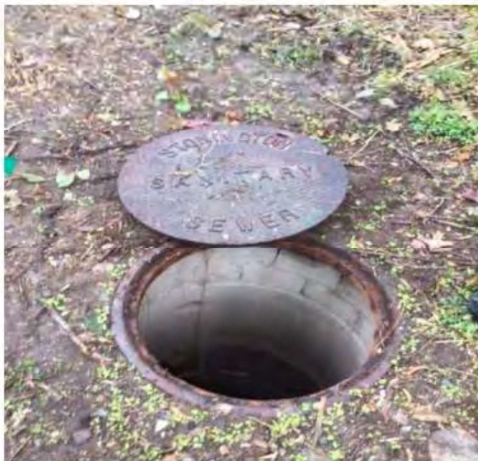
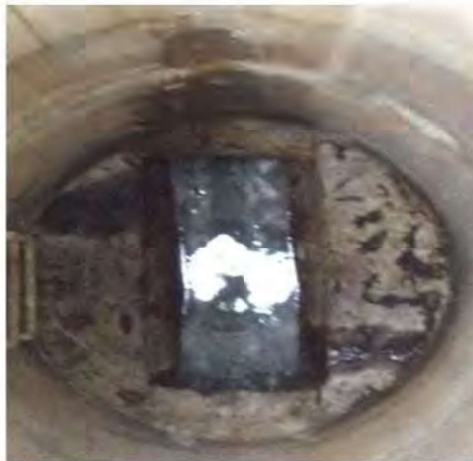
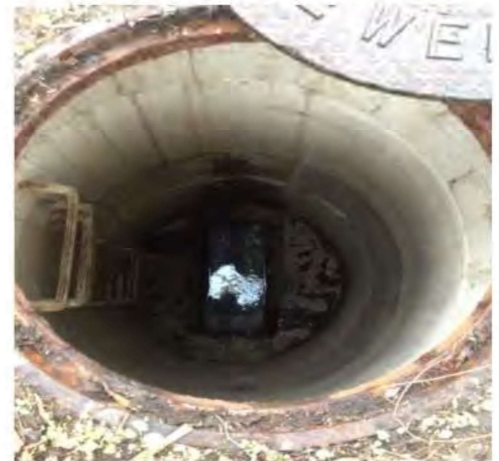
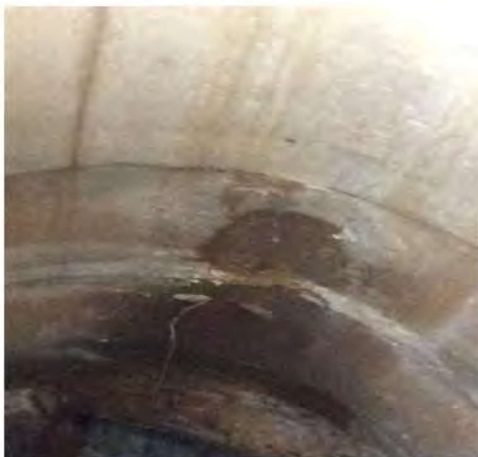
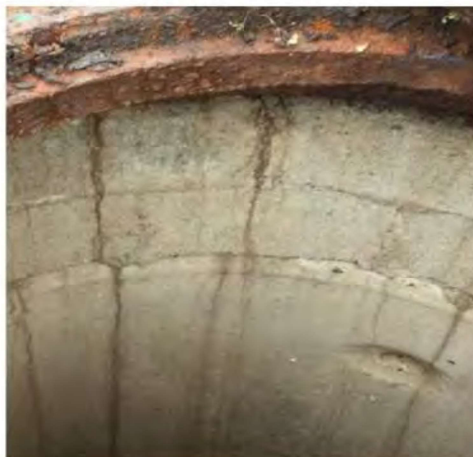
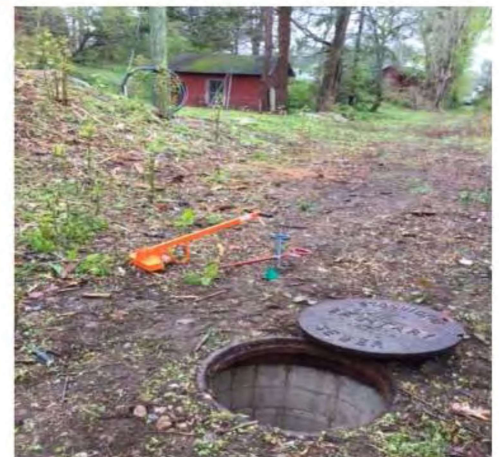
Location in MH	Mtrl. Code	Infil. Code	Cond. Code	Repair Codes	Comments
Frame/Cover	CAST IRON	WEEPER	DEFECTIVE	REPLACE FRAME AND COVER	
Chimney	CONCRETE BLOCK	NONE	SOUND	NONE	
Cone	CONCRETE (PRECAST)	NONE	SOUND	NONE	
Wall	CONCRETE (PRECAST)	STAINS	DEFECTIVE	LINE_MANHOLE, REMOVE ROOT IN WALL	
Bench	BRICK	NONE	SOUND	NONE	
Invert/Channel	BRICK	NONE	SOUND	NONE

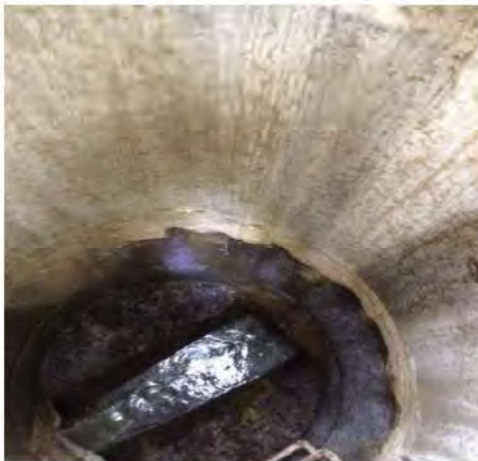
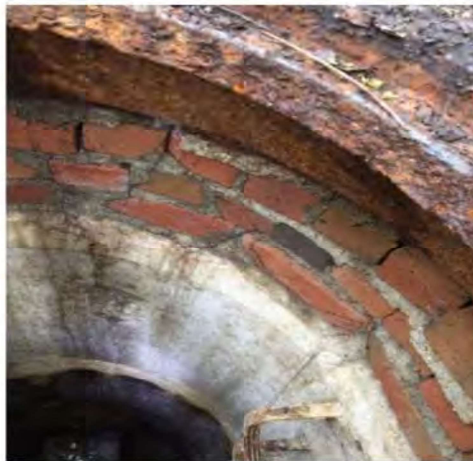
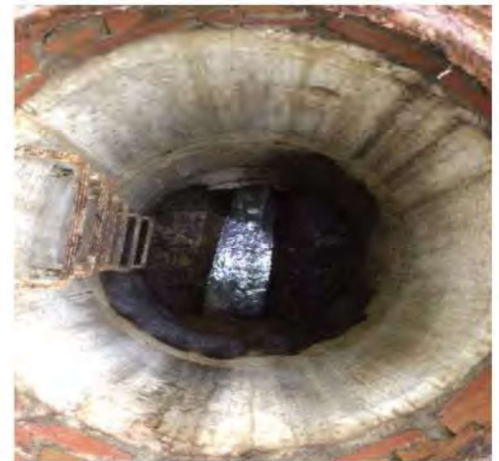
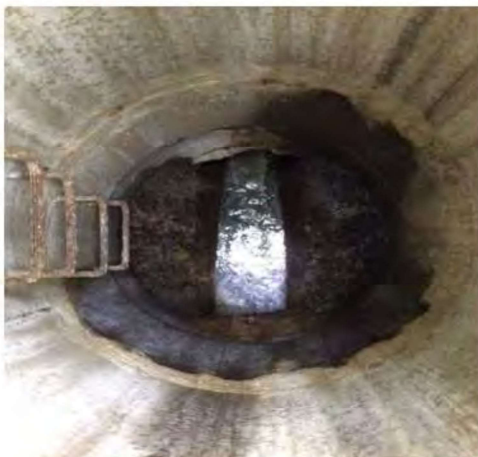
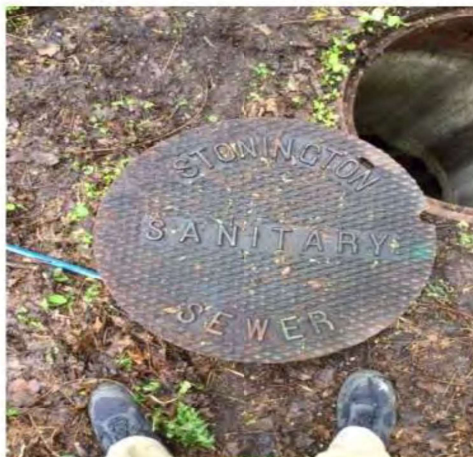
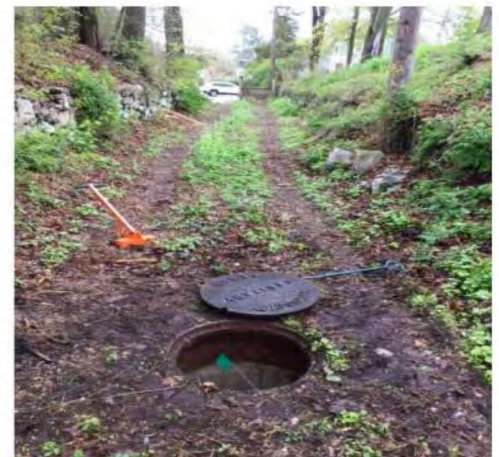
Location in MH	Mtrl. Code	Infil. Code	Cond. Code	Repair Codes	Comments
Frame/Cover	CAST IRON	NONE	SOUND	NONE	
Chimney	BRICK	NONE	DEFECTIVE	LINE MANHOLE AND REMOVE ROOTS	SMALL ROOTS IN CHIMNEY
Cone	CONCRETE (PRECAST)	NONE	SOUND	NONE	
Wall	CONCRETE (PRECAST)	STAINS	DEFECTIVE	LINE_MANHOLE,REMOVE	SMALL ROOTS AND STAINING
Bench	BRICK	NONE	SOUND	NONE	
Invert/Channel	BRICK	NONE	SOUND	NONE

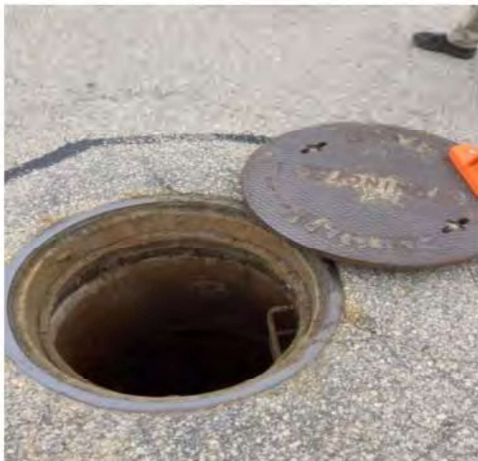
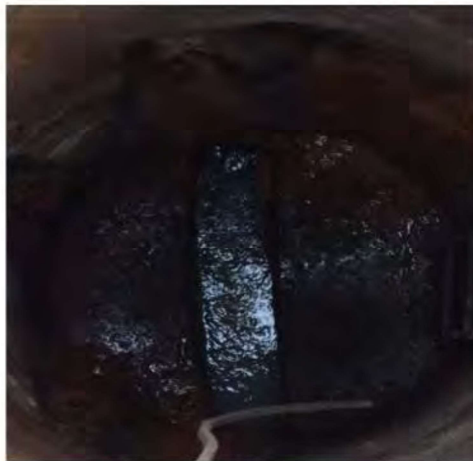
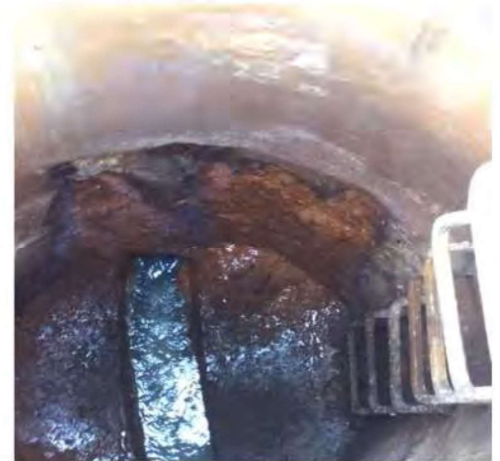
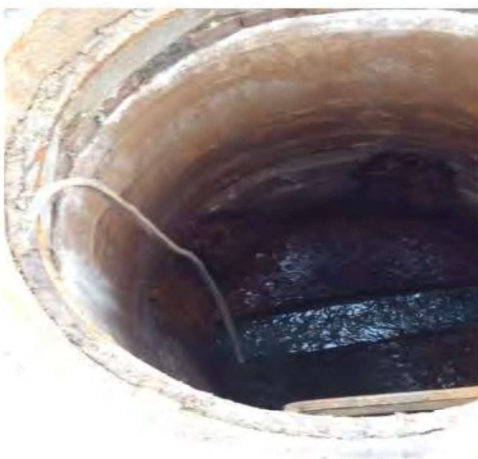
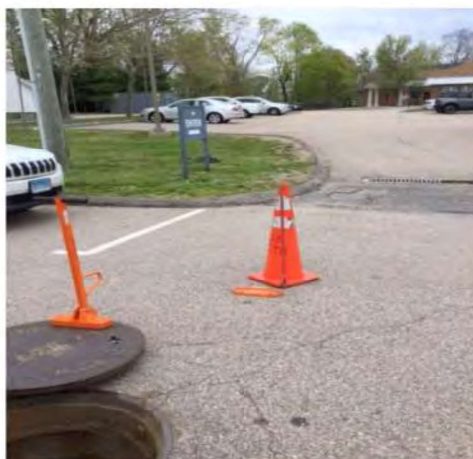
Location in MH	Mtrl. Code	Infil. Code	Cond. Code	Repair Codes	Comments
Frame/Cover	CAST IRON	NONE	BROKEN	REPLACE FRAME AND COVER	COVER DOES NOT HAVE HANDLES
Chimney	BRICK	NONE	SOUND	NONE	BRICK AND CONCRETE BLOCK
Cone	CONCRETE (PRECAST)	NONE	SOUND	NONE	
Wall	CONCRETE (PRECAST)	WEEPER	DEFECTIVE	LINE_MANHOLE	LOTS OF SEDIMENT AS WELL FROM INFILTRATION
Bench	BRICK	NONE	SOUND	NONE	
Invert/Channel	BRICK	NONE	SOUND	NONE

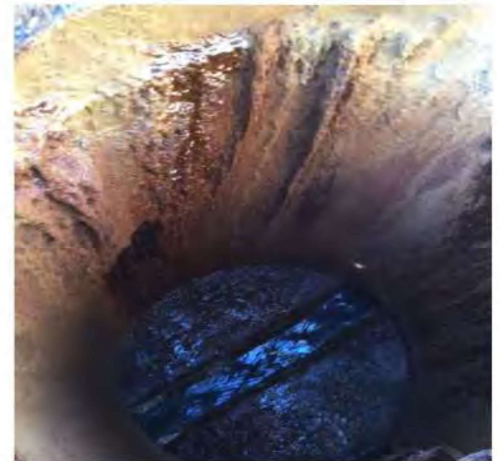
Location in MH	Mtrl. Code	Infil. Code	Cond. Code	Repair Codes	Comments
Frame/Cover	CAST IRON	NONE	SOUND	RESET EXISTING FRAME AND CHIMNEY	
Chimney	CONCRETE BLOCK	NONE	SOUND	NONE	
Cone	CONCRETE (PRECAST)	WEEPER	DEFECTIVE	LINE_MANHOLE	
Wall	CONCRETE (PRECAST)	WEEPER	DEFECTIVE	LINE_MANHOLE	
Bench	BRICK	NONE	SOUND	NONE	
Invert/Channel	BRICK	NONE	SOUND	NONE

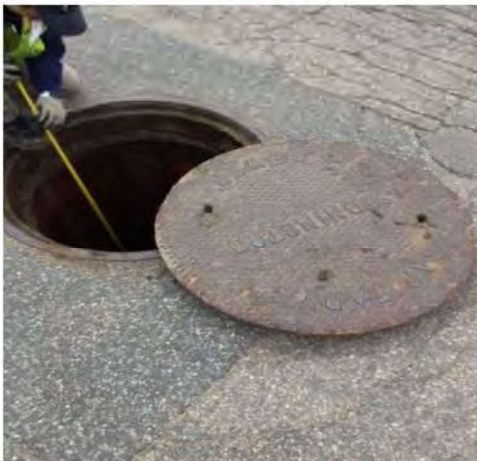
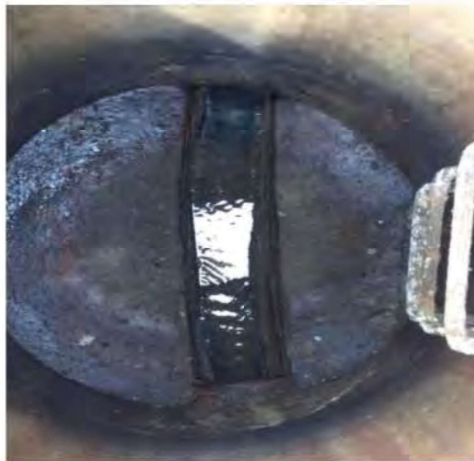
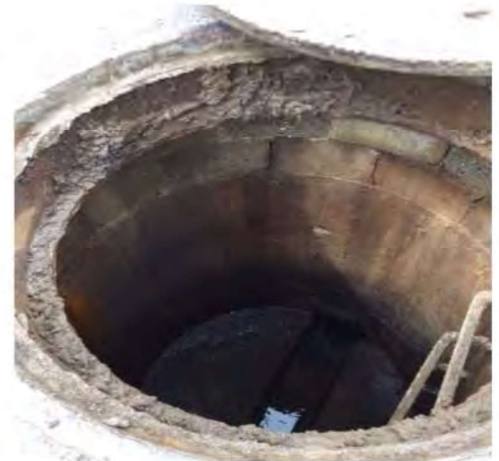
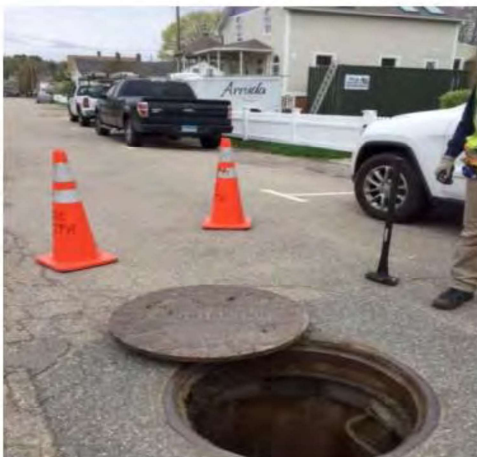
Location in MH	Mtrl. Code	Infil. Code	Cond. Code	Repair Codes	Comments
Frame/Cover	CAST IRON	STAINS	SOUND	REPLACE FRAME AND COVER	NO HANDLES ON COVER, MAY WANT TO REPLACE
Chimney	CONCRETE BLOCK	NONE	SOUND	NONE	
Cone	CONCRETE (PRECAST)	NONE	SOUND	NONE	
Wall	CONCRETE (PRECAST)	NONE	SOUND	NONE	
Bench	BRICK	NONE	SOUND	NONE	
Invert/Channel	BRICK	NONE	SOUND	NONE
