CDM
Smith

Town of Stonington, Connecticut

Manhole Inspection Form

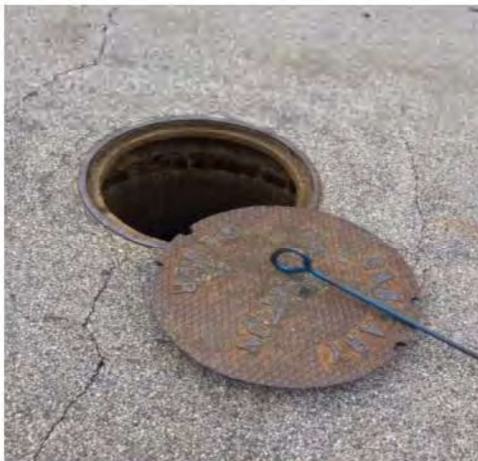
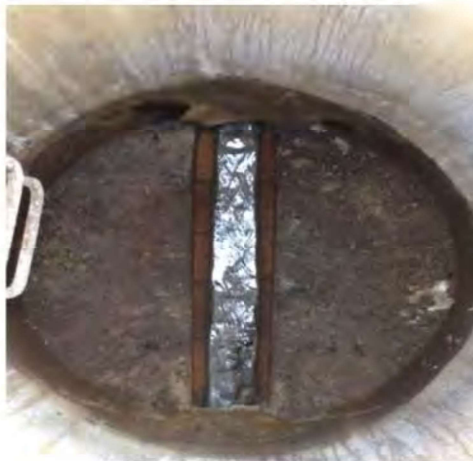
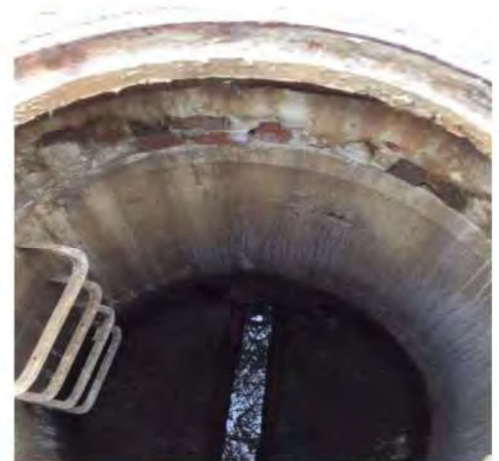
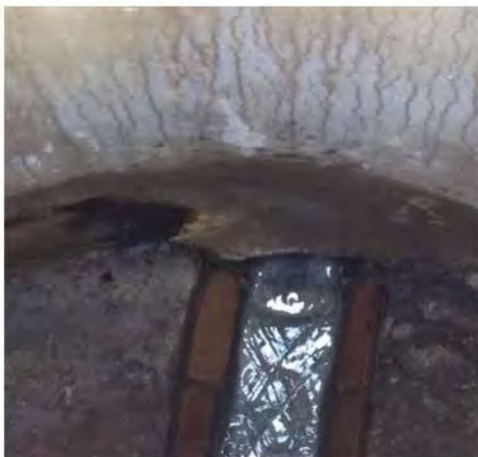
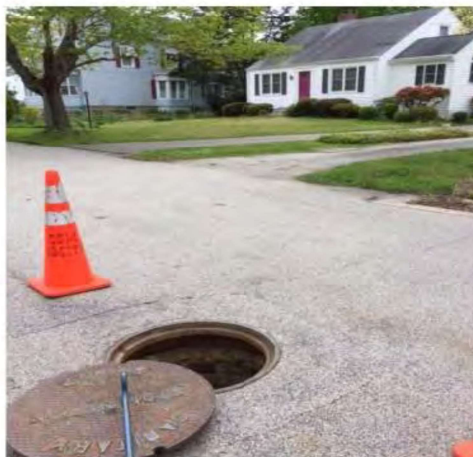
GIS MH No: 1-112

Location in MH	Mtrl. Code	Infil. Code	Cond. Code	Repair Codes	Comments
Frame/Cover	CAST IRON	WEEPER	SOUND	NONE	
Chimney	BRICK	NONE	SOUND	NONE	
Cone	CONCRETE (PRECAST)	NONE	SOUND	NONE	
Wall	CONCRETE (PRECAST)	WEEPER	DEFECTIVE	LINE_MANHOLE	
Bench	BRICK	NONE	SOUND	NONE	
Invert/Channel	BRICK	NONE	SOUND	NONE

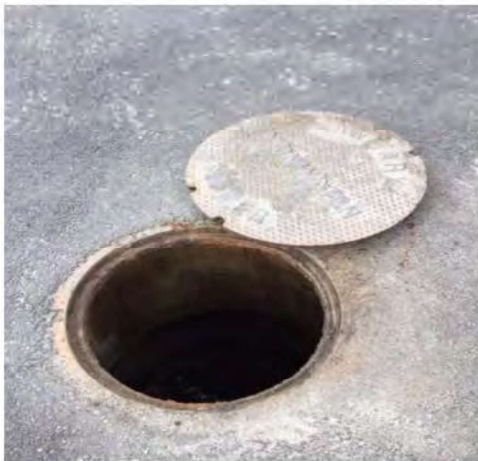
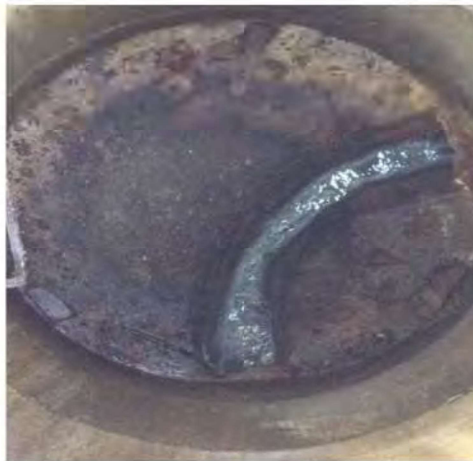
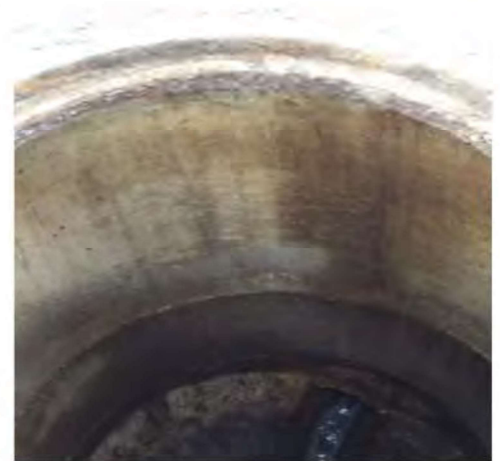
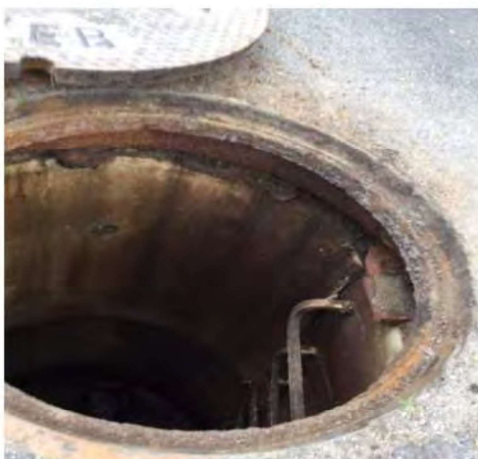
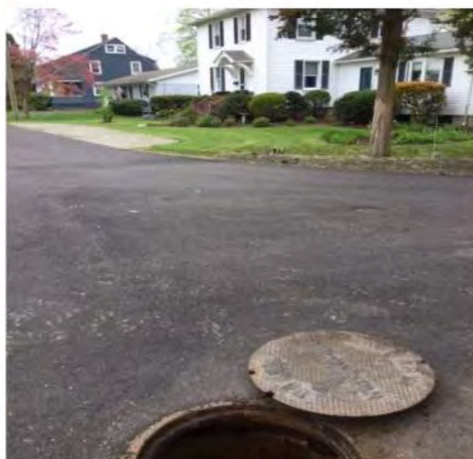
GIS MH No: 1-118

Location in MH	Mtrl. Code	Infil. Code	Cond. Code	Repair Codes	Comments
Frame/Cover	CAST IRON	STAINS	SOUND	NONE	
Chimney	BRICK	NONE	DEFECTIVE	RESET EXISTING FRAME AND CHIMNEY	CHIMNEY STARTING TO BE DISPLACED
Cone	CONCRETE (PRECAST)	NONE	SOUND	NONE	
Wall	CONCRETE (PRECAST)	NONE	SOUND	NONE	
Bench	BRICK	NONE	SOUND	NONE	
Invert/Channel	BRICK	NONE	SOUND	NONE

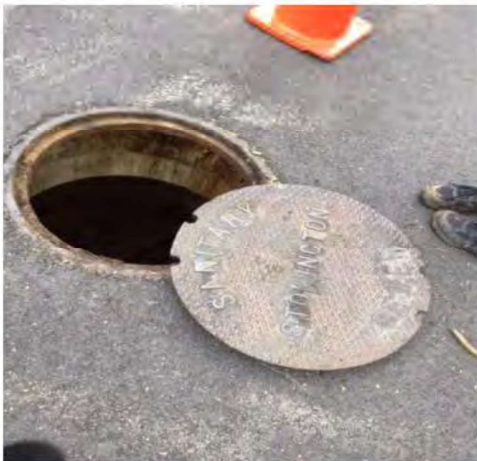
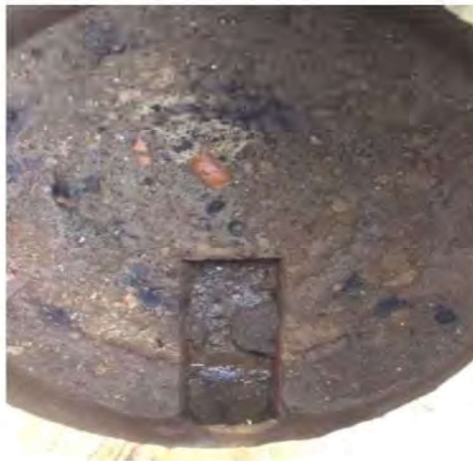
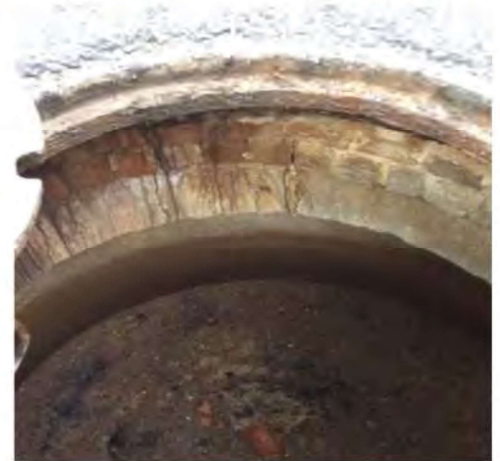
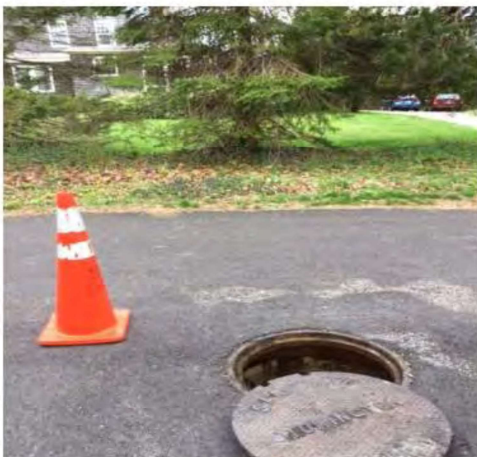
GIS MH No: 1-119A

Location in MH	Mtrl. Code	Infil. Code	Cond. Code	Repair Codes	Comments
Frame/Cover	CAST IRON	WEEPER	SOUND	NONE	
Chimney	BRICK	NONE	DEFECTIVE	RESET EXISTING FRAME AND CHIMNEY	CHIMNEY BRICKS ARE BECOMING DISPLACED
Cone	CONCRETE (PRECAST)	NONE	SOUND	NONE	
Wall	CONCRETE (PRECAST)	NONE	SOUND	NONE	
Bench	BRICK	NONE	SOUND	NONE	
Invert/Channel	BRICK	NONE	SOUND	NONE

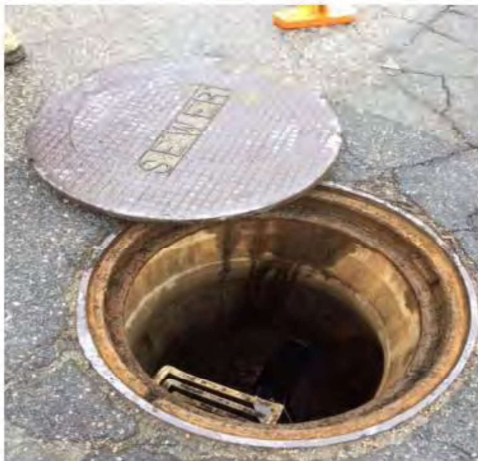
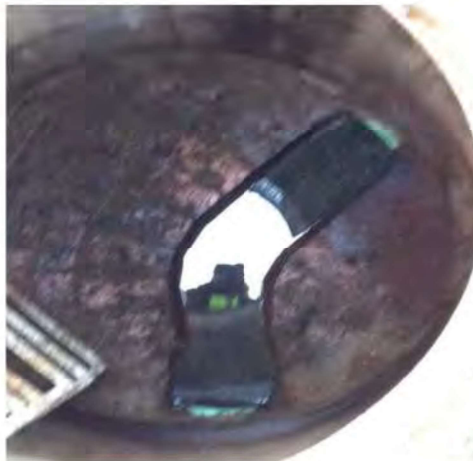
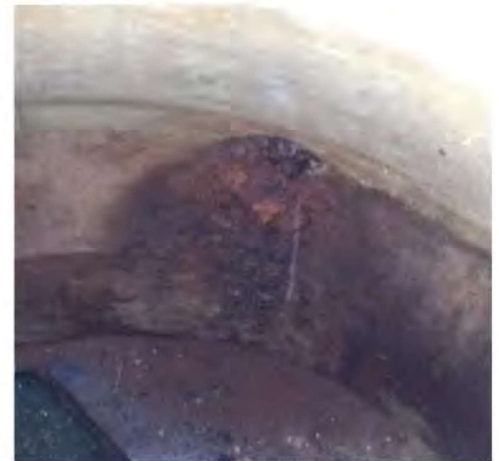
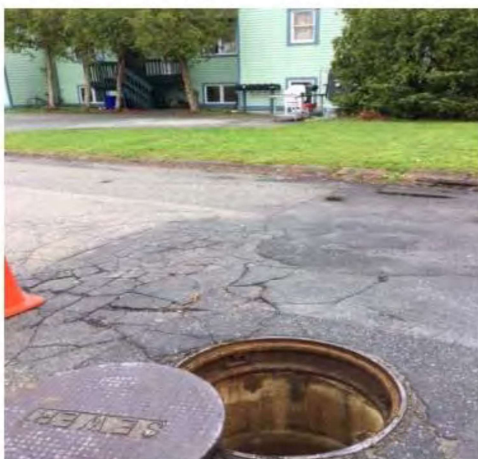
Location in MH	Mtrl. Code	Infil. Code	Cond. Code	Repair Codes	Comments
Frame/Cover	CAST IRON	NONE	SOUND	NONE	LOOKS LIKE FRAME SHOULD HAVE WATERTIGHT SEAL BUT DOES NOT.
Chimney	OTHER (DESCRIBE IN DETAILS)	NONE	SOUND	NONE	NO CHIMNEY
Cone	CONCRETE (PRECAST)	NONE	SOUND	NONE	
Wall	CONCRETE (PRECAST)	WEEPER	DEFECTIVE	LINE_MANHOLE	LOOKS LIKE SEDIMENT AND INFILTRATION FROM WALL AT 3 PM
Bench	BRICK	NONE	SOUND	NONE	
Invert/Channel	BRICK	NONE	SOUND	NONE

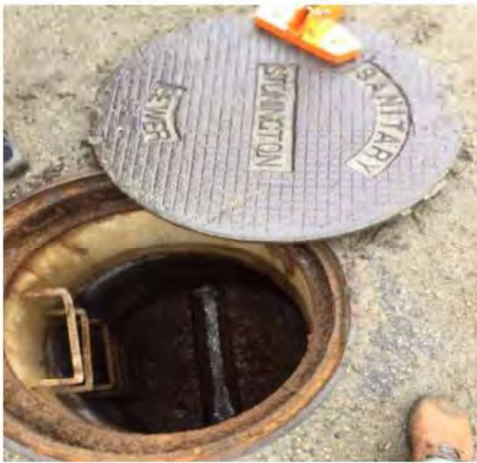
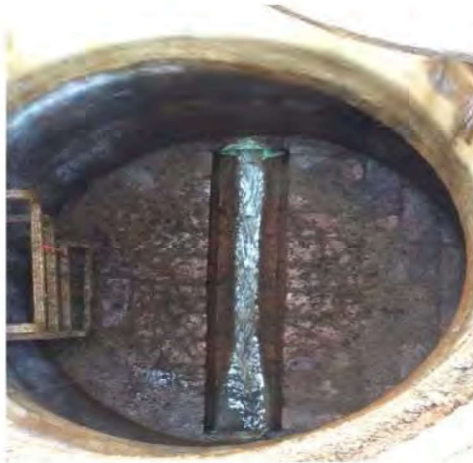
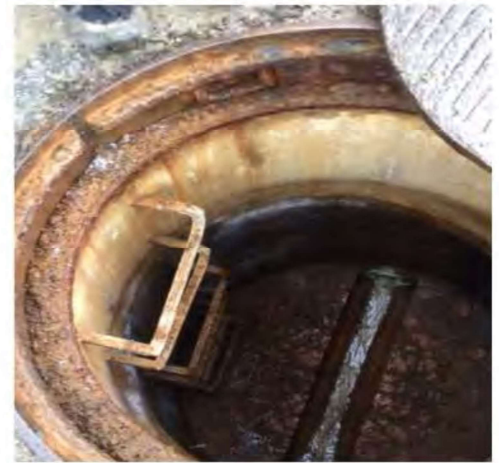
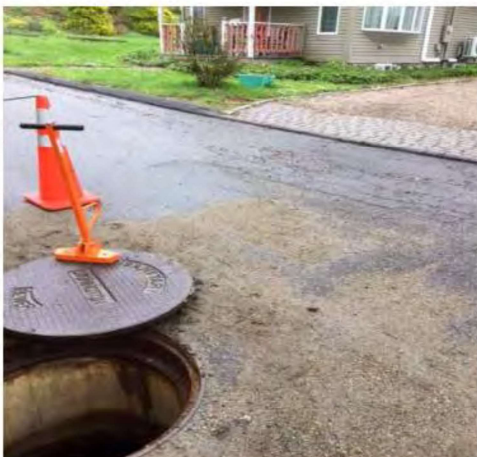
Location in MH	Mtrl. Code	Infil. Code	Cond. Code	Repair Codes	Comments
Frame/Cover	CAST IRON	STAINS	SOUND	NONE	MISSING WATER TIGHT COVER
Chimney	OTHER (DESCRIBE IN DETAILS)	NONE	SOUND	NONE	NO CHIMNEY
Cone	CONCRETE (PRECAST)	NONE	SOUND	NONE	
Wall	CONCRETE (PRECAST)	NONE	SOUND	NONE	
Bench	BRICK	NONE	SOUND	NONE	
Invert/Channel	BRICK	NONE	SOUND	NONE

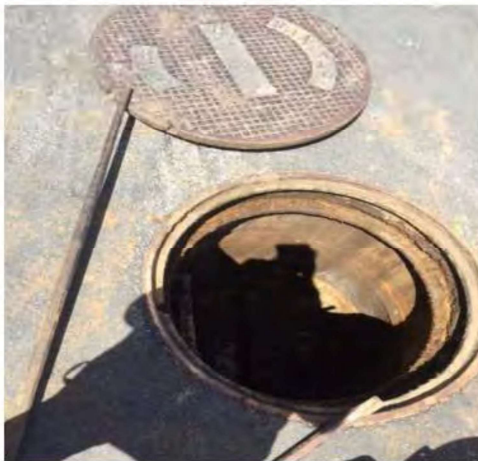
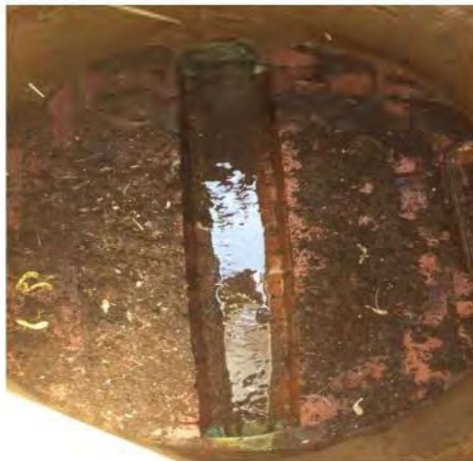
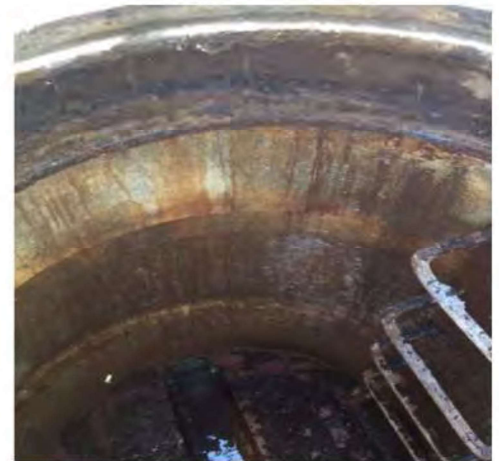
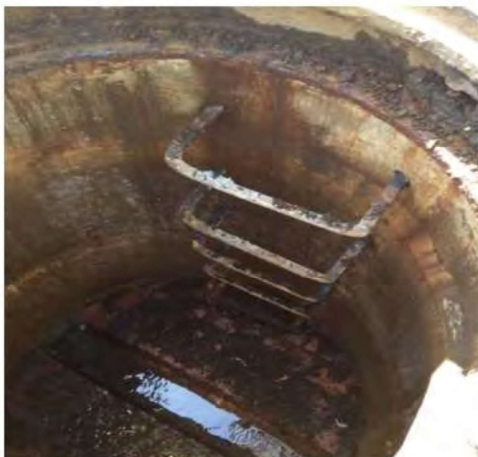
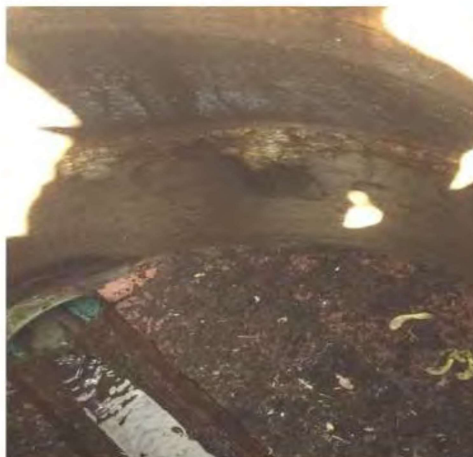
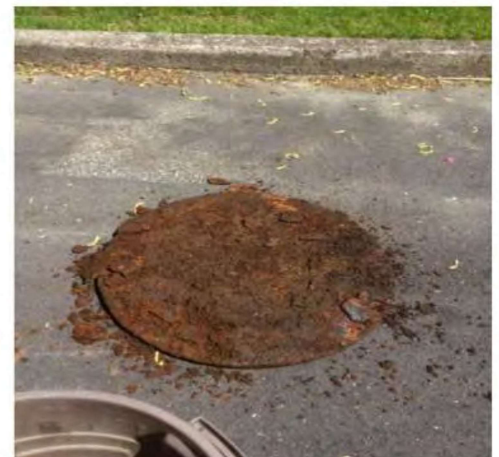
Location in MH	Mtrl. Code	Infil. Code	Cond. Code	Repair Codes	Comments
Frame/Cover	CAST IRON	WEEPER	SOUND	OTHER	WATER TIGHT SEAL DOES NOT HAVE HANDLES. REPLACE SEAL
Chimney	CONCRETE (PRECAST)	NONE	SOUND	NONE	
Cone	CONCRETE (PRECAST)	NONE	SOUND	NONE	
Wall	CONCRETE (PRECAST)	STAINS	DEFECTIVE	LINE_MANHOLE	
Bench	BRICK	NONE	SOUND	NONE	
Invert/Channel	BRICK	NONE	SOUND	NONE
