CDM
Smith

Town of Stonington, Connecticut

Manhole Inspection Form

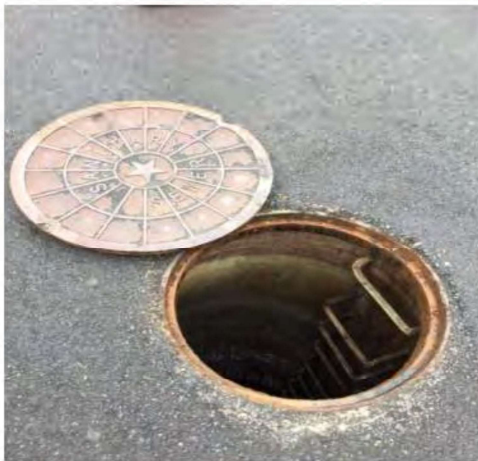
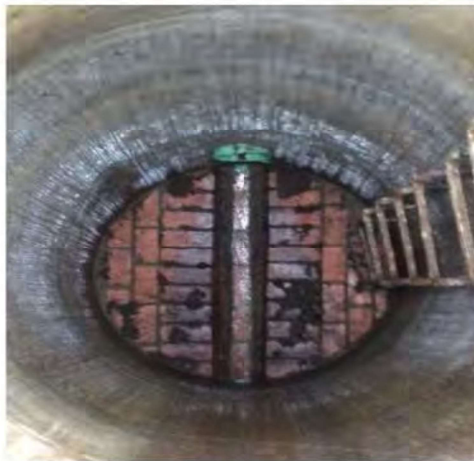
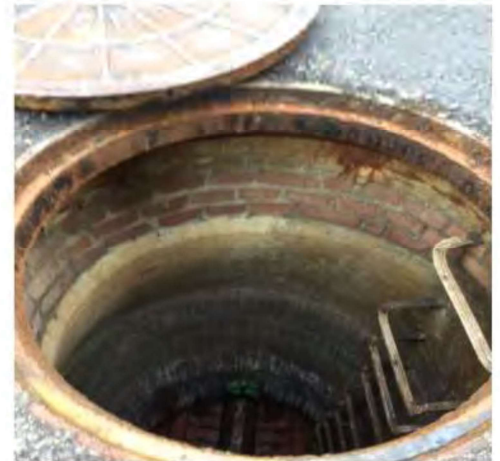
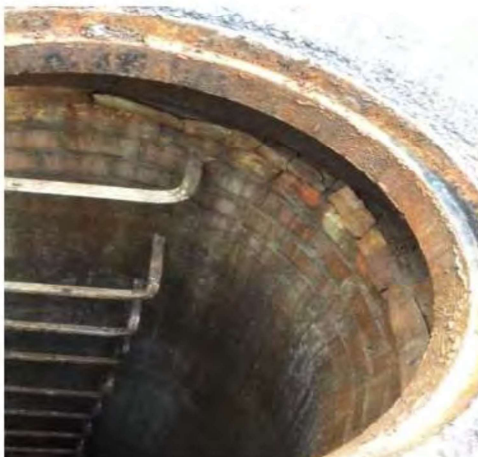
GIS MH No: 1-160

Location in MH	Mtrl. Code	Infil. Code	Cond. Code	Repair Codes	Comments
Frame/Cover	CAST IRON	STAINS	SOUND	NONE	
Chimney	BRICK	NONE	DEFECTIVE	RESET EXISTING FRAME AND CHIMNEY	BRICKS ARE STARTING TO BE DISPLACED
Cone	CONCRETE (PRECAST)	NONE	SOUND	NONE	
Wall	CONCRETE (PRECAST)	NONE	SOUND	NONE	
Bench	BRICK	NONE	SOUND	NONE	
Invert/Channel	BRICK	NONE	SOUND	NONE

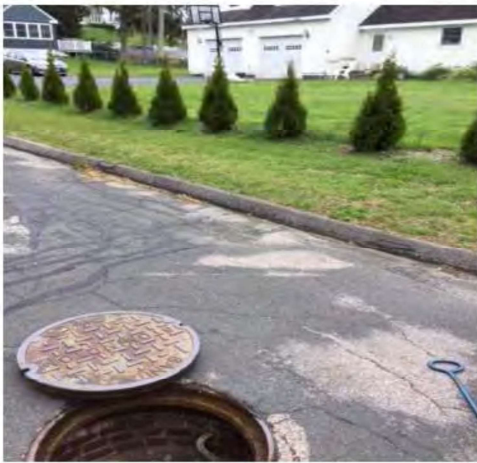
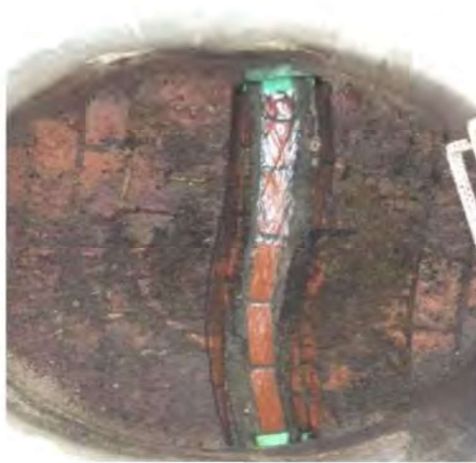
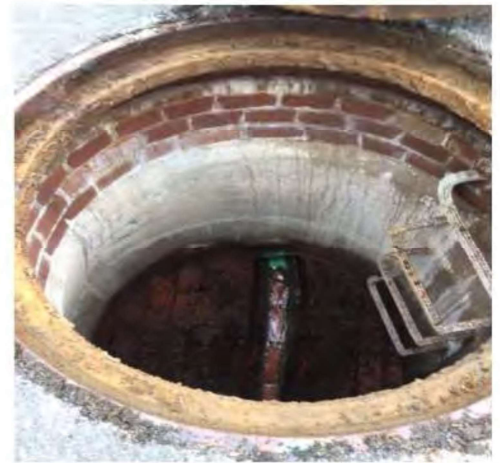
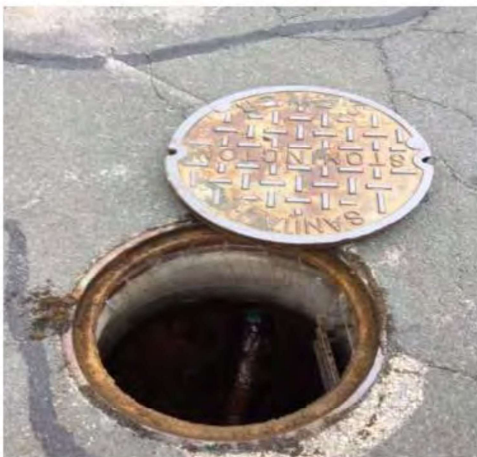
GIS MH No: 1-170

Location in MH	Mtrl. Code	Infil. Code	Cond. Code	Repair Codes	Comments
Frame/Cover	CAST IRON	WEEPER	SOUND	NONE	
Chimney	BRICK	NONE	SOUND	NONE	
Cone	CONCRETE (PRECAST)	NONE	SOUND	NONE	
Wall	CONCRETE (PRECAST)	NONE	SOUND	NONE	
Bench	BRICK	NONE	SOUND	NONE	SLIGHT DEGRADATION FROM 3-6 O CLOCK, BUT NOT DEFECTIVE
Invert/Channel	BRICK	NONE	SOUND	NONE

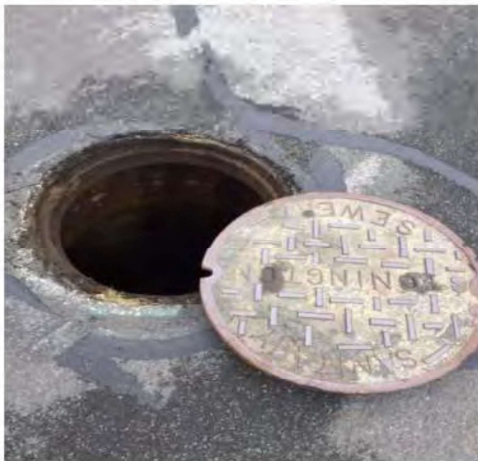
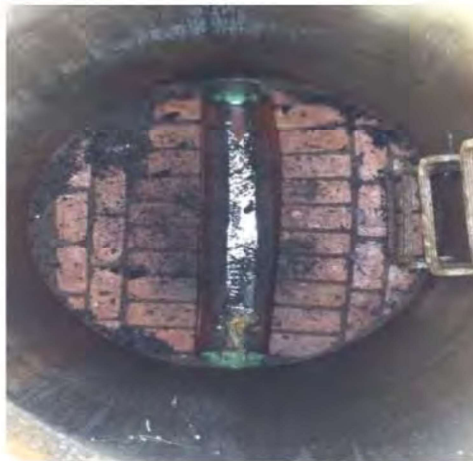
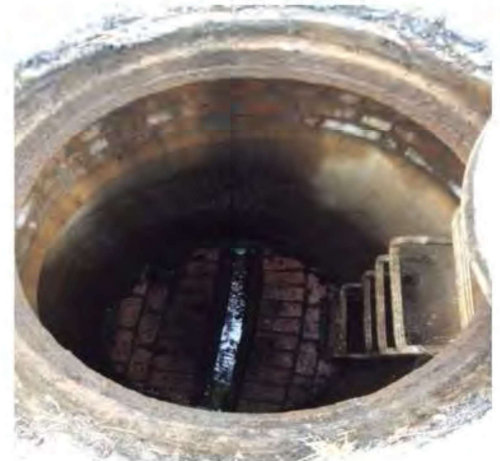
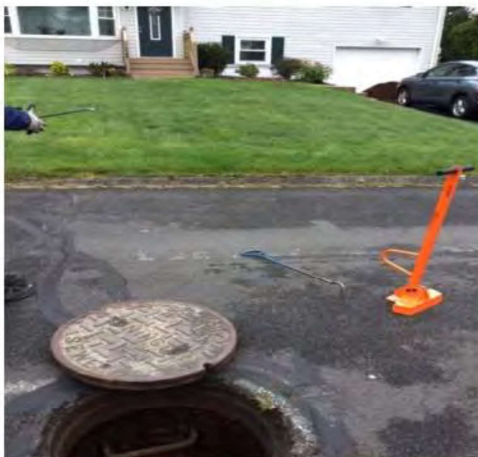
Location in MH	Mtrl. Code	Infil. Code	Cond. Code	Repair Codes	Comments
Frame/Cover	CAST IRON	WEEPER	SOUND	ADD RISER RING TO FRAME AND CHIMNEY	
Chimney	BRICK	NONE	SOUND	NONE	
Cone	CONCRETE (CAST IN PLACE)	NONE	SOUND	NONE	
Wall	CONCRETE (PRECAST)	NONE	SOUND	NONE	
Bench	BRICK	NONE	SOUND	NONE	
Invert/Channel	BRICK	NONE	SOUND	NONE

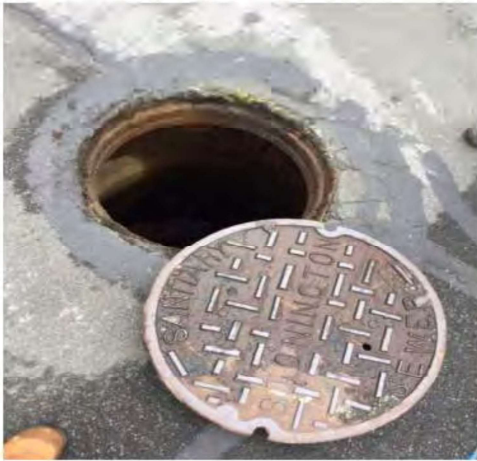
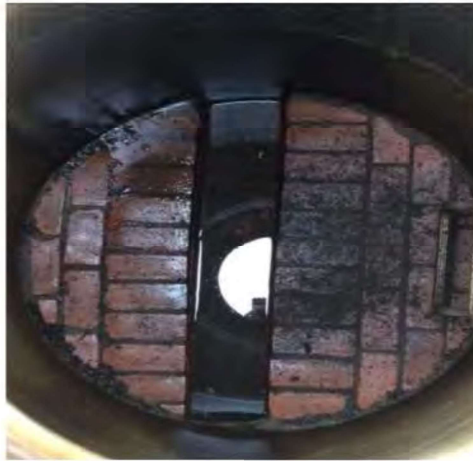
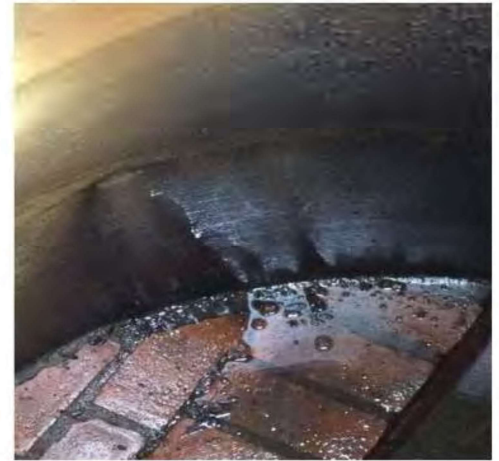
Location in MH	Mtrl. Code	Infil. Code	Cond. Code	Repair Codes	Comments
Frame/Cover	CAST IRON	STAINS	SOUND	NONE	
Chimney	BRICK	NONE	DEFECTIVE	RESET EXISTING FRAME AND CHIMNEY	
Cone	CONCRETE (PRECAST)	NONE	SOUND	NONE	
Wall	CONCRETE (PRECAST)	RUNNER	DEFECTIVE	LINE_MANHOLE	
Bench	BRICK	NONE	SOUND	NONE	
Invert/Channel	BRICK	NONE	SOUND	NONE
