CDM  
Smith

## Town of Stonington, Connecticut

### Manhole Inspection Form

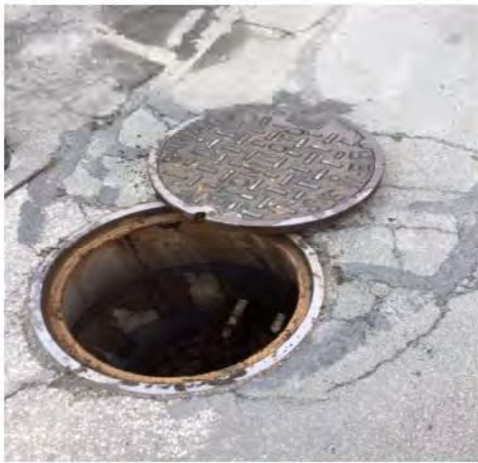
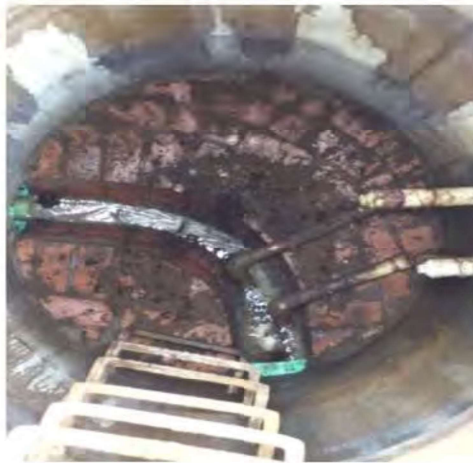
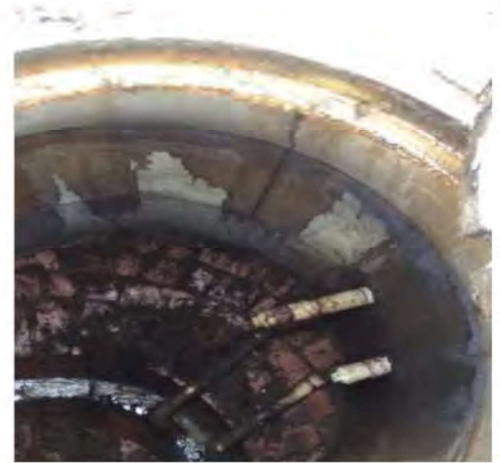
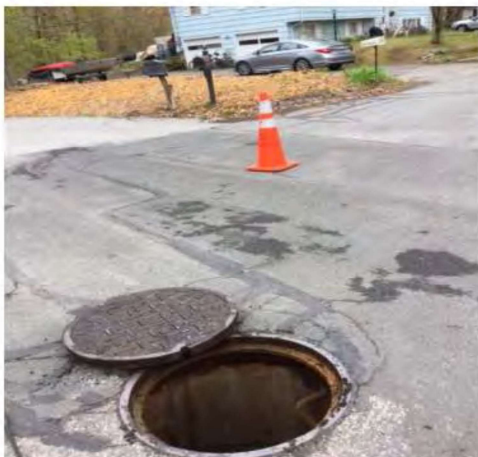
GIS MH No: 1-184

Location in MH	Mtrl. Code	Infil. Code	Cond. Code	Repair Codes	Comments
Frame/Cover	CAST IRON	NONE	SOUND	NONE	
Chimney	OTHER (DESCRIBE IN DETAILS)	NONE	SOUND	NONE	NO CHIMNEY
Cone	CONCRETE (PRECAST)	NONE	SOUND	NONE	
Wall	CONCRETE (PRECAST)	STAINS	DEFECTIVE	LINE_MANHOLE	
Bench	BRICK	NONE	SOUND	NONE	
Invert/Channel	BRICK	NONE	SOUND	NONE

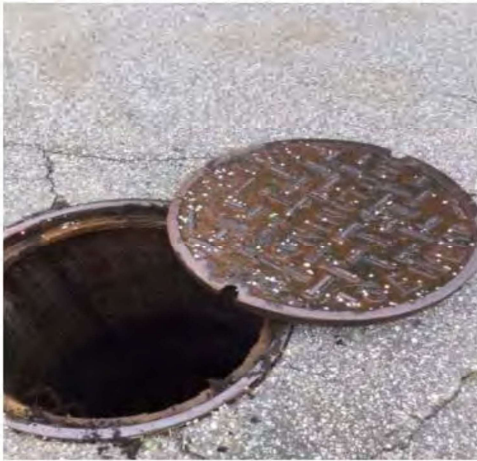
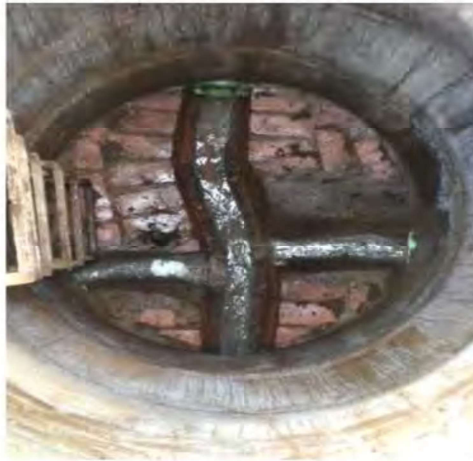
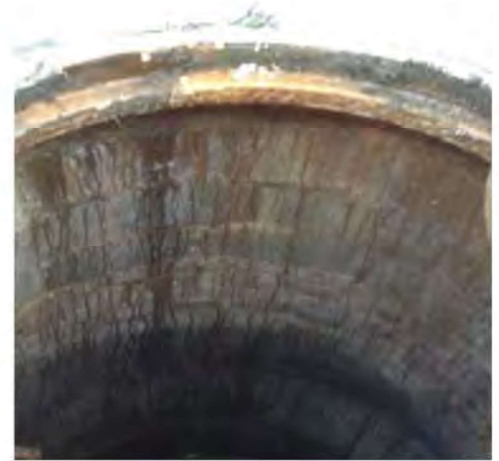
GIS MH No: 1-188

Location in MH	Mtrl. Code	Infil. Code	Cond. Code	Repair Codes	Comments
Frame/Cover	CAST IRON	WEEPER	BROKEN	REPLACE FRAME AND COVER	
Chimney	CONCRETE BLOCK	NONE	SOUND	NONE	
Cone	CONCRETE (PRECAST)	NONE	SOUND	NONE	
Wall	CONCRETE (PRECAST)	NONE	SOUND	NONE	
Bench	BRICK	NONE	SOUND	NONE	
Invert/Channel	BRICK	NONE	SOUND	NONE

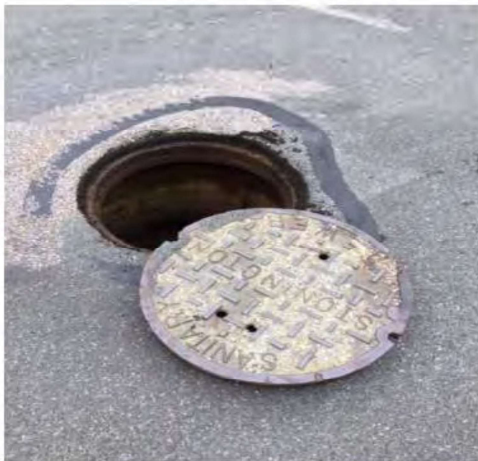
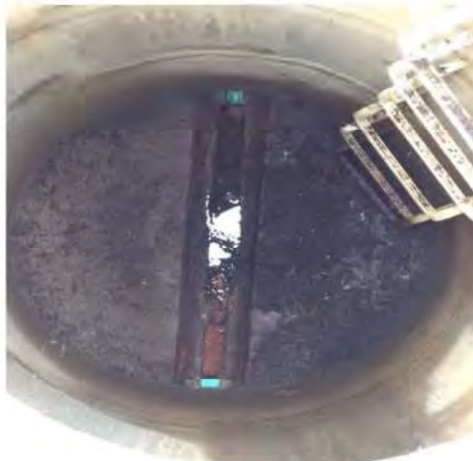
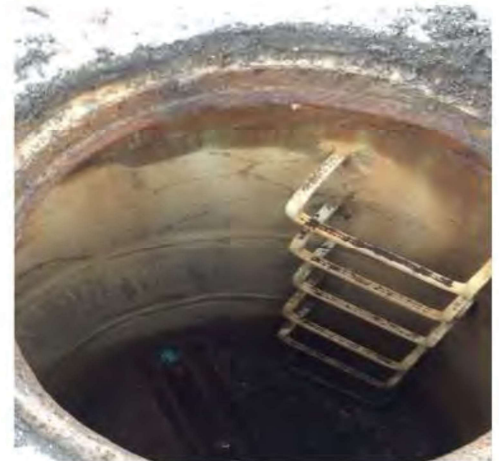
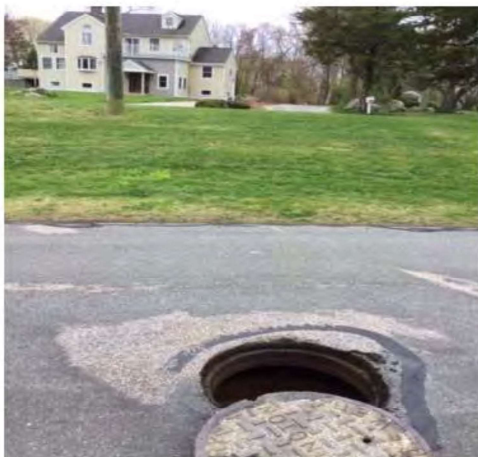
GIS MH No: 1-196

Location in MH	Mtrl. Code	Infil. Code	Cond. Code	Repair Codes	Comments
Frame/Cover	CAST IRON	STAINS	SOUND	ADD RISER RING TO FRAME AND CHIMNEY	
Chimney	BRICK	NONE	SOUND	NONE	
Cone	CONCRETE (PRECAST)	NONE	SOUND	NONE	
Wall	CONCRETE (PRECAST)	NONE	SOUND	NONE	
Bench	BRICK	NONE	SOUND	NONE	
Invert/Channel	BRICK	NONE	SOUND	NONE

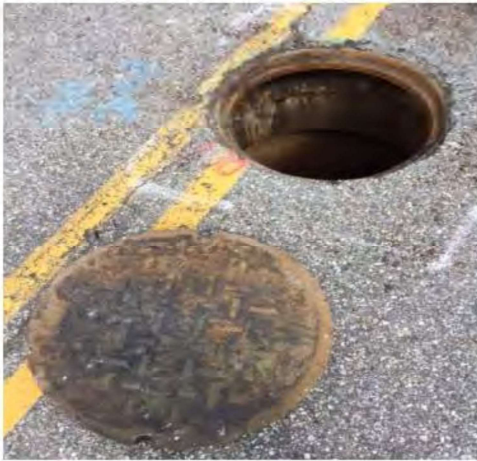
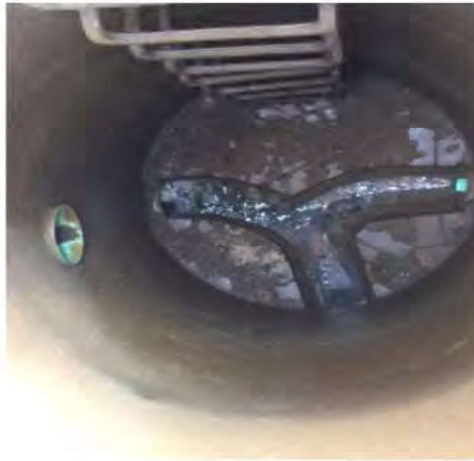
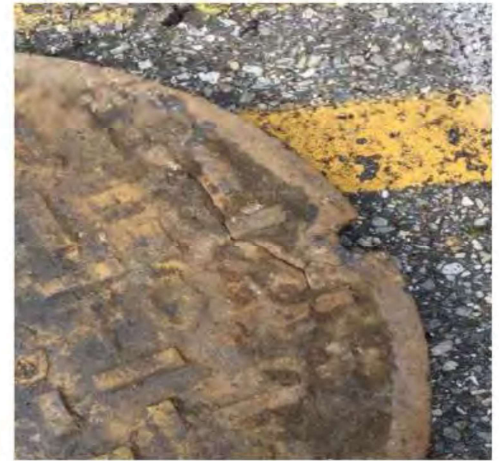
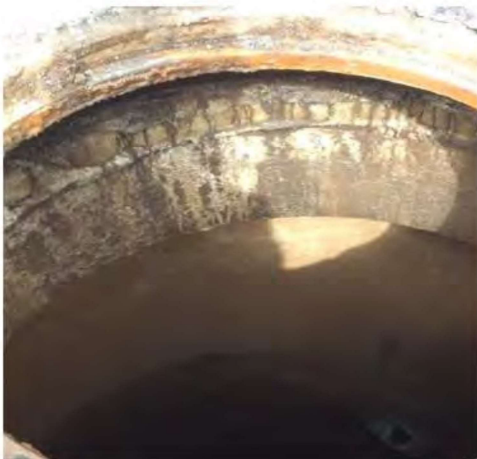
Location in MH	Mtrl. Code	Infil. Code	Cond. Code	Repair Codes	Comments
Frame/Cover	CAST IRON	WEEPER	CORRODED	REPLACE FRAME AND COVER	
Chimney	CONCRETE BLOCK	STAINS	DEFECTIVE	RESET EXISTING FRAME AND CHIMNEY, ADD RISER RING TO FRAME	
Cone	CONCRETE (PRECAST)	NONE	SOUND	NONE	
Wall	CONCRETE (PRECAST)	NONE	SOUND	NONE	
Bench	BRICK	NONE	SOUND	NONE	
Invert/Channel	BRICK	NONE	SOUND	NONE

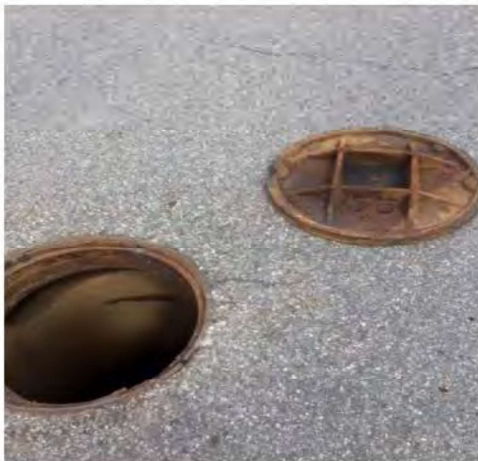
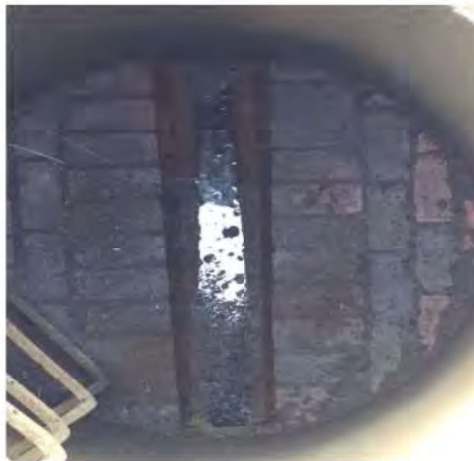
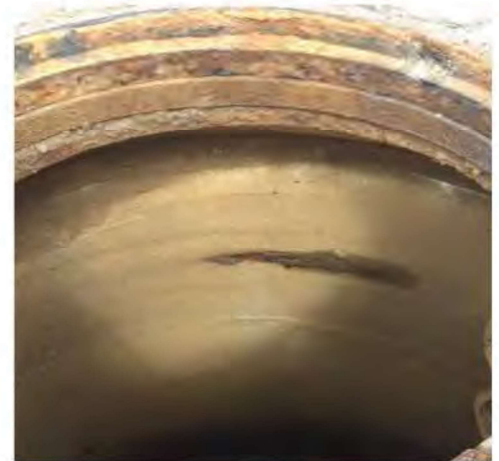
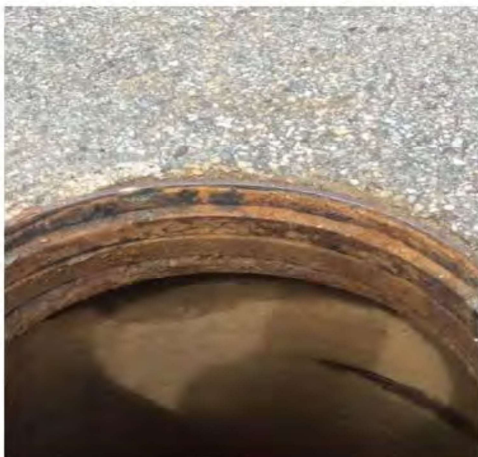
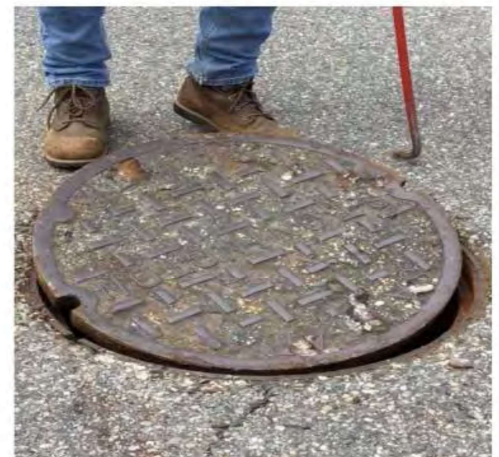
Location in MH	Mtrl. Code	Infil. Code	Cond. Code	Repair Codes	Comments
Frame/Cover	CAST IRON	STAINS	SOUND	NONE	
Chimney	OTHER (DESCRIBE IN DETAILS)	NONE	SOUND	NONE	NO CHIMNEY
Cone	CONCRETE (PRECAST)	NONE	SOUND	NONE	
Wall	CONCRETE (PRECAST)	STAINS	DEFECTIVE	LINE_MANHOLE	
Bench	BRICK	NONE	SOUND	NONE	
Invert/Channel	BRICK	NONE	SOUND	NONE

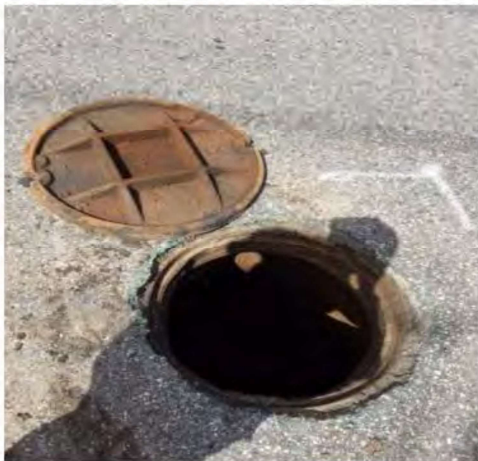
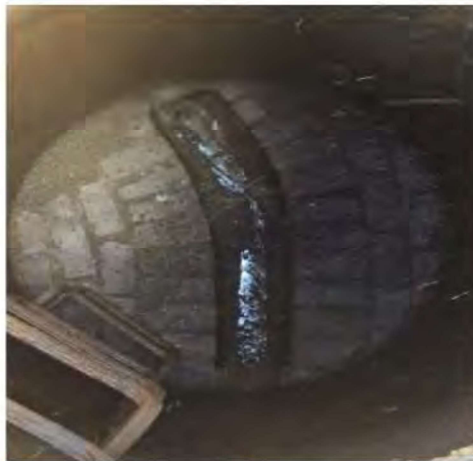
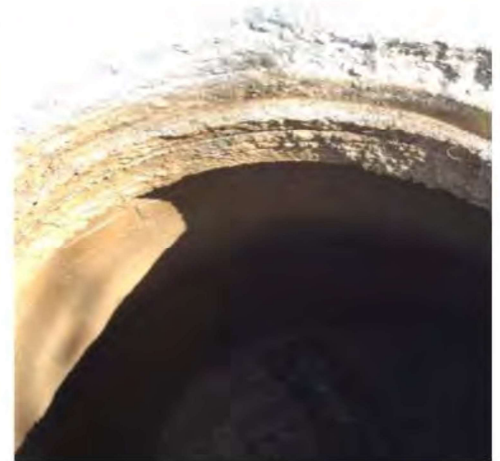
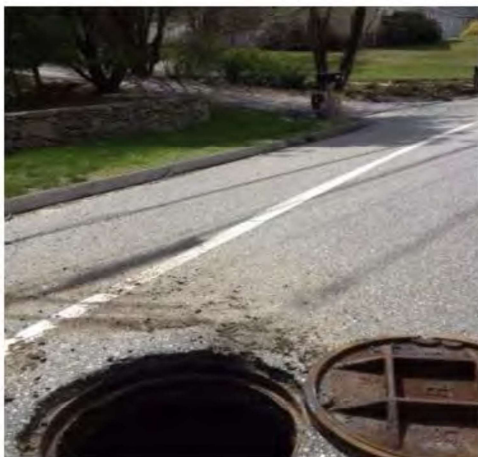
Location in MH	Mtrl. Code	Infil. Code	Cond. Code	Repair Codes	Comments
Frame/Cover	CAST IRON	NONE	CORRODED	ADD RISER RING TO FRAME AND CHIMNEY	
Chimney	BRICK	NONE	SOUND	REPLACE FRAME AND NONE	
Cone	CONCRETE (PRECAST)	NONE	SOUND	NONE	
Wall	CONCRETE (PRECAST)	NONE	SOUND	NONE	
Bench	BRICK	NONE	SOUND	NONE	
Invert/Channel	BRICK	NONE	SOUND	NONE
