Town of Stonington, Connecticut

Manhole Inspection Form

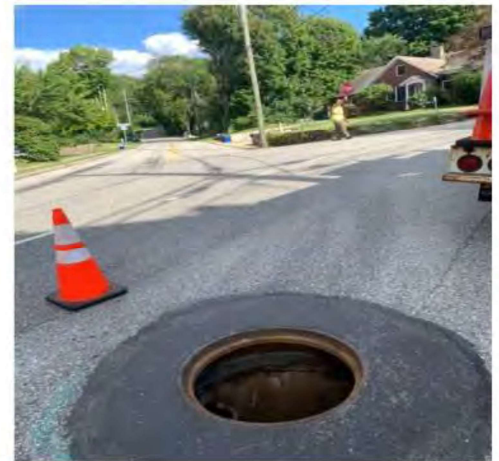
GIS MH No: 1-212

Location in MH	Mtrl. Code	Infil. Code	Cond. Code	Repair Codes	Comments
Frame/Cover	CAST IRON	NONE	CORRODED	REPLACE FRAME AND COVER	
Chimney	BRICK	NONE	SOUND	NONE	
Cone	CONCRETE (PRECAST)	NONE	SOUND	NONE	
Wall	CONCRETE (PRECAST)	NONE	SOUND	NONE	
Bench	BRICK	NONE	SOUND	NONE	
Invert/Channel	BRICK	NONE	SOUND	NONE

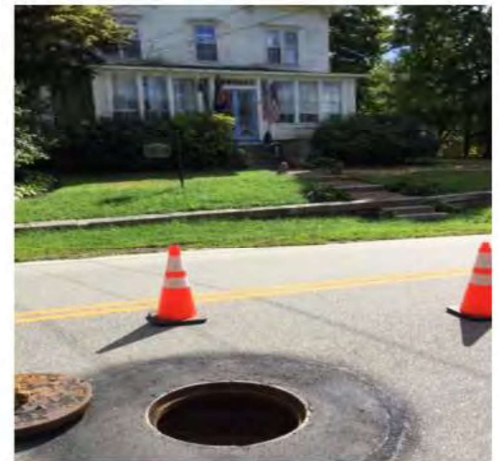
GIS MH No: 1-215

Location in MH	Mtrl. Code	Infil. Code	Cond. Code	Repair Codes	Comments
Frame/Cover	CAST IRON	NONE	CORRODED	REPLACE FRAME AND COVER	
Chimney	BRICK	NONE	SOUND	NONE	
Cone	CONCRETE (PRECAST)	NONE	SOUND	NONE	
Wall	CONCRETE (PRECAST)	NONE	SOUND	NONE	
Bench	BRICK	NONE	SOUND	NONE	
Invert/Channel	BRICK	NONE	SOUND	NONE

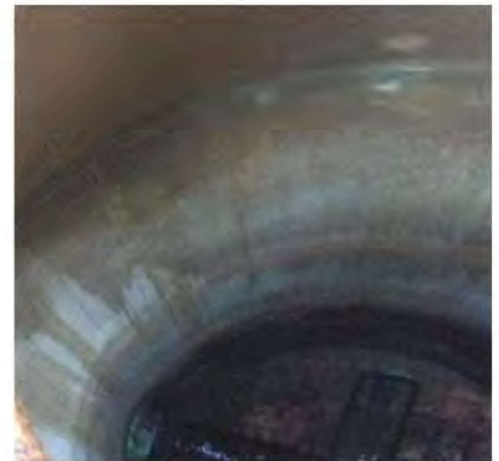
GIS MH No: 1-216

Surcharge: NO
Infiltration: YES

Location in MH	Mtrl. Code	Infil. Code	Cond. Code	Repair Codes	Comments
Frame/Cover	CAST IRON	NONE	SOUND	OTHER	WATER TIGHT COVER NEEDS TO BE REPLACED, NO HANDLES
Chimney	OTHER (DESCRIBE IN DETAILS)	NONE	SOUND	NONE	NO CHIMNEY
Cone	CONCRETE (PRECAST)	NONE	SOUND	NONE	
Wall	CONCRETE (PRECAST)	STAINS	SOUND	NONE	
Bench	BRICK	NONE	SOUND	NONE	
Invert/Channel	BRICK	NONE	SOUND	NONE

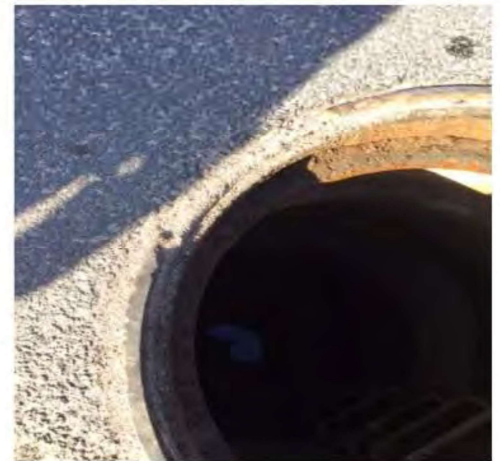
GIS MH No: 1-217

Location in MH	Mtrl. Code	Infil. Code	Cond. Code	Repair Codes	Comments
Frame/Cover	CAST IRON	NONE	BROKEN	REPLACE FRAME AND COVER	FRAME NEEDS TO BE REPLACED, ALSO WATER TIGHT COVER NEEDS TO BE REPLACED, NO HANDLES BRICK AND CONCRETE
Chimney	BRICK	NONE	SOUND	NONE	
Cone	CONCRETE (PRECAST)	NONE	SOUND	NONE	
Wall	CONCRETE (PRECAST)	NONE	SOUND	NONE	
Bench	BRICK	NONE	SOUND	NONE	
Invert/Channel	BRICK	NONE	SOUND	NONE

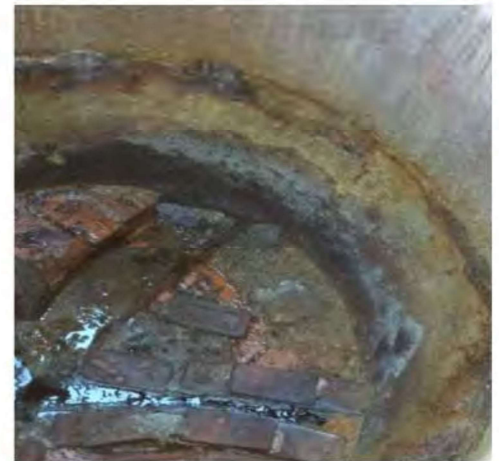
GIS MH No: 1-218

Surcharge: NO
Infiltration: YES

Location in MH	Mtrl. Code	Infil. Code	Cond. Code	Repair Codes	Comments
Frame/Cover	CAST IRON	WEEPER	BROKEN	REPLACE FRAME AND COVER	REPLACE FRAME AND WATER TIGHT COVER
Chimney	BRICK	NONE	SOUND	NONE	
Cone	CONCRETE (PRECAST)	NONE	SOUND	NONE	
Wall	CONCRETE (PRECAST)	STAINS	DEFECTIVE	LINE_MANHOLE	
Bench	BRICK	NONE	DEFECTIVE	CLEAN	MULTIPLE ADDITIONAL BRICKS
Invert/Channel	BRICK	NONE	SOUND	NONE

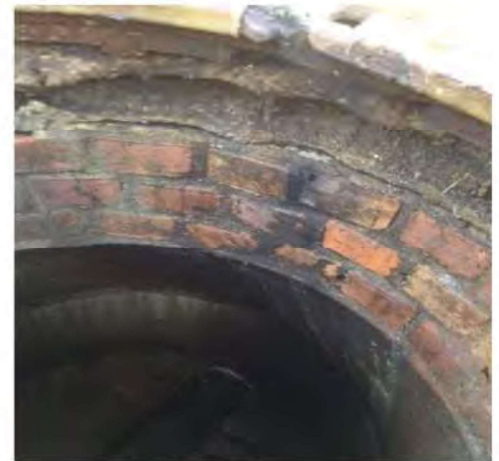
Location in MH	Mtrl. Code	Infil. Code	Cond. Code	Repair Codes	Comments
Frame/Cover	CAST IRON	NONE	SOUND	NONE	
Chimney	BRICK	NONE	DEFECTIVE	OTHER	REPLACE PART OF CHIMNEY
Cone	CONCRETE (PRECAST)	NONE	SOUND	NONE	
Wall	CONCRETE (PRECAST)	NONE	SOUND	NONE	
Bench	BRICK	NONE	SOUND	NONE	
Invert/Channel	BRICK	NONE	SOUND	NONE

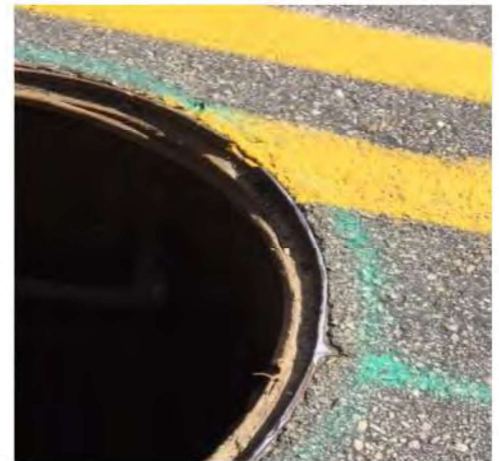
Location in MH	Mtrl. Code	Infil. Code	Cond. Code	Repair Codes	Comments
Frame/Cover	CAST IRON	NONE	BROKEN	REPLACE FRAME AND COVER	SEAL IS COMING OFF FROM FRAME
Chimney	OTHER (DESCRIBE IN DETAILS)	NONE	SOUND	NONE	NO CHIMNEY
Cone	CONCRETE (PRECAST)	NONE	SOUND	NONE	
Wall	CONCRETE (PRECAST)	STAINS	SOUND	NONE	
Bench	BRICK	NONE	SOUND	NONE	
Invert/Channel	BRICK	NONE	SOUND	NONE

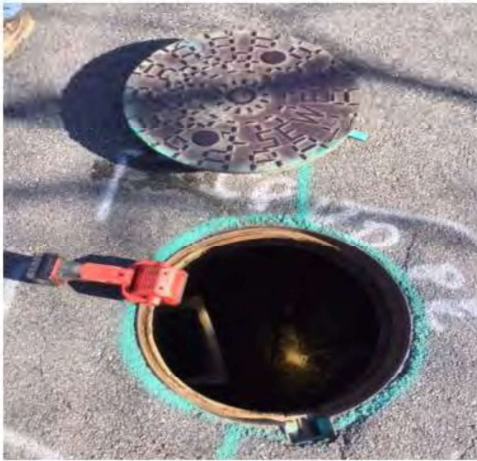
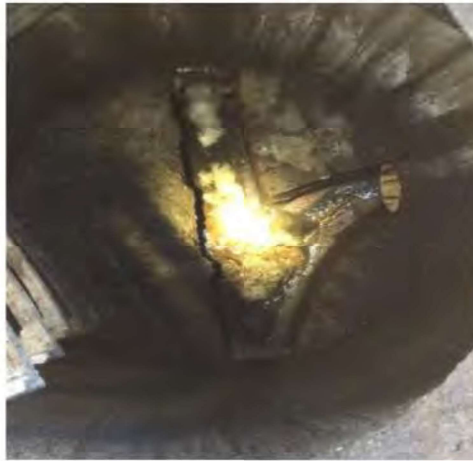
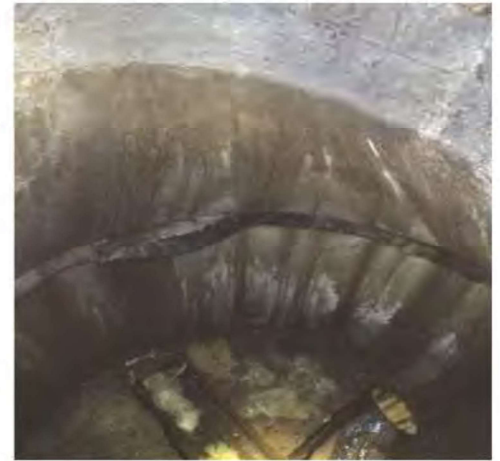
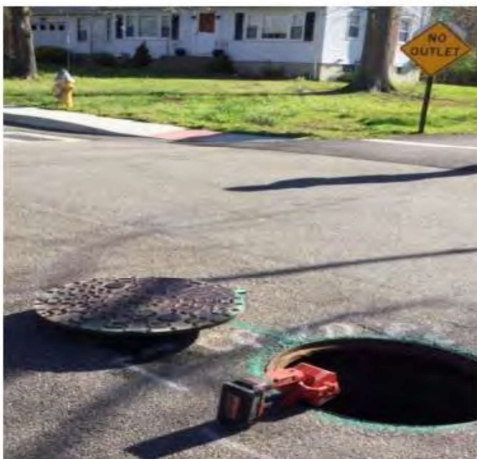
Location in MH	Mtrl. Code	Infil. Code	Cond. Code	Repair Codes	Comments
Frame/Cover	CAST IRON	STAINS	SOUND	NONE	
Chimney	BRICK	STAINS	SOUND	LINE MANHOLE	
Cone	CONCRETE (PRECAST)	NONE	SOUND	NONE	
Wall	CONCRETE (PRECAST)	STAINS	DEFECTIVE	LINE_MANHOLE	
Bench	BRICK	NONE	SOUND	NONE	
Invert/Channel	BRICK	NONE	SOUND	CLEAN

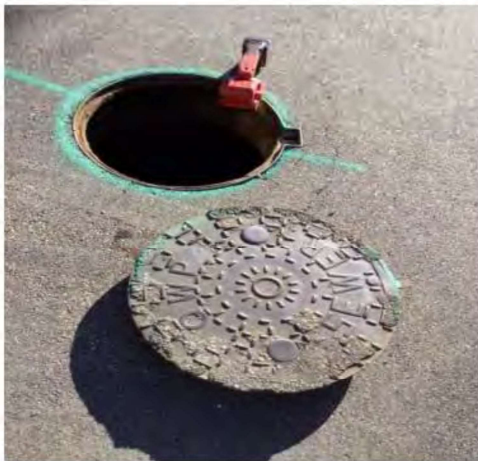
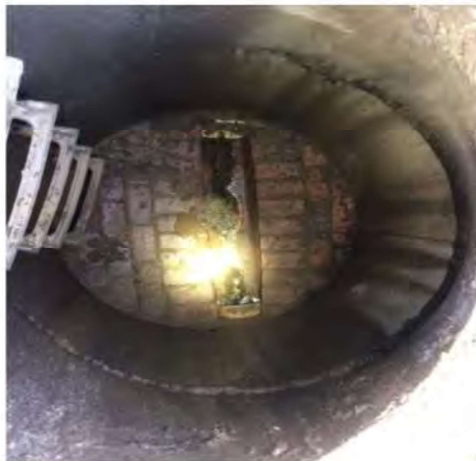
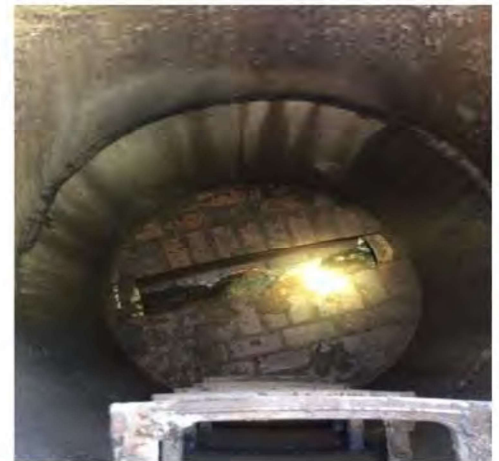
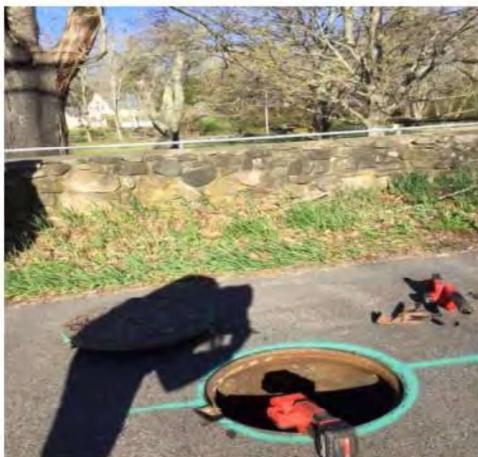
Location in MH	Mtrl. Code	Infil. Code	Cond. Code	Repair Codes	Comments
Frame/Cover	CAST IRON	STAINS	SOUND	NONE	
Chimney	BRICK	NONE	SOUND	NONE	
Cone	CONCRETE (PRECAST)	NONE	SOUND	NONE	
Wall	CONCRETE (PRECAST)	STAINS	DEFECTIVE	LINE_MANHOLE	
Bench	BRICK	NONE	SOUND	NONE	
Invert/Channel	BRICK	NONE	SOUND	NONE

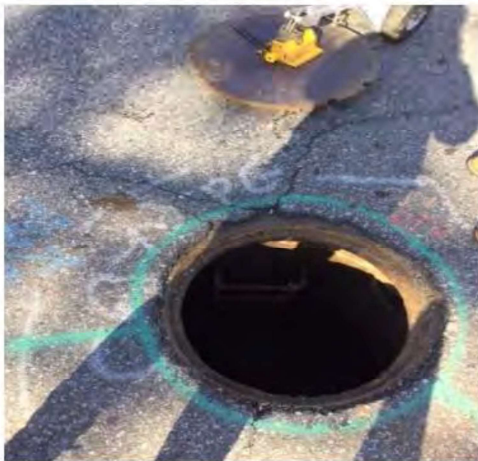
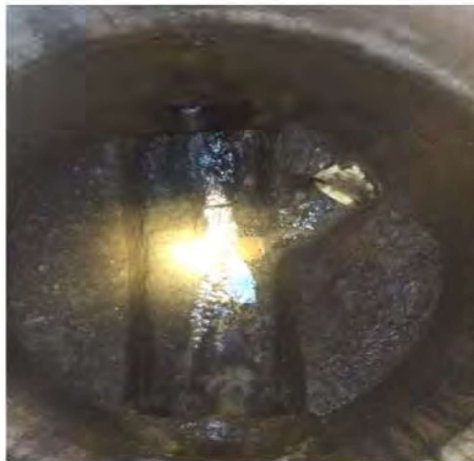
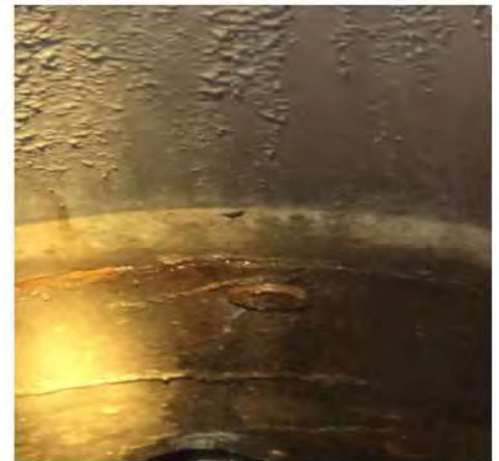
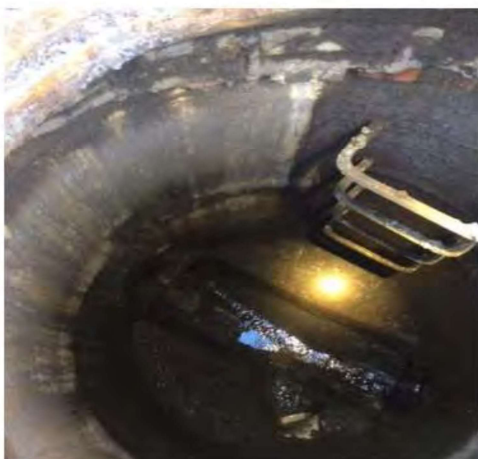
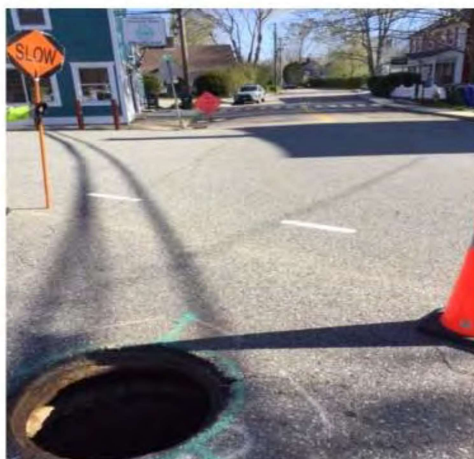
Location in MH	Mtrl. Code	Infil. Code	Cond. Code	Repair Codes	Comments
Frame/Cover	CAST IRON	NONE	SOUND	ADD RISER RING TO FRAME AND CHIMNEY	
Chimney	BRICK	STAINS	DEFECTIVE	LINE MANHOLE	
Cone	CONCRETE (PRECAST)	NONE	SOUND	NONE	
Wall	CONCRETE (PRECAST)	RUNNER	DEFECTIVE	LINE_MANHOLE	RUNNER COMING FROM PATCHED TAP AT 12 O CLOCK
Bench	BRICK	NONE	SOUND	NONE	
Invert/Channel	BRICK	NONE	SOUND	NONE

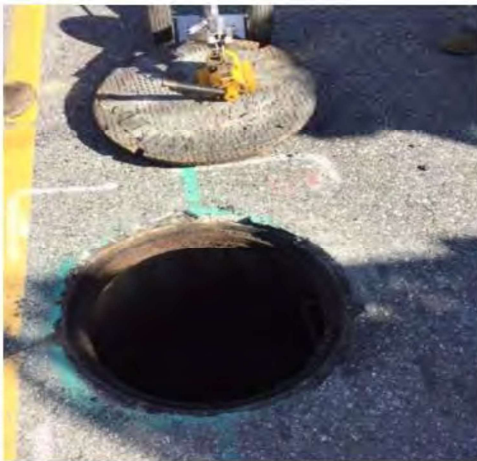
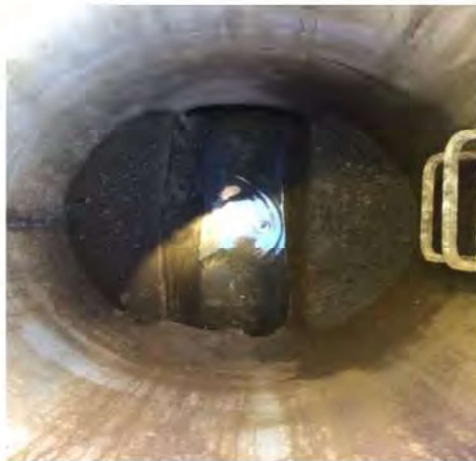
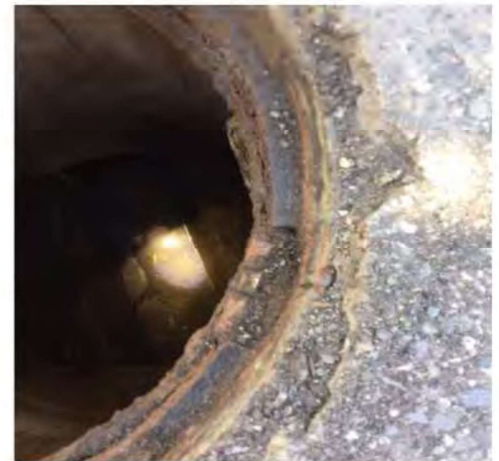
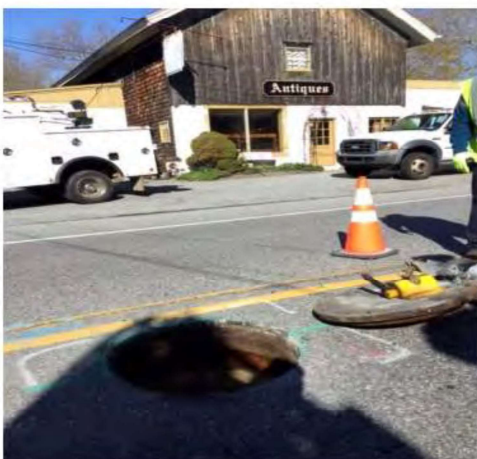
Location in MH	Mtrl. Code	Infil. Code	Cond. Code	Repair Codes	Comments
Frame/Cover	CAST IRON	NONE	BROKEN	REPLACE FRAME AND COVER	
Chimney	OTHER (DESCRIBE IN DETAILS)	NONE	NOT KNOWN	NONE	NO CHIMNEY
Cone	CONCRETE (PRECAST)	NONE	SOUND	NONE	
Wall	CONCRETE (PRECAST)	NONE	SOUND	NONE	
Bench	BRICK	NONE	SOUND	NONE	
Invert/Channel	BRICK	NONE	SOUND	NONE

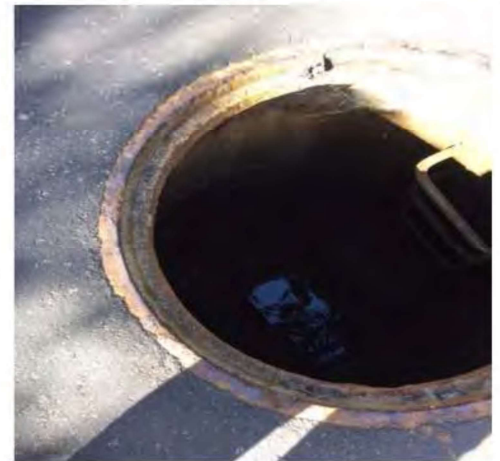
Location in MH	Mtrl. Code	Infil. Code	Cond. Code	Repair Codes	Comments
Frame/Cover	CAST IRON	NONE	CORRODED	REPLACE FRAME AND COVER	
Chimney	BRICK	NONE	SOUND	NONE	
Cone	OTHER (DESCRIBE IN DETAILS)	NONE	SOUND	NONE	NO CONE
Wall	CONCRETE (PRECAST)	NONE	SOUND	NONE	
Bench	BRICK	NONE	SOUND	NONE	
Invert/Channel	BRICK	NONE	SOUND	NONE

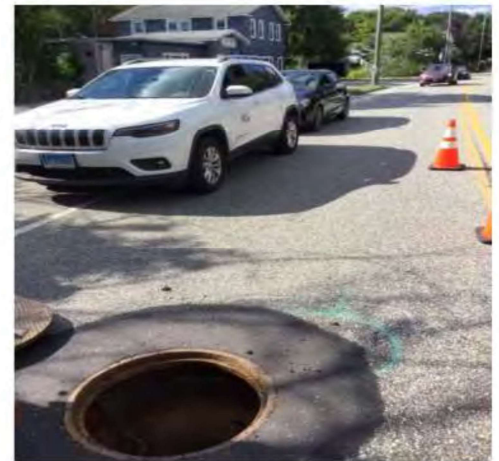
Location in MH	Mtrl. Code	Infil. Code	Cond. Code	Repair Codes	Comments
Frame/Cover	CAST IRON	NONE	CORRODED	REPLACE FRAME AND COVER	
Chimney	BRICK	NONE	SOUND	NONE	
Cone	CONCRETE (PRECAST)	NONE	SOUND	NONE	
Wall	CONCRETE (PRECAST)	NONE	SOUND	NONE	
Bench	BRICK	NONE	SOUND	NONE	
Invert/Channel	BRICK	NONE	SOUND	NONE

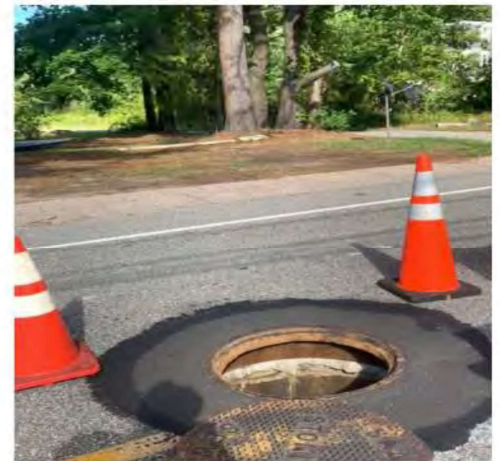
Location in MH	Mtrl. Code	Infil. Code	Cond. Code	Repair Codes	Comments
Frame/Cover	CAST IRON	NONE	CORRODED	REPLACE FRAME AND COVER	
Chimney	CONCRETE (PRECAST)	NONE	SOUND	NONE	
Cone	OTHER (DESCRIBE IN DETAILS)	NONE	SOUND	NONE	NO CONE
Wall	CONCRETE (PRECAST)	NONE	SOUND	NONE	
Bench	BRICK	NONE	SOUND	NONE	
Invert/Channel	BRICK	NONE	SOUND	NONE
