CDM  
Smith

## Town of Stonington, Connecticut

### Manhole Inspection Form

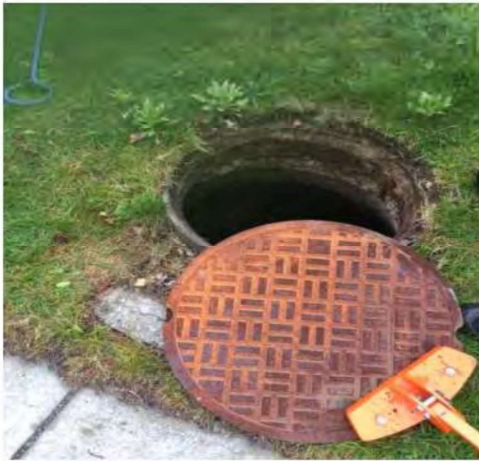
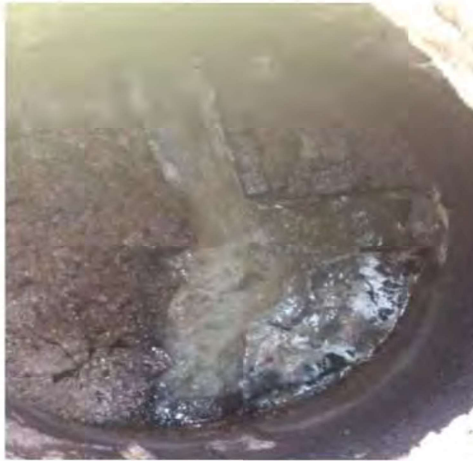
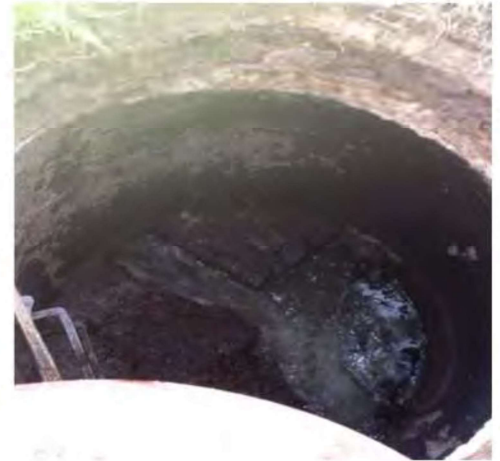
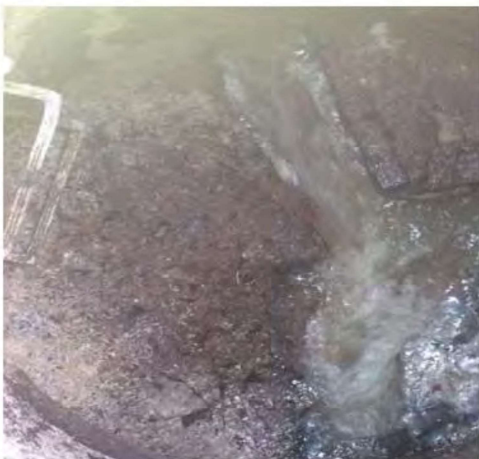
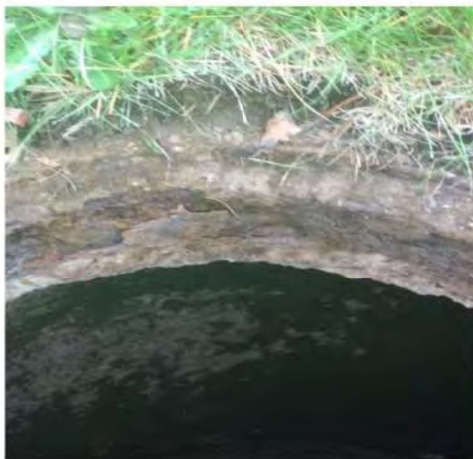
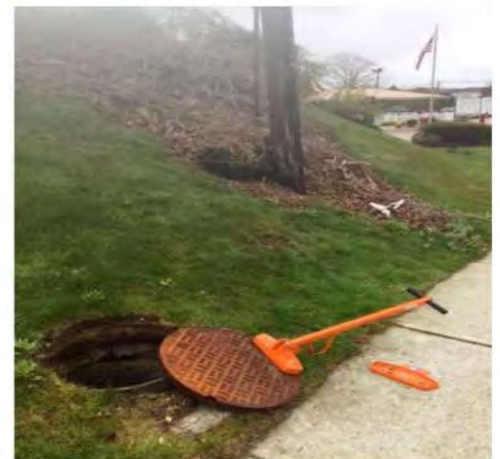
GIS MH No: 1-287

Location in MH	Mtrl. Code	Infil. Code	Cond. Code	Repair Codes	Comments
Frame/Cover	CAST IRON	NONE	CORRODED	REPLACE FRAME AND COVER	
Chimney	OTHER (DESCRIBE IN DETAILS)	NONE	SOUND	NONE	NO CHIMNEY
Cone	CONCRETE (CAST IN PLACE)	NONE	DEFECTIVE	LINE_MANHOLE	
Wall	CONCRETE (CAST IN PLACE)	NONE	DEFECTIVE	LINE_MANHOLE	
Bench	BRICK	NONE	DEFECTIVE	REPAIR_CHANNEL	FLOW DEGRADATION, VERY DIRTY
Invert/Channel	BRICK	NONE	SOUND	NONE

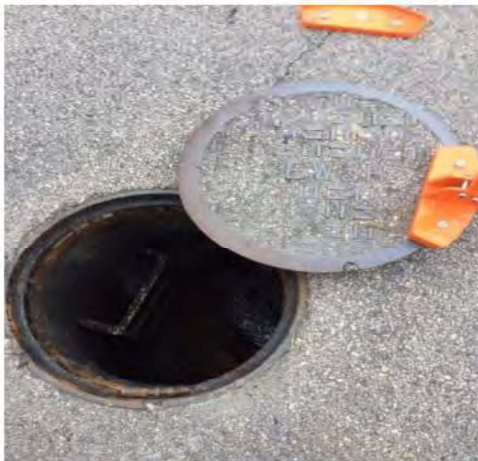
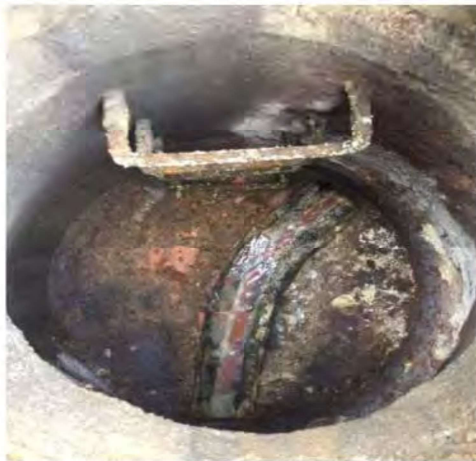
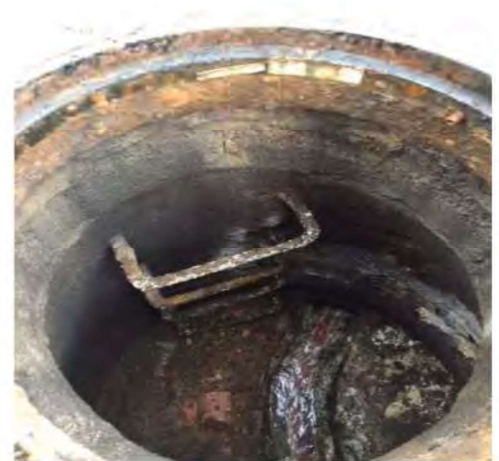
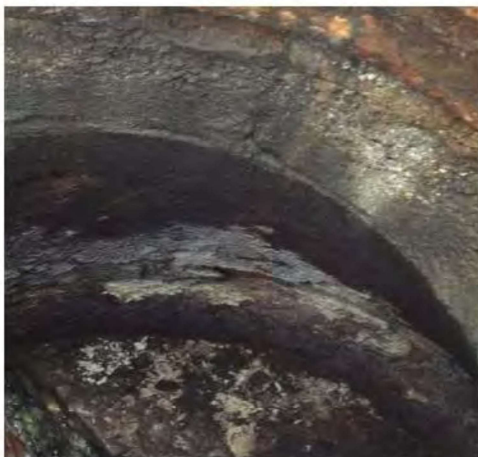
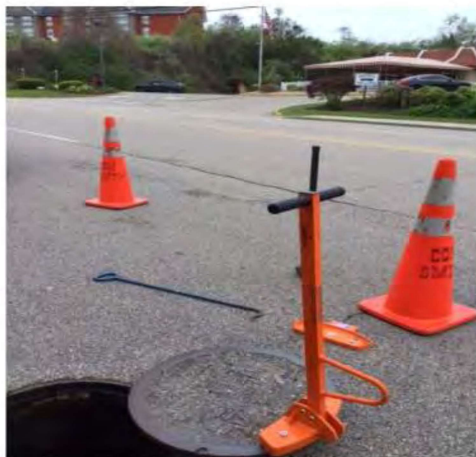
GIS MH No: 1-289

Location in MH	Mtrl. Code	Infil. Code	Cond. Code	Repair Codes	Comments
Frame/Cover	CAST IRON	STAINS	BROKEN	REPLACE FRAME AND COVER	
Chimney	BRICK	NONE	DEFECTIVE	LINE MANHOLE	CORRODED
Cone	CONCRETE (PRECAST)	NONE	DEFECTIVE	LINE_MANHOLE	CORRODED
Wall	CONCRETE (PRECAST)	NONE	DEFECTIVE	LINE_MANHOLE	CORRODED
Bench	BRICK	NONE	SOUND	NONE	
Invert/Channel	BRICK	NONE	SOUND	NONE

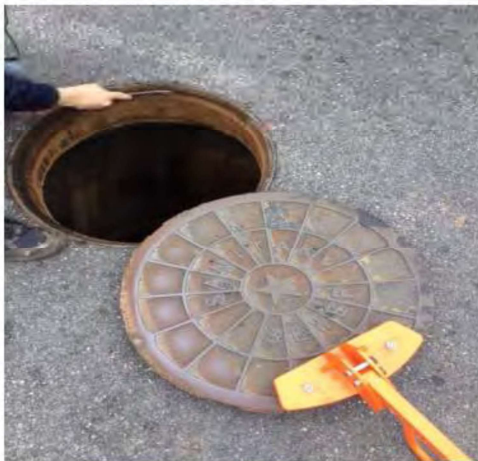
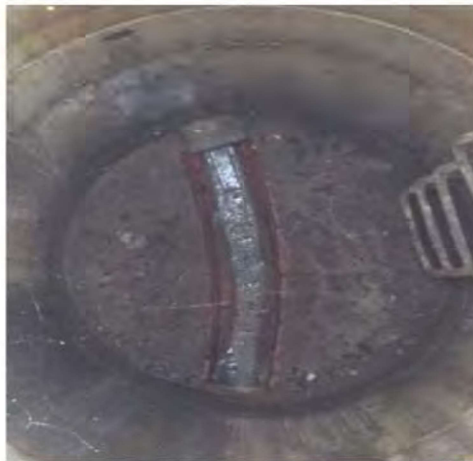
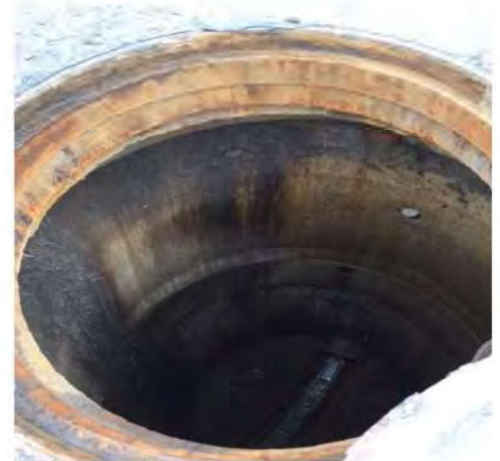
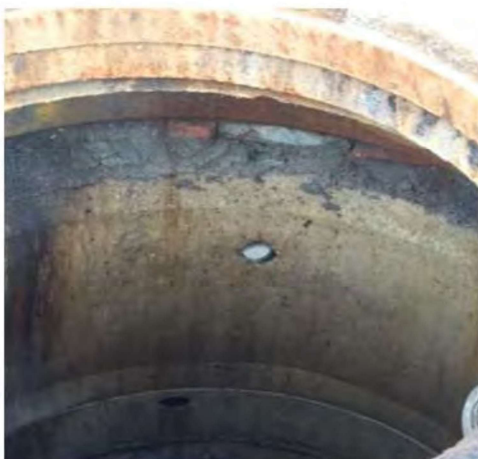
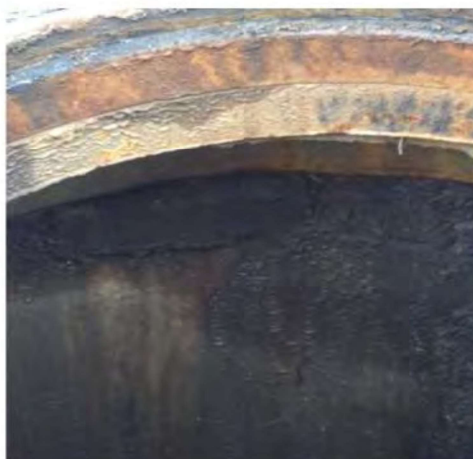
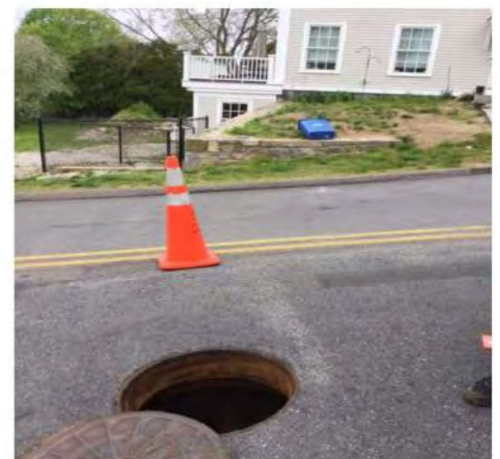
Location in MH	Mtrl. Code	Infil. Code	Cond. Code	Repair Codes	Comments
Frame/Cover	CAST IRON	WEEPER	SOUND	NONE	
Chimney	BRICK	NONE	DEFECTIVE	REBUILD TOP, REPLACE FRAME AND CHIMNEY	CHIKNEY MATERIAL BEGINNING TO BE DISPLACED.
Cone	CONCRETE (PRECAST)	NONE	SOUND	NONE	
Wall	CONCRETE (PRECAST)	NONE	SOUND	NONE	
Bench	BRICK	NONE	SOUND	NONE	
Invert/Channel	BRICK	NONE	SOUND	NONE

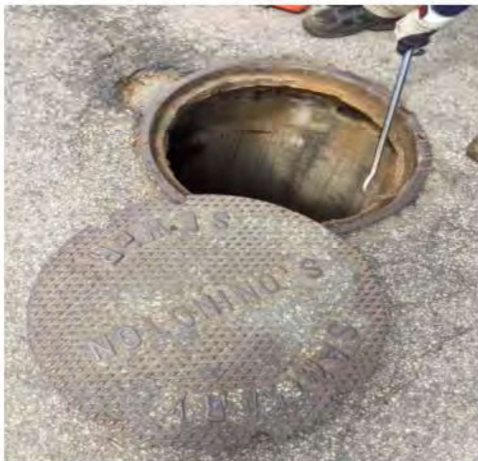
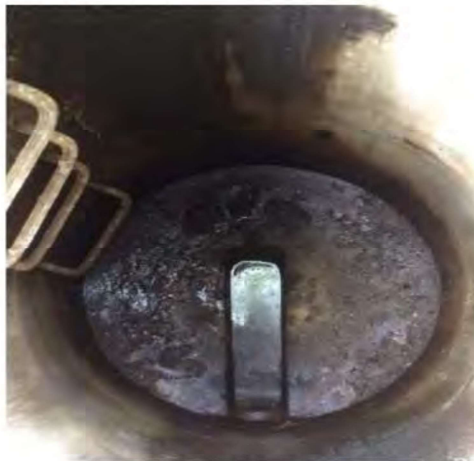
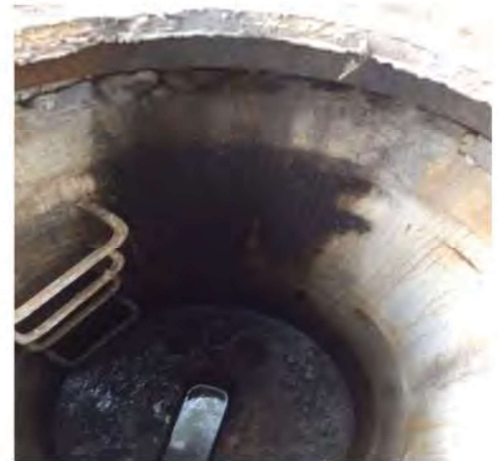
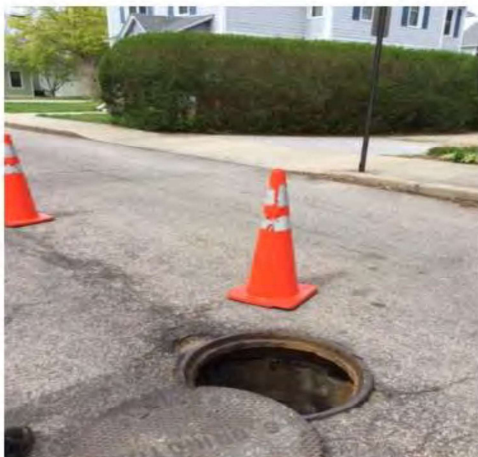
Location in MH	Mtrl. Code	Infil. Code	Cond. Code	Repair Codes	Comments
Frame/Cover	CAST IRON	WEEPER	SOUND	REPLACE FRAME AND COVER	LOTS OF INFLOW
Chimney	BRICK	NONE	SOUND	NONE	
Cone	CONCRETE (PRECAST)	NONE	SOUND	NONE	
Wall	CONCRETE (PRECAST)	NONE	SOUND	NONE	
Bench	BRICK	NONE	SOUND	NONE	
Invert/Channel	BRICK	NONE	SOUND	NONE

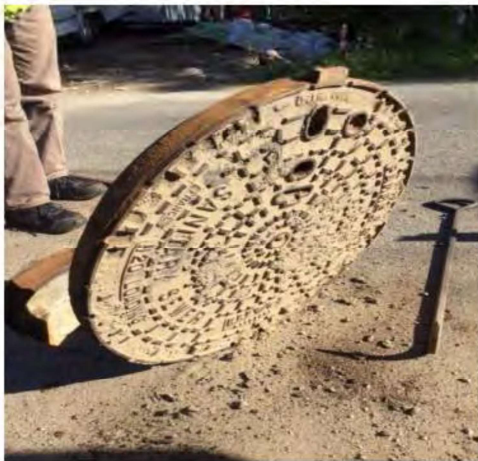
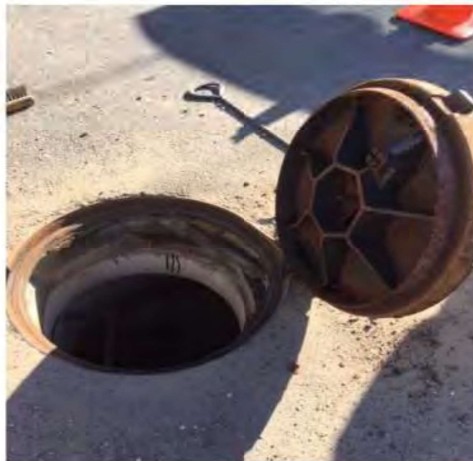
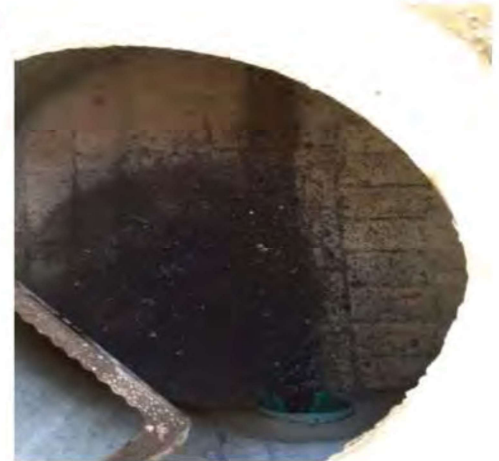
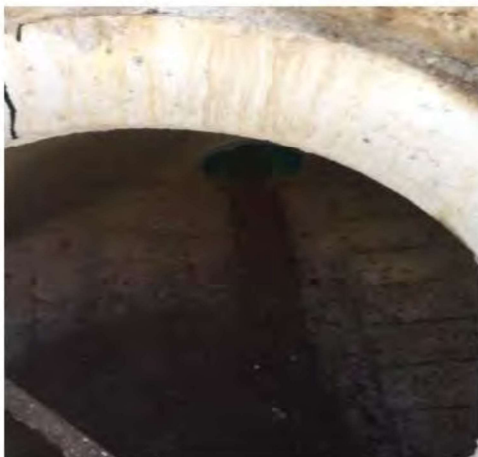
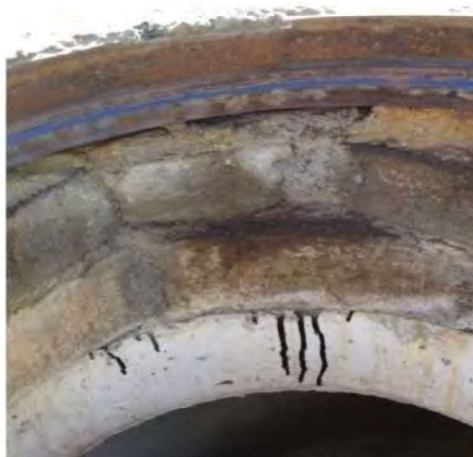
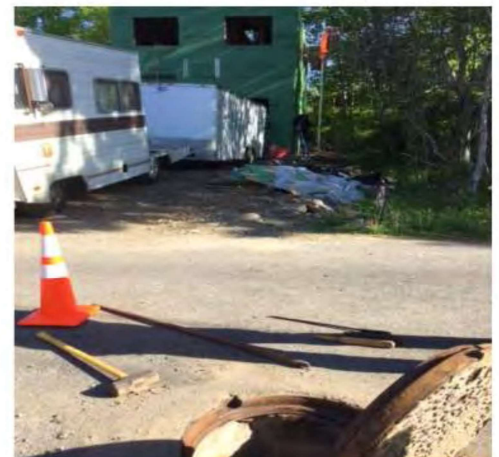
Location in MH	Mtrl. Code	Infil. Code	Cond. Code	Repair Codes	Comments
Frame/Cover	CAST IRON	NONE	SOUND	REPLACE FRAME AND COVER	
Chimney	CONCRETE BLOCK	NONE	SOUND	NONE	
Cone	CONCRETE (PRECAST)	NONE	SOUND	NONE	
Wall	CONCRETE (PRECAST)	NONE	SOUND	NONE	
Bench	BRICK	NONE	SOUND	NONE	
Invert/Channel	BRICK	NONE	SOUND	NONE

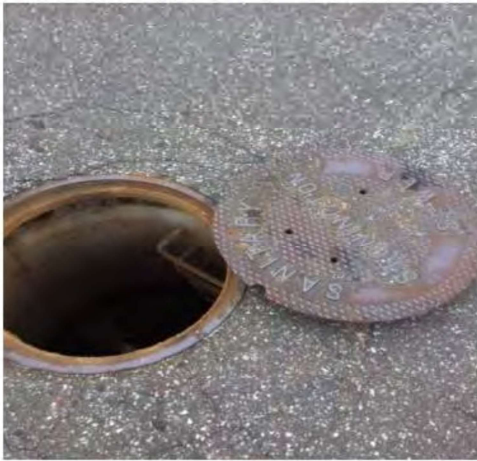
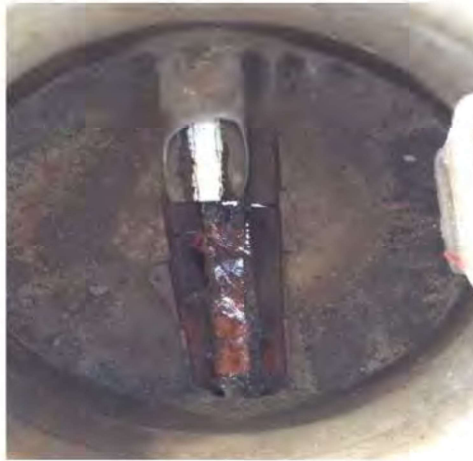
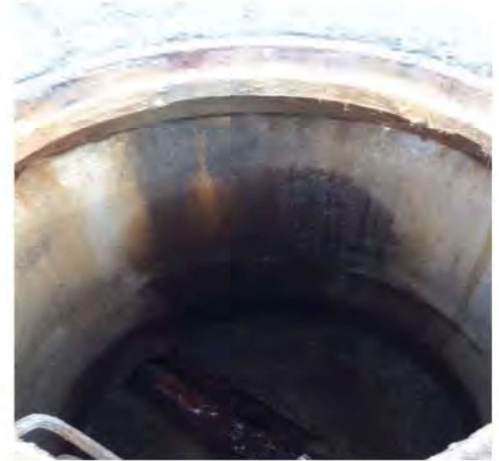
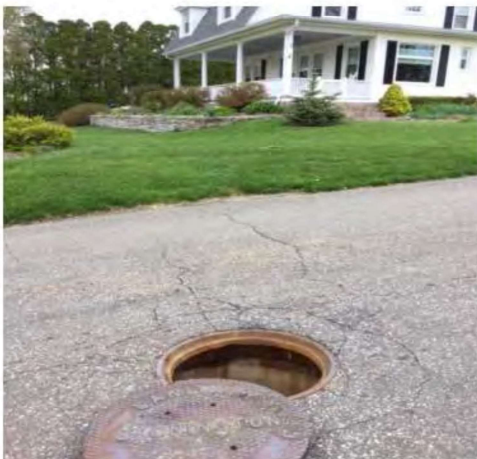
Location in MH	Mtrl. Code	Infil. Code	Cond. Code	Repair Codes	Comments
Frame/Cover	CAST IRON	NONE	SOUND	NONE	
Chimney	BRICK	NONE	SOUND	NONE	
Cone	CONCRETE (PRECAST)	STAINS	DEFECTIVE	LINE_MANHOLE	
Wall	CONCRETE (PRECAST)	STAINS	DEFECTIVE	LINE_MANHOLE	
Bench	BRICK	NONE	SOUND	NONE	
Invert/Channel	BRICK	NONE	SOUND	NONE
