### Mystic Area Dye Water Testing Results

# DYED-WATER FLOODING

STONINGTON, CONNECTICUT 06355

OCTOBER 2022  
MCA PROJECT NO.: 2021-335

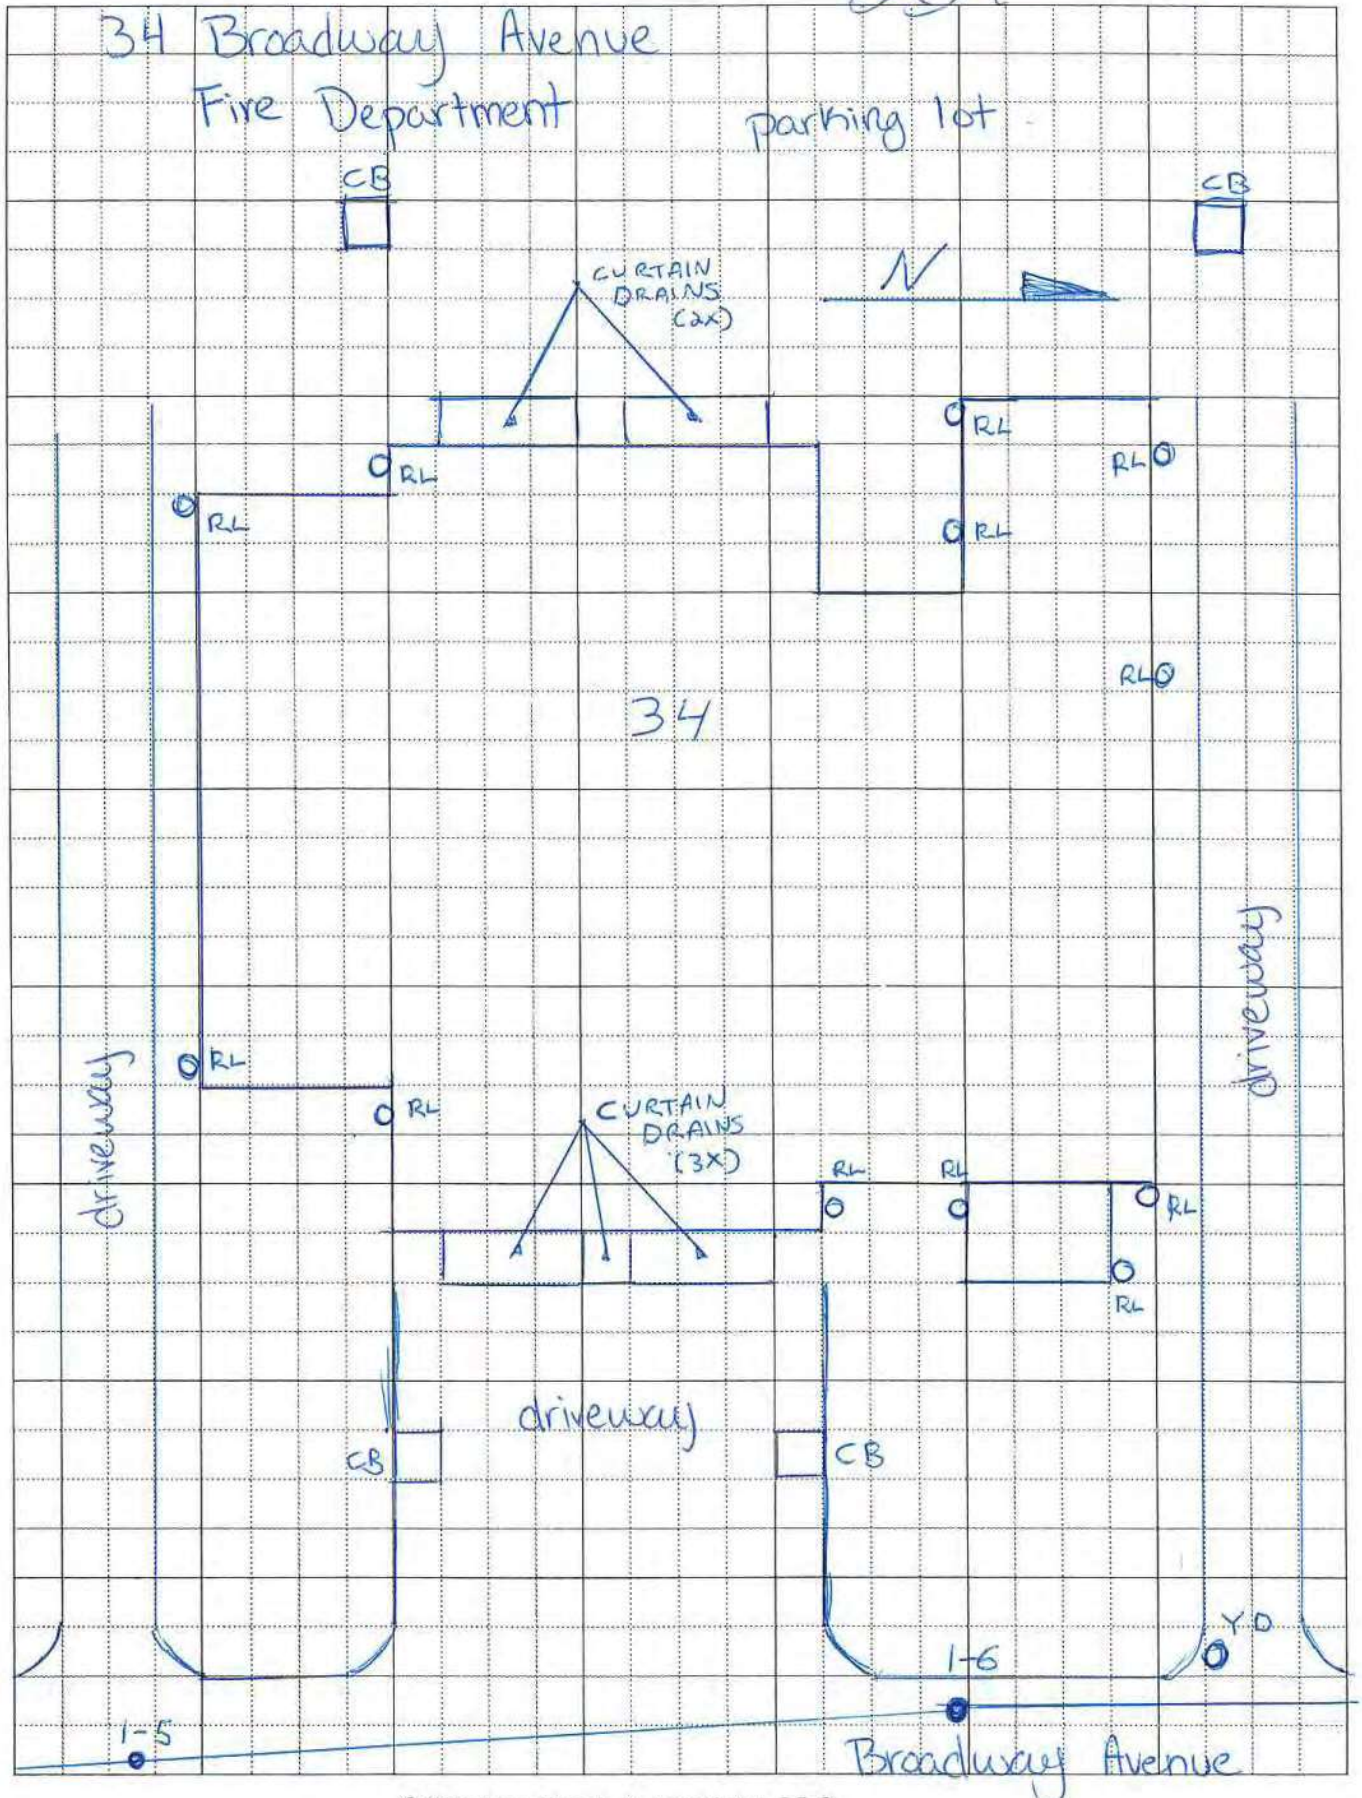
34 Broadway Avenue

\* All roof leaders (12) go into ground and drain to the storm drainage system. They all connect to the CB's throughout the parking lot

\* The 5 curtain drains at the fronts of the garage bay doors drain into the storm drainage system. They all connect and drain to the CB's in the parking lot.

\* The 1 yard drain connects to the CB in the front driveway in front of the truck bay doors

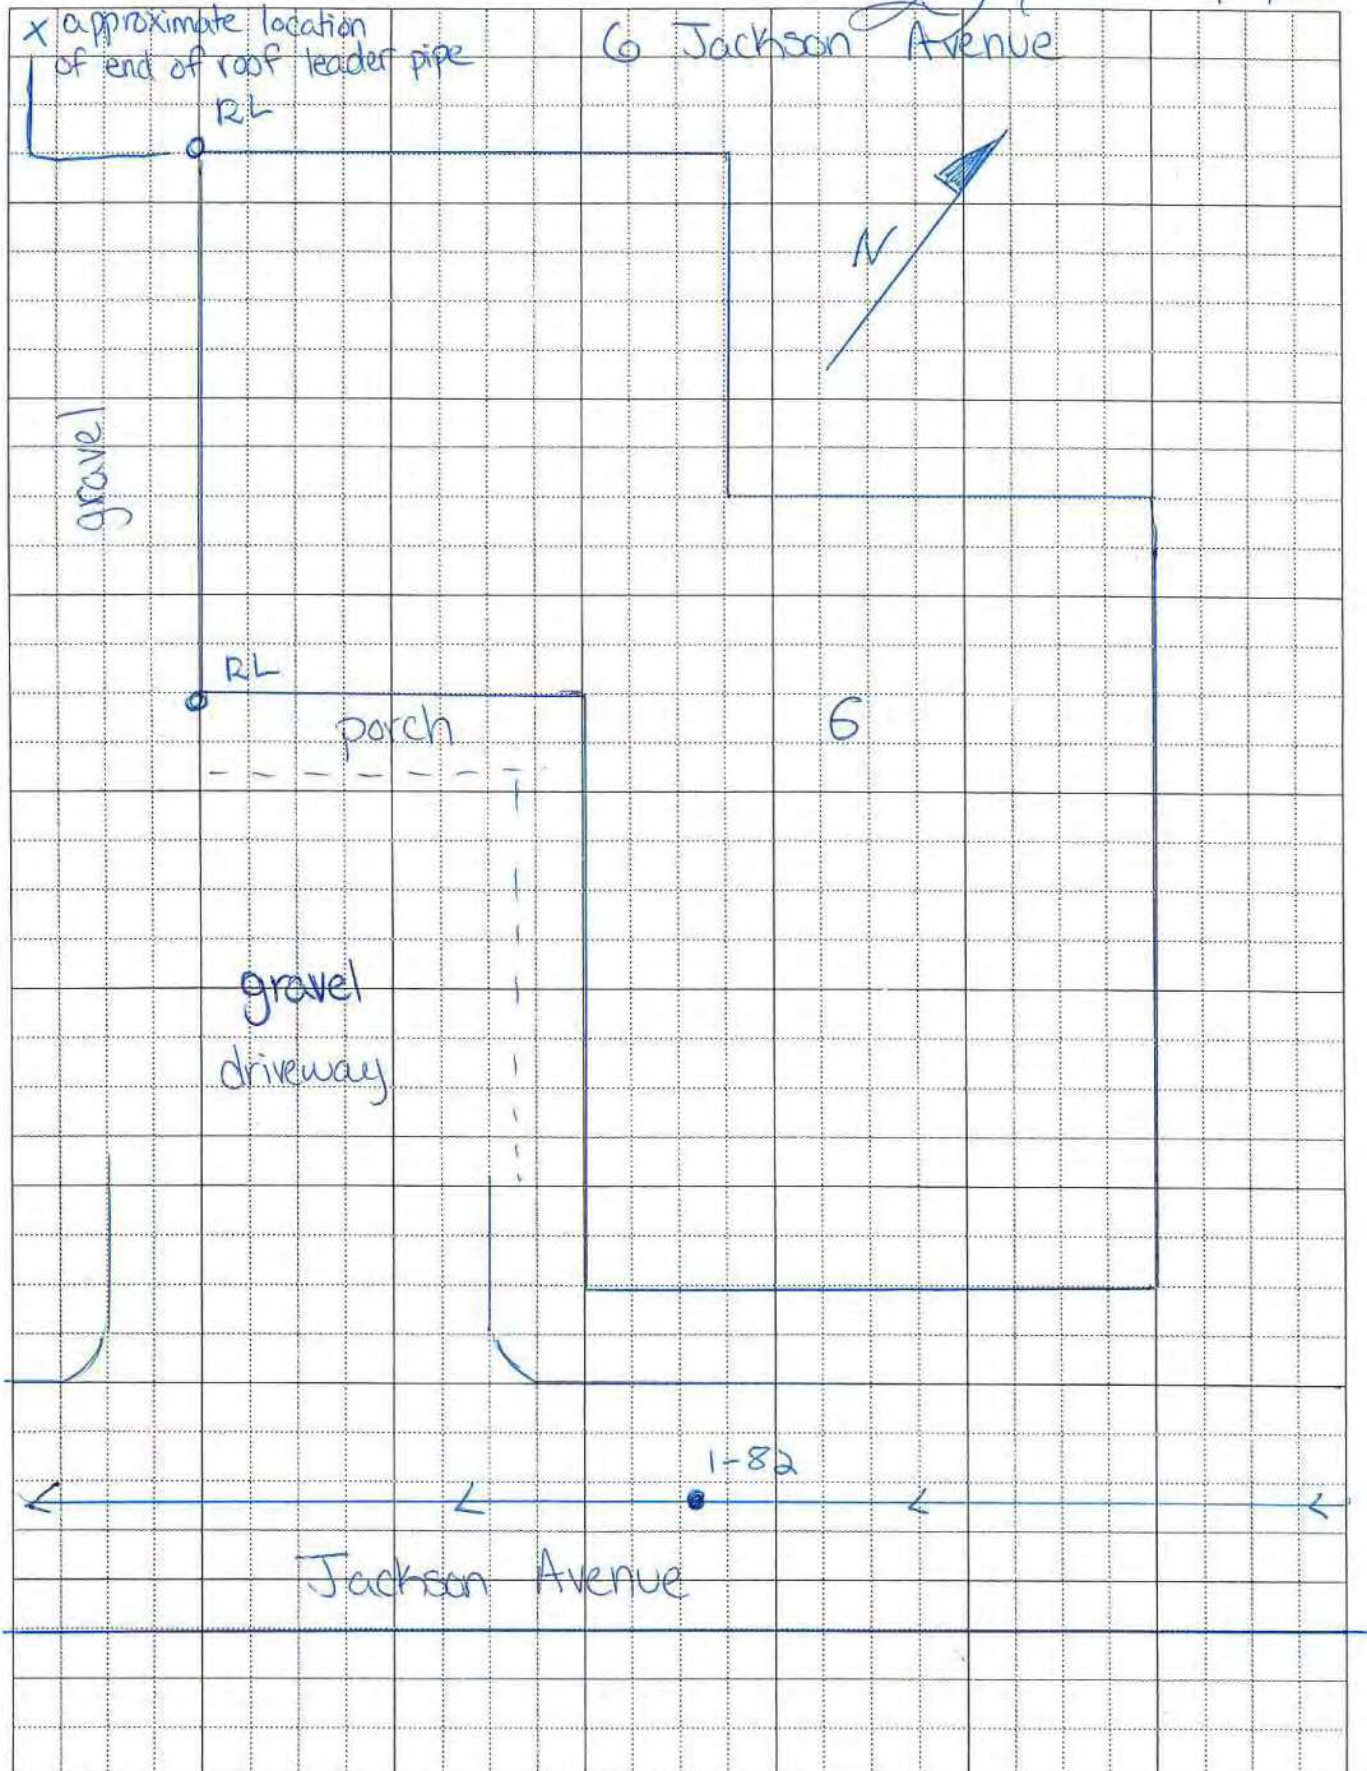
6 Jackson Avenue

\* Roof leaders connect and dye was observed  
at end of roof leader extension pipe in ground,  
exits at end of gravel driveway in yard.  
See photos

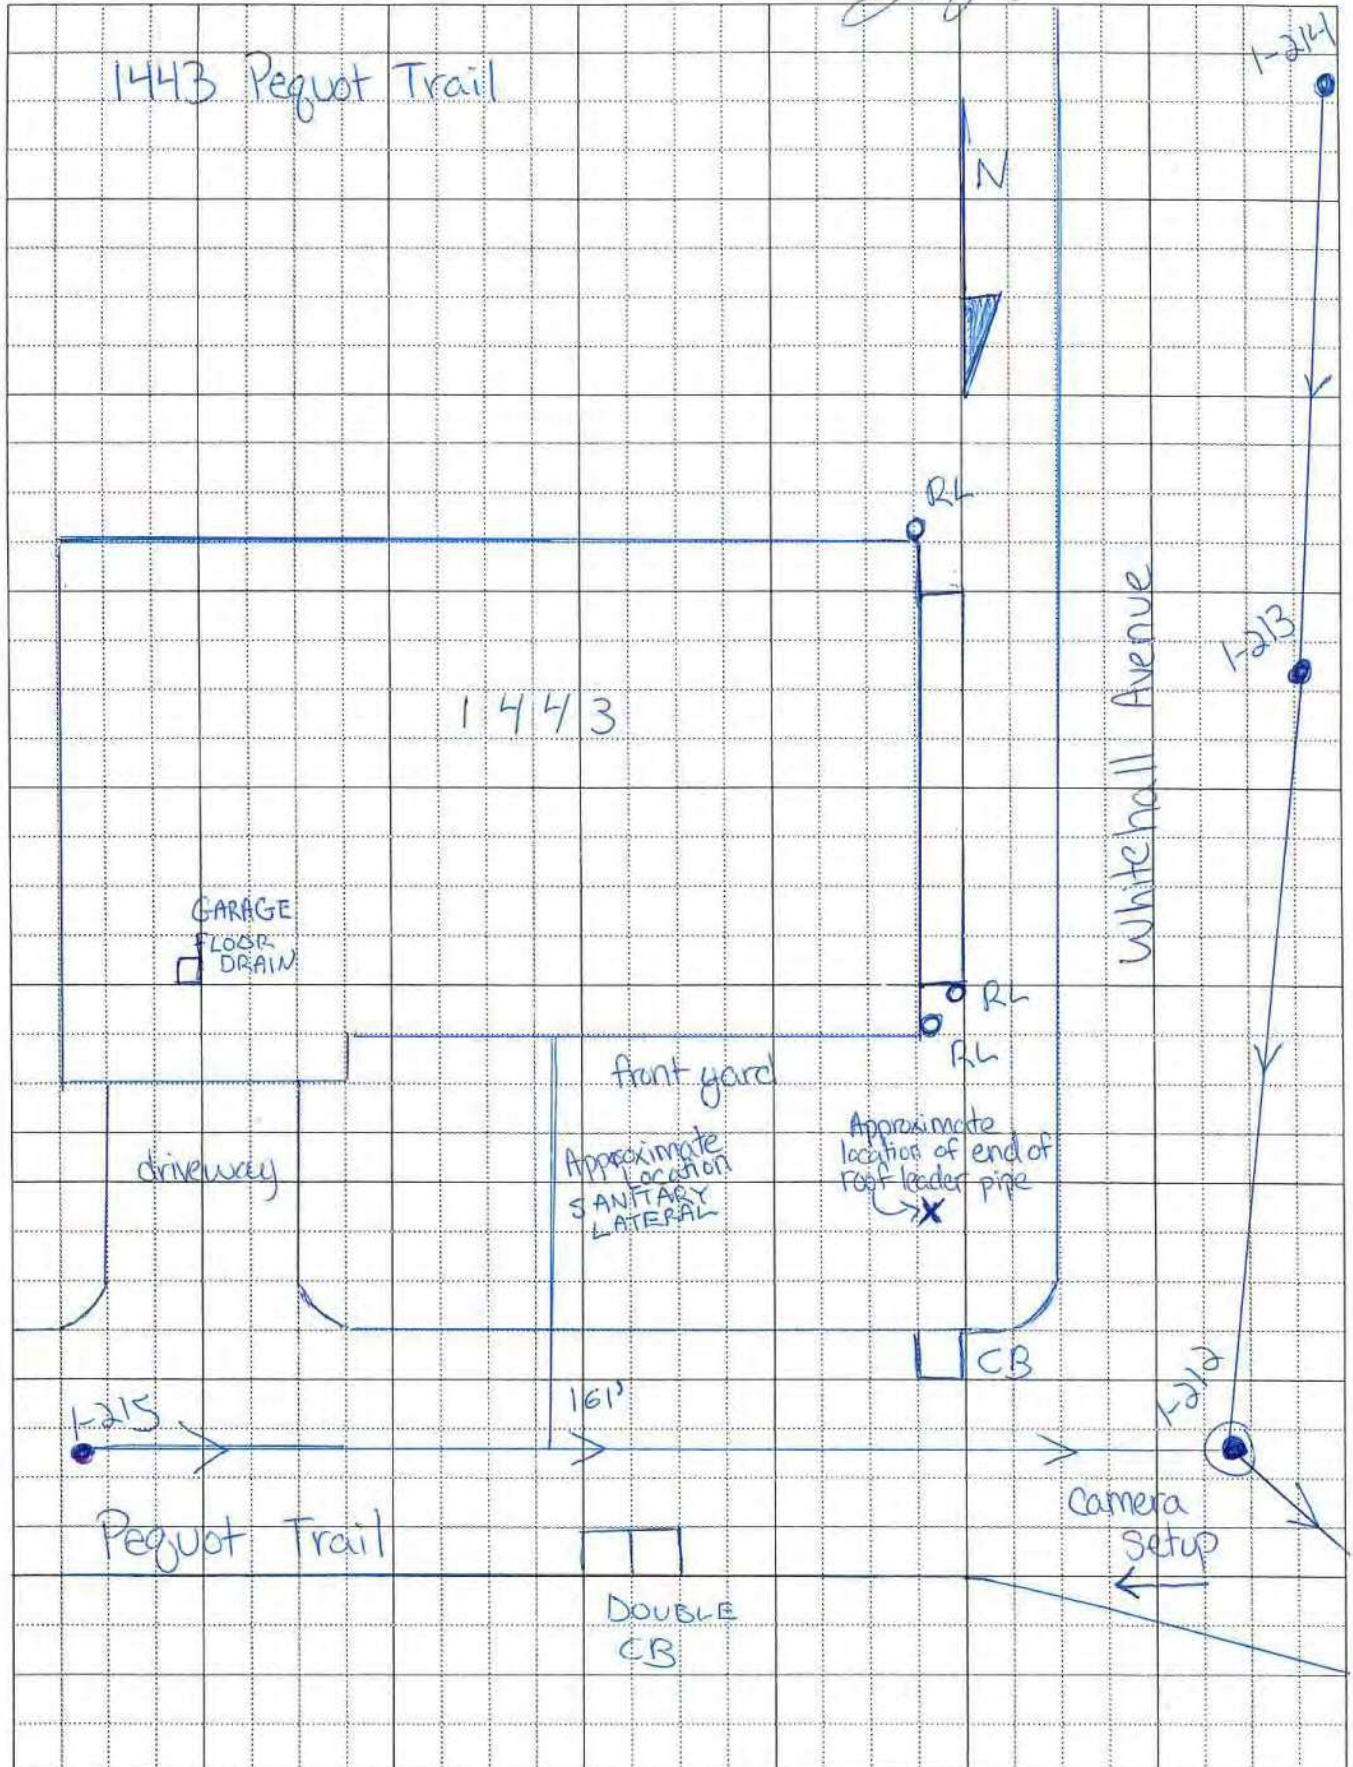
1443 Peguot Trail

\* 3 Roof leaders on West side of house connect and exit in grass of front yard through roof leader piping. See photos

\* Filled garage floor drain with green dye and several gallons of water. Did not observe any dye in setup MH 1-212 or throughout the line heading towards MH 1-215. No dye visible in any CB's or in sanitary lateral or driveway. CB's filled with water and debris at time of testing. Floor drain continued to drain throughout testing, no back ups.

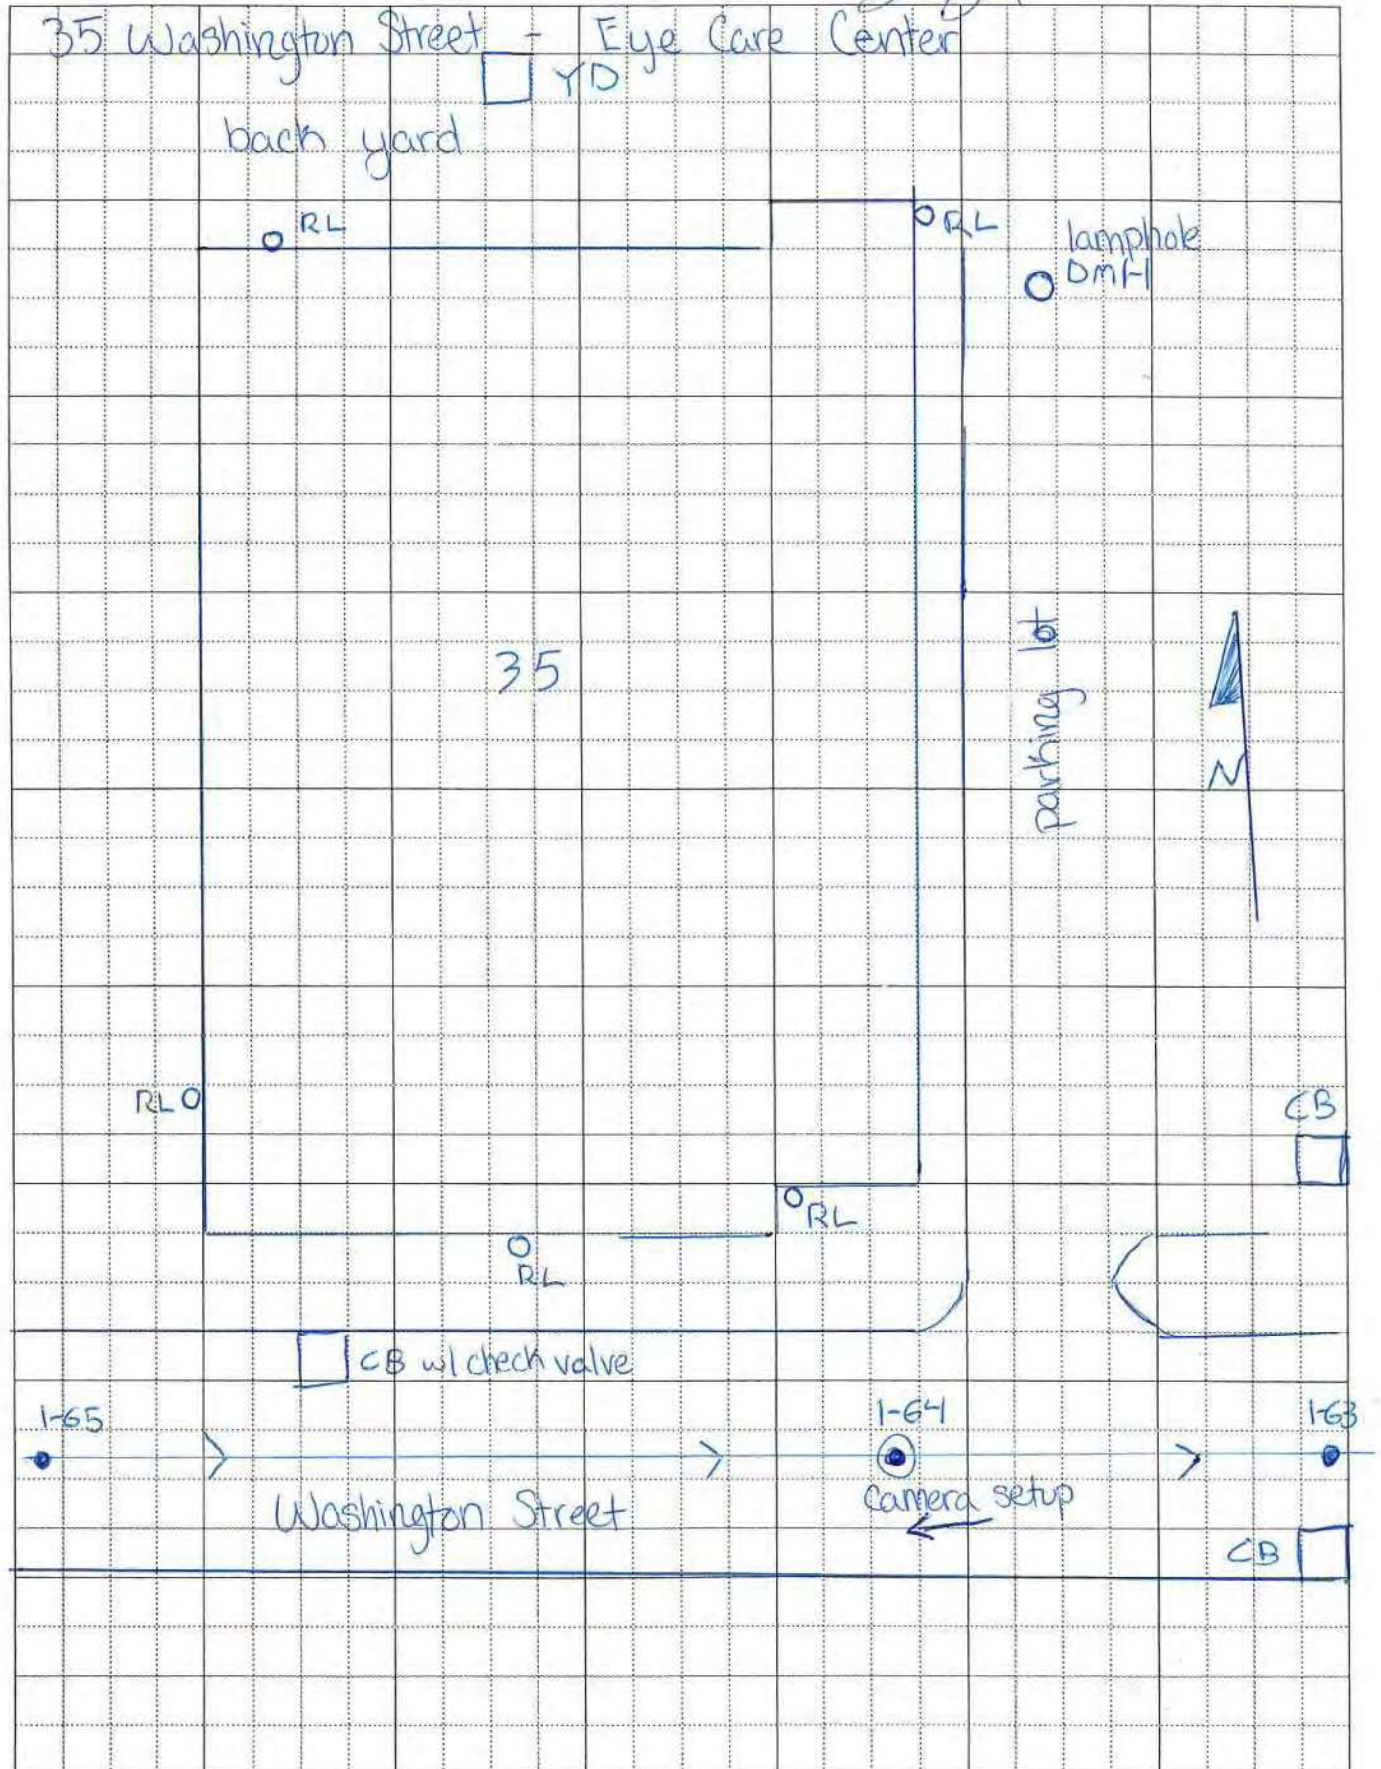
35 Washington Street

- \* All roof leaders(5) go into ground and connect to storm drainage system. Building owner confirmed that all roof leaders connect to drainage lamp hole manhole in parking lot, which leads to CB in Southeastern corner of parking lot. CB drains to CB in street.
- \* Yard drain in back yard of property connects to CB with check valve in street. The town required the building owner to route all roof leaders to storm drains.
- \* Stonington WPCA was present for testing
- \* Dan from WPCA informed that CB's in street are full due to the tidal flows. The water backs up from the waterways during tidal events. All were full during time of testing

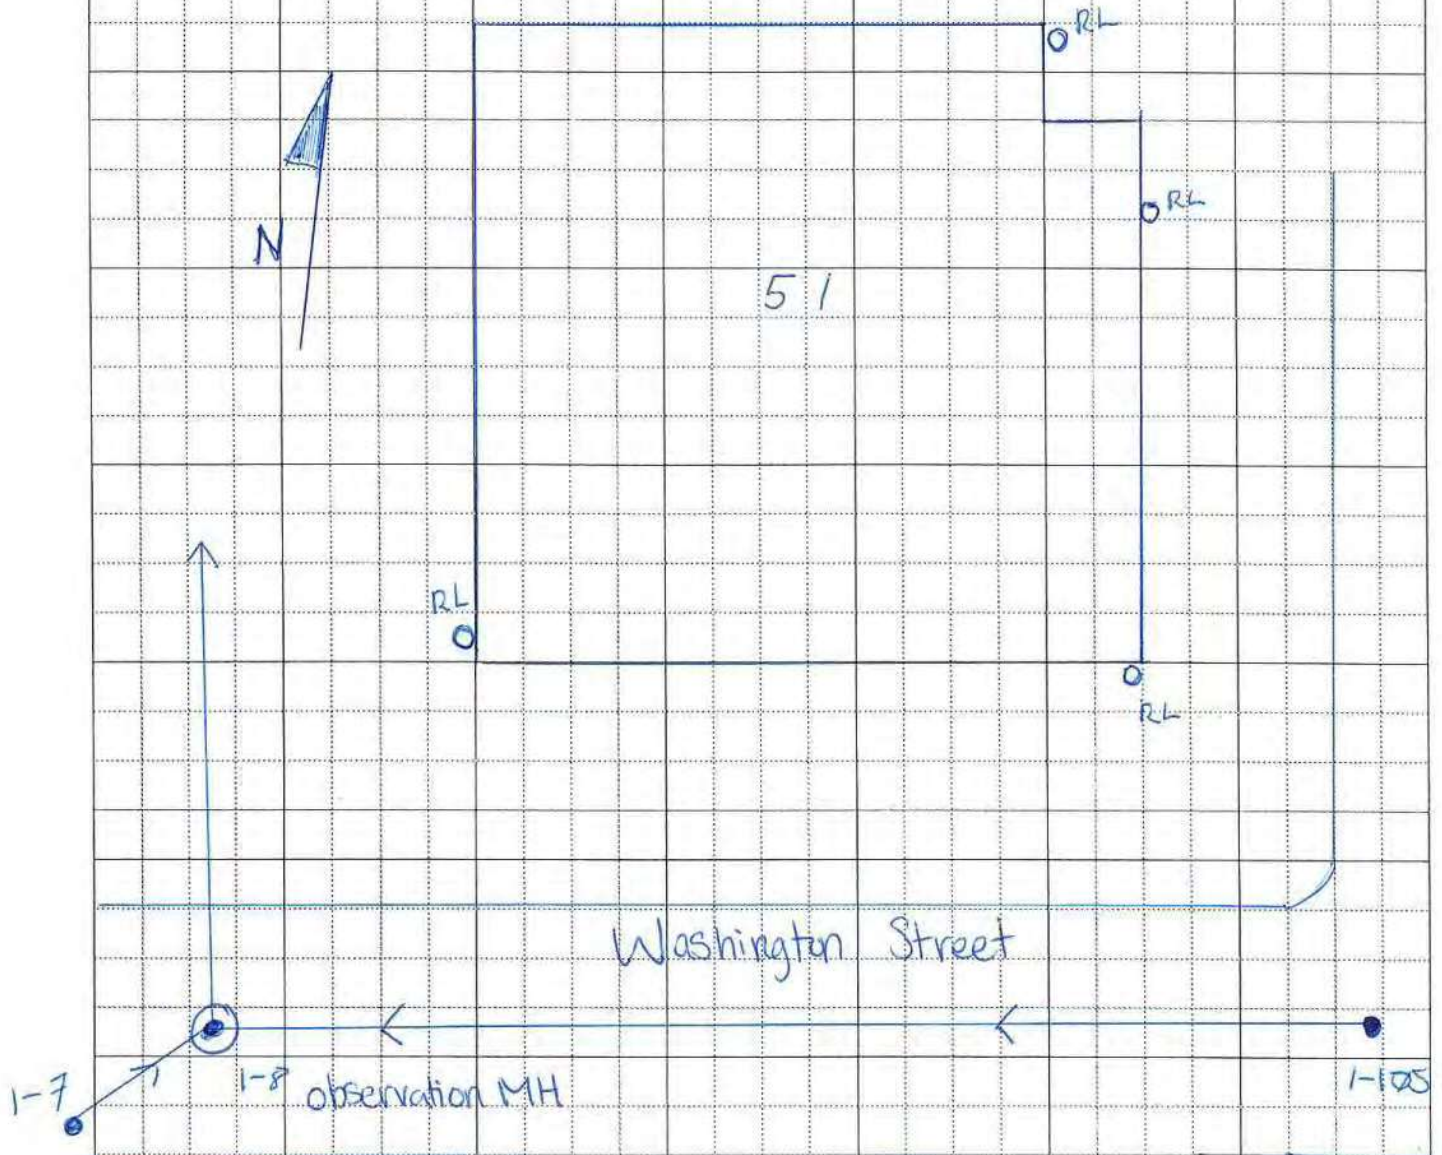
51 Washington Street

No dye visible in observation manhole. flex pipes at ends of roof leaders disperse into ground in front and back yard. we stuck the hose down the pipes about 1 ft - 1.5 ft before hitting dirt.

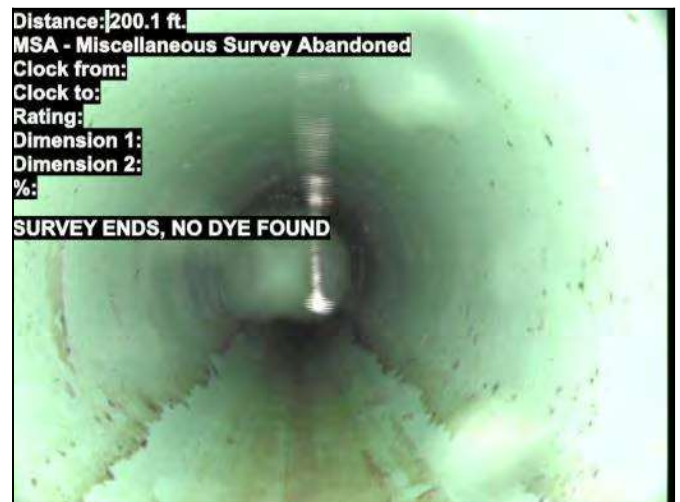
Distance: 200.1 ft.  
MSA - Miscellaneous Survey Abandoned  
Clock from:  
Clock to:  
Rating:  
Dimension 1:  
Dimension 2:  
%:  
SURVEY ENDS, NO DYE FOUND  
Photo: 1-215-1-212-20221025-091723-093532.JPG  
At: 200.053 ft. MSA - Miscellaneous Survey Abandoned  
Joint: No SURVEY ENDS, NO DYE FOUND
