Phase 2: Sanitary Sewer Evaluation Survey Mystic Area Investigations and Report

Town of Stonington, CT

Water Pollution Control Authority

JULY 2023

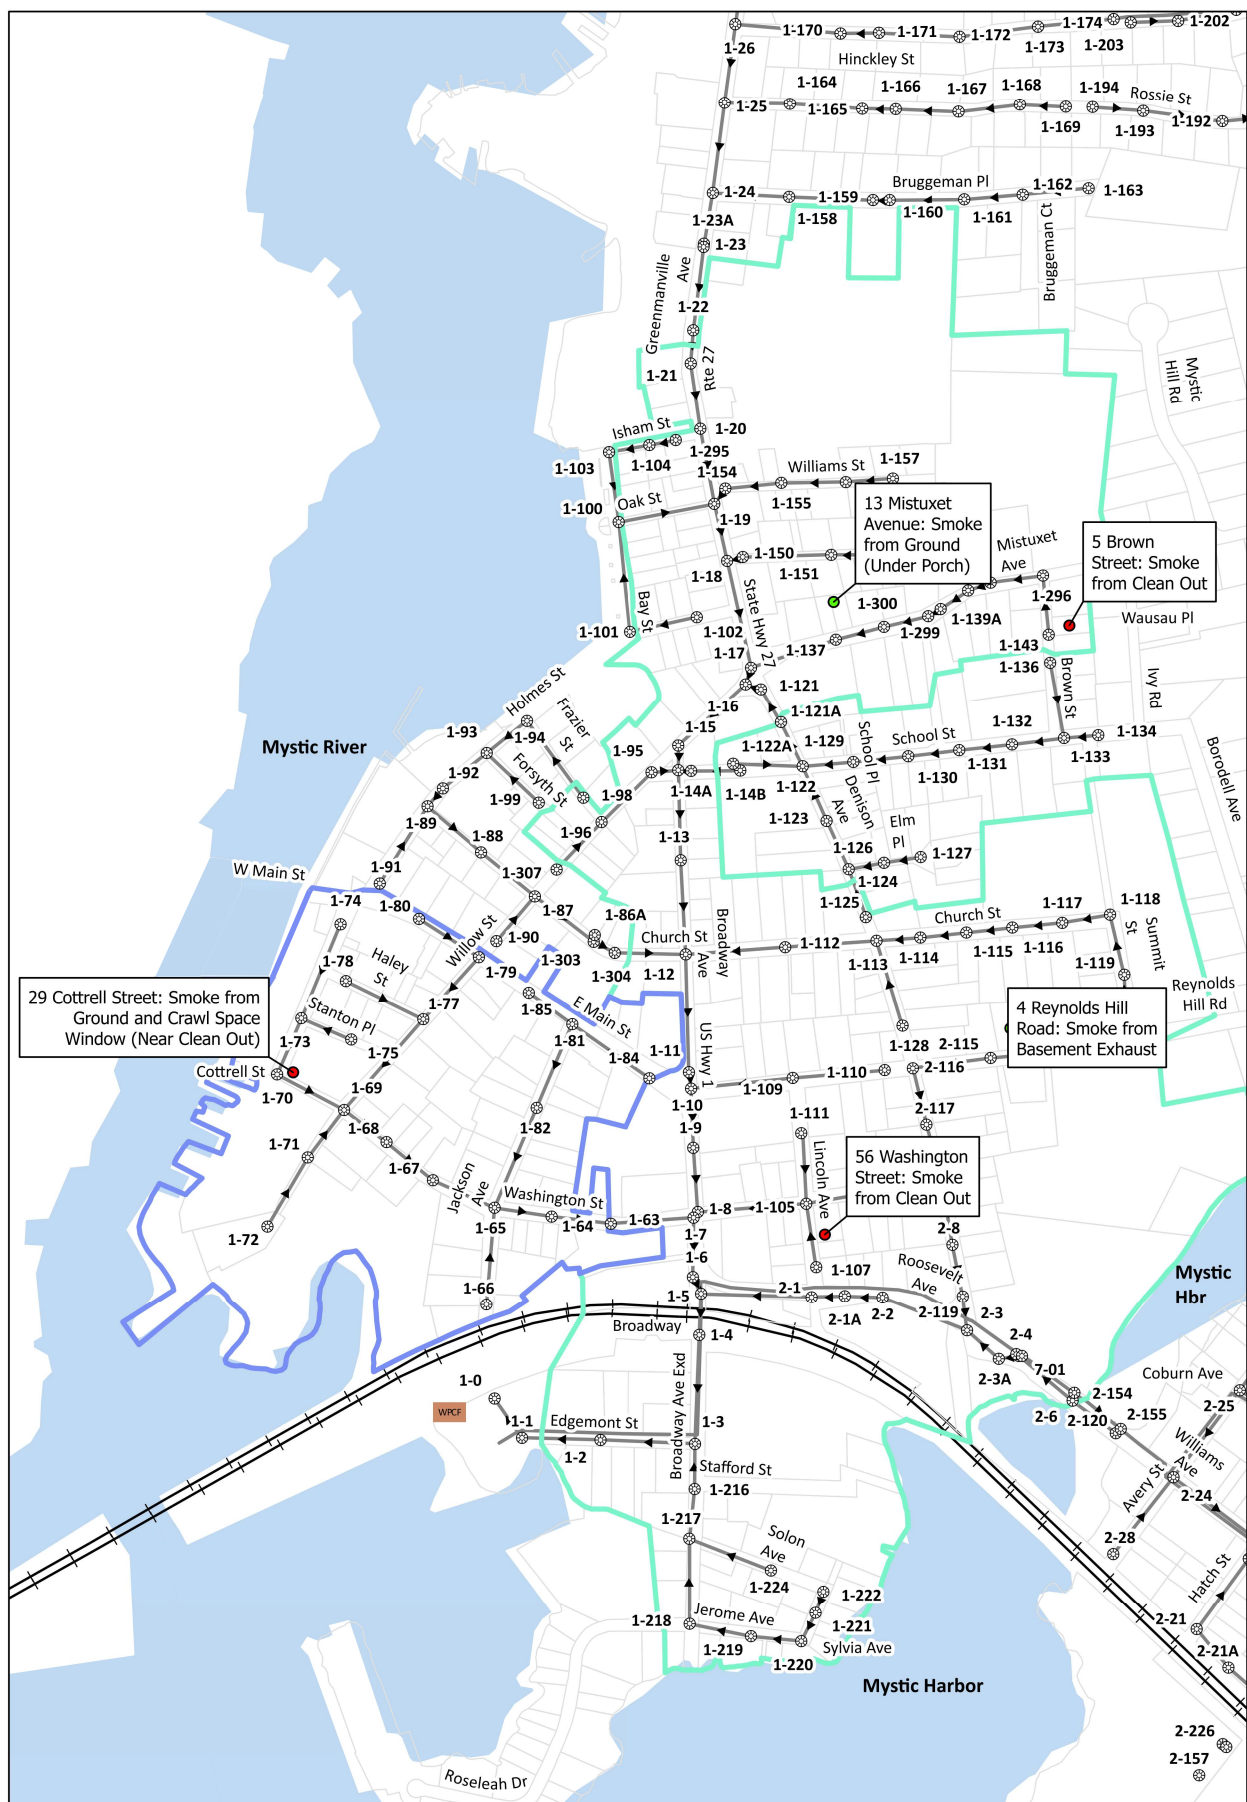
Location	Sewershed Area	Inflow Type	Private/ Public Property	Source of Smoke	Recommendation
5 Brown Street	M-08	Direct	Private	Clean out	Town to notify owner to fix broken cleanout
13 Mistuxet Avenue	M-08	Indirect	Private	Ground (under porch)	No building inspection previously completed, Town to complete building inspection in basement to look for potential source(s)
4 Reynolds Hill Road	M-08	Indirect	Private	Basement exhaust	No building inspection previously completed, Town to complete building inspection in basement to look for potential source(s)
56 Washington Street	M-08	Direct	Private	Clean out	Town to notify owner to fix broken cleanout
29 Cottrell Street	M-09	Indirect	Private	Ground & crawl space window near clean out	Building inspection previously completed, Town to complete additional building inspection in basement to look for potential source(s)

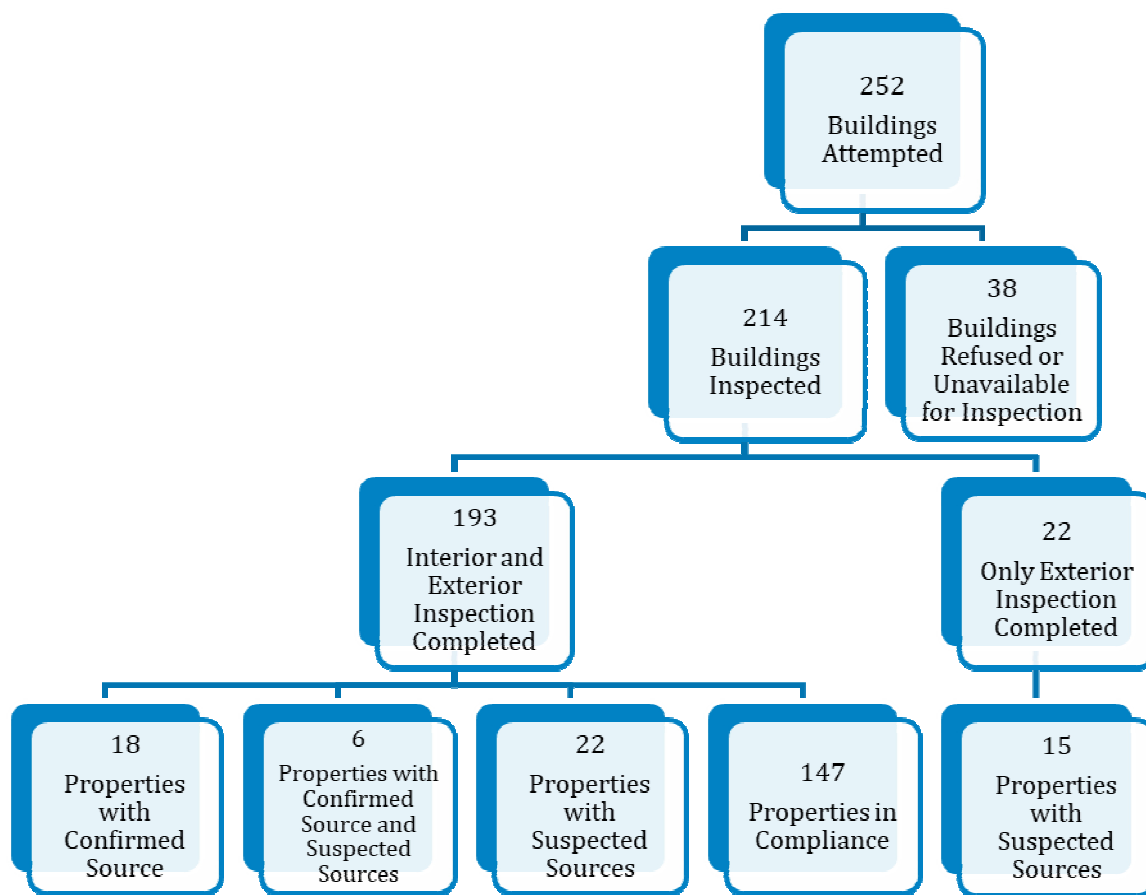
Figure 5-1
Summary of Building Inspections Results

Figure 5-1 on the next page shows a summary of the results. Following the figure, **Table 5-1** includes a detailed summary of observations, which includes roof leaders discharging into the ground, drains, and sump pumps. **Table 5-1** is sorted alphabetically by street name and then by address. **Figure 5-2**, **Figure 5-3** and **Figure 5-4** following this section, show the locations and results provided in **Table 5-1** by sewershed. Additional detailed information on building inspections, including sketches and photos, can be found in Appendix D.

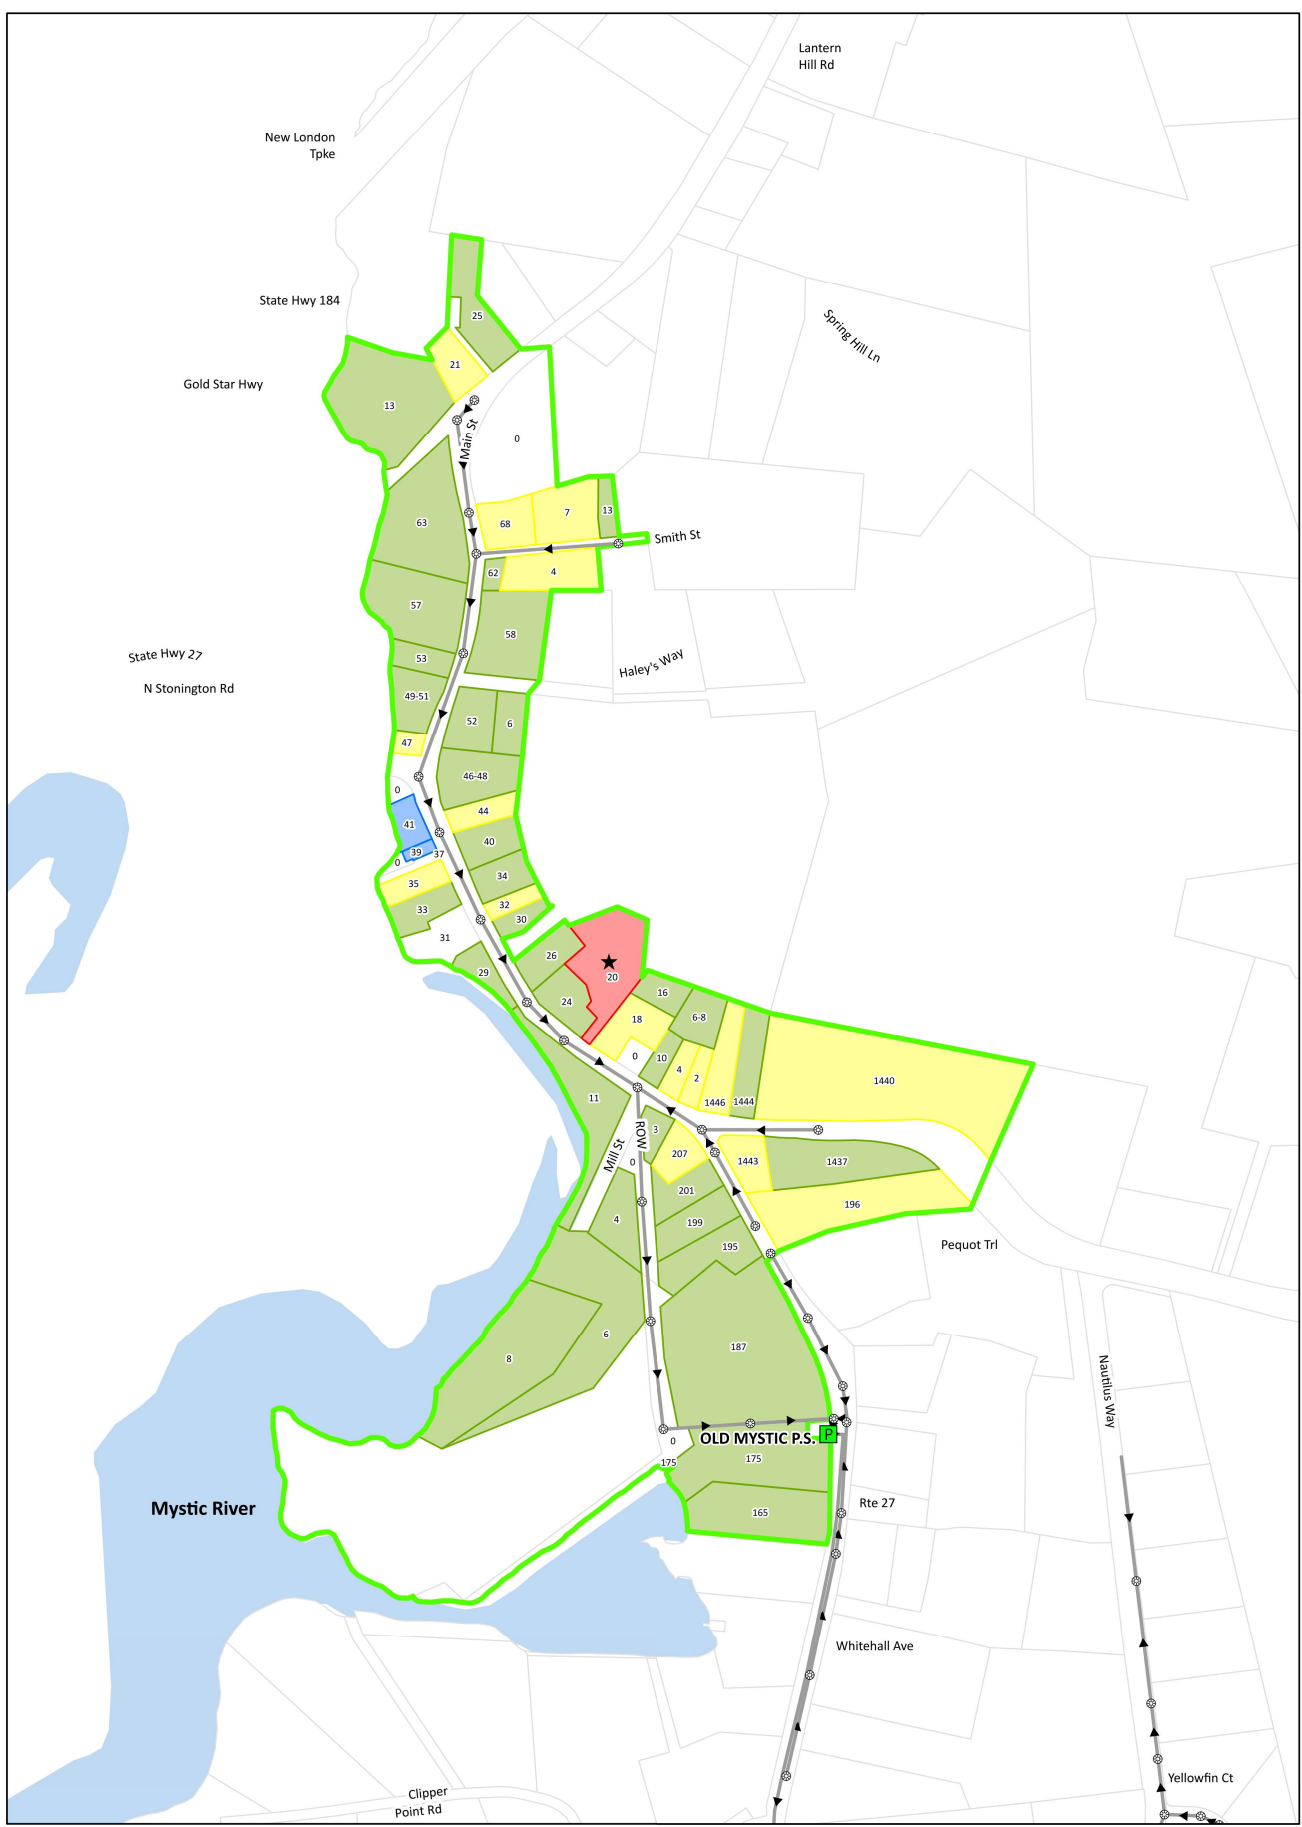
Town of Stonington, Connecticut
 Sanitary Sewer Evaluation Survey
 Building Inspection Results in Sewershed M-01
 July 2023
 Figure 5-2

Address	Description
10 Alden Street	One sump pump to sanitary sewer
7 Broadway Avenue Ext	One sump pump to sanitary sewer
51 Church Street	Two sump pumps to sanitary sewer
27 Cottrell Street	One sump pump to sanitary sewer
14 Denison Avenue	One sump pump to sanitary sewer
18 Denison Avenue	One sump pump to sanitary sewer
39 Denison Avenue	One sump pump to sanitary sewer
22 East Main Street	One sump pump to sanitary sewer
15 Edgemont Street	One sump pump to sanitary sewer
9 Haley Street	One sump pump to sanitary sewer
6 Jackson Avenue	One sump pump to sanitary sewer
2 Lincoln Avenue	One sump pump to sanitary sewer
20 Main Street	One sump pump to sanitary sewer
