Phase I Environmental Site Assessment

**Pawcatuck Neighborhood Center
27 Chase Street
Pawcatuck, Connecticut**

March 6, 2006
FSS Project # 28105

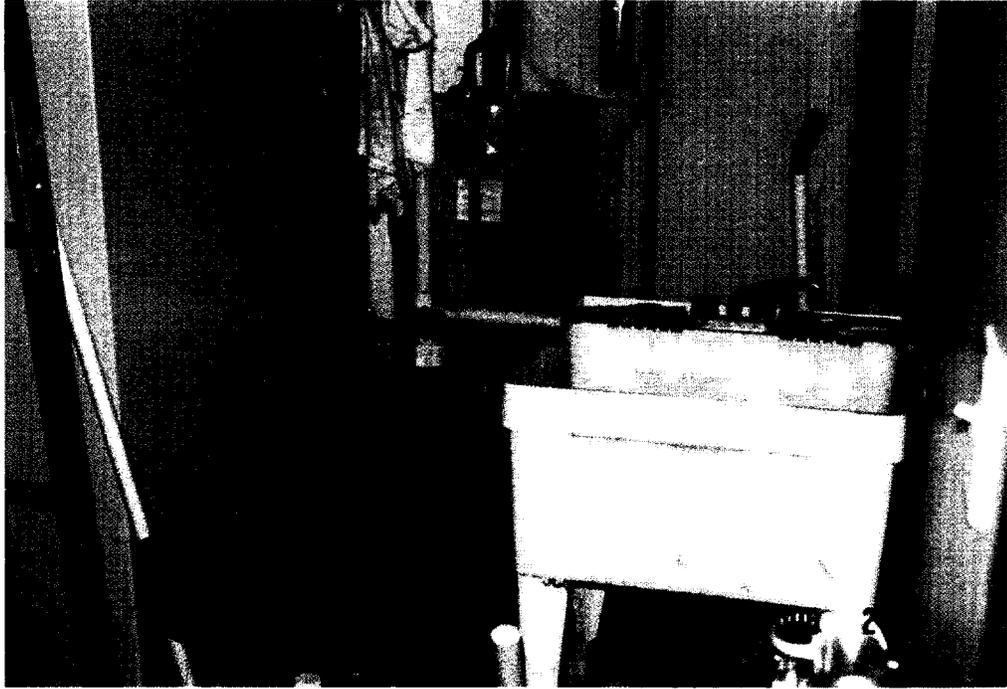
View of first floor utility room. Slop sink, water heater and original oil furnace.

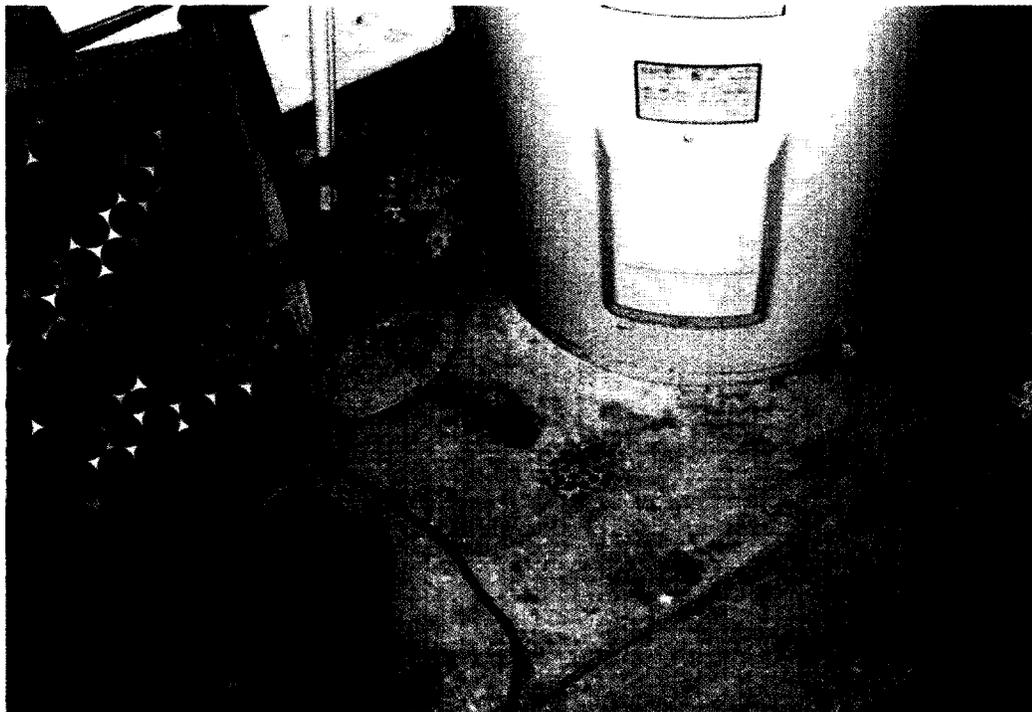
Close up of floor drain by water heater.

One floor drain was observed in the utility room located on the first floor. No sumps or drywells were indicated through interior/exterior site inspection or reported by the site contact. The utility room contains a slop sink and a hot water heater. The discharge location for the floor drain is presumed to be the sanitary sewer.

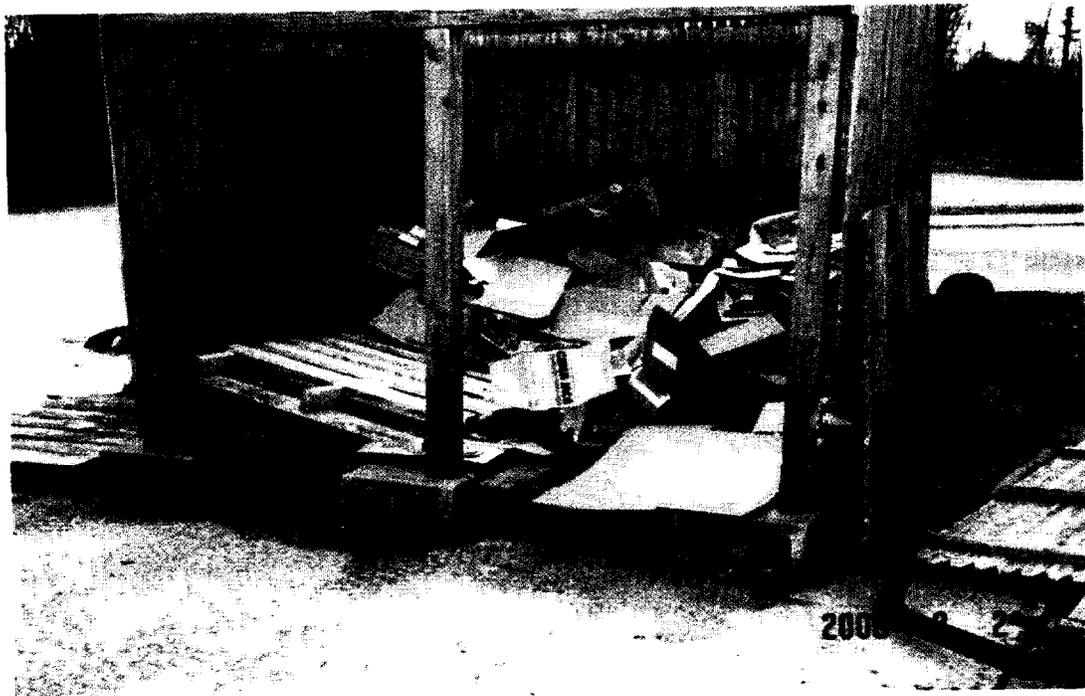
Card board storage area outside the south end of the building.

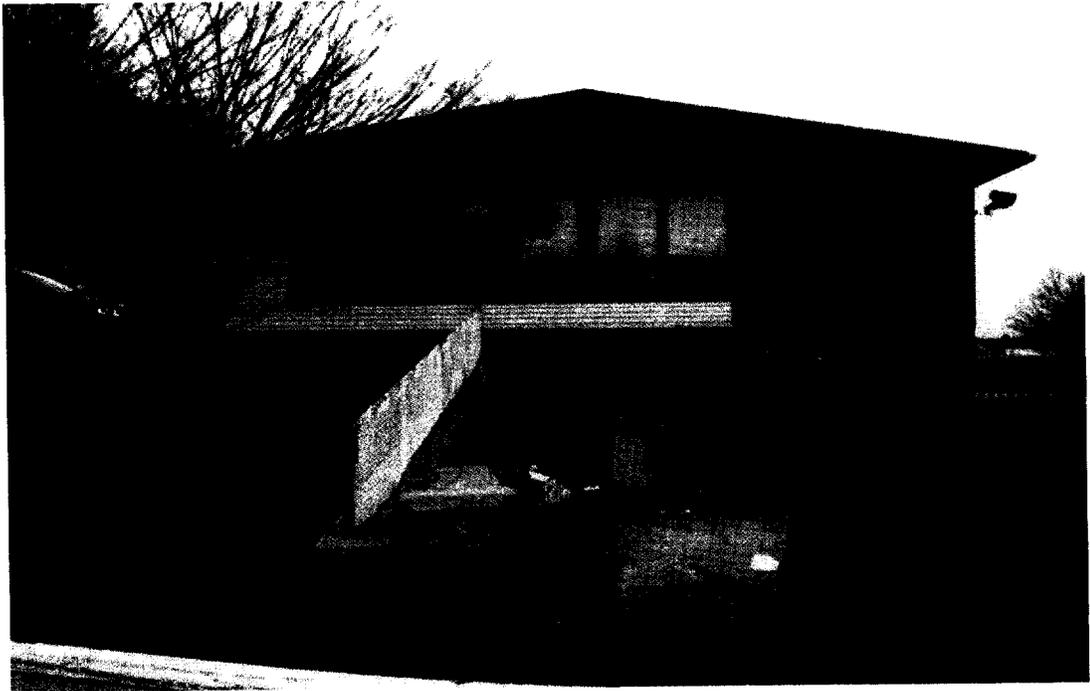
South end of the building, area of the proposed Senior Center Annex addition.

Pink painted trim visible.

- Lead paint, asbestos containing building materials (ACBM), radon and mold samples were collected and analyzed. The ACBM sample results indicated the absence of asbestos containing materials. Radon results were acceptable and below recommended action levels. Mold was present in the existing oil storage tank room and on the exterior clapboard siding. Lead containing paint was identified on the hand railing for the rear entrance to the second floor exercise room. The pink painted exterior wood trim will need to be retested for lead paint concentration.

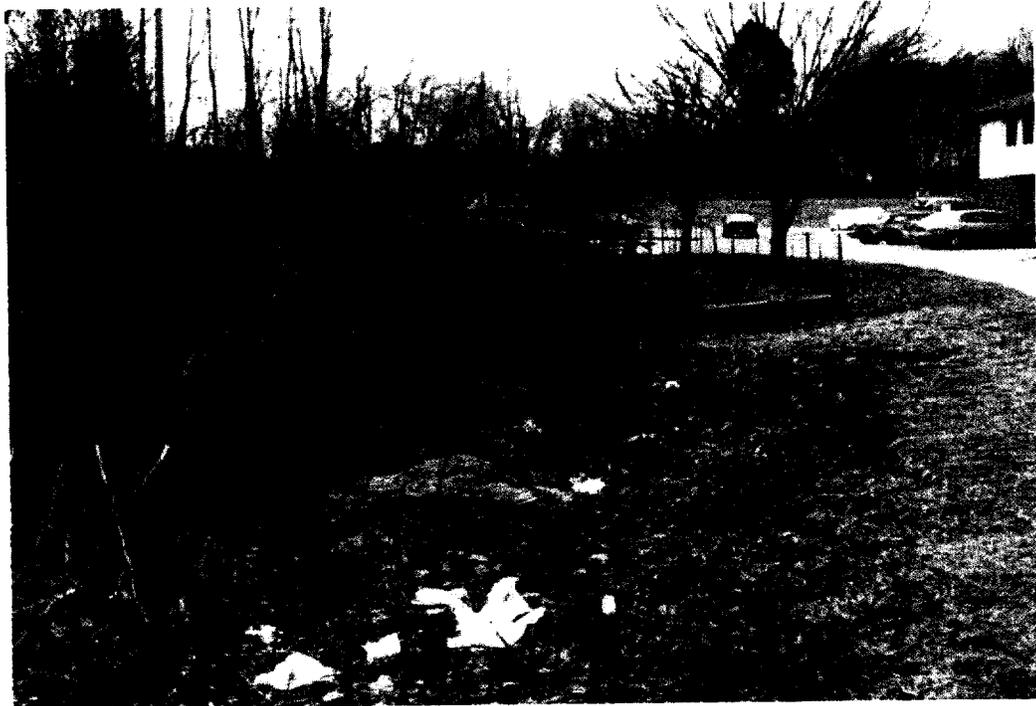
The Undeveloped Thavanet Machine/Grinding Shop property abutting the northeast corner of the site.

- The subject site was not listed on any of the State and Federal environmental databases searched for this assessment. No sites were found in close proximity to the Site that would raise a concern in regards to current or historic ground contamination impact to the site. The Thavanet Machine/Grinding Shop owns the northeast abutting, undeveloped wooded property and is located on the next parcel located approximately 200 feet away from the site in the down gradient direction. Local Fire Marshal and CTDEP records did not identify environmental concerns for the Thavanet Machine/Grinding Shop.

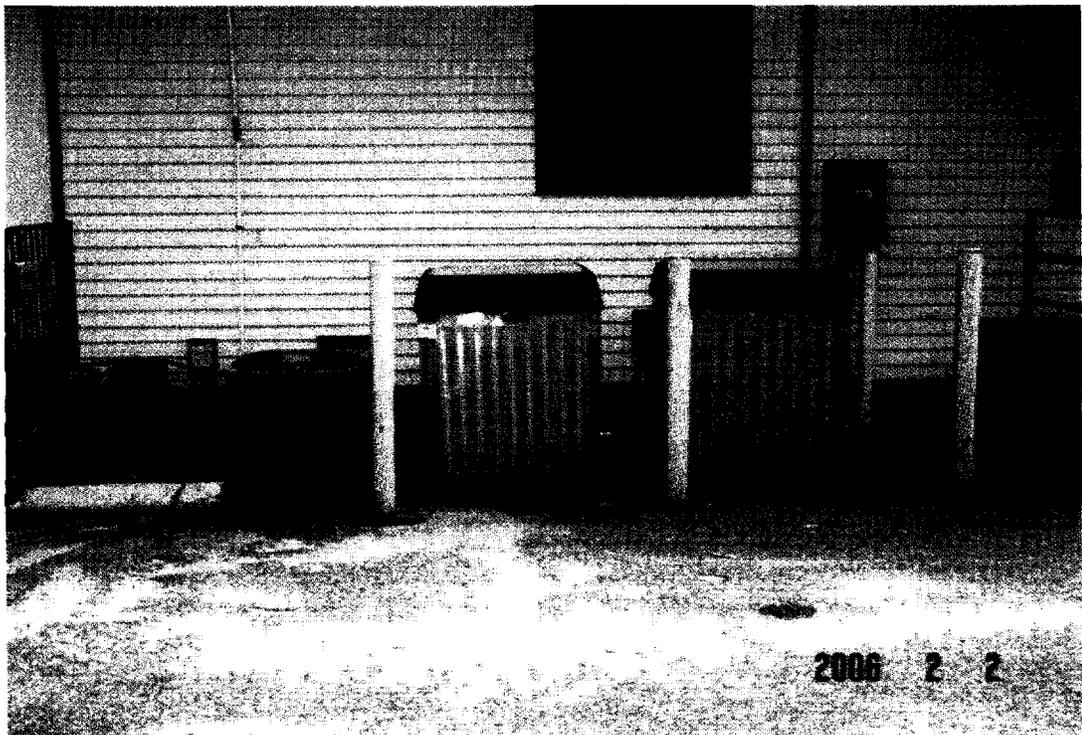
View of air conditioning units at rear of building.

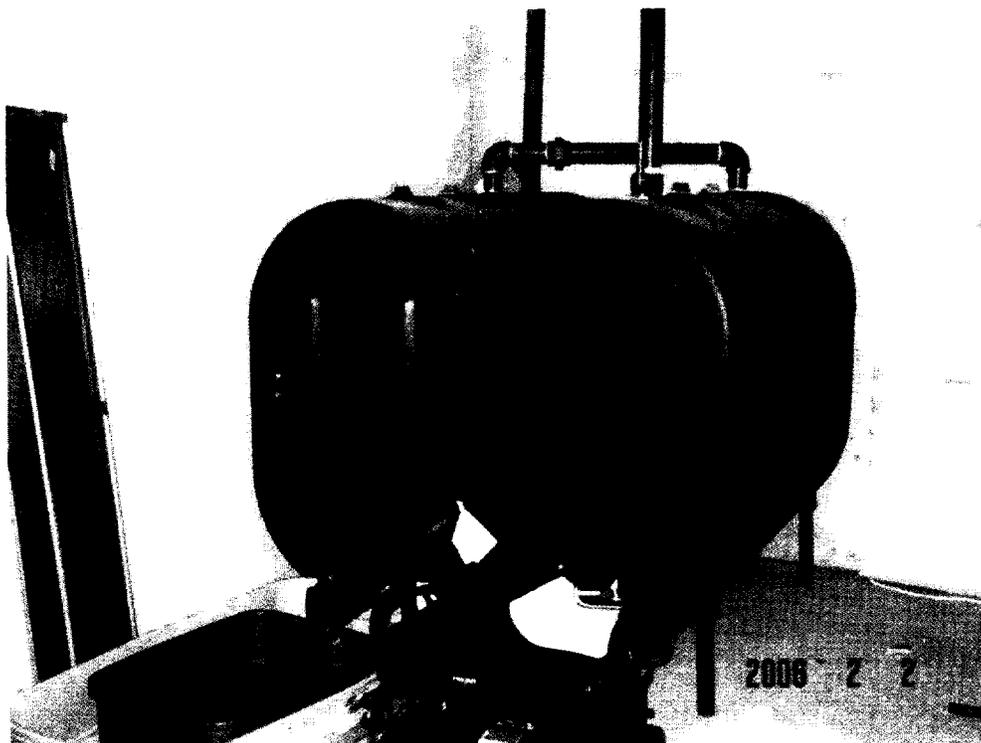
View of heating oil tanks that replaced the original UST.

Two 275-gallon fuel oil Above Ground Storage Tanks (ASTs) were observed in the northwest corner of the first floor that is part of the 1998 addition.

A 1,000 gallon UST was formerly located adjacent to the north side of the original building and was in use from 1983 to 1998. The Fire Marshal reports he was present at the time of the UST removal and that the UST was in very good condition with no evidence of leakage or soil contamination. The site contact reported that a small amount of oil was spilled from the fuel lines and that the impacted soil was removed. Review of CTDEP Underground Storage Tank (UST) files has revealed that there are no registered UST's on the Site.
