# REHABILITATION STUDY REPORT

State Project No. 137-164  
Bridge No. 03906 in Stonington  
Alpha Avenue over Amtrak and Local Roads

State of Connecticut  
Department of Transportation  
Newington, Connecticut

*Submitted:* April 2022

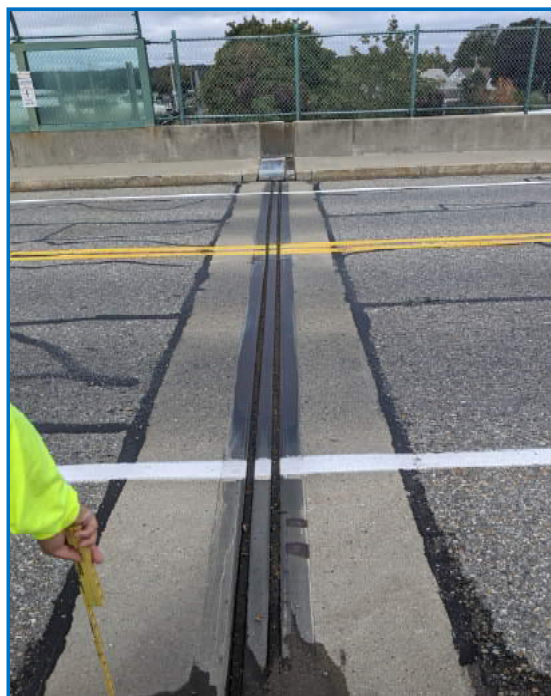
*Photo 6: Condition of modular expansion joint with concrete headers over pier bend 4.*

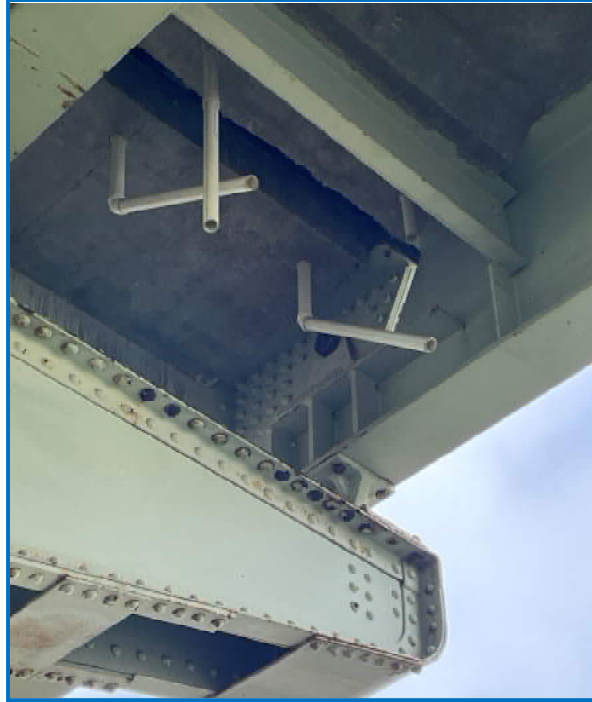
*Photo 9: Bridge deck weephole drains extended to prevent drainage onto structure below (location in photo over pier bent 4).*

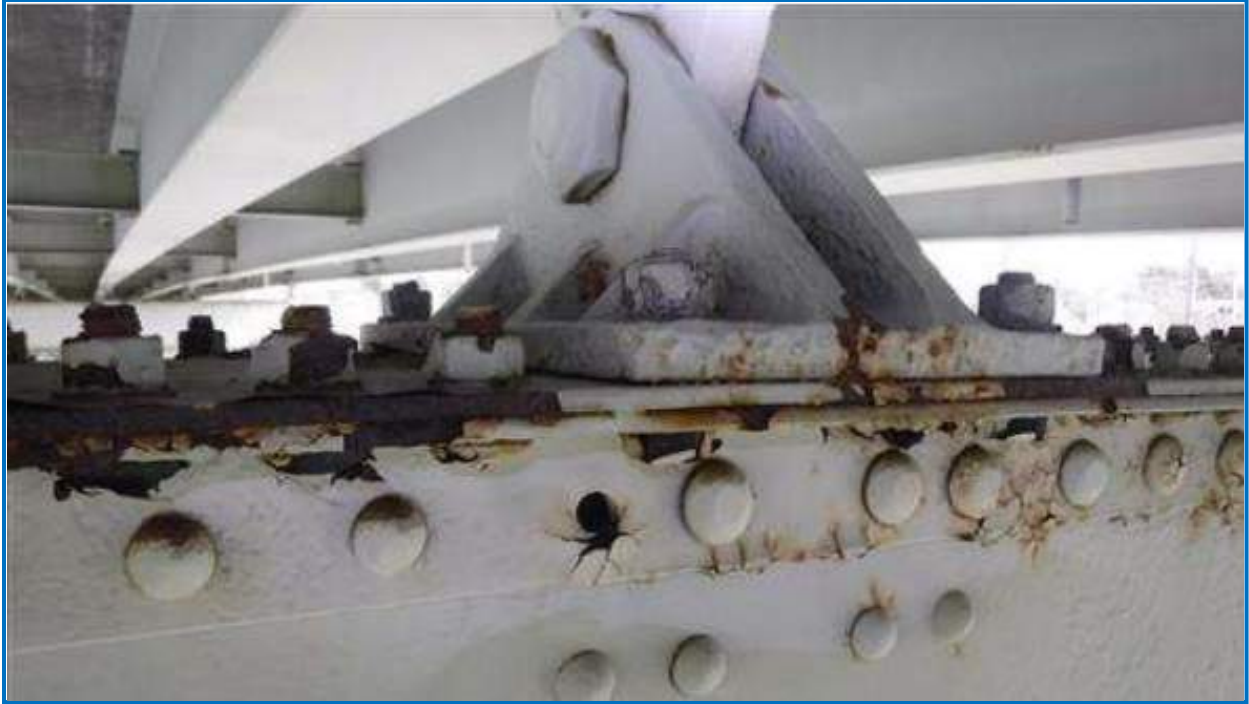
*Photo 13: Typical condition of fixed rocker bearings.*

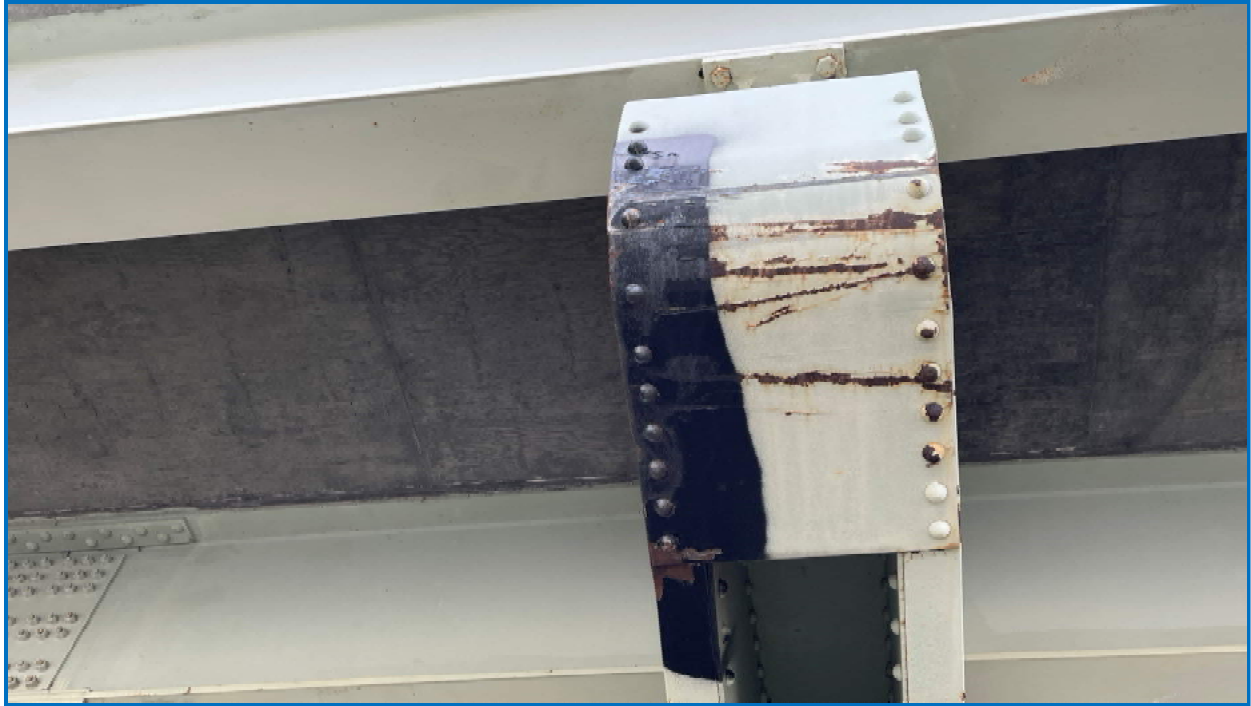
*Photo 15: Minor Collision scrape at Pier Cap 3.*

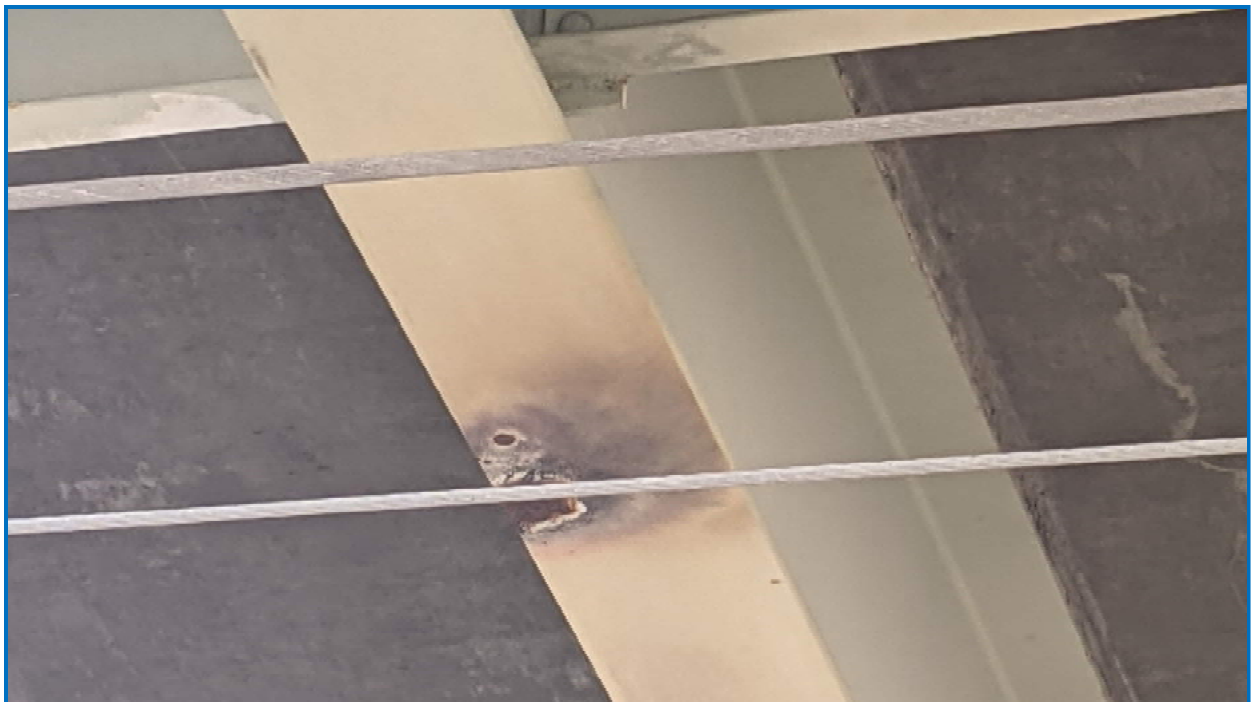
*Photo 16: Typical Span 4 girder 2" diameter x 1/8" deep section loss due to electrical arcing over Amtrak rail lines.*

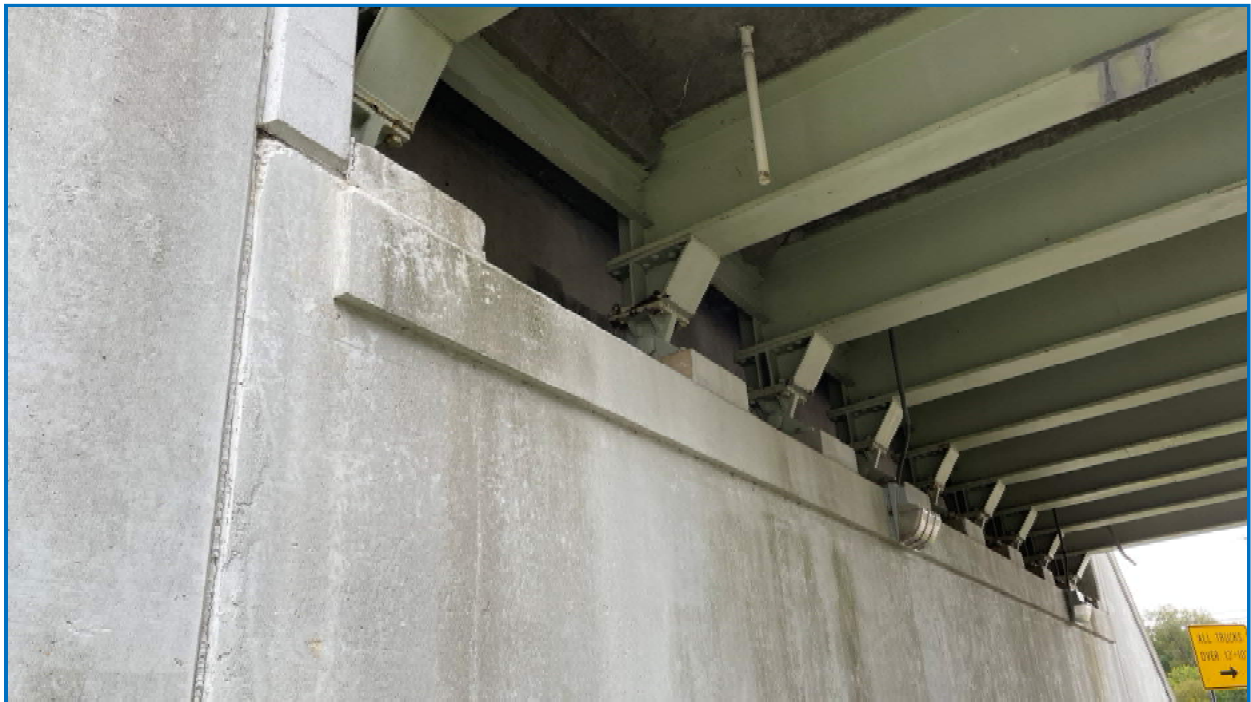
*Photo 20: Abutment 2 adjacent to Cutler Street. Note scrape marks on bottom flange of Girder G2 painted over in top right of photo.*

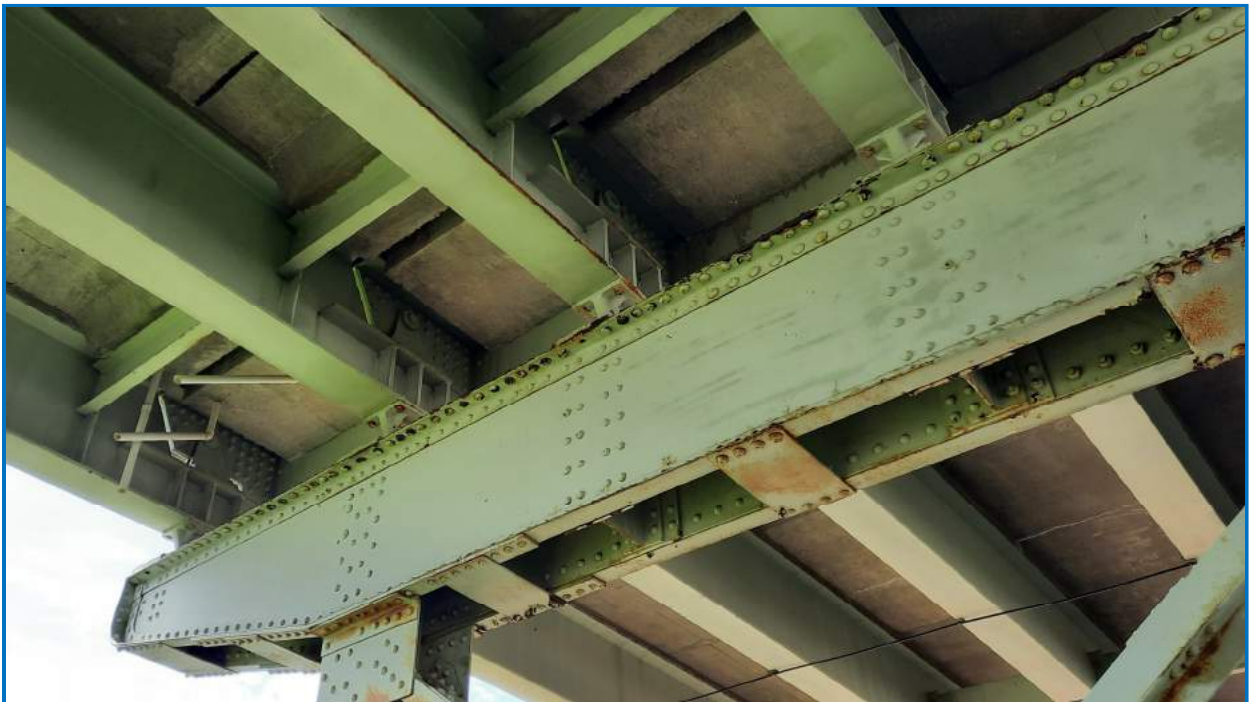
*Photo 26: Pier Cap 4 North side located within Amtrak fence line.*

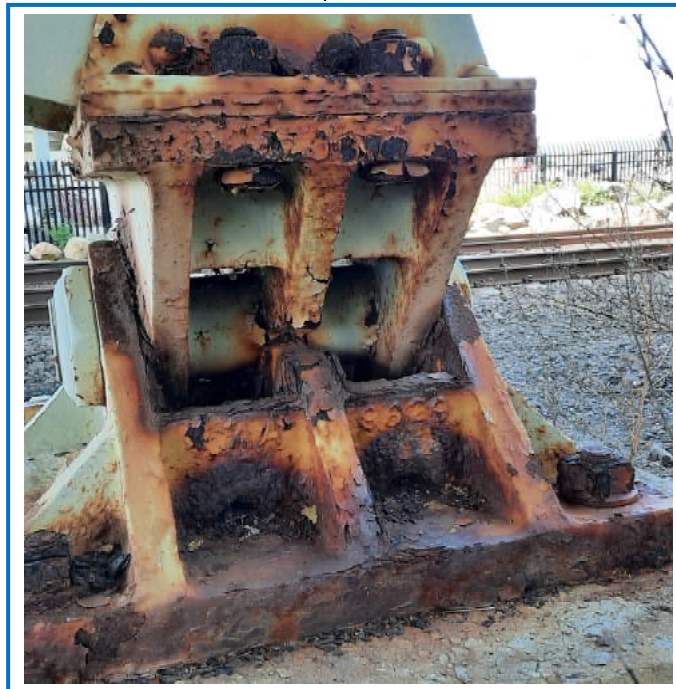
*Photo 28: Pier bent bearing under pier 4 showing heavy laminar rust and pack rusting between plates.*

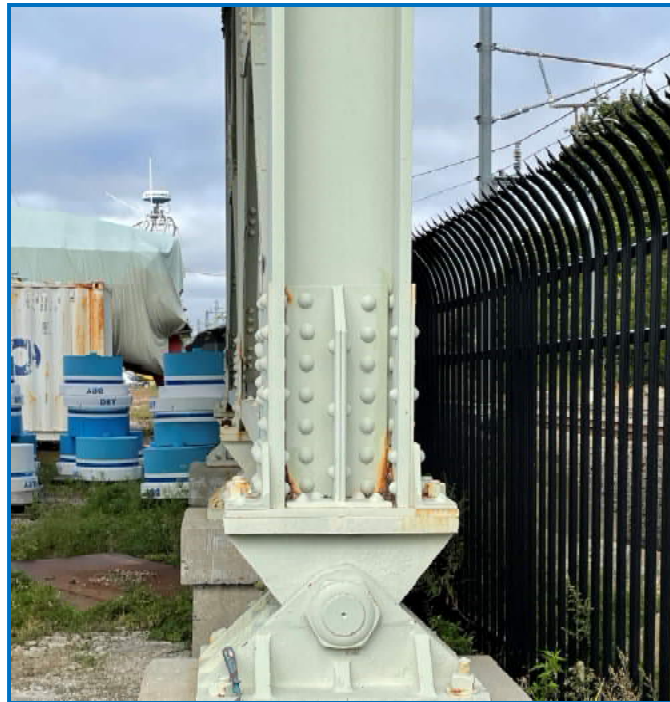
*Photo 30: Elevation of Pier 3 column and bearing. Note laminated rust and section losses on interior column legs near bases.*

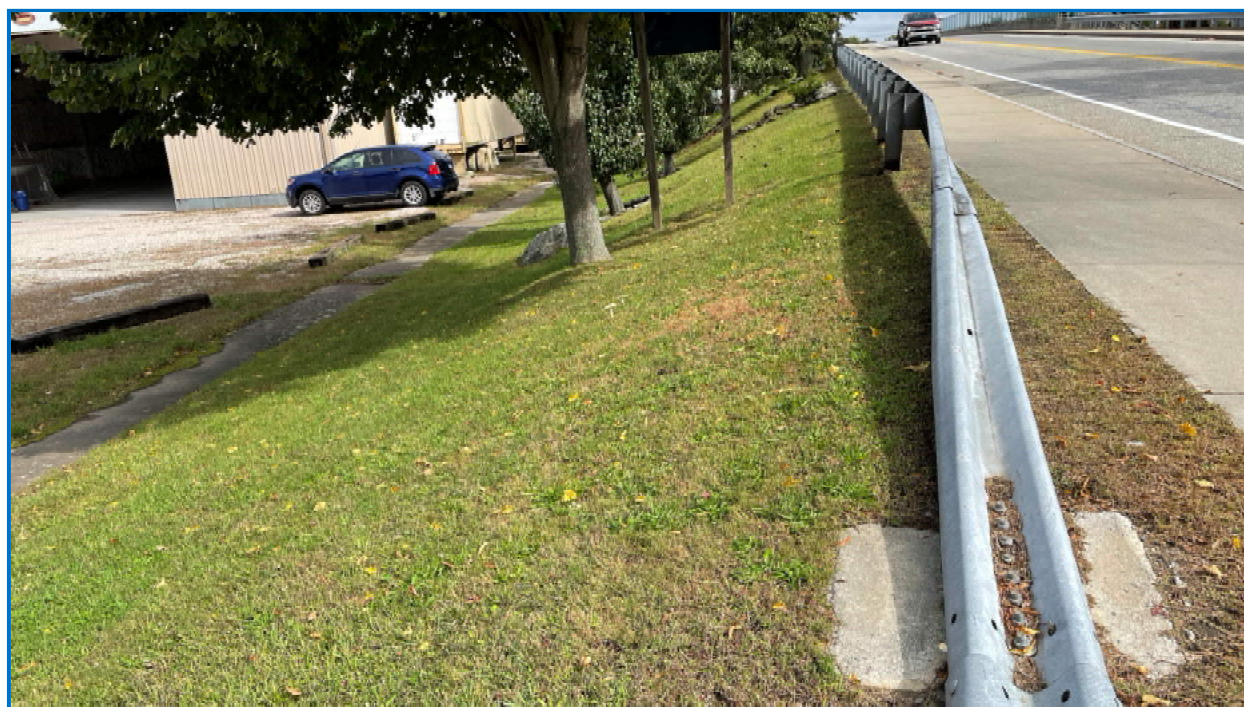
*Photo 34: Guidrail end treatment and southwest approach embankment.*

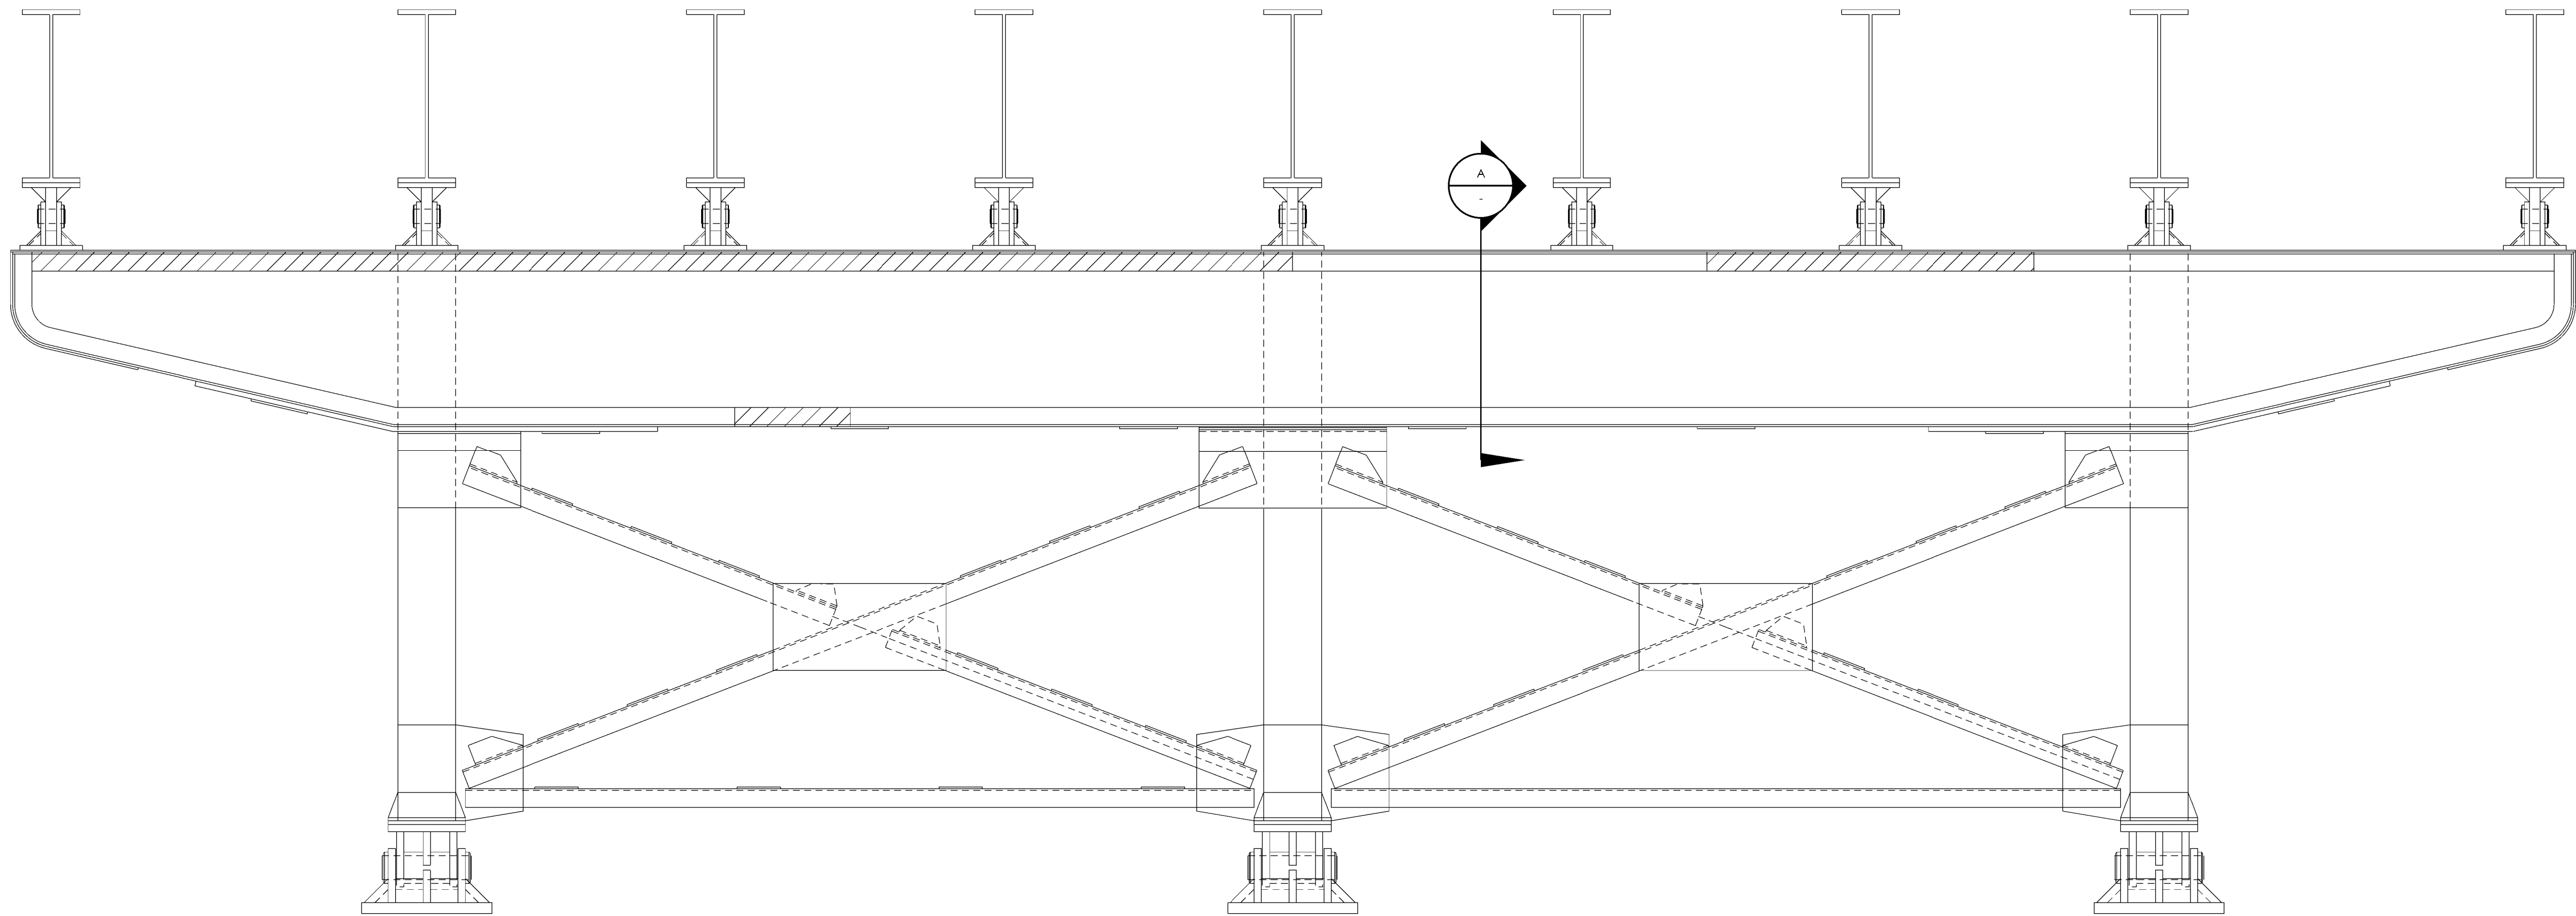
**BRIDGE CROSS SECTION**  
SCALE: 9/16" = 1'-0"  
PIER 6 SOUTH ELEVATION SHOWN FOR REFERENCE. OTHER PIERS SIMILAR

NOTES:  
- SECTION LOSS TO BE VERIFIED IN FIELD. APPROXIMATE SIZES SHOWN IN TABLE EXTEND A MINIMUM OF 6' PAST LIMITS OF SIGNIFICANT DETERIORATION

\* IN SPAN P7, GIRDER SIZE DECREASES FROM W36X160 TO W24X162 AT FIELD SPLICE LOCATED 10'-0" FROM PIER 7

INSPECTED DETERIORATION			
PIER	FACE	COMPONENT	APPROXIMATE SIZE/ COMPONENT
P1	SOUTH	TOP FLANGE PLATE	36"x12"x $\frac{3}{8}$ "
P1	SOUTH	WEB	16"x6"x $\frac{3}{8}$ "
P1	SOUTH	WEB	42"x3"x $\frac{3}{8}$ "
P1	NORTH	TOP ANGLE	180" OF ANGLE
P2	SOUTH	TOP ANGLE	60" OF ANGLE
P2	SOUTH	BOT. ANGLE	60" OF ANGLE
P2	SOUTH	BOT. ANGLE	84" OF ANGLE
P2	NORTH	TOP ANGLE	102" OF ANGLE
P2	NORTH	BOT. ANGLE	92" OF ANGLE
P3	SOUTH	BOT. ANGLE	120" OF ANGLE
P3	NORTH	BOT. ANGLE	108" OF ANGLE
P5	NORTH	BOT. ANGLE	12" OF ANGLE
P6	SOUTH	TOP ANGLE	266" OF ANGLE
P6	SOUTH	TOP ANGLE	102" OF ANGLE
P6	SOUTH	BOT. ANGLE	48" OF ANGLE
P7	SOUTH	WEB	24"x8"x $\frac{3}{8}$ "
P7	NORTH	TOP FLANGE PLATE	300"x24"x $\frac{3}{8}$ "

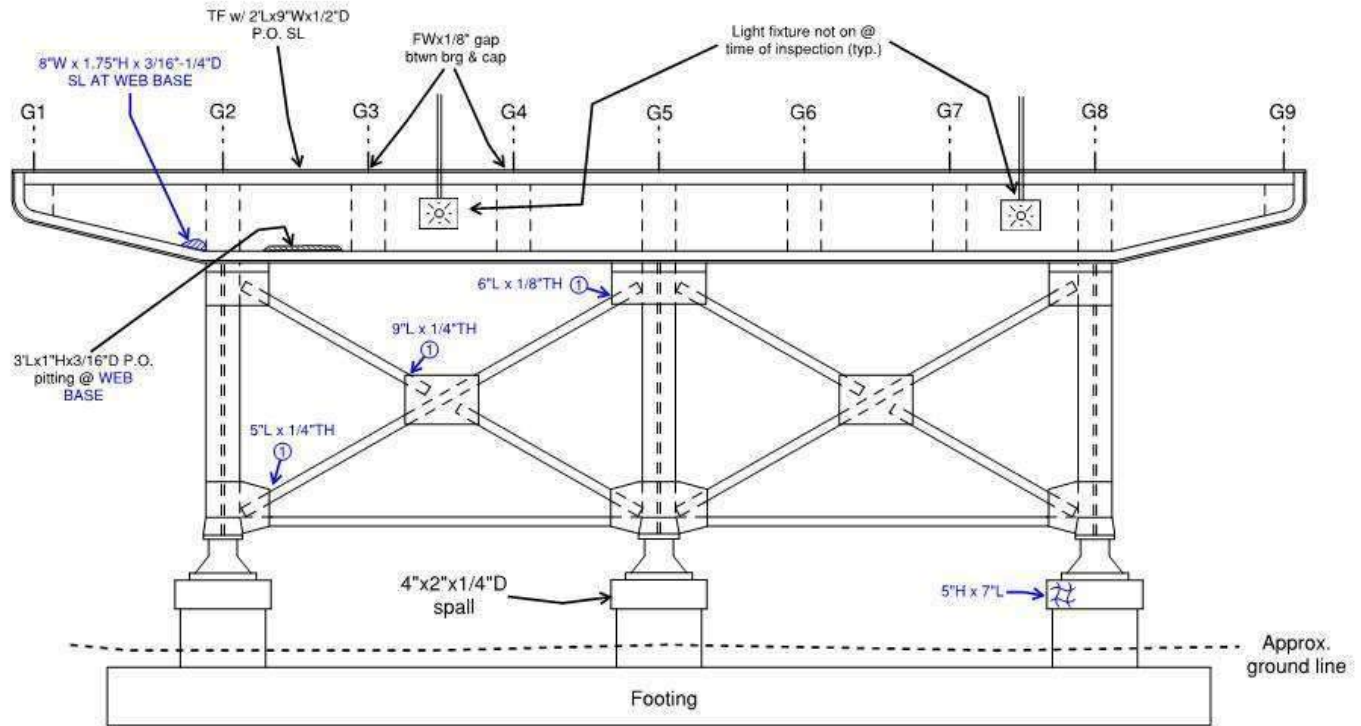
- ① Pack rust btwn gusset plate and member.

- Pier column bearings have areas of peeling paint w/ spotty light-moderate rust; random brg's have drain hole with isolated areas of laminated rust around the holes.
- Random areas of pack rust up to 3/16" thick between vertical bearing plates.
- Steel random areas of peeling paint w/ light to moderate rust. (ISOLATED LOCATIONS w/ LAMINATED RUST)
- Steel has random areas of painted over pitting up to 1/8"D (not full sections; worst areas noted on sketch).

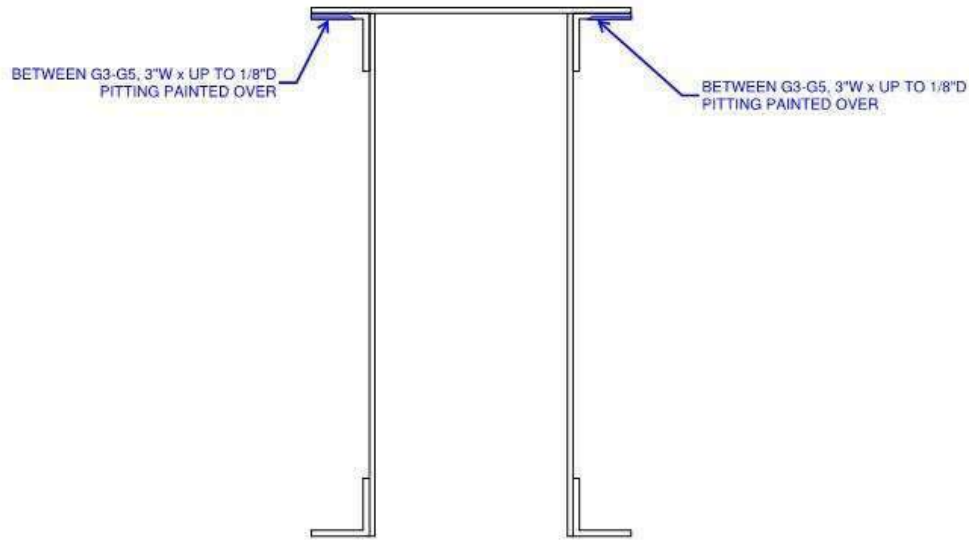
REVISION <u>1</u>	DATE: 1/19/2020	CREW: PRIME AE : JK, EA, EB, IS, MM, AN	REVISION <u>3</u>	DATE:	CREW:
REVISION <u>2</u>	DATE:	CREW:	REVISION <u>4</u>	DATE:	CREW:

SECTION B-B (LOOKING EAST)TOP FLANGE SECTION LOSS (CRITICAL):ORIGINAL TOP FLANGE AREA =  $2(4" \times 7/16") + (22" \times 3/8") = 11.75 \text{ in}^2$ TOP FLANGE LOSS AREA =  $2(3" \times 1/8") = 0.75 \text{ in}^2$ PERCENT SECTION LOSS =  $(0.75 \text{ in}^2 / 11.75 \text{ in}^2) \times 100 = 6.4\% \text{ LOSS}$ SECTION PROPERTIES:WEB = (2)  $36" \times 3/8"$ ANGLES = (4)  $4" \times 4" \times 7/16"$ COVER PLATE =  $22" \times 3/8"$ DETAIL B  
PIER 3 CAP  
AT GIRDER G5

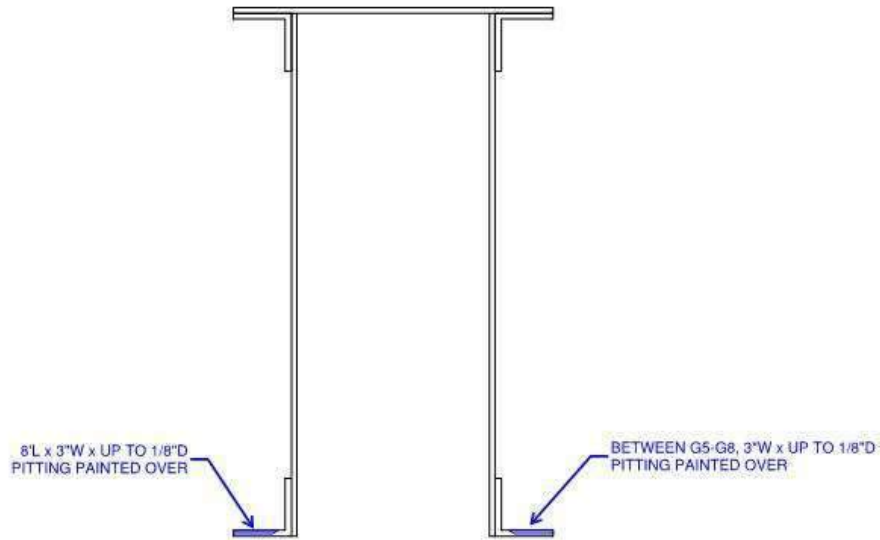
DETAIL C  
PIER 3 CAP  
BETWEEN GIRDERS G6 & G7

SECTION C-C (LOOKING EAST)BOTTOM FLANGE SECTION LOSS (CRITICAL):ORIGINAL BOTTOM FLANGE AREA =  $2(4" \times 7/16") = 3.50 \text{ in}^2$ BOTTOM FLANGE LOSS AREA =  $2(3" \times 1/8") = 0.75 \text{ in}^2$ PERCENT SECTION LOSS =  $(0.75 \text{ in}^2 / 3.50 \text{ in}^2) \times 100 = 21.4\% \text{ LOSS}$ SECTION PROPERTIES:WEB = (2)  $36" \times 3/8"$ ANGLES = (4)  $4" \times 4" \times 7/16"$ COVER PLATE =  $22" \times 3/8"$

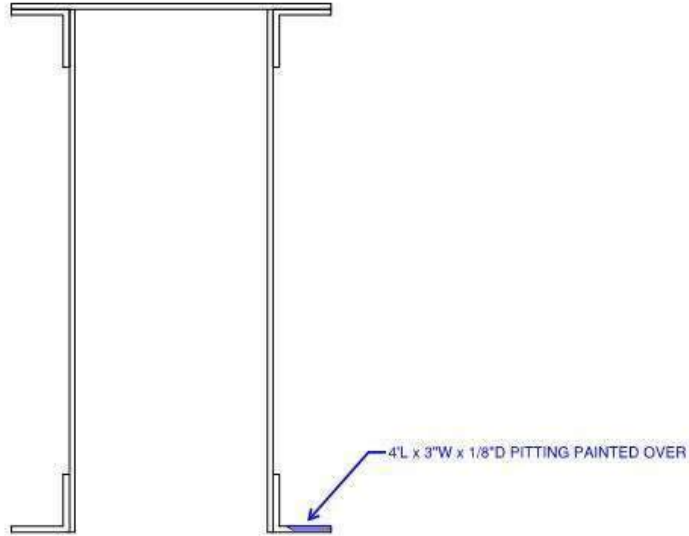
DETAIL D  
PIER 4 CAP  
BETWEEN GIRDERS G3 & G4

SECTION D-D (LOOKING EAST)BOTTOM FLANGE SECTION LOSS (CRITICAL):ORIGINAL BOTTOM FLANGE AREA =  $2(4" \times 7/16") = 3.50 \text{ in}^2$ BOTTOM FLANGE LOSS AREA =  $(3" \times 1/8") = 0.94 \text{ in}^2$ PERCENT SECTION LOSS =  $(0.94 \text{ in}^2 / 3.50 \text{ in}^2) \times 100 = 10.7\% \text{ LOSS}$ SECTION PROPERTIES:WEB = (2)  $36" \times 3/8"$ ANGLES = (4)  $4" \times 4" \times 7/16"$ COVER PLATE =  $22" \times 3/8"$

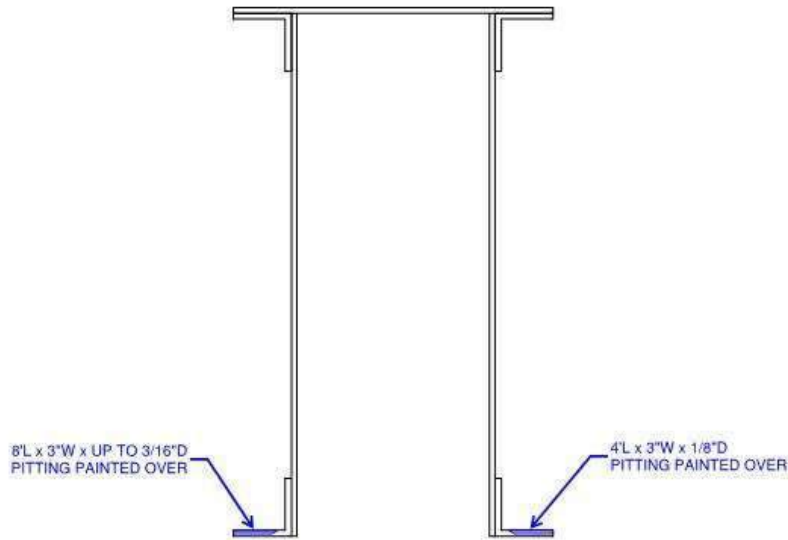
DETAIL E  
PIER 4 CAP  
BETWEEN GIRDERS G6 & G7

SECTION E-E (LOOKING EAST)BOTTOM FLANGE SECTION LOSS (CRITICAL):ORIGINAL BOTTOM FLANGE AREA =  $2(4" \times 7/16") = 3.50 \text{ in}^2$ BOTTOM FLANGE LOSS AREA =  $(3" \times 3/16") + (3" \times 1/8") = 0.94 \text{ in}^2$ PERCENT SECTION LOSS =  $(0.94 \text{ in}^2 / 3.50 \text{ in}^2) \times 100 = 26.9\% \text{ LOSS}$ SECTION PROPERTIES:WEB = (2)  $36" \times 3/8"$ ANGLES = (4)  $4" \times 4" \times 7/16"$ COVER PLATE =  $22" \times 3/8"$

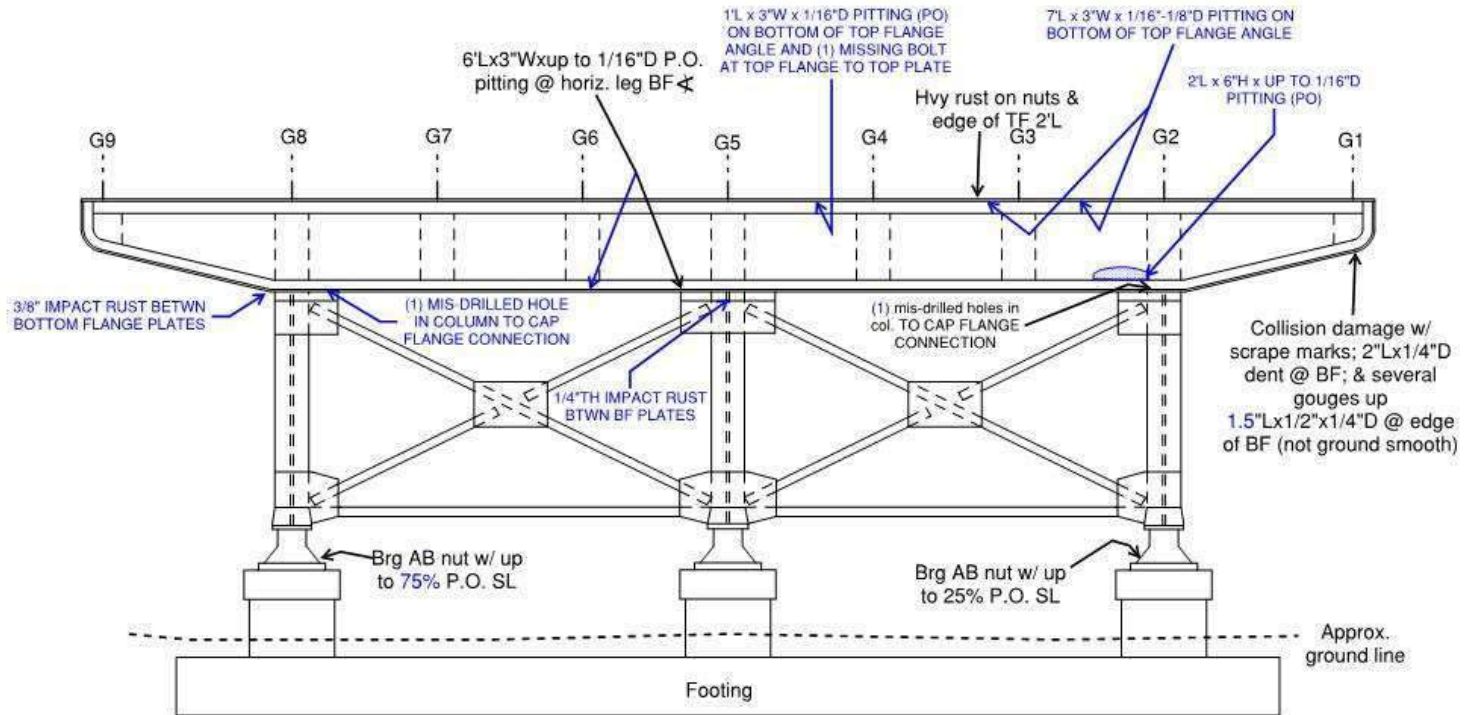
- SEE "PIER 5 - SOUTH ELEVATION" GENERAL NOTES.
- Up to 1/8"th, pack rust between the TF PL's & angles at random locations.

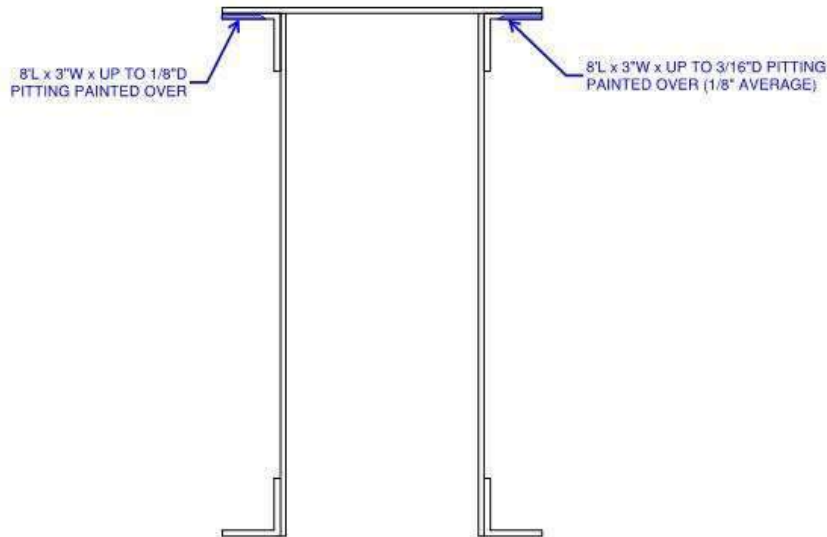
DETAIL F  
PIER 6 CAP  
AT GIRDER G8

SECTION F-F (LOOKING EAST)TOP FLANGE SECTION LOSS (CRITICAL):ORIGINAL TOP FLANGE AREA =  $2(4" \times 7/16") + (22" \times 3/8") = 11.75 \text{ in}^2$ TOP FLANGE LOSS AREA =  $(3" \times 1/8") + (3" \times 3/16") = 0.94 \text{ in}^2$ PERCENT SECTION LOSS =  $(0.94 \text{ in}^2 / 11.75 \text{ in}^2) \times 100 = 8.0\% \text{ LOSS}$ SECTION PROPERTIES:WEB = (2)  $36" \times 3/8"$ ANGLES = (4)  $4" \times 4" \times 7/16"$ COVER PLATE =  $22" \times 3/8"$

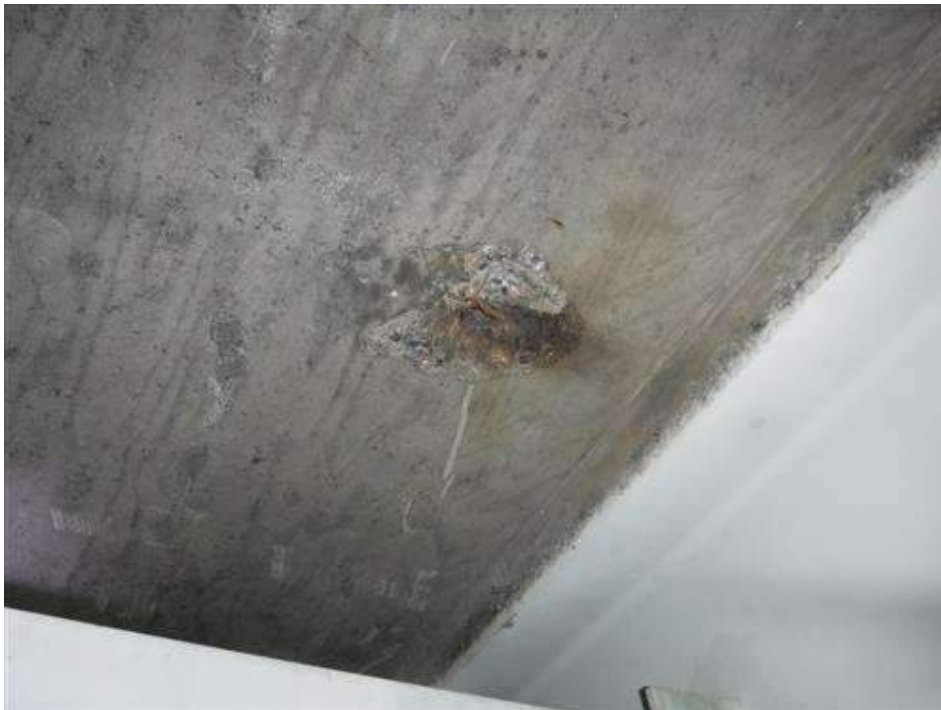
Photo Number: 10

Span 4, Bay 8 underside of deck between Diaphragm D2 & Pier 4 has a spall with exposed rebar.

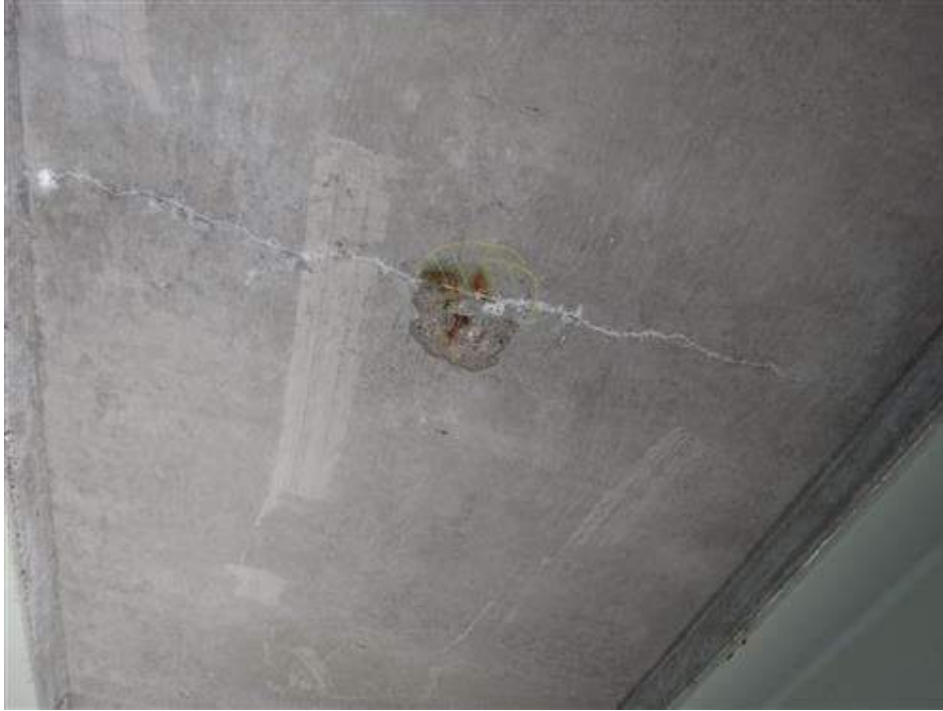
Photo Number: 11

Span 6, Bay 3 underside of deck between Diaphragms D2 & D3 near Diaphragm D3 has a spall with an adjacent hollow area over the parking lot below.

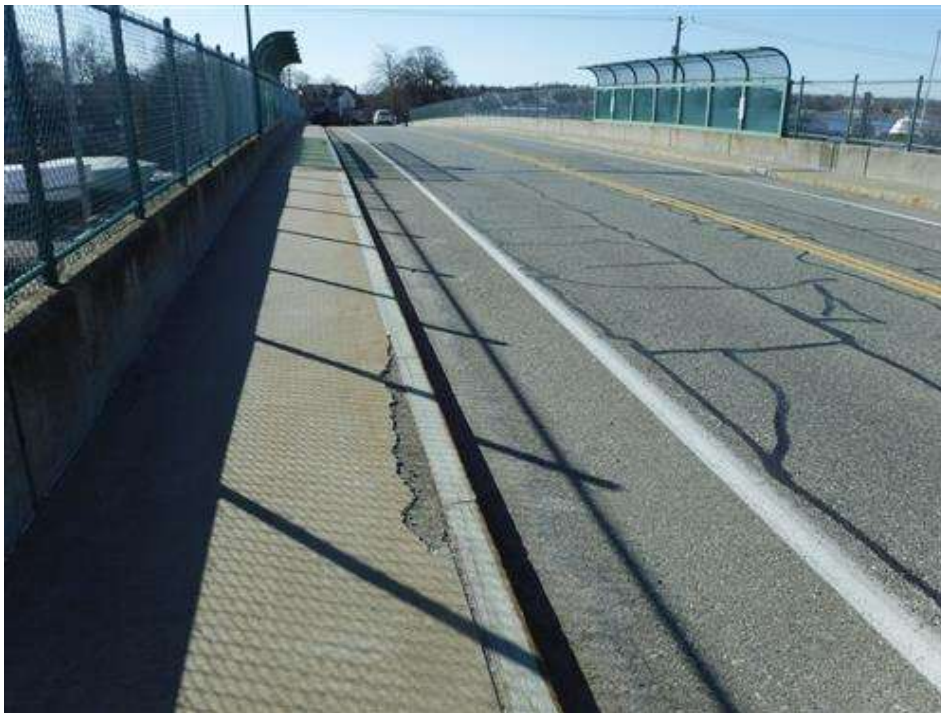
Photo Number: 14

Span 5, east sidewalk walk adjacent to the curb has a large scale area, looking south. Note: Seal between sidewalk and curb missing/deteriorated.

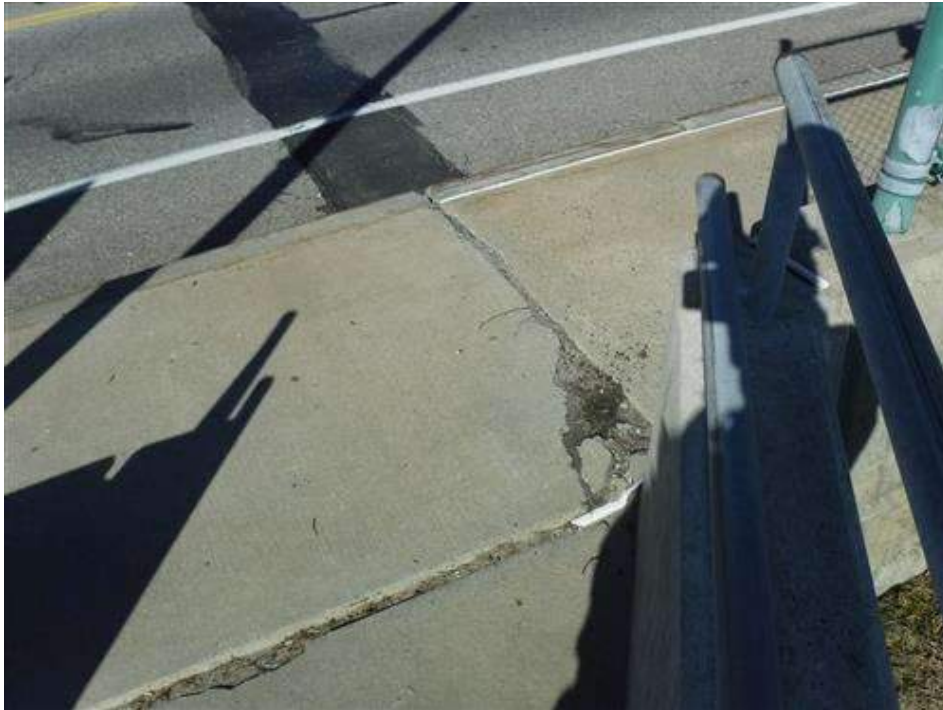
Photo Number: 15

Southeast approach sidewalk at Abutment 1 deck joint has a scale area. Note: Abutment 1 sidewalk joint open with failed seal and staircase slab is settled.

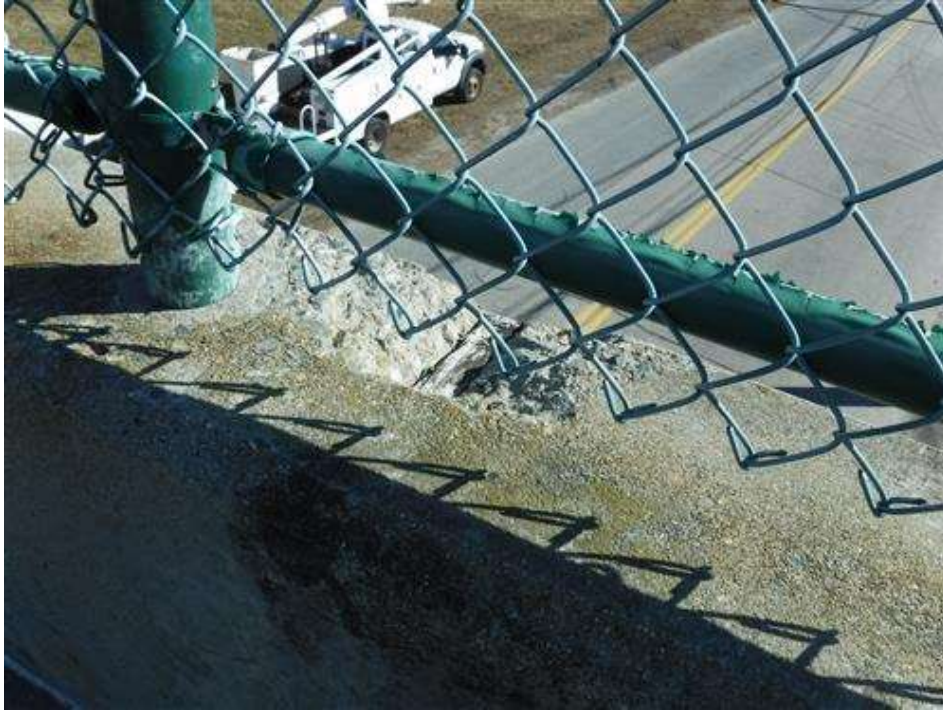
Photo Number: 17

Span 8, east parapet has a spall on top of the parapet over the travelway. Note: Previously noted gap at fence not found.

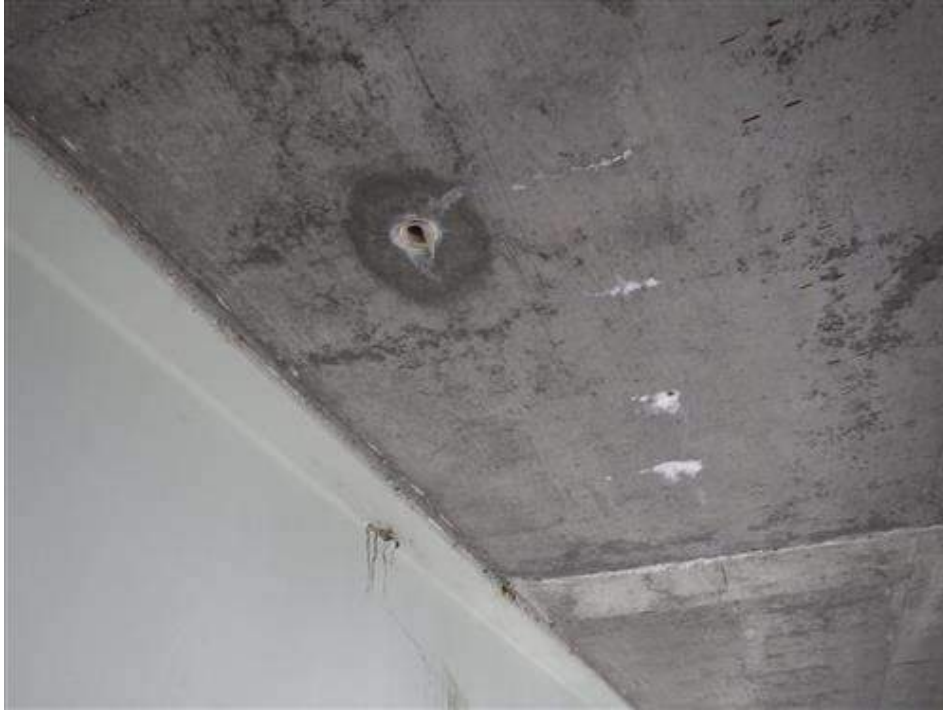
Photo Number: 19

Span 2, Bay 1 underside of deck between Pier 1 and Diaphragm D1 has a short/broken weep, which drains onto the deck.

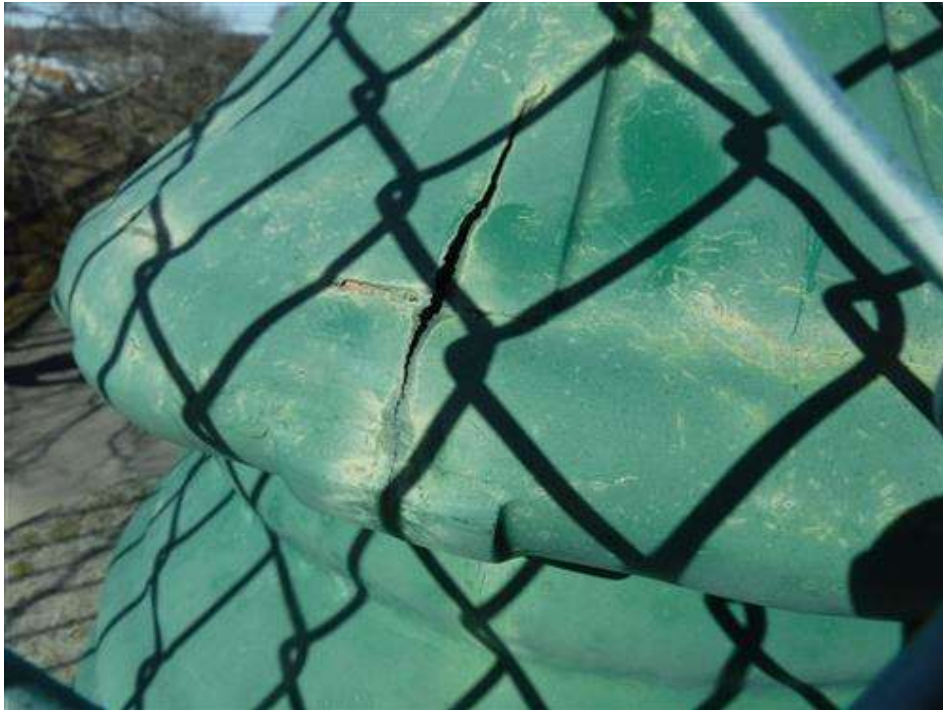
Photo Number: 21

Span 5, west parapet lighting standard has a vertical crack in the architectural dome at the base.

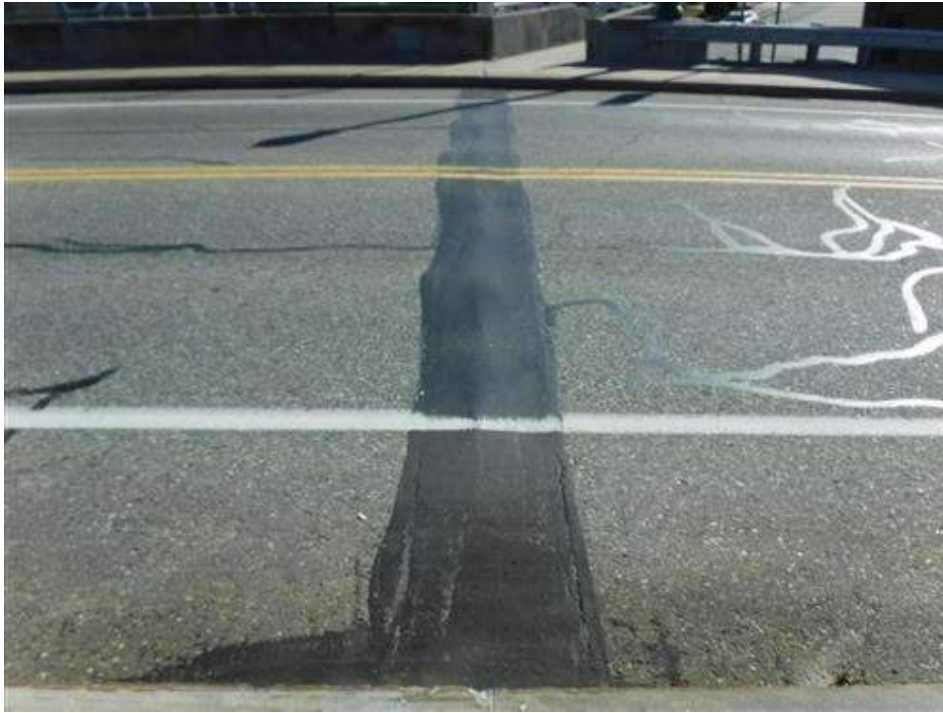
Photo Number: 23

Abutment 1 plug joint has multiple adhesion cracks with full length settlement/depressions, looking east.

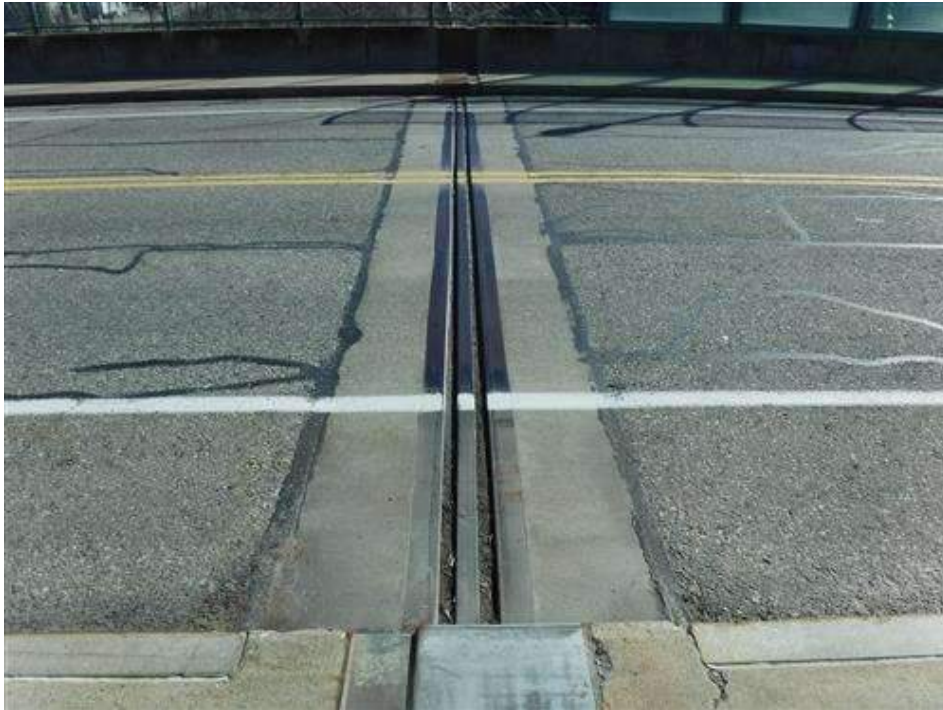
Photo Number: 25

Pier 4 strip seal joint has accumulation of sand debris and random transverse hairline cracks in the concrete headers, looking east.

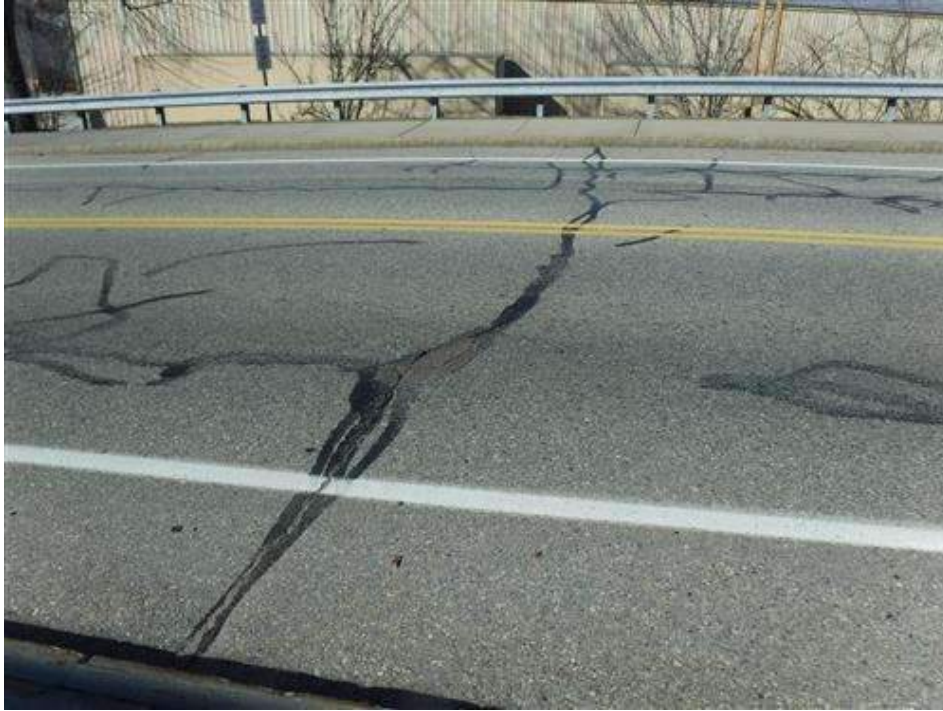
Photo Number: 27

South approach pavement has a full length transverse crack, which has been sealed and re-cracked, looking west.

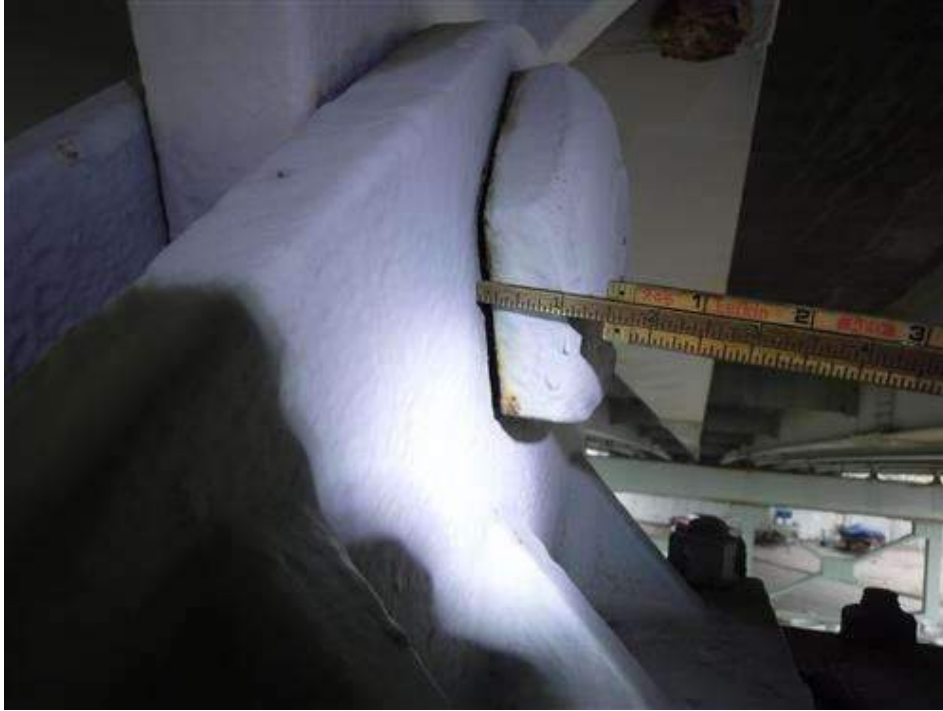
Photo Number: 29

West elevation of Girder G6 fixed bearing at Pier 2, the west pin has a 1/8" wide gap between the nut and masonry plate.
