# REHABILITATION STUDY REPORT

State Project No. 137-164  
Bridge No. 03906 in Stonington  
Alpha Avenue over Amtrak and Local Roads

State of Connecticut  
Department of Transportation  
Newington, Connecticut

*Submitted:* April 2022

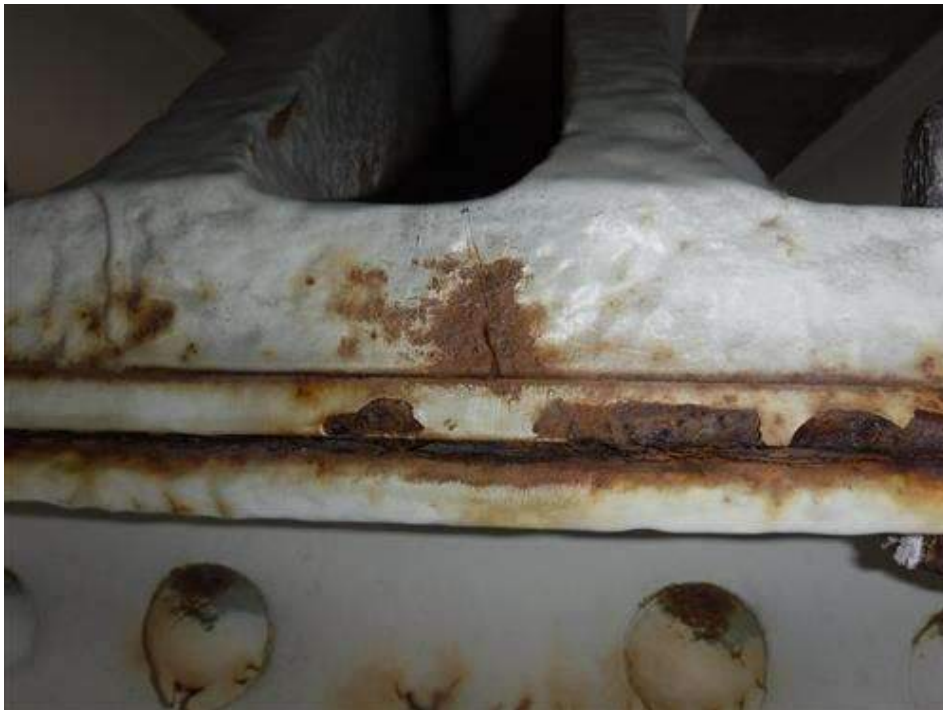
Photo Number: 30

South elevation of Girder G6 fixed bearing at Pier 2 has a 5/8" long crack in the masonry plate at the base.

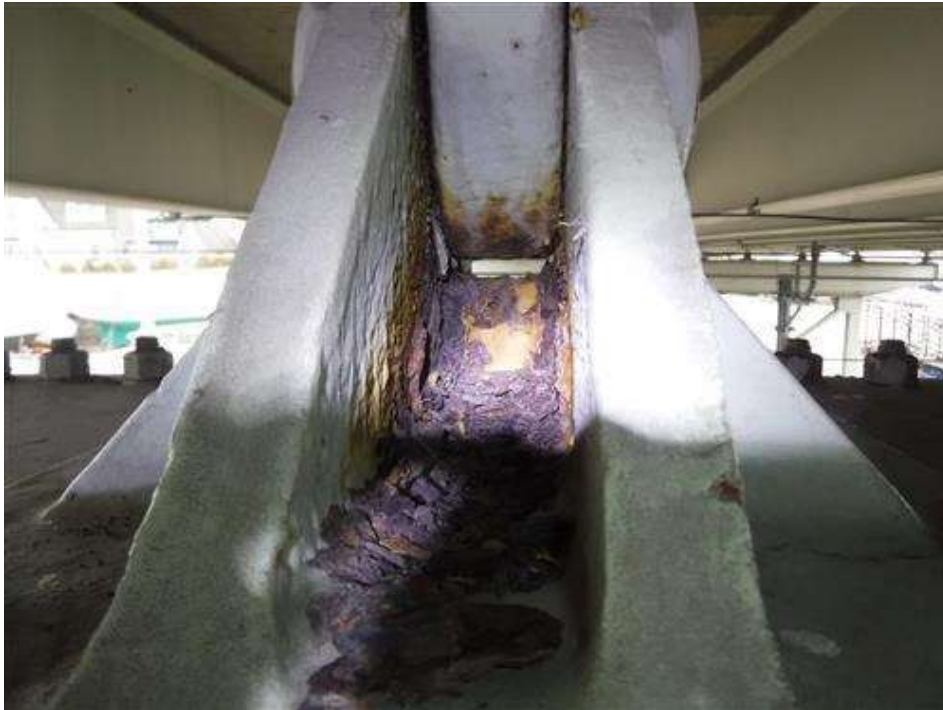
Photo Number: 31

Span 5, north elevation Girder G8 fixed bearing at Pier 4 has laminated rust and section loss on the interior face of the masonry plate.

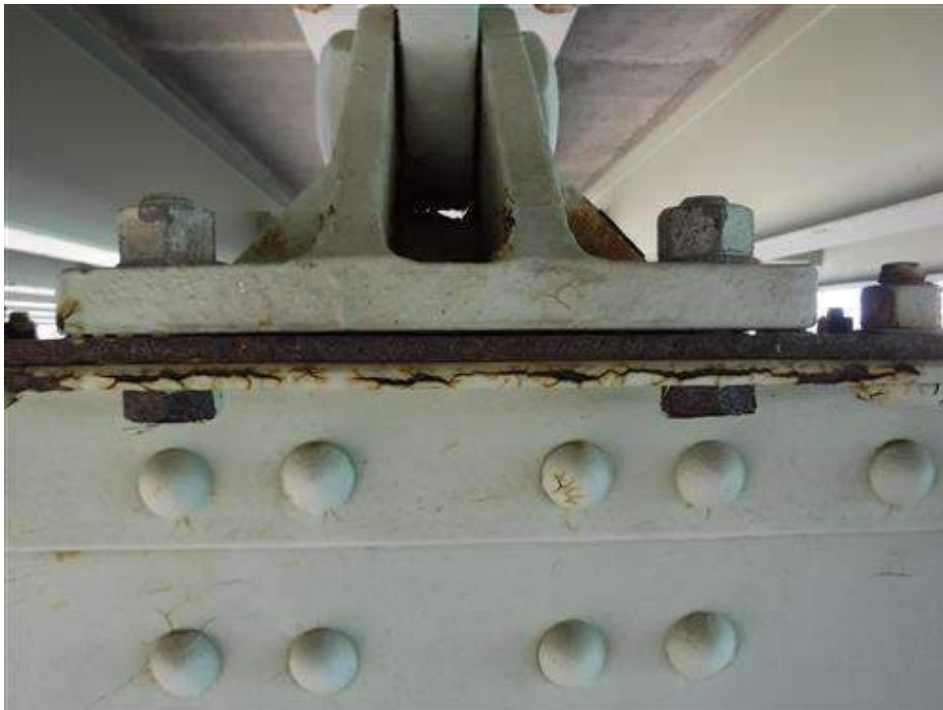
Photo Number: 32

North elevation of Girder G3 fixed bearing at Pier 6 has a gap between the masonry plate and pier cap due to pack rust.

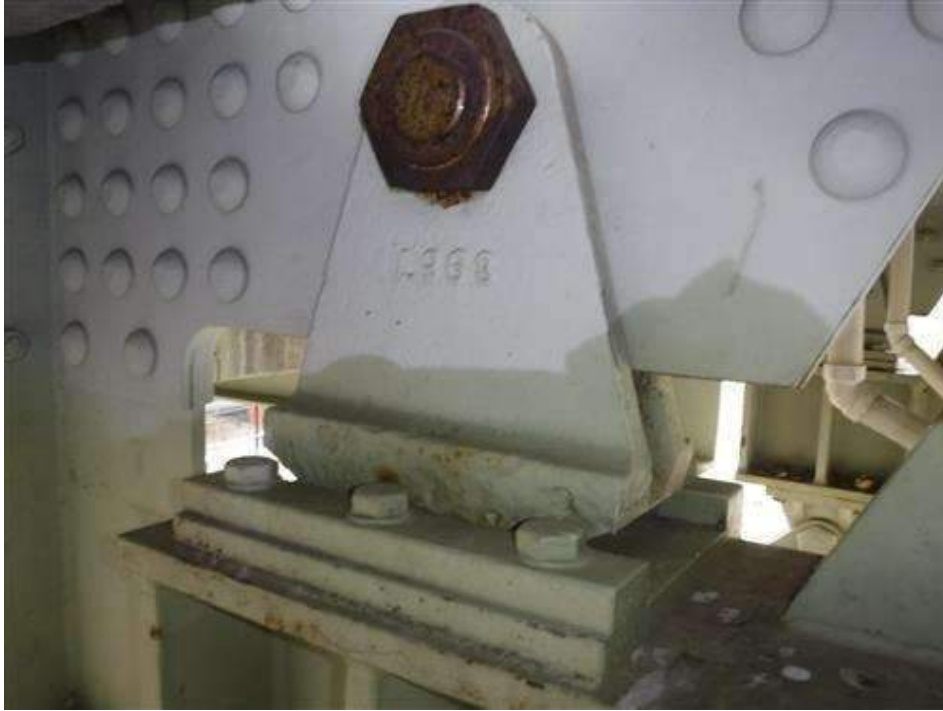
Photo Number: 33

Span 4, east elevation Girder G2 expansion bearing at Pier 4 has painted over section loss on the rocker plate. Note: Nut & pin have no paint with surface rust.

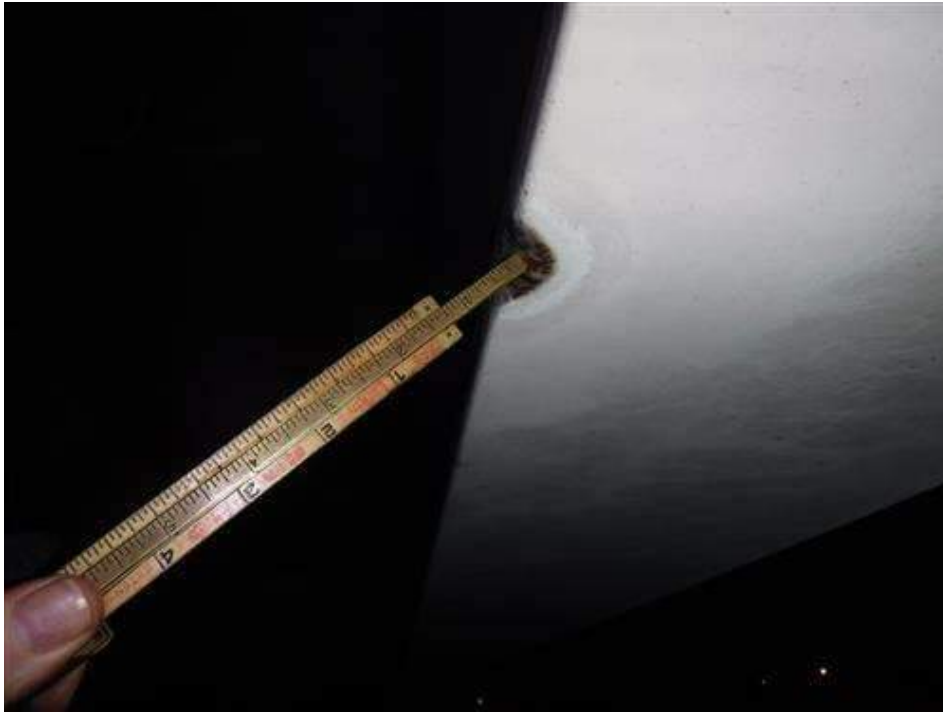
Photo Number: 35

Span 4, Girder G8 west bottom flange over Track 2 has arcing section loss.

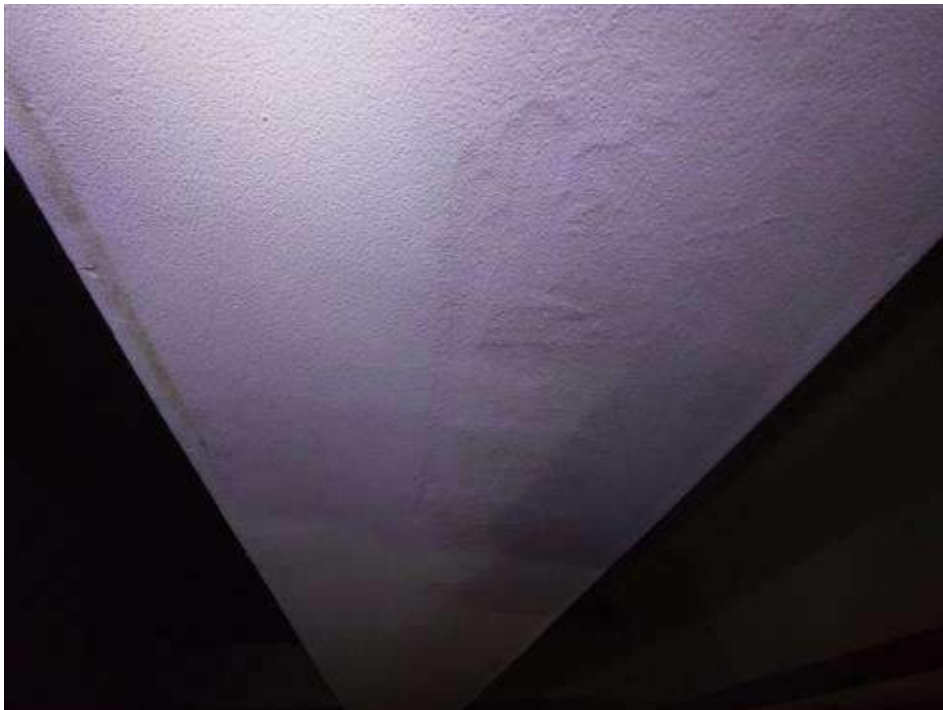
Photo Number: 36

Span 4, Girder G3 bottom of bottom flange between Diaphragms D1 & D2 has minor rolling defects, looking south.

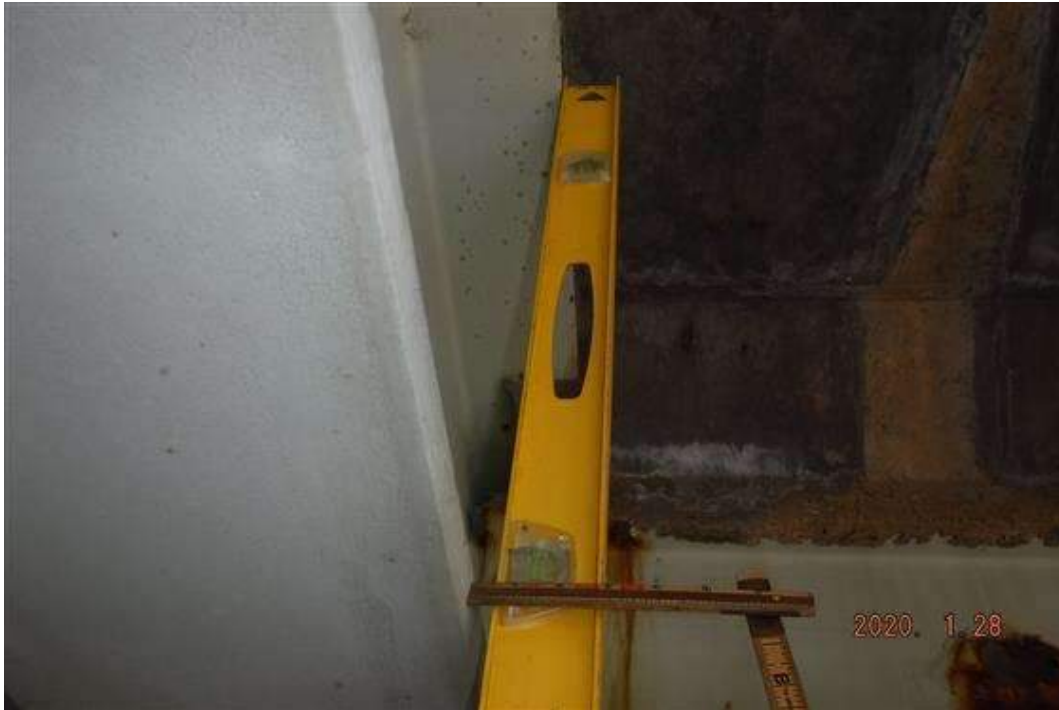
Photo Number: 37

Span 8, Girder G8 at Abutment 2 is out of plumb 1/2" to the west, east elevation shown.

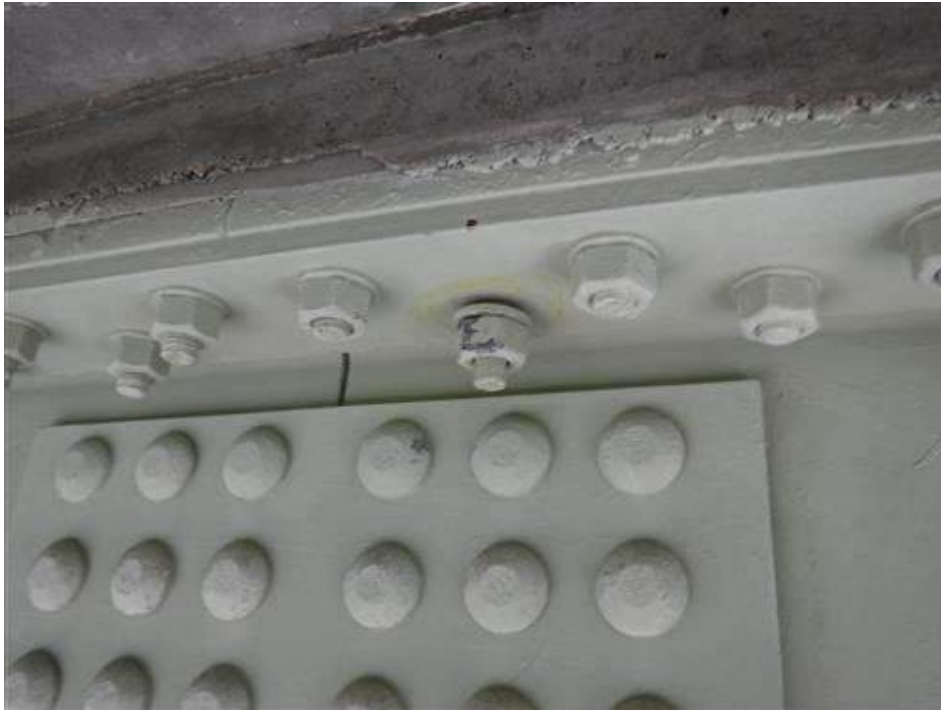
Photo Number: 39

Span 6, Girder G7 east elevation at the bolted field splice. Top flange has one (1) bolt with a nut not fully engaged.

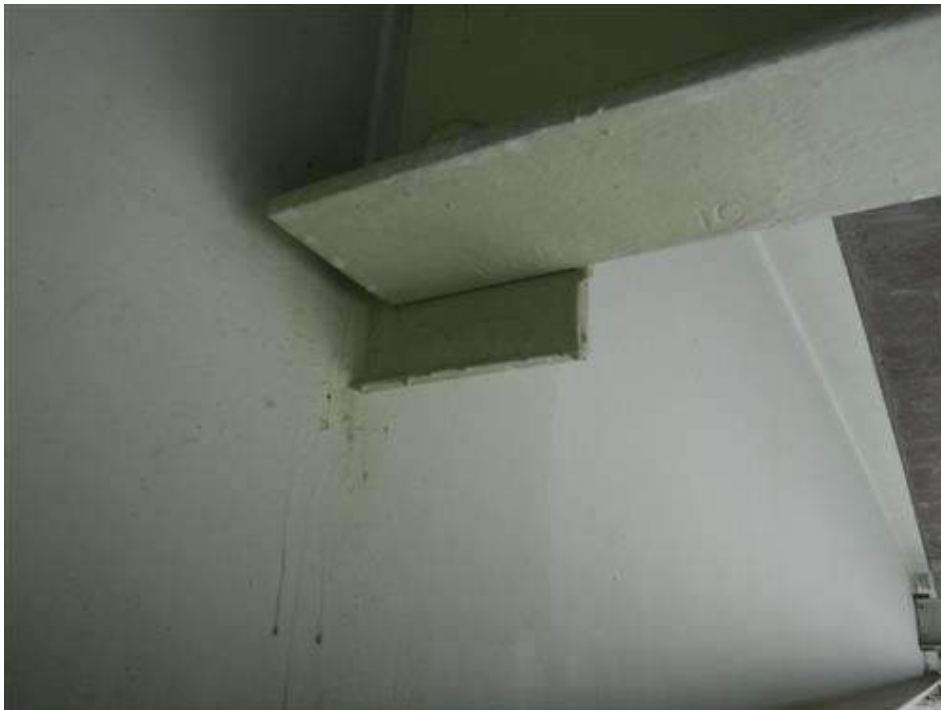
Photo Number: 40

Span 3, Bay 6 at Diaphragm D1 connection to Girder G6 has a missing lower horizontal weld.

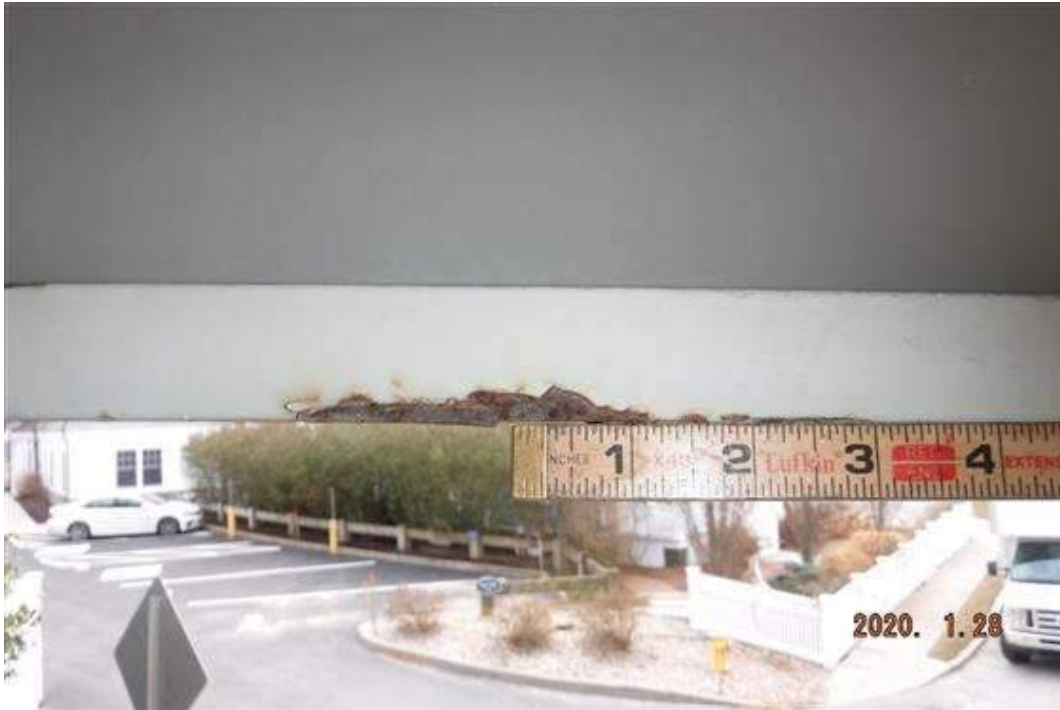
Photo Number: 41

Span 1, Girder G7 west bottom flange between Diaphragms D2 & D3 has an impact gouge.

**Comments:** - Span 1, Girder G7 west bottom flange between Diaphragms D2 & D3 has a 3/4" long x 1/8" high x 1/16" deep gouge, which has not been ground smooth.  
- Span 1, Girder G9 west bottom flange at 8" north of Diaphragm D1 has a 1/4" long x 1/8" high x 1/16" deep gouge, which has not been ground smooth.  
- Span 6, Girder G1 west bottom flange between Diaphragms D1 & D2 has a 30" long scrape with a 3.5" long x 1/2" wide x 1/16" - 1/8" deep notch, which has not been ground smooth.  
- Span 8, Girder G6 bottom of bottom flange near Pier 7 has two (2) full width x 3/8" wide x 1/8" deep gouges, which has not been ground smooth.

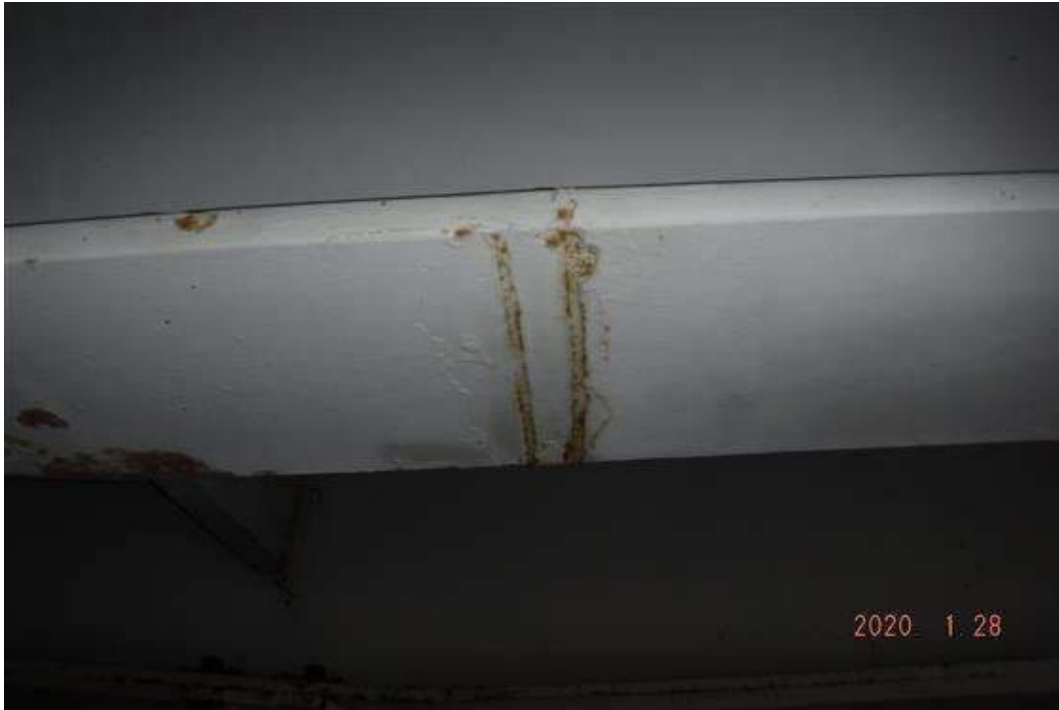
Photo Number: 43

Span 8, Girder G6 bottom of bottom flange near Pier 7 has two (2) impact gouges.

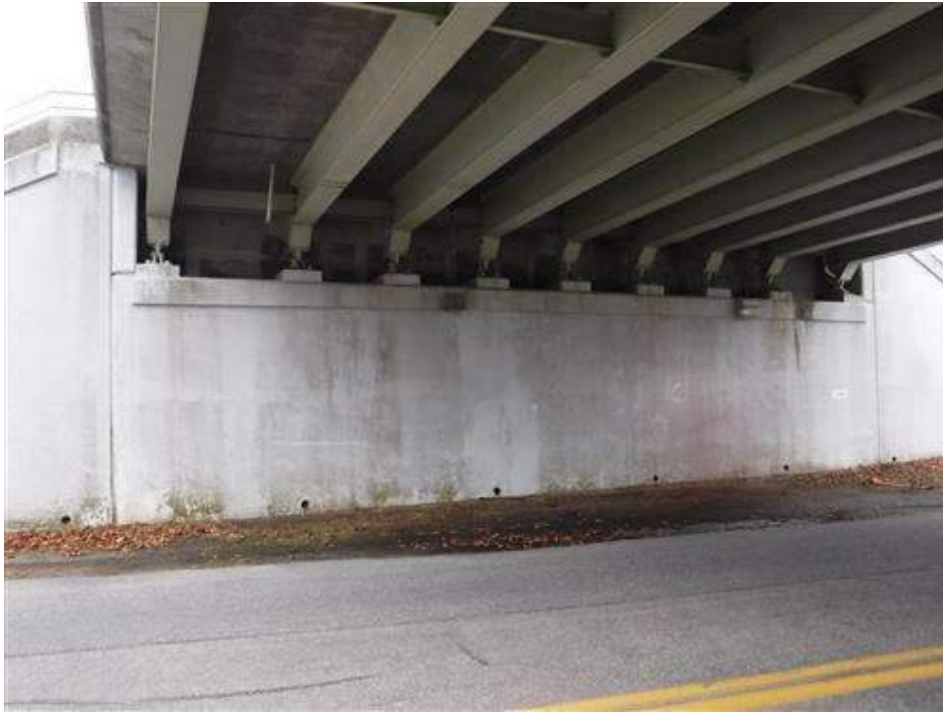
Photo Number: 45

Abutment 2 elevation.

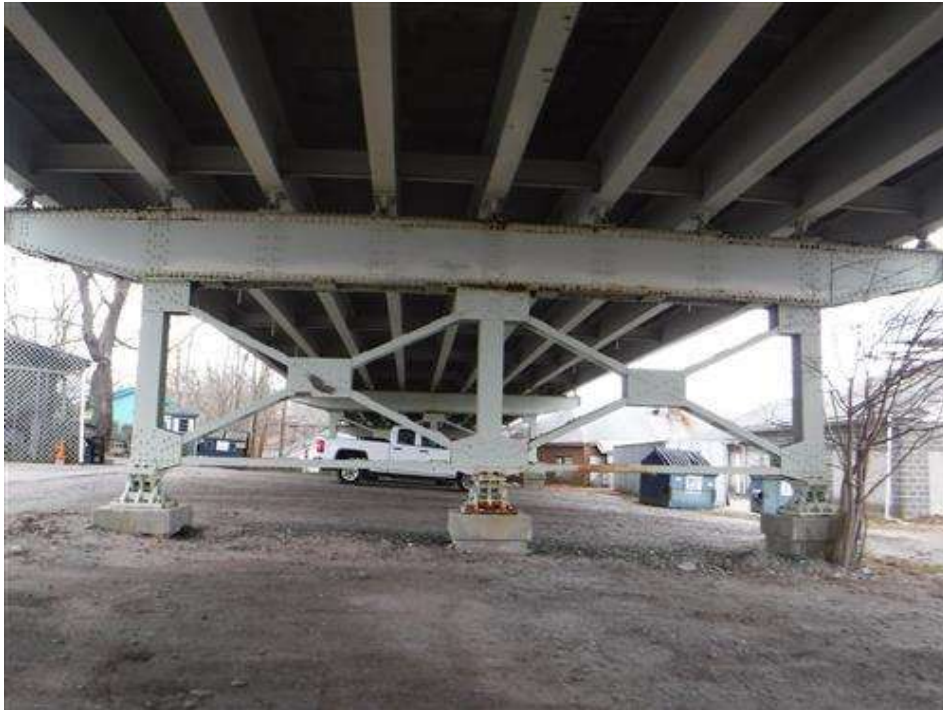
Photo Number: 47

Pier 5, south elevation.

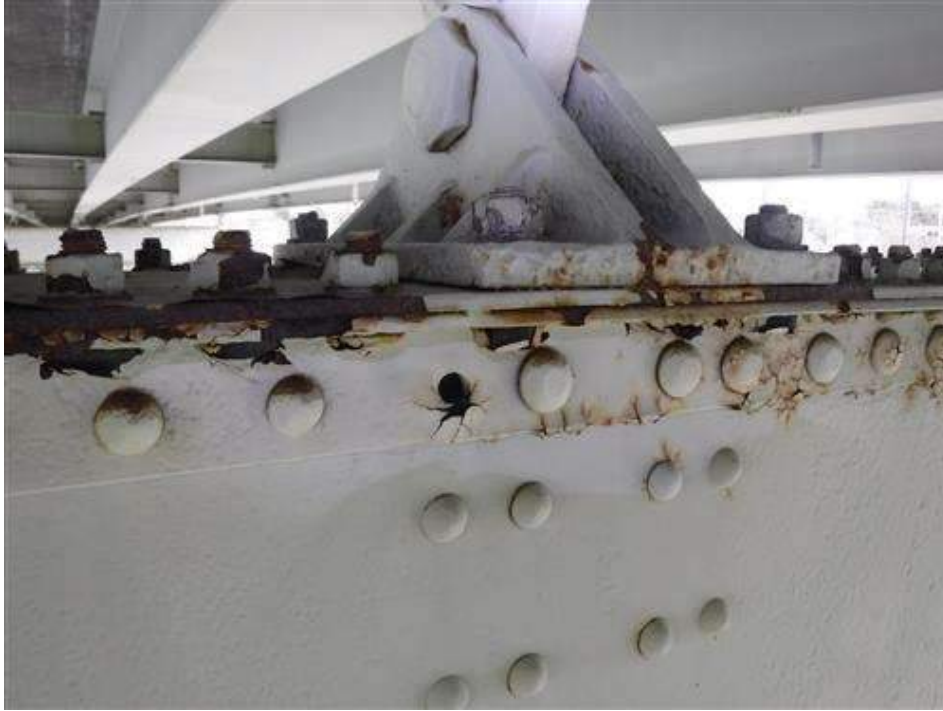
Photo Number: 49

Pier 2 cap, south elevation at Girder G7 has pack rust between the top flange angle and cover plate. Note: One (1) missing rivet in web.

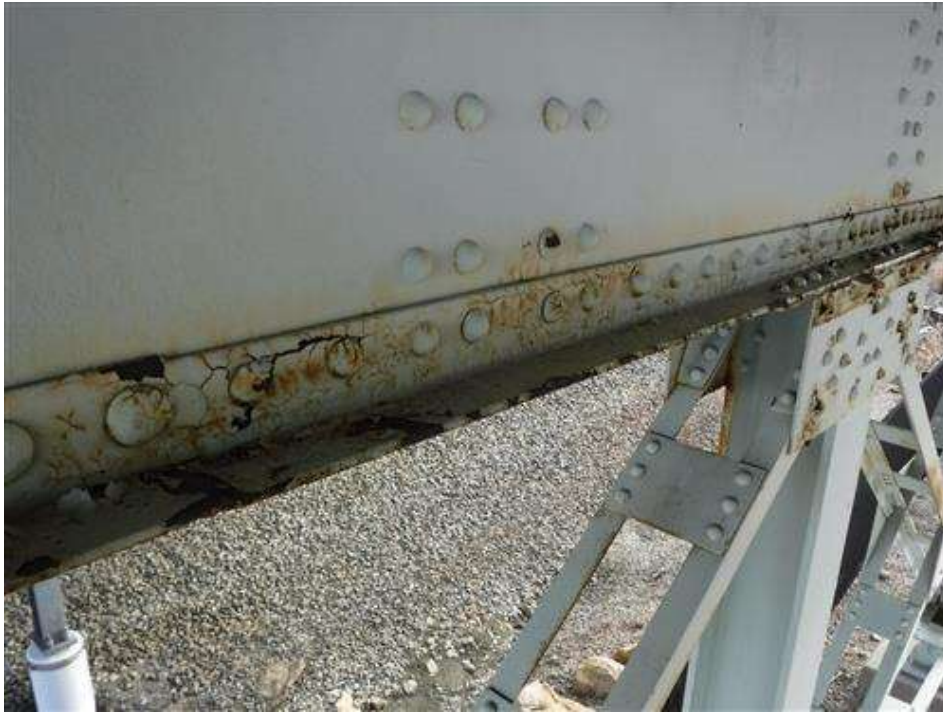
Photo Number: 51

Pier 3 cap, south elevation below Girder G4, the top of the bottom flange has painted over section loss.

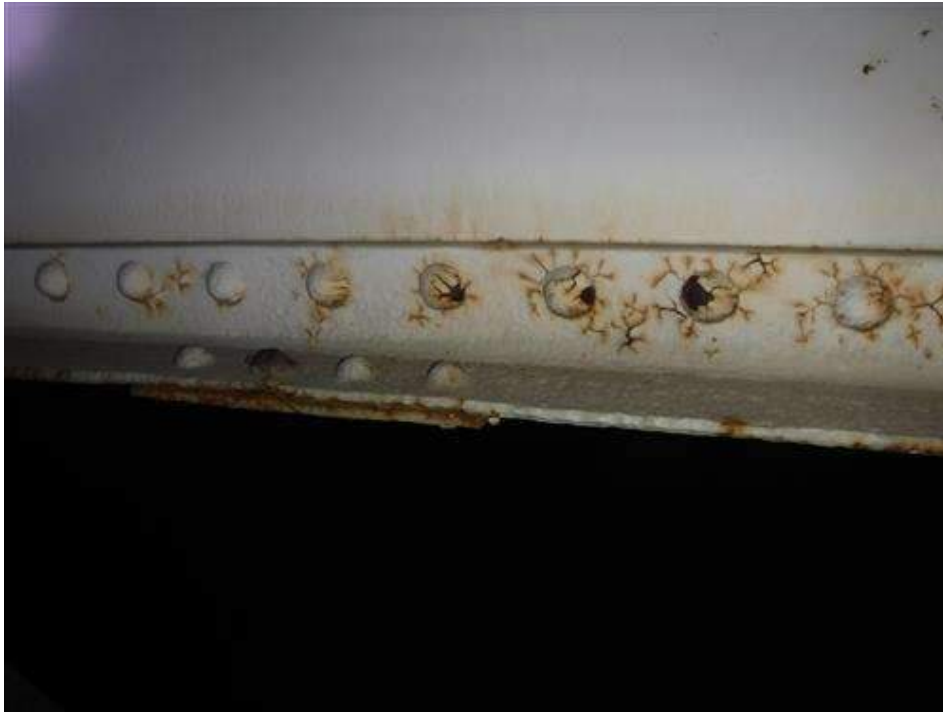
Photo Number: 53

Pier 4 cap, south elevation between Girders G6 - G7, the top of the bottom flange angle has painted over pitting.

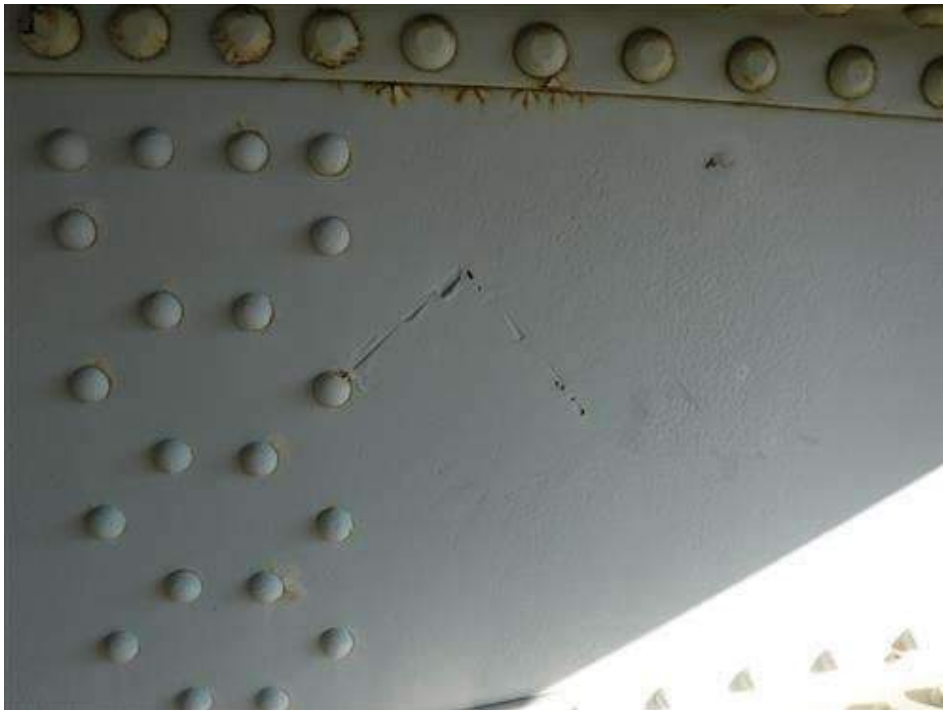
Photo Number: 54

Pier 7 cap, south elevation over Column C3, the web has a gouge/fabrication defect.

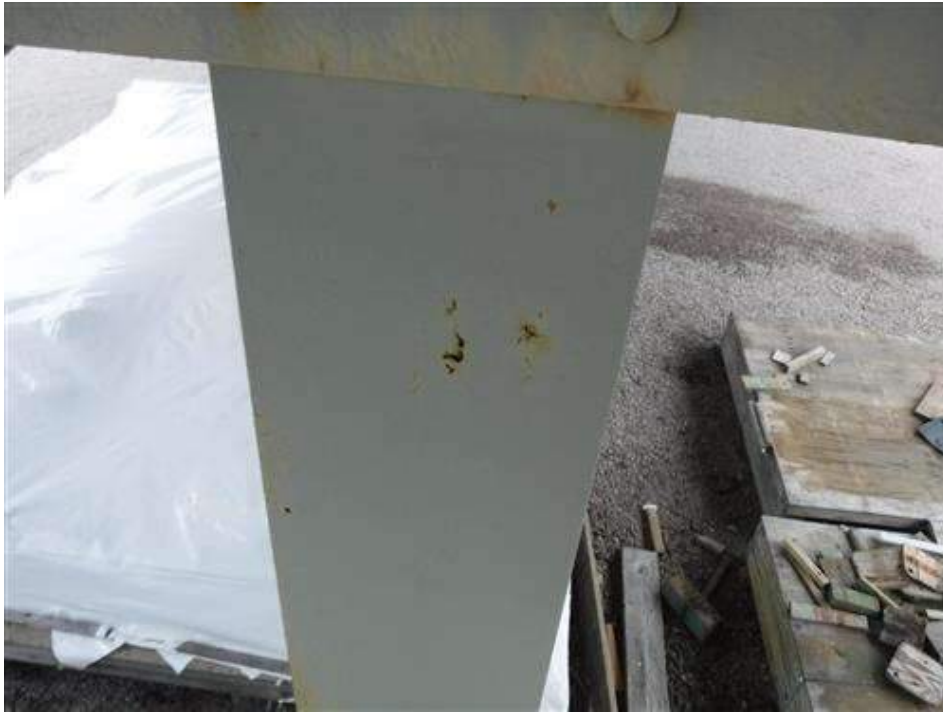
Photo Number: 55

Pier 2, Column C2 south elevation at the top has gouges/fabrication defects.

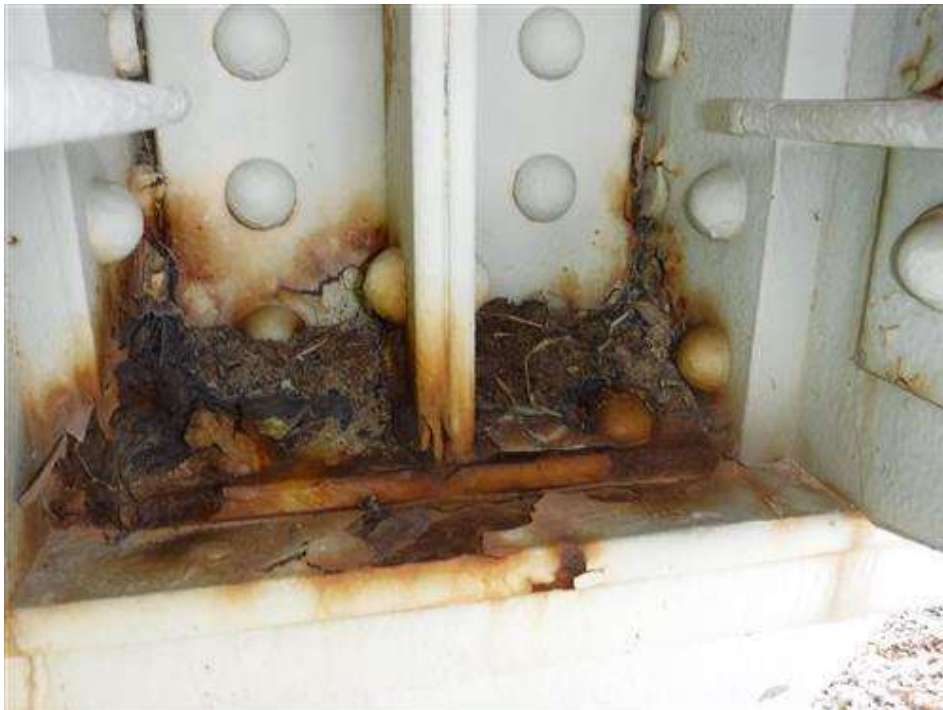
Photo Number: 56

Pier 3, Column 3 west elevation at the base has laminated rust and section loss on the interior column legs.

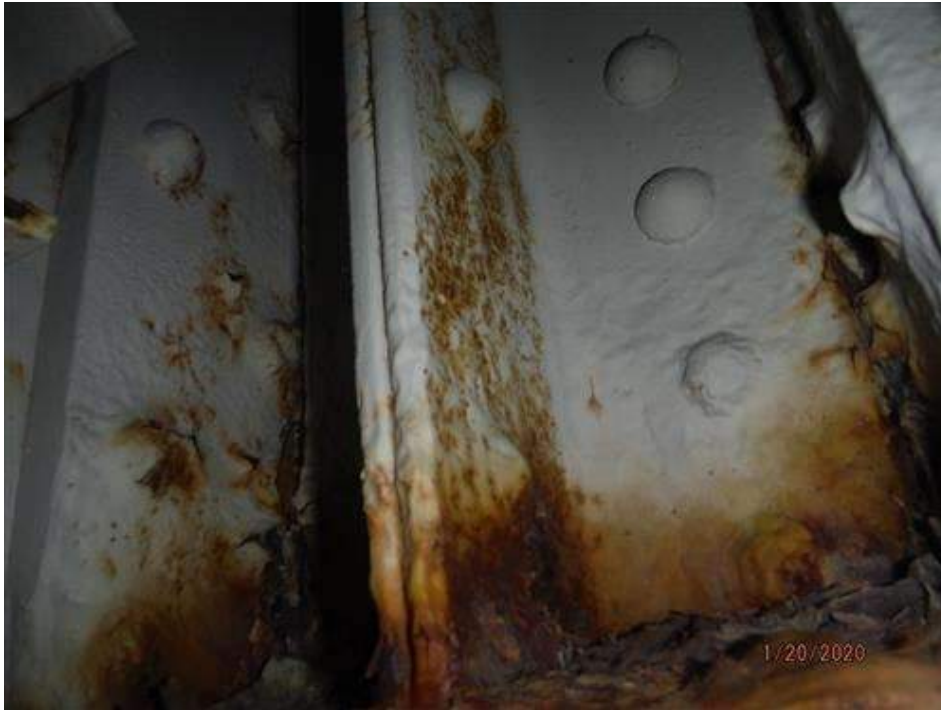
Photo Number: 57

Pier 4, Column C3 west elevation at the base has laminated rust with section loss and areas of painted over section loss on the interior column legs.

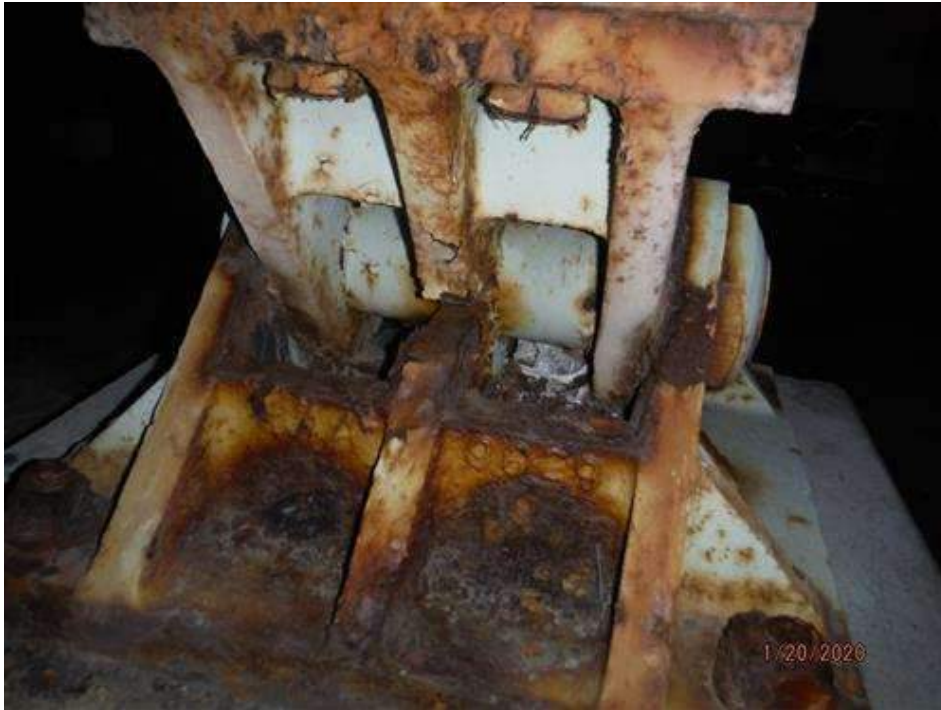
Photo Number: 59

Pier 4, north elevation of Column C1 bearing has laminated rust with section loss on the bearing plates and pack rust between the vertical plates.

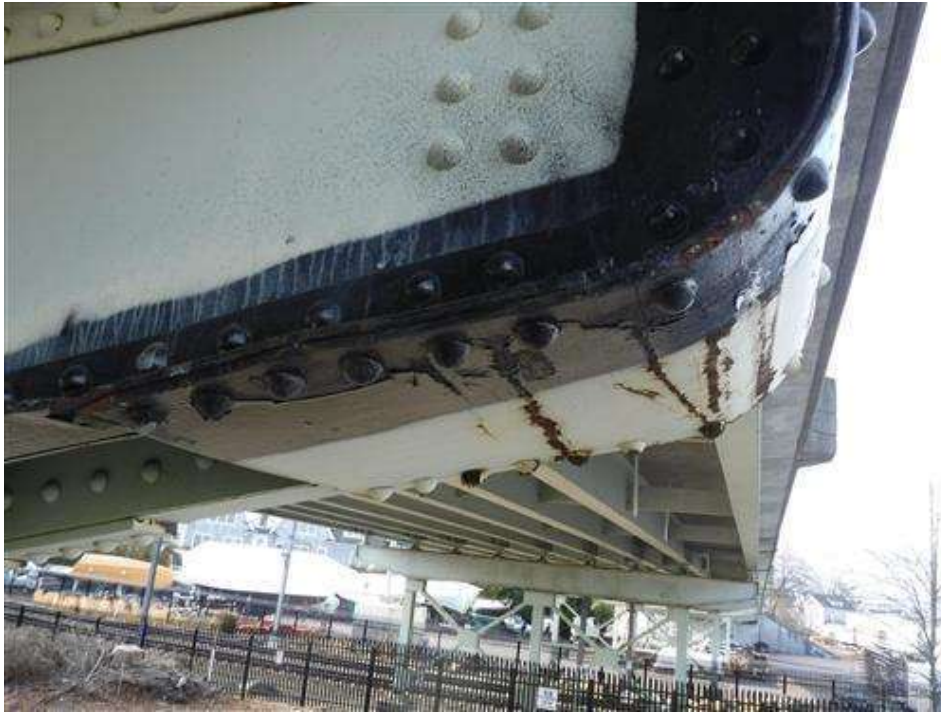
Photo Number: 61

Pier 5 cap, north elevation below Girder G1 has impact damage and gouges/notches on the bottom flange cover plate, which has been painted over.

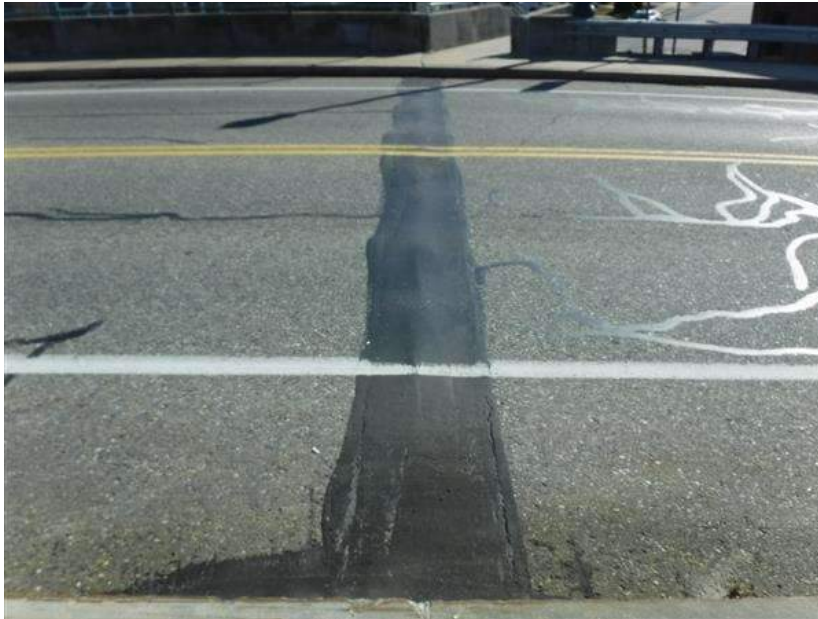
**Comments:** - The plug joints have random areas of exposed aggregate and evidence of past leakage noted below at the abutment backwalls.  
- Abutment 1 plug joint has adhesion cracks up to 7' long x 1/4" wide and the approach side is settled/depressed for full length x 1/2" deep.  
- Abutment 2 plug joint has adhesion cracks up to 15' long x 1/2" wide and the approach side is settled/depressed for full length x 1" deep.  
- The east sidewalk at Abutment 1 deck joint is open for 2" wide with a failed/missing seal.

Abutment 1 plug joint has multiple adhesion cracks with full length settlement/depressions, looking east.

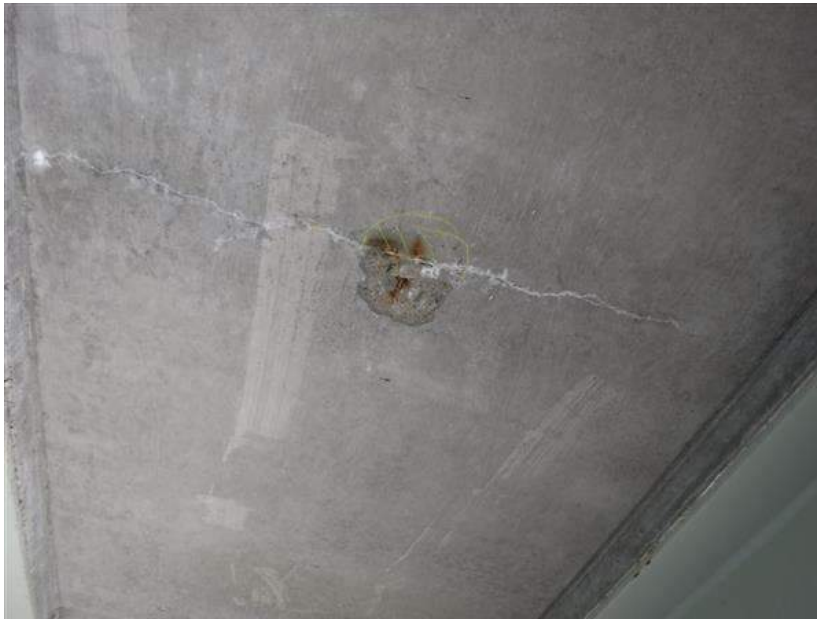
Span 6, Bay 3 underside of deck between Diaphragms D2 & D3 near Diaphragm D3 has a spall with an adjacent hollow area over the parking lot below.

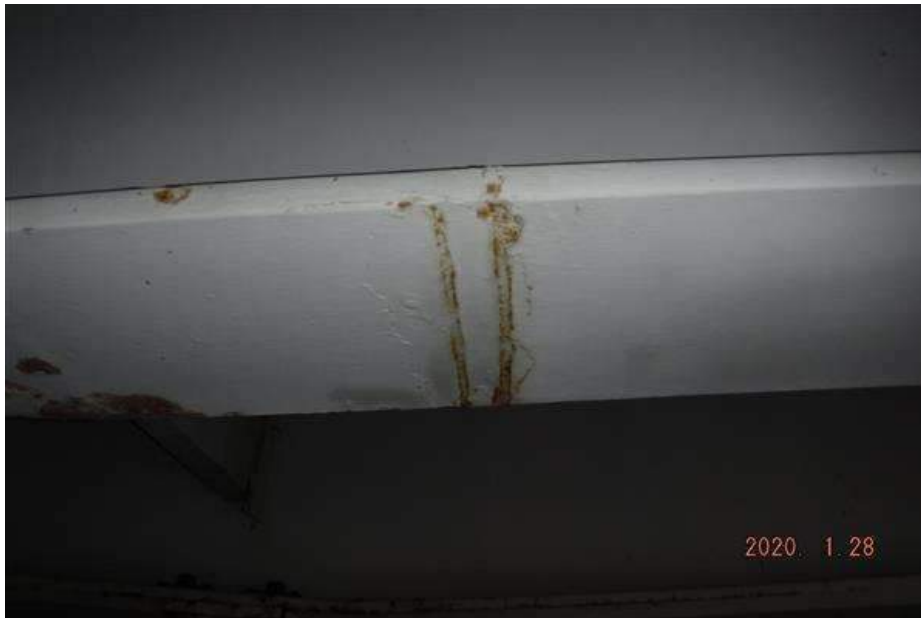
Span 8, Girder G6 bottom of bottom flange near Pier 7 has two (2) impact gouges.

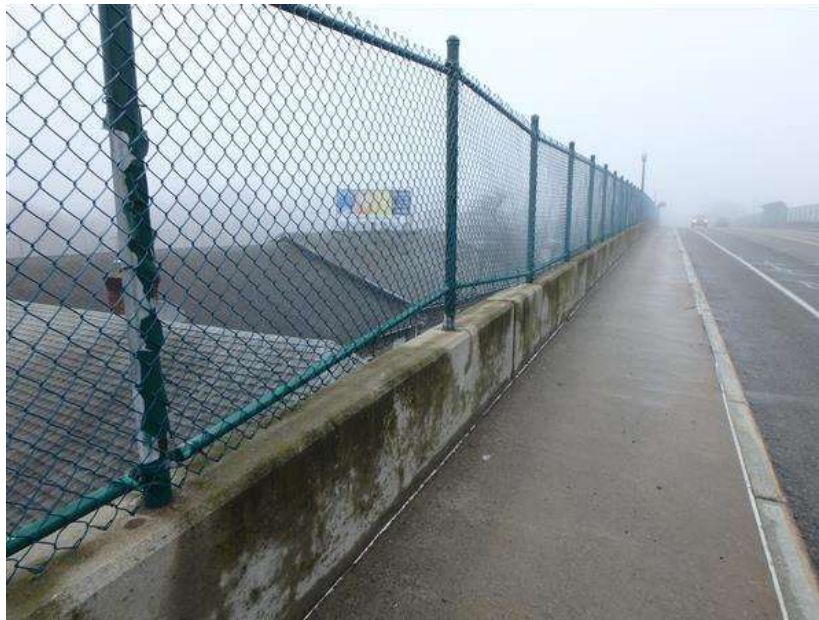
- Random disconnected top and bottom horizontal rails, total 6 locations. See photo 15.
- There are three locations where the fence posts are partially pulled out of the parapet causing gaps between the fence and the top of the parapet located over Mathews Street (4" high) in span 1, over paved parking area (7" high) in span 7, and over Cutler Street (7" high) in span 8. See photos 9 & 13.

General view of the east sidewalk, parapet and fence. Note the fence post partially lifted out of parapet causing a gap between the fence and top of the parapet in span 7. Also see photo 13.

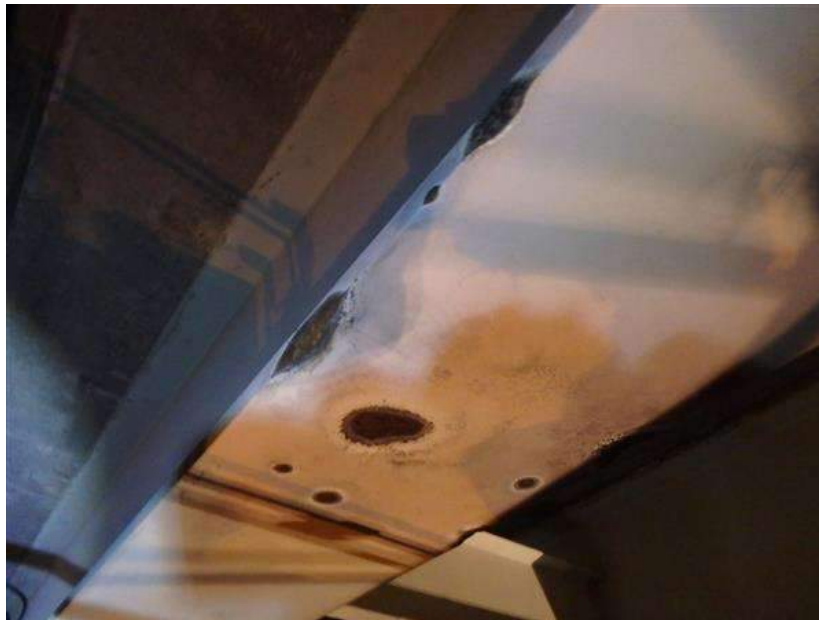
**Comments:** - In Span 4, the girder bottom flanges have areas of section loss above the Amtrak electrical lines due to electrical arcing and melted steel. The areas of section loss are typically 2" diameter x 1/8" deep average with areas up to 6" long x 1" high on the edges. There are a few locations of section loss up to 2" diameter x 1/4" deep, which results in up to a 4.4% loss to bottom flange capacity at a critical location. Two (2) new locations have been noted since the last inspection and conditions are advancing at previously noted locations.

Typical melting section loss at girder G1 over track 1, typical.

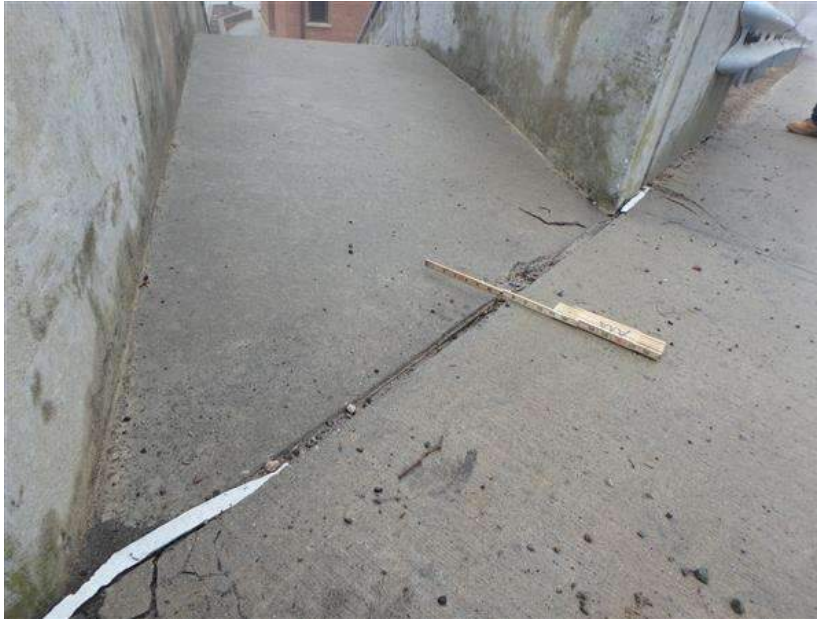
Deteriorated sealant and vertical misalignment at the southeast staircase and southeast approach sidewalk.
