Appendix B

Mystic Area Manhole Inspection Reports and Photos

Town of Stonington, Connecticut

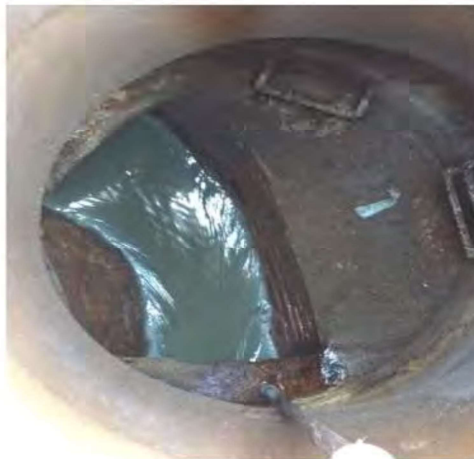
Location in MH	Mtrl. Code	Infil. Code	Cond. Code	Repair Codes	Comments
Frame/Cover	CAST IRON	NONE	CORRODED	REPLACE FRAME AND COVER	
Chimney	CONCRETE BLOCK	NONE	SOUND	NONE	
Cone	CONCRETE (PRECAST)	NONE	SOUND	NONE	
Wall	CONCRETE (PRECAST)	NONE	SOUND	NONE	
Bench	BRICK	NONE	SOUND	NONE	
Invert/Channel	BRICK	NONE	SOUND	NONE

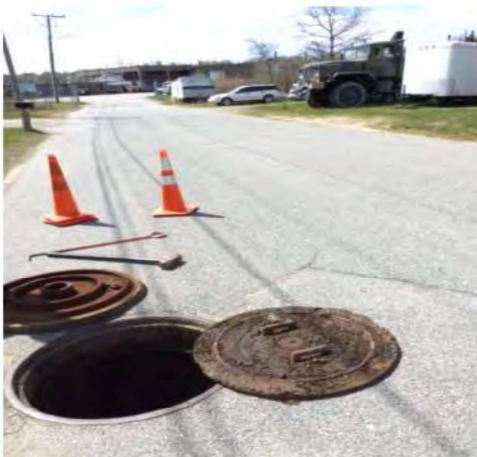
Location in MH	Mtrl. Code	Infil. Code	Cond. Code	Repair Codes	Comments
Frame/Cover	CAST IRON	NONE	CORRODED	REPLACE FRAME AND COVER	
Chimney	OTHER (DESCRIBE IN DETAILS)	NONE	NOT KNOWN	NONE	NO CHIMNEY
Cone	OTHER (DESCRIBE IN DETAILS)	NONE	SOUND	NONE	NO CHIMNEY
Wall	CONCRETE (PRECAST)	WEEPER	SOUND	LINE_MANHOLE	
Bench	BRICK	NONE	SOUND	NONE	
Invert/Channel	BRICK	NONE	SOUND	NONE

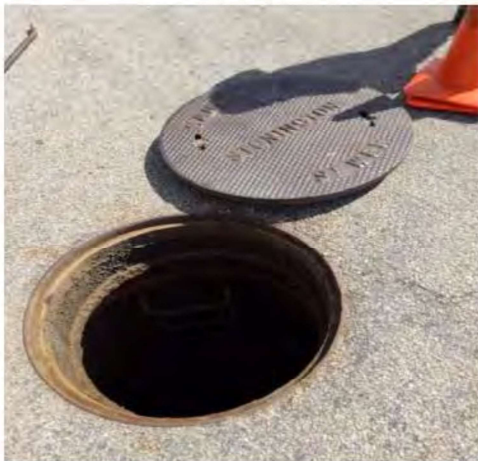
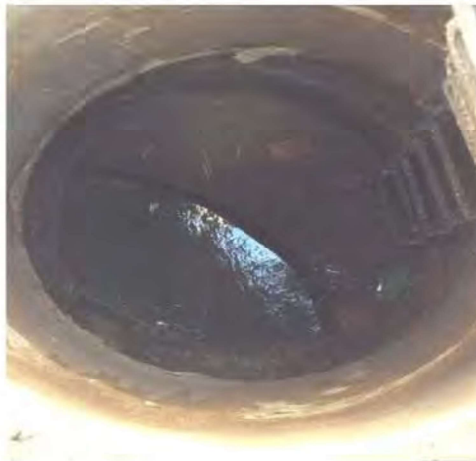
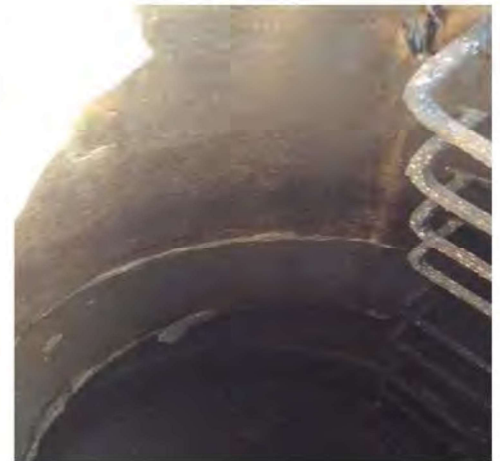
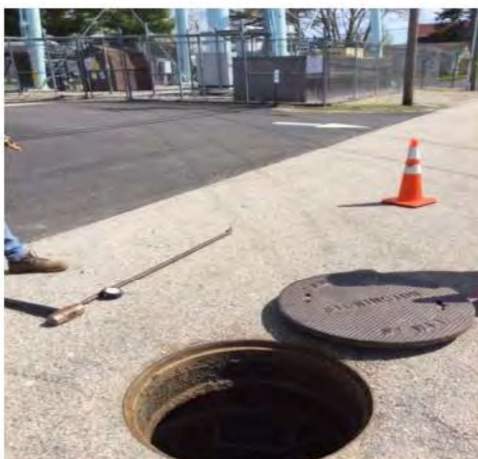
Location in MH	Mtrl. Code	Infil. Code	Cond. Code	Repair Codes	Comments
Frame/Cover	CAST IRON	NONE	SOUND	NONE	
Chimney	OTHER (DESCRIBE IN DETAILS)	NONE	SOUND	NONE	NO CHIMNEY.
Cone	OTHER (DESCRIBE IN DETAILS)	NONE	SOUND	NONE	NO CONE.
Wall	CONCRETE (PRECAST)	STAINS	SOUND	NONE	
Bench	BRICK	NONE	SOUND	NONE	
Invert/Channel	BRICK	NONE	SOUND	NONE

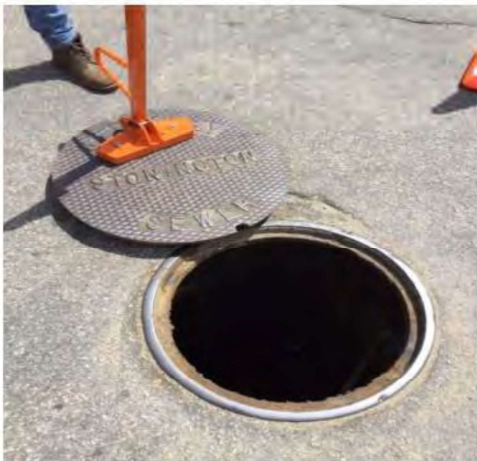
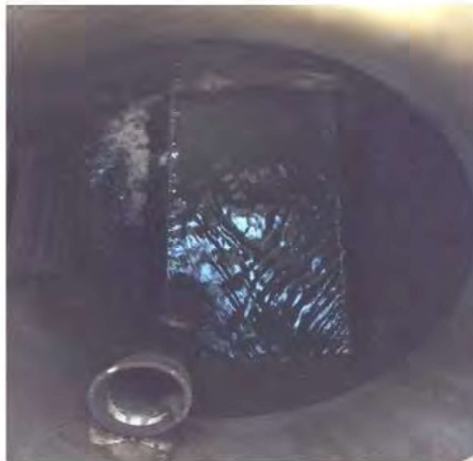
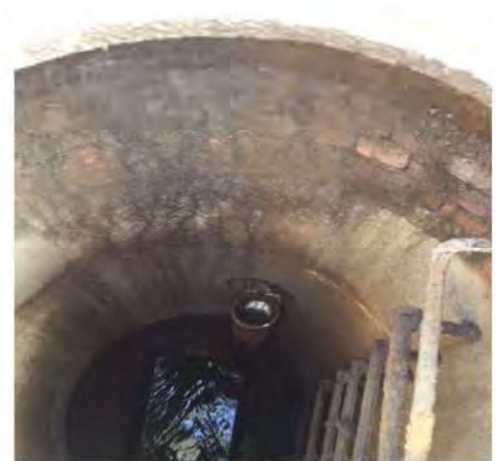
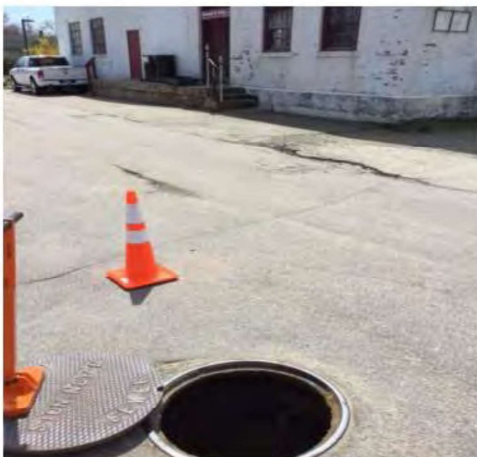
Location in MH	Mtrl. Code	Infil. Code	Cond. Code	Repair Codes	Comments
Frame/Cover	CAST IRON	STAINS	SOUND	NONE	
Chimney	BRICK	NONE	SOUND	NONE	
Cone	CONCRETE (PRECAST)	NONE	SOUND	NONE	DOUBLE CONE
Wall	CONCRETE (PRECAST)	NONE	SOUND	NONE	
Bench	BRICK	NONE	SOUND	NONE	
Invert/Channel	BRICK	NONE	SOUND	NONE

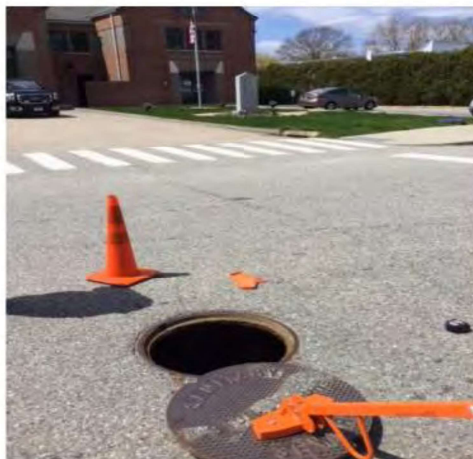
Location in MH	Mtrl. Code	Infil. Code	Cond. Code	Repair Codes	Comments
Frame/Cover	CAST IRON	NONE	CORRODED	REPLACE FRAME AND COVER	
Chimney	BRICK	NONE	SOUND	NONE	
Cone	OTHER (DESCRIBE IN DETAILS)	NONE	SOUND	NONE	NO CONE
Wall	CONCRETE (PRECAST)	WEEPER	DEFECTIVE	LINE_MANHOLE	TONS OF CORROSION
Bench	BRICK	NONE	SOUND	NONE	
Invert/Channel	BRICK	NONE	SOUND	NONE

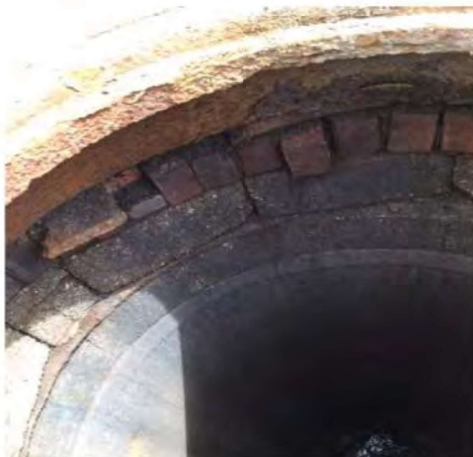
Location in MH	Mtrl. Code	Infil. Code	Cond. Code	Repair Codes	Comments
Frame/Cover	CAST IRON	NONE	SOUND	NONE	
Chimney	BRICK	STAINS	DEFECTIVE	REBUILD TOP, REPLACE FRAME AND CHIMNEY	
Cone	OTHER (DESCRIBE IN DETAILS)	NONE	SOUND	NONE	NO CONE.
Wall	CONCRETE (PRECAST)	STAINS	SOUND	NONE	
Bench	BRICK	NONE	SOUND	NONE	
Invert/Channel	BRICK	NONE	SOUND	NONE

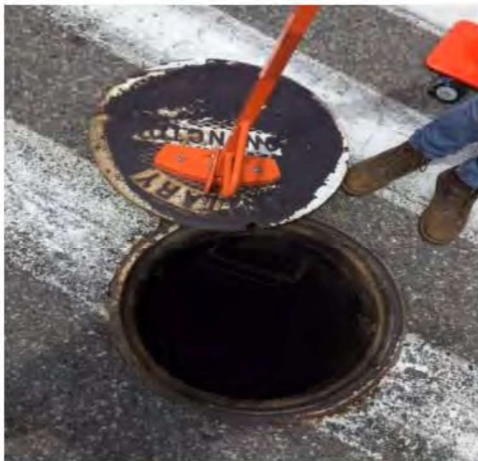
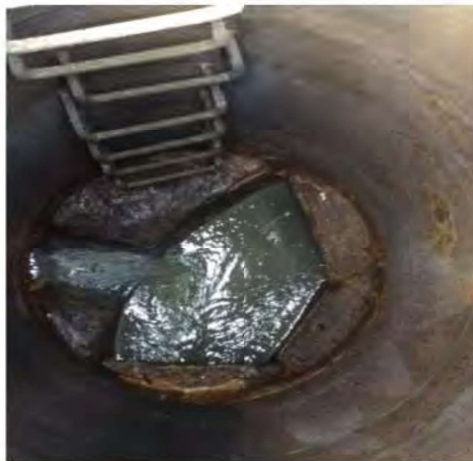
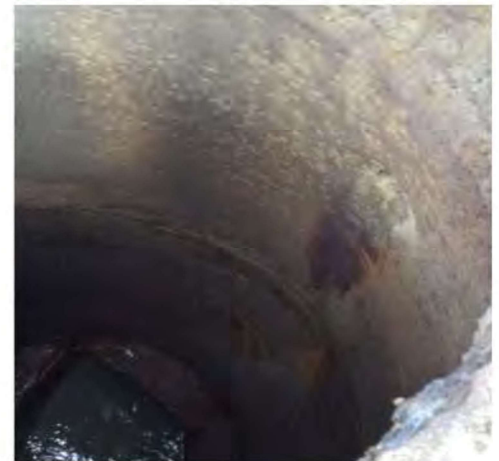
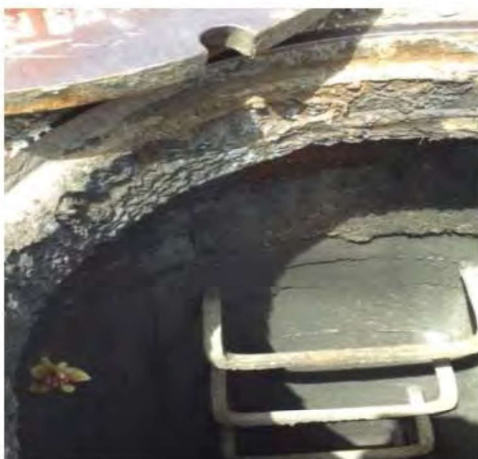
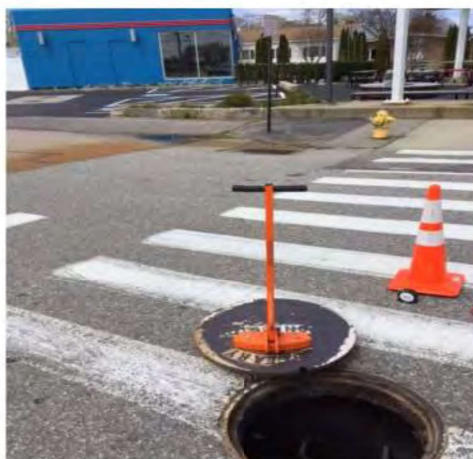
Location in MH	Mtrl. Code	Infil. Code	Cond. Code	Repair Codes	Comments
Frame/Cover	CAST IRON	NONE	SOUND	NONE	
Chimney	CONCRETE BLOCK	NONE	SOUND	NONE	
Cone	OTHER (DESCRIBE IN DETAILS)	NONE	SOUND	NONE	NO CONE.
Wall	CONCRETE (PRECAST)	STAINS	SOUND	NONE	
Bench	BRICK	NONE	SOUND	NONE	
Invert/Channel	BRICK	NONE	SOUND	NONE

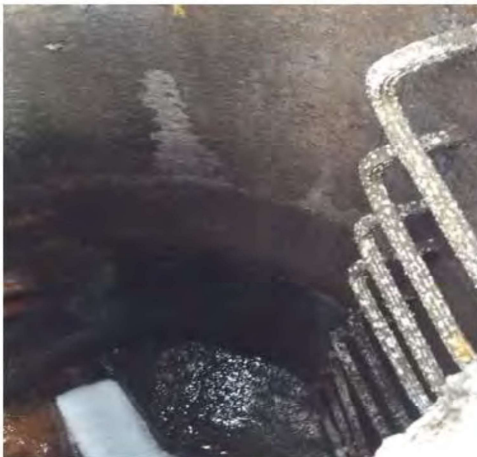
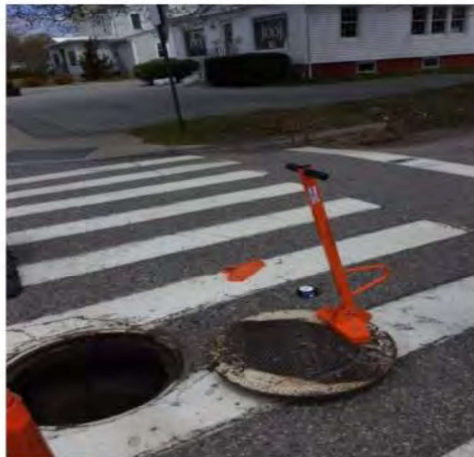
Location in MH	Mtrl. Code	Infil. Code	Cond. Code	Repair Codes	Comments
Frame/Cover	CAST IRON	NONE	BROKEN	REPLACE FRAME AND COVER	
Chimney	CONCRETE BLOCK	NONE	SOUND	NONE	
Cone	OTHER (DESCRIBE IN DETAILS)	NONE	SOUND	OTHER	NO CONE.
Wall	CONCRETE (PRECAST)	RUNNER	DEFECTIVE	LINE_MANHOLE	SEDIMENT ALSO ON WALL AROUND NINE O CLOCK PIPE. RUNNER AROUND 2 O CLOCK.
Bench	BRICK	NONE	SOUND	NONE	
Invert/Channel	BRICK	NONE	SOUND	NONE

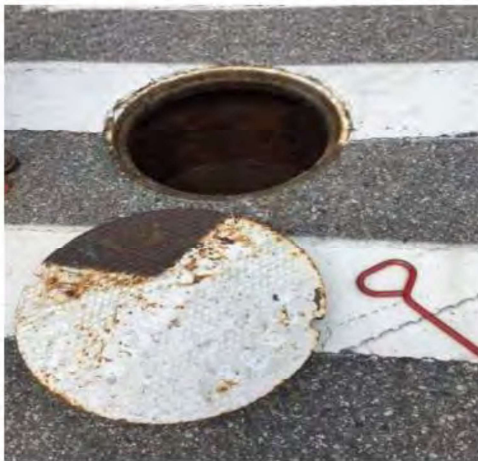
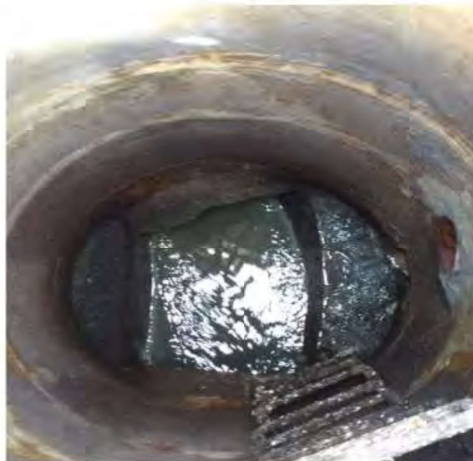
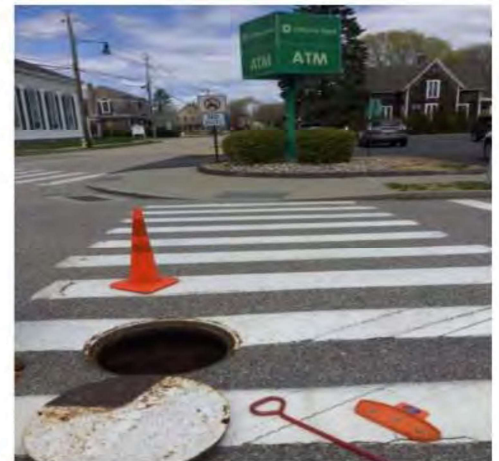
Location in MH	Mtrl. Code	Infil. Code	Cond. Code	Repair Codes	Comments
Frame/Cover	CAST IRON	NONE	SOUND	NONE	
Chimney	BRICK	NONE	DEFECTIVE	LINE MANHOLE	
Cone	OTHER (DESCRIBE IN DETAILS)	NONE	NOT KNOWN	NONE	
Wall	CONCRETE (PRECAST)	WEEPER	DEFECTIVE	LINE_MANHOLE	WEEPER WHERE HOLE FOR CARING WAS. MINERALS AND INFILTRATION ABOVE 12 O'CLOCK PIPE.
Bench	BRICK	NONE	SOUND	NONE	
Invert/Channel	BRICK	NONE	SOUND	NONE

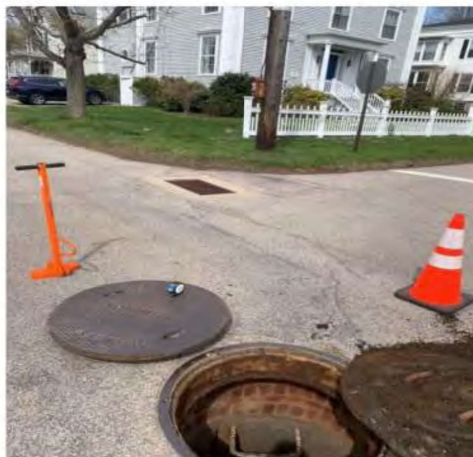
Location in MH	Mtrl. Code	Infil. Code	Cond. Code	Repair Codes	Comments
Frame/Cover	CAST IRON	STAINS	SOUND	REPLACE FRAME AND COVER	
Chimney	BRICK	NONE	SOUND	NONE	
Cone	OTHER (DESCRIBE IN DETAILS)	NONE	SOUND	NONE	NO CONE
Wall	CONCRETE (PRECAST)	NONE	SOUND	NONE	
Bench	BRICK	NONE	SOUND	NONE	
Invert/Channel	BRICK	NONE	SOUND	NONE

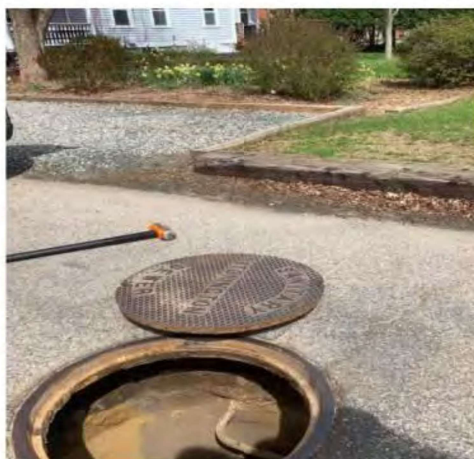
Location in MH	Mtrl. Code	Infil. Code	Cond. Code	Repair Codes	Comments
Frame/Cover	CAST IRON	NONE	SOUND	NONE	
Chimney	BRICK	STAINS	DEFECTIVE	LINE MANHOLE	
Cone	OTHER (DESCRIBE IN DETAILS)	NONE	SOUND	NONE	NO CONE
Wall	CONCRETE (PRECAST)	STAINS	DEFECTIVE	LINE_MANHOLE	
Bench	BRICK	NONE	SOUND	NONE	
Invert/Channel	BRICK	NONE	SOUND	NONE

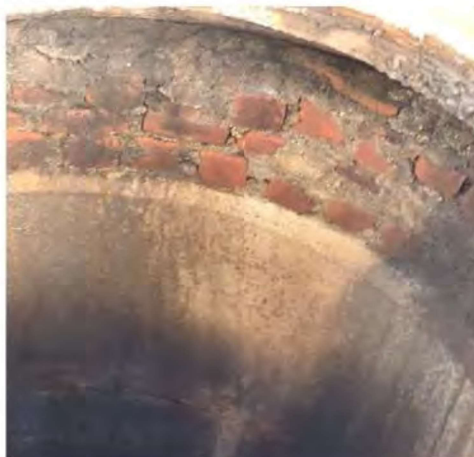
Location in MH	Mtrl. Code	Infil. Code	Cond. Code	Repair Codes	Comments
Frame/Cover	CAST IRON	STAINS	BROKEN	REPLACE FRAME AND COVER	
Chimney	BRICK	NONE	SOUND	NONE	
Cone	NOT KNOWN	NONE	SOUND	NONE	
Wall	CONCRETE (PRECAST)	NONE	SOUND	NONE	
Bench	BRICK	NONE	SOUND	NONE	
Invert/Channel	BRICK	NONE	SOUND	NONE

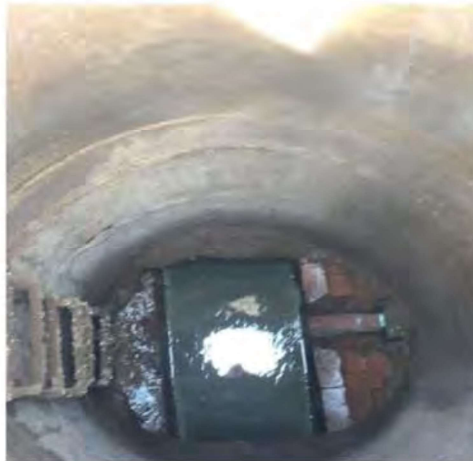
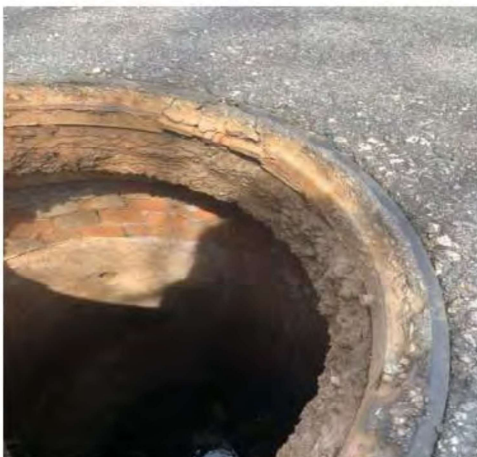
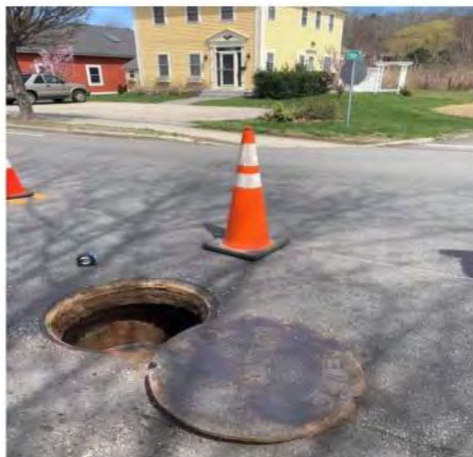
Location in MH	Mtrl. Code	Infil. Code	Cond. Code	Repair Codes	Comments
Frame/Cover	CAST IRON	STAINS	SOUND	REPLACE FRAME AND COVER	
Chimney	BRICK	NONE	DEFECTIVE	RESET EXISTING FRAME AND CHIMNEY	
Cone	OTHER (DESCRIBE IN DETAILS)	NONE	SOUND	NONE	NO CONE
Wall	CONCRETE (PRECAST)	NONE	SOUND	NONE	
Bench	BRICK	NONE	SOUND	NONE	
Invert/Channel	BRICK	NONE	SOUND	NONE

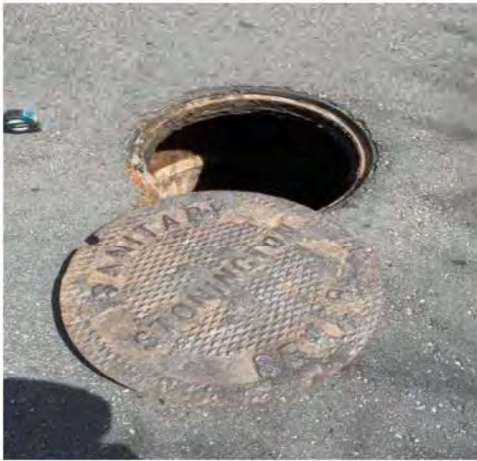
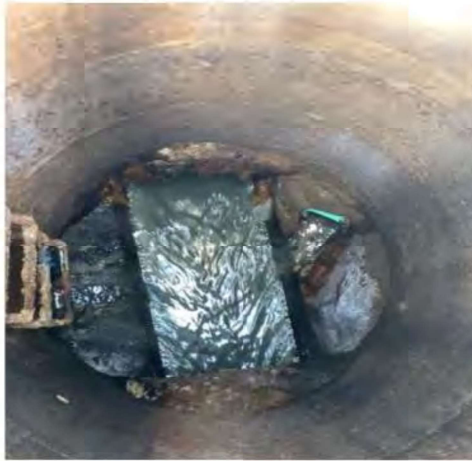
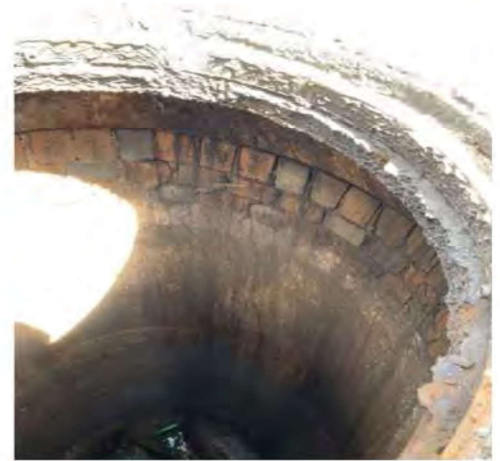
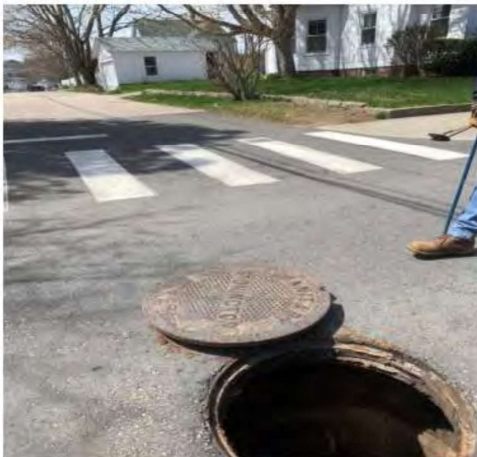
Location in MH	Mtrl. Code	Infil. Code	Cond. Code	Repair Codes	Comments
Frame/Cover	CAST IRON	STAINS	BROKEN	REPLACE FRAME AND COVER	
Chimney	BRICK	NONE	SOUND	NONE	
Cone	NOT KNOWN	NONE	SOUND	NONE	NO CONE
Wall	CONCRETE (PRECAST)	NONE	SOUND	NONE	
Bench	BRICK	NONE	SOUND	NONE	
Invert/Channel	BRICK	NONE	SOUND	NONE

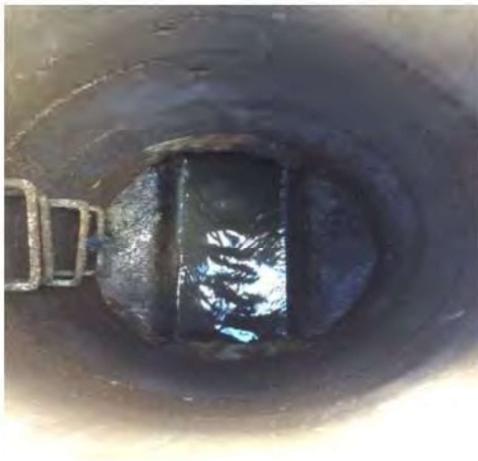
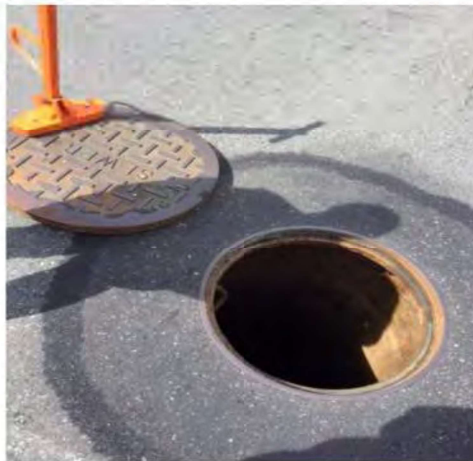
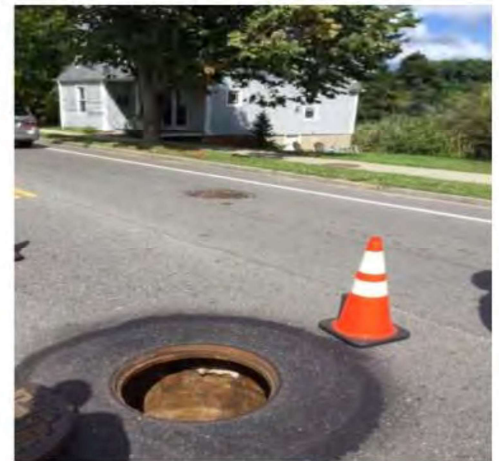
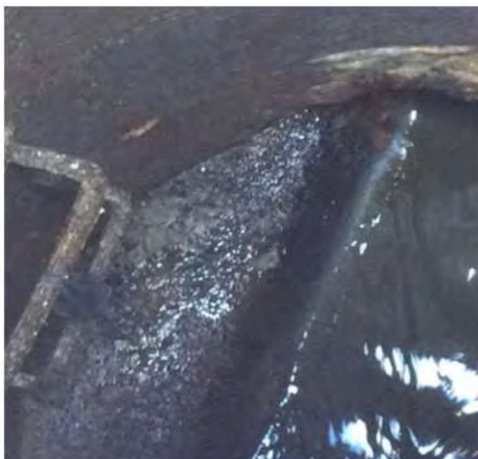
Location in MH	Mtrl. Code	Infil. Code	Cond. Code	Repair Codes	Comments
Frame/Cover	CAST IRON	STAINS	SOUND	REPLACE FRAME AND COVER	
Chimney	BRICK	NONE	SOUND	NONE	
Cone	OTHER (DESCRIBE IN DETAILS)	NONE	SOUND	NONE	NO CONE
Wall	CONCRETE (PRECAST)	NONE	SOUND	NONE	
Bench	BRICK	NONE	SOUND	NONE	
Invert/Channel	BRICK	NONE	SOUND	NONE

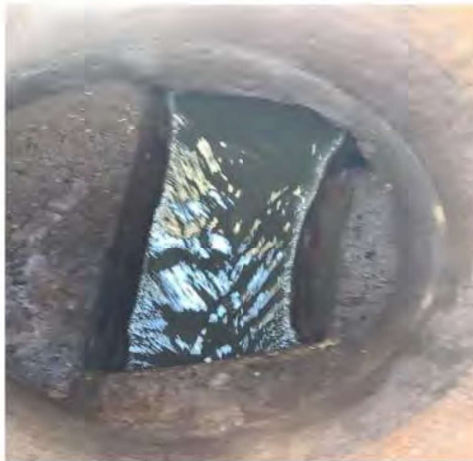
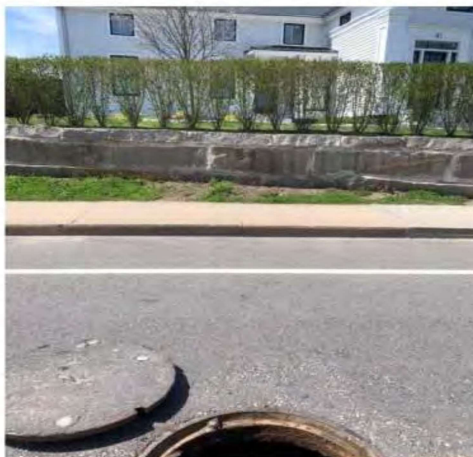
Location in MH	Mtrl. Code	Infil. Code	Cond. Code	Repair Codes	Comments
Frame/Cover	CAST IRON	NONE	SOUND	NONE	
Chimney	BRICK	NONE	SOUND	NONE	
Cone	CONCRETE (PRECAST)	NONE	SOUND	NONE	
Wall	CONCRETE (PRECAST)	WEEPER	DEFECTIVE	SEAL_REPOINT	MINOR INFILTRATION AT BOTTOM OF WALL
Bench	BRICK	NONE	SOUND	NONE	
Invert/Channel	BRICK	NONE	SOUND	NONE

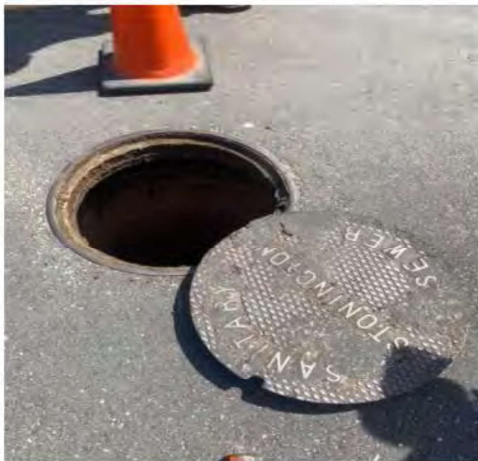
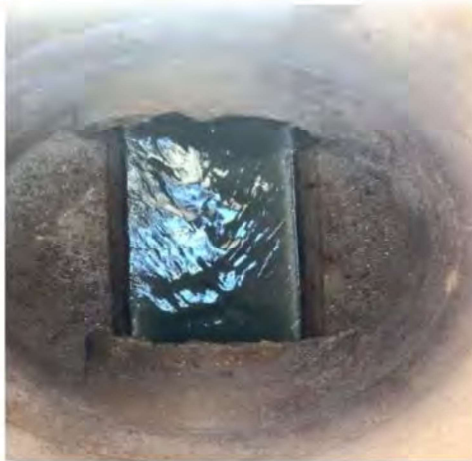
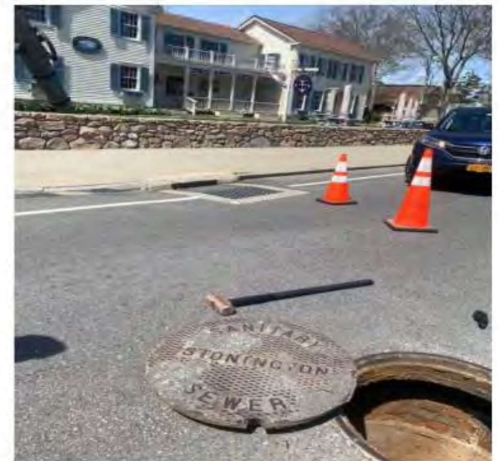
Location in MH	Mtrl. Code	Infil. Code	Cond. Code	Repair Codes	Comments
Frame/Cover	CAST IRON	NONE	BROKEN	REPLACE FRAME AND COVER	
Chimney	BRICK	STAINS	SOUND	LINE MANHOLE	
Cone	OTHER (DESCRIBE IN DETAILS)	NONE	SOUND	NONE	NO CONE
Wall	CONCRETE (PRECAST)	STAINS	SOUND	LINE_MANHOLE	
Bench	BRICK	NONE	SOUND	NONE	
Invert/Channel	BRICK	NONE	SOUND	NONE
