CDM
Smith

Town of Stonington, Connecticut

Manhole Inspection Form

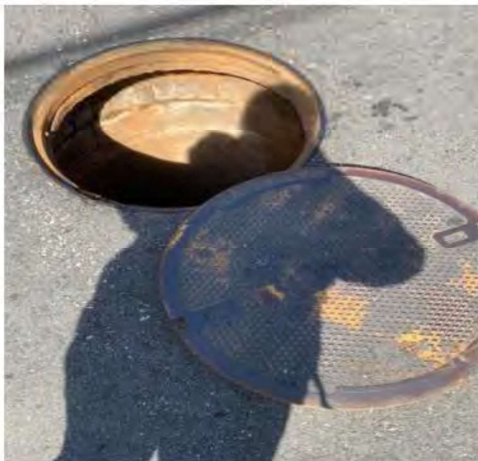
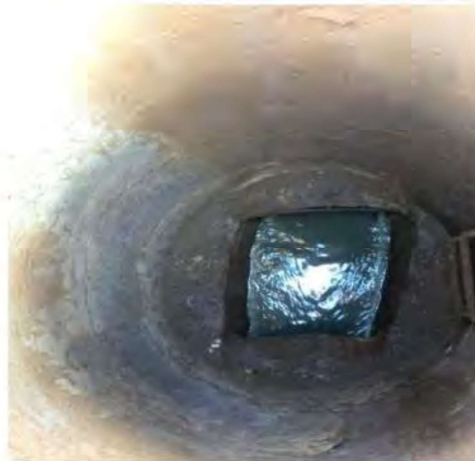
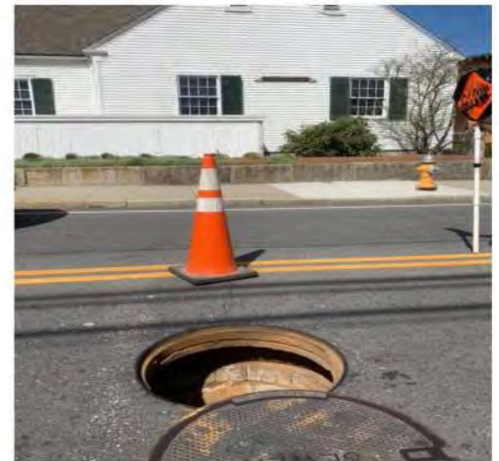
Location in MH	Mtrl. Code	Infil. Code	Cond. Code	Repair Codes	Comments
Frame/Cover	CAST IRON	NONE	SOUND	NONE	
Chimney	BRICK	NONE	SOUND	NONE	BRICK AND CONCRETE BLOCK
Cone	OTHER (DESCRIBE IN DETAILS)	NONE	SOUND	NONE	NO CONE
Wall	CONCRETE (PRECAST)	NONE	SOUND	NONE	
Bench	BRICK	NONE	SOUND	NONE	
Invert/Channel	BRICK	NONE	SOUND	NONE

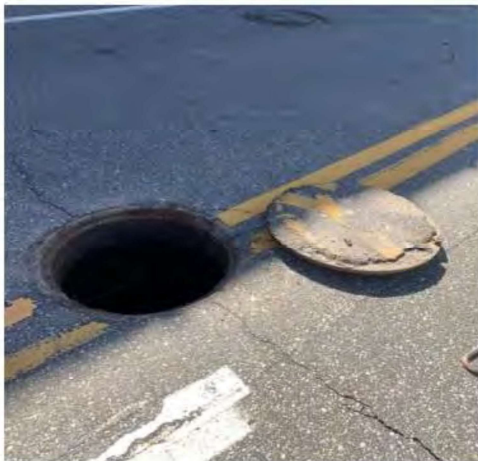
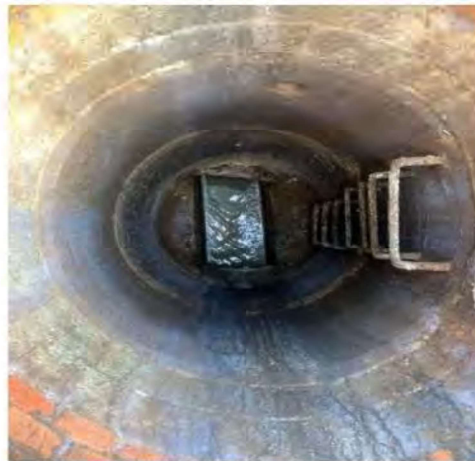
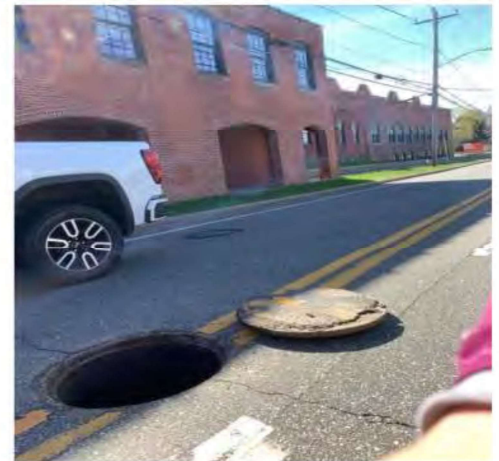
Location in MH	Mtrl. Code	Infil. Code	Cond. Code	Repair Codes	Comments
Frame/Cover	CAST IRON	NONE	SOUND	NONE	
Chimney	BRICK	NONE	SOUND	NONE	
Cone	OTHER (DESCRIBE IN DETAILS)	NONE	SOUND	OTHER	NO CONE
Wall	CONCRETE (PRECAST)	NONE	SOUND	NONE	
Bench	BRICK	NONE	SOUND	NONE	
Invert/Channel	BRICK	NONE	SOUND	NONE

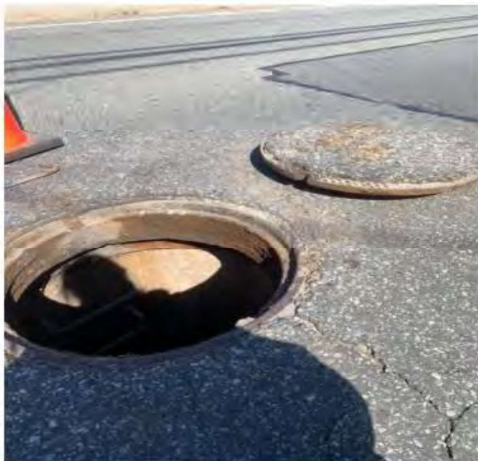
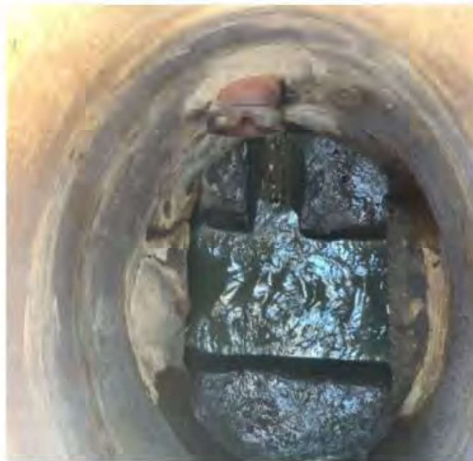
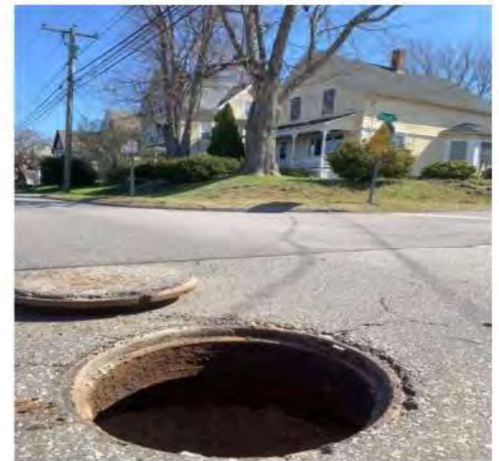
Location in MH	Mtrl. Code	Infil. Code	Cond. Code	Repair Codes	Comments
Frame/Cover	CAST IRON	NONE	SOUND	NONE	
Chimney	BRICK	NONE	SOUND	NONE	
Cone	OTHER (DESCRIBE IN DETAILS)	NONE	SOUND	NONE	NO CONE
Wall	CONCRETE (PRECAST)	NONE	SOUND	NONE	
Bench	BRICK	NONE	SOUND	NONE	
Invert/Channel	BRICK	NONE	SOUND	NONE

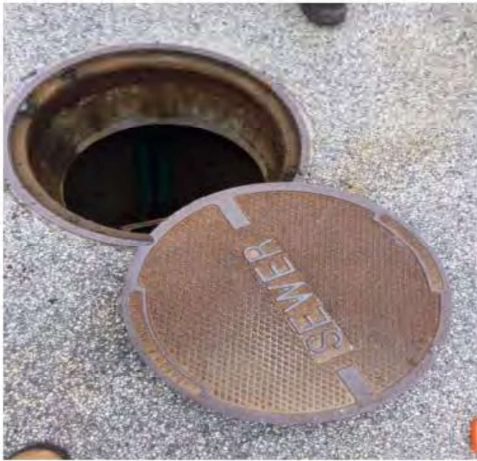
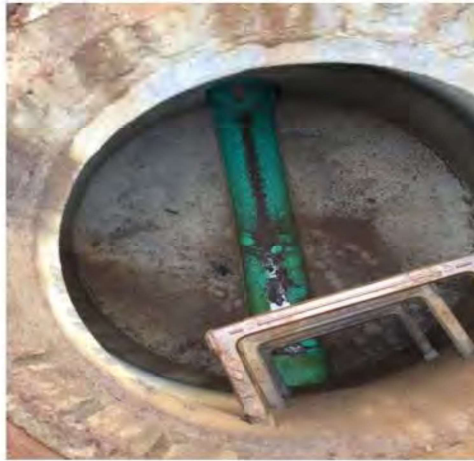
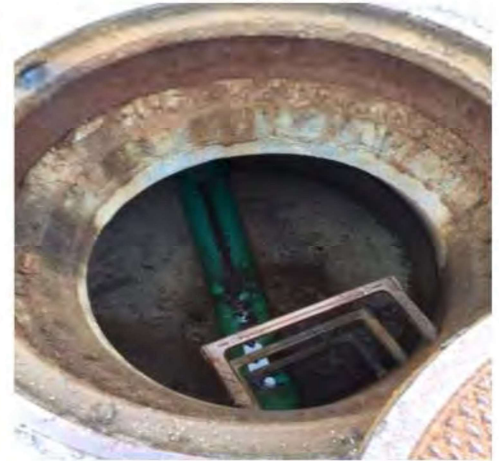
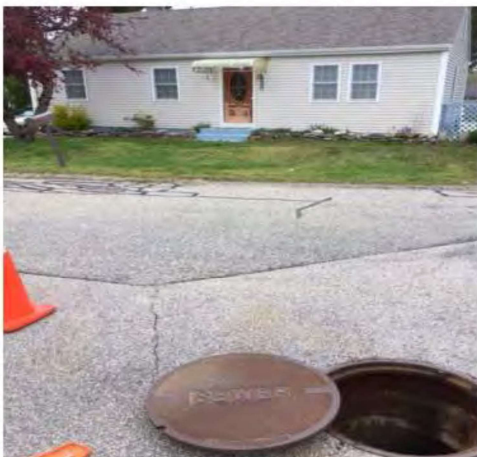
Location in MH	Mtrl. Code	Infil. Code	Cond. Code	Repair Codes	Comments
Frame/Cover	CAST IRON	NONE	SOUND	NONE	
Chimney	CONCRETE BLOCK	NONE	SOUND	NONE	
Cone	CONCRETE (PRECAST)	NONE	SOUND	NONE	
Wall	CONCRETE (PRECAST)	NONE	SOUND	NONE	
Bench	CONCRETE (PRECAST)	NONE	SOUND	NONE	
Invert/Channel	POLY VINYL CHLORIDE	NONE	SOUND	NONE

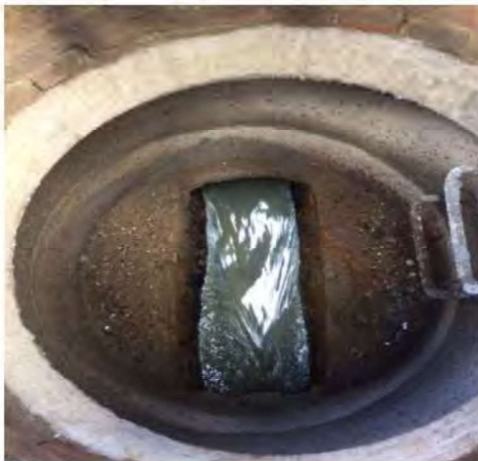
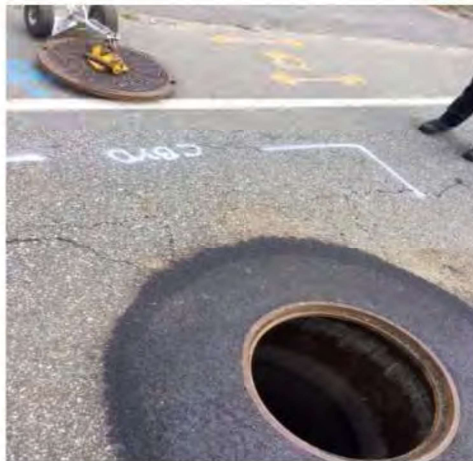
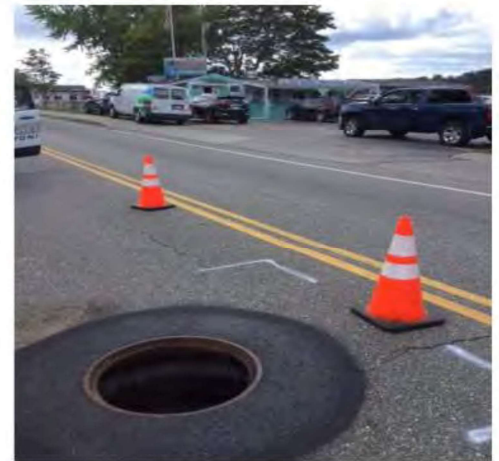
Location in MH	Mtrl. Code	Infil. Code	Cond. Code	Repair Codes	Comments
Frame/Cover	CAST IRON	NONE	SOUND	NONE	
Chimney	BRICK	NONE	SOUND	NONE	
Cone	OTHER (DESCRIBE IN DETAILS)	NONE	SOUND	NONE	NO CONE
Wall	CONCRETE (PRECAST)	NONE	SOUND	NONE	
Bench	BRICK	NONE	SOUND	NONE	
Invert/Channel	BRICK	NONE	SOUND	NONE

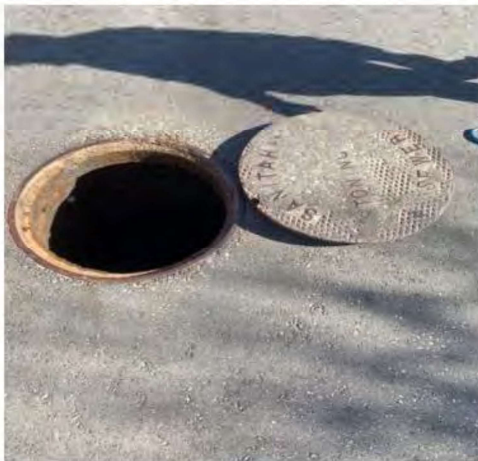
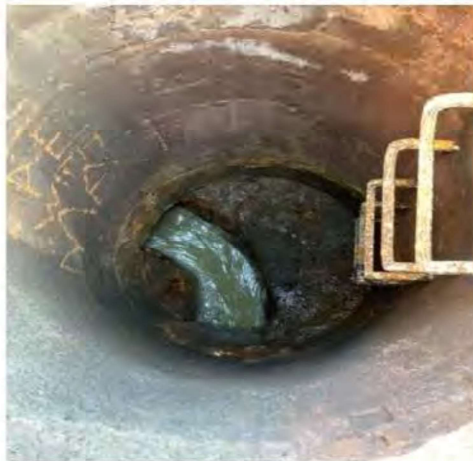
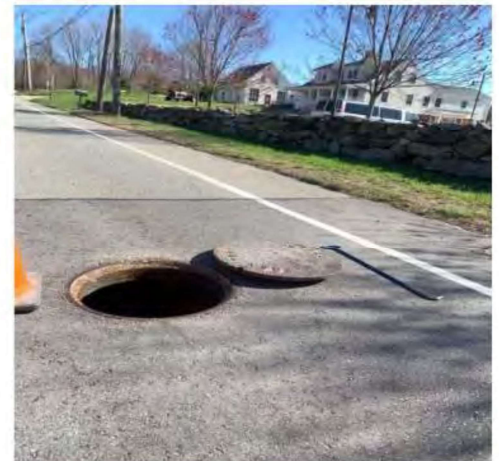
Location in MH	Mtrl. Code	Infil. Code	Cond. Code	Repair Codes	Comments
Frame/Cover	CAST IRON	NONE	SOUND	NONE	
Chimney	BRICK	NONE	SOUND	NONE	
Cone	OTHER (DESCRIBE IN DETAILS)	NONE	SOUND	NONE	NO CONE
Wall	CONCRETE (PRECAST)	NONE	SOUND	NONE	
Bench	BRICK	NONE	SOUND	NONE	
Invert/Channel	BRICK	NONE	SOUND	NONE

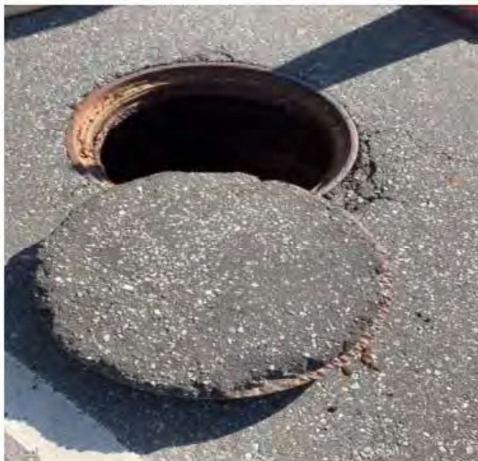
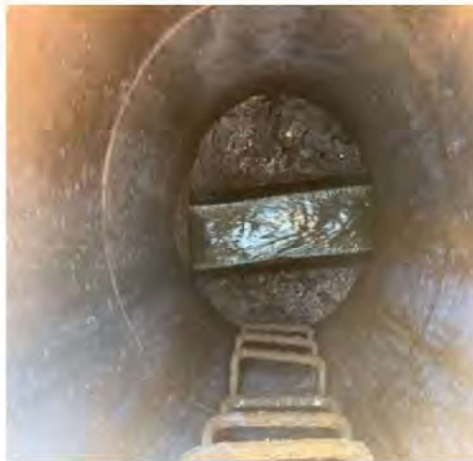
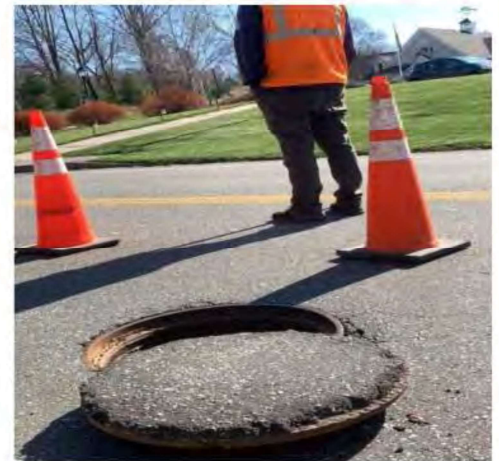
Location in MH	Mtrl. Code	Infil. Code	Cond. Code	Repair Codes	Comments
Frame/Cover	CAST IRON	NONE	SOUND	NONE	
Chimney	BRICK	NONE	SOUND	NONE	
Cone	OTHER (DESCRIBE IN DETAILS)	NONE	NOT KNOWN	NONE	NO CONE
Wall	CONCRETE (PRECAST)	NONE	SOUND	NONE	
Bench	BRICK	NONE	SOUND	NONE	
Invert/Channel	BRICK	NONE	SOUND	NONE

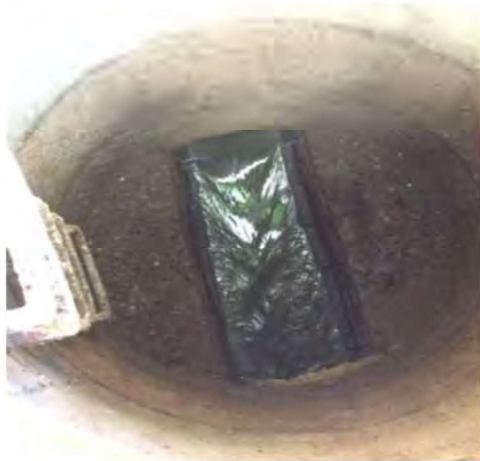
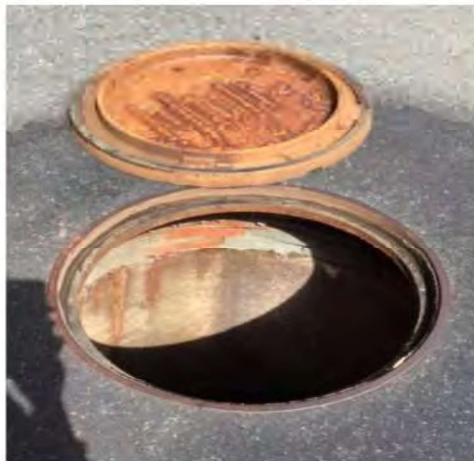
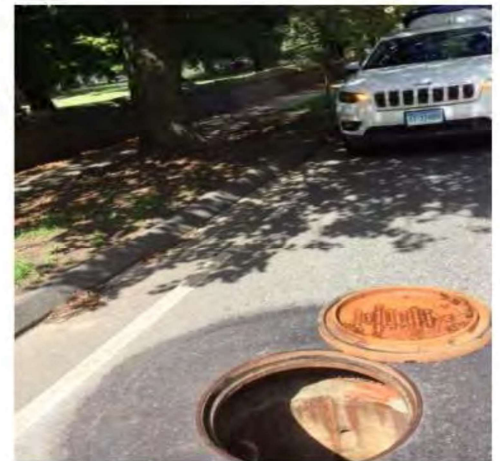
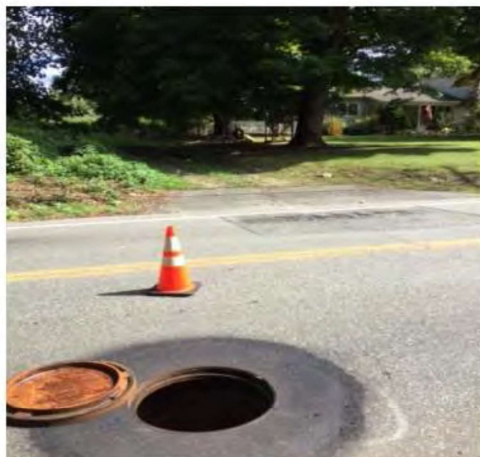
Location in MH	Mtrl. Code	Infil. Code	Cond. Code	Repair Codes	Comments
Frame/Cover	CAST IRON	NONE	SOUND	NONE	
Chimney	BRICK	NONE	SOUND	NONE	
Cone	CONCRETE (PRECAST)	NONE	SOUND	NONE	
Wall	CONCRETE (PRECAST)	NONE	SOUND	NONE	
Bench	BRICK	NONE	SOUND	NONE	
Invert/Channel	BRICK	NONE	SOUND	NONE

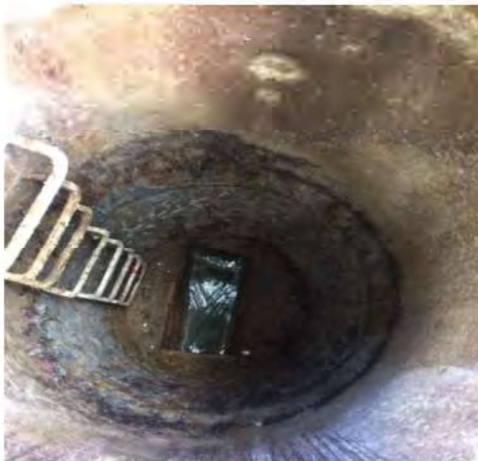
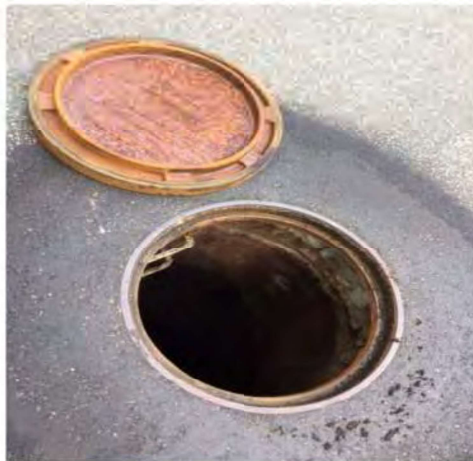
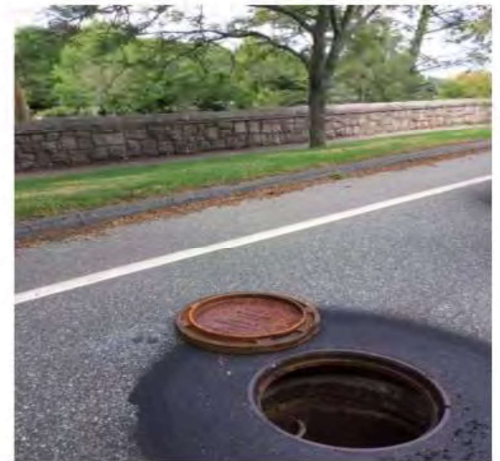
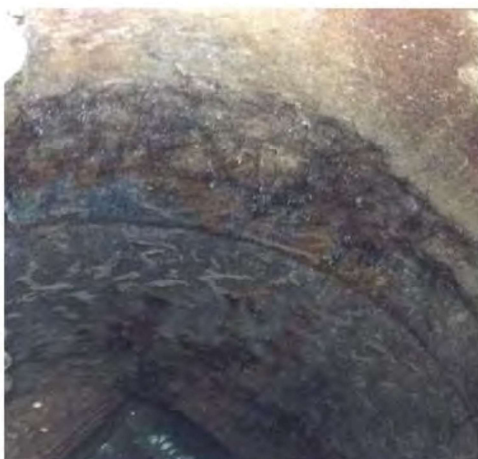
Location in MH	Mtrl. Code	Infil. Code	Cond. Code	Repair Codes	Comments
Frame/Cover	CAST IRON	NONE	SOUND	NONE	
Chimney	BRICK	NONE	SOUND	NONE	
Cone	OTHER (DESCRIBE IN DETAILS)	NONE	SOUND	NONE	NO CONE
Wall	CONCRETE (PRECAST)	NONE	DEFECTIVE	LINE_MANHOLE,REMOVE ROOTS	
Bench	BRICK	NONE	SOUND	NONE	
Invert/Channel	BRICK	NONE	SOUND	NONE

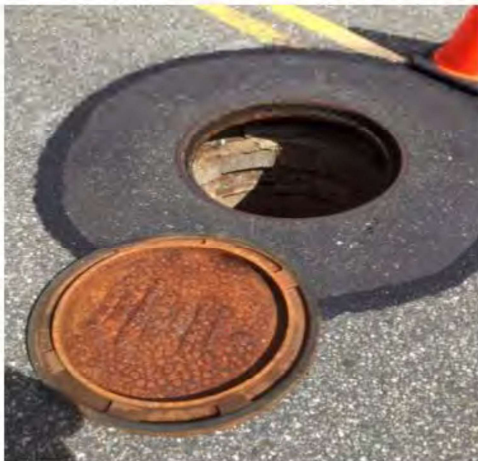
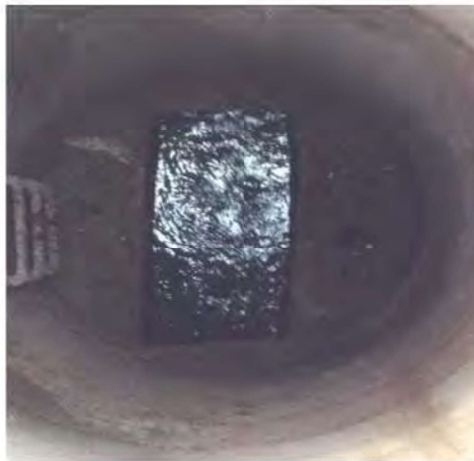
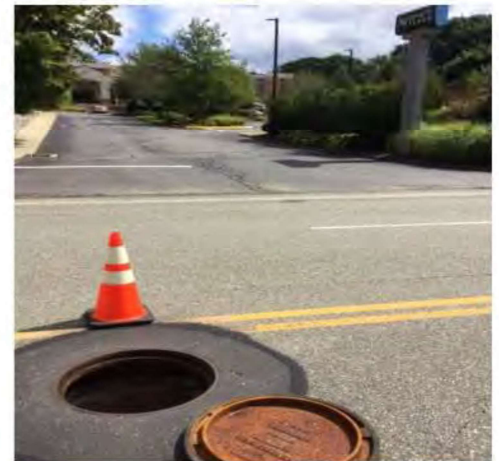
Location in MH	Mtrl. Code	Infil. Code	Cond. Code	Repair Codes	Comments
Frame/Cover	CAST IRON	NONE	SOUND	NONE	
Chimney	BRICK	NONE	SOUND	NONE	BRICK AND CONCRETE BLOCK
Cone	OTHER (DESCRIBE IN DETAILS)	NONE	SOUND	NONE	NO CONE
Wall	CONCRETE (PRECAST)	NONE	SOUND	CLEAN	
Bench	BRICK	NONE	SOUND	NONE	
Invert/Channel	BRICK	NONE	SOUND	NONE

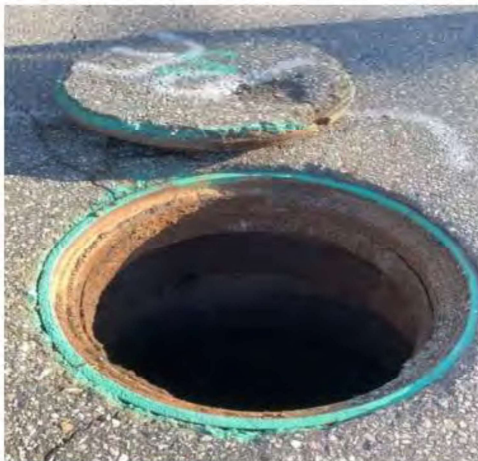
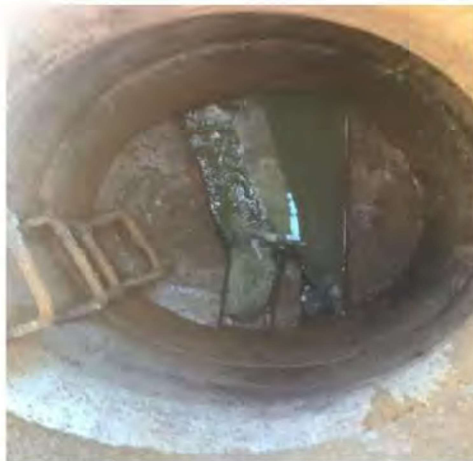
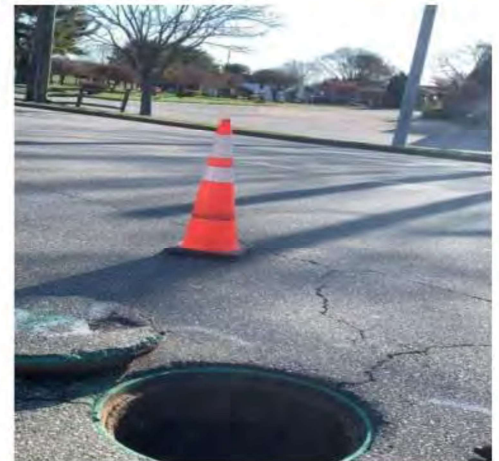
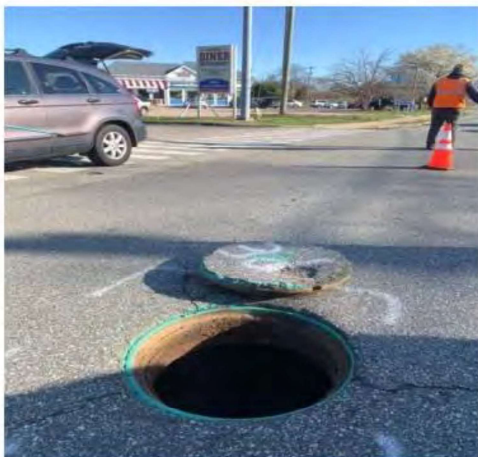
Location in MH	Mtrl. Code	Infil. Code	Cond. Code	Repair Codes	Comments
Frame/Cover	CAST IRON	NONE	SOUND	NONE	
Chimney	CONCRETE (PRECAST)	NONE	SOUND	NONE	
Cone	CONCRETE (PRECAST)	NONE	SOUND	NONE	
Wall	CONCRETE (PRECAST)	NONE	SOUND	NONE	
Bench	BRICK	NONE	SOUND	NONE	
Invert/Channel	BRICK	NONE	SOUND	NONE
