Manhole Inspection Form

Town of Stonington, Connecticut

CDM
Smith

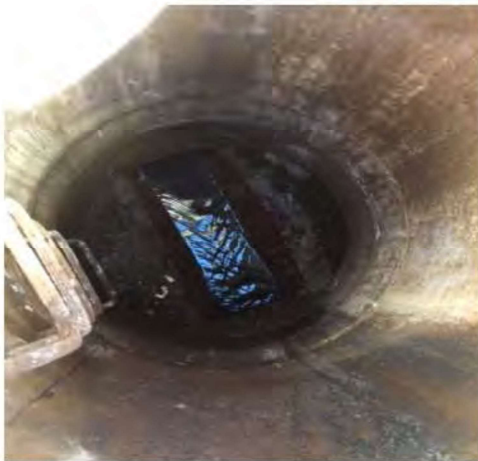
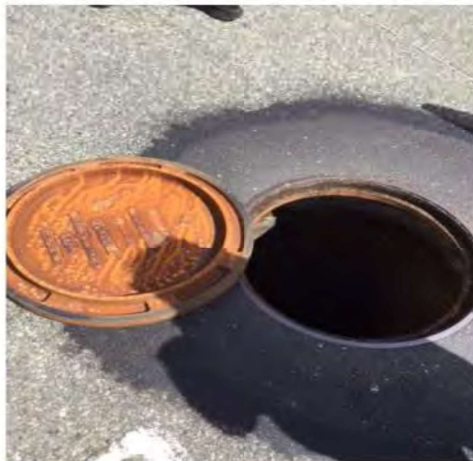
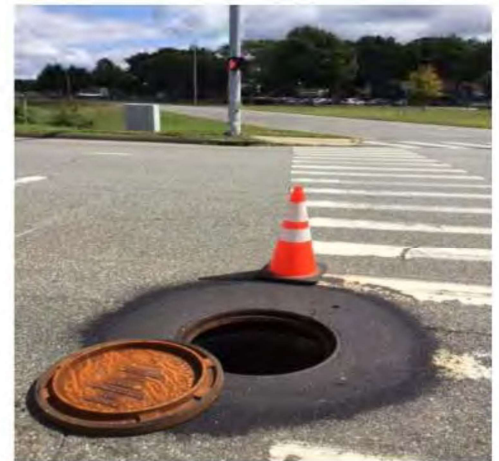
Location in MH	Mtrl. Code	Infil. Code	Cond. Code	Repair Codes	Comments
Frame/Cover	CAST IRON	NONE	SOUND	NONE	
Chimney	BRICK	NONE	SOUND	NONE	
Cone	CONCRETE (PRECAST)	NONE	SOUND	NONE	
Wall	CONCRETE (PRECAST)	NONE	SOUND	NONE	
Bench	BRICK	NONE	SOUND	NONE	
Invert/Channel	BRICK	NONE	SOUND	NONE

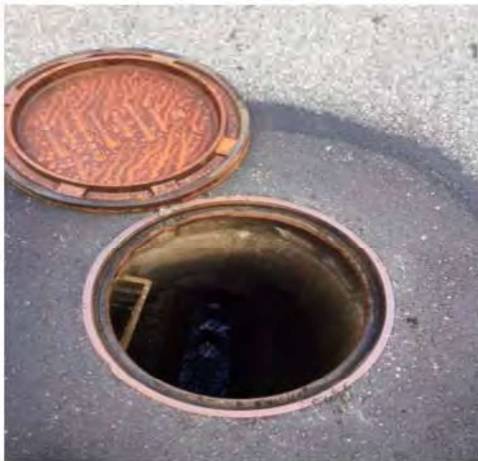
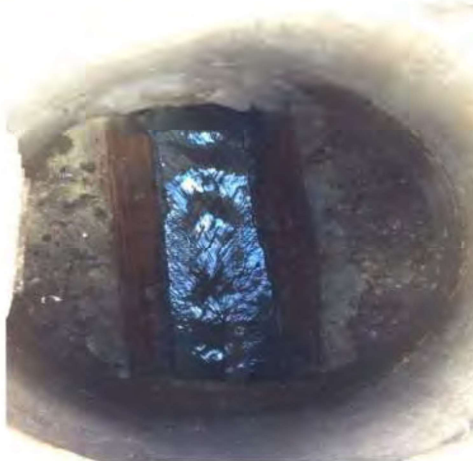
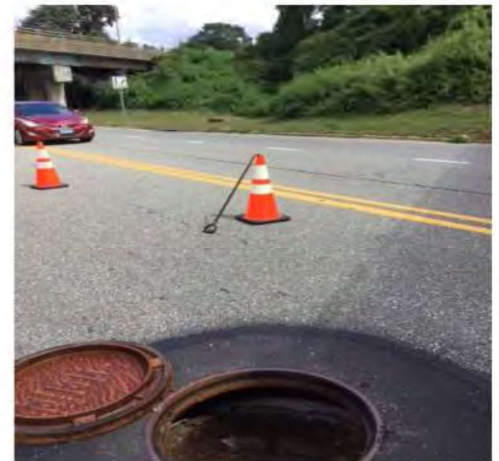
Location in MH	Mtrl. Code	Infil. Code	Cond. Code	Repair Codes	Comments
Frame/Cover	CAST IRON	NONE	SOUND	NONE	
Chimney	BRICK	NONE	SOUND	NONE	BRICK AND CONCRETE BLOCK
Cone	CONCRETE (PRECAST)	NONE	SOUND	NONE	
Wall	CONCRETE (PRECAST)	NONE	SOUND	NONE	
Bench	BRICK	NONE	SOUND	NONE	
Invert/Channel	BRICK	NONE	SOUND	NONE

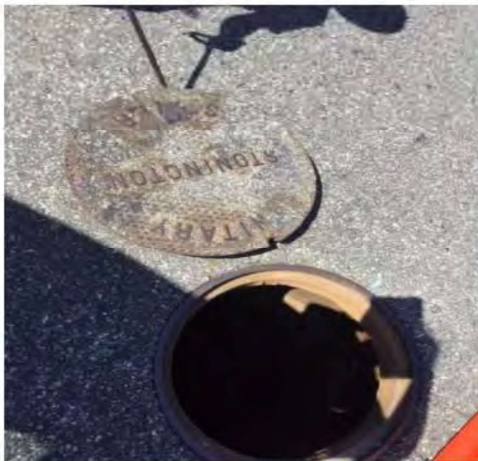
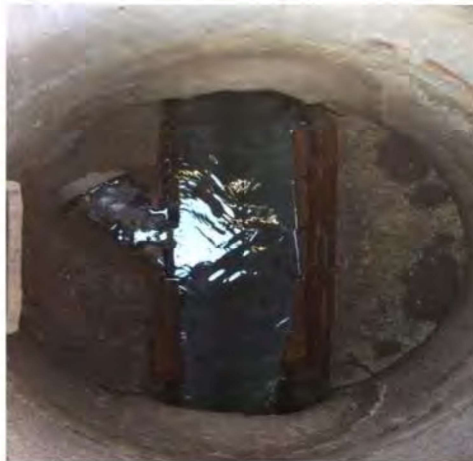
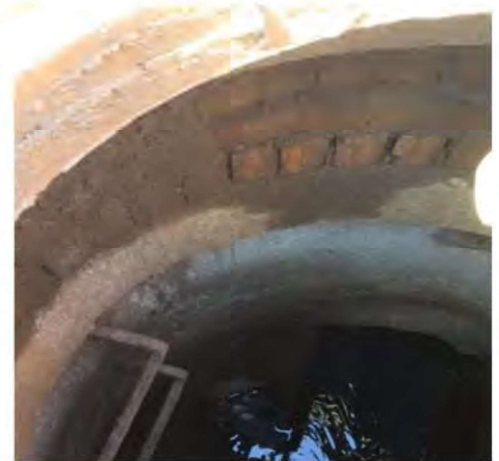
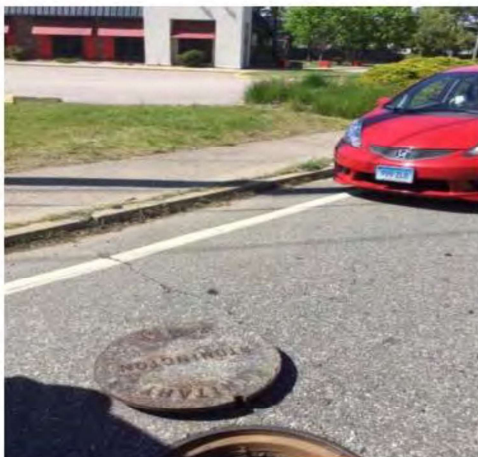
Surcharge: NO **Number of Holes:** 0
Infiltration: NO **Metal Riser:** YES

Location in MH	Mtrl. Code	Infil. Code	Cond. Code	Repair Codes	Comments
Frame/Cover	CAST IRON	STAINS	SOUND	NONE	
Chimney	BRICK	NONE	SOUND	NONE	
Cone	CONCRETE (PRECAST)	NONE	SOUND	NONE	
Wall	CONCRETE (PRECAST)	NONE	SOUND	NONE	
Bench	BRICK	NONE	SOUND	NONE	
Invert/Channel	BRICK	NONE	SOUND	NONE

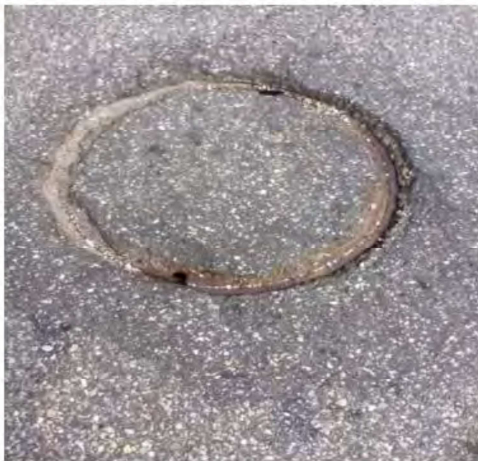
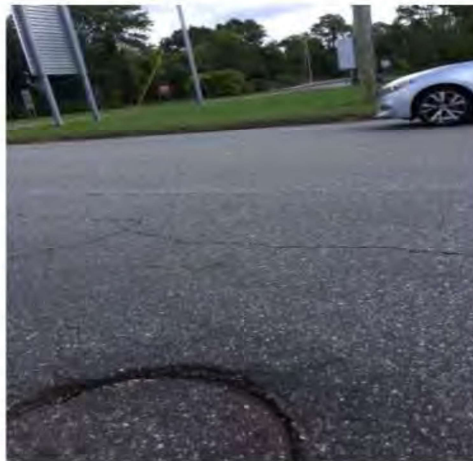
Inspection Status: NO ACCESS

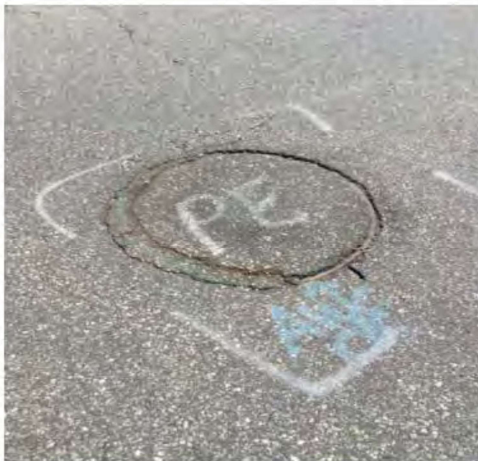
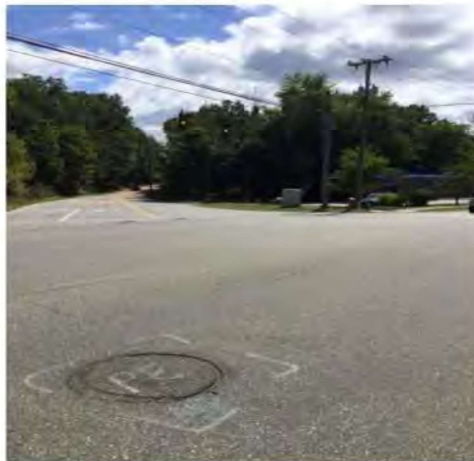
Location in MH	Mtrl. Code	Infil. Code	Cond. Code	Repair Codes	Comments
Frame/Cover	CAST IRON	NONE	SOUND	NONE	
Chimney	BRICK	NONE	SOUND	NONE	
Cone	CONCRETE (PRECAST)	NONE	SOUND	NONE	
Wall	CONCRETE (PRECAST)	NONE	SOUND	NONE	
Bench	BRICK	NONE	DEFECTIVE	CLEAN, OTHER	CLEAN SEDIMENT FROM 6-12:00. BRICKS ALSO DISPLACED IN THIS AREA
Invert/Channel	BRICK	NONE	SOUND	NONE

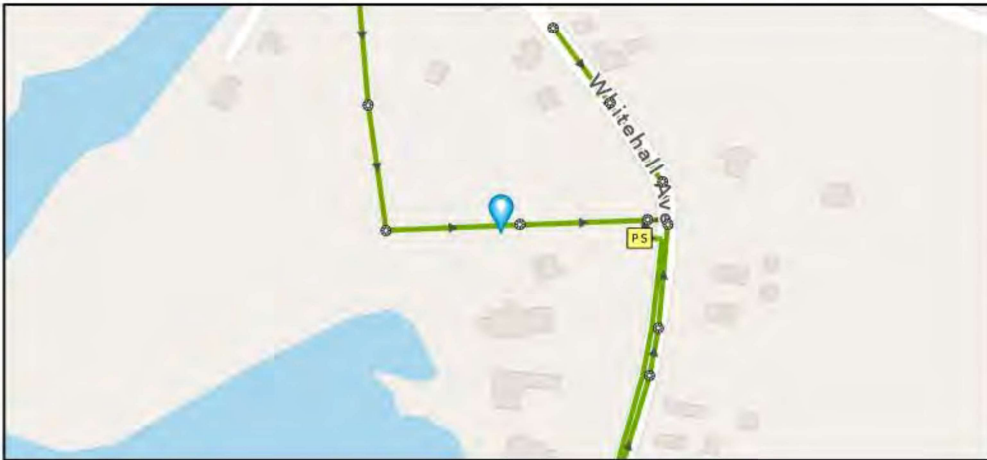
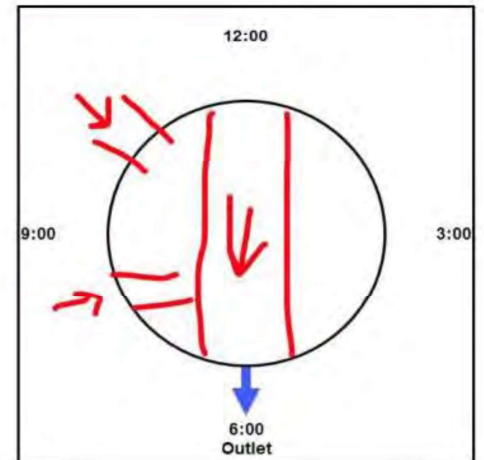
Location in MH	Mtrl. Code	Infil. Code	Cond. Code	Repair Codes	Comments
Frame/Cover	CAST IRON	NONE	SOUND	NONE	
Chimney	CONCRETE BLOCK	NONE	SOUND	NONE	
Cone	CONCRETE (PRECAST)	NONE	SOUND	NONE	
Wall	CONCRETE (PRECAST)	DRIPPER	DEFECTIVE	LINE_MANHOLE	
Bench	BRICK	NONE	SOUND	NONE	
Invert/Channel	BRICK	NONE	SOUND	NONE

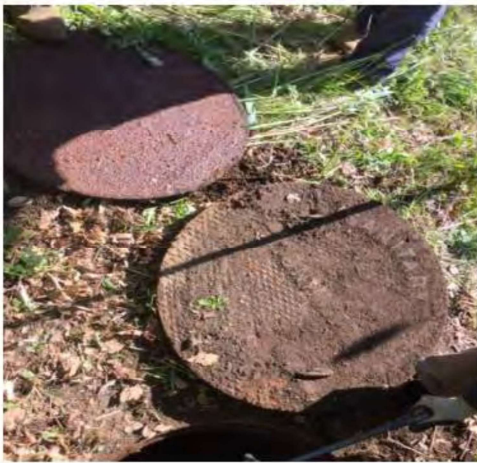
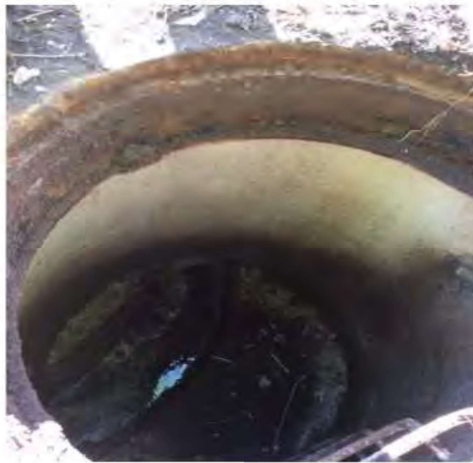
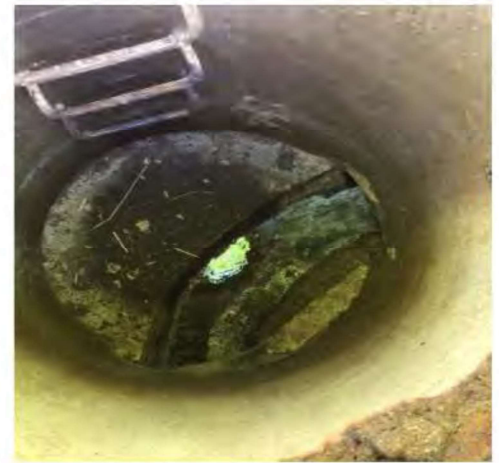
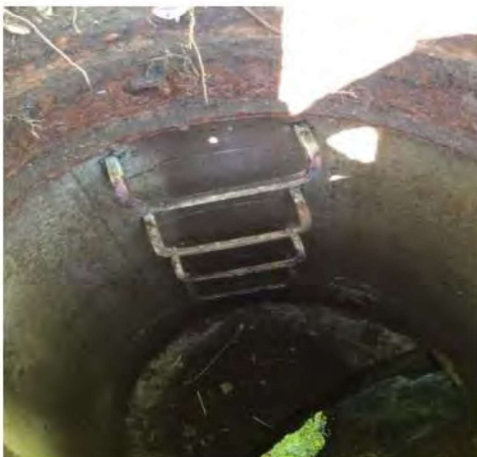
Location in MH	Mtrl. Code	Infil. Code	Cond. Code	Repair Codes	Comments
Frame/Cover	CAST IRON	NONE	SOUND	NONE	
Chimney	CONCRETE (PRECAST)	NONE	SOUND	NONE	
Cone	CONCRETE (PRECAST)	NONE	SOUND	NONE	
Wall	CONCRETE (PRECAST)	NONE	SOUND	NONE	
Bench	BRICK	NONE	SOUND	NONE	
Invert/Channel	BRICK	NONE	SOUND	NONE

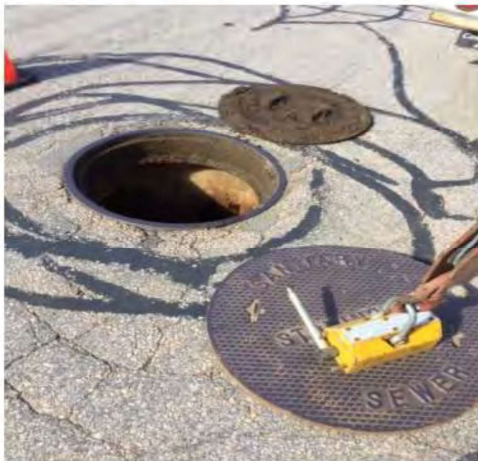
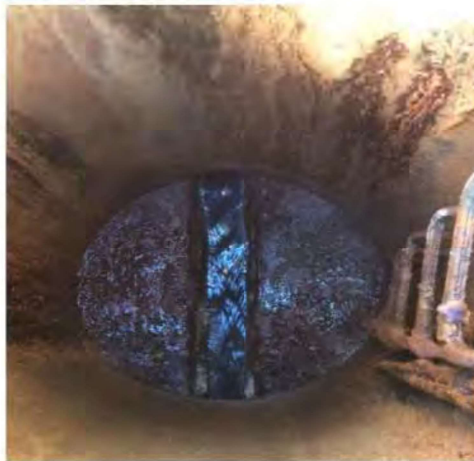
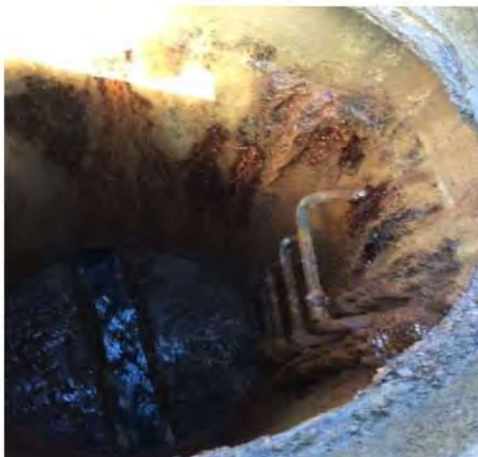
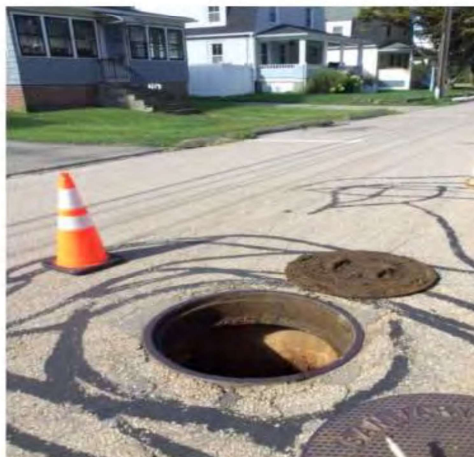
Location in MH	Mtrl. Code	Infil. Code	Cond. Code	Repair Codes	Comments
Frame/Cover	CAST IRON	NONE	SOUND	RESET EXISTING FRAME AND CHIMNEY	
Chimney	CONCRETE BLOCK	NONE	SOUND	NONE	
Cone	CONCRETE (PRECAST)	WEEPER	DEFECTIVE	LINE_MANHOLE	
Wall	CONCRETE (PRECAST)	WEEPER	DEFECTIVE	LINE_MANHOLE	
Bench	BRICK	NONE	SOUND	NONE	
Invert/Channel	BRICK	NONE	SOUND	NONE

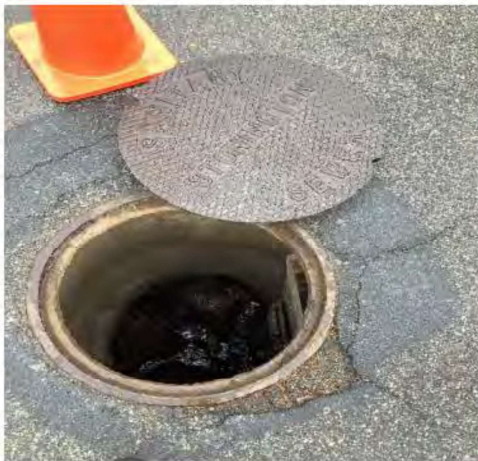
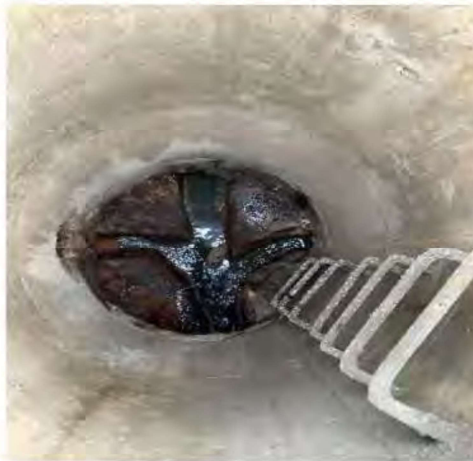
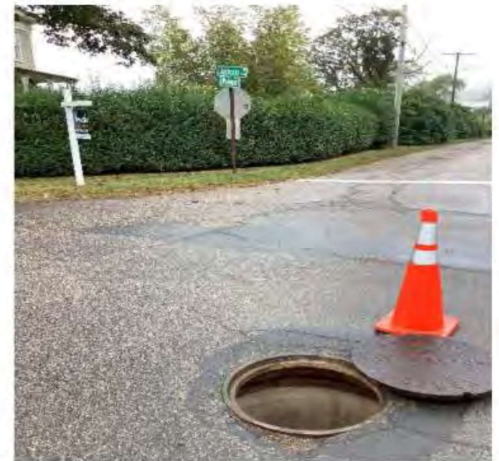
Location in MH	Mtrl. Code	Infil. Code	Cond. Code	Repair Codes	Comments
Frame/Cover	CAST IRON	NONE	SOUND	NONE	
Chimney	BRICK	NONE	SOUND	NONE	
Cone	CONCRETE (PRECAST)	NONE	SOUND	NONE	
Wall	CONCRETE (PRECAST)	NONE	SOUND	NONE	
Bench	BRICK	NONE	SOUND	NONE	
Invert/Channel	BRICK	NONE	SOUND	NONE

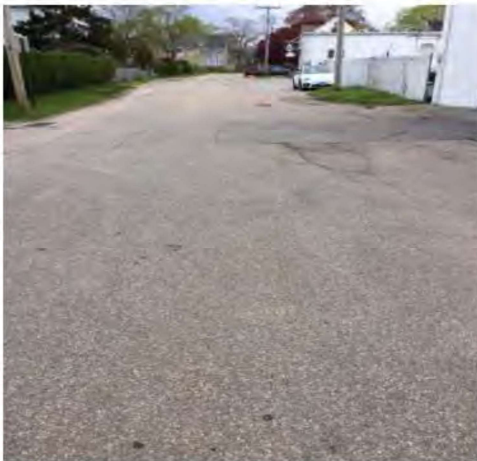
Inspection Status: NOT FOUND

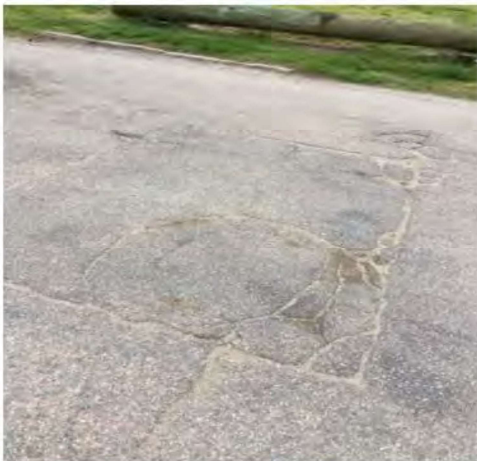
Inspection Status: NOT FOUND
