CDM
Smith

Town of Stonington, Connecticut

Manhole Inspection Form

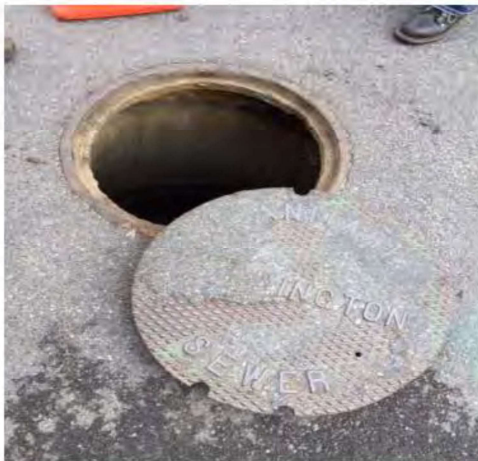
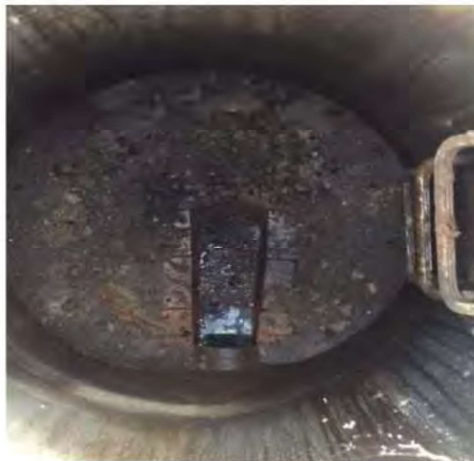
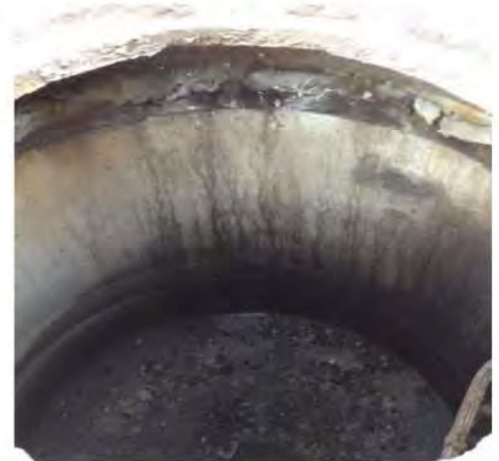
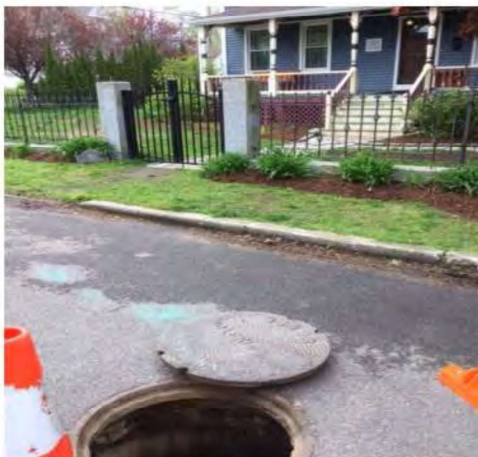
GIS MH No: 1-110

Location in MH	Mtrl. Code	Infil. Code	Cond. Code	Repair Codes	Comments
Frame/Cover	CAST IRON	WEEPER	DEFECTIVE	NONE	
Chimney	BRICK	NONE	SOUND	NONE	
Cone	CONCRETE (PRECAST)	NONE	SOUND	NONE	
Wall	CONCRETE (PRECAST)	NONE	SOUND	NONE	
Bench	BRICK	NONE	SOUND	NONE	
Invert/Channel	BRICK	NONE	SOUND	NONE

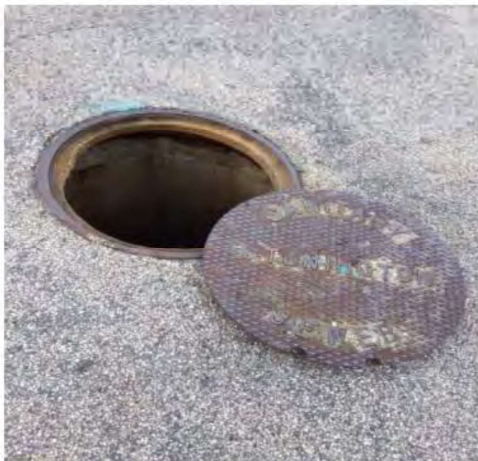
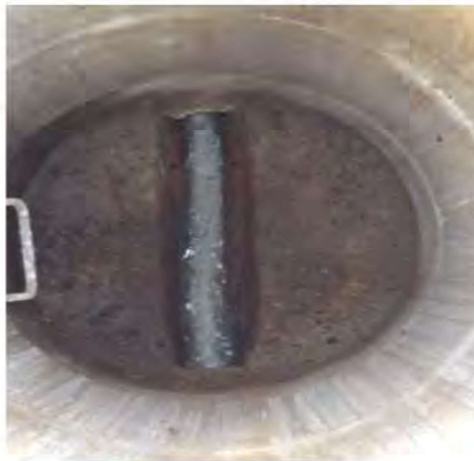
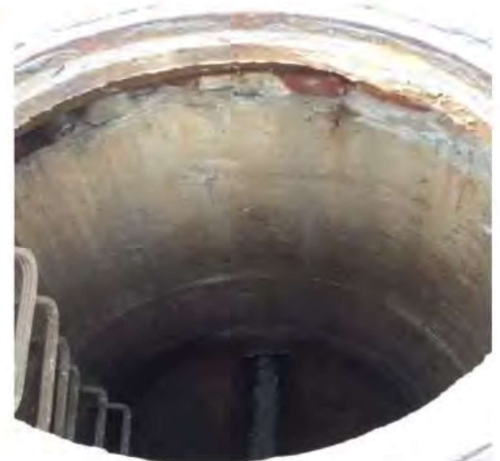
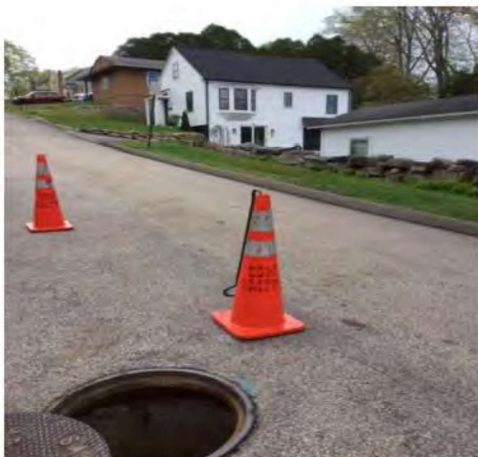
Location in MH	Mtrl. Code	Infil. Code	Cond. Code	Repair Codes	Comments
Frame/Cover	CAST IRON	NONE	SOUND	NONE	
Chimney	BRICK	NONE	SOUND	NONE	
Cone	CONCRETE (PRECAST)	NONE	SOUND	NONE	
Wall	CONCRETE (PRECAST)	NONE	SOUND	NONE	
Bench	BRICK	NONE	SOUND	NONE	
Invert/Channel	BRICK	NONE	SOUND	NONE

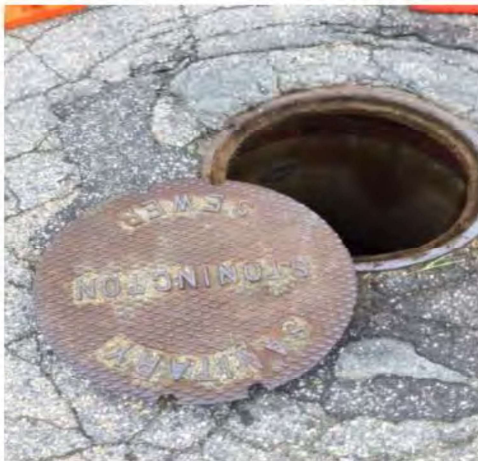
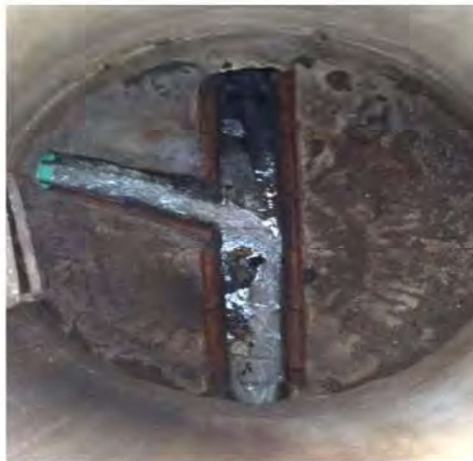
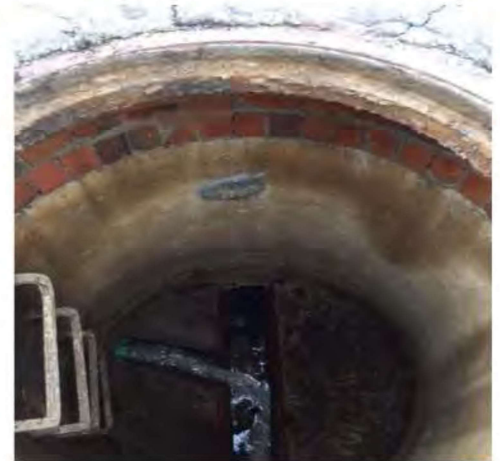
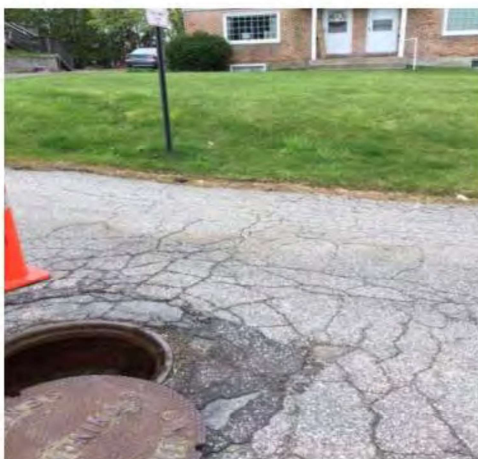
Location in MH	Mtrl. Code	Infil. Code	Cond. Code	Repair Codes	Comments
Frame/Cover	CAST IRON	STAINS	SOUND	NONE	
Chimney	BRICK	NONE	SOUND	NONE	
Cone	CONCRETE (PRECAST)	NONE	SOUND	NONE	
Wall	CONCRETE (PRECAST)	NONE	SOUND	NONE	
Bench	BRICK	NONE	SOUND	NONE	
Invert/Channel	CONCRETE BLOCK	NONE	SOUND	NONE

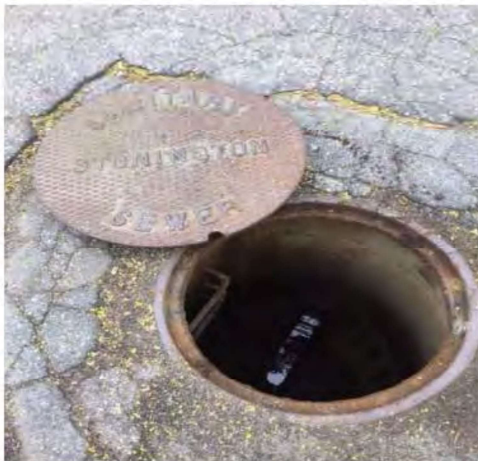
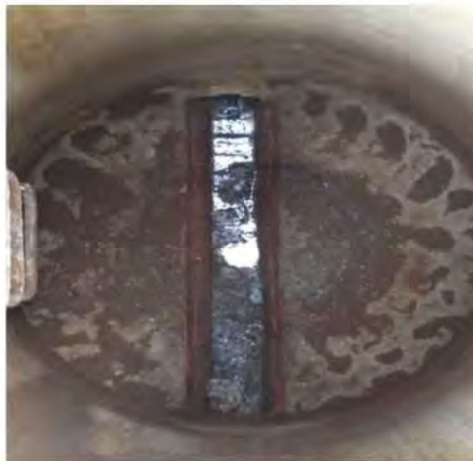
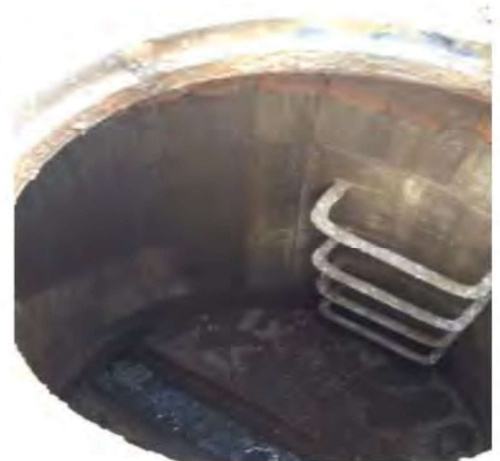
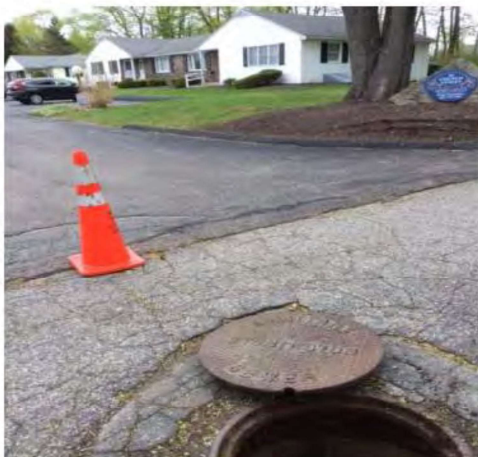
Location in MH	Mtrl. Code	Infil. Code	Cond. Code	Repair Codes	Comments
Frame/Cover	CAST IRON	STAINS	SOUND	NONE	
Chimney	BRICK	NONE	SOUND	NONE	
Cone	CONCRETE (PRECAST)	NONE	SOUND	NONE	
Wall	CONCRETE (PRECAST)	NONE	SOUND	NONE	
Bench	BRICK	NONE	SOUND	NONE	
Invert/Channel	BRICK	NONE	SOUND	NONE

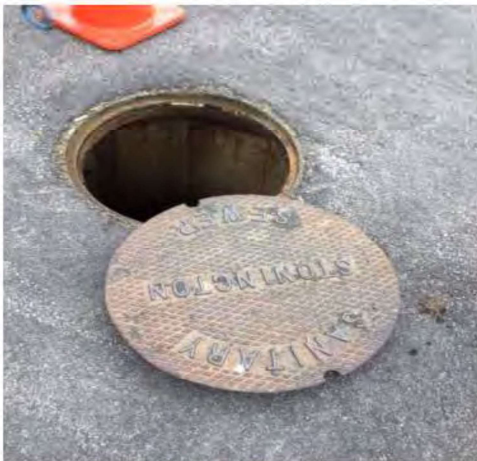
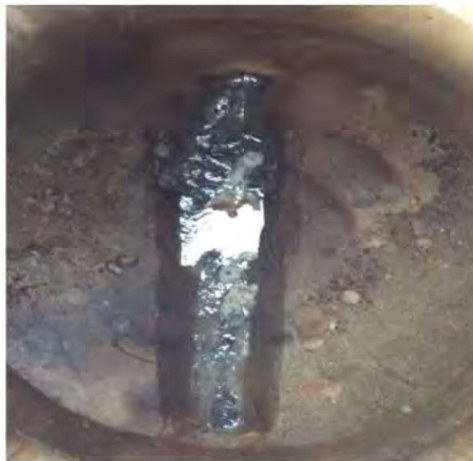
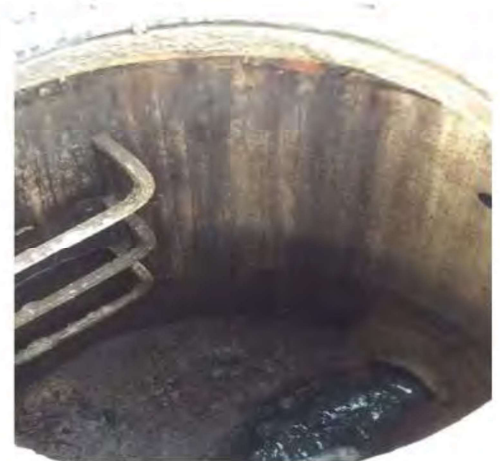
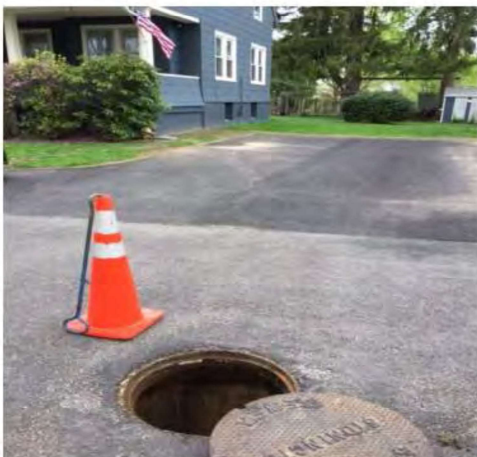
Location in MH	Mtrl. Code	Infil. Code	Cond. Code	Repair Codes	Comments
Frame/Cover	CAST IRON	STAINS	SOUND	NONE	
Chimney	BRICK	NONE	DEFECTIVE	RESET EXISTING FRAME AND CHIMNEY	CHIMNEY STARTING TO BE DISPLACED
Cone	CONCRETE (PRECAST)	NONE	SOUND	NONE	
Wall	CONCRETE (PRECAST)	NONE	SOUND	NONE	
Bench	BRICK	NONE	SOUND	NONE	
Invert/Channel	BRICK	NONE	SOUND	NONE

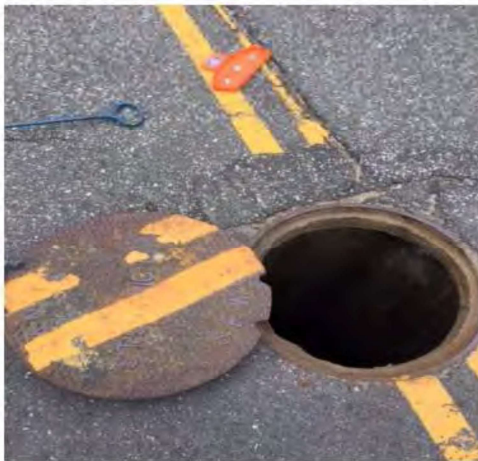
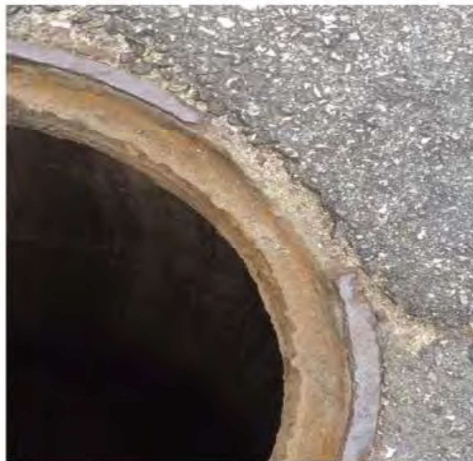
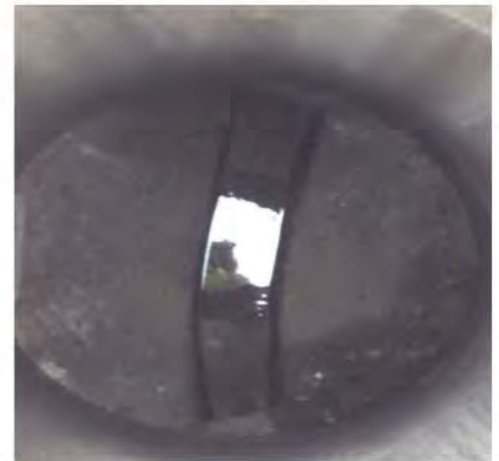
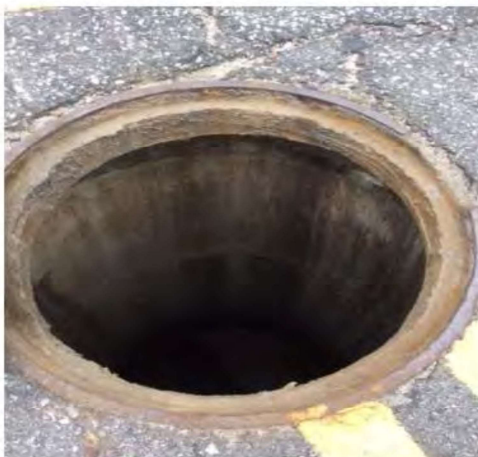
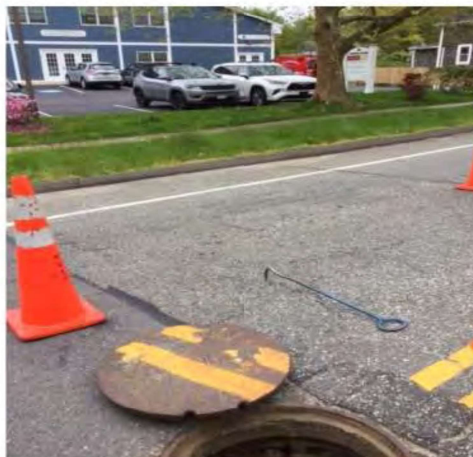
Location in MH	Mtrl. Code	Infil. Code	Cond. Code	Repair Codes	Comments
Frame/Cover	CAST IRON	WEEPER	SOUND	NONE	
Chimney	BRICK	NONE	DEFECTIVE	RESET EXISTING FRAME AND CHIMNEY	CHIMNEY BRICKS ARE BECOMING DISPLACED
Cone	CONCRETE (PRECAST)	NONE	SOUND	NONE	
Wall	CONCRETE (PRECAST)	NONE	SOUND	NONE	
Bench	BRICK	NONE	SOUND	NONE	
Invert/Channel	BRICK	NONE	SOUND	NONE

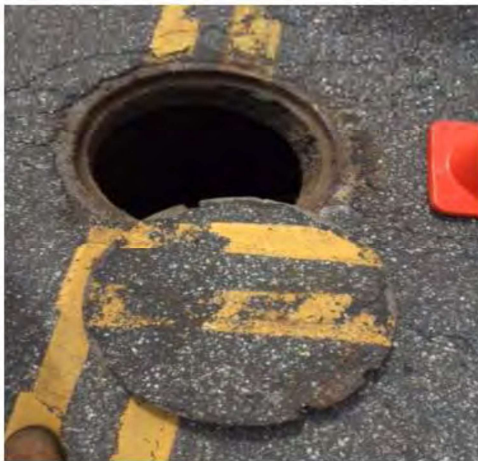
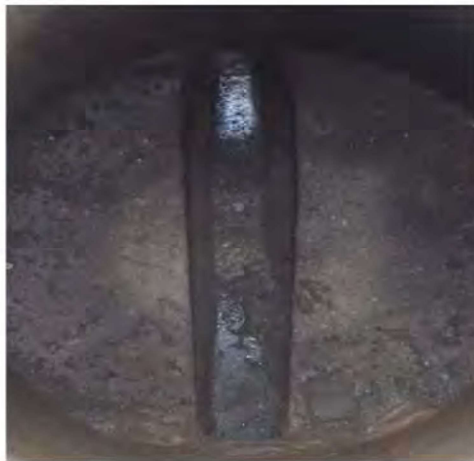
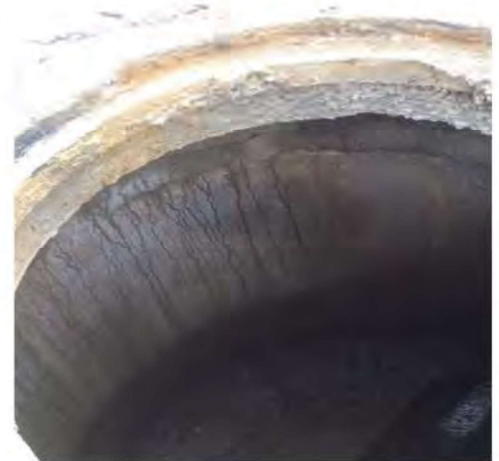
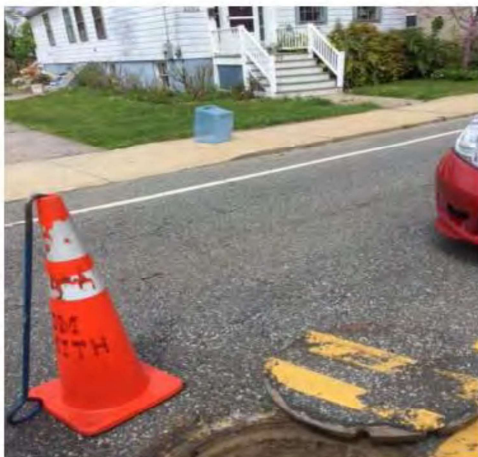
Location in MH	Mtrl. Code	Infil. Code	Cond. Code	Repair Codes	Comments
Frame/Cover	CAST IRON	WEEPER	BROKEN	REPLACE FRAME AND COVER	
Chimney	BRICK	NONE	SOUND	NONE	
Cone	CONCRETE (PRECAST)	NONE	SOUND	NONE	
Wall	CONCRETE (PRECAST)	NONE	SOUND	NONE	
Bench	BRICK	NONE	SOUND	NONE	
Invert/Channel	BRICK	NONE	SOUND	NONE

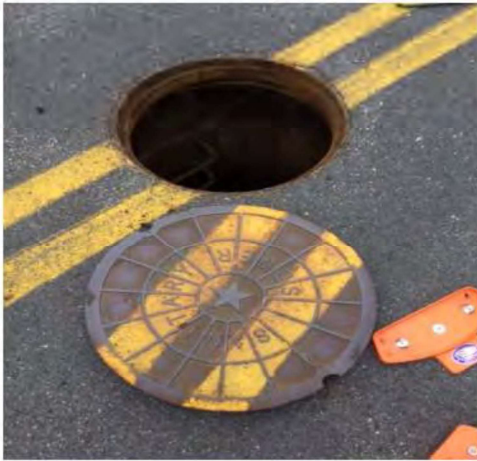
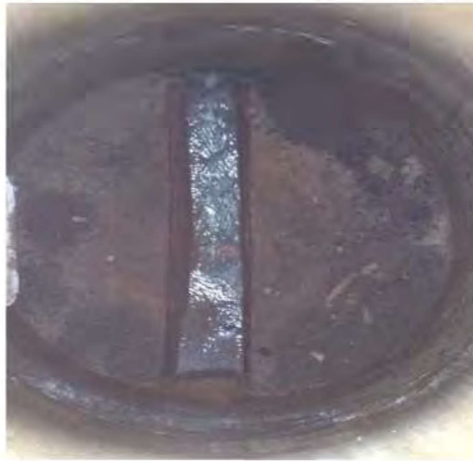
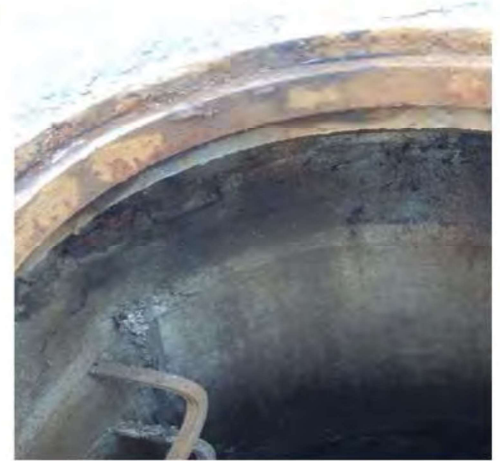
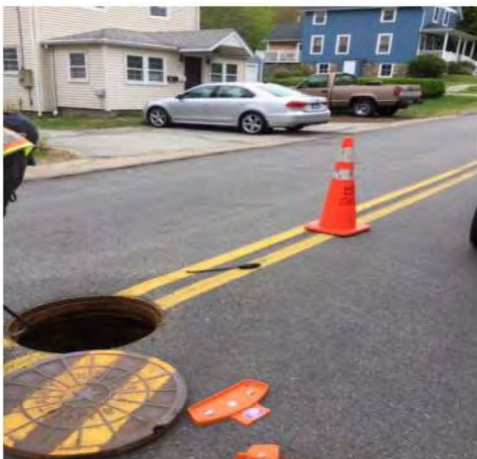
Location in MH	Mtrl. Code	Infil. Code	Cond. Code	Repair Codes	Comments
Frame/Cover	CAST IRON	WEEPER	CORRODED	REPLACE FRAME AND COVER	
Chimney	CONCRETE BLOCK	NONE	SOUND	NONE	
Cone	CONCRETE (PRECAST)	NONE	SOUND	NONE	
Wall	CONCRETE (PRECAST)	NONE	SOUND	NONE	
Bench	BRICK	NONE	SOUND	NONE	
Invert/Channel	BRICK	NONE	SOUND	NONE

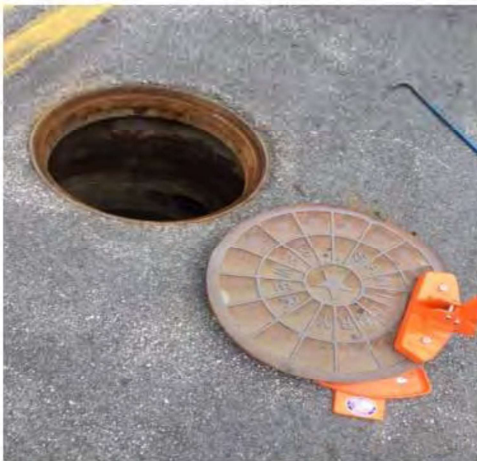
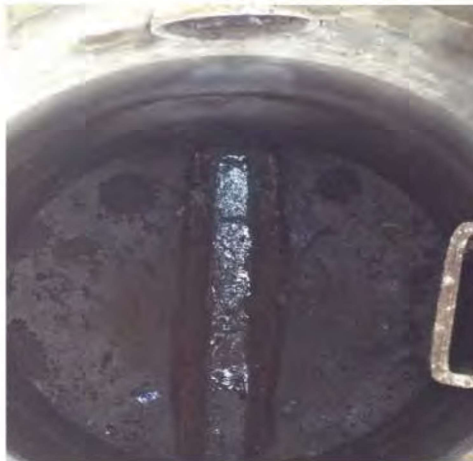
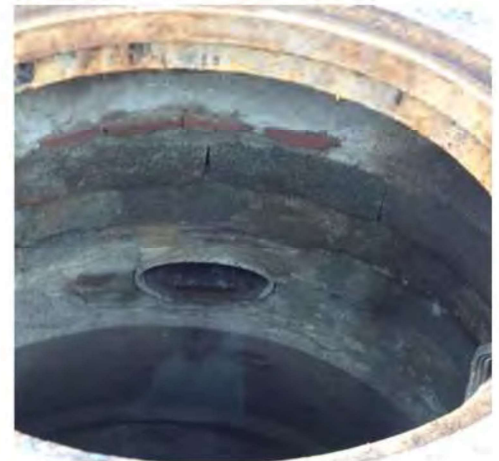
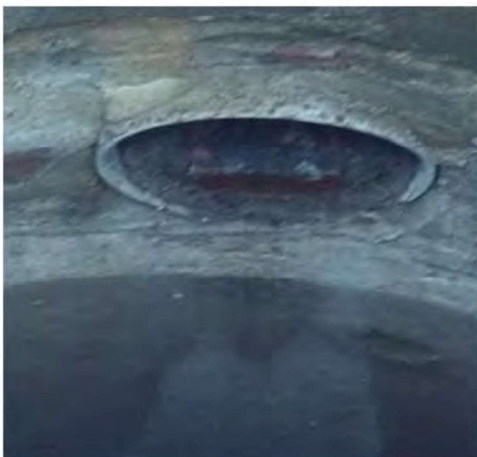
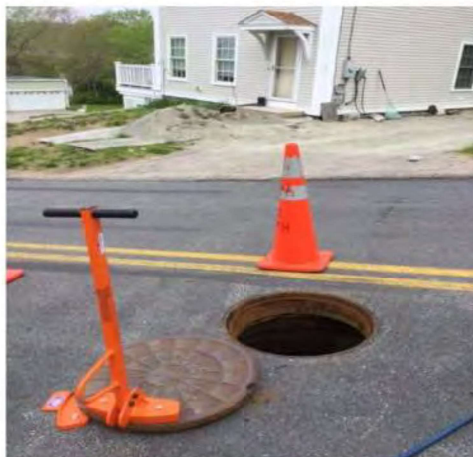
Location in MH	Mtrl. Code	Infil. Code	Cond. Code	Repair Codes	Comments
Frame/Cover	CAST IRON	NONE	SOUND	NONE	
Chimney	BRICK	STAINS	DEFECTIVE	REBUILD TOP, REPLACE FRAME AND CHIMNEY	CHIMNEY MATERIAL STARTING TO DEGRADE
Cone	CONCRETE (PRECAST)	STAINS	SOUND	NONE	
Wall	CONCRETE (PRECAST)	NONE	SOUND	NONE	
Bench	BRICK	NONE	SOUND	NONE	
Invert/Channel	BRICK	NONE	SOUND	NONE

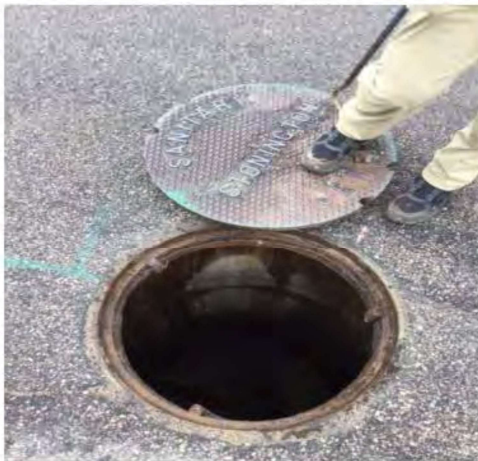
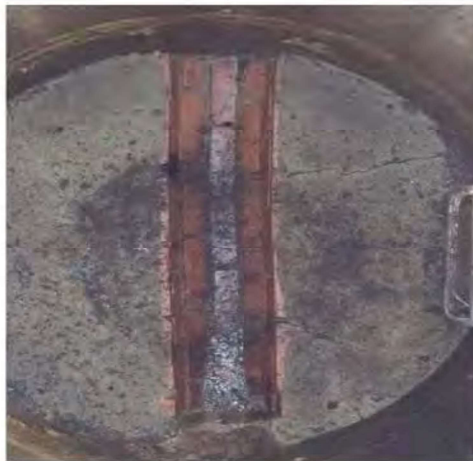
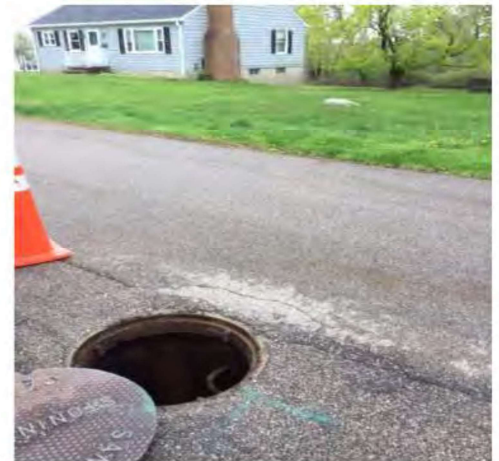
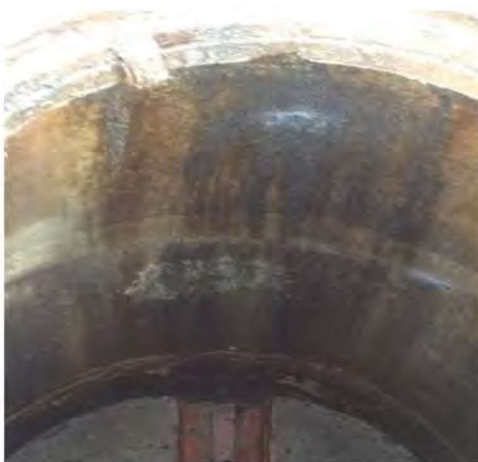
Location in MH	Mtrl. Code	Infil. Code	Cond. Code	Repair Codes	Comments
Frame/Cover	CAST IRON	STAINS	SOUND	NONE	
Chimney	BRICK	NONE	DEFECTIVE	REBUILD TOP, REPLACE FRAME AND CHIMNEY	CHIMNEY NOT FLUSH WITH FRAME, SOME MATERIAL LOOSE. CHIMNEY IS BRICK AND CONCRETE BLOCK
Cone	CONCRETE (PRECAST)	NONE	SOUND	NONE	
Wall	CONCRETE (PRECAST)	NONE	SOUND	NONE	
Bench	BRICK	NONE	SOUND	NONE	
Invert/Channel	BRICK	NONE	SOUND	NONE

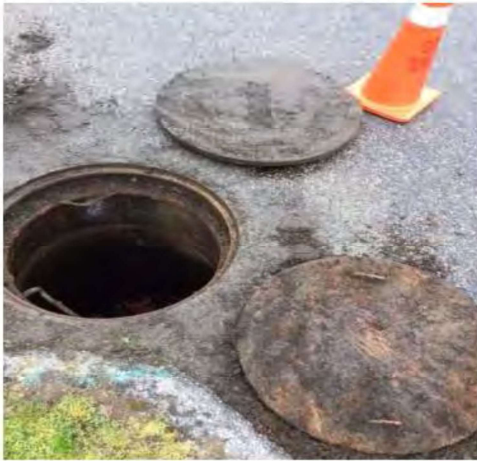
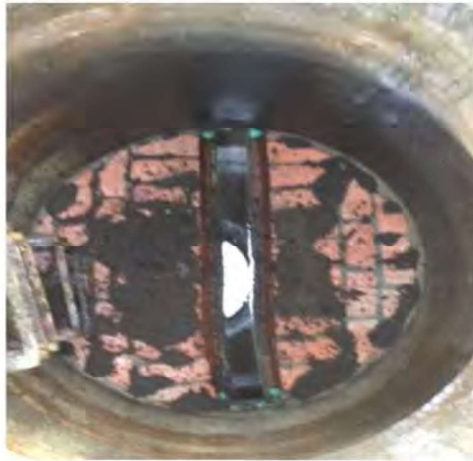
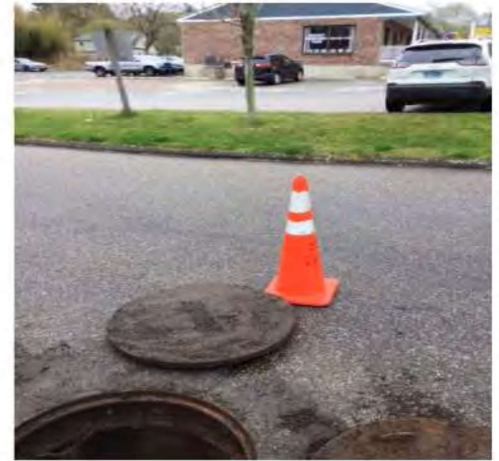
Location in MH	Mtrl. Code	Infil. Code	Cond. Code	Repair Codes	Comments
Frame/Cover	CAST IRON	WEEPER	SOUND	NONE	
Chimney	OTHER (DESCRIBE IN DETAILS)	NONE	SOUND	NONE	
Cone	CONCRETE (PRECAST)	NONE	SOUND	NONE	
Wall	CONCRETE (PRECAST)	NONE	SOUND	NONE	
Bench	BRICK	NONE	SOUND	NONE	
Invert/Channel	BRICK	NONE	SOUND	NONE

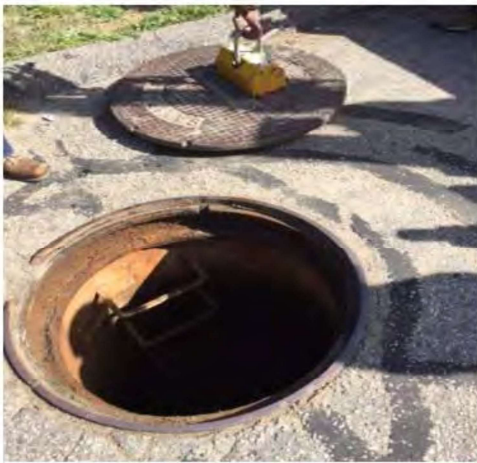
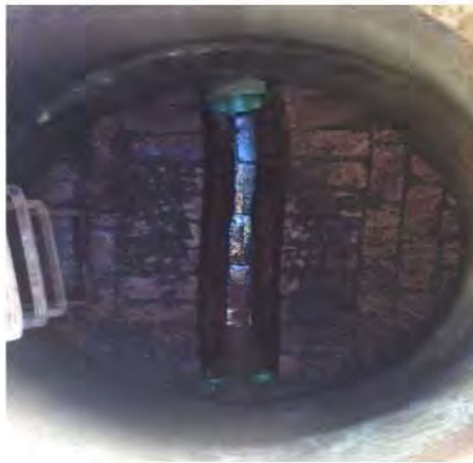
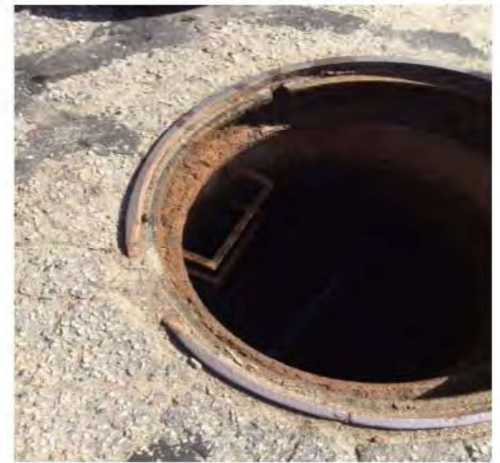
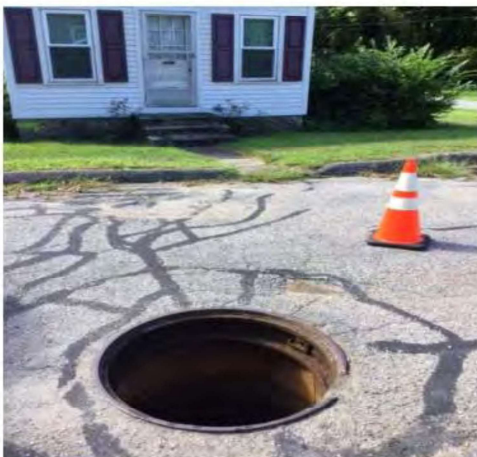
Location in MH	Mtrl. Code	Infil. Code	Cond. Code	Repair Codes	Comments
Frame/Cover	CAST IRON	NONE	SOUND	NONE	
Chimney	OTHER (DESCRIBE IN DETAILS)	NONE	SOUND	NONE	NO CHIMNEY
Cone	CONCRETE (PRECAST)	NONE	SOUND	NONE	
Wall	CONCRETE (PRECAST)	NONE	SOUND	NONE	
Bench	BRICK	NONE	SOUND	NONE	
Invert/Channel	BRICK	NONE	SOUND	NONE

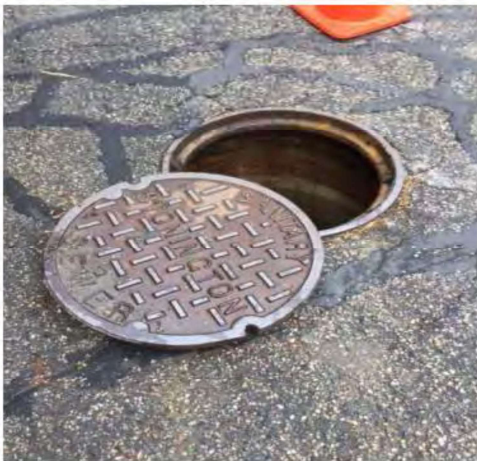
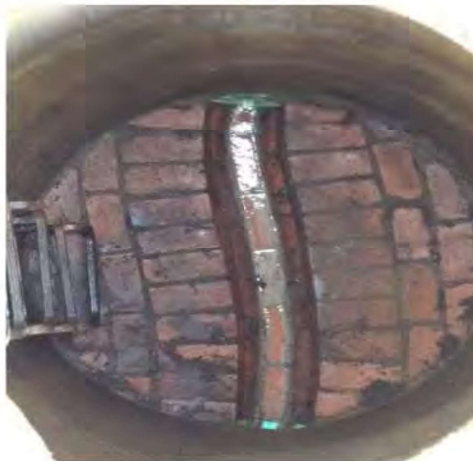
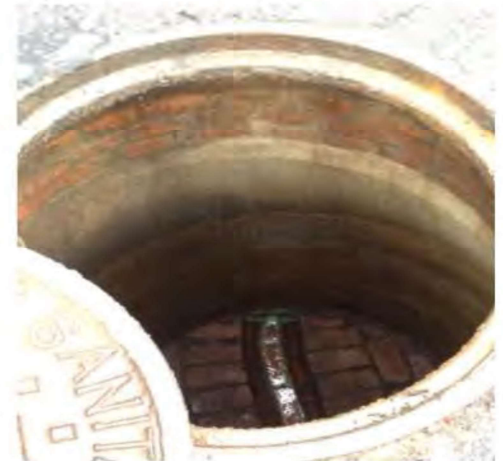
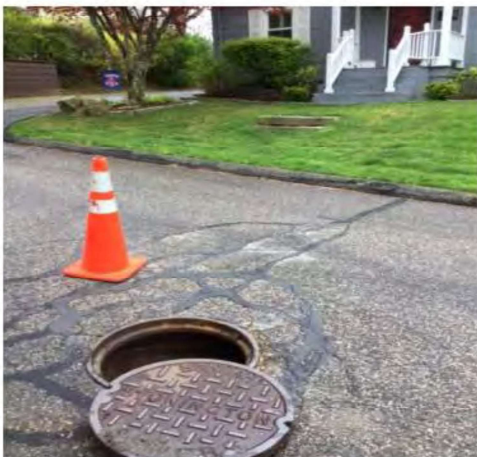
Location in MH	Mtrl. Code	Infil. Code	Cond. Code	Repair Codes	Comments
Frame/Cover	CAST IRON	NONE	BROKEN	REPLACE FRAME AND COVER	ALSO REPLACE WATER TIGHT COVER, NO HANDLES
Chimney	CONCRETE (PRECAST)	NONE	SOUND	NONE	
Cone	CONCRETE (PRECAST)	NONE	SOUND	NONE	
Wall	CONCRETE (PRECAST)	NONE	SOUND	NONE	
Bench	BRICK	NONE	SOUND	NONE	
Invert/Channel	BRICK	NONE	SOUND	NONE

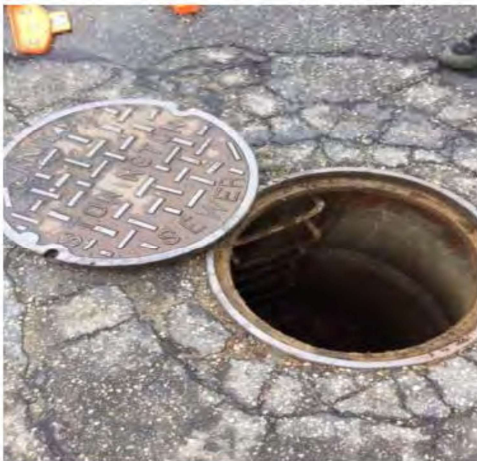
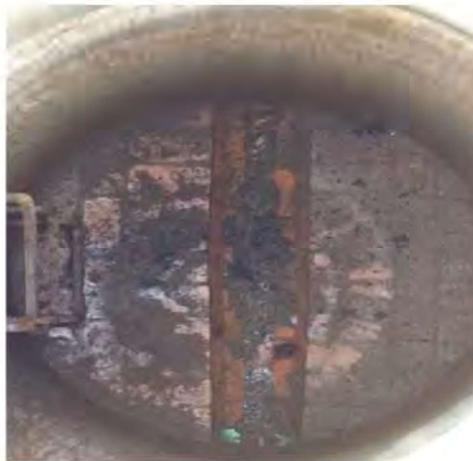
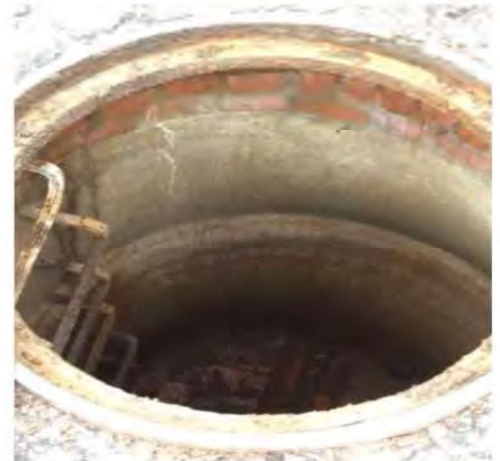
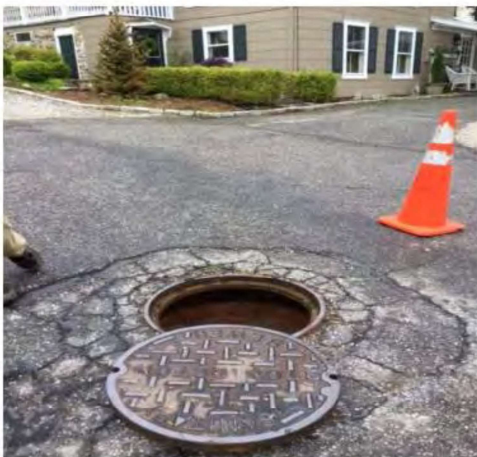
Location in MH	Mtrl. Code	Infil. Code	Cond. Code	Repair Codes	Comments
Frame/Cover	CAST IRON	NONE	SOUND	NONE	
Chimney	BRICK	NONE	SOUND	NONE	
Cone	CONCRETE (CAST IN PLACE)	NONE	SOUND	NONE	
Wall	CONCRETE (PRECAST)	NONE	SOUND	NONE	
Bench	BRICK	NONE	SOUND	NONE	
Invert/Channel	BRICK	NONE	SOUND	NONE

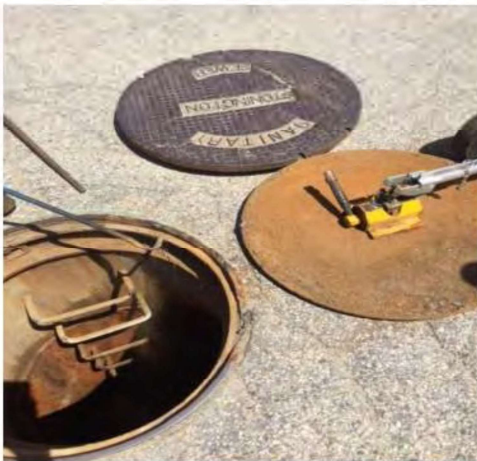
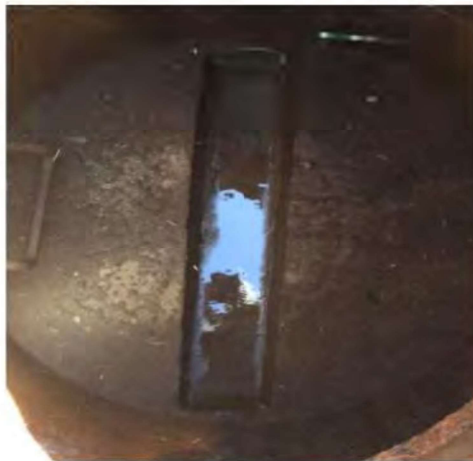
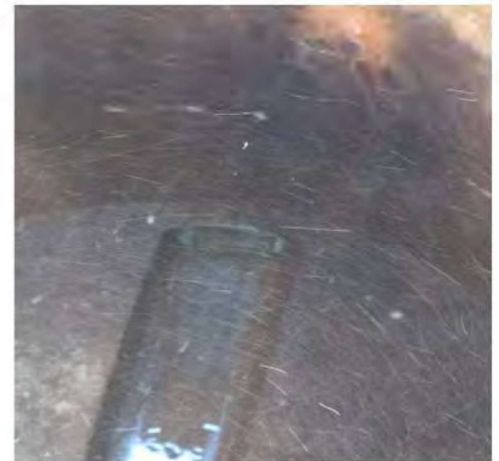
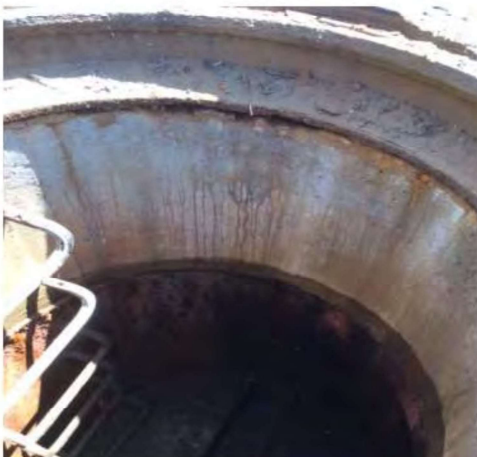
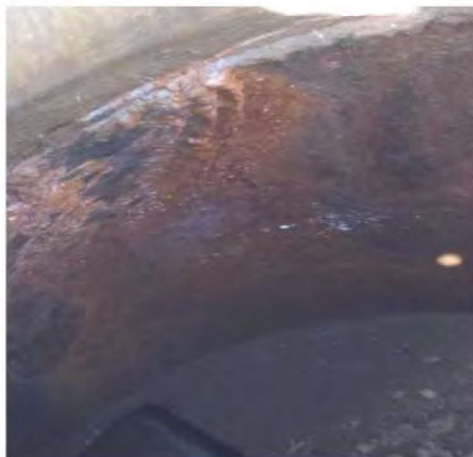
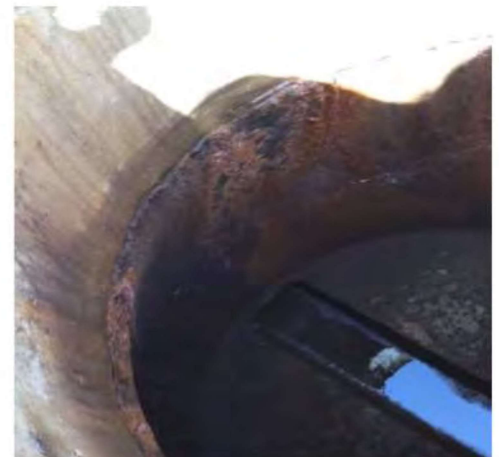
Location in MH	Mtrl. Code	Infil. Code	Cond. Code	Repair Codes	Comments
Frame/Cover	CAST IRON	NONE	SOUND	NONE	LOOKS LIKE FRAME SHOULD HAVE WATERTIGHT SEAL BUT DOES NOT.
Chimney	OTHER (DESCRIBE IN DETAILS)	NONE	SOUND	NONE	NO CHIMNEY
Cone	CONCRETE (PRECAST)	NONE	SOUND	NONE	
Wall	CONCRETE (PRECAST)	WEEPER	DEFECTIVE	LINE_MANHOLE	LOOKS LIKE SEDIMENT AND INFILTRATION FROM WALL AT 3 PM
Bench	BRICK	NONE	SOUND	NONE	
Invert/Channel	BRICK	NONE	SOUND	NONE

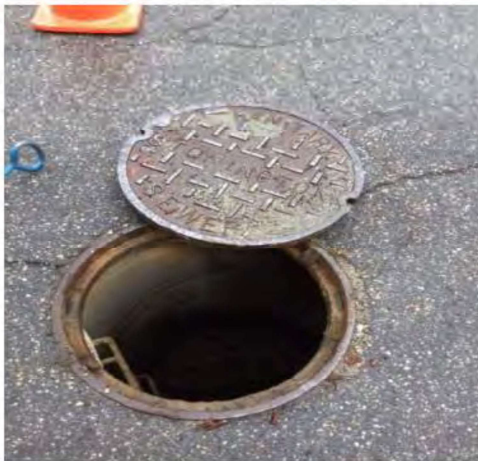
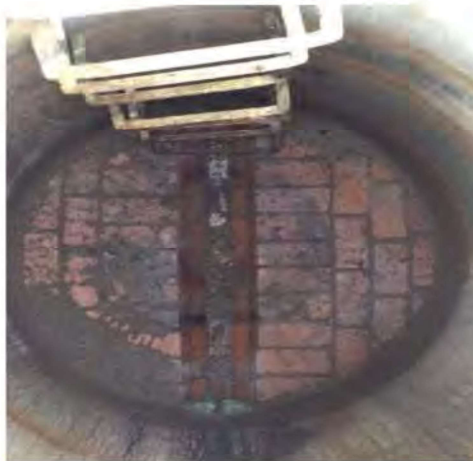
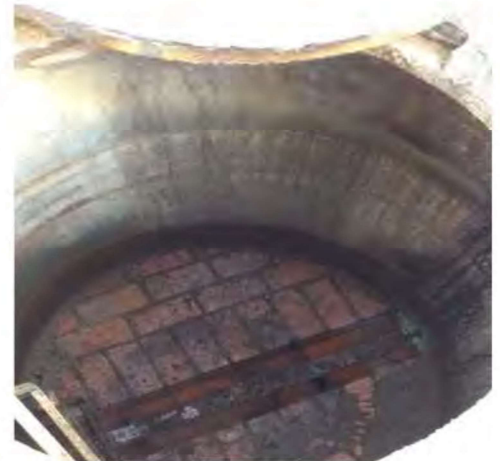
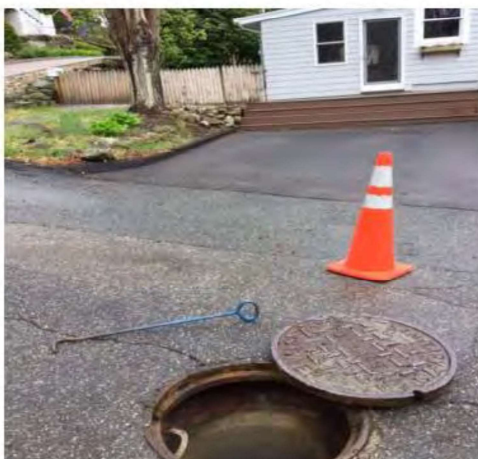
Inspection Photos

Location in MH	Mtrl. Code	Infil. Code	Cond. Code	Repair Codes	Comments
Frame/Cover	CAST IRON	STAINS	SOUND	NONE	MISSING WATER TIGHT COVER
Chimney	OTHER (DESCRIBE IN DETAILS)	NONE	SOUND	NONE	NO CHIMNEY
Cone	CONCRETE (PRECAST)	NONE	SOUND	NONE	
Wall	CONCRETE (PRECAST)	NONE	SOUND	NONE	
Bench	BRICK	NONE	SOUND	NONE	
Invert/Channel	BRICK	NONE	SOUND	NONE

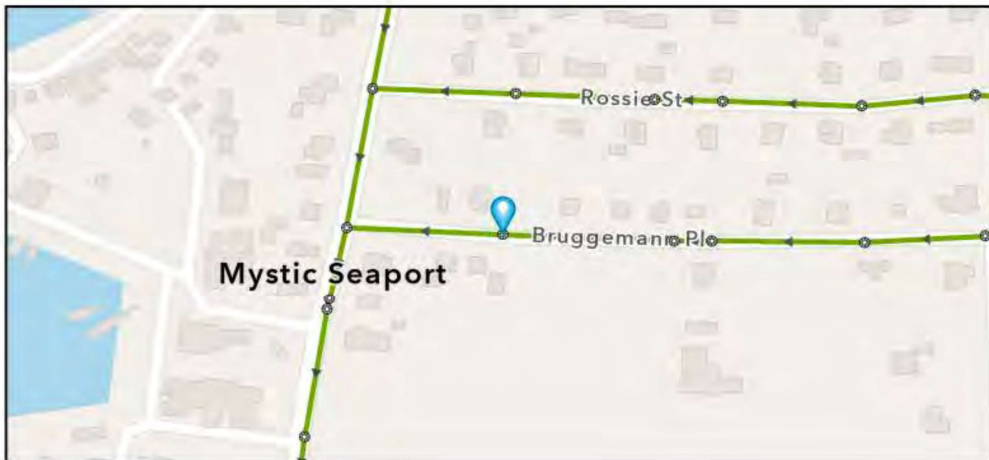
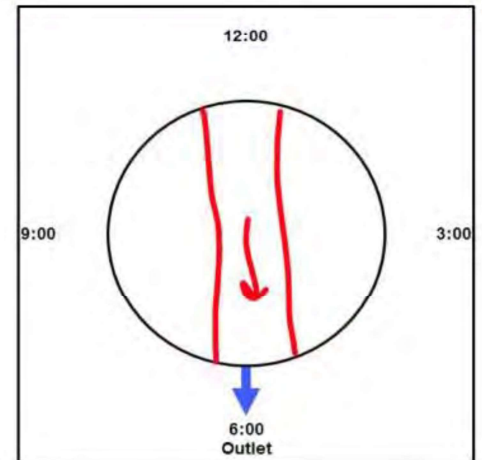
Manhole Location and Configuration

Location in MH	Mtrl. Code	Infil. Code	Cond. Code	Repair Codes	Comments
Frame/Cover	CAST IRON	WEEPER	SOUND	OTHER	WATER TIGHT SEAL DOES NOT HAVE HANDLES. REPLACE SEAL
Chimney	CONCRETE (PRECAST)	NONE	SOUND	NONE	
Cone	CONCRETE (PRECAST)	NONE	SOUND	NONE	
Wall	CONCRETE (PRECAST)	STAINS	DEFECTIVE	LINE_MANHOLE	
Bench	BRICK	NONE	SOUND	NONE	
Invert/Channel	BRICK	NONE	SOUND	NONE
