CDM
Smith

Town of Stonington, Connecticut

Manhole Inspection Form

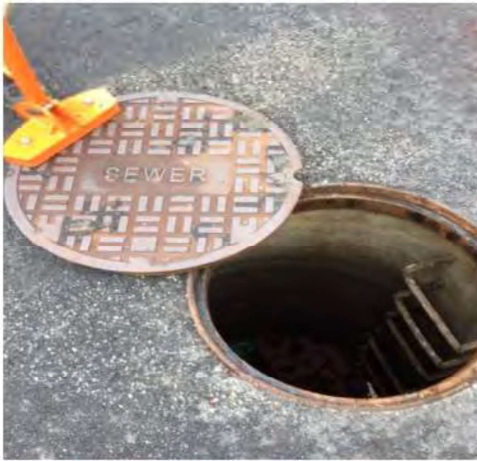
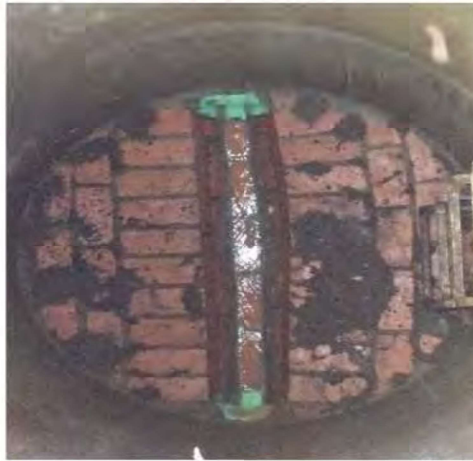
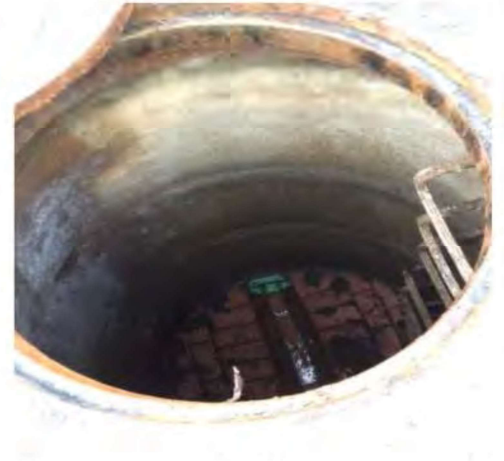
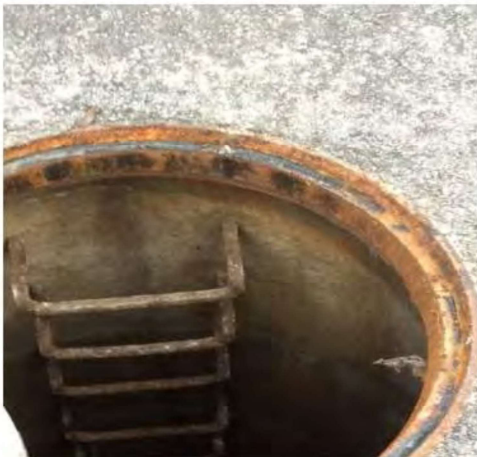
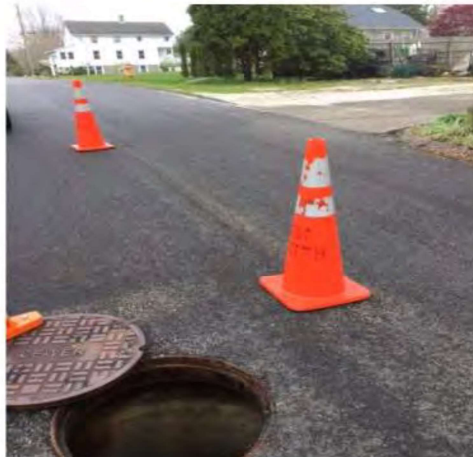
Location in MH	Mtrl. Code	Infil. Code	Cond. Code	Repair Codes	Comments
Frame/Cover	CAST IRON	STAINS	SOUND	NONE	
Chimney	BRICK	NONE	DEFECTIVE	RESET EXISTING FRAME AND CHIMNEY	BRICKS ARE STARTING TO BE DISPLACED
Cone	CONCRETE (PRECAST)	NONE	SOUND	NONE	
Wall	CONCRETE (PRECAST)	NONE	SOUND	NONE	
Bench	BRICK	NONE	SOUND	NONE	
Invert/Channel	BRICK	NONE	SOUND	NONE

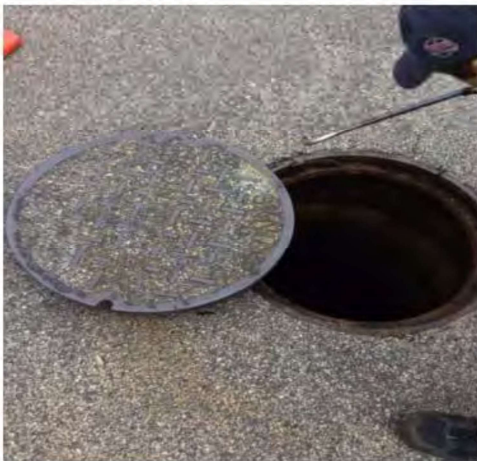
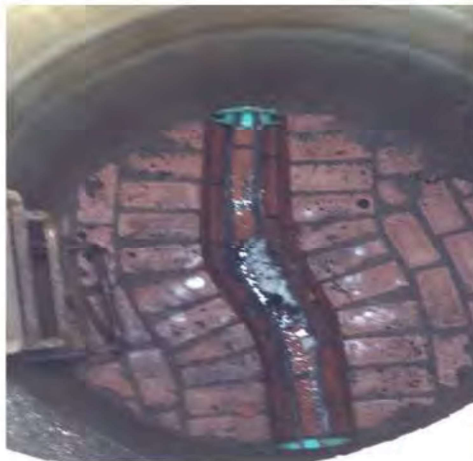
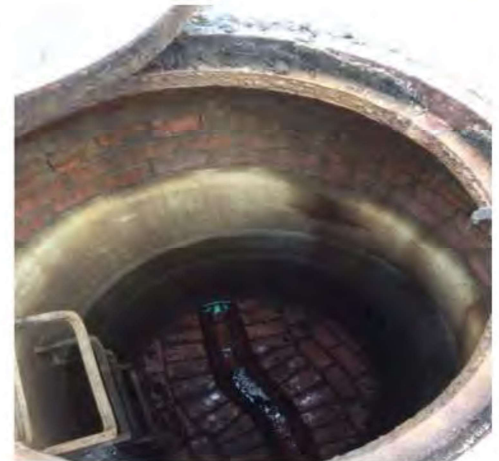
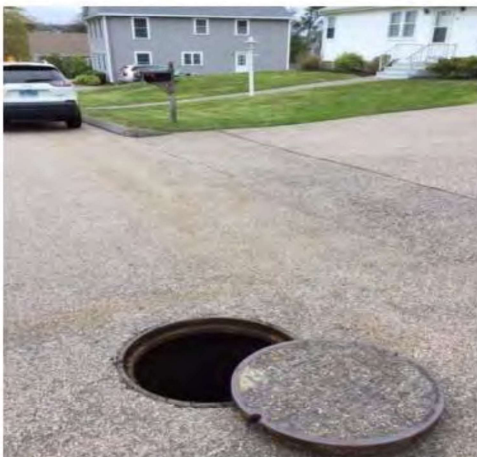
Location in MH	Mtrl. Code	Infil. Code	Cond. Code	Repair Codes	Comments
Frame/Cover	CAST IRON	STAINS	SOUND	NONE	
Chimney	BRICK	NONE	SOUND	NONE	
Cone	CONCRETE (PRECAST)	NONE	SOUND	NONE	
Wall	CONCRETE (PRECAST)	NONE	SOUND	NONE	
Bench	BRICK	NONE	SOUND	NONE	
Invert/Channel	BRICK	NONE	SOUND	NONE

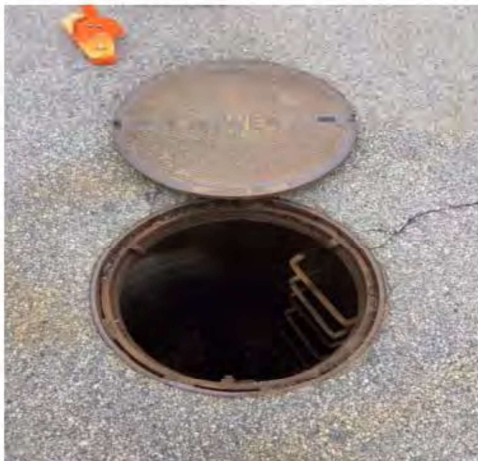
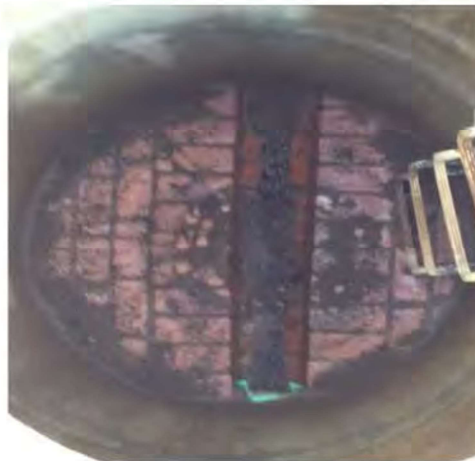
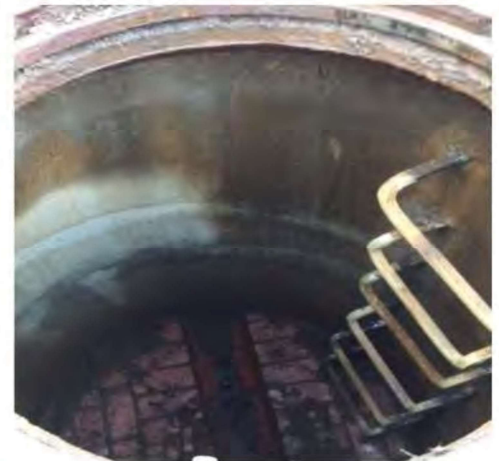
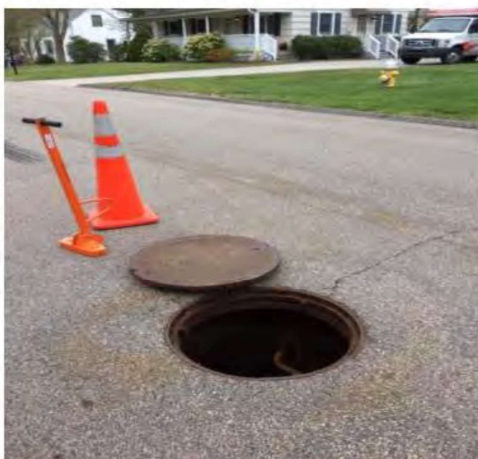
Location in MH	Mtrl. Code	Infil. Code	Cond. Code	Repair Codes	Comments
Frame/Cover	CAST IRON	STAINS	SOUND	NONE	
Chimney	BRICK	NONE	SOUND	NONE	
Cone	CONCRETE (PRECAST)	NONE	SOUND	NONE	
Wall	CONCRETE (PRECAST)	NONE	SOUND	NONE	
Bench	BRICK	NONE	SOUND	NONE	
Invert/Channel	BRICK	NONE	SOUND	NONE

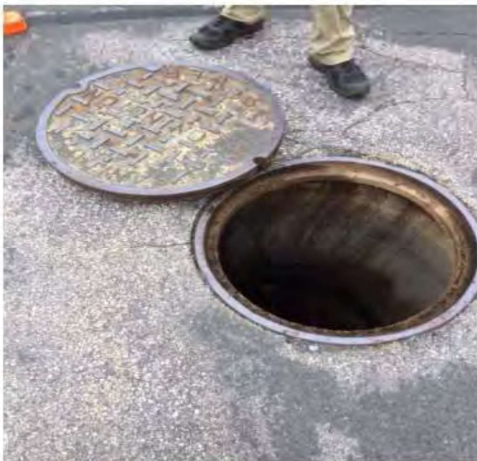
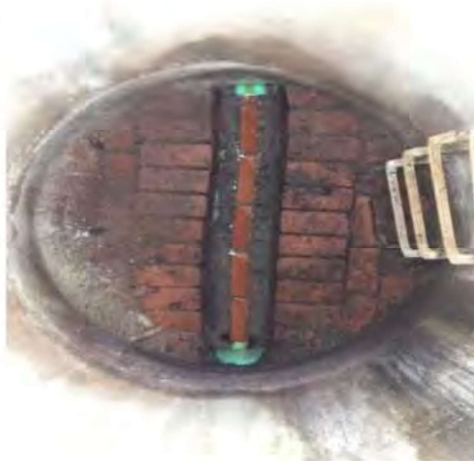
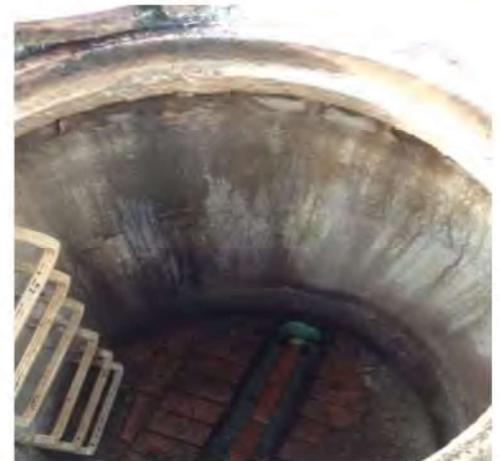
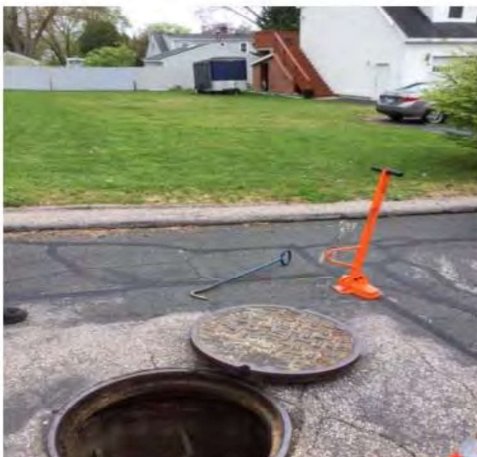
Location in MH	Mtrl. Code	Infil. Code	Cond. Code	Repair Codes	Comments
Frame/Cover	CAST IRON	WEEPER	SOUND	NONE	
Chimney	BRICK	NONE	SOUND	NONE	
Cone	CONCRETE (PRECAST)	NONE	SOUND	NONE	
Wall	CONCRETE (PRECAST)	NONE	SOUND	NONE	
Bench	BRICK	NONE	SOUND	NONE	SLIGHT DEGRADATION FROM 3-6 O CLOCK, BUT NOT DEFECTIVE
Invert/Channel	BRICK	NONE	SOUND	NONE

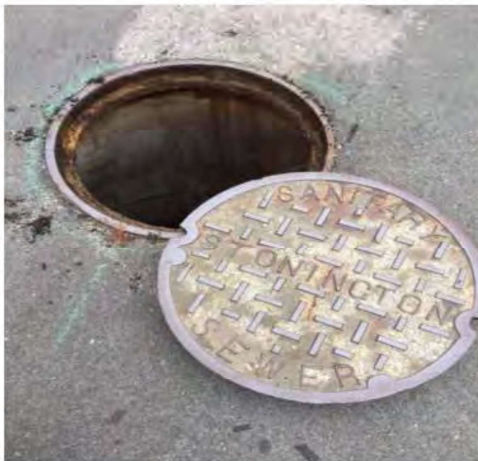
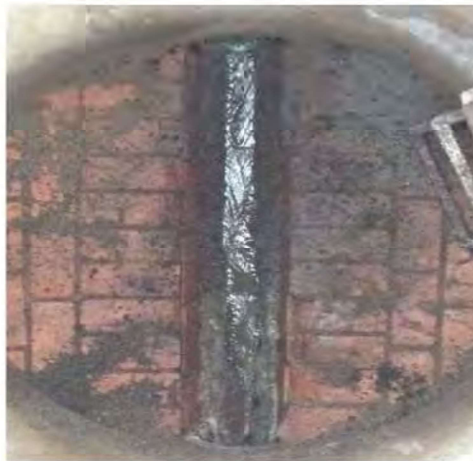
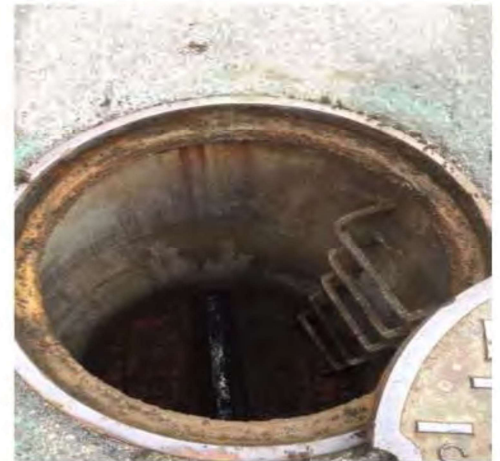
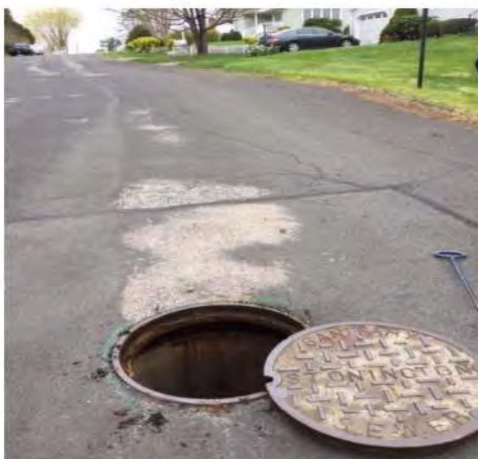
Location in MH	Mtrl. Code	Infil. Code	Cond. Code	Repair Codes	Comments
Frame/Cover	CAST IRON	WEEPER	SOUND	NONE	
Chimney	BRICK	NONE	SOUND	NONE	
Cone	CONCRETE (PRECAST)	NONE	SOUND	NONE	
Wall	CONCRETE (PRECAST)	NONE	SOUND	NONE	
Bench	BRICK	NONE	SOUND	NONE	
Invert/Channel	BRICK	NONE	SOUND	NONE

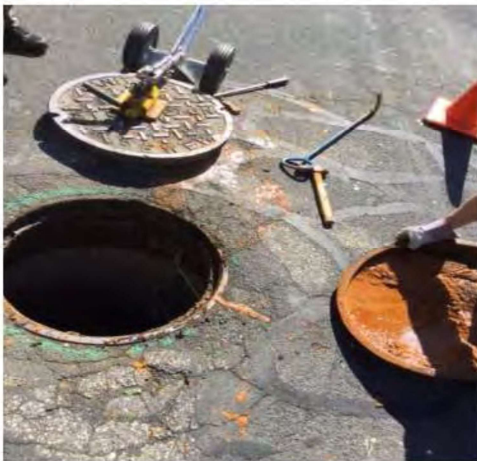
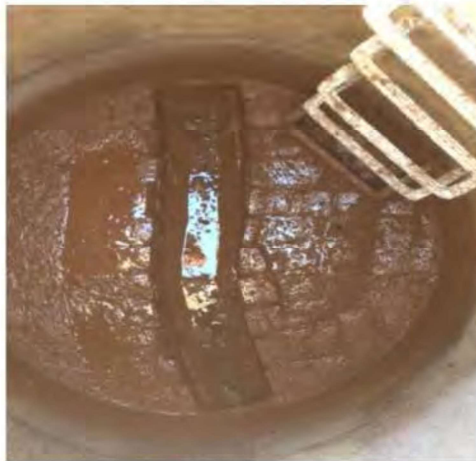
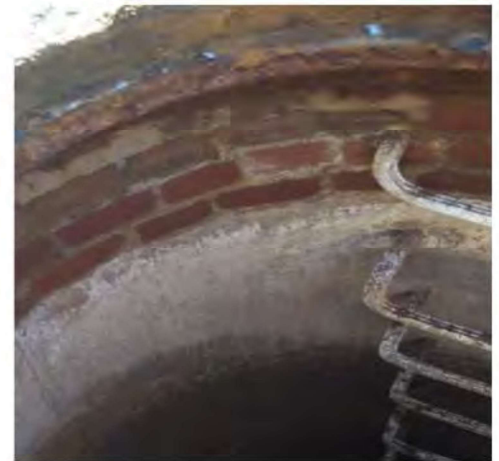
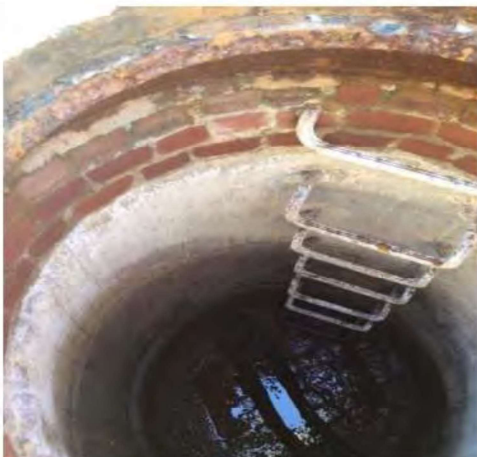
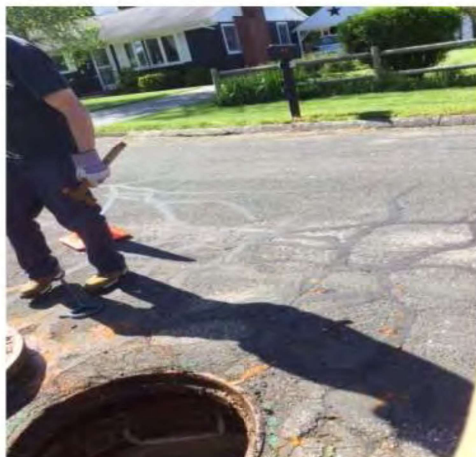
Location in MH	Mtrl. Code	Infil. Code	Cond. Code	Repair Codes	Comments
Frame/Cover	CAST IRON	STAINS	SOUND	NONE	
Chimney	BRICK	NONE	SOUND	NONE	
Cone	CONCRETE (PRECAST)	NONE	SOUND	NONE	
Wall	CONCRETE (PRECAST)	NONE	SOUND	NONE	
Bench	BRICK	NONE	SOUND	NONE	
Invert/Channel	BRICK	NONE	SOUND	NONE

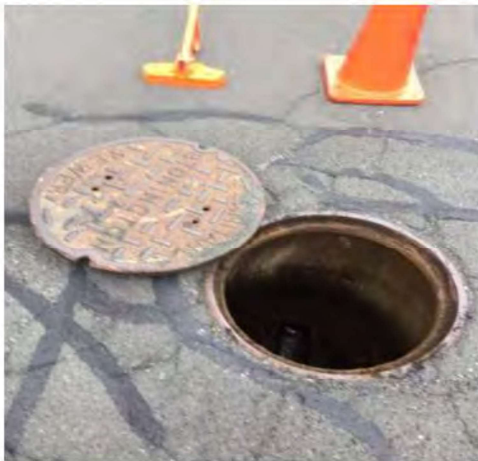
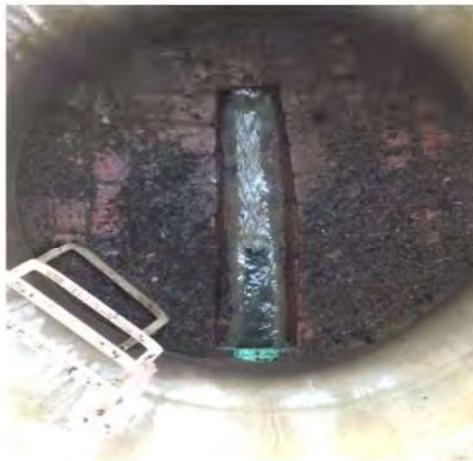
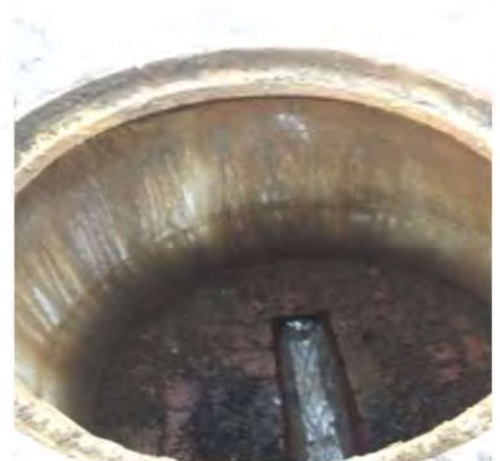
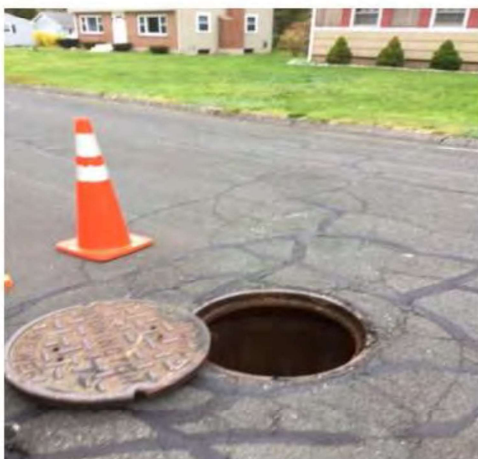
Location in MH	Mtrl. Code	Infil. Code	Cond. Code	Repair Codes	Comments
Frame/Cover	CAST IRON	WEEPER	SOUND	NONE	
Chimney	OTHER (DESCRIBE IN DETAILS)	NONE	SOUND	NONE	
Cone	CONCRETE (PRECAST)	NONE	SOUND	NONE	
Wall	CONCRETE (PRECAST)	NONE	SOUND	NONE	
Bench	BRICK	NONE	SOUND	NONE	
Invert/Channel	BRICK	NONE	SOUND	NONE

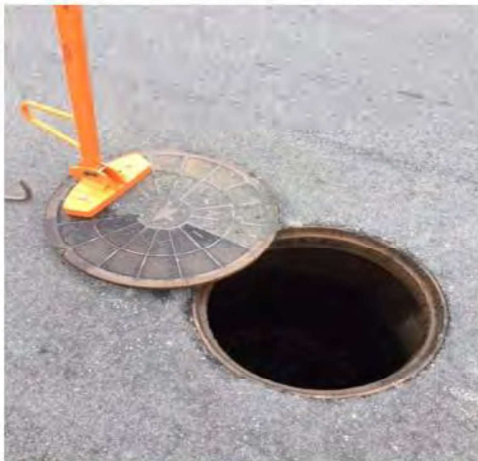
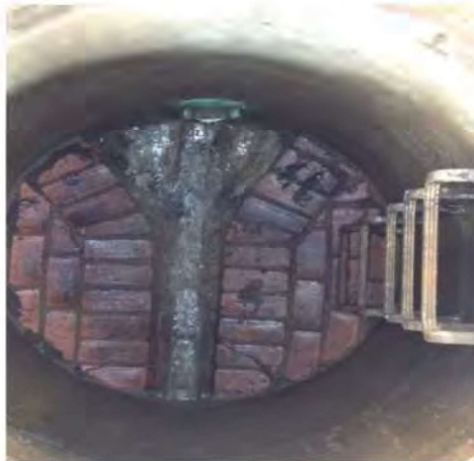
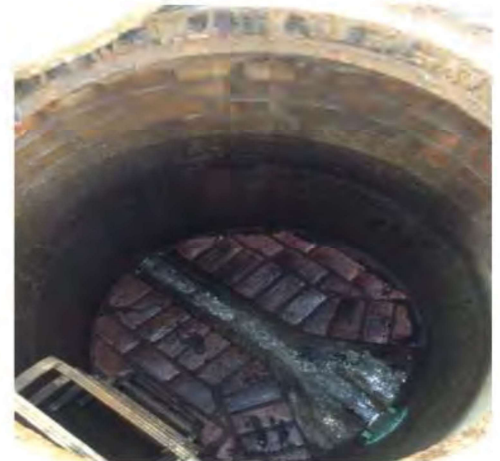
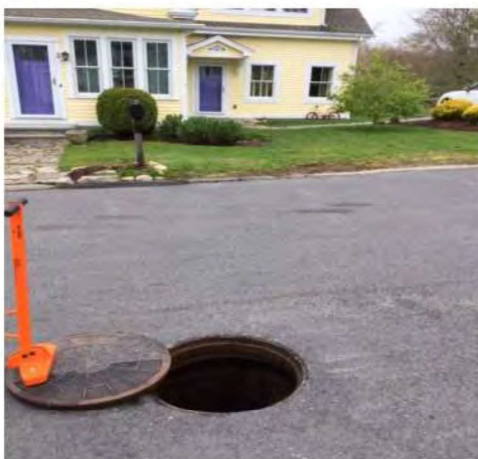
Location in MH	Mtrl. Code	Infil. Code	Cond. Code	Repair Codes	Comments
Frame/Cover	CAST IRON	STAINS	SOUND	NONE	
Chimney	BRICK	NONE	SOUND	NONE	
Cone	CONCRETE (PRECAST)	NONE	SOUND	NONE	
Wall	CONCRETE (PRECAST)	NONE	SOUND	NONE	
Bench	BRICK	NONE	SOUND	NONE	
Invert/Channel	BRICK	NONE	SOUND	NONE

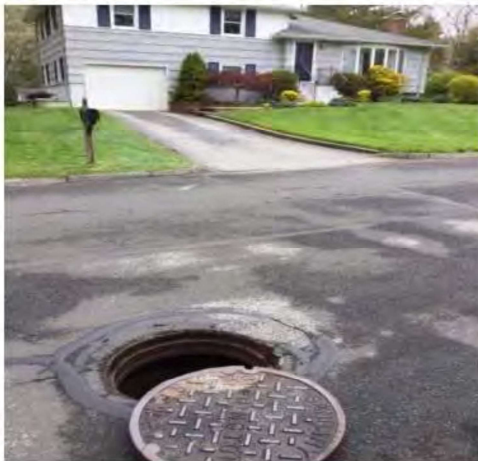
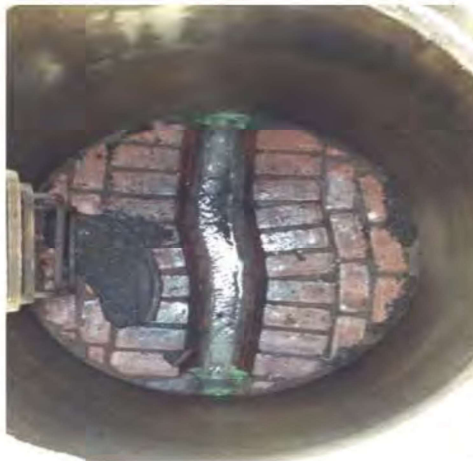
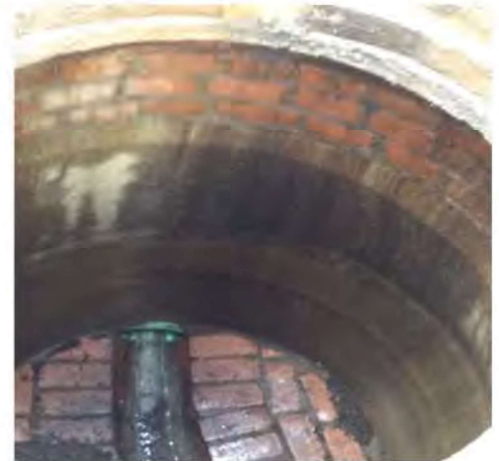
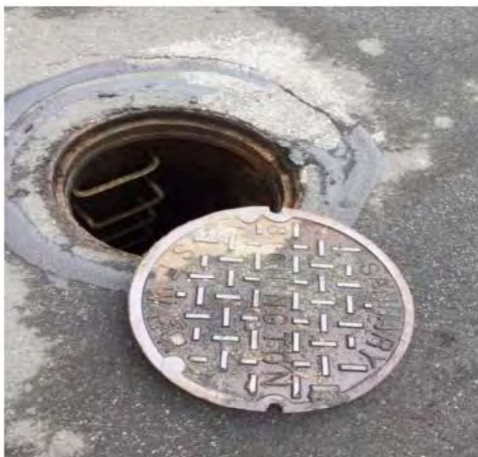
Location in MH	Mtrl. Code	Infil. Code	Cond. Code	Repair Codes	Comments
Frame/Cover	CAST IRON	STAINS	SOUND	NONE	
Chimney	BRICK	NONE	SOUND	NONE	
Cone	CONCRETE (PRECAST)	NONE	SOUND	NONE	
Wall	CONCRETE (PRECAST)	NONE	SOUND	NONE	
Bench	BRICK	NONE	SOUND	CLEAN	PIECE OF OLD COVER ON BENCH
Invert/Channel	BRICK	NONE	SOUND	NONE

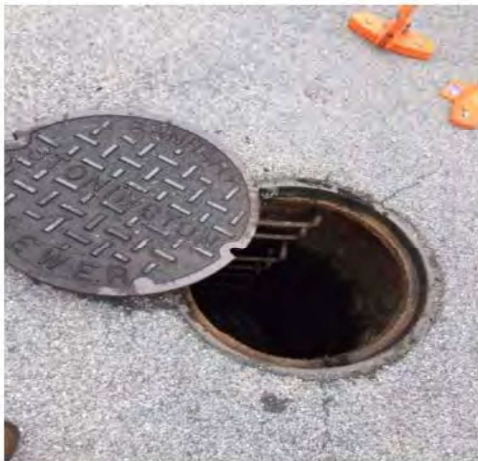
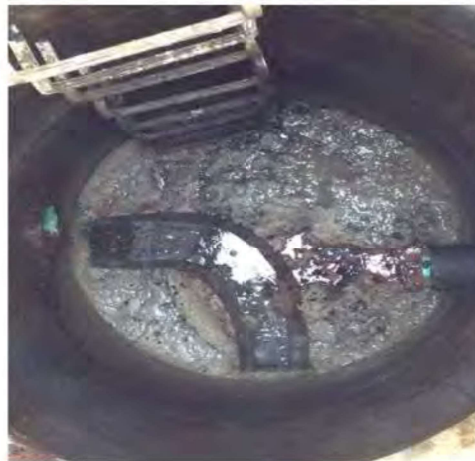
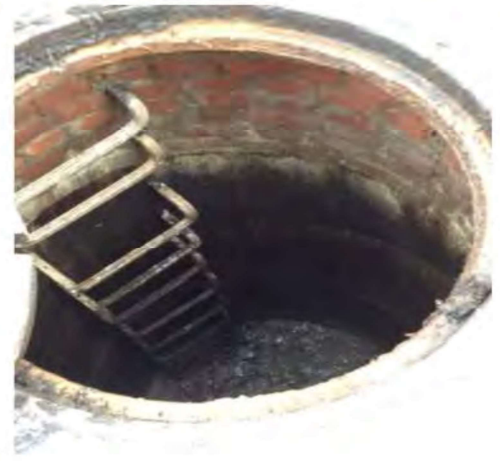
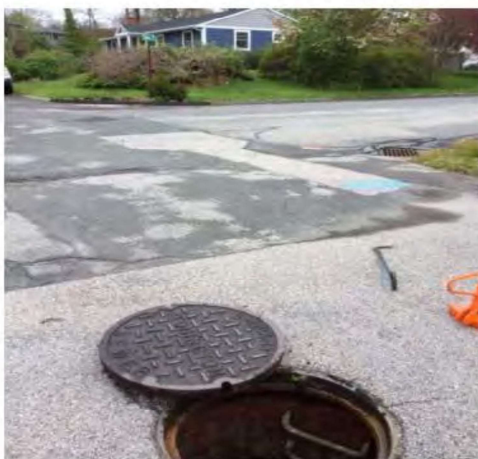
Inspection Photos

Location in MH	Mtrl. Code	Infil. Code	Cond. Code	Repair Codes	Comments
Frame/Cover	CAST IRON	NONE	SOUND	NONE	
Chimney	BRICK	NONE	SOUND	NONE	
Cone	CONCRETE (PRECAST)	STAINS	SOUND	NONE	
Wall	CONCRETE (PRECAST)	NONE	SOUND	NONE	
Bench	BRICK	NONE	SOUND	CLEAN	
Invert/Channel	BRICK	NONE	SOUND	NONE

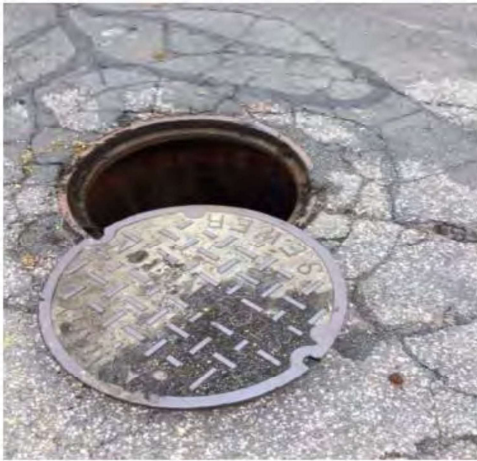
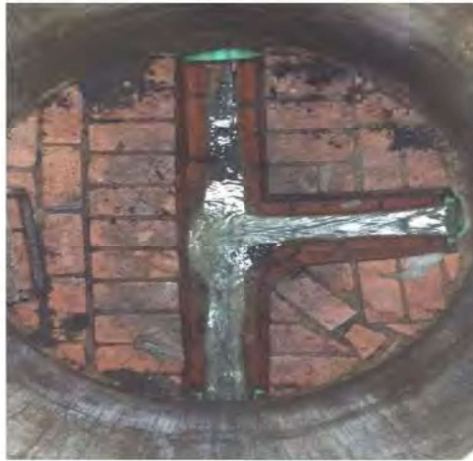
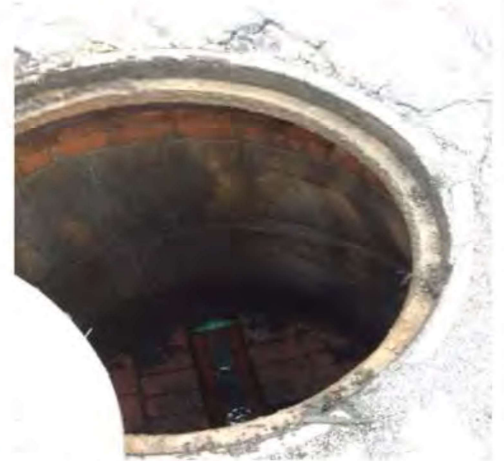
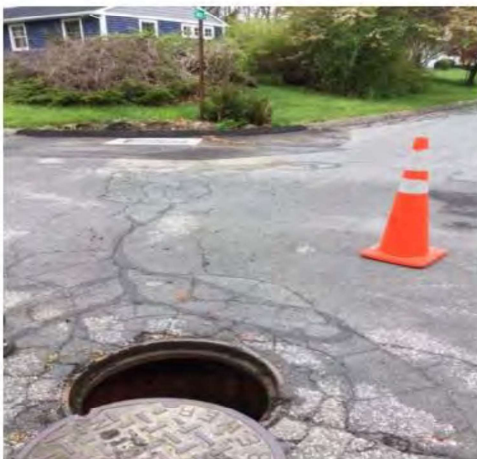
Inspection Photos

Location in MH	Mtrl. Code	Infil. Code	Cond. Code	Repair Codes	Comments
Frame/Cover	CAST IRON	STAINS	SOUND	NONE	
Chimney	BRICK	NONE	SOUND	NONE	
Cone	CONCRETE (PRECAST)	NONE	SOUND	NONE	
Wall	CONCRETE (PRECAST)	NONE	SOUND	NONE	
Bench	BRICK	NONE	SOUND	NONE	
Invert/Channel	BRICK	NONE	SOUND	NONE

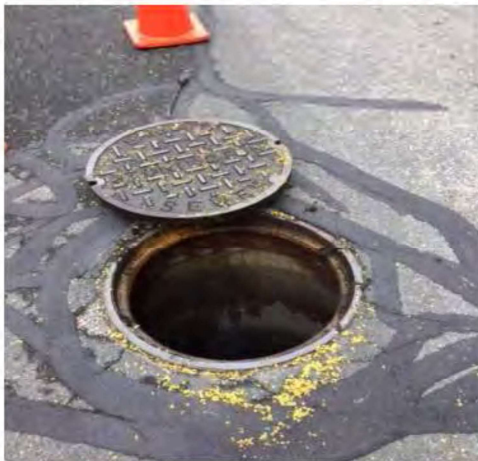
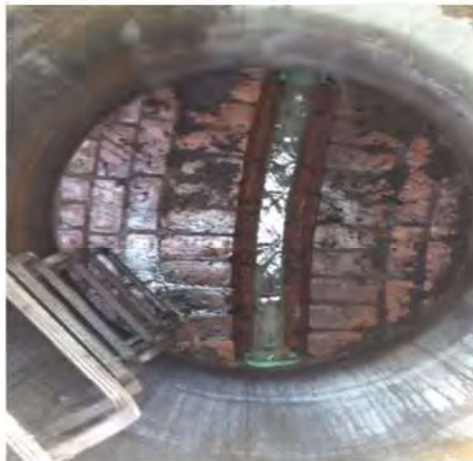
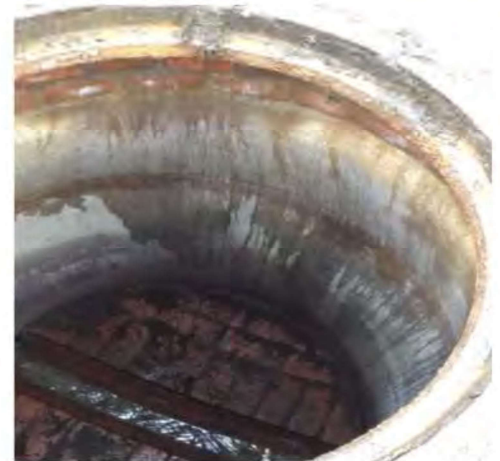
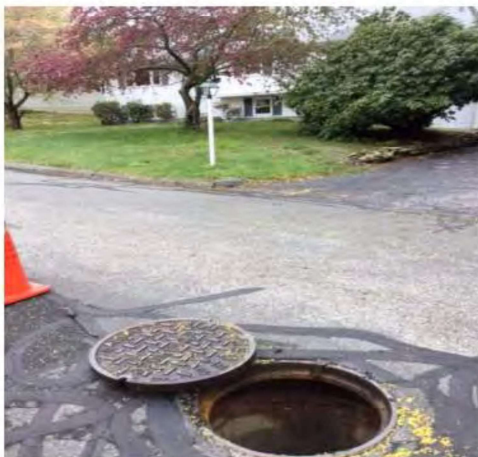
Inspection Photos

Location in MH	Mtrl. Code	Infil. Code	Cond. Code	Repair Codes	Comments
Frame/Cover	CAST IRON	WEEPER	SOUND	NONE	
Chimney	BRICK	NONE	SOUND	NONE	
Cone	CONCRETE (PRECAST)	NONE	SOUND	NONE	
Wall	CONCRETE (PRECAST)	STAINS	SOUND	NONE	
Bench	BRICK	NONE	SOUND	NONE	
Invert/Channel	BRICK	NONE	SOUND	NONE

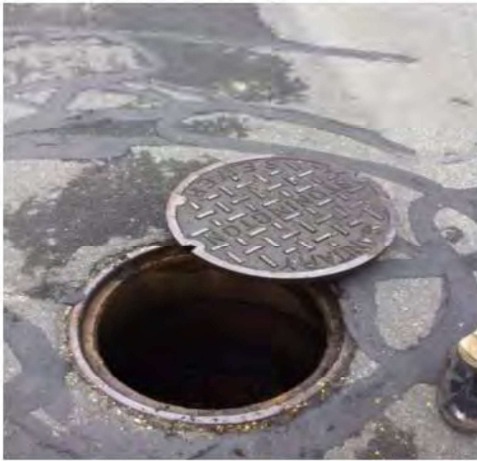
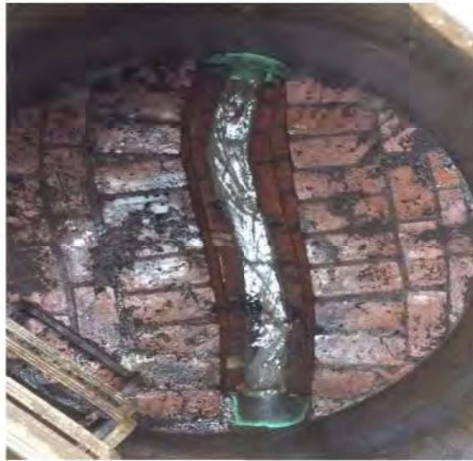
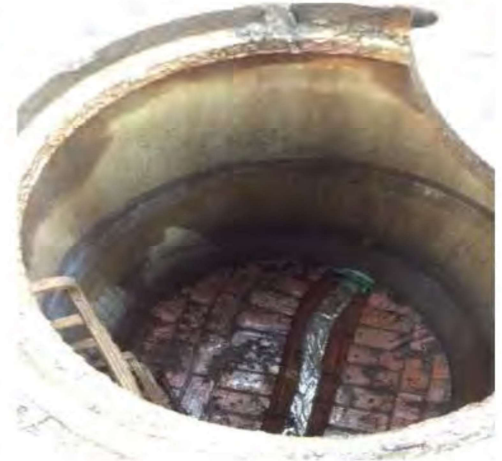
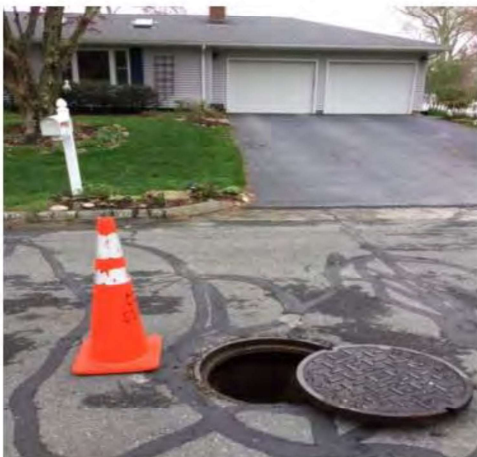
Inspection Photos

Location in MH	Mtrl. Code	Infil. Code	Cond. Code	Repair Codes	Comments
Frame/Cover	CAST IRON	STAINS	SOUND	NONE	
Chimney	OTHER (DESCRIBE IN DETAILS)	NONE	SOUND	NONE	NO CHIMNEY
Cone	CONCRETE (PRECAST)	NONE	SOUND	NONE	
Wall	CONCRETE (PRECAST)	STAINS	SOUND	NONE	
Bench	BRICK	NONE	SOUND	NONE	
Invert/Channel	BRICK	NONE	SOUND	NONE
