CDM  
Smith

## Town of Stonington, Connecticut

### Manhole Inspection Form

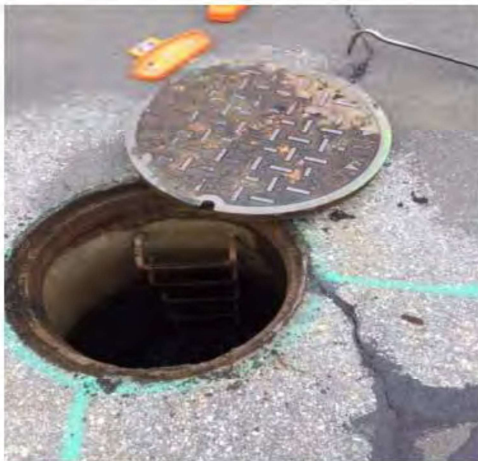
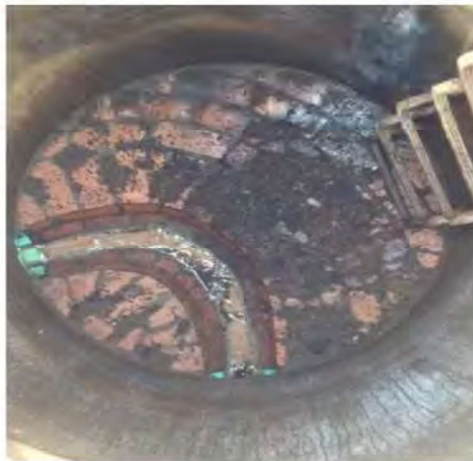
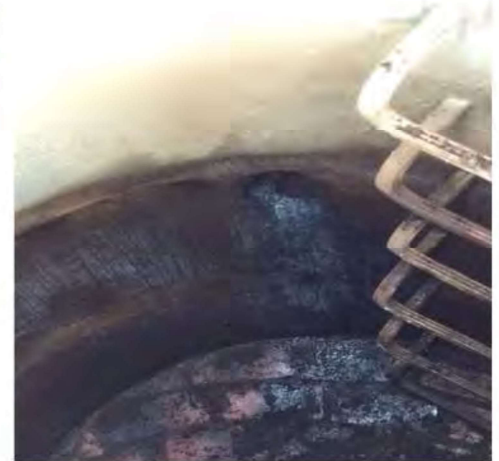
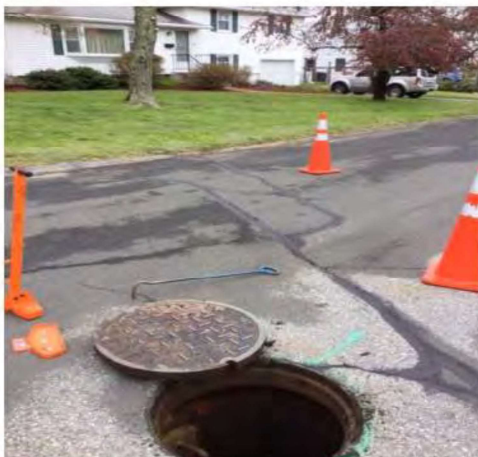
**Manhole Inspection Form****Manhole Information****Inspector:** BM AND JC**Date:** 5/3/2022**Weather:** DRY (NO PRECIPITATION DURING SURVEY)**GIS MH No:** 1-185**Type of Manhole:** SANITARY SEWER (GRAVITY)**Inspection Status:** SURFACE INSPECTION: LEVEL 1 (NO MANHOLE ENTRY)**Street:** 3 SCHOONER DRIVE**Location:** LOCAL RURAL STREETS**Rim to Invert (ft):** 8.5**Grade to Rim (in):** 0**Manhole Infiltration****Surcharge:** NO**Infiltration:** YES**Number of Holes:** 0**Metal Riser:** YES**Manhole Characteristics**

Location in MH	Mtrl. Code	Infil. Code	Cond. Code	Repair Codes	Comments
Frame/Cover	CAST IRON	STAINS	SOUND	NONE	
Chimney	BRICK	NONE	SOUND	NONE	
Cone	CONCRETE (PRECAST)	NONE	SOUND	NONE	
Wall	CONCRETE (PRECAST)	STAINS	SOUND	NONE	
Bench	BRICK	NONE	SOUND	NONE	
Invert/Channel	BRICK	NONE	SOUND	NONE

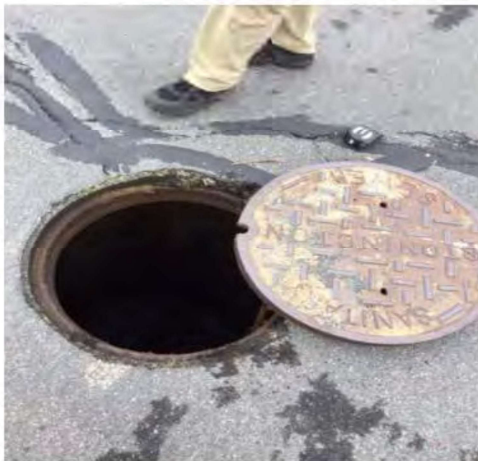
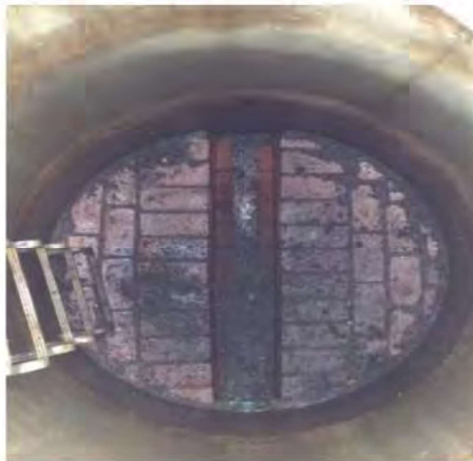
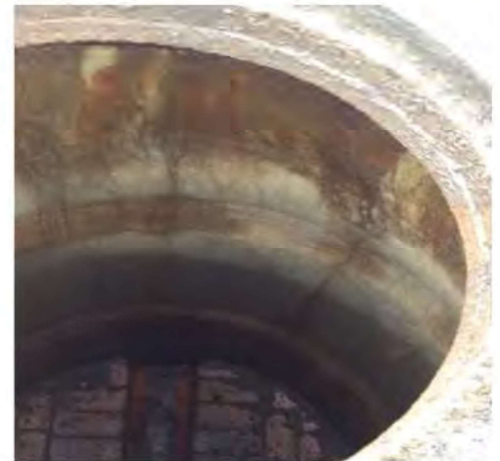
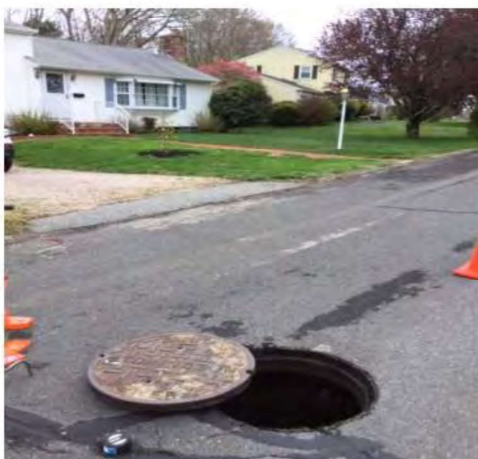
**Manhole Inspection Form****Manhole Information****Inspector:** BM AND JC**Date:** 5/3/2022**Weather:** DRY (NO PRECIPITATION DURING SURVEY)**GIS MH No:** 1-186**Type of Manhole:** SANITARY SEWER (GRAVITY)**Inspection Status:** SURFACE INSPECTION: LEVEL 1 (NO MANHOLE ENTRY)**Street:** 36 CLIPPER DRIVE**Location:** LOCAL RURAL STREETS**Rim to Invert (ft):** 9.5**Grade to Rim (in):** 0**Manhole Infiltration****Surcharge:** NO**Infiltration:** NO**Number of Holes:** 2**Metal Riser:** YES**Manhole Characteristics**

Location in MH	Mtrl. Code	Infil. Code	Cond. Code	Repair Codes	Comments
Frame/Cover	CAST IRON	NONE	SOUND	NONE	
Chimney	BRICK	NONE	SOUND	NONE	
Cone	CONCRETE (PRECAST)	NONE	SOUND	NONE	
Wall	CONCRETE (PRECAST)	NONE	SOUND	NONE	
Bench	BRICK	NONE	SOUND	NONE	
Invert/Channel	BRICK	NONE	SOUND	NONE

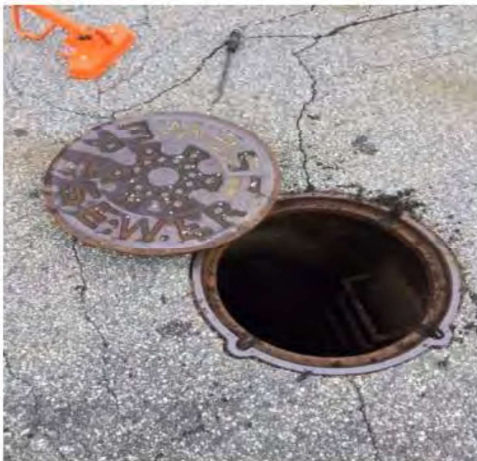
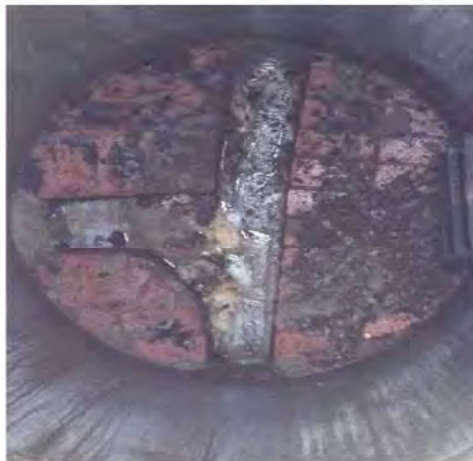
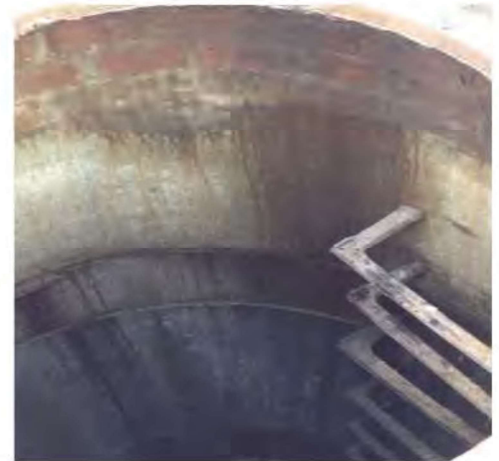
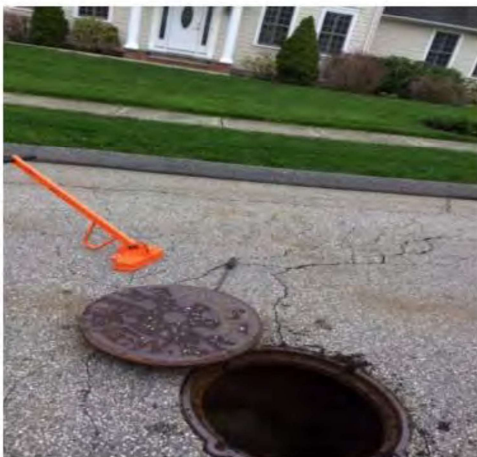
**Manhole Inspection Form****Manhole Information****Inspector:** BM AND JC**Date:** 5/3/2022**Weather:** DRY (NO PRECIPITATION DURING SURVEY)**GIS MH No:** 1-187**Type of Manhole:** SANITARY SEWER (GRAVITY)**Inspection Status:** SURFACE INSPECTION: LEVEL 1 (NO MANHOLE ENTRY)**Street:** 12 ROSSIE ST**Location:** LOCAL RURAL STREETS**Rim to Invert (ft):** 11.25**Grade to Rim (in):** 0**Manhole Infiltration****Surcharge:** NO**Number of Holes:** 0**Infiltration:** NO**Metal Riser:** NO**Manhole Characteristics**

Location in MH	Mtrl. Code	Infil. Code	Cond. Code	Repair Codes	Comments
Frame/Cover	CAST IRON	STAINS	SOUND	NONE	
Chimney	BRICK	NONE	SOUND	NONE	
Cone	CONCRETE (PRECAST)	NONE	SOUND	NONE	
Wall	CONCRETE (PRECAST)	NONE	SOUND	NONE	
Bench	BRICK	NONE	SOUND	NONE	
Invert/Channel	BRICK	NONE	SOUND	NONE

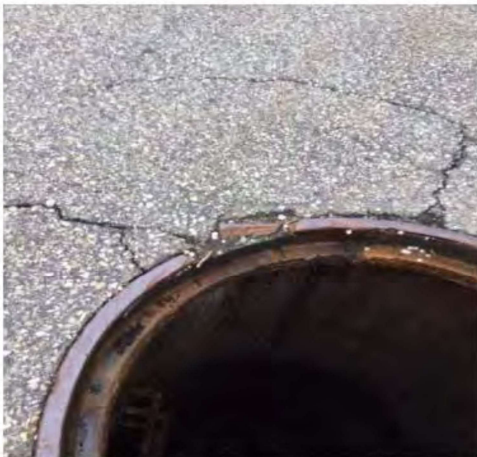
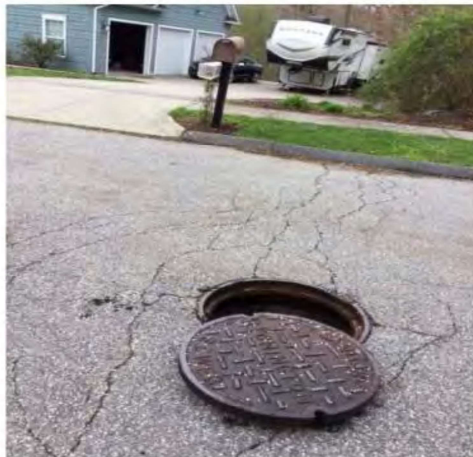
**Manhole Inspection Form****Manhole Information****Inspector:** BM AND JC**Date:** 5/3/2022**Weather:** DRY (NO PRECIPITATION DURING SURVEY)**GIS MH No:** 1-188**Type of Manhole:** SANITARY SEWER (GRAVITY)**Inspection Status:** SURFACE INSPECTION: LEVEL 1 (NO MANHOLE ENTRY)**Street:** 8 ROSSIE ST**Location:** LOCAL RURAL STREETS**Rim to Invert (ft):** 10.75**Grade to Rim (in):** 0**Manhole Infiltration****Surcharge:** NO**Number of Holes:** 0**Infiltration:** NO**Metal Riser:** NO**Manhole Characteristics**

Location in MH	Mtrl. Code	Infil. Code	Cond. Code	Repair Codes	Comments
Frame/Cover	CAST IRON	WEEPER	BROKEN	REPLACE FRAME AND COVER	
Chimney	CONCRETE BLOCK	NONE	SOUND	NONE	
Cone	CONCRETE (PRECAST)	NONE	SOUND	NONE	
Wall	CONCRETE (PRECAST)	NONE	SOUND	NONE	
Bench	BRICK	NONE	SOUND	NONE	
Invert/Channel	BRICK	NONE	SOUND	NONE

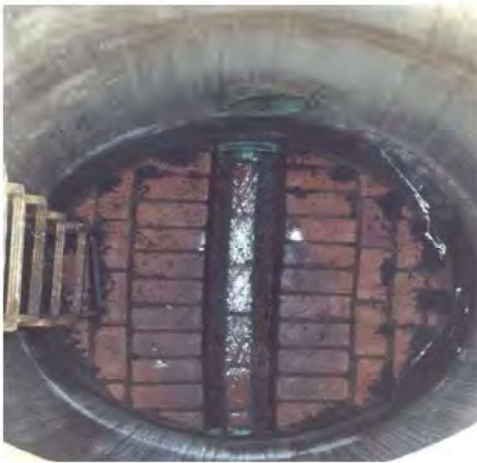
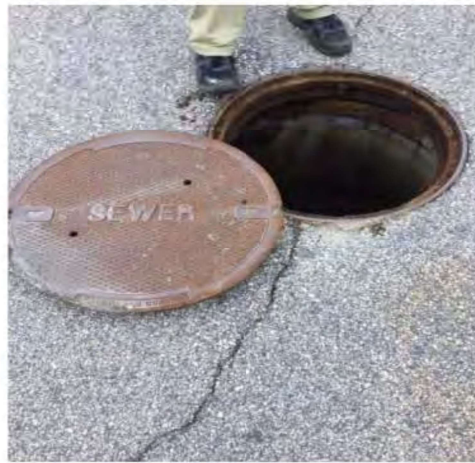
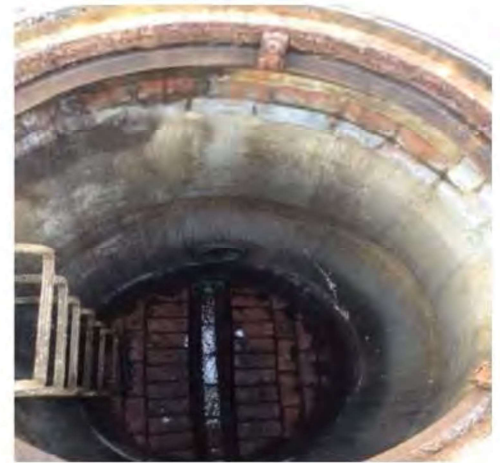
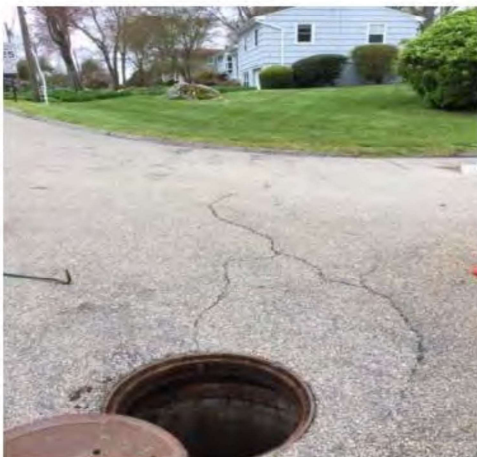
**Manhole Inspection Form****Manhole Information****Inspector:** BM AND JC**Date:** 5/3/2022**Weather:** DRY (NO PRECIPITATION DURING SURVEY)**GIS MH No:** 1-190**Type of Manhole:** SANITARY SEWER (GRAVITY)**Inspection Status:** SURFACE INSPECTION: LEVEL 1 (NO MANHOLE ENTRY)**Street:** ROSSIE STREET**Rim to Invert (ft):** 9.75**Location:** LOCAL RURAL STREETS**Grade to Rim (in):** 0**Manhole Infiltration****Surcharge:** NO**Number of Holes:** 2**Infiltration:** NO**Metal Riser:** YES**Manhole Characteristics**

Location in MH	Mtrl. Code	Infil. Code	Cond. Code	Repair Codes	Comments
Frame/Cover	CAST IRON	STAINS	SOUND	NONE	
Chimney	BRICK	NONE	SOUND	NONE	
Cone	CONCRETE (PRECAST)	NONE	SOUND	NONE	
Wall	CONCRETE (PRECAST)	NONE	SOUND	NONE	
Bench	BRICK	NONE	SOUND	NONE	
Invert/Channel	BRICK	NONE	SOUND	NONE

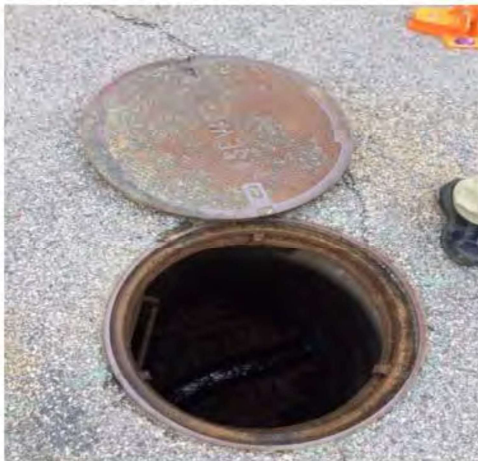
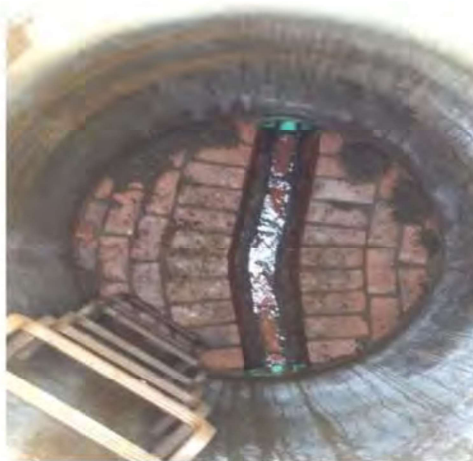
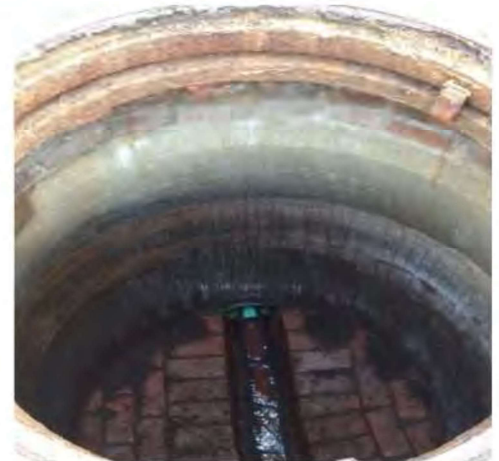
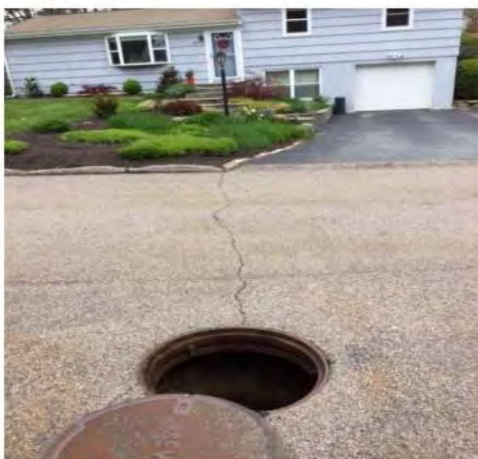
**Manhole Inspection Form****Manhole Information****Inspector:** BM AND JC**Date:** 5/3/2022**Weather:** DRY (NO PRECIPITATION DURING SURVEY)**GIS MH No:** 1-191**Type of Manhole:** SANITARY SEWER (GRAVITY)**Inspection Status:** SURFACE INSPECTION: LEVEL 1 (NO MANHOLE ENTRY)**Street:** 39 ROSSIE ST**Location:** LOCAL RURAL STREETS**Rim to Invert (ft):** 9**Grade to Rim (in):** 0**Manhole Infiltration****Surcharge:** NO**Infiltration:** NO**Number of Holes:** 0**Metal Riser:** YES**Manhole Characteristics**

Location in MH	Mtrl. Code	Infil. Code	Cond. Code	Repair Codes	Comments
Frame/Cover	CAST IRON	STAINS	SOUND	NONE	
Chimney	BRICK	NONE	SOUND	NONE	
Cone	CONCRETE (PRECAST)	NONE	SOUND	NONE	
Wall	CONCRETE (PRECAST)	NONE	SOUND	NONE	
Bench	BRICK	NONE	SOUND	NONE	
Invert/Channel	BRICK	NONE	SOUND	NONE

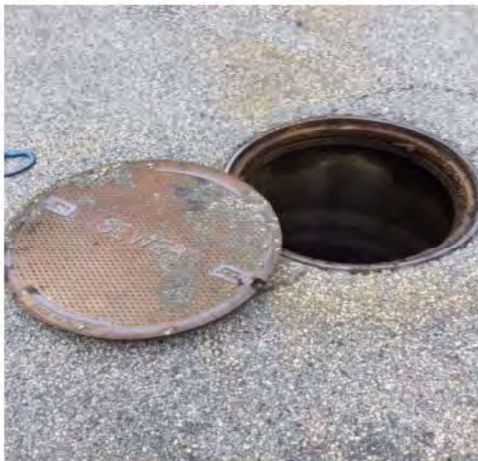
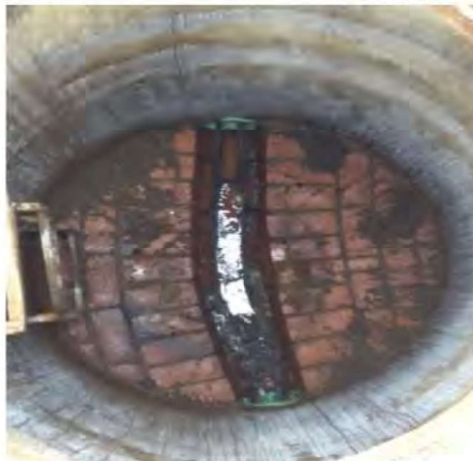
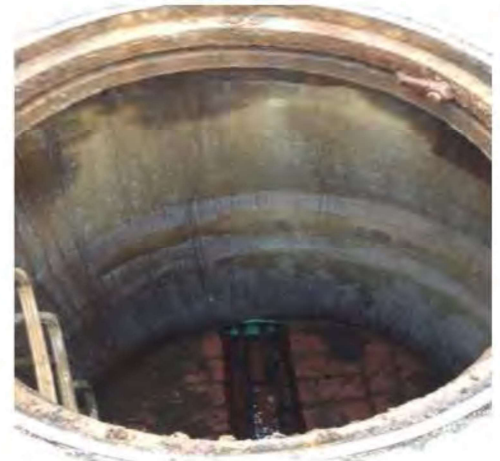
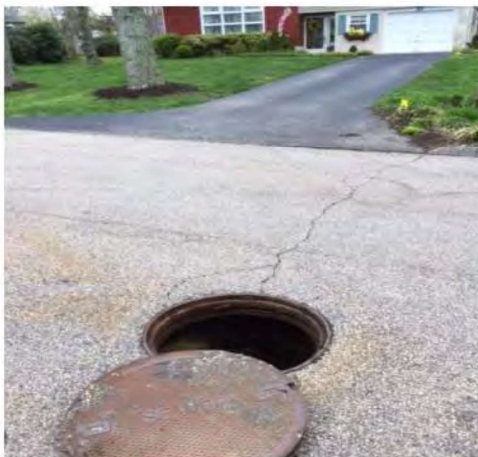
**Manhole Inspection Form****Manhole Information****Inspector:** BM AND JC**Date:** 5/3/2022**Weather:** DRY (NO PRECIPITATION DURING SURVEY)**GIS MH No:** 1-192**Type of Manhole:** SANITARY SEWER (GRAVITY)**Inspection Status:** SURFACE INSPECTION: LEVEL 1 (NO MANHOLE ENTRY)**Street:** 37 ROSSIE STREET**Location:** LOCAL RURAL STREETS**Rim to Invert (ft):** 8.5**Grade to Rim (in):** 0**Manhole Infiltration****Surcharge:** NO**Infiltration:** NO**Number of Holes:** 0**Metal Riser:** YES**Manhole Characteristics**

Location in MH	Mtrl. Code	Infil. Code	Cond. Code	Repair Codes	Comments
Frame/Cover	CAST IRON	WEEPER	SOUND	NONE	
Chimney	BRICK	NONE	SOUND	NONE	
Cone	CONCRETE (PRECAST)	NONE	SOUND	NONE	
Wall	CONCRETE (PRECAST)	NONE	SOUND	NONE	
Bench	BRICK	NONE	SOUND	NONE	
Invert/Channel	BRICK	NONE	SOUND	NONE

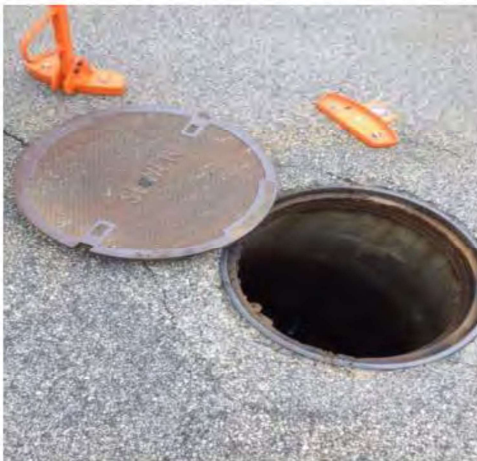
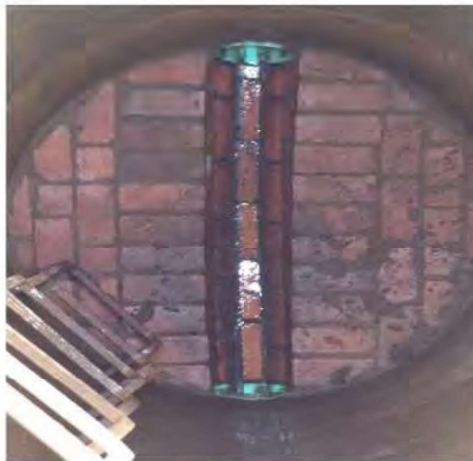
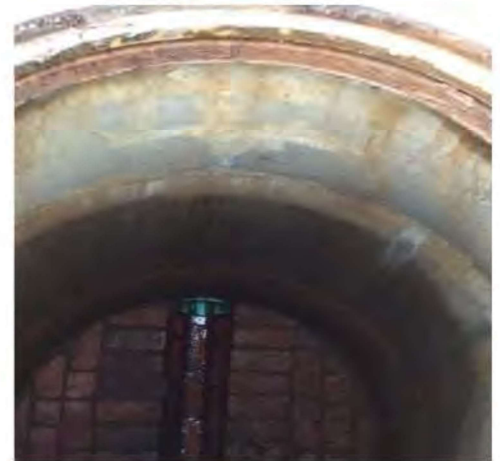
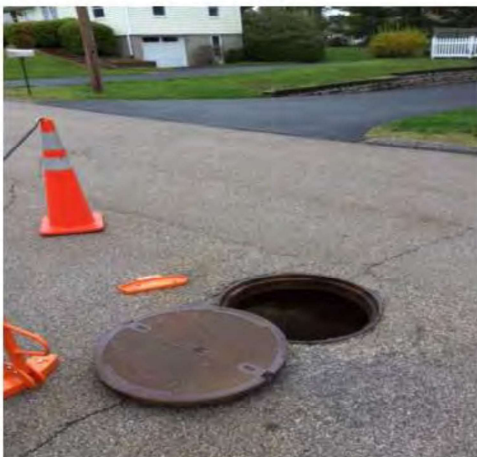
**Manhole Inspection Form****Manhole Information****Inspector:** BM AND JC**Date:** 5/3/2022**Weather:** DRY (NO PRECIPITATION DURING SURVEY)**GIS MH No:** 1-193**Type of Manhole:** SANITARY SEWER (GRAVITY)**Inspection Status:** SURFACE INSPECTION: LEVEL 1 (NO MANHOLE ENTRY)**Street:** 31 ROSSIE STREET**Location:** LOCAL RURAL STREETS**Rim to Invert (ft):** 9.25**Grade to Rim (in):** 0**Manhole Infiltration****Surcharge:** NO**Infiltration:** NO**Number of Holes:** 0**Metal Riser:** YES**Manhole Characteristics**

Location in MH	Mtrl. Code	Infil. Code	Cond. Code	Repair Codes	Comments
Frame/Cover	CAST IRON	STAINS	SOUND	NONE	
Chimney	BRICK	NONE	SOUND	NONE	
Cone	CONCRETE (PRECAST)	NONE	SOUND	NONE	
Wall	CONCRETE (PRECAST)	NONE	SOUND	NONE	
Bench	BRICK	NONE	SOUND	NONE	
Invert/Channel	BRICK	NONE	SOUND	NONE

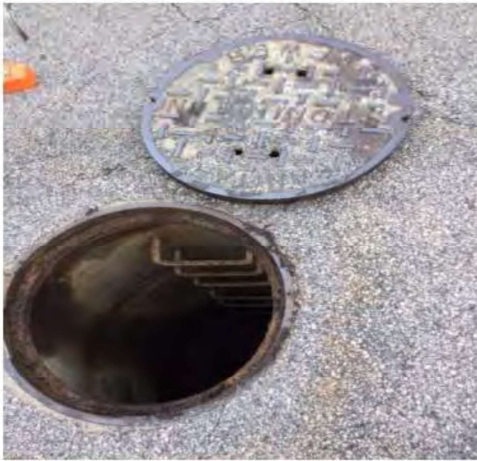
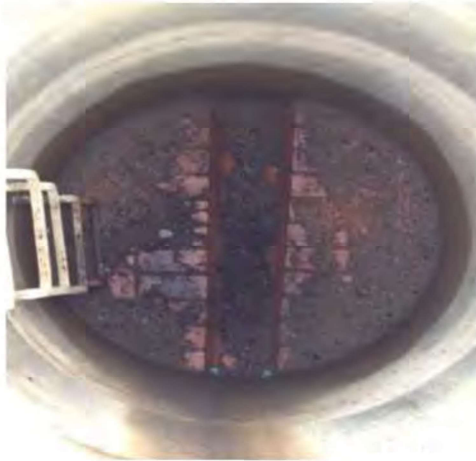
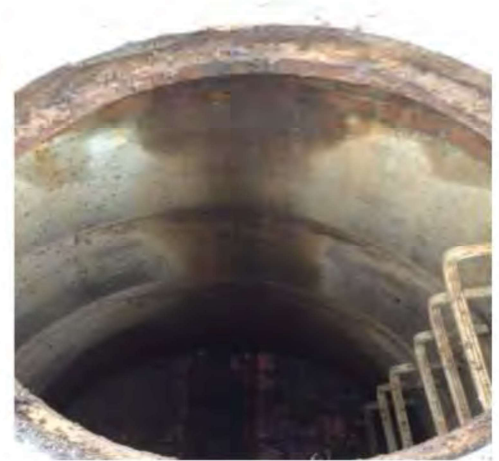
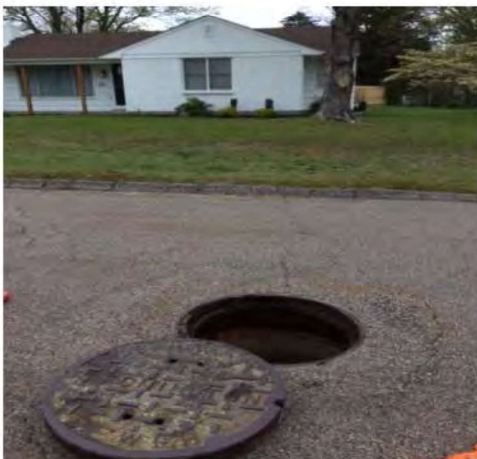
**Manhole Inspection Form****Manhole Information****Inspector:** BM AND JC**Date:** 5/3/2022**Weather:** DRY (NO PRECIPITATION DURING SURVEY)**Street:** 29 ROSSIE ST**Location:** LOCAL RURAL STREETS**GIS MH No:** 1-194**Type of Manhole:** SANITARY SEWER (GRAVITY)**Inspection Status:** SURFACE INSPECTION: LEVEL 1 (NO MANHOLE ENTRY)**Rim to Invert (ft):** 9.25**Grade to Rim (in):** 0**Manhole Infiltration****Surcharge:** NO**Infiltration:** NO**Number of Holes:** 4**Metal Riser:** NO**Manhole Characteristics**

Location in MH	Mtrl. Code	Infil. Code	Cond. Code	Repair Codes	Comments
Frame/Cover	CAST IRON	STAINS	SOUND	NONE	
Chimney	BRICK	NONE	SOUND	NONE	
Cone	CONCRETE (PRECAST)	NONE	SOUND	NONE	
Wall	CONCRETE (PRECAST)	NONE	SOUND	NONE	
Bench	BRICK	NONE	SOUND	NONE	
Invert/Channel	BRICK	NONE	SOUND	NONE

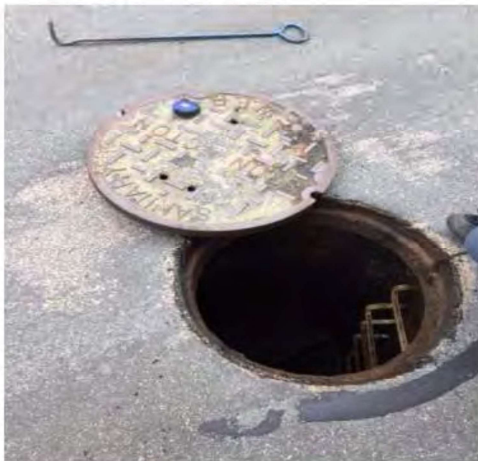
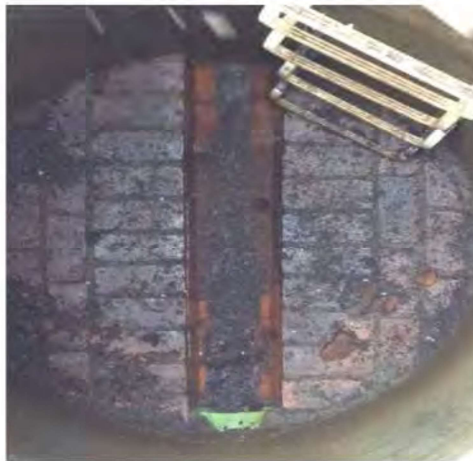
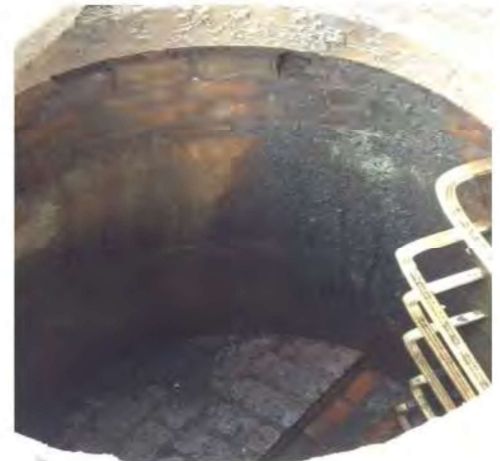
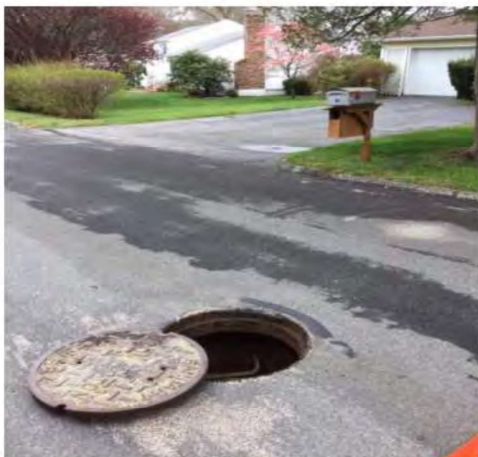
Location in MH	Mtrl. Code	Infil. Code	Cond. Code	Repair Codes	Comments
Frame/Cover	CAST IRON	STAINS	SOUND	NONE	
Chimney	BRICK	NONE	SOUND	NONE	
Cone	CONCRETE (PRECAST)	NONE	SOUND	NONE	
Wall	CONCRETE (PRECAST)	NONE	SOUND	NONE	
Bench	BRICK	NONE	SOUND	NONE	
Invert/Channel	BRICK	NONE	SOUND	NONE

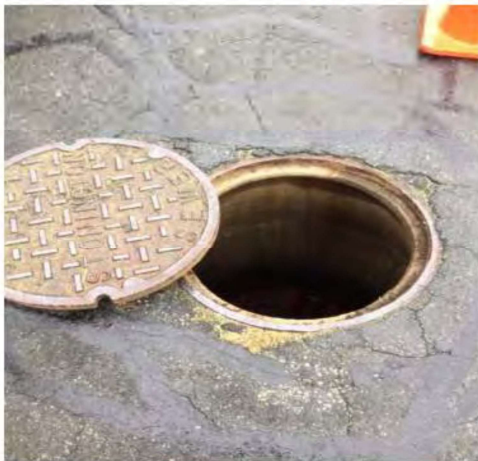
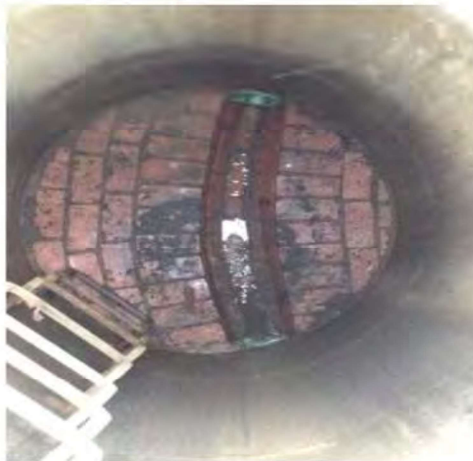
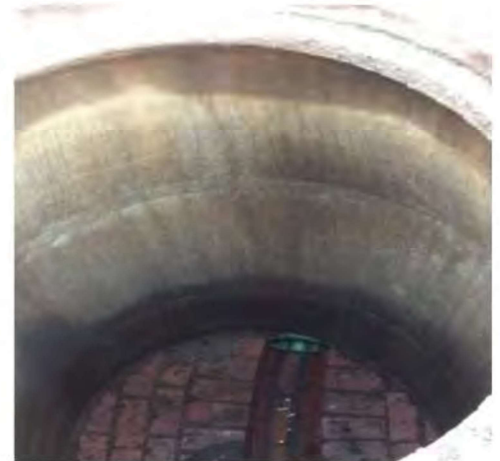
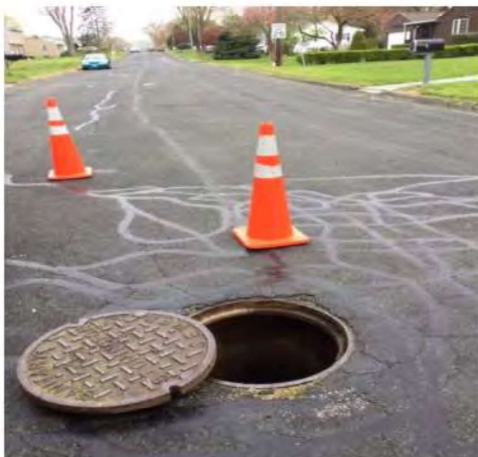
Location in MH	Mtrl. Code	Infil. Code	Cond. Code	Repair Codes	Comments
Frame/Cover	CAST IRON	STAINS	SOUND	NONE	
Chimney	OTHER (DESCRIBE IN DETAILS)	NONE	SOUND	NONE	NO CHIMNEY
Cone	CONCRETE (PRECAST)	NONE	SOUND	NONE	
Wall	CONCRETE (PRECAST)	NONE	SOUND	NONE	
Bench	BRICK	NONE	SOUND	NONE	
Invert/Channel	BRICK	NONE	SOUND	NONE

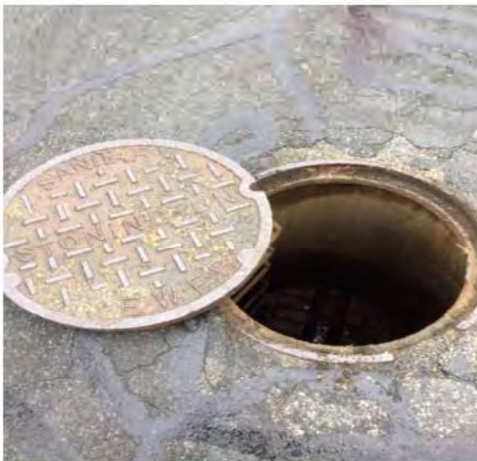
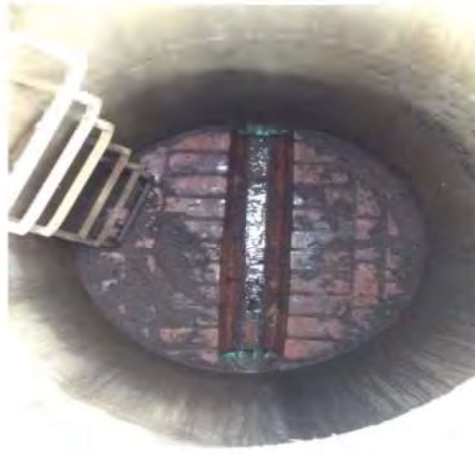
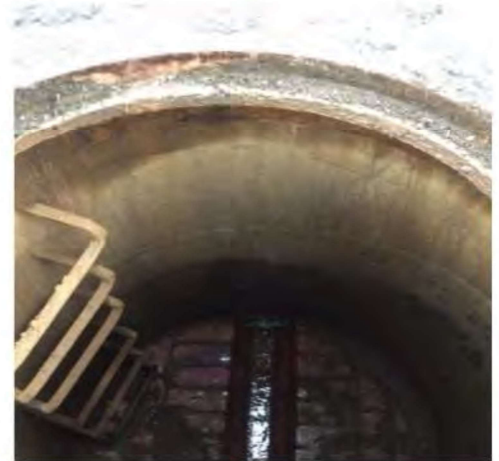
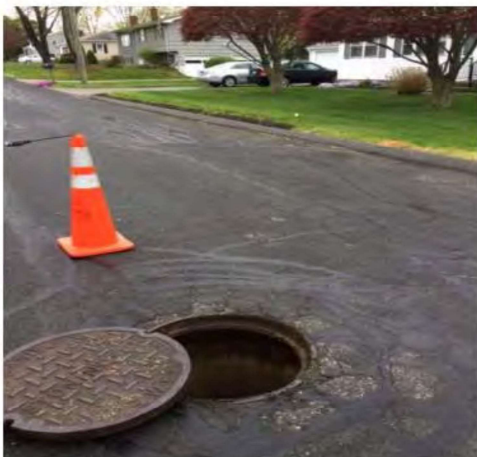
Location in MH	Mtrl. Code	Infil. Code	Cond. Code	Repair Codes	Comments
Frame/Cover	CAST IRON	STAINS	SOUND	NONE	
Chimney	BRICK	NONE	SOUND	NONE	
Cone	CONCRETE (PRECAST)	NONE	SOUND	NONE	
Wall	CONCRETE (PRECAST)	NONE	SOUND	NONE	
Bench	BRICK	NONE	SOUND	NONE	
Invert/Channel	BRICK	NONE	SOUND	NONE

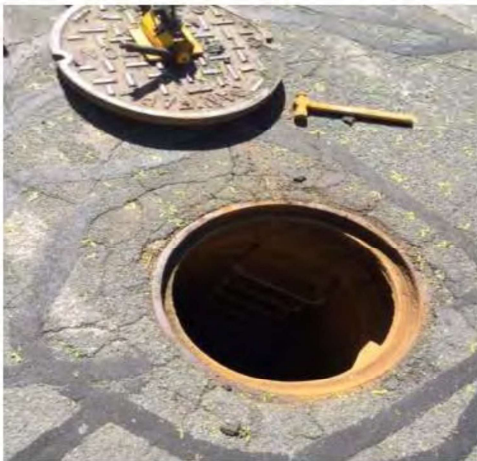
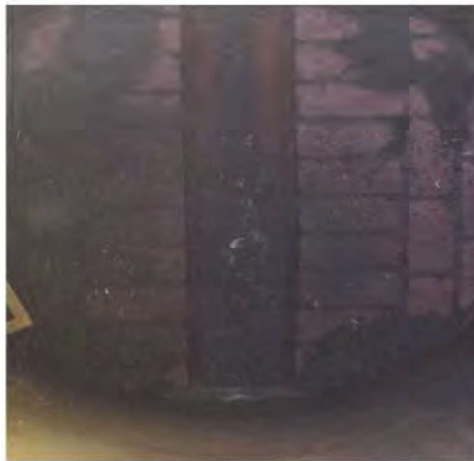
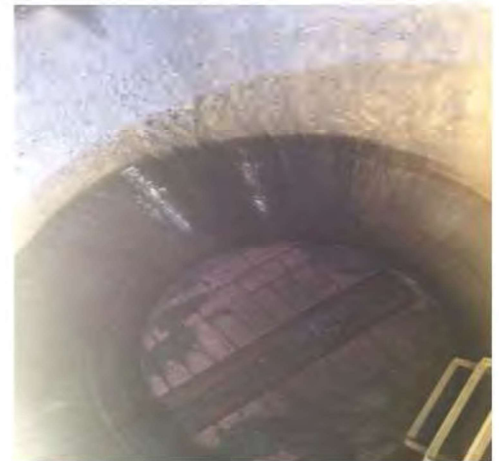
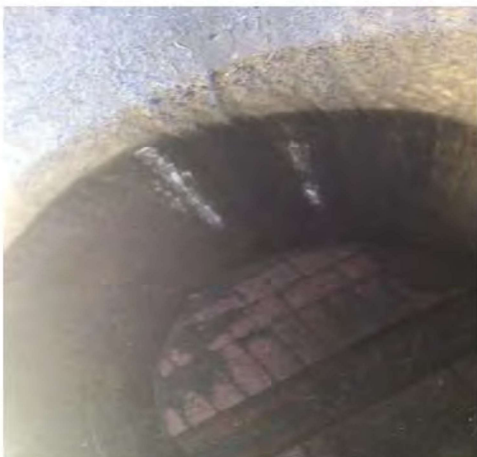
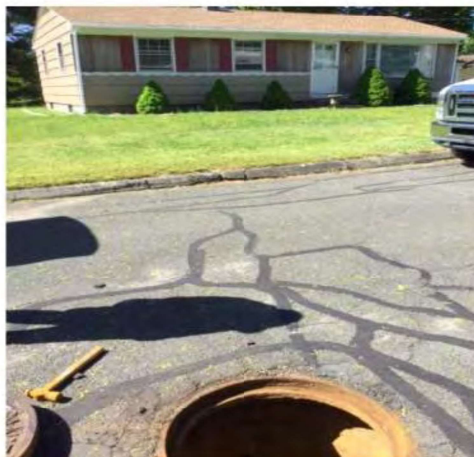
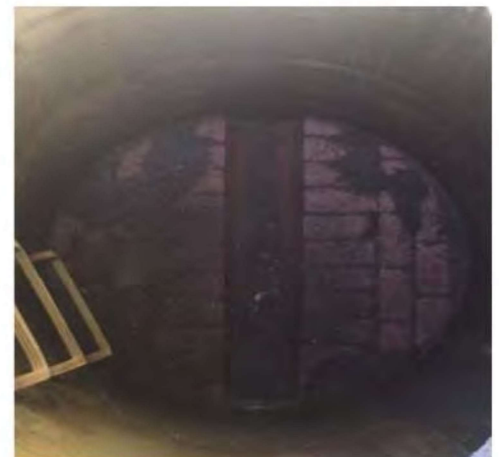
Location in MH	Mtrl. Code	Infil. Code	Cond. Code	Repair Codes	Comments
Frame/Cover	CAST IRON	NONE	SOUND	NONE	
Chimney	OTHER (DESCRIBE IN DETAILS)	NONE	SOUND	NONE	NO CHIMNEY
Cone	CONCRETE (PRECAST)	NONE	SOUND	NONE	
Wall	CONCRETE (PRECAST)	STAINS	DEFECTIVE	LINE_MANHOLE	
Bench	BRICK	NONE	SOUND	NONE	
Invert/Channel	BRICK	NONE	SOUND	NONE

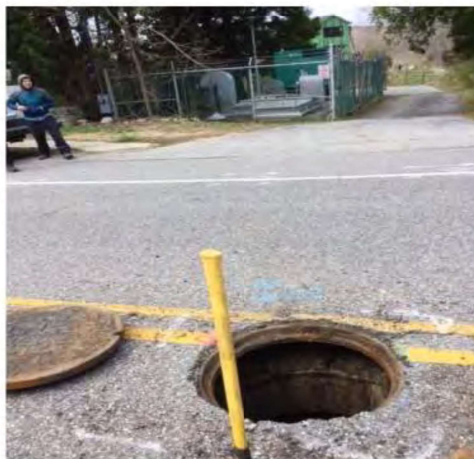
Location in MH	Mtrl. Code	Infil. Code	Cond. Code	Repair Codes	Comments
Frame/Cover	CAST IRON	WEEPER	CORRODED	REPLACE FRAME AND COVER	
Chimney	CONCRETE BLOCK	STAINS	DEFECTIVE	RESET EXISTING FRAME AND CHIMNEY, ADD RISER RING TO FRAME	
Cone	CONCRETE (PRECAST)	NONE	SOUND	NONE	
Wall	CONCRETE (PRECAST)	NONE	SOUND	NONE	
Bench	BRICK	NONE	SOUND	NONE	
Invert/Channel	BRICK	NONE	SOUND	NONE

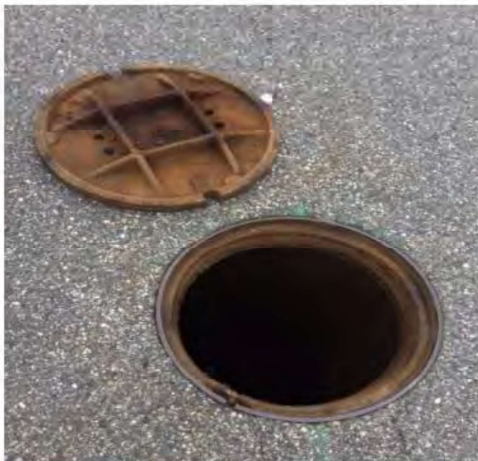
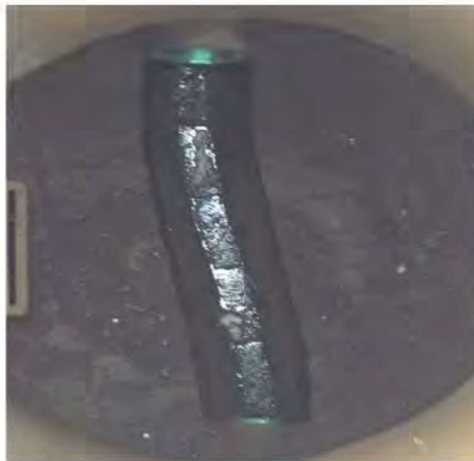
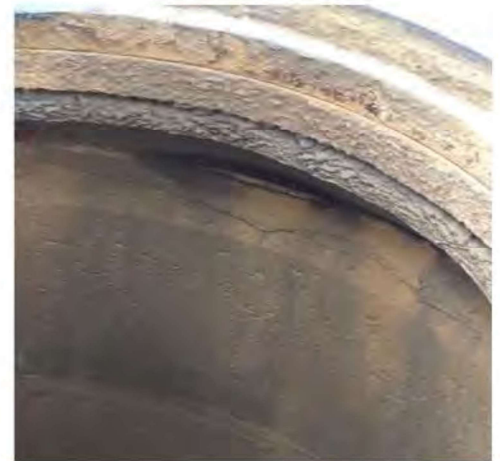
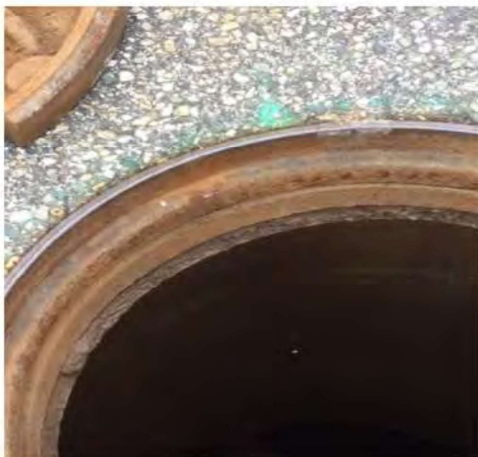
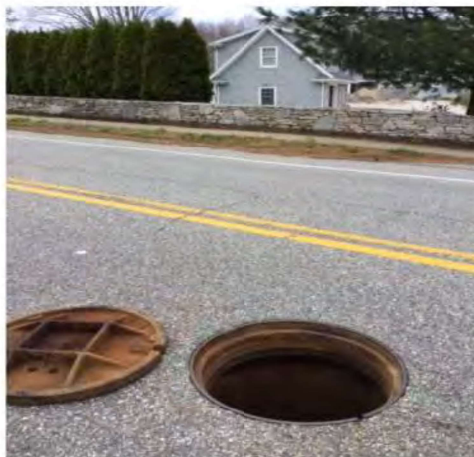
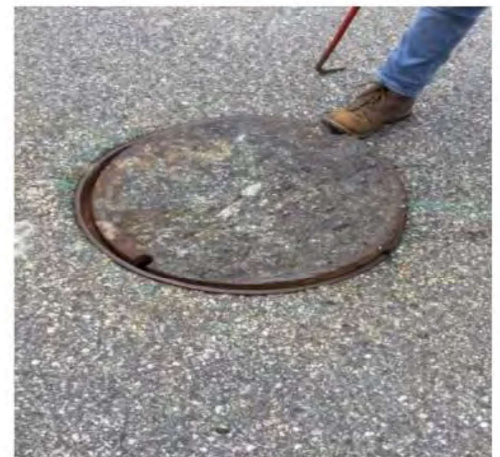
Location in MH	Mtrl. Code	Infil. Code	Cond. Code	Repair Codes	Comments
Frame/Cover	CAST IRON	NONE	SOUND	NONE	
Chimney	OTHER (DESCRIBE IN DETAILS)	NONE	SOUND	NONE	NO CHIMNEY.
Cone	CONCRETE (PRECAST)	STAINS	DEFECTIVE	OTHER	GROUT LOCATION ON CONE WHERE INFILTRATION IS COMING IN
Wall	CONCRETE (PRECAST)	NONE	SOUND	NONE	
Bench	BRICK	NONE	SOUND	NONE	
Invert/Channel	BRICK	NONE	SOUND	NONE

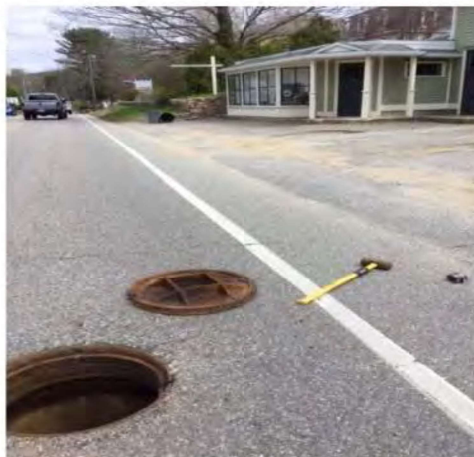
Location in MH	Mtrl. Code	Infil. Code	Cond. Code	Repair Codes	Comments
Frame/Cover	CAST IRON	STAINS	SOUND	NONE	
Chimney	OTHER (DESCRIBE IN DETAILS)	NONE	SOUND	NONE	NO CHIMNEY
Cone	CONCRETE (PRECAST)	NONE	SOUND	NONE	
Wall	CONCRETE (PRECAST)	STAINS	DEFECTIVE	LINE_MANHOLE	
Bench	BRICK	NONE	SOUND	NONE	
Invert/Channel	BRICK	NONE	SOUND	NONE

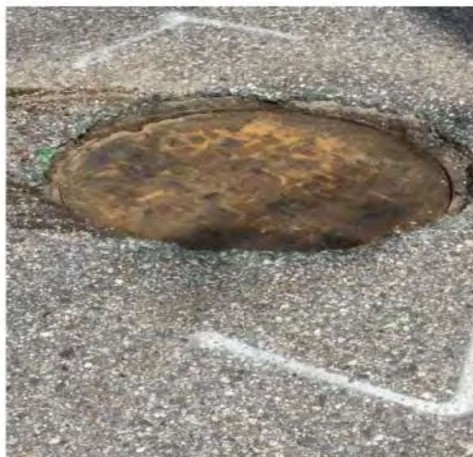
Location in MH	Mtrl. Code	Infil. Code	Cond. Code	Repair Codes	Comments
Frame/Cover	CAST IRON	NONE	CORRODED	ADD RISER RING TO FRAME AND CHIMNEY	
Chimney	BRICK	NONE	SOUND	REPLACE FRAME AND NONE	
Cone	CONCRETE (PRECAST)	NONE	SOUND	NONE	
Wall	CONCRETE (PRECAST)	NONE	SOUND	NONE	
Bench	BRICK	NONE	SOUND	NONE	
Invert/Channel	BRICK	NONE	SOUND	NONE
