Town of Stonington, Connecticut

Manhole Inspection Form

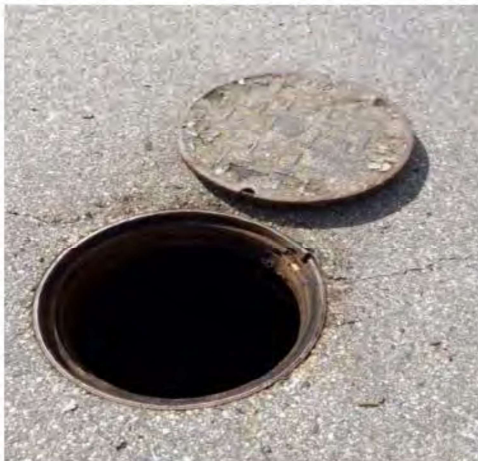
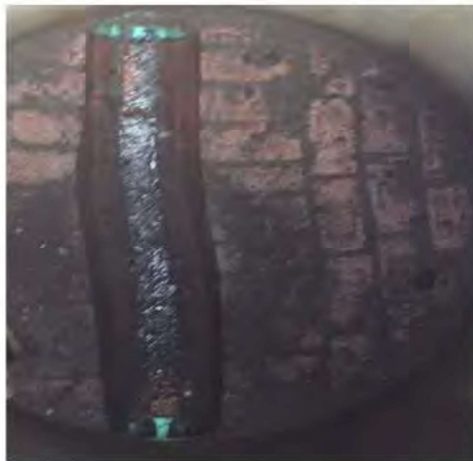
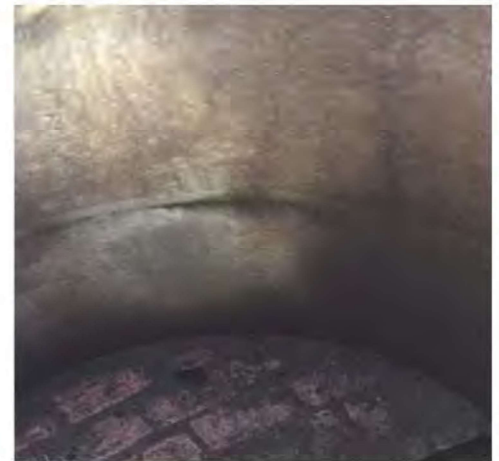
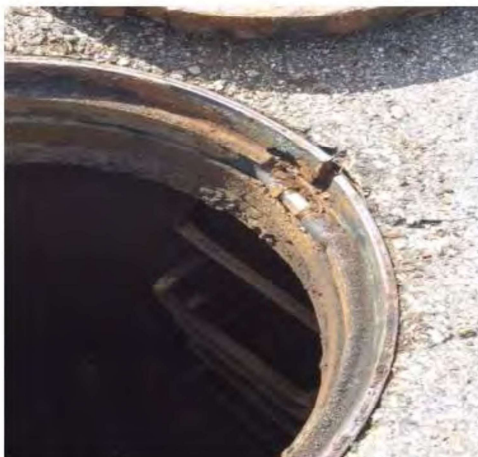
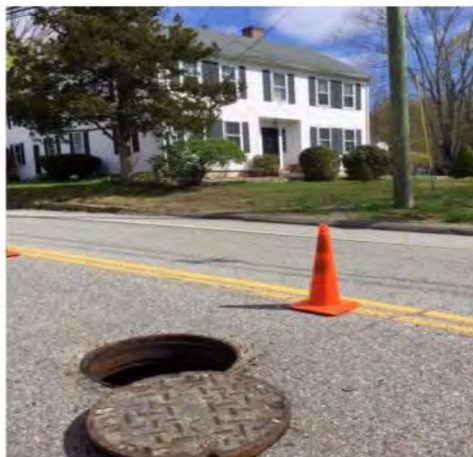
Location in MH	Mtrl. Code	Infil. Code	Cond. Code	Repair Codes	Comments
Frame/Cover	CAST IRON	NONE	SOUND	NONE	
Chimney	BRICK	NONE	SOUND	NONE	
Cone	CONCRETE (PRECAST)	NONE	SOUND	NONE	
Wall	CONCRETE (PRECAST)	STAINS	SOUND	LINE_MANHOLE	
Bench	BRICK	NONE	SOUND	NONE	
Invert/Channel	BRICK	NONE	SOUND	NONE

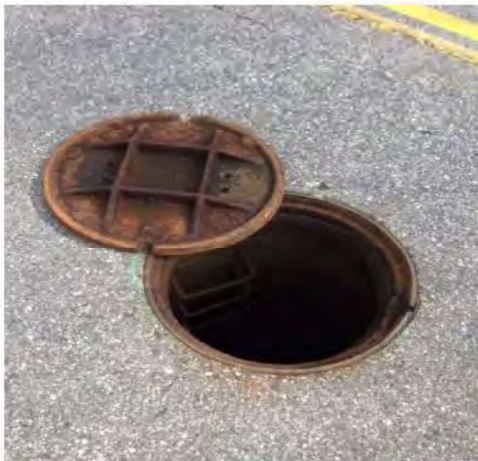
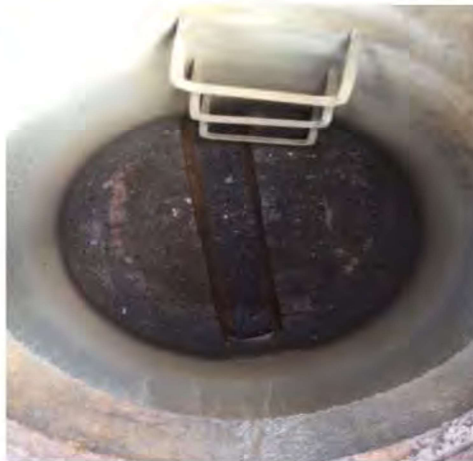
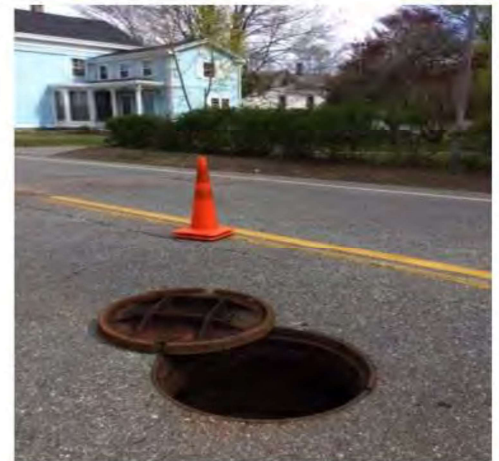
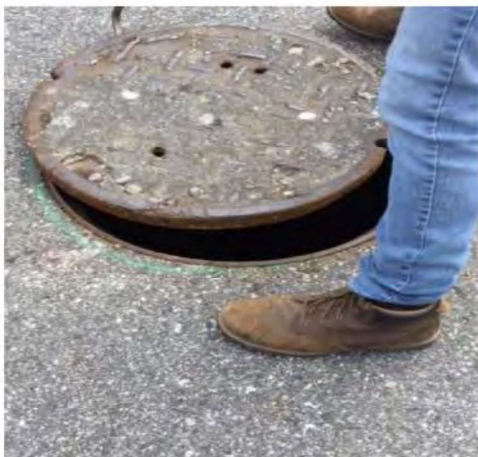
Location in MH	Mtrl. Code	Infil. Code	Cond. Code	Repair Codes	Comments
Frame/Cover	CAST IRON	NONE	SOUND	NONE	
Chimney	OTHER (DESCRIBE IN DETAILS)	NONE	SOUND	NONE	NO CHIMNEY
Cone	CONCRETE (PRECAST)	NONE	SOUND	NONE	
Wall	CONCRETE (PRECAST)	NONE	SOUND	NONE	
Bench	BRICK	NONE	SOUND	NONE	
Invert/Channel	BRICK	NONE	SOUND	NONE

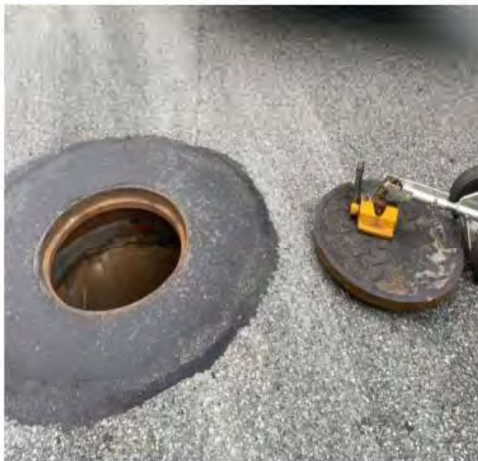
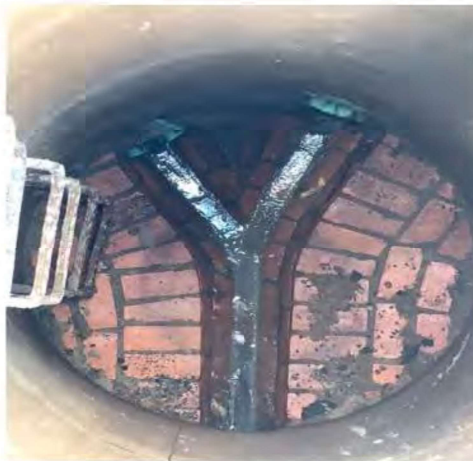
Location in MH	Mtrl. Code	Infil. Code	Cond. Code	Repair Codes	Comments
Frame/Cover	CAST IRON	NONE	CORRODED	REPLACE FRAME AND COVER	
Chimney	BRICK	NONE	SOUND	NONE	
Cone	CONCRETE (PRECAST)	NONE	SOUND	NONE	
Wall	CONCRETE (PRECAST)	NONE	SOUND	NONE	
Bench	BRICK	NONE	SOUND	NONE	
Invert/Channel	BRICK	NONE	SOUND	NONE

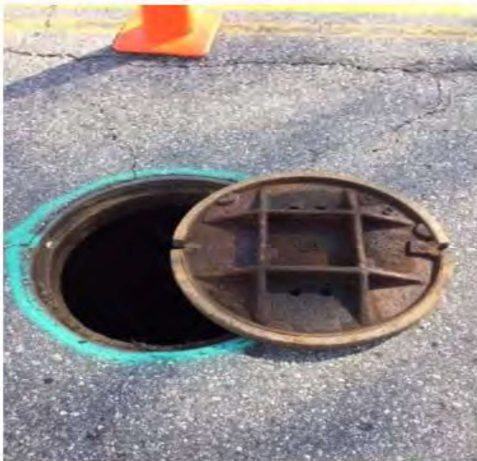
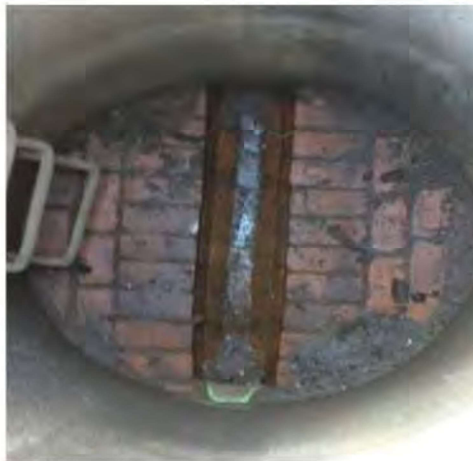
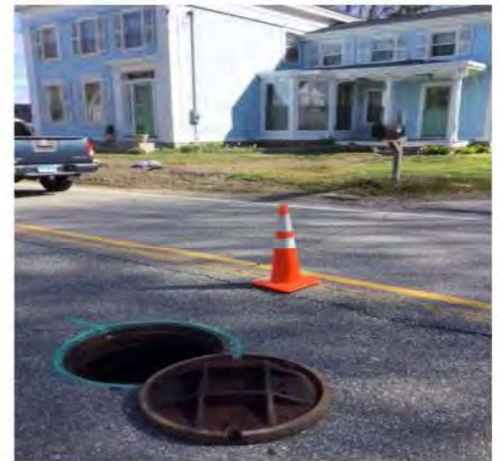
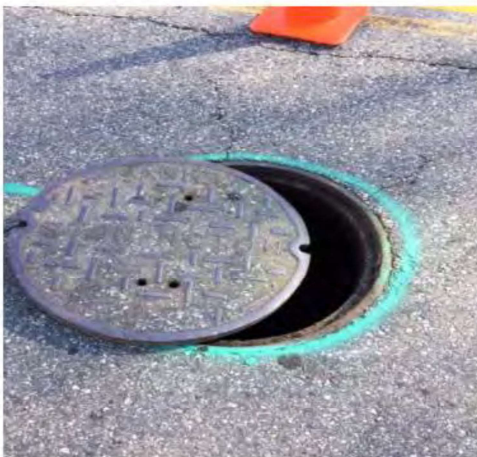
Location in MH	Mtrl. Code	Infil. Code	Cond. Code	Repair Codes	Comments
Frame/Cover	CAST IRON	NONE	SOUND	NONE	
Chimney	BRICK	NONE	SOUND	NONE	
Cone	OTHER (DESCRIBE IN DETAILS)	NONE	SOUND	NONE	NO CONE
Wall	CONCRETE (PRECAST)	NONE	SOUND	NONE	
Bench	BRICK	NONE	SOUND	NONE	
Invert/Channel	BRICK	NONE	SOUND	NONE

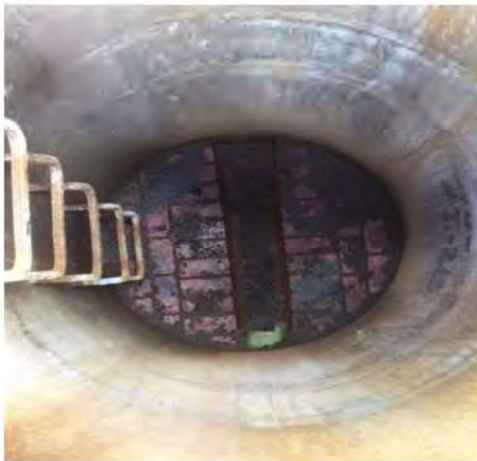
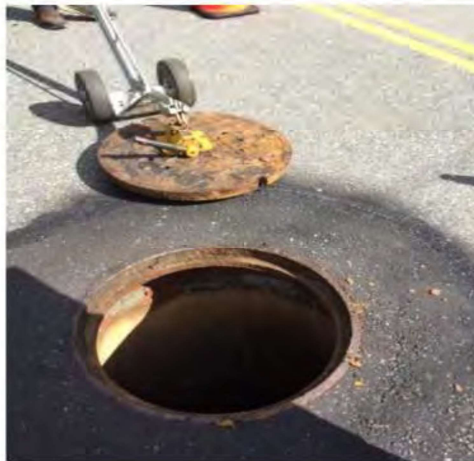
Location in MH	Mtrl. Code	Infil. Code	Cond. Code	Repair Codes	Comments
Frame/Cover	CAST IRON	NONE	CORRODED	REPLACE FRAME AND COVER	
Chimney	BRICK	NONE	SOUND	NONE	
Cone	CONCRETE (PRECAST)	NONE	SOUND	NONE	
Wall	CONCRETE (PRECAST)	NONE	SOUND	NONE	
Bench	BRICK	NONE	SOUND	NONE	
Invert/Channel	BRICK	NONE	SOUND	NONE

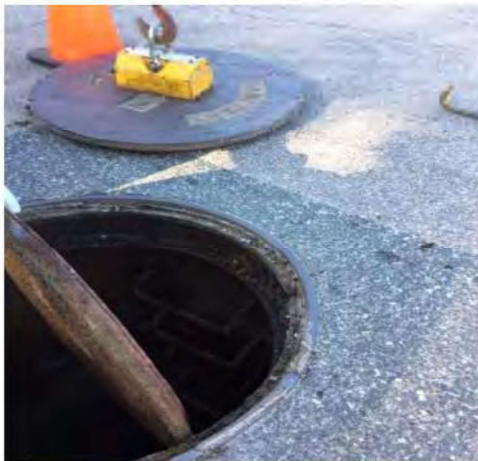
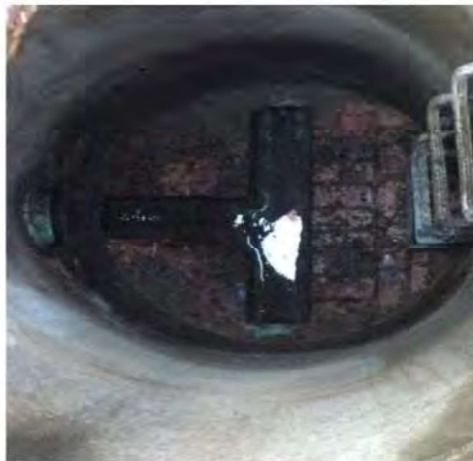
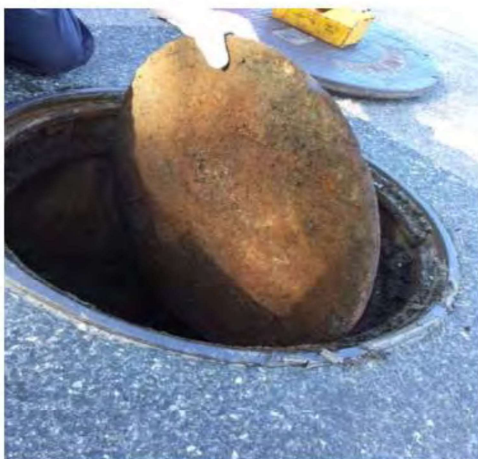
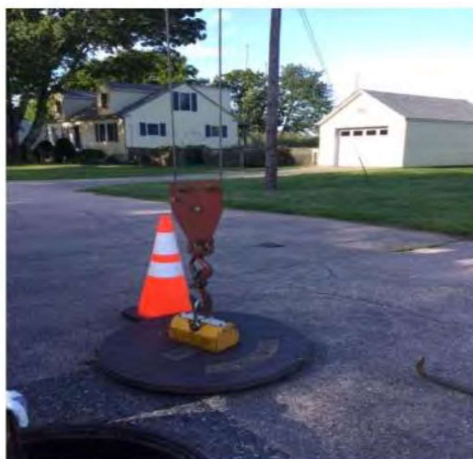
Location in MH	Mtrl. Code	Infil. Code	Cond. Code	Repair Codes	Comments
Frame/Cover	CAST IRON	NONE	SOUND	OTHER	WATER TIGHT COVER NEEDS TO BE REPLACED, NO HANDLES
Chimney	OTHER (DESCRIBE IN DETAILS)	NONE	SOUND	NONE	NO CHIMNEY
Cone	CONCRETE (PRECAST)	NONE	SOUND	NONE	
Wall	CONCRETE (PRECAST)	STAINS	SOUND	NONE	
Bench	BRICK	NONE	SOUND	NONE	
Invert/Channel	BRICK	NONE	SOUND	NONE

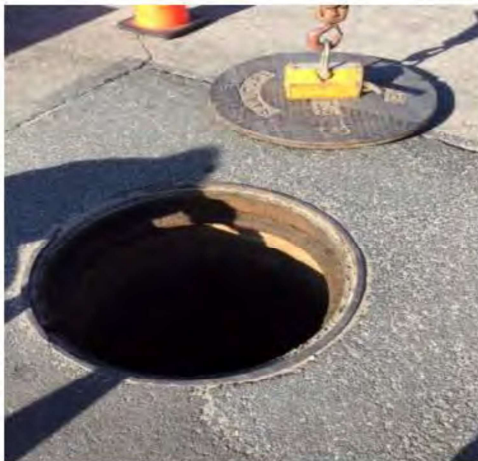
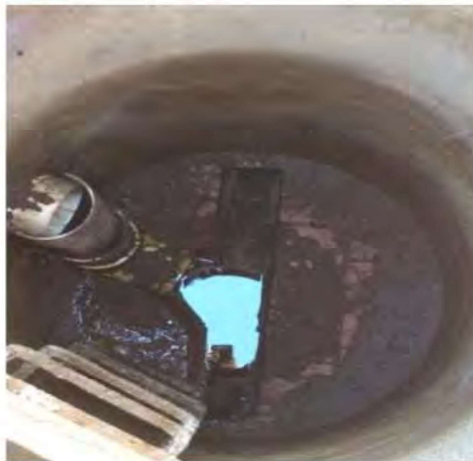
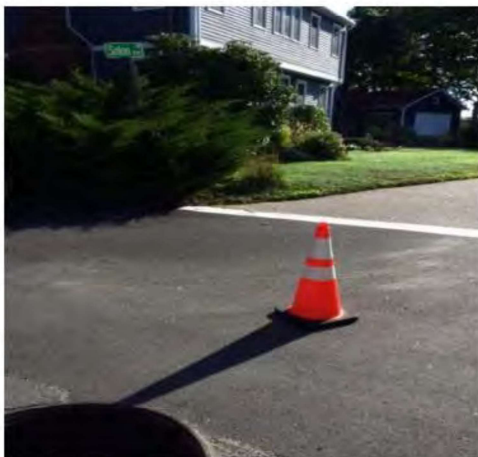
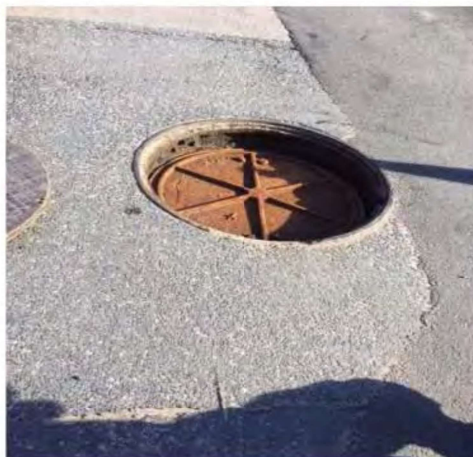
Inspection Photos

Location in MH	Mtrl. Code	Infil. Code	Cond. Code	Repair Codes	Comments
Frame/Cover	CAST IRON	NONE	BROKEN	REPLACE FRAME AND COVER	FRAME NEEDS TO BE REPLACED, ALSO WATER TIGHT COVER NEEDS TO BE REPLACED, NO HANDLES BRICK AND CONCRETE
Chimney	BRICK	NONE	SOUND	NONE	
Cone	CONCRETE (PRECAST)	NONE	SOUND	NONE	
Wall	CONCRETE (PRECAST)	NONE	SOUND	NONE	
Bench	BRICK	NONE	SOUND	NONE	
Invert/Channel	BRICK	NONE	SOUND	NONE

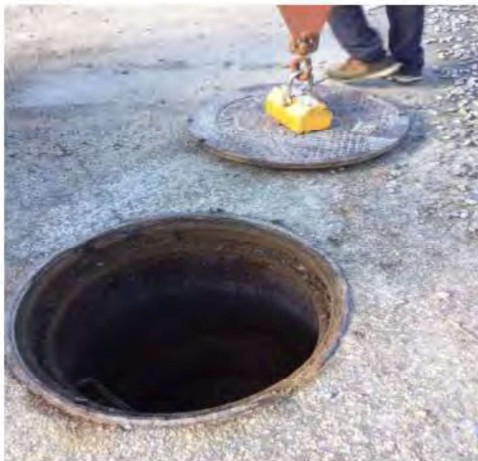
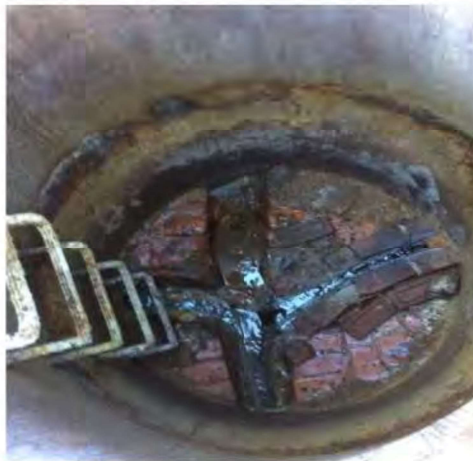
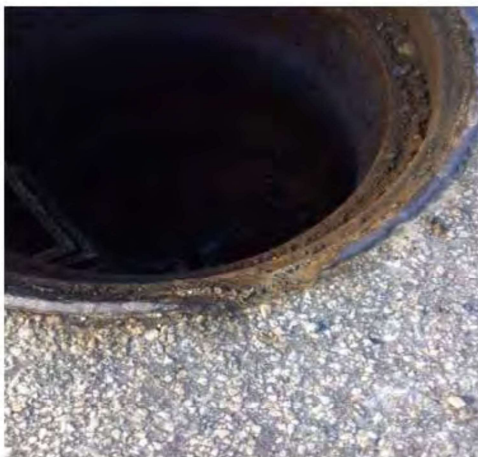
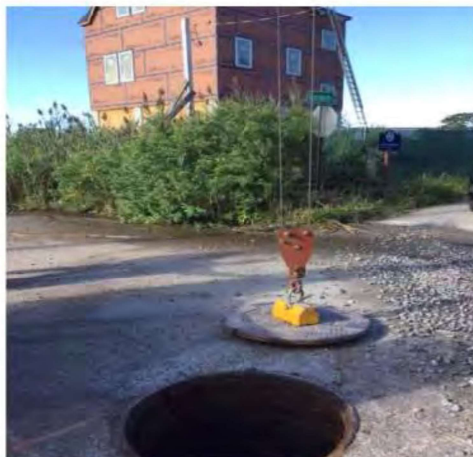
Inspection Photos

Location in MH	Mtrl. Code	Infil. Code	Cond. Code	Repair Codes	Comments
Frame/Cover	CAST IRON	WEEPER	BROKEN	REPLACE FRAME AND COVER	REPLACE FRAME AND WATER TIGHT COVER
Chimney	BRICK	NONE	SOUND	NONE	
Cone	CONCRETE (PRECAST)	NONE	SOUND	NONE	
Wall	CONCRETE (PRECAST)	STAINS	DEFECTIVE	LINE_MANHOLE	
Bench	BRICK	NONE	DEFECTIVE	CLEAN	MULTIPLE ADDITIONAL BRICKS
Invert/Channel	BRICK	NONE	SOUND	NONE

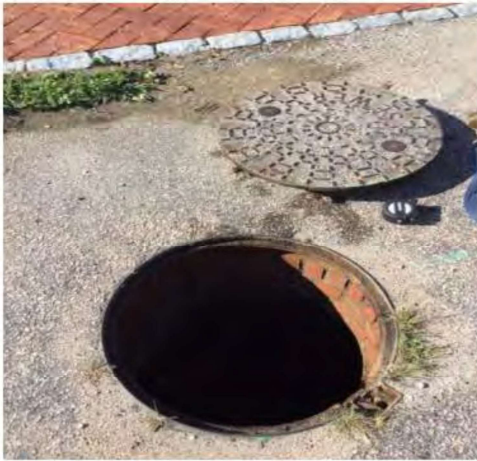
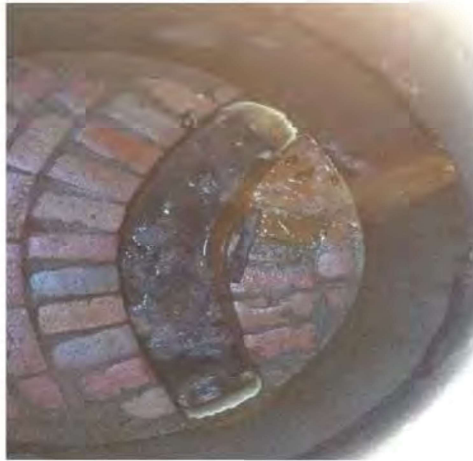
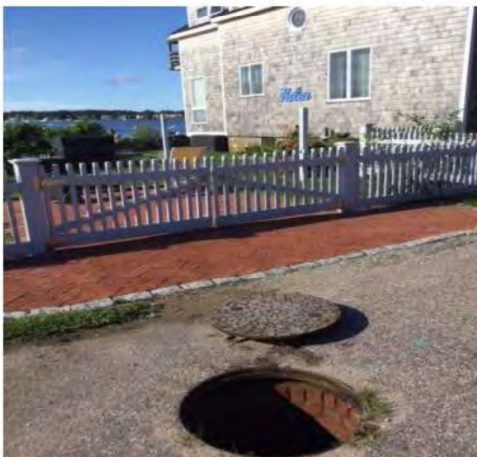
Inspection Photos

Location in MH	Mtrl. Code	Infil. Code	Cond. Code	Repair Codes	Comments
Frame/Cover	CAST IRON	NONE	SOUND	NONE	
Chimney	BRICK	NONE	SOUND	NONE	
Cone	CONCRETE (PRECAST)	NONE	SOUND	NONE	
Wall	CONCRETE (PRECAST)	RUNNER	DEFECTIVE	LINE_MANHOLE	INFILTRATION WHERE WALL MEETS CONE, IN JOINT
Bench	BRICK	NONE	SOUND	NONE	
Invert/Channel	BRICK	NONE	SOUND	NONE

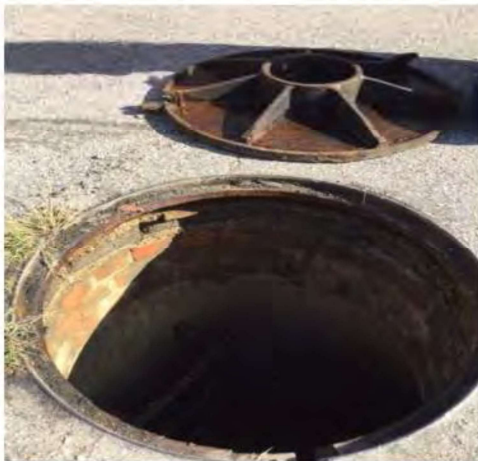
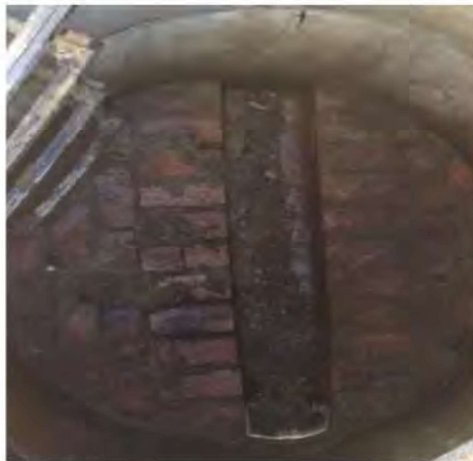
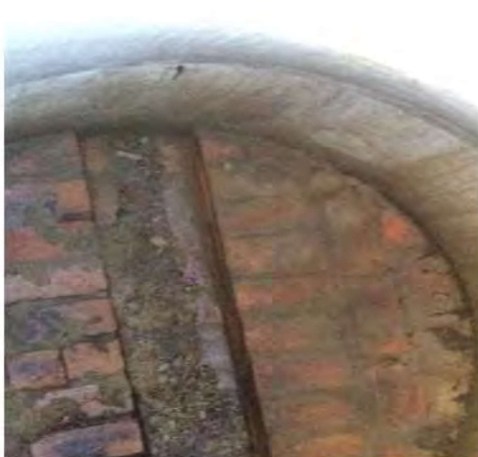
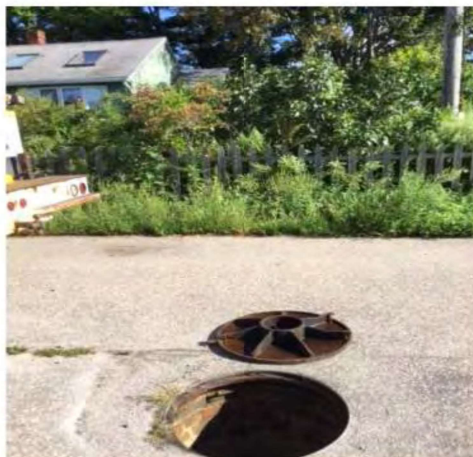
Inspection Photos

Location in MH	Mtrl. Code	Infil. Code	Cond. Code	Repair Codes	Comments
Frame/Cover	CAST IRON	NONE	SOUND	NONE	
Chimney	BRICK	NONE	DEFECTIVE	OTHER	REPLACE PART OF CHIMNEY
Cone	CONCRETE (PRECAST)	NONE	SOUND	NONE	
Wall	CONCRETE (PRECAST)	NONE	SOUND	NONE	
Bench	BRICK	NONE	SOUND	NONE	
Invert/Channel	BRICK	NONE	SOUND	NONE

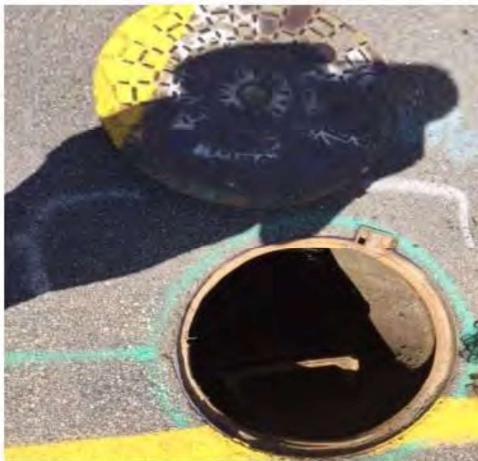
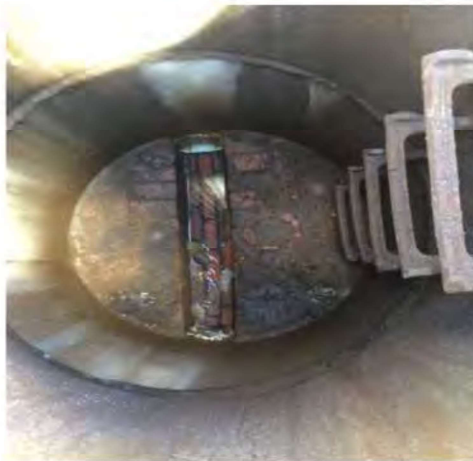
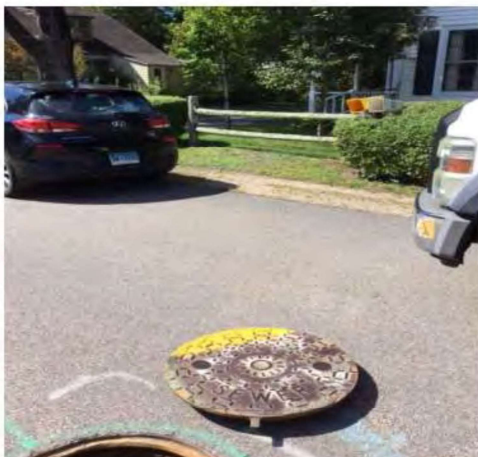
Location in MH	Mtrl. Code	Infil. Code	Cond. Code	Repair Codes	Comments
Frame/Cover	CAST IRON	NONE	BROKEN	REPLACE FRAME AND COVER	SEAL IS COMING OFF FROM FRAME
Chimney	OTHER (DESCRIBE IN DETAILS)	NONE	SOUND	NONE	NO CHIMNEY
Cone	CONCRETE (PRECAST)	NONE	SOUND	NONE	
Wall	CONCRETE (PRECAST)	STAINS	SOUND	NONE	
Bench	BRICK	NONE	SOUND	NONE	
Invert/Channel	BRICK	NONE	SOUND	NONE

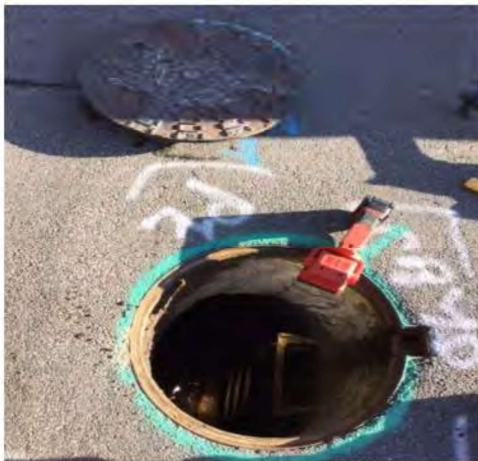
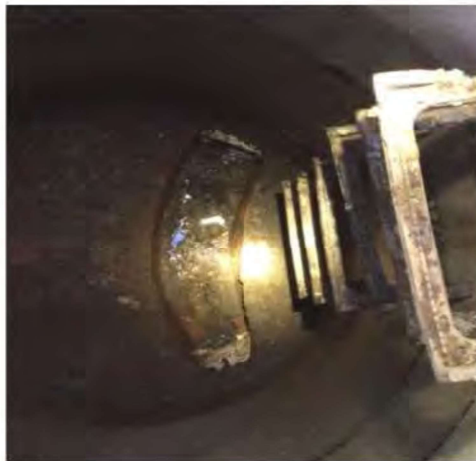
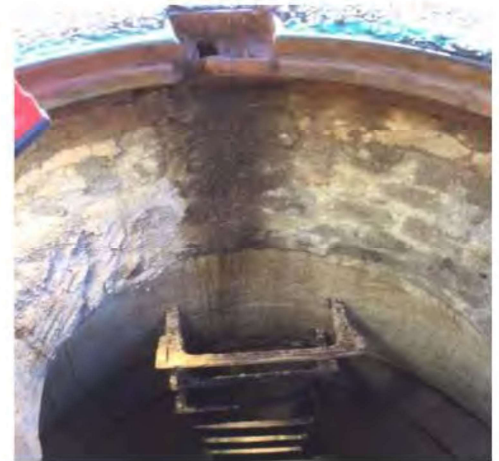
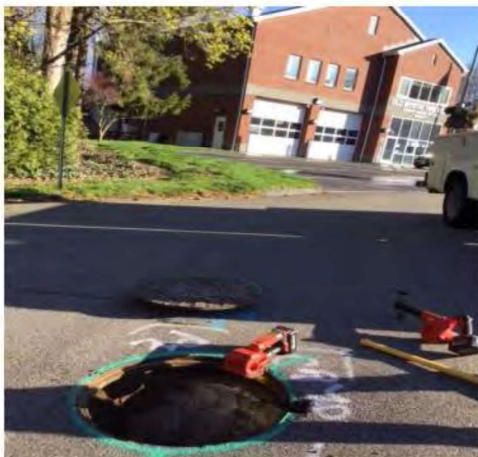
Location in MH	Mtrl. Code	Infil. Code	Cond. Code	Repair Codes	Comments
Frame/Cover	CAST IRON	STAINS	SOUND	NONE	
Chimney	BRICK	NONE	SOUND	SEAL/REPOINT	
Cone	CONCRETE (PRECAST)	NONE	SOUND	NONE	
Wall	CONCRETE (PRECAST)	NONE	SOUND	NONE	
Bench	BRICK	NONE	SOUND	NONE	
Invert/Channel	BRICK	NONE	SOUND	NONE

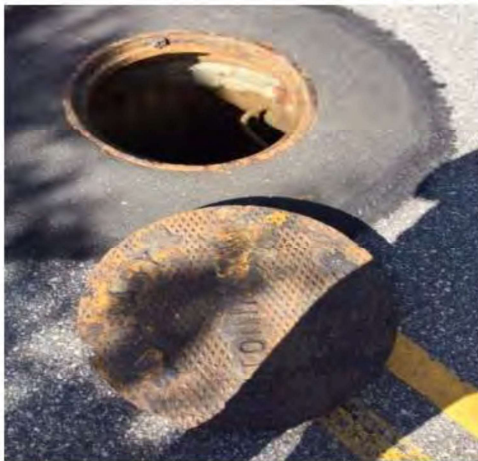
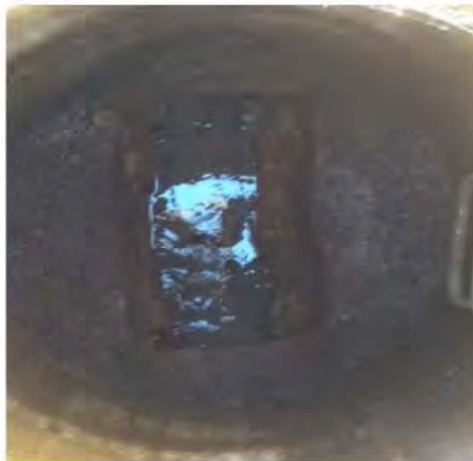
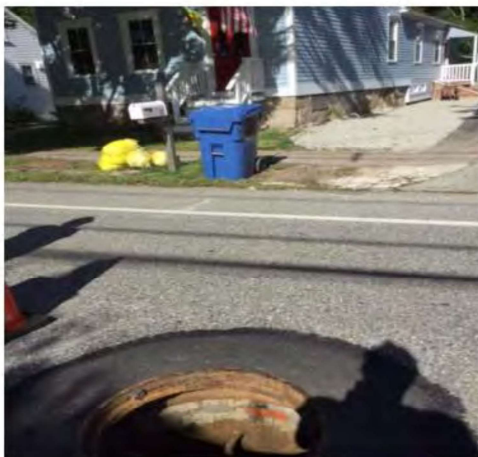
Location in MH	Mtrl. Code	Infil. Code	Cond. Code	Repair Codes	Comments
Frame/Cover	CAST IRON	NONE	BROKEN	REPLACE FRAME AND COVER	
Chimney	OTHER (DESCRIBE IN DETAILS)	NONE	NOT KNOWN	NONE	NO CHIMNEY
Cone	CONCRETE (PRECAST)	NONE	SOUND	NONE	
Wall	CONCRETE (PRECAST)	NONE	SOUND	NONE	
Bench	BRICK	NONE	SOUND	NONE	
Invert/Channel	BRICK	NONE	SOUND	NONE
