CDM  
Smith

## Town of Stonington, Connecticut

### Manhole Inspection Form

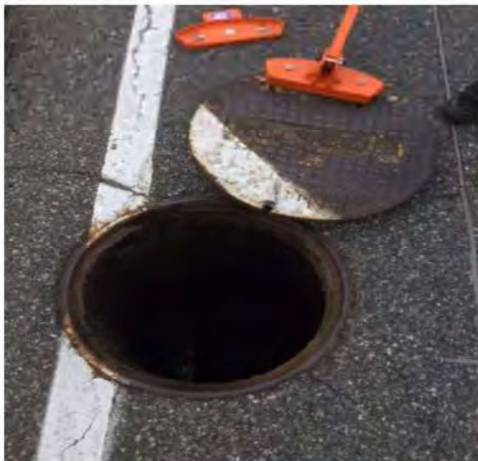
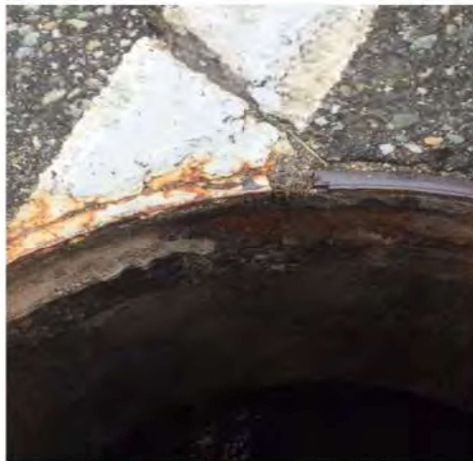
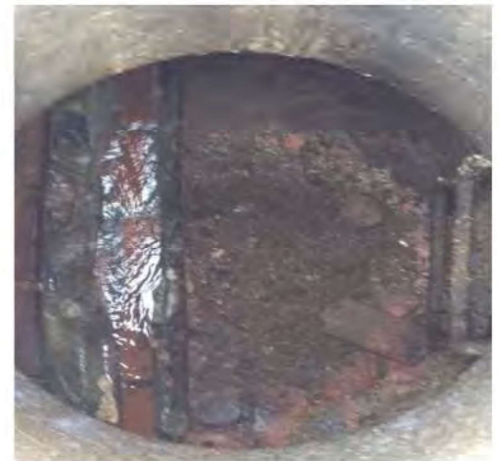
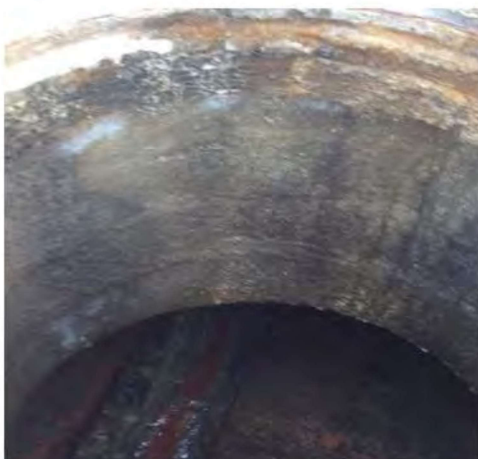
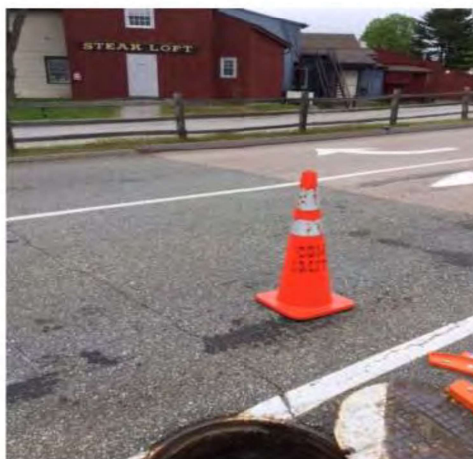
Location in MH	Mtrl. Code	Infil. Code	Cond. Code	Repair Codes	Comments
Frame/Cover	CAST IRON	STAINS	BROKEN	REPLACE FRAME AND COVER	
Chimney	BRICK	NONE	SOUND	NONE	
Cone	CONCRETE (PRECAST)	NONE	SOUND	NONE	
Wall	CONCRETE (PRECAST)	NONE	SOUND	NONE	
Bench	BRICK	NONE	DEFECTIVE	OTHER	REPAIR BENCH, BRICKS STARTING TO BE DISPLACED
Invert/Channel	BRICK	NONE	SOUND	NONE

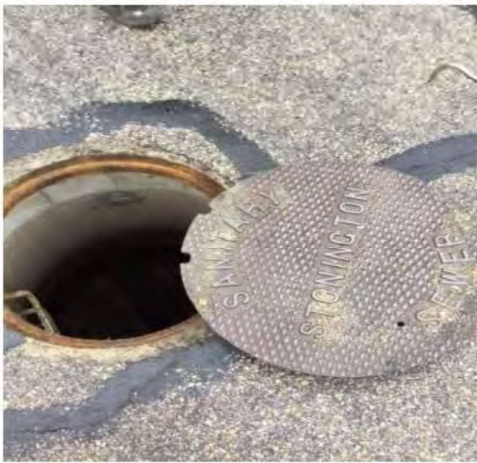
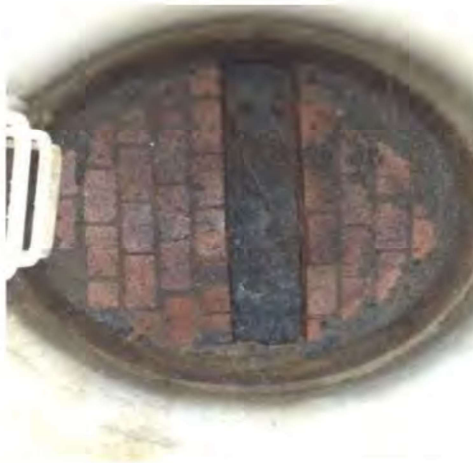
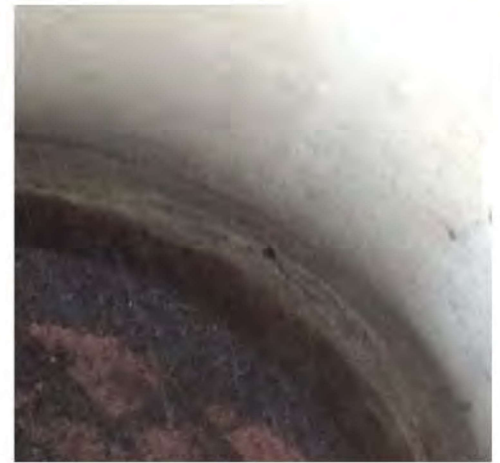
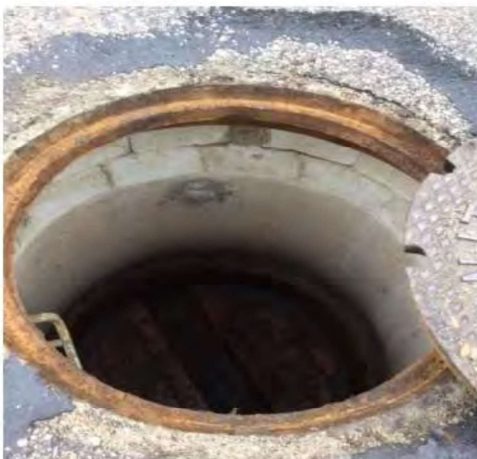
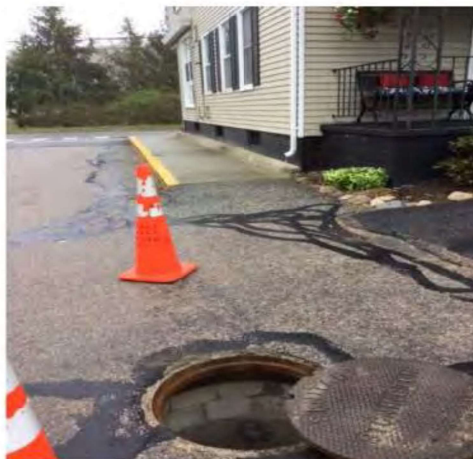
Location in MH	Mtrl. Code	Infil. Code	Cond. Code	Repair Codes	Comments
Frame/Cover	CAST IRON	NONE	SOUND	NONE	
Chimney	CONCRETE BLOCK	NONE	SOUND	NONE	
Cone	CONCRETE (PRECAST)	NONE	SOUND	NONE	
Wall	CONCRETE (PRECAST)	STAINS	DEFECTIVE	LINE_MANHOLE	CRACK IN WALL AT 3:00
Bench	BRICK	NONE	SOUND	NONE	
Invert/Channel	BRICK	NONE	SOUND	NONE

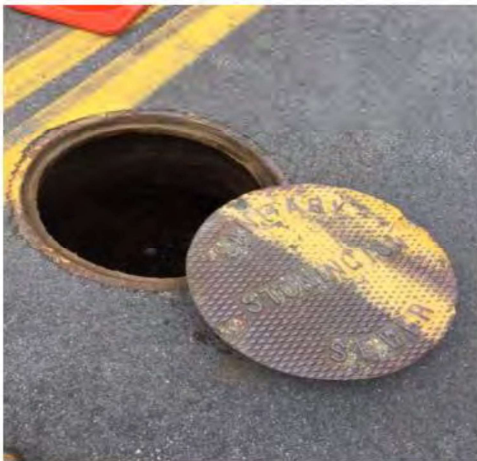
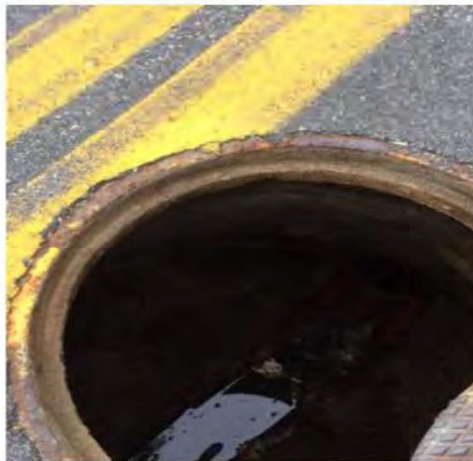
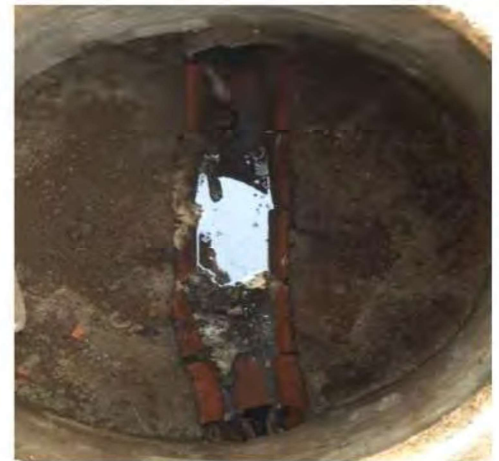
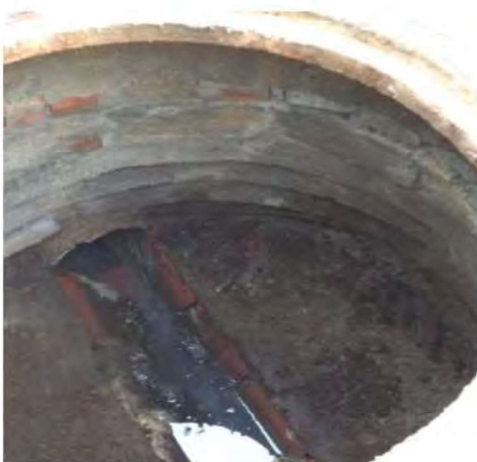
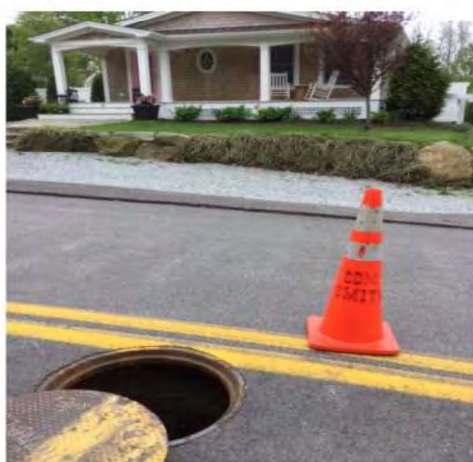
Location in MH	Mtrl. Code	Infil. Code	Cond. Code	Repair Codes	Comments
Frame/Cover	CAST IRON	STAINS	SOUND	NONE	
Chimney	BRICK	NONE	DEFECTIVE	REBUILD TOP, REPLACE FRAME AND CHIMNEY	REBUILD CHIMNEY, MATERIAL STARTING TO BE DISPLACED
Cone	CONCRETE (PRECAST)	NONE	SOUND	NONE	
Wall	CONCRETE (PRECAST)	NONE	SOUND	NONE	
Bench	BRICK	NONE	SOUND	NONE	
Invert/Channel	BRICK	NONE	DEFECTIVE	CLEAN	BRICK AND DEBRIS IN CHANNEL COULD BLOCK FLOW

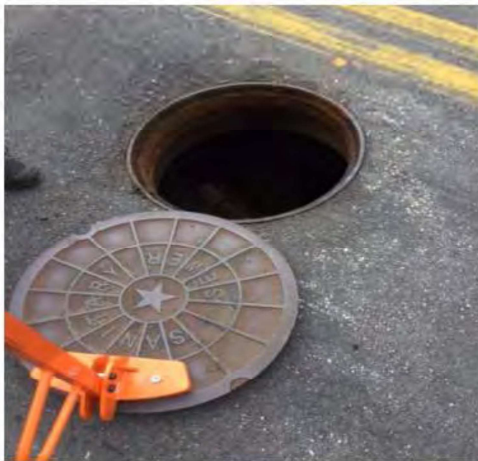
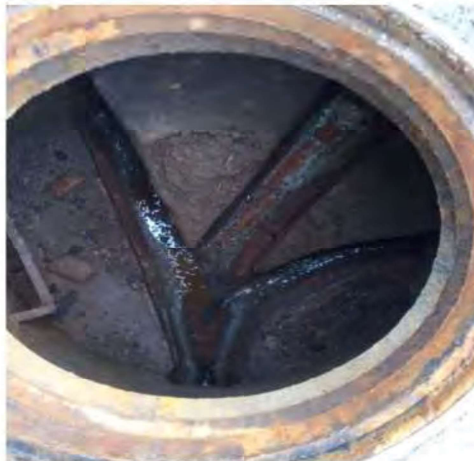
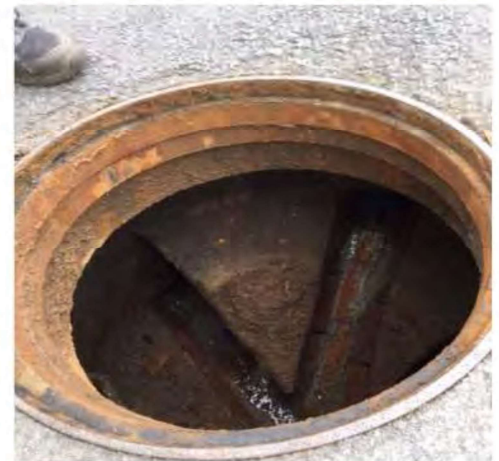
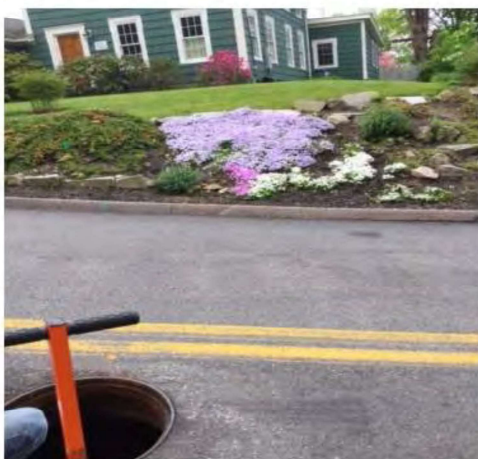
Location in MH	Mtrl. Code	Infil. Code	Cond. Code	Repair Codes	Comments
Frame/Cover	CAST IRON	NONE	CORRODED	REPLACE FRAME AND COVER	
Chimney	BRICK	NONE	SOUND	NONE	
Cone	CONCRETE BLOCK	NONE	SOUND	NONE	
Wall	CONCRETE BLOCK	NONE	SOUND	NONE	
Bench	BRICK	NONE	SOUND	CLEAN	LOTS OF SEDIMENT
Invert/Channel	BRICK	NONE	SOUND	CLEAN

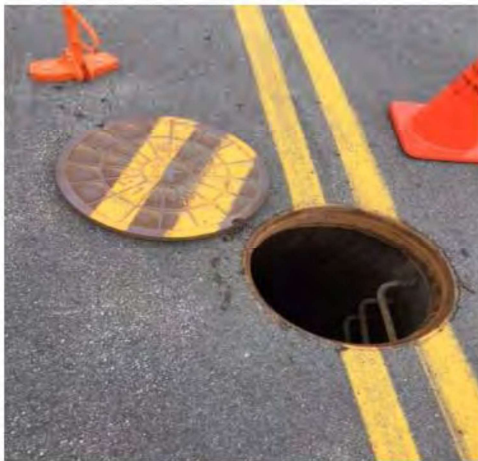
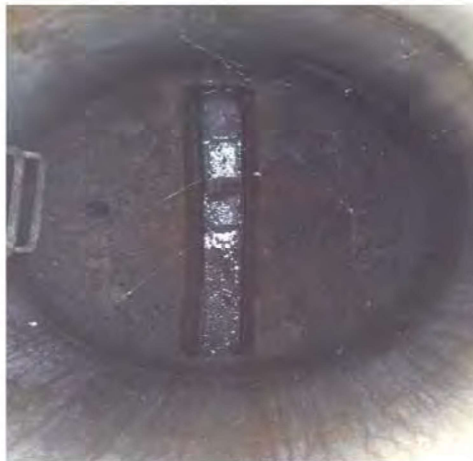
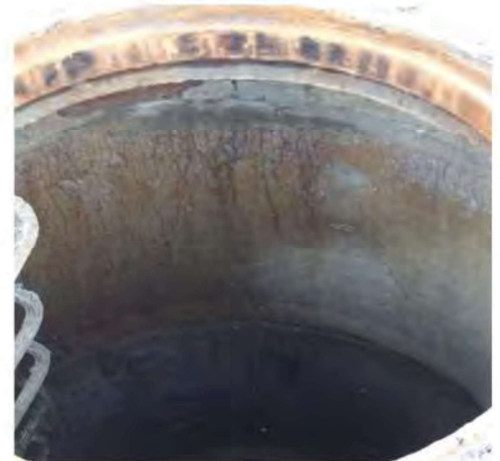
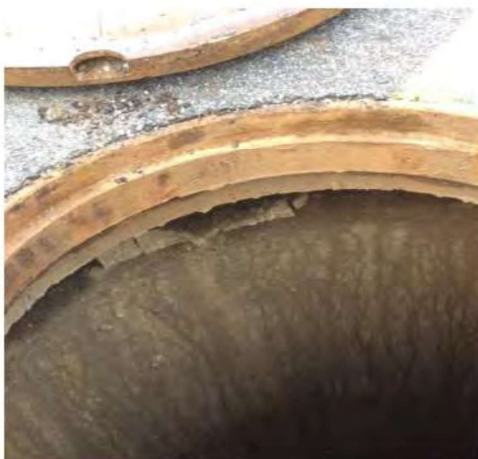
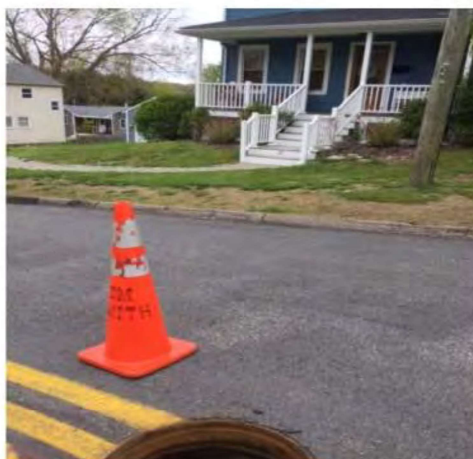
Location in MH	Mtrl. Code	Infil. Code	Cond. Code	Repair Codes	Comments
Frame/Cover	CAST IRON	WEEPER	SOUND	NONE	
Chimney	BRICK	NONE	DEFECTIVE	REBUILD TOP, REPLACE FRAME AND CHIMNEY	MATERIAL DEGRADING/COMING OUT FROM CHIMNEY
Cone	CONCRETE (PRECAST)	NONE	SOUND	NONE	
Wall	CONCRETE (PRECAST)	NONE	SOUND	NONE	
Bench	BRICK	NONE	SOUND	NONE	
Invert/Channel	BRICK	NONE	SOUND	NONE

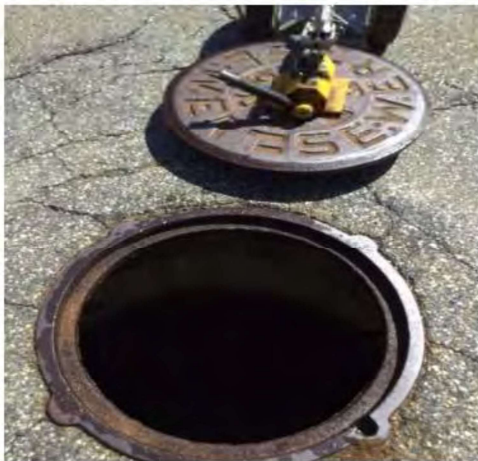
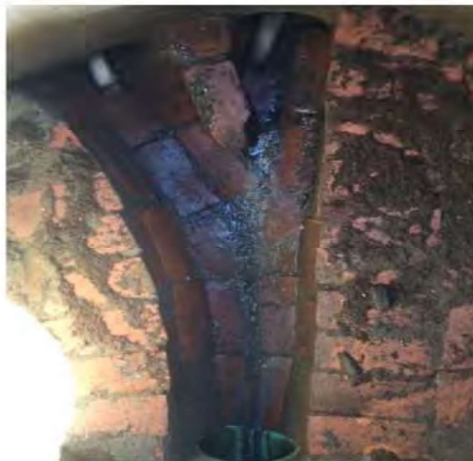
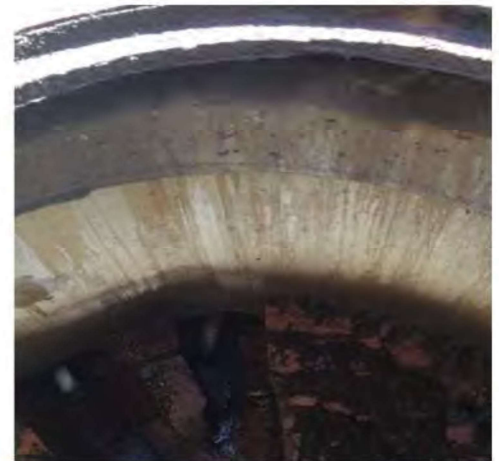
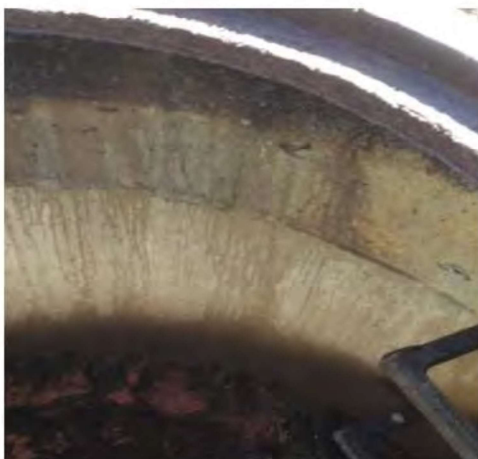
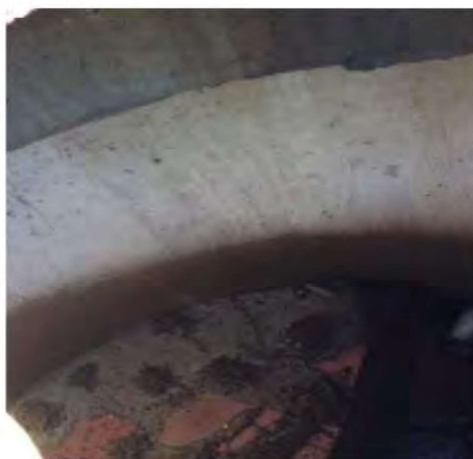
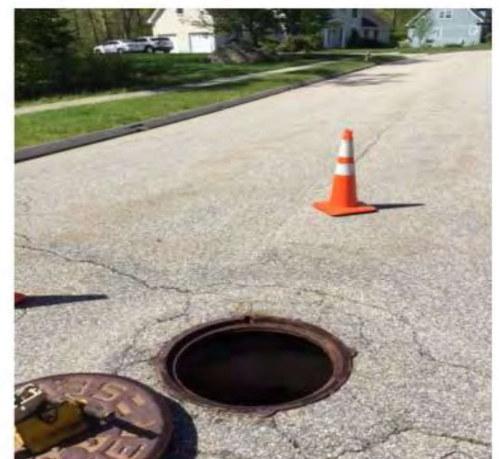
Location in MH	Mtrl. Code	Infil. Code	Cond. Code	Repair Codes	Comments
Frame/Cover	CAST IRON	WEEPER	SOUND	REPLACE FRAME AND COVER	
Chimney	CONCRETE (PRECAST)	NONE	SOUND	NONE	
Cone	CONCRETE (PRECAST)	NONE	SOUND	NONE	
Wall	CONCRETE (PRECAST)	NONE	SOUND	NONE	
Bench	BRICK	NONE	SOUND	NONE	
Invert/Channel	BRICK	NONE	SOUND	NONE

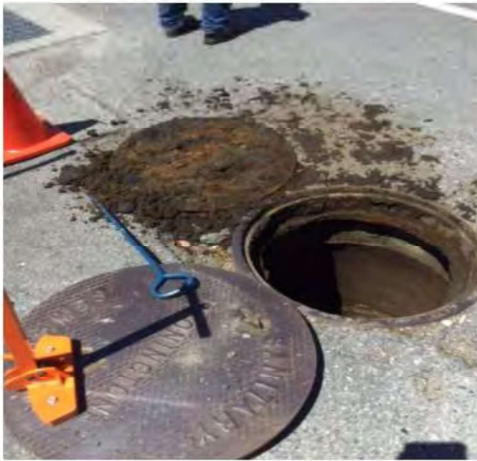
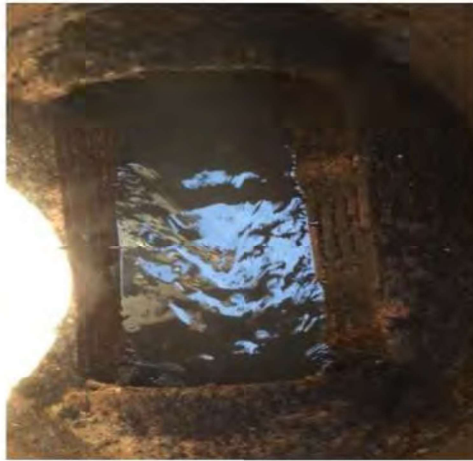
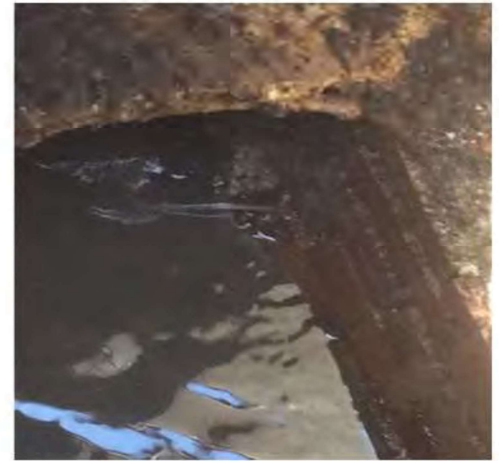
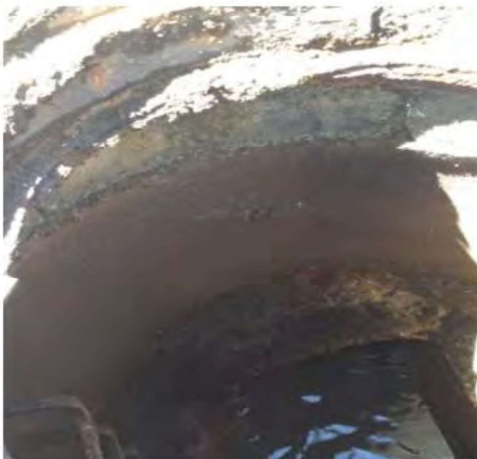
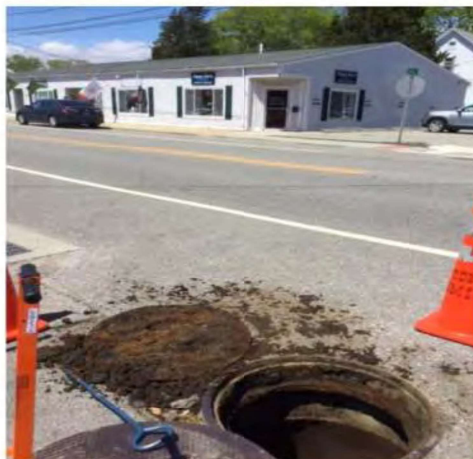
Location in MH	Mtrl. Code	Infil. Code	Cond. Code	Repair Codes	Comments
Frame/Cover	CAST IRON	NONE	SOUND	REPLACE FRAME AND COVER	
Chimney	CONCRETE BLOCK	NONE	SOUND	NONE	
Cone	CONCRETE (PRECAST)	NONE	SOUND	NONE	
Wall	CONCRETE (PRECAST)	NONE	SOUND	NONE	
Bench	BRICK	NONE	SOUND	NONE	
Invert/Channel	BRICK	NONE	SOUND	NONE

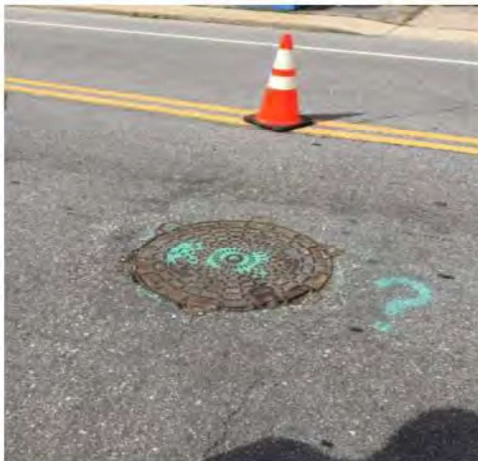
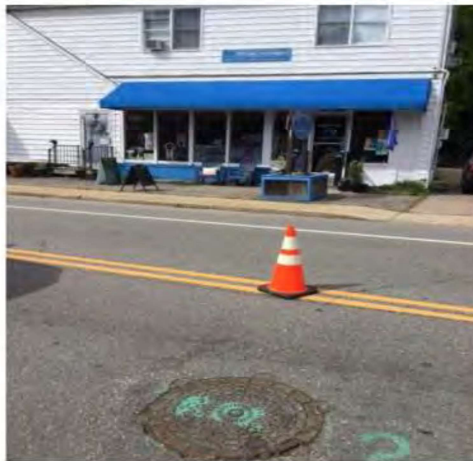
Location in MH	Mtrl. Code	Infil. Code	Cond. Code	Repair Codes	Comments
Frame/Cover	CAST IRON	NONE	SOUND	REPLACE FRAME AND COVER	REPLACE COVER, HANDLES ARE BROKEN
Chimney	CONCRETE BLOCK	NONE	SOUND	NONE	
Cone	CONCRETE (PRECAST)	NONE	SOUND	NONE	
Wall	CONCRETE (PRECAST)	NONE	DEFECTIVE	LINE_MANHOLE	BOTTOM OF WALL IS CORRODED
Bench	BRICK	NONE	SOUND	NONE	
Invert/Channel	BRICK	RUNNER	DEFECTIVE	REPAIR_CHANNEL	RUNNER IN CHANNEL BY OUTLET

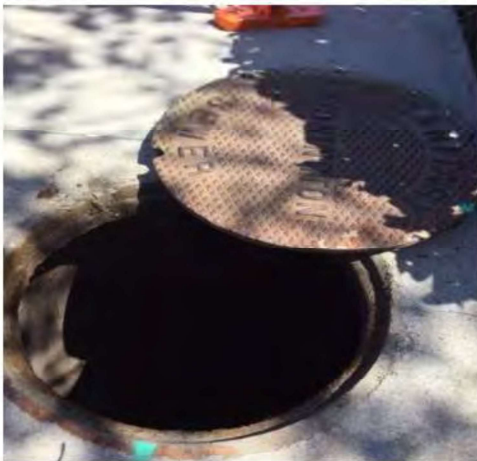
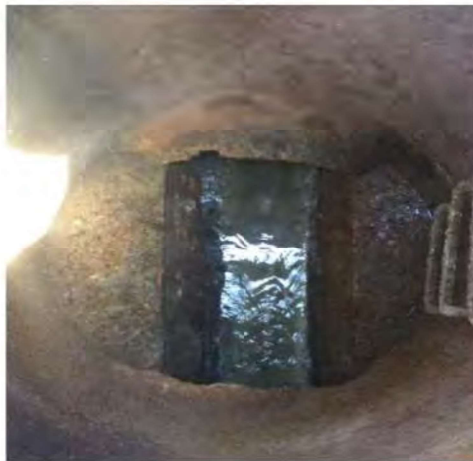
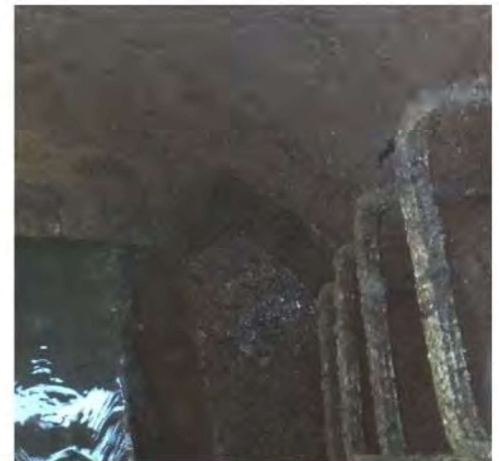
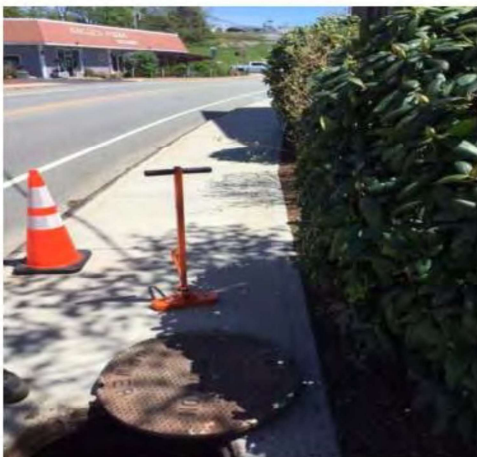
Location in MH	Mtrl. Code	Infil. Code	Cond. Code	Repair Codes	Comments
Frame/Cover	CAST IRON	NONE	SOUND	NONE	
Chimney	BRICK	NONE	SOUND	NONE	BRICK AND CONCRETE BLOCK
Cone	CONCRETE (PRECAST)	NONE	SOUND	NONE	
Wall	BRICK	WEEPER	DEFECTIVE	LINE_MANHOLE	INFILTRATION NEAR 2:00
Bench	BRICK	NONE	SOUND	NONE	
Invert/Channel	BRICK	NONE	SOUND	NONE

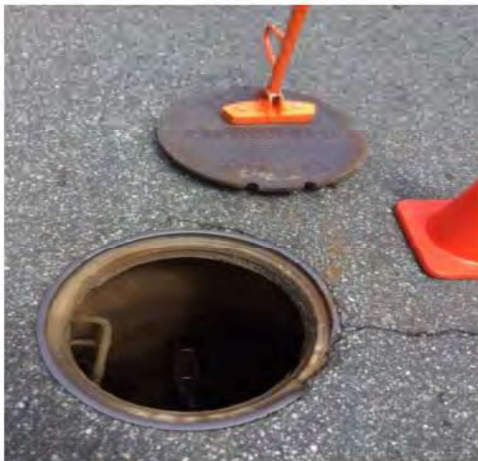
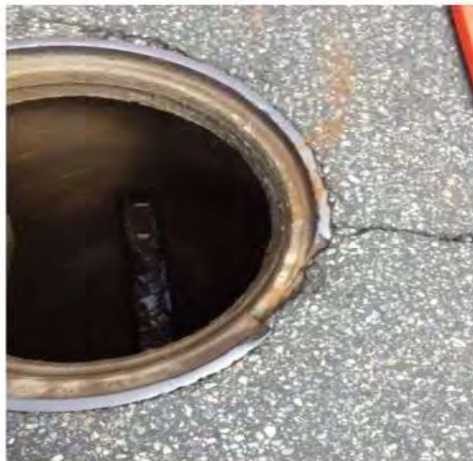
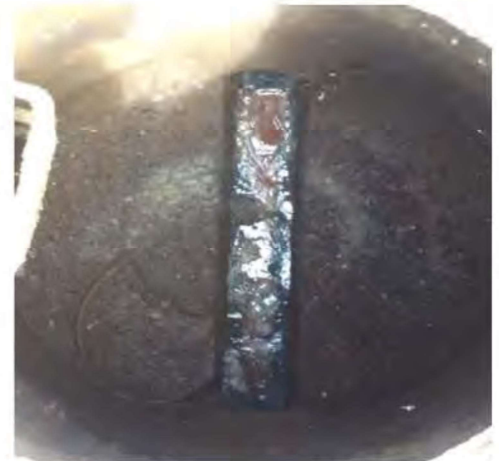
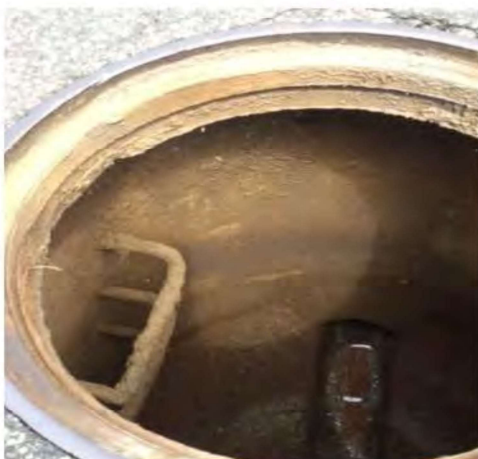
### Inspection Photos

Location in MH	Mtrl. Code	Infil. Code	Cond. Code	Repair Codes	Comments
Frame/Cover	CAST IRON	WEEPER	BROKEN	REPLACE FRAME AND COVER	
Chimney	BRICK	NONE	SOUND	NONE	
Cone	CONCRETE (PRECAST)	NONE	SOUND	NONE	
Wall	CONCRETE (PRECAST)	NONE	SOUND	NONE	
Bench	BRICK	NONE	SOUND	NONE	
Invert/Channel	BRICK	NONE	SOUND	NONE

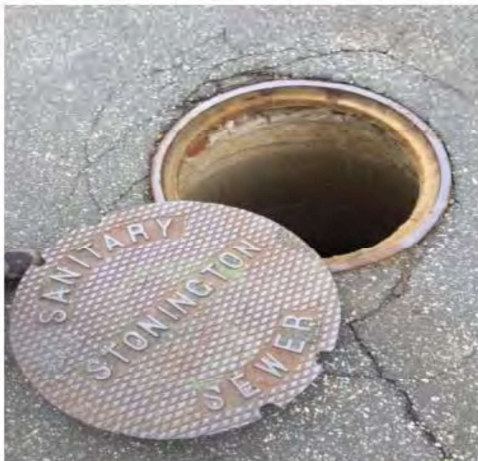
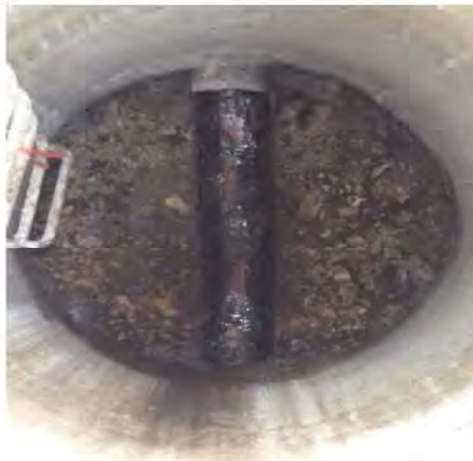
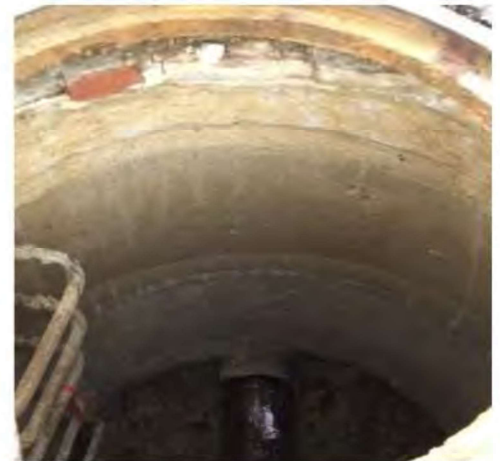
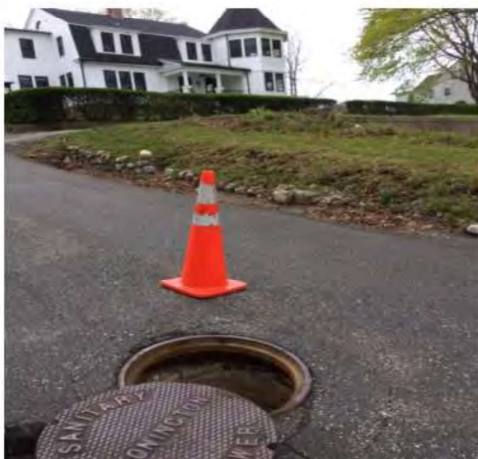
#### Inspection Photos

Location in MH	Mtrl. Code	Infil. Code	Cond. Code	Repair Codes	Comments
Frame/Cover	CAST IRON	NONE	SOUND	NONE	
Chimney	BRICK	NONE	SOUND	NONE	BRICK AND CONCRETE BLOCK
Cone	CONCRETE (PRECAST)	NONE	SOUND	NONE	
Wall	CONCRETE (PRECAST)	NONE	SOUND	NONE	
Bench	BRICK	NONE	SOUND	NONE	
Invert/Channel	BRICK	NONE	SOUND	NONE

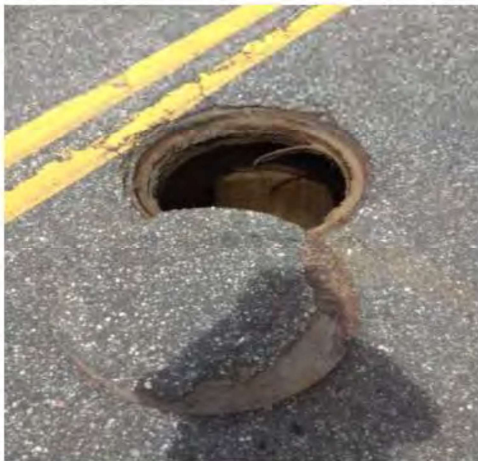
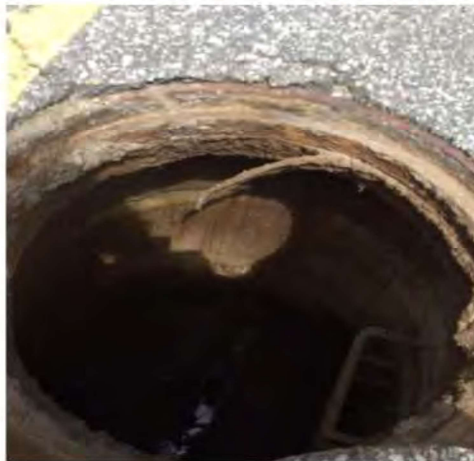
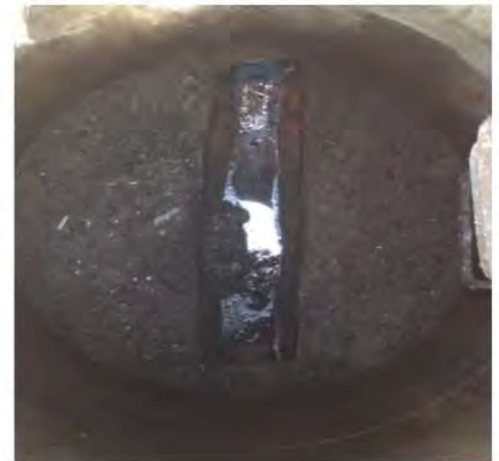
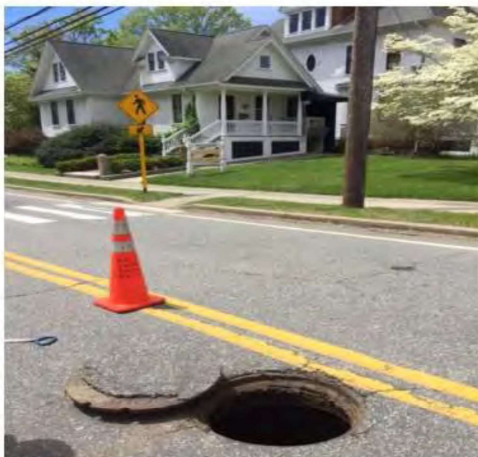
#### Inspection Photos

Location in MH	Mtrl. Code	Infil. Code	Cond. Code	Repair Codes	Comments
Frame/Cover	CAST IRON	WEEPER	BROKEN	REPLACE FRAME AND COVER	
Chimney	BRICK	NONE	SOUND	NONE	
Cone	CONCRETE (PRECAST)	NONE	SOUND	NONE	
Wall	CONCRETE (PRECAST)	NONE	SOUND	NONE	
Bench	BRICK	NONE	SOUND	NONE	
Invert/Channel	BRICK	NONE	SOUND	NONE

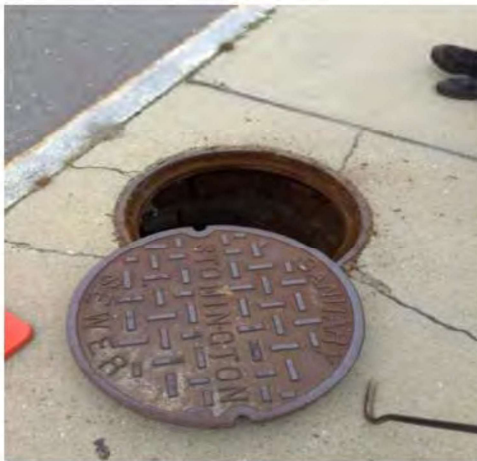
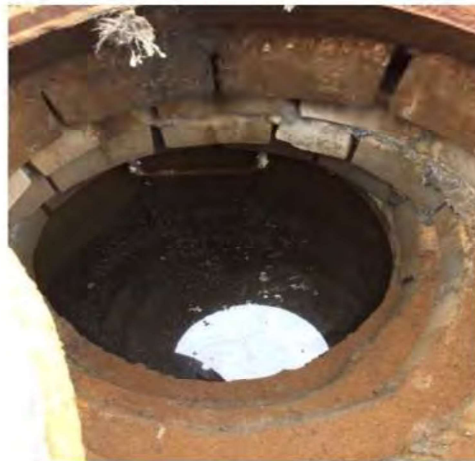
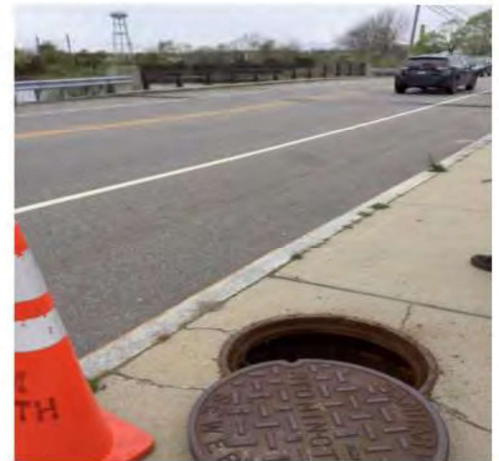
Location in MH	Mtrl. Code	Infil. Code	Cond. Code	Repair Codes	Comments
Frame/Cover	CAST IRON	NONE	SOUND	NONE	
Chimney	CONCRETE BLOCK	NONE	SOUND	NONE	
Cone	CONCRETE BLOCK	NONE	SOUND	NONE	
Wall	CONCRETE (CAST IN PLACE)	NONE	SOUND	NONE	
Bench	BRICK	NONE	SOUND	NONE	
Invert/Channel	BRICK	NONE	SOUND	NONE
