### Mystic Area Dye Water Testing Results

# DYED-WATER FLOODING

STONINGTON, CONNECTICUT 06355

OCTOBER 2022  
MCA PROJECT NO.: 2021-335

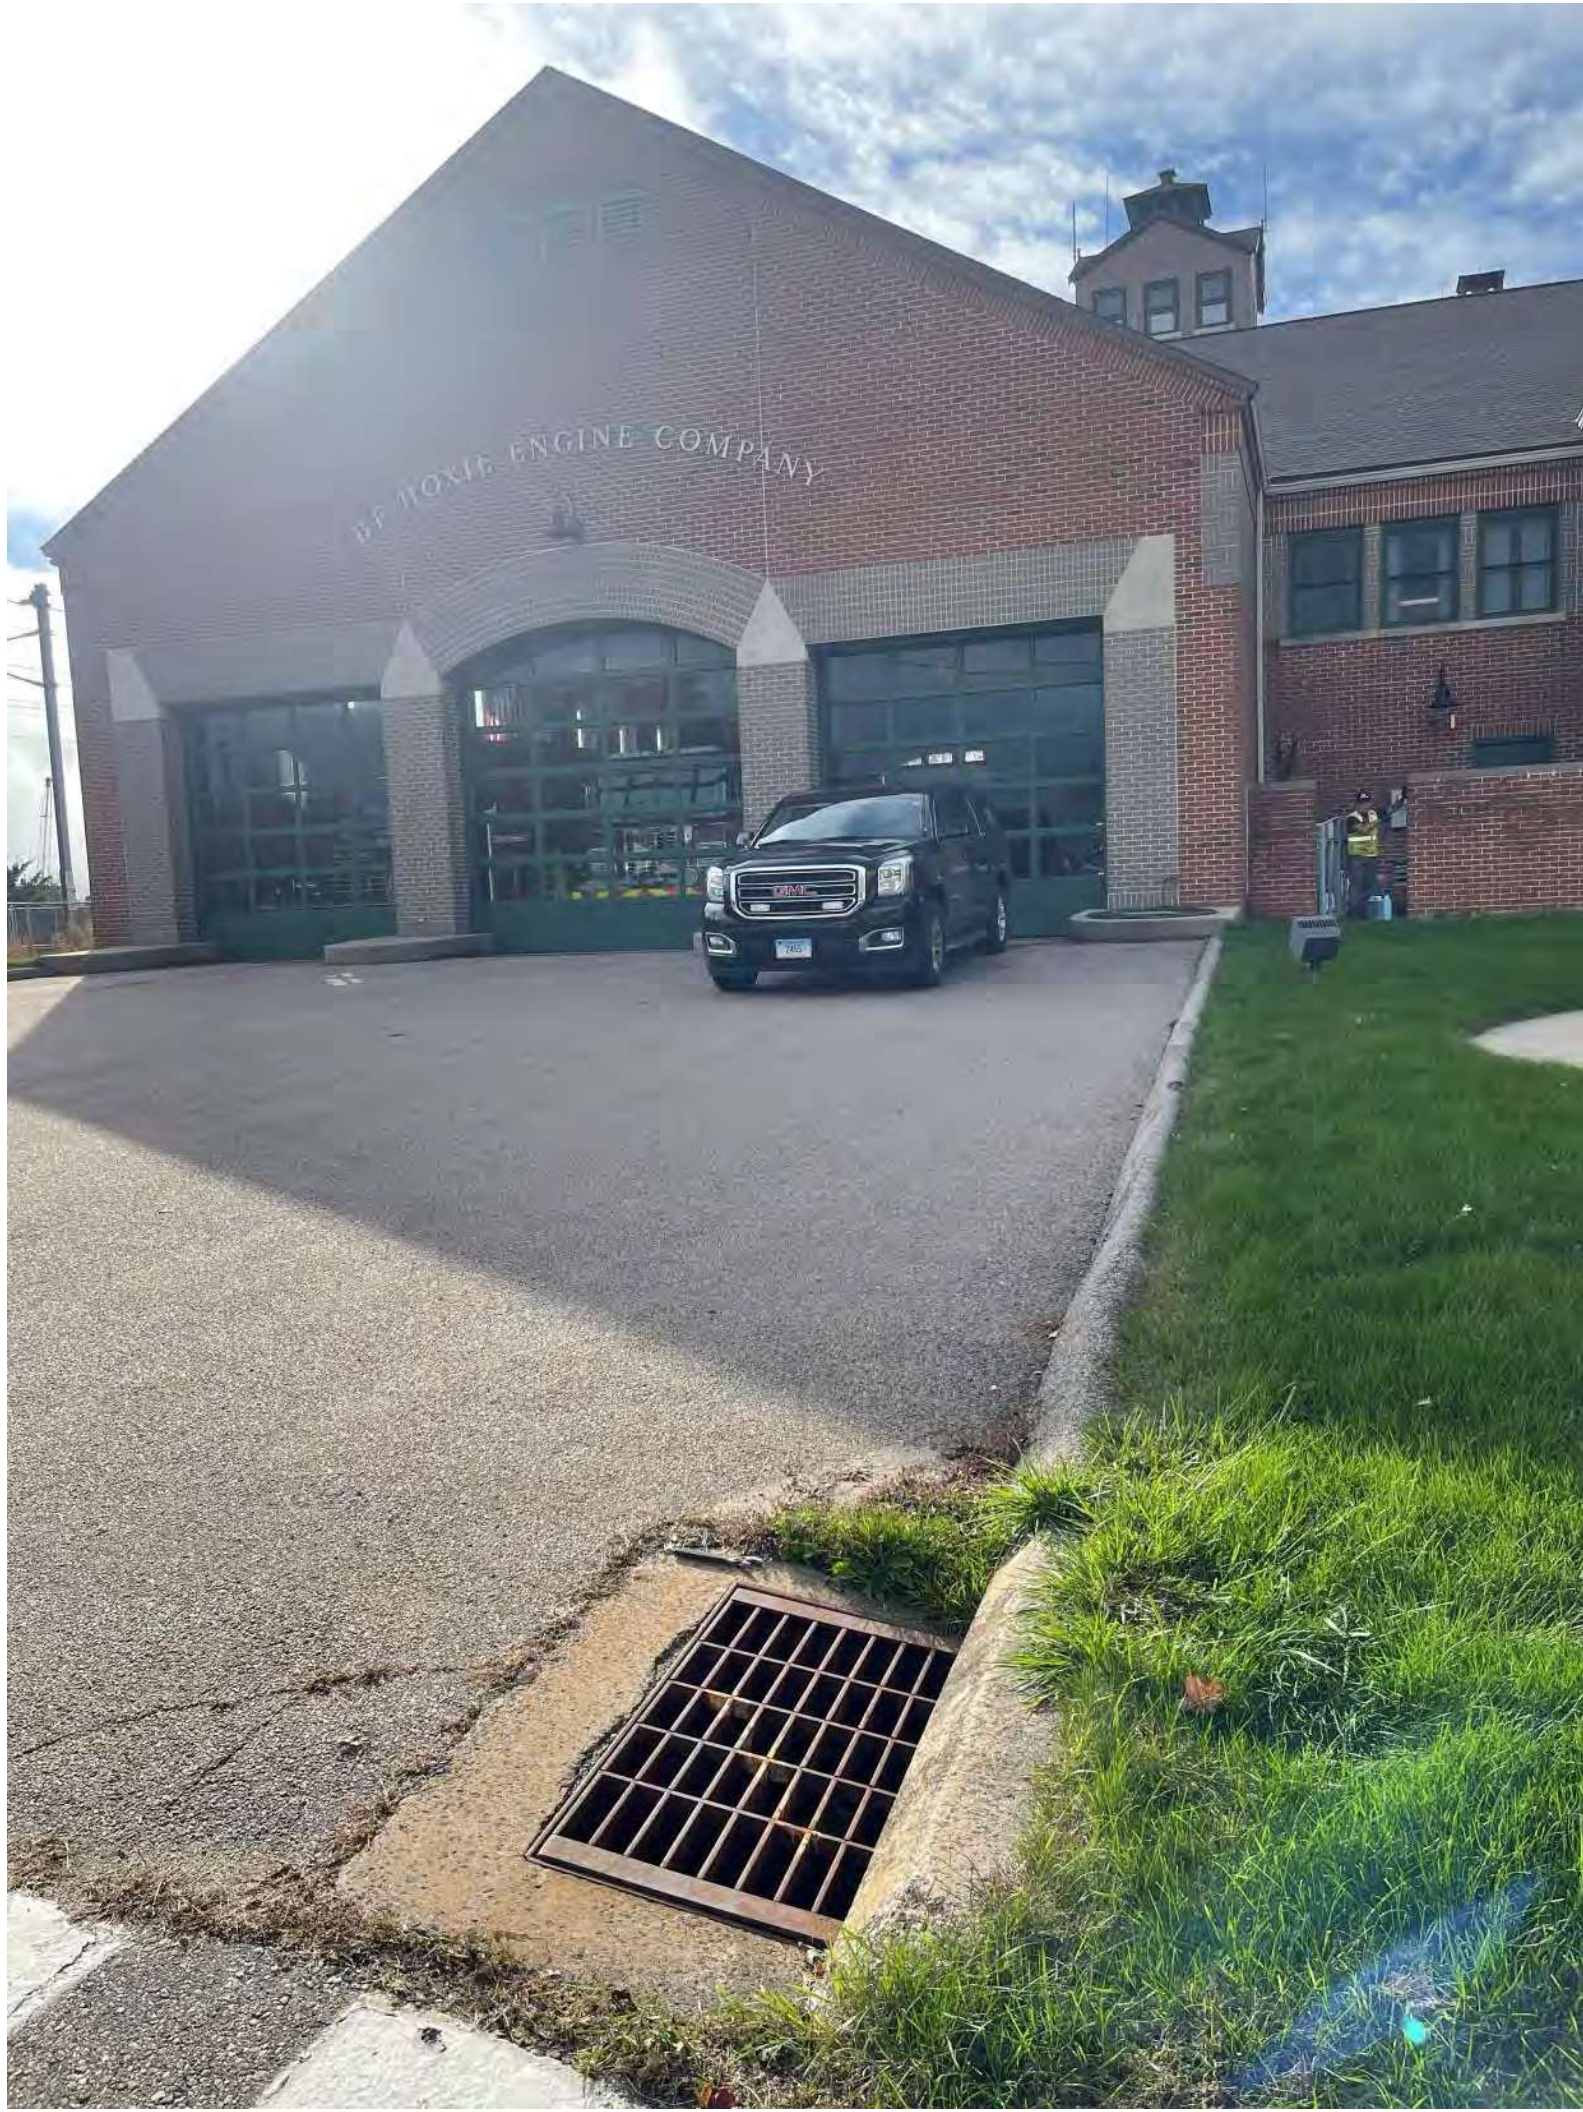
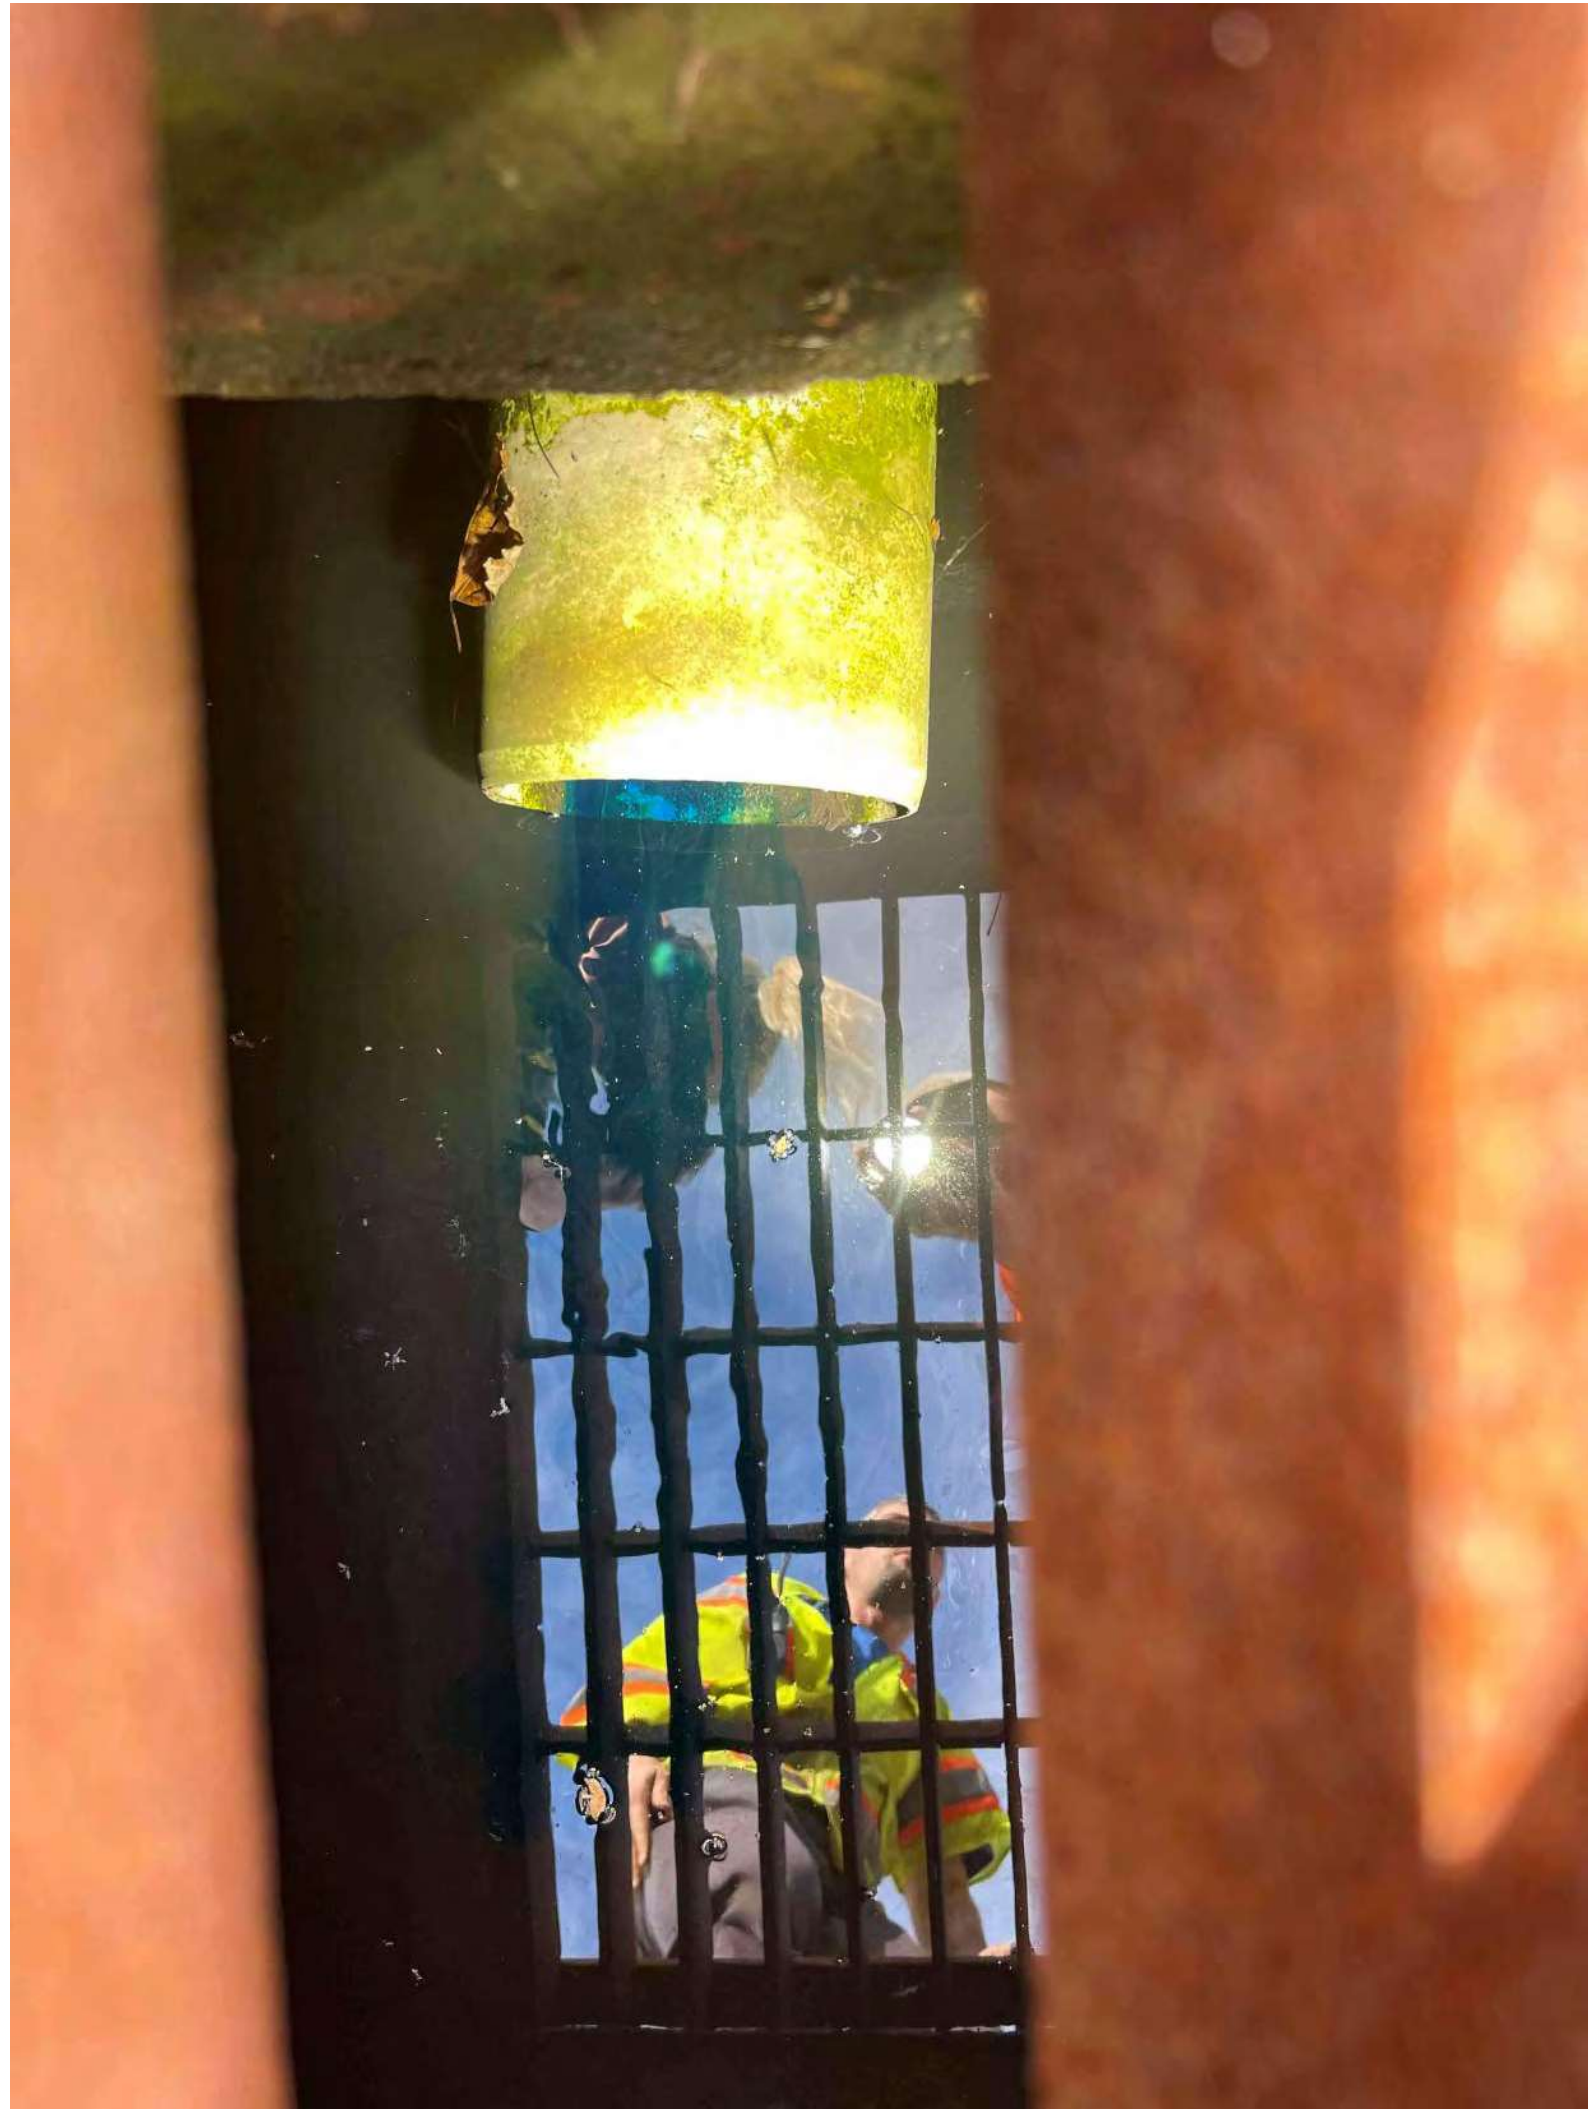
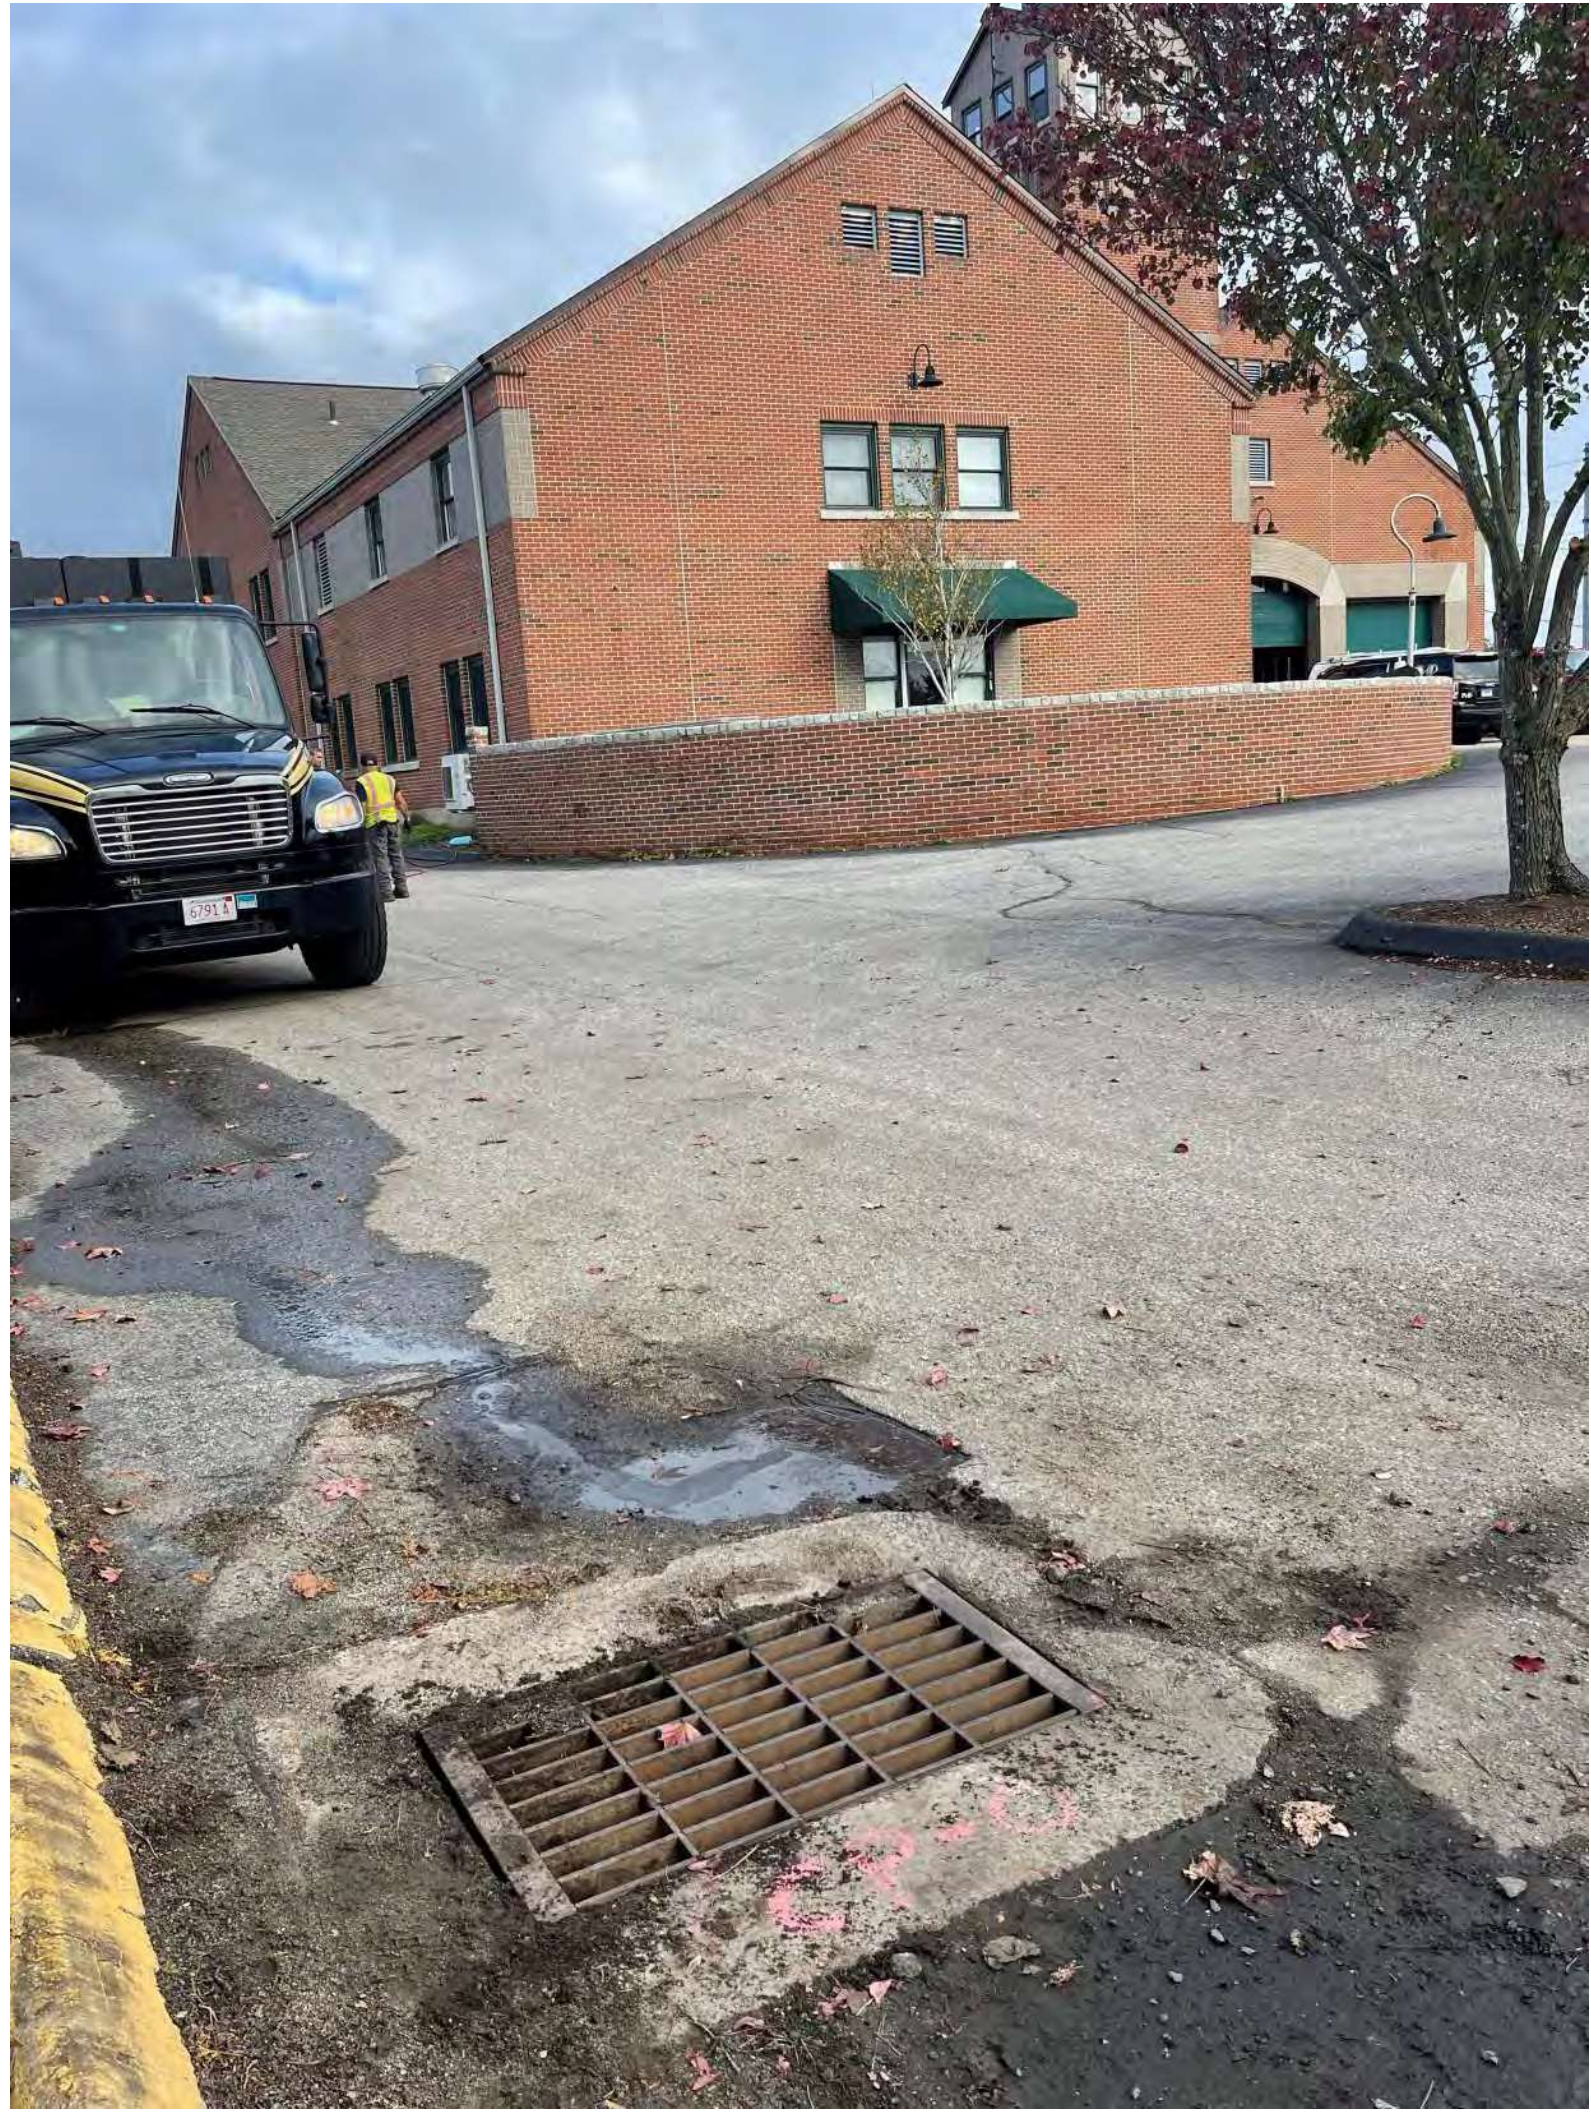
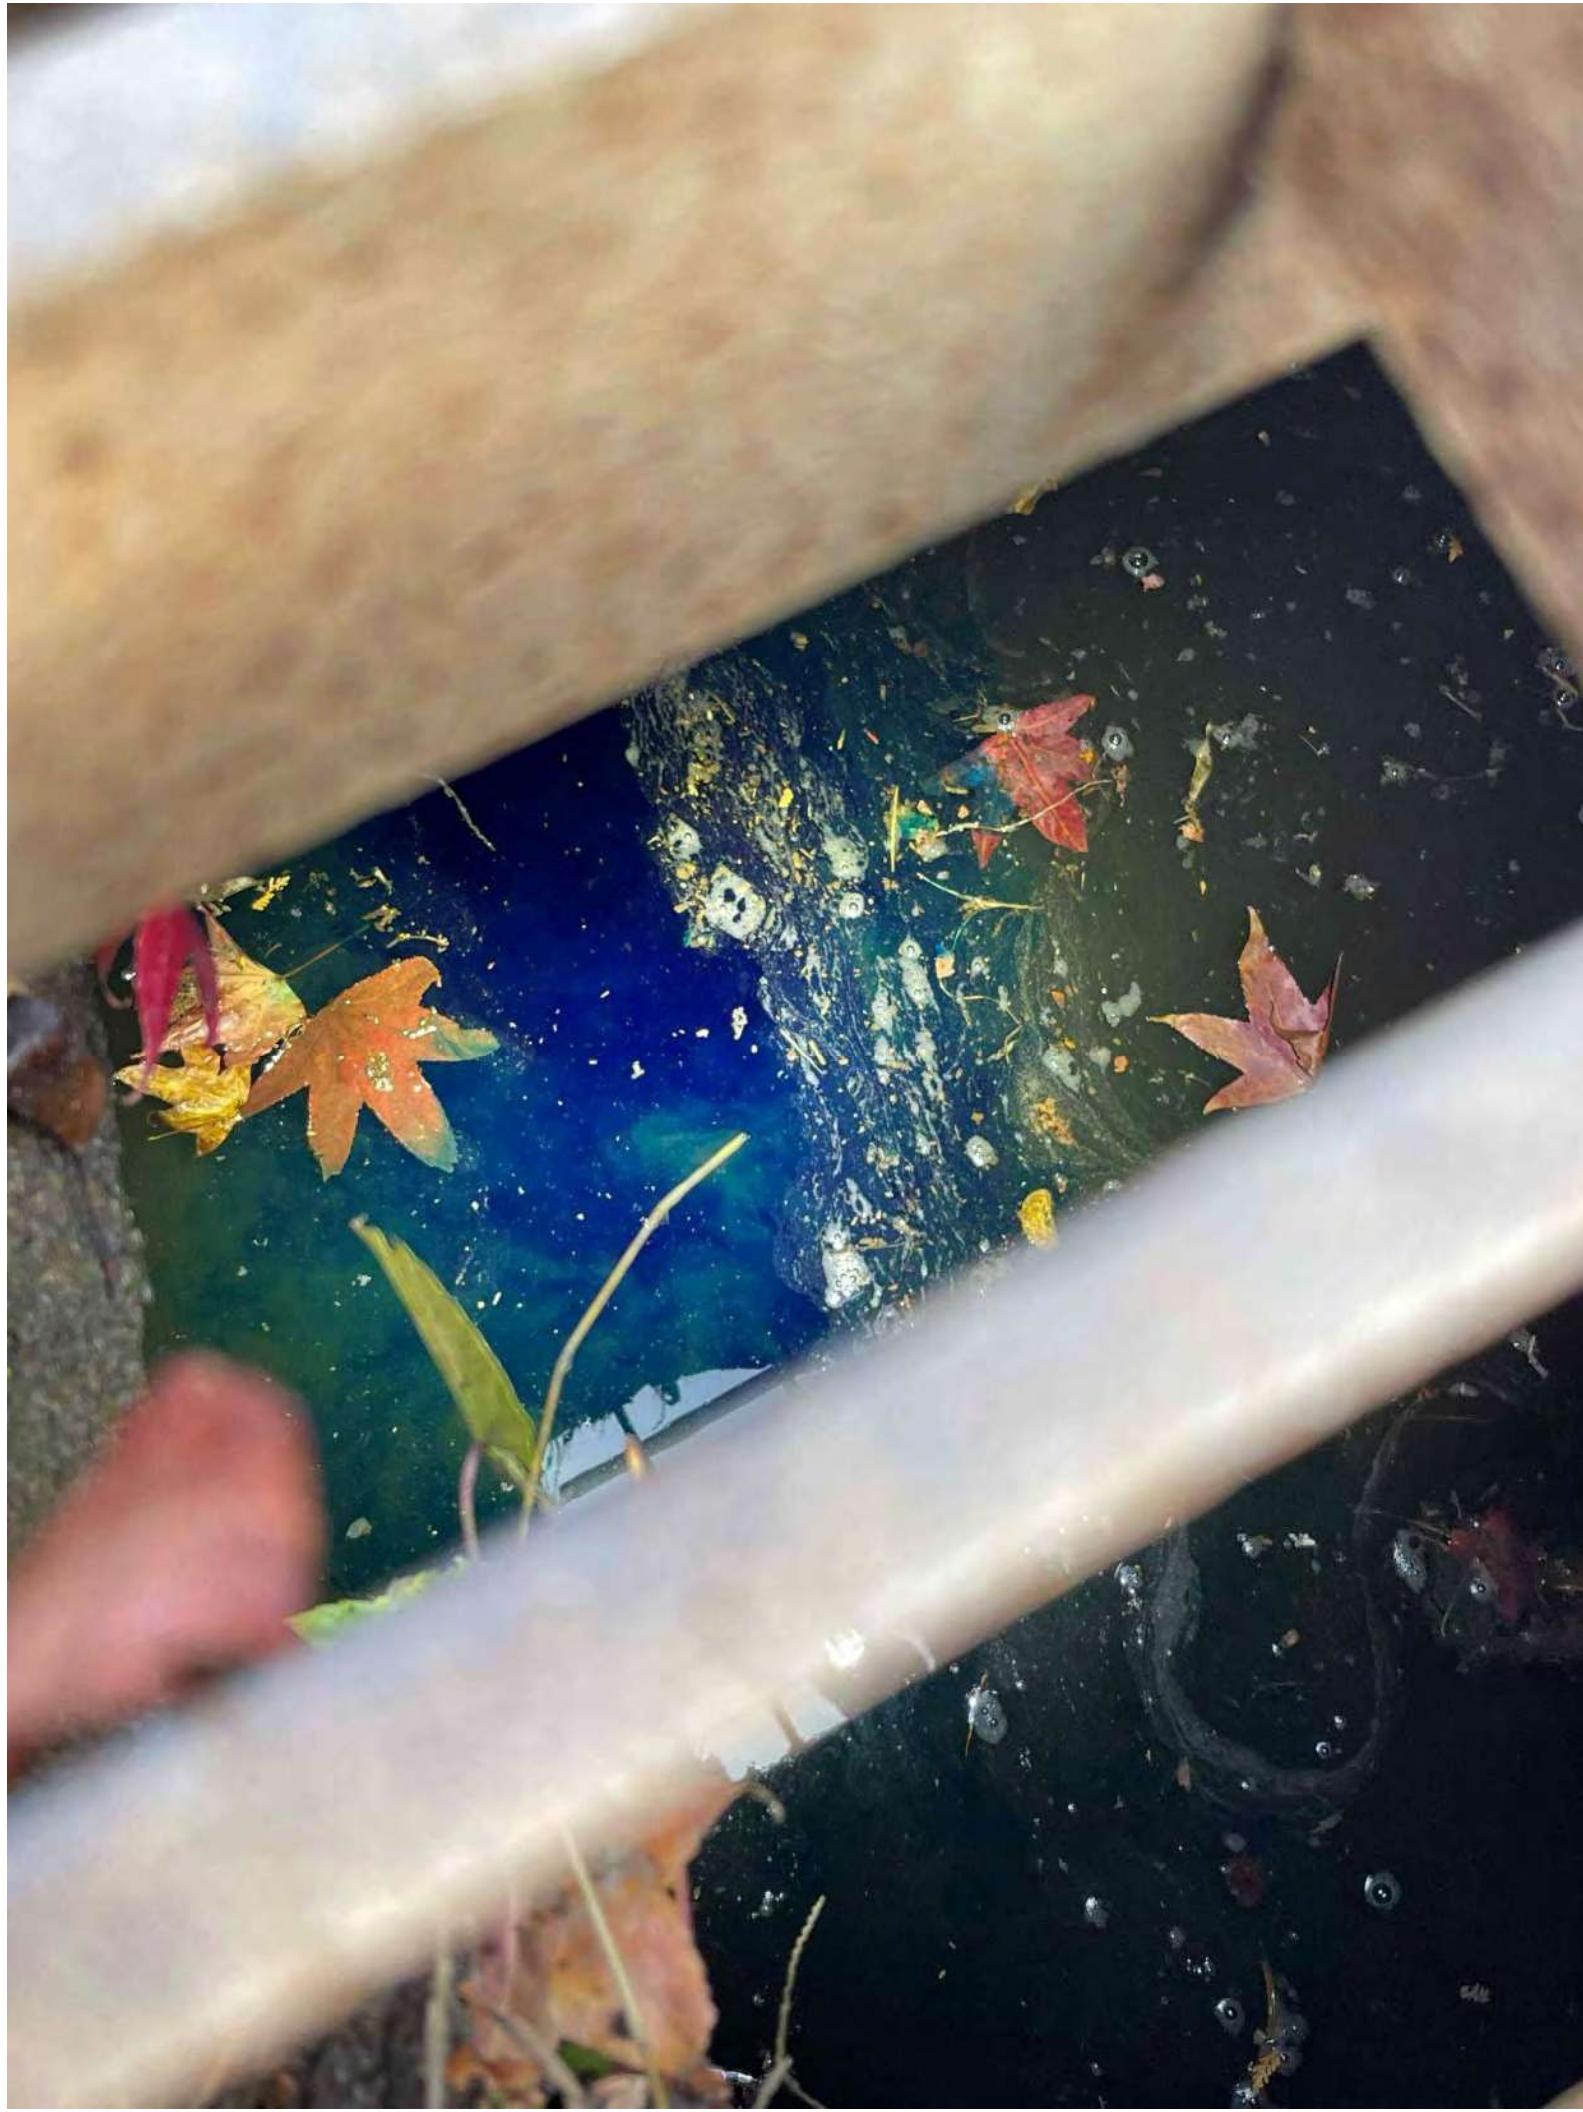
34 Broadway Avenue

\* All roof leaders (12) go into ground and drain to the storm drainage system. They all connect to the CB's throughout the parking lot

\* The 5 curtain drains at the fronts of the garage bay doors drain into the storm drainage system. They all connect and drain to the CB's in the parking lot.

\* The 1 yard drain connects to the CB in the front driveway in front of the truck bay doors
