### Mystic Area Dye Water Testing Results

# DYED-WATER FLOODING

STONINGTON, CONNECTICUT 06355

OCTOBER 2022  
MCA PROJECT NO.: 2021-335

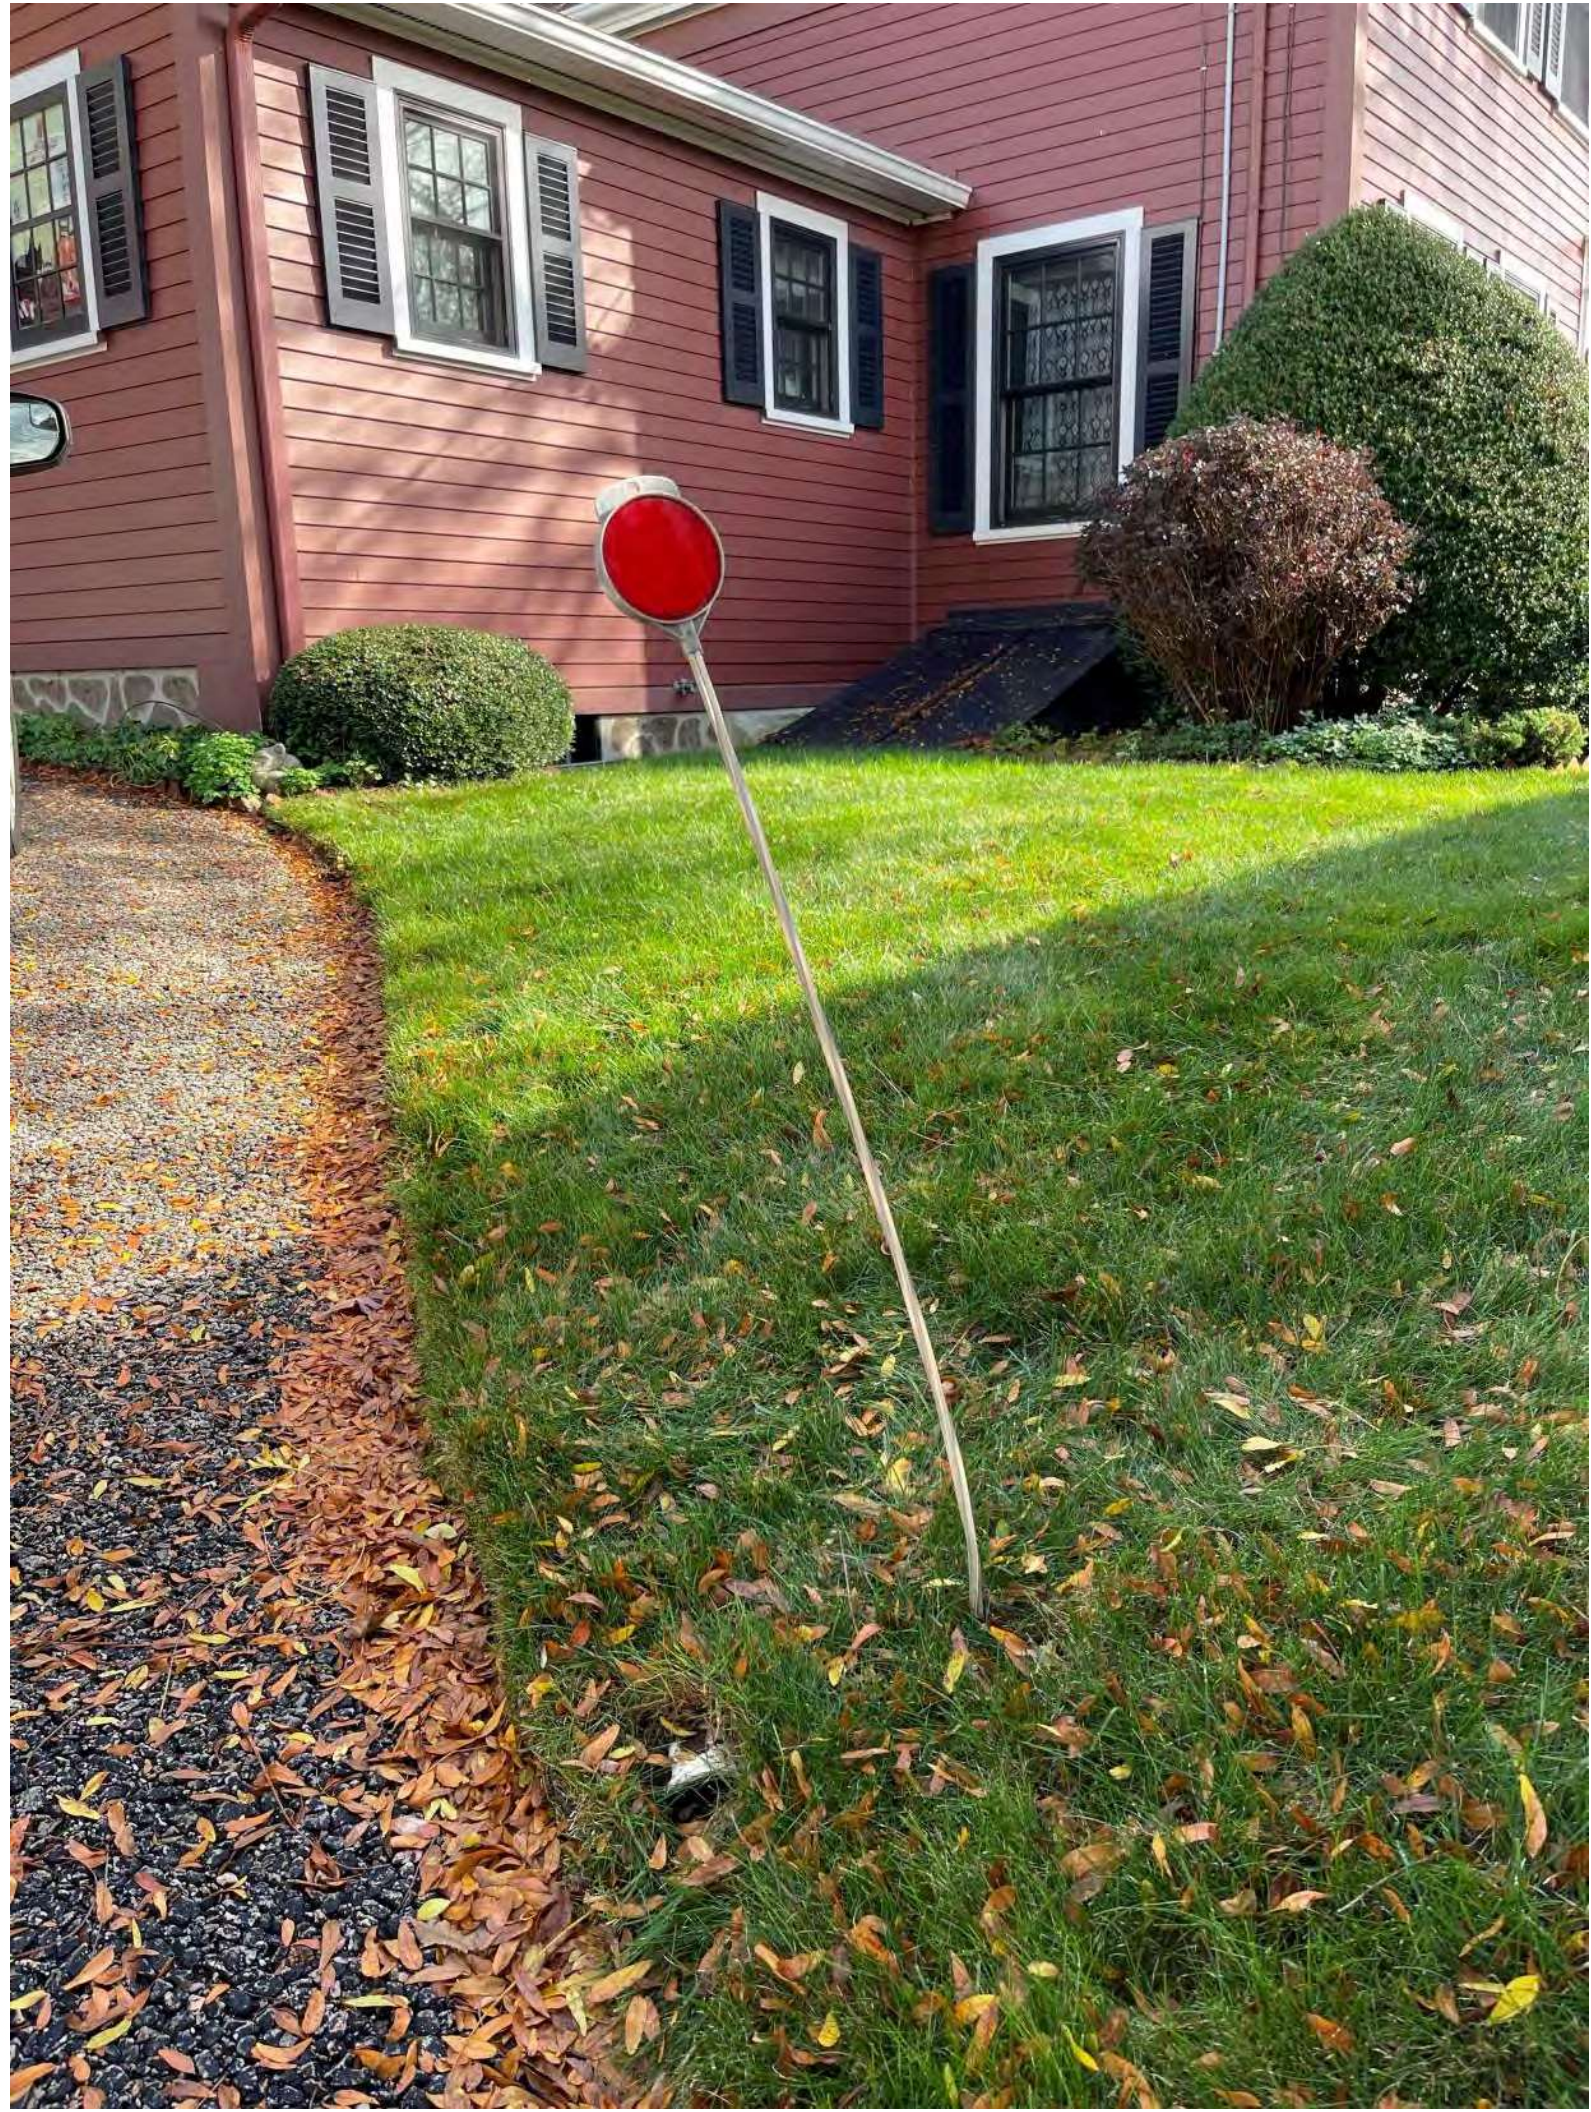
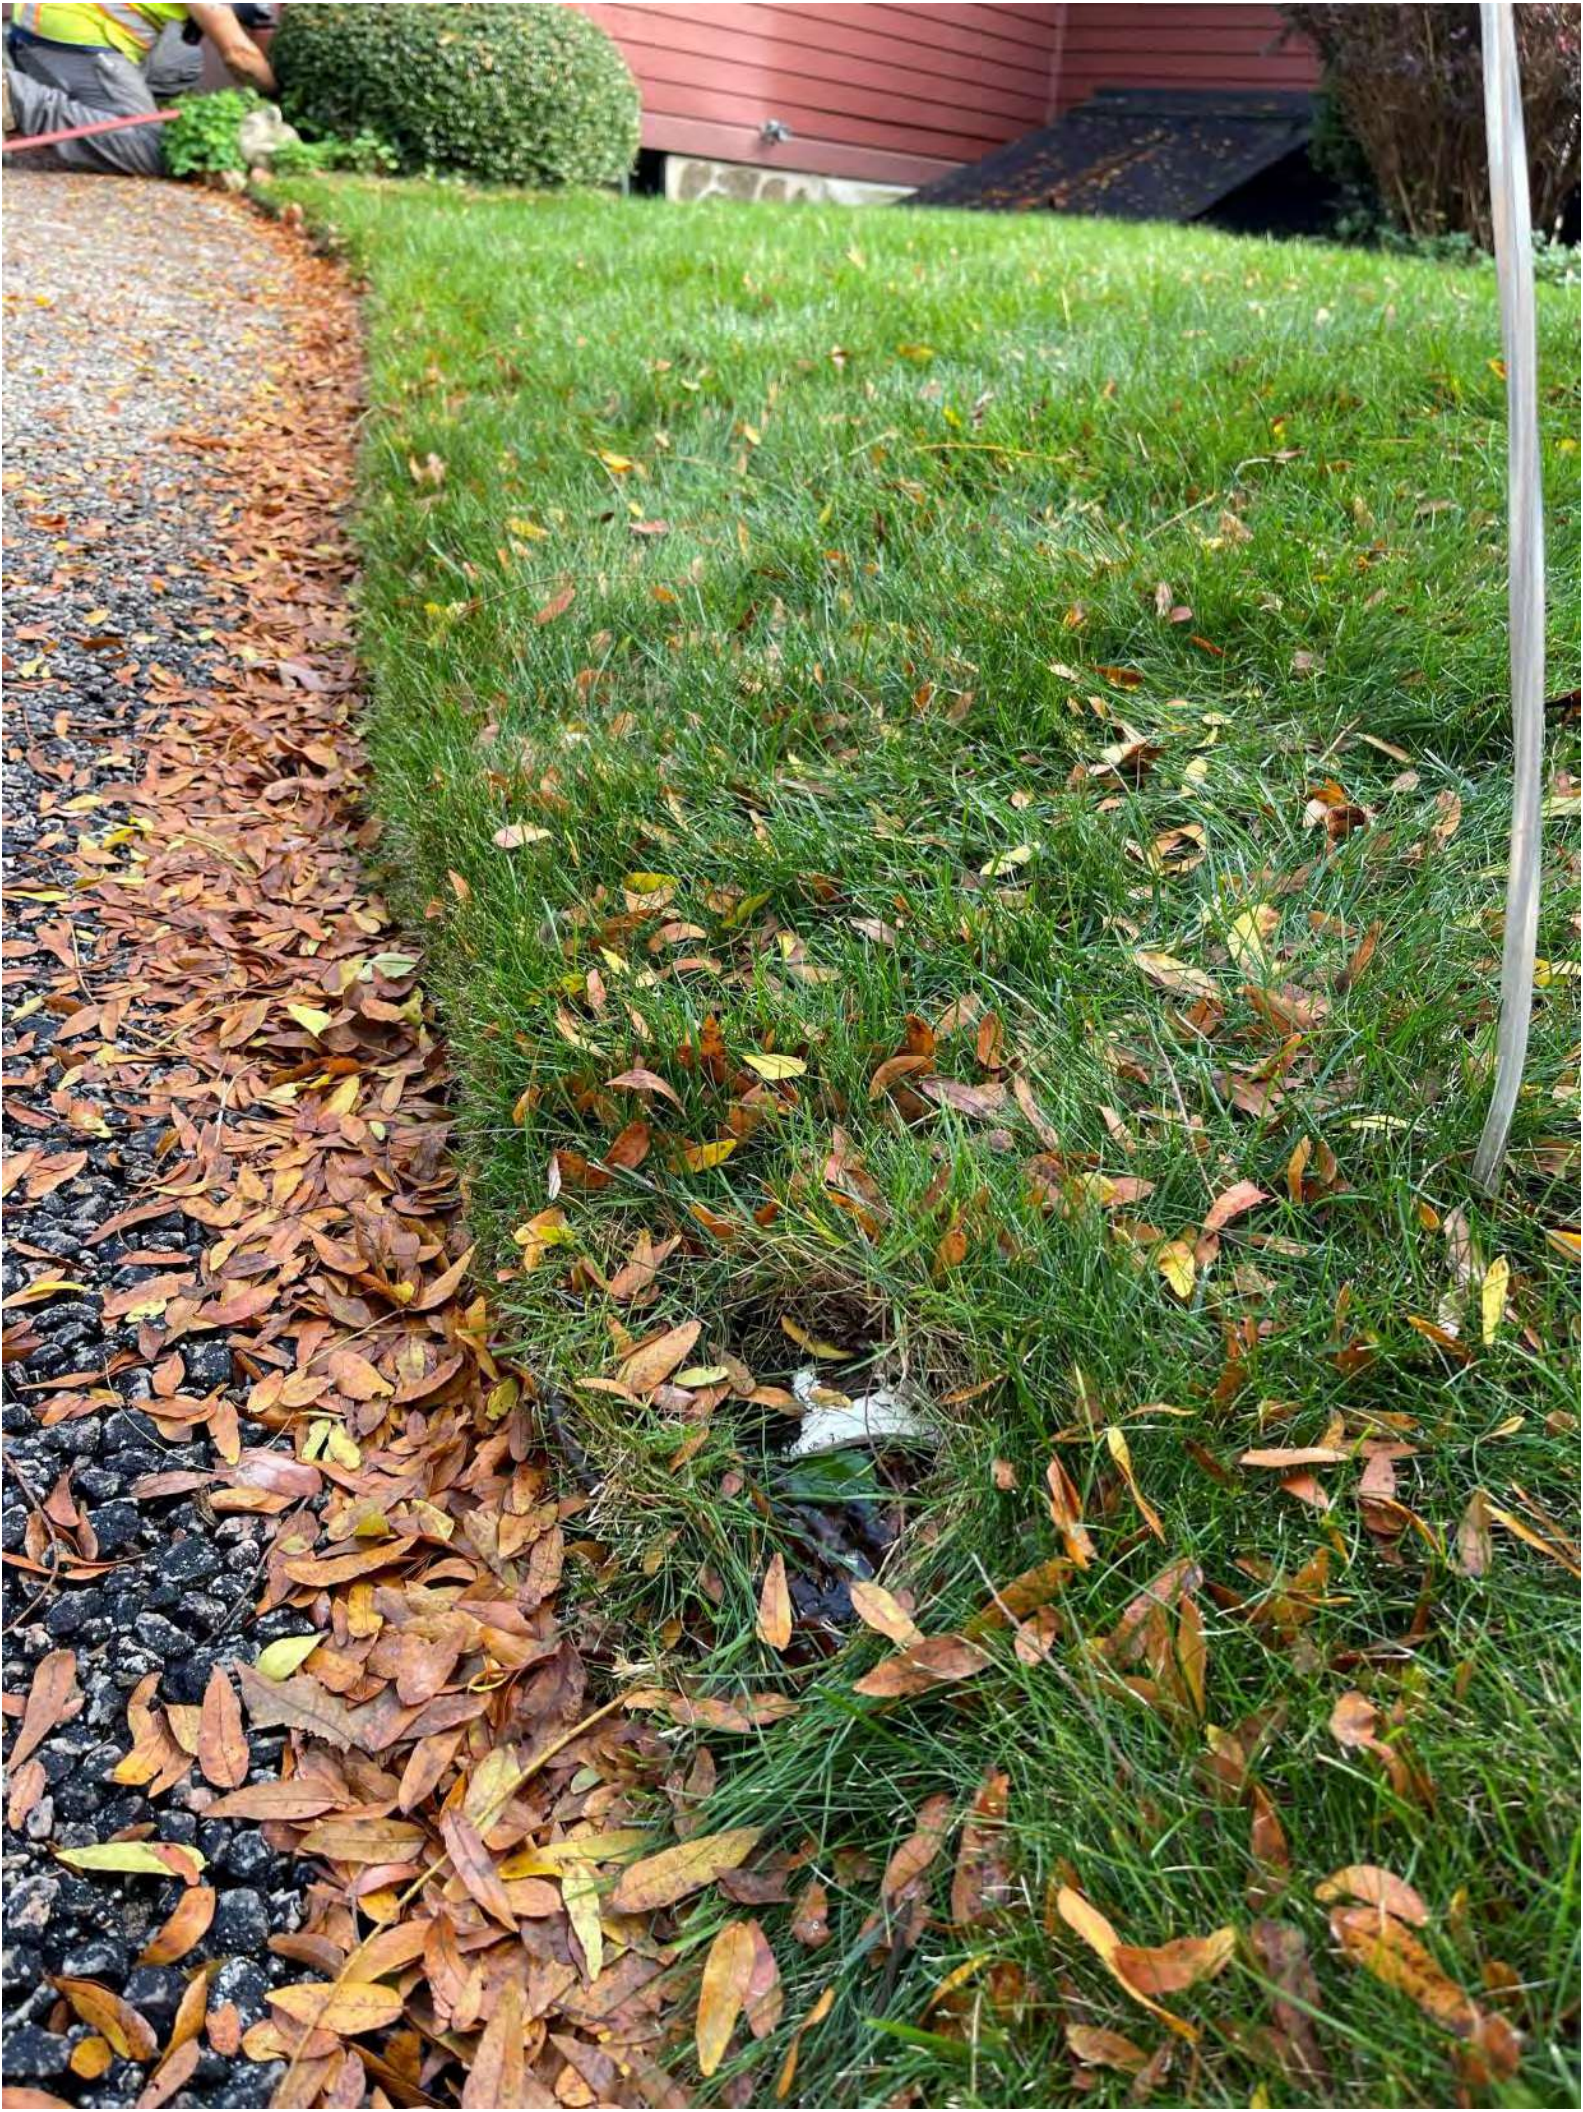
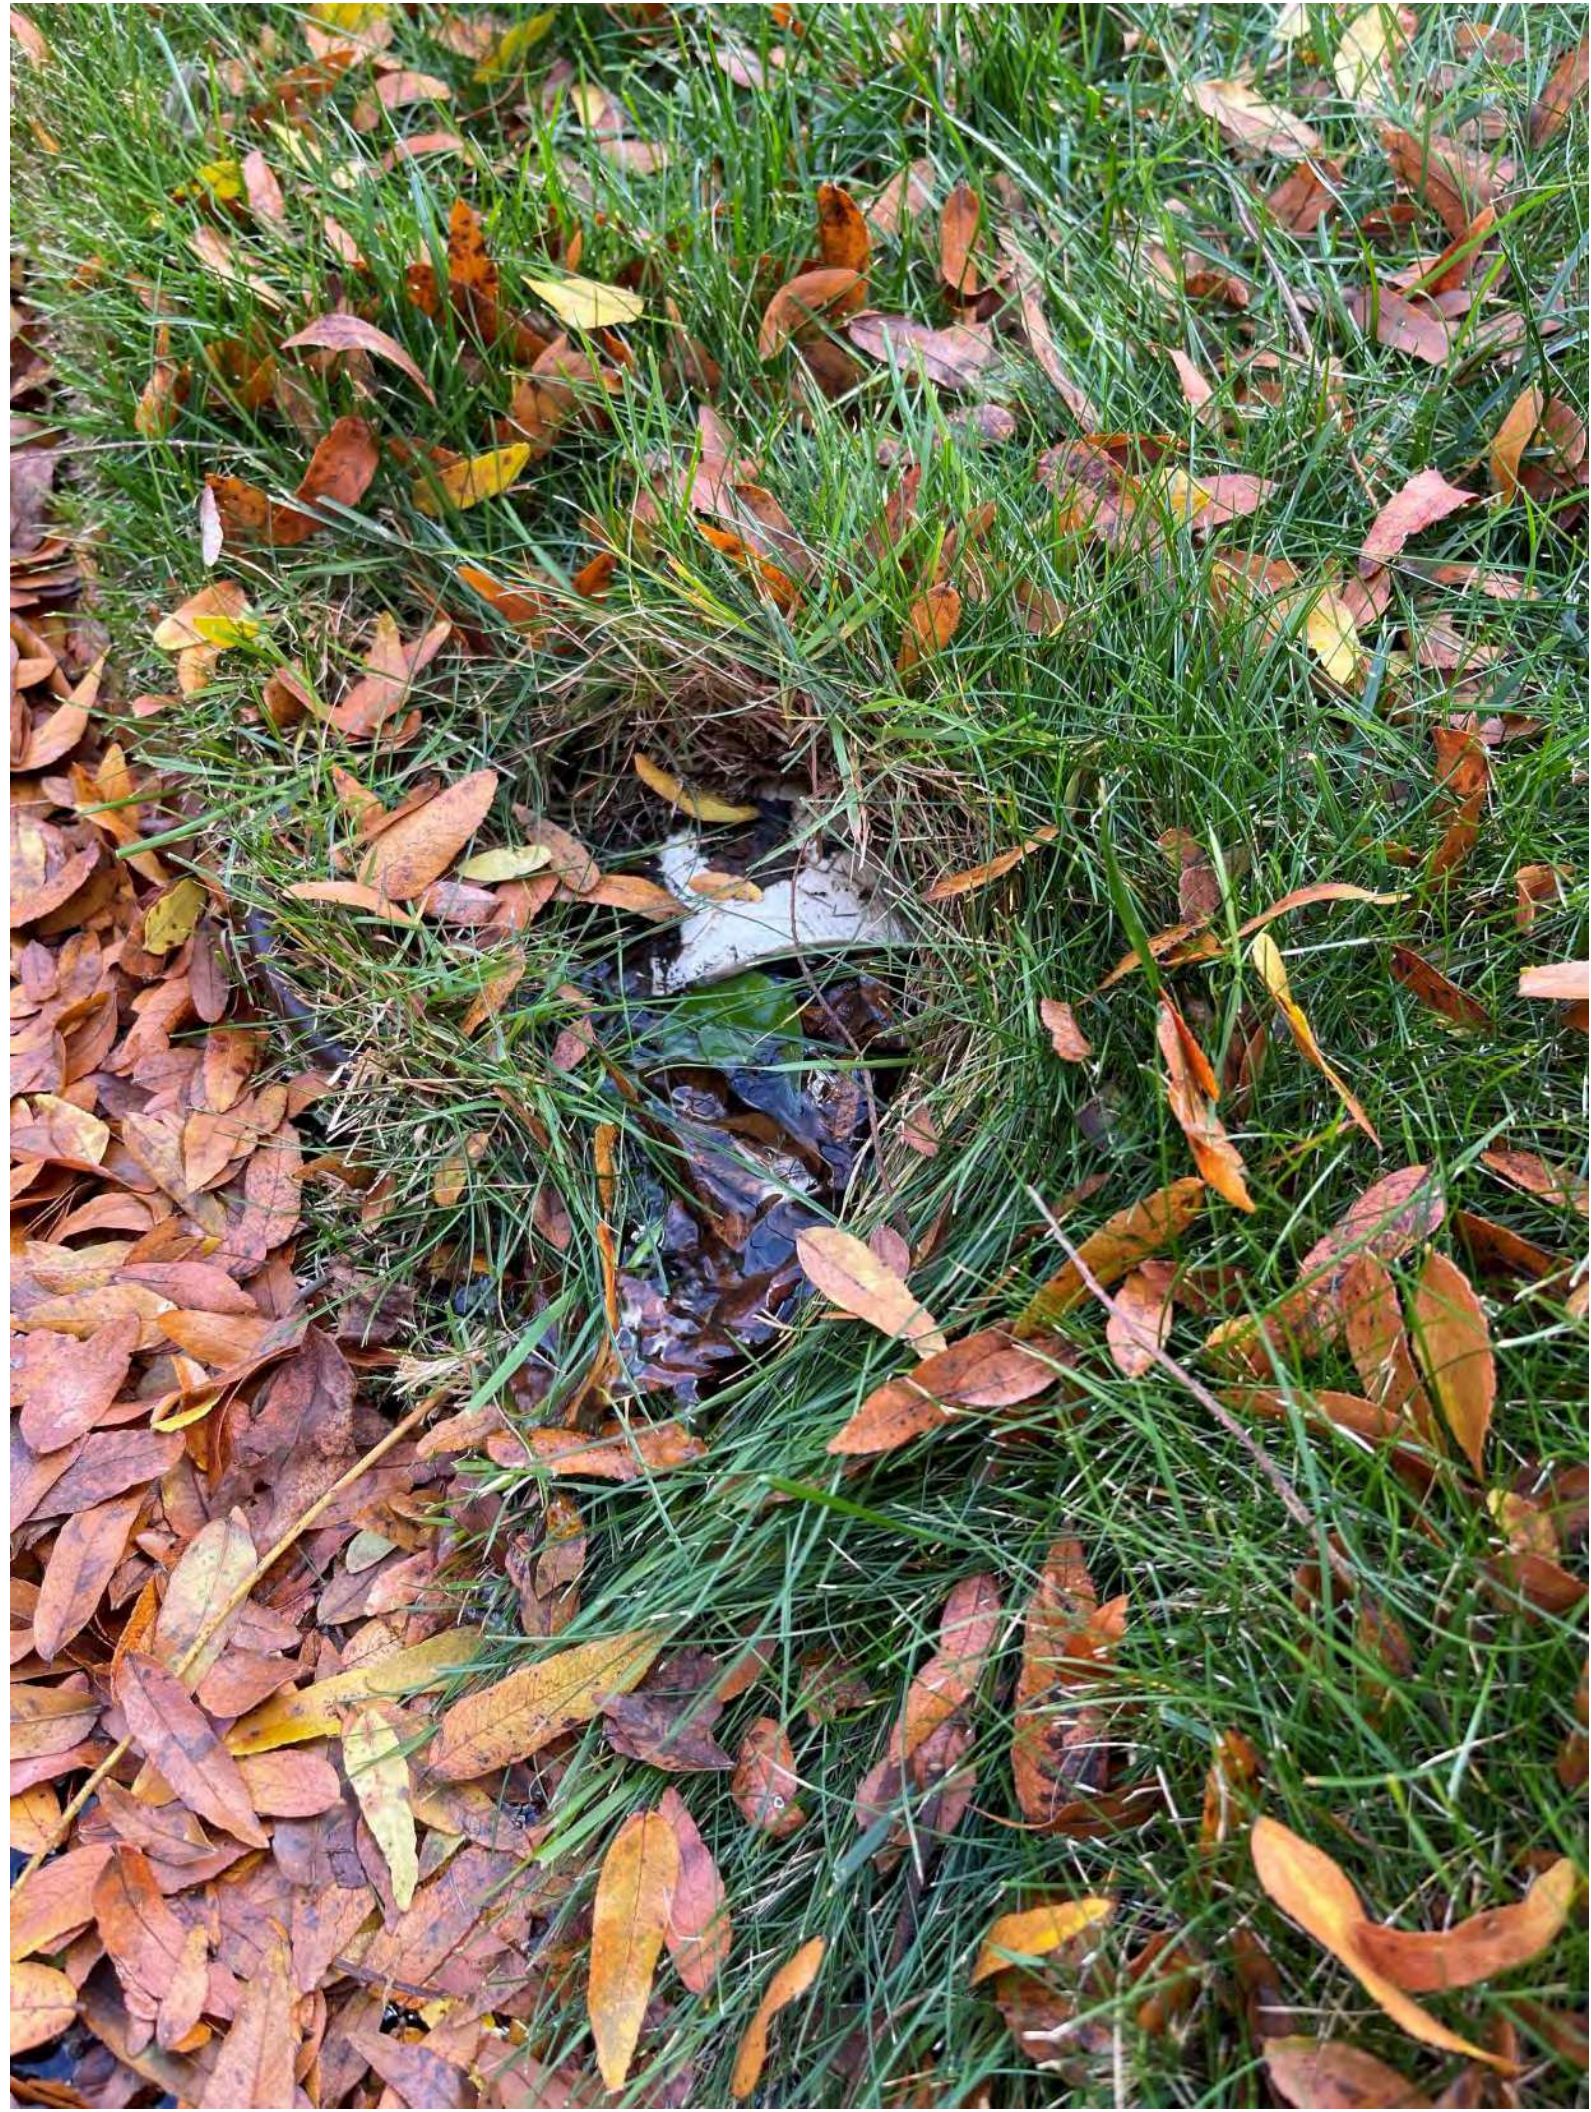
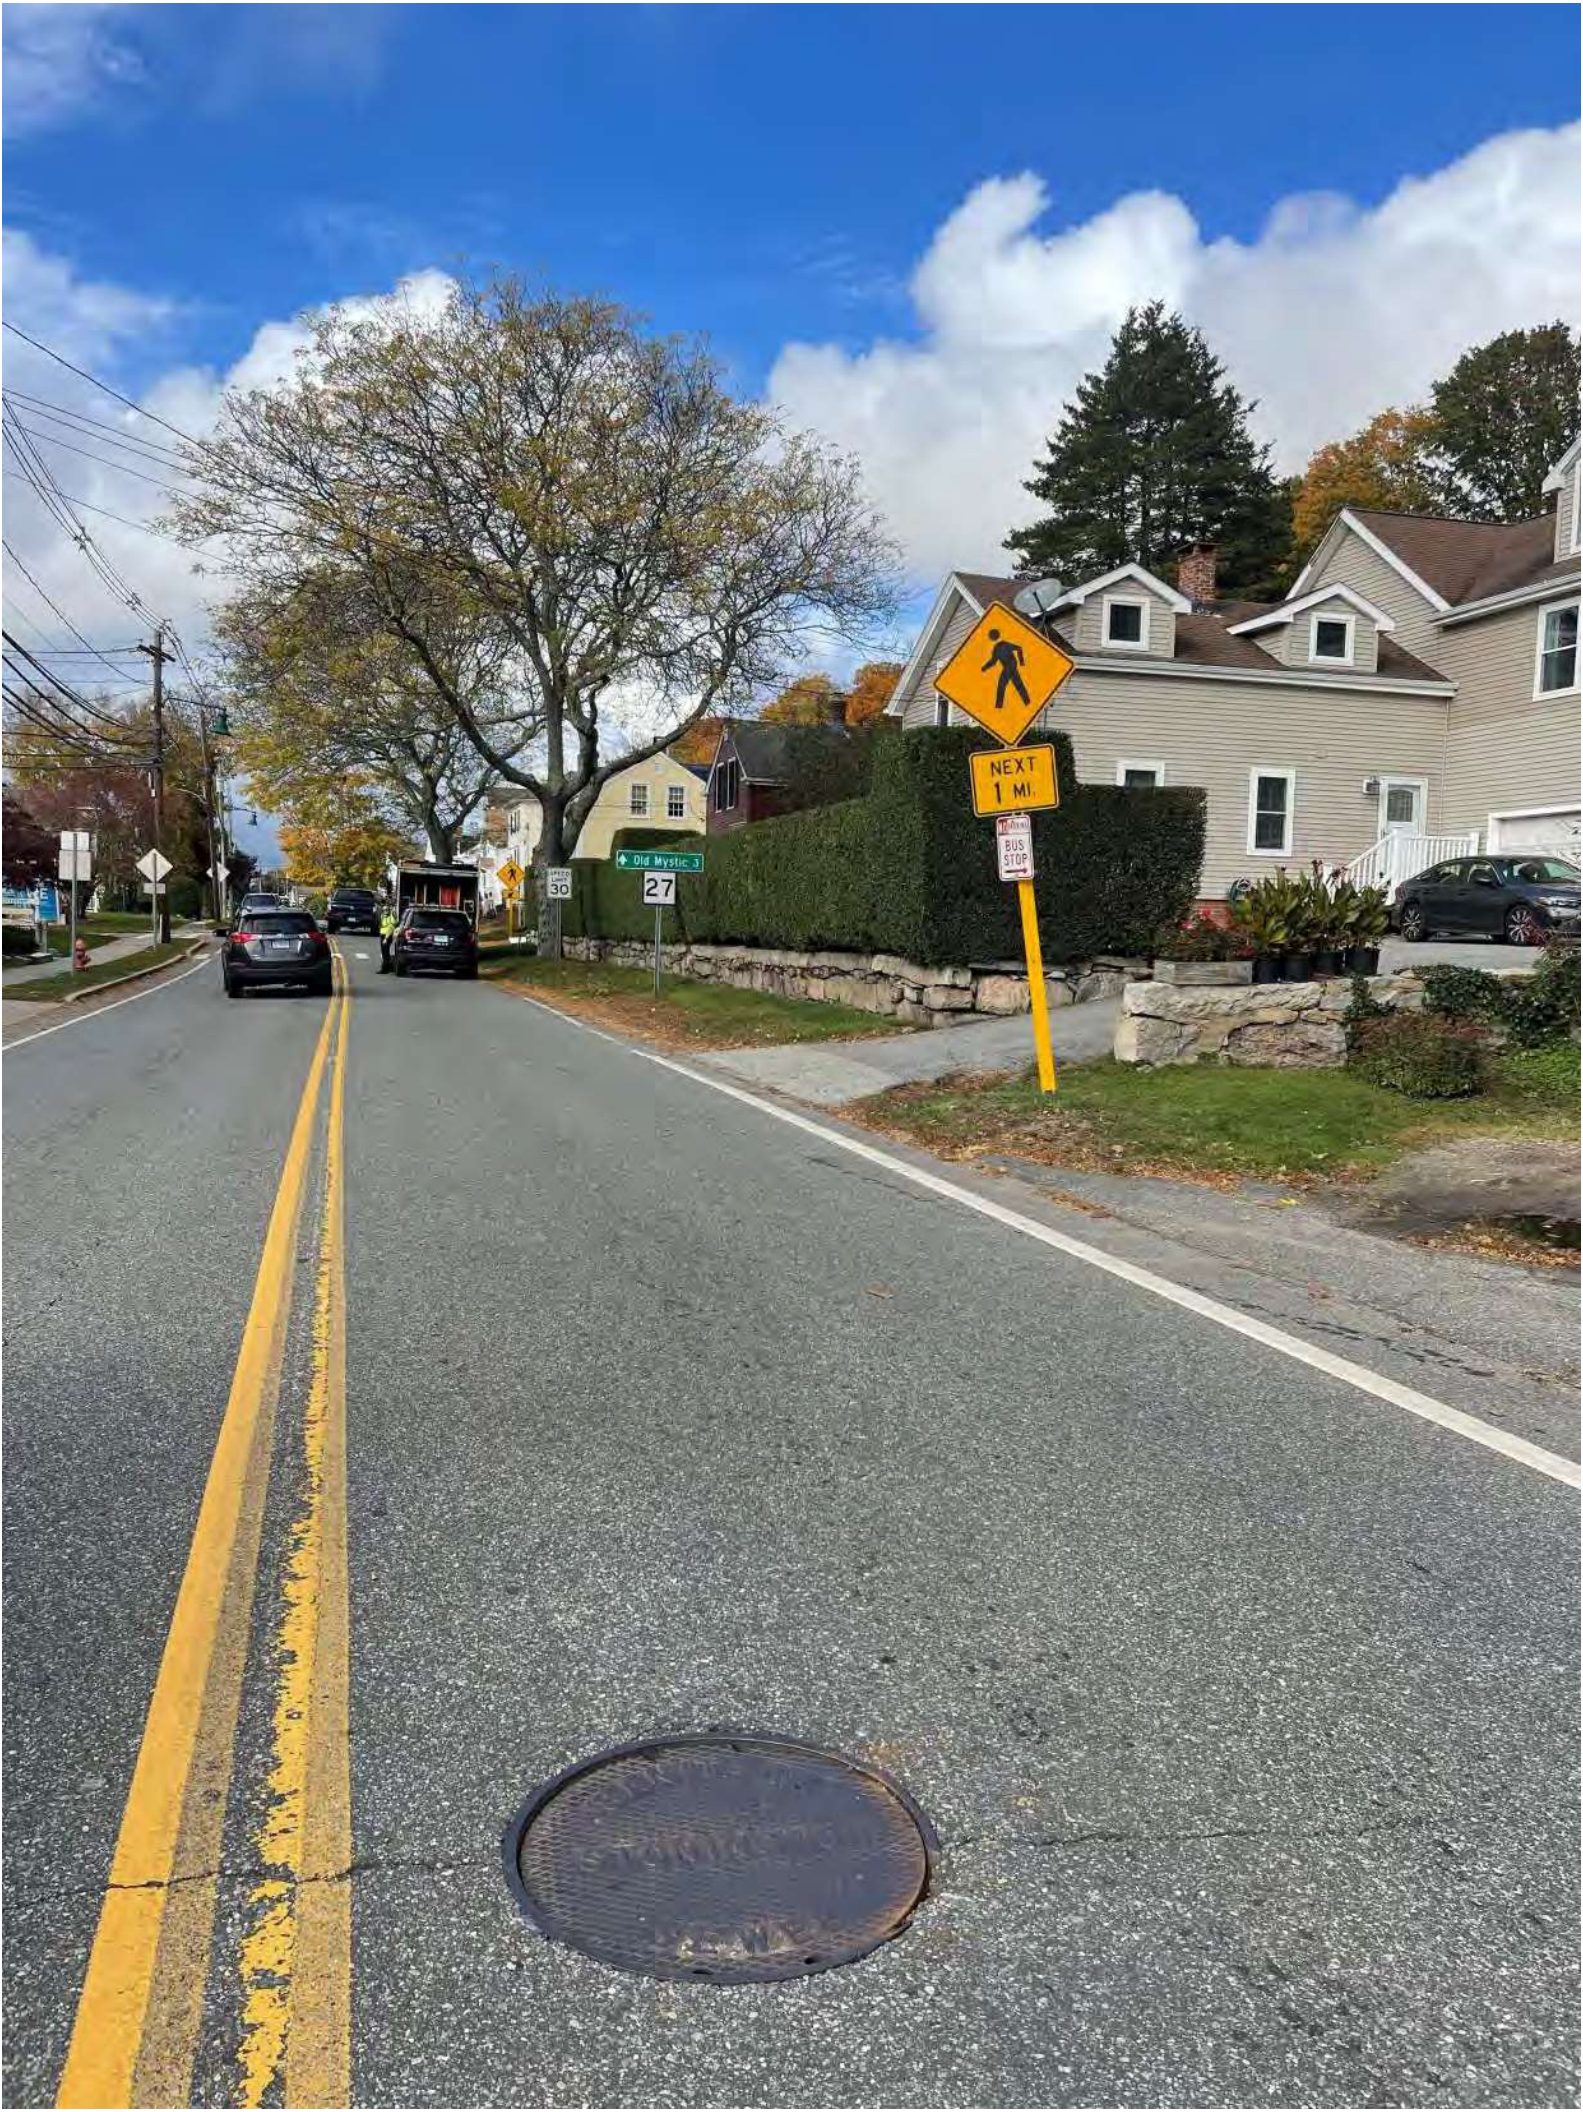
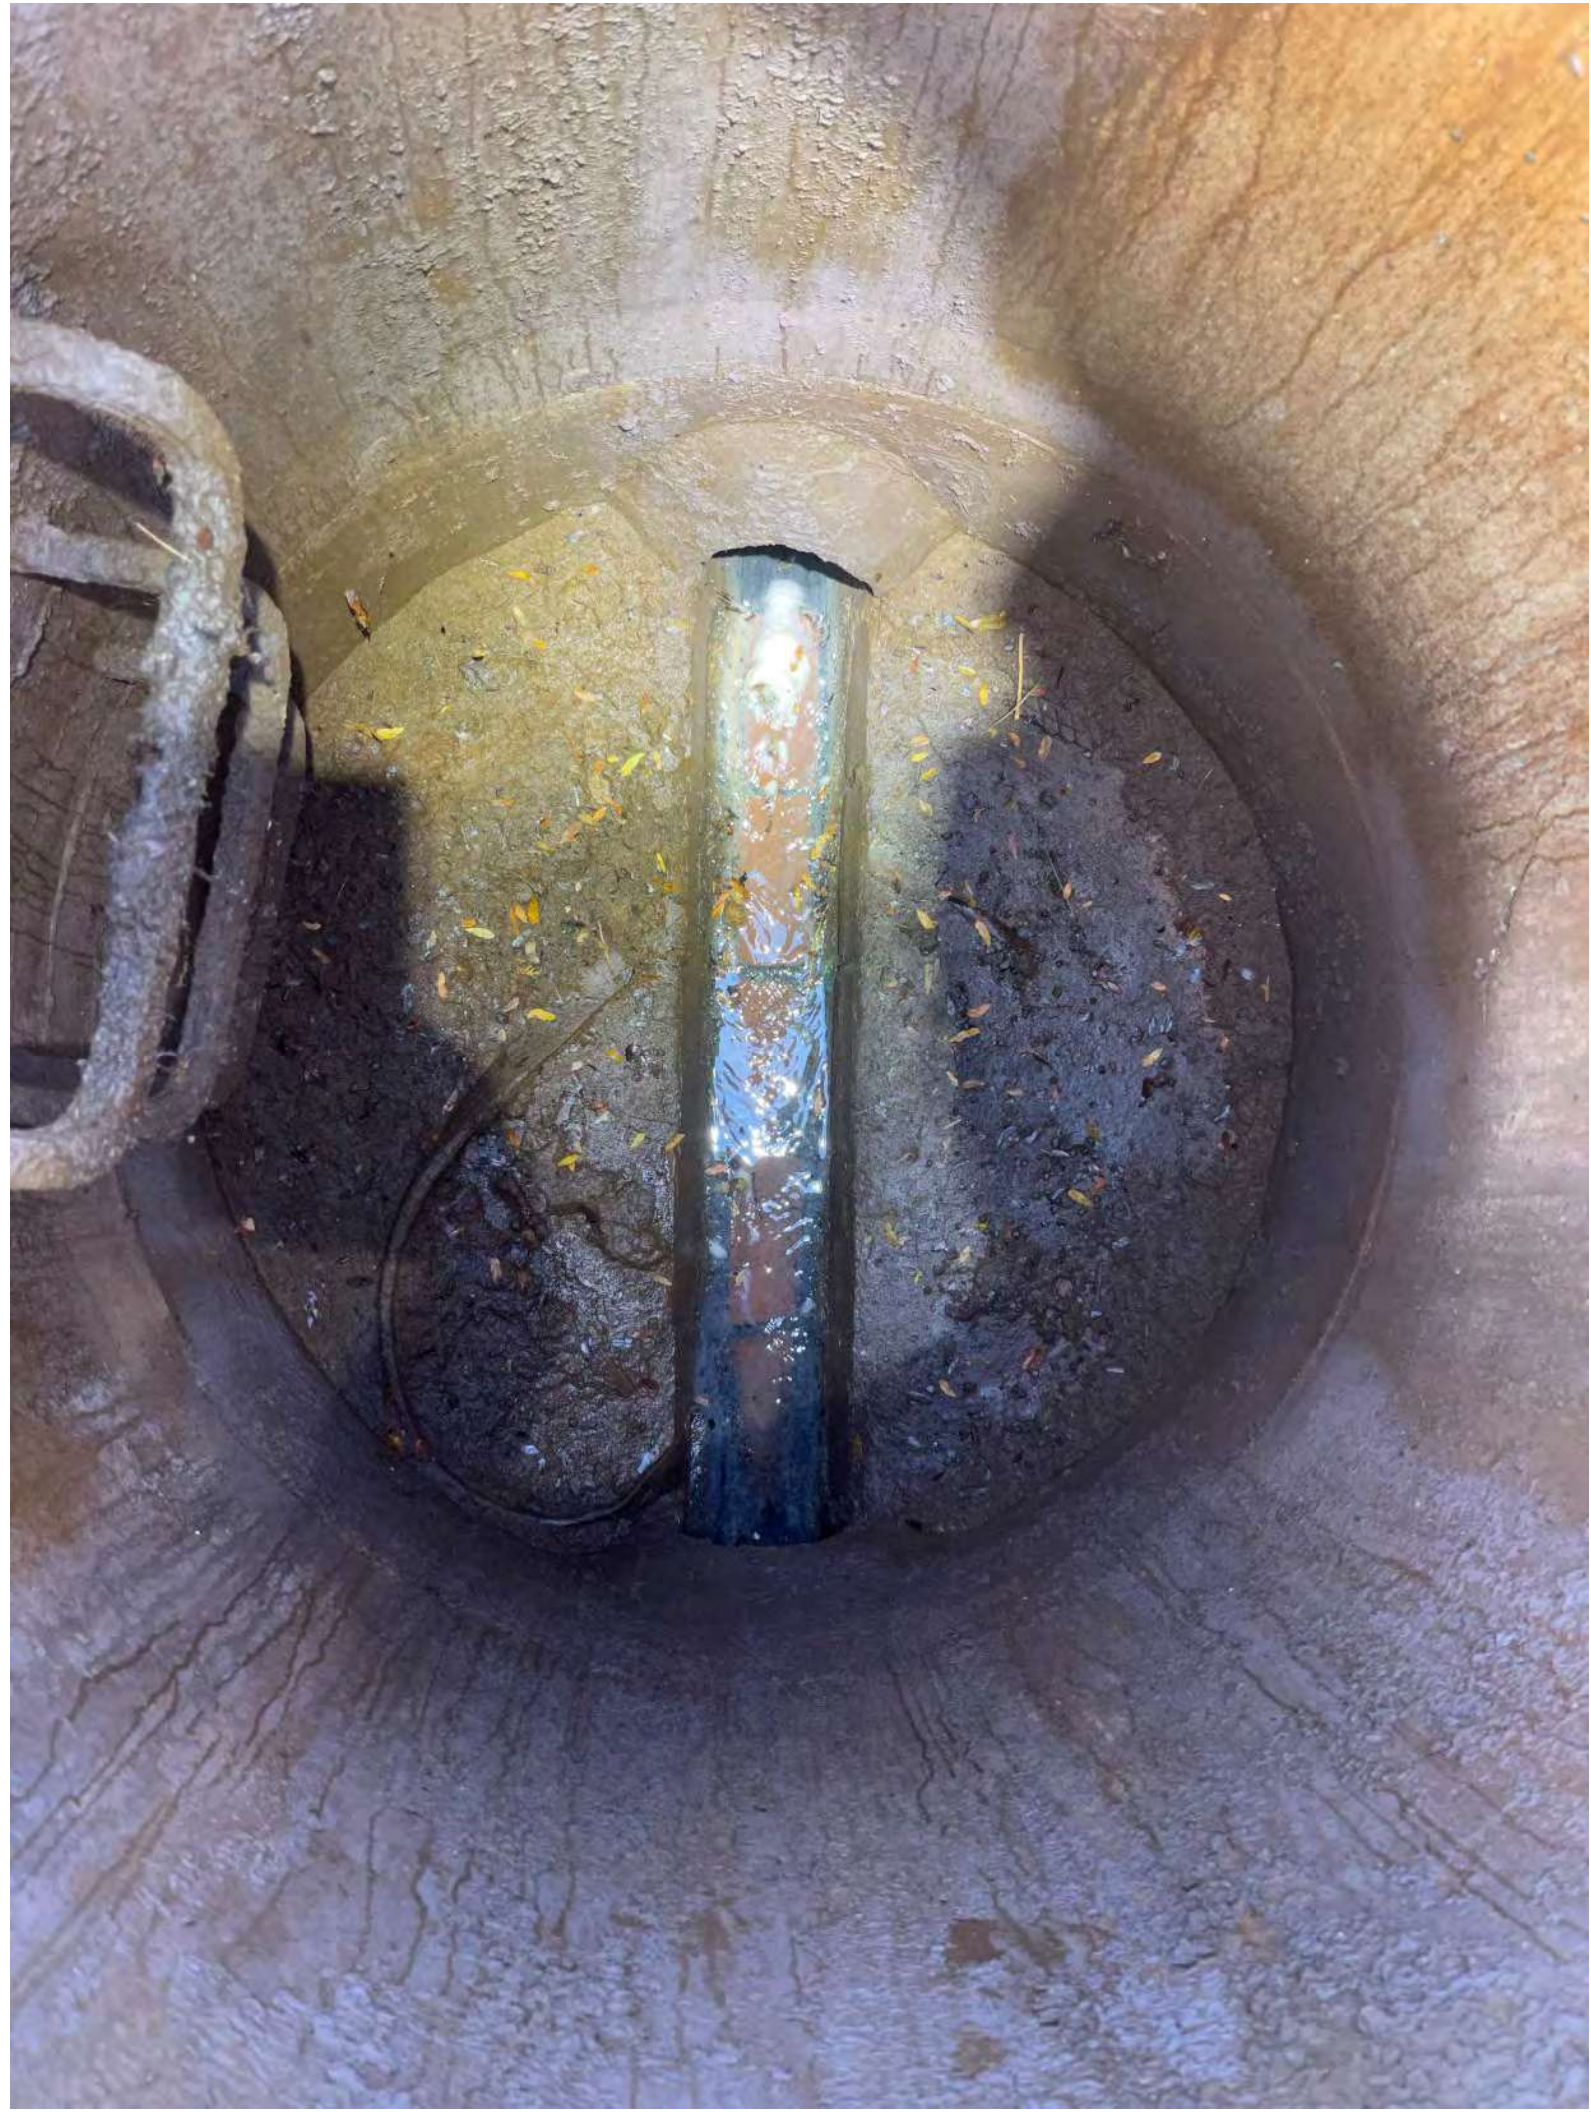
14 Denison Avenue

- \* Observed MH 2-8 and did not see any dye enter the sanitary system
- \* no yard drain on property
- \* Roof leader to South of house drains into drywell in front of home. Homeowner confirmed
- \* 3 roof leaders to East of house<sup>connect and</sup> drain into pipe that exits on driveway
- \* 4 Roof leaders into ground total
