### Mystic Area Dye Water Testing Results

# DYED-WATER FLOODING

STONINGTON, CONNECTICUT 06355

OCTOBER 2022  
MCA PROJECT NO.: 2021-335

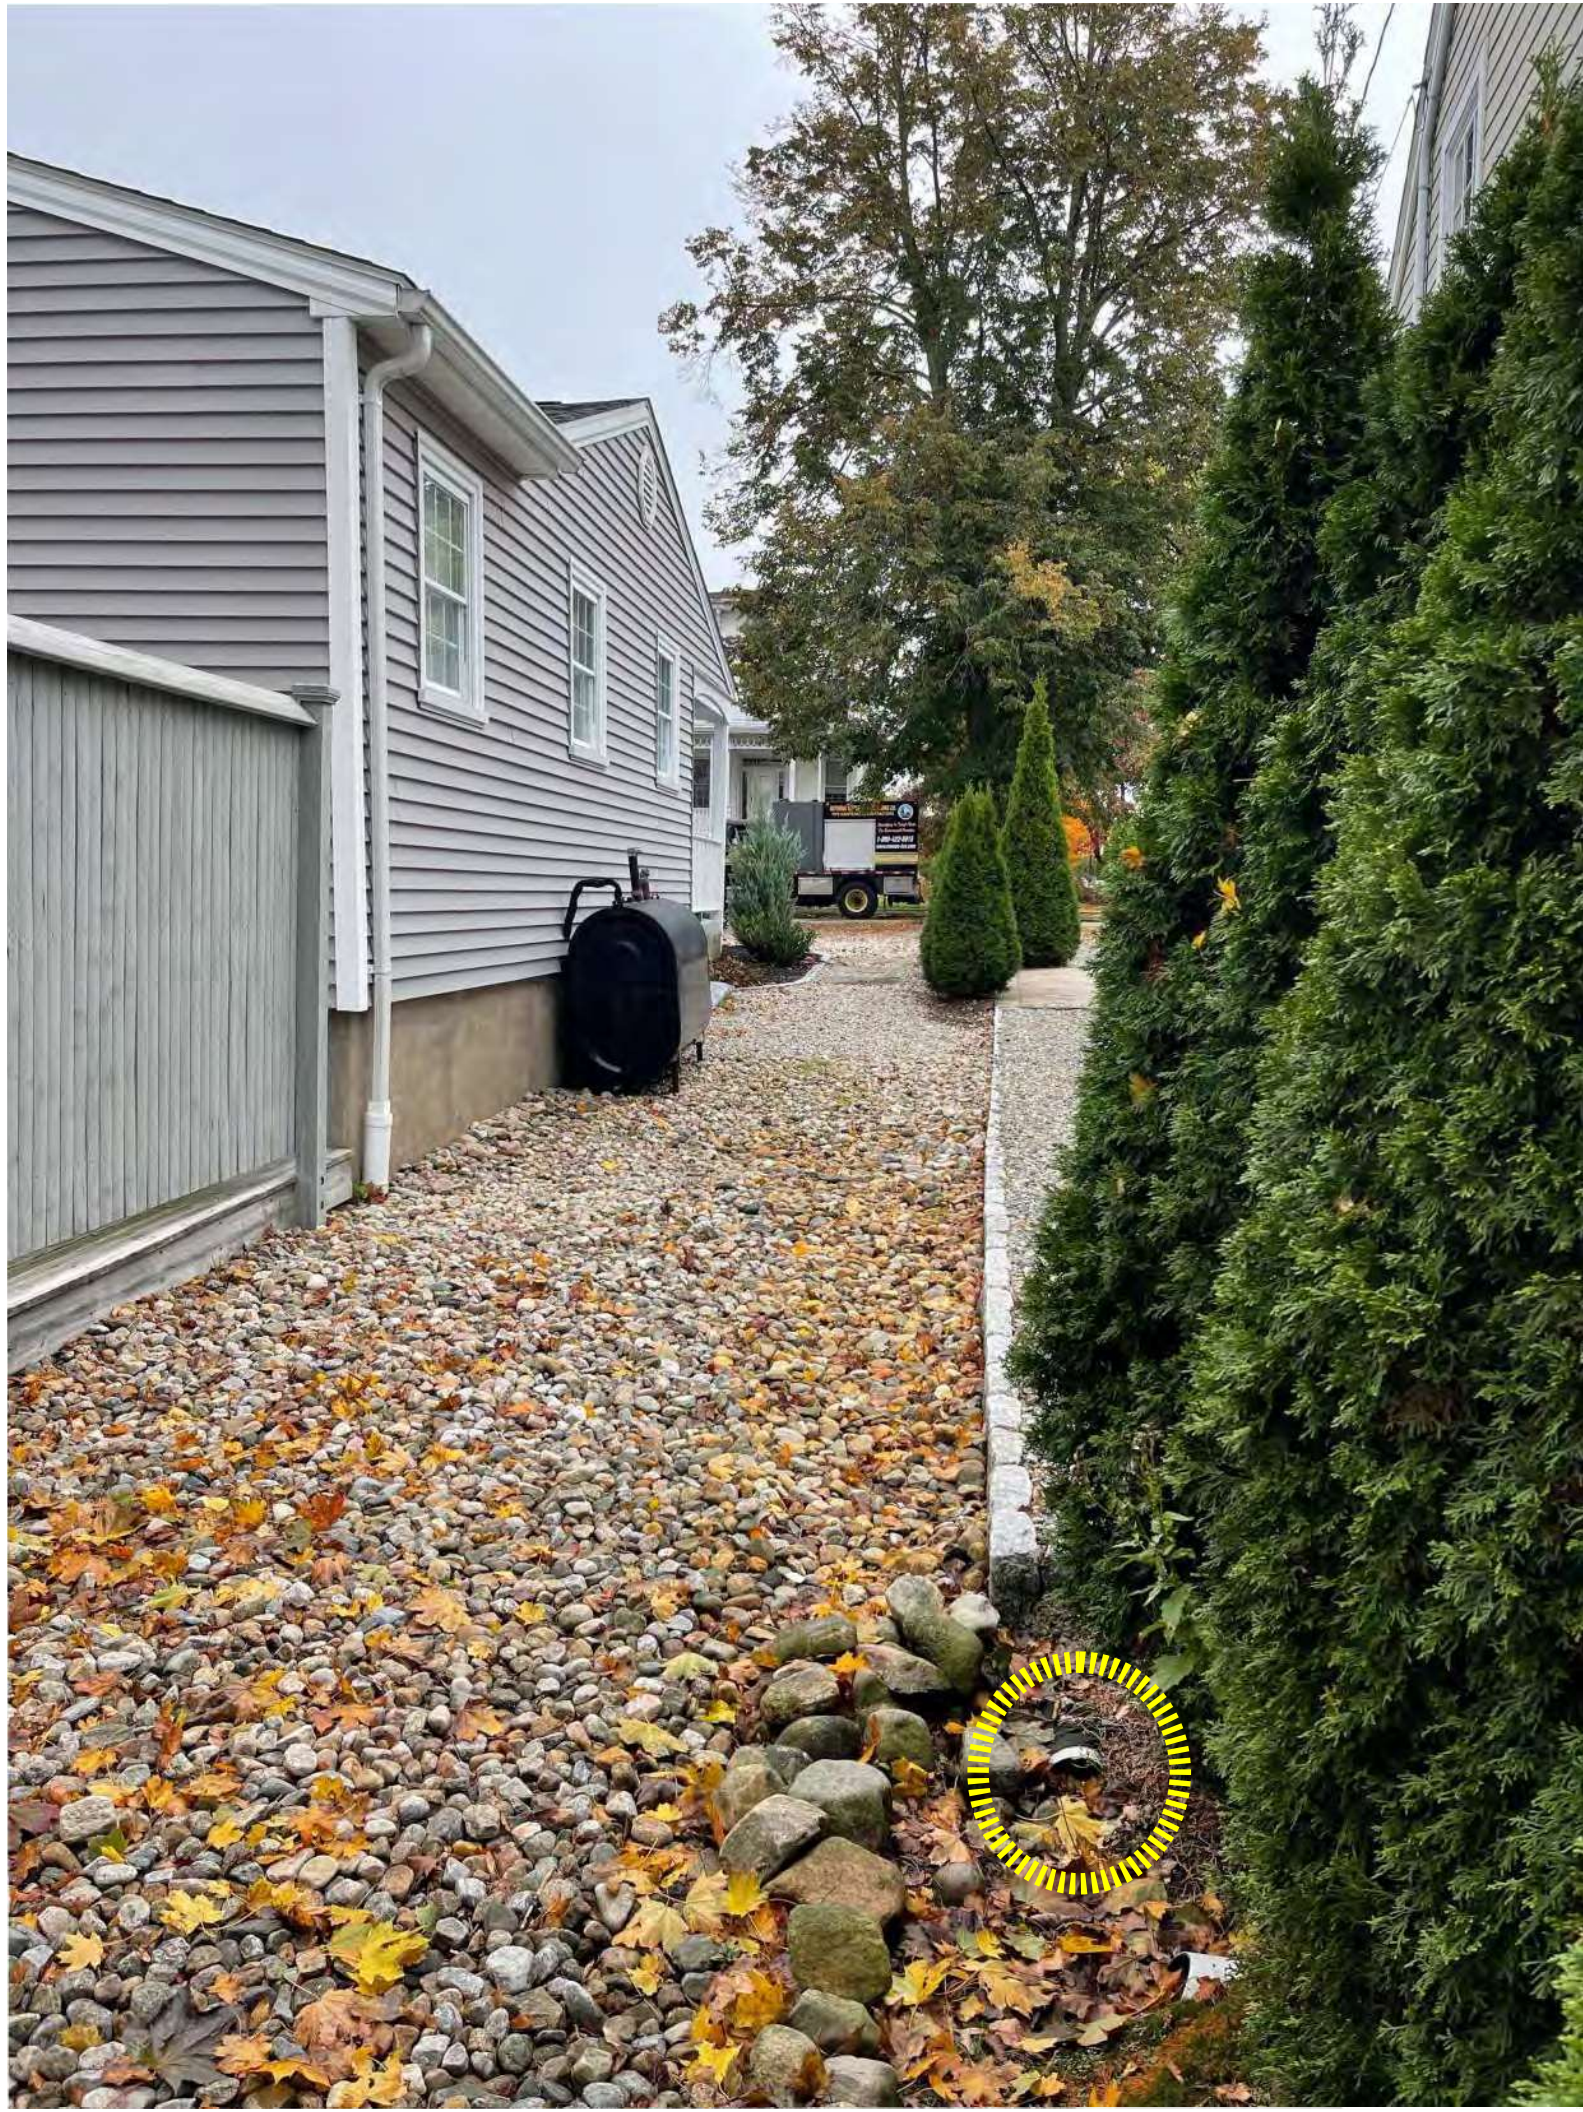
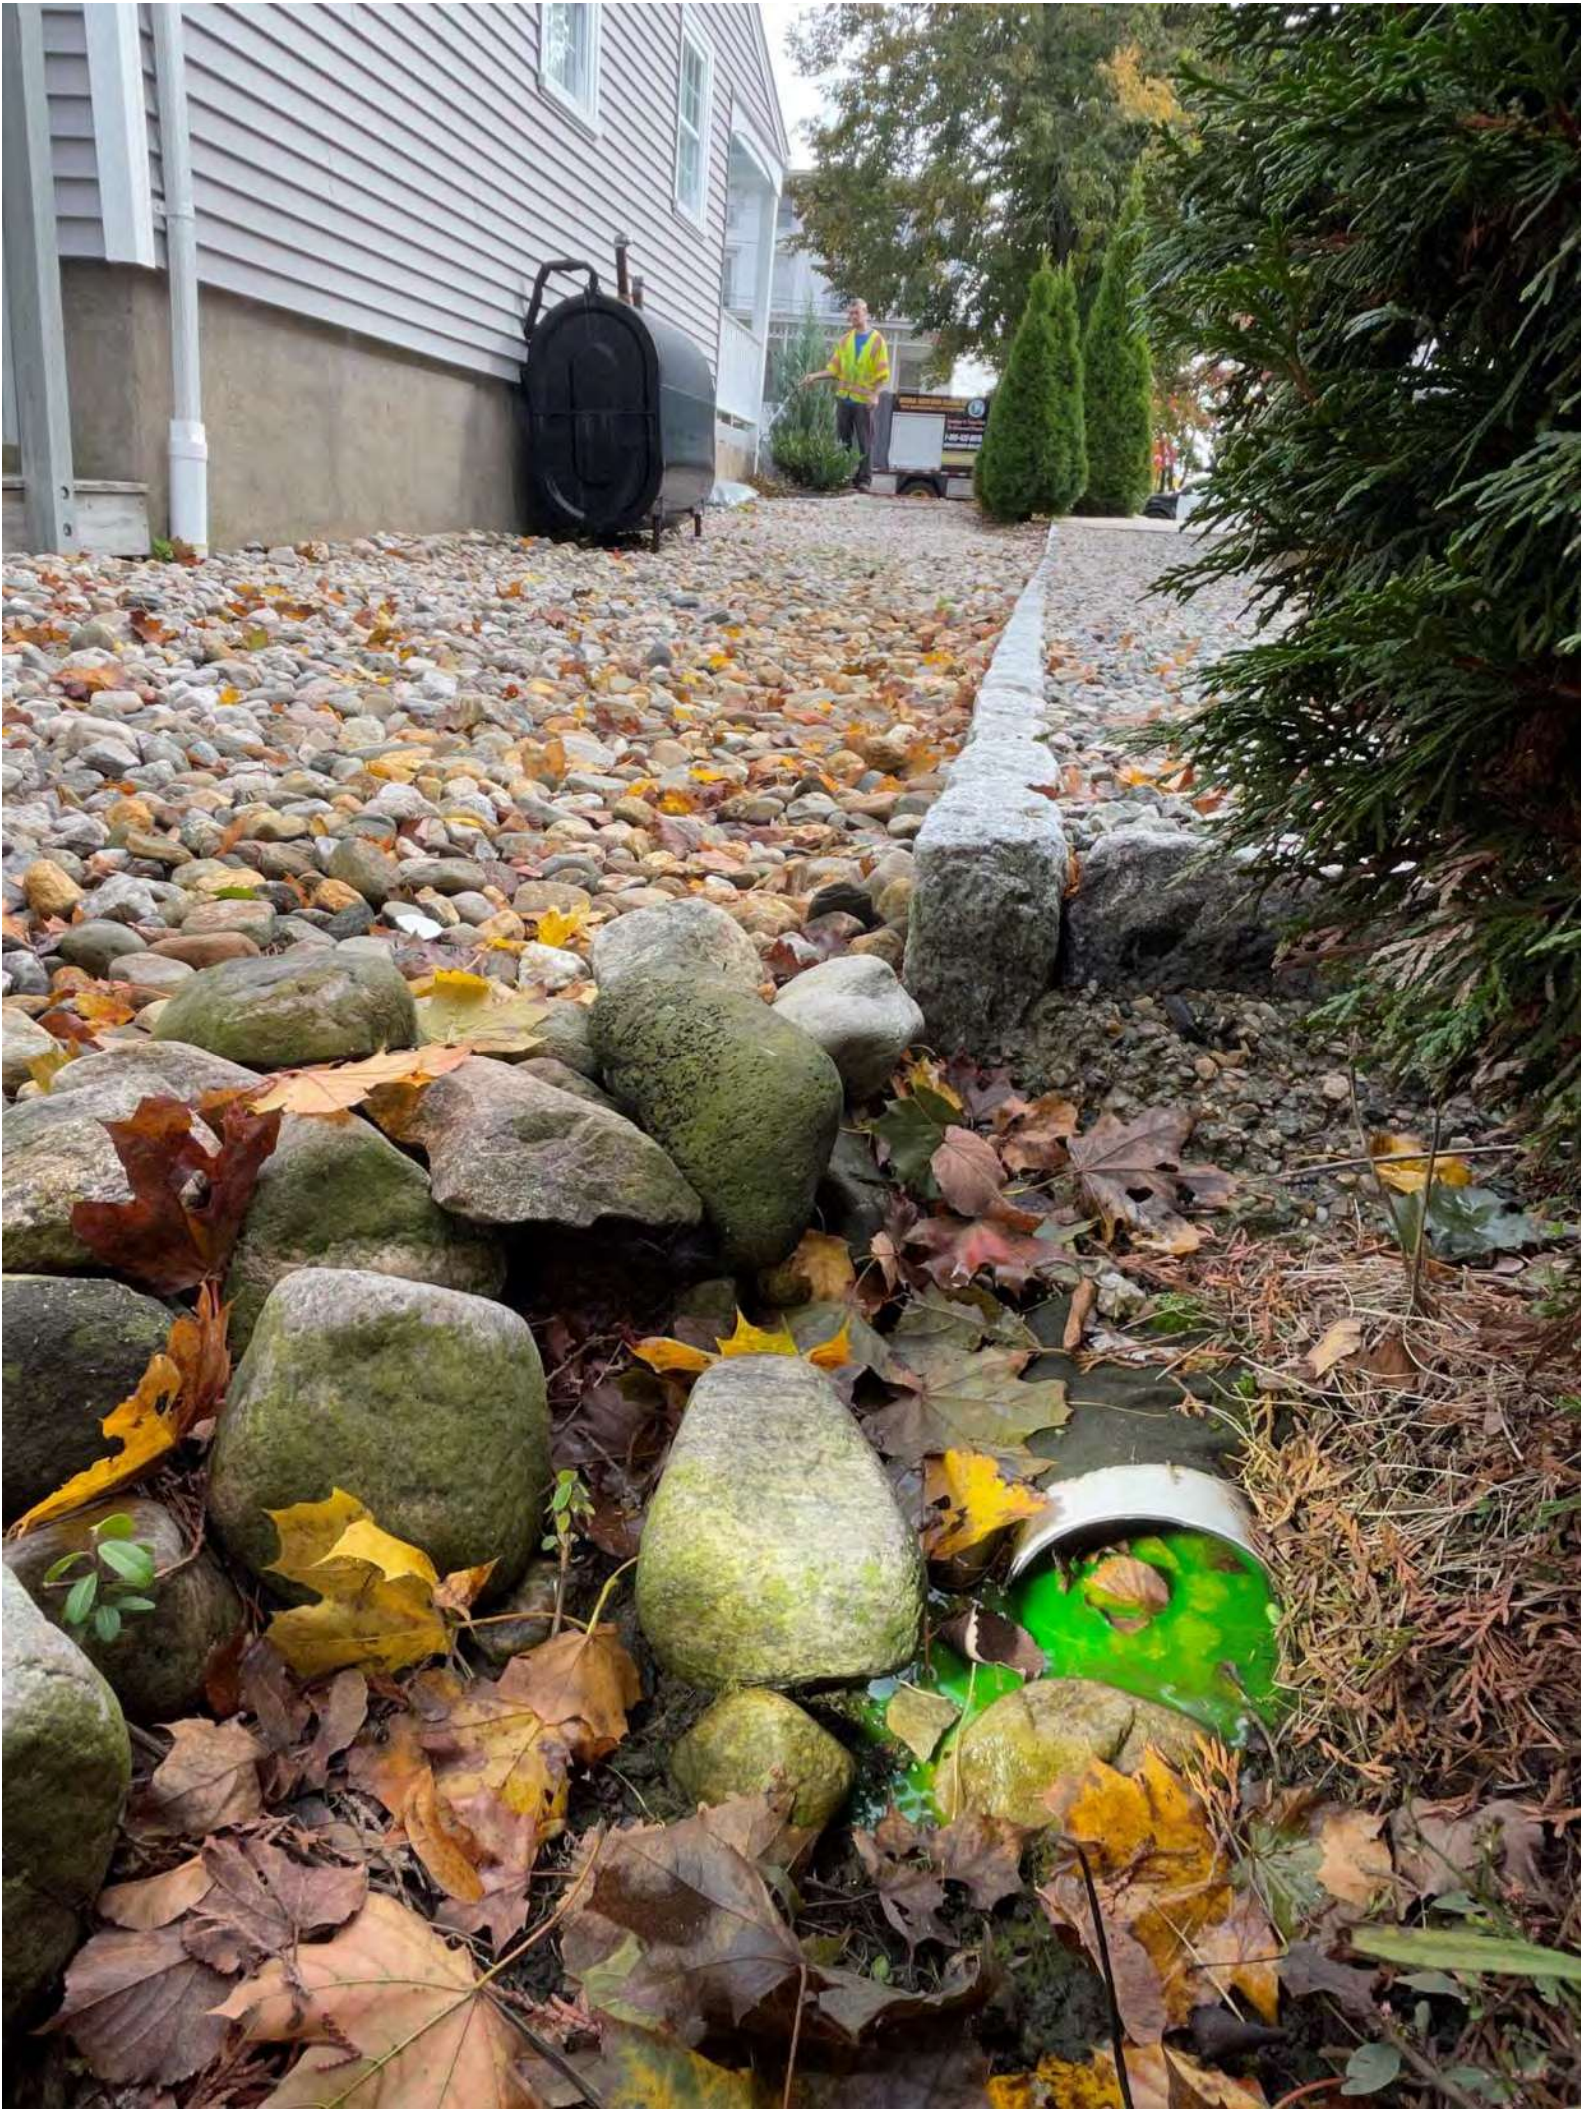
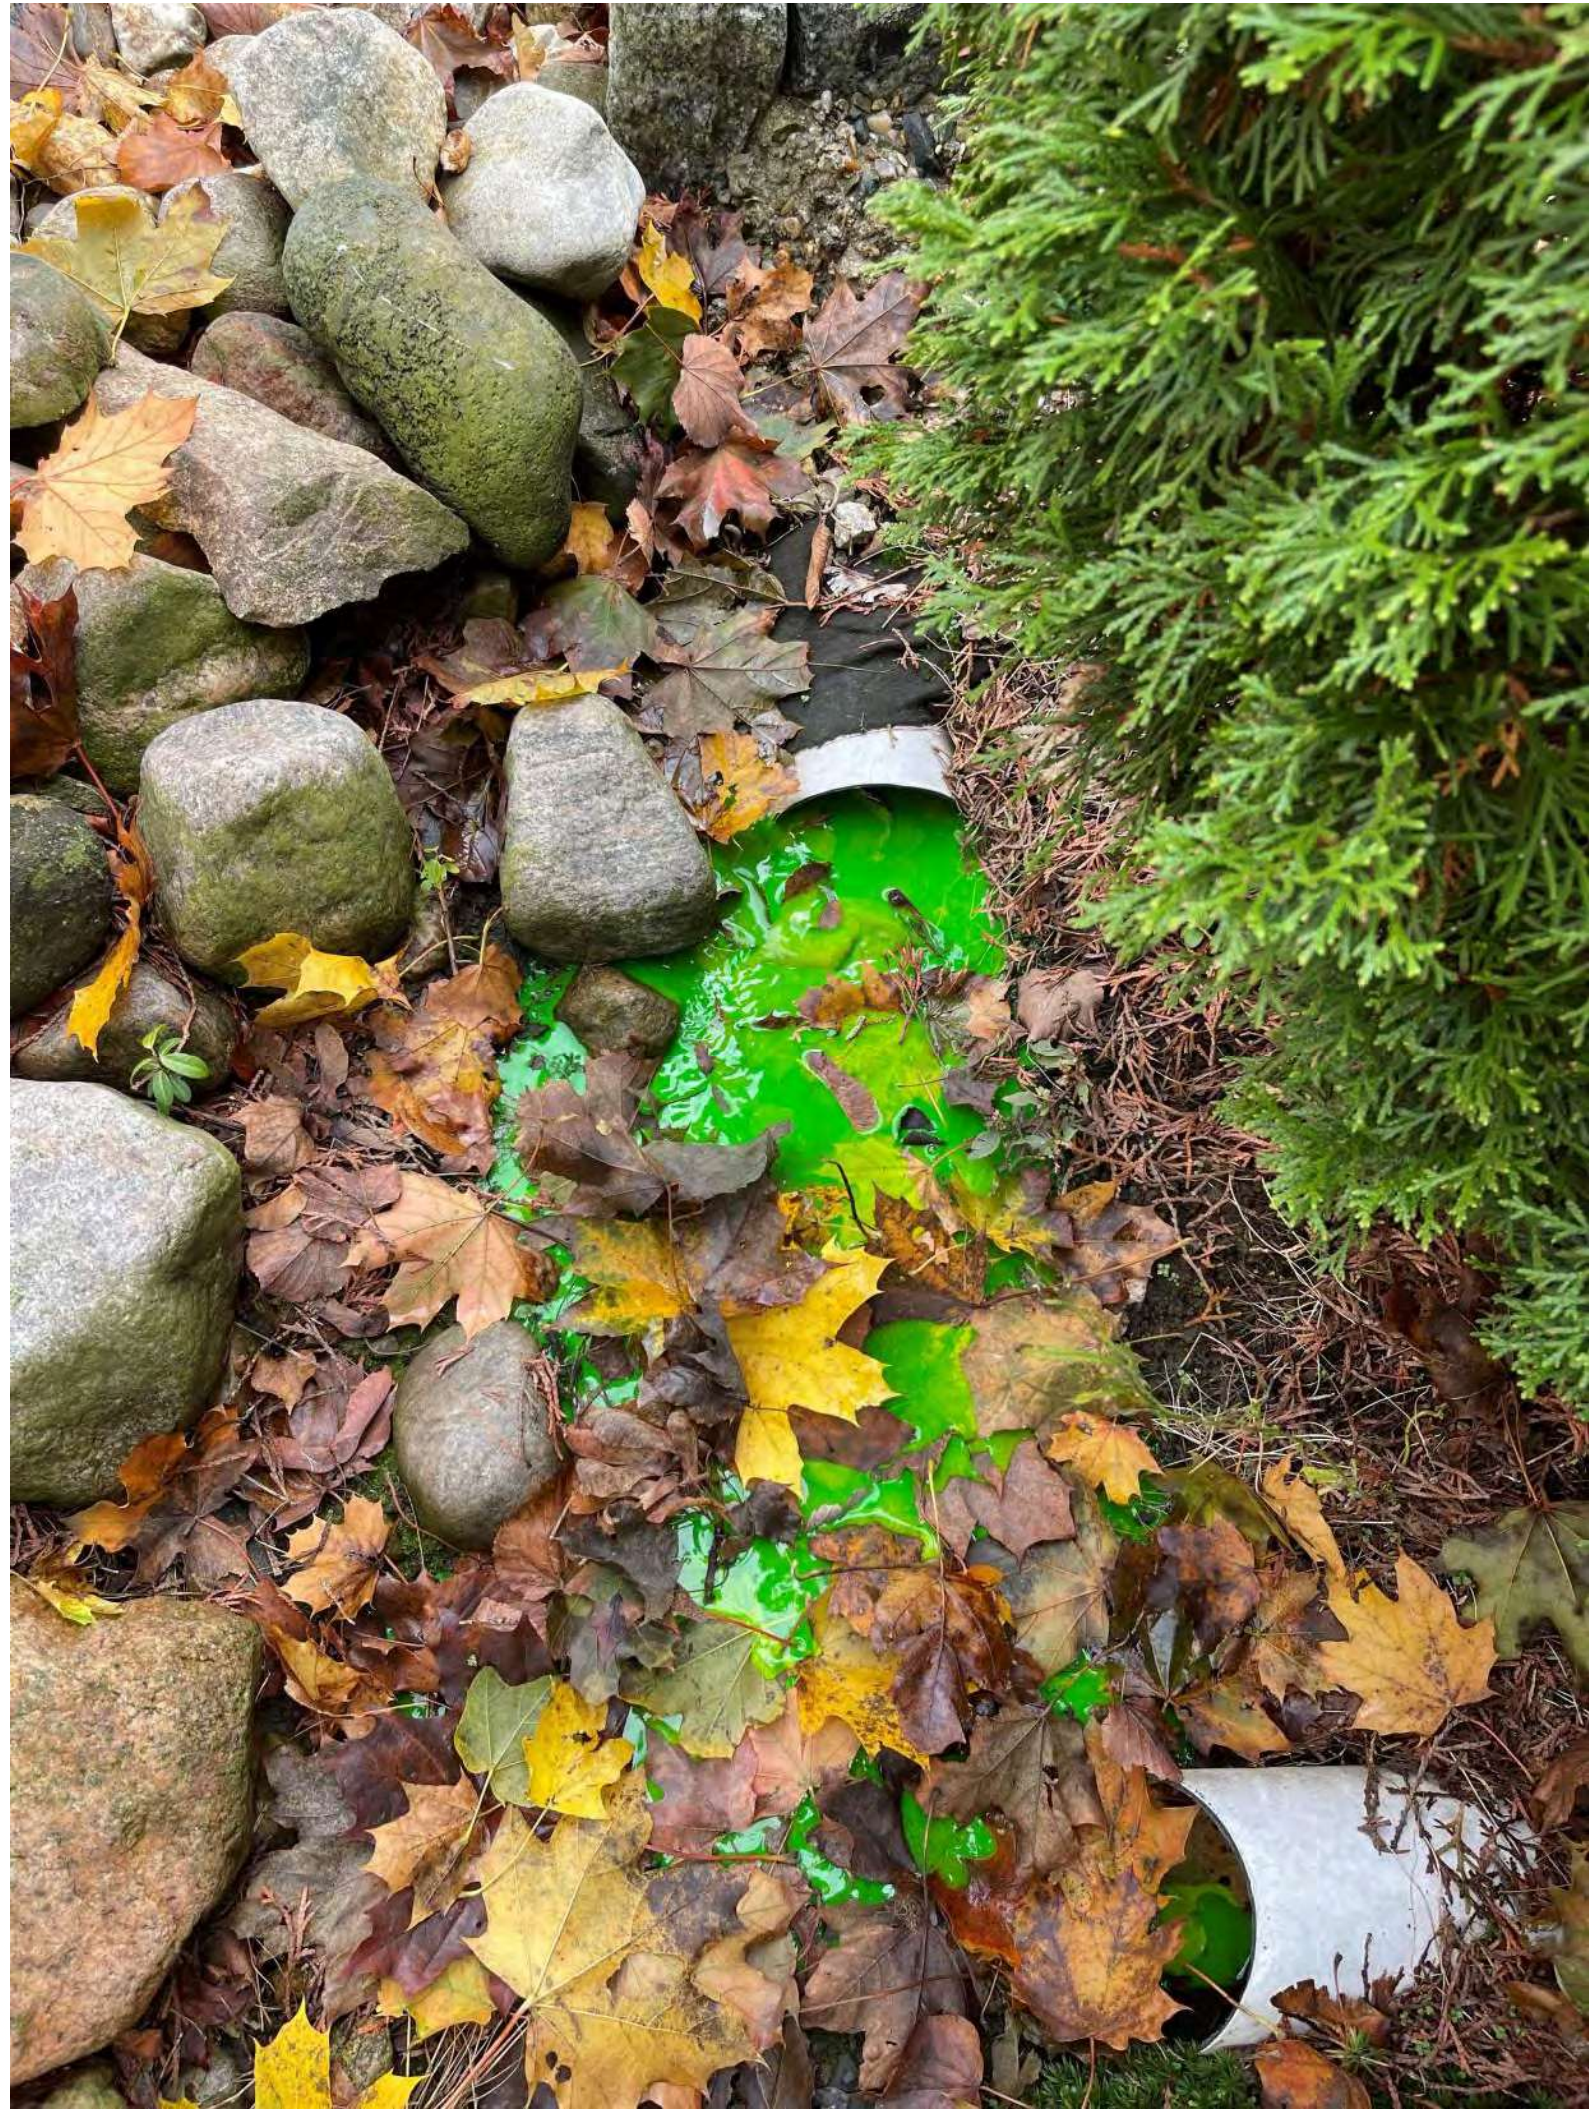
6 Jackson Avenue

\* Roof leaders connect and dye was observed  
at end of roof leader extension pipe in ground,  
exits at end of gravel driveway in yard.  
See photos
