### Mystic Area Dye Water Testing Results

# DYED-WATER FLOODING

STONINGTON, CONNECTICUT 06355

OCTOBER 2022  
MCA PROJECT NO.: 2021-335

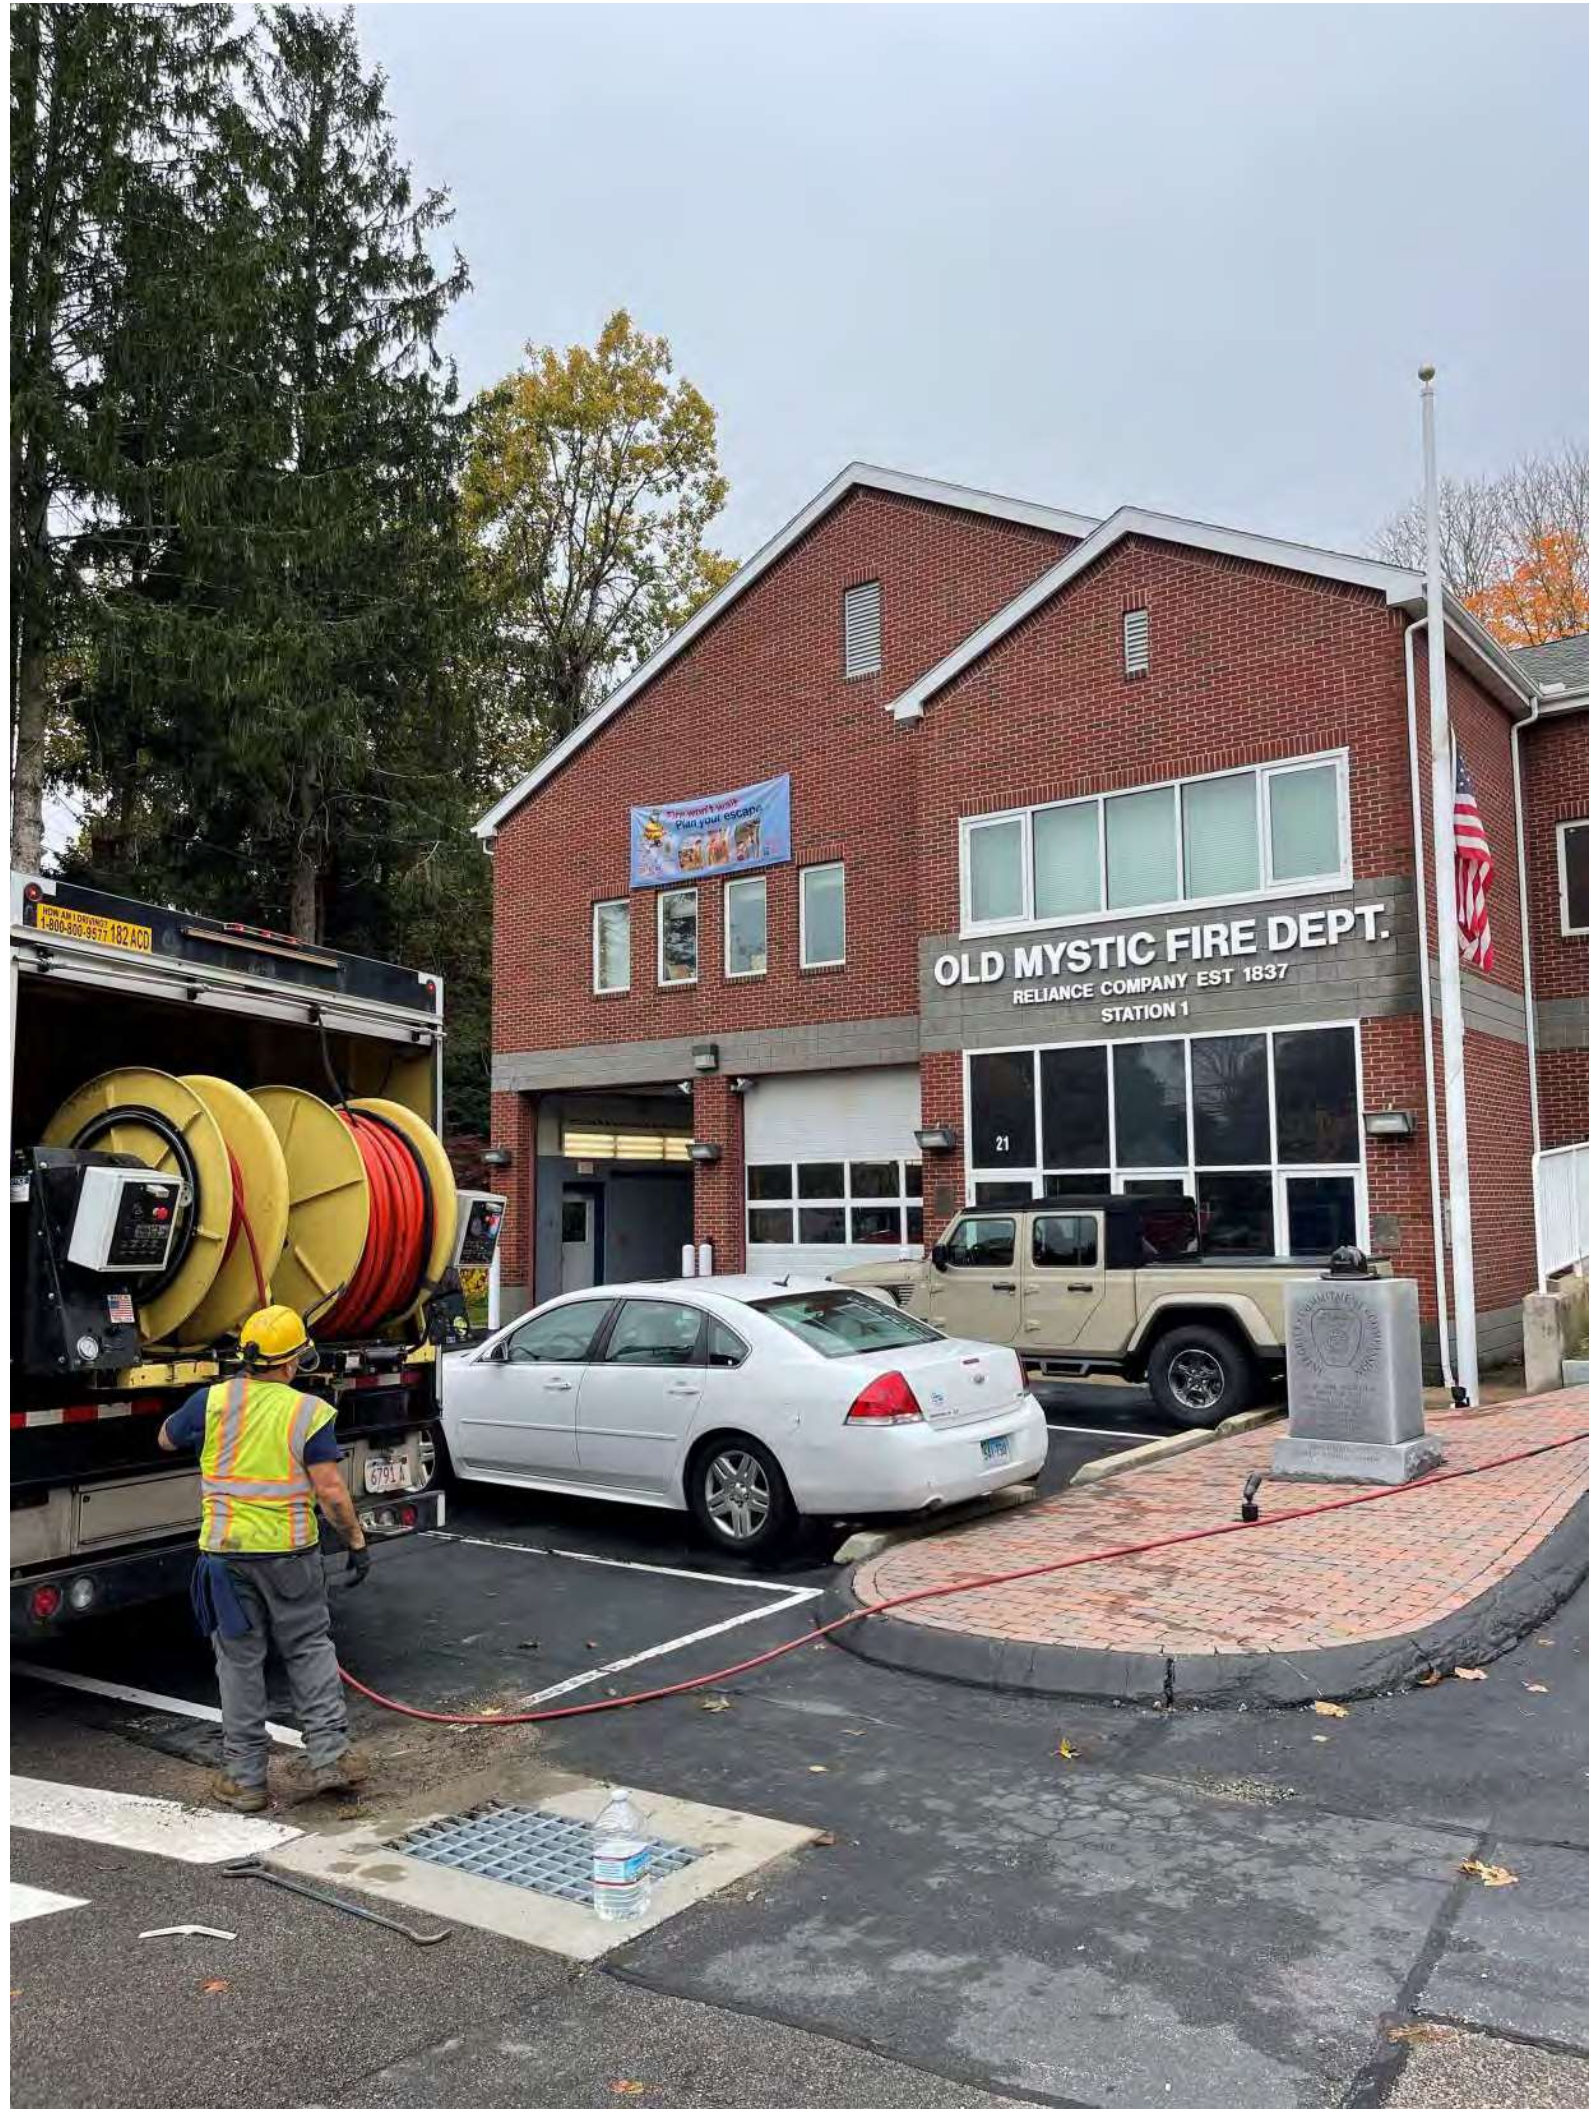
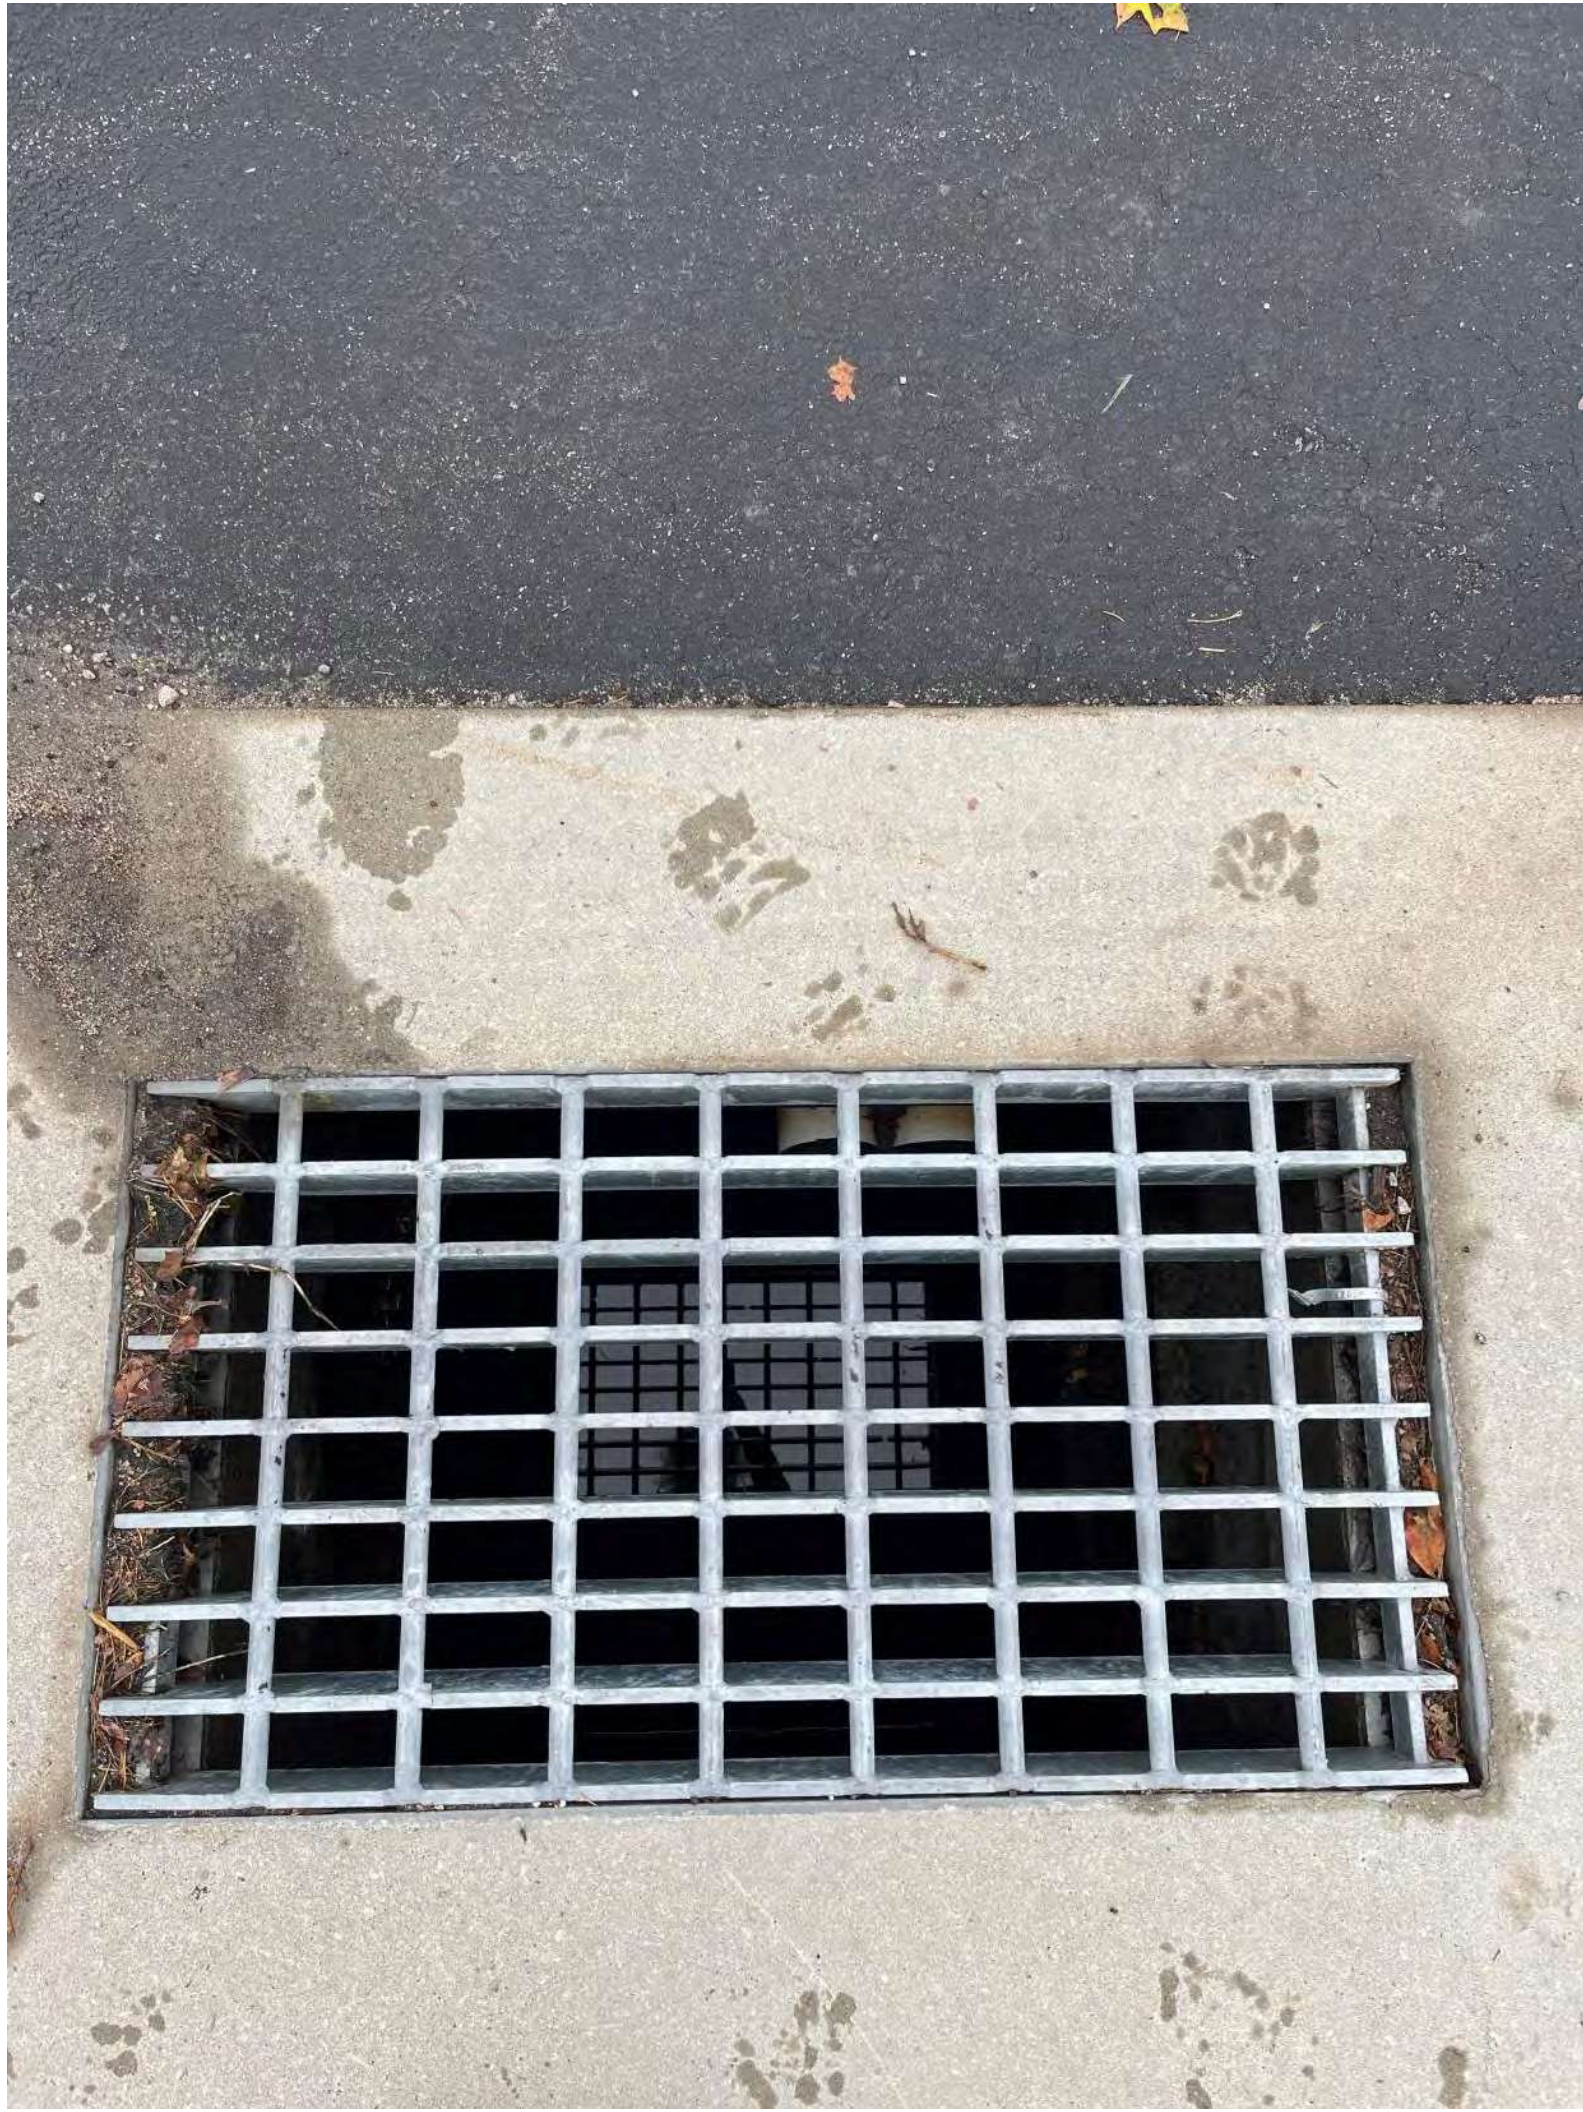
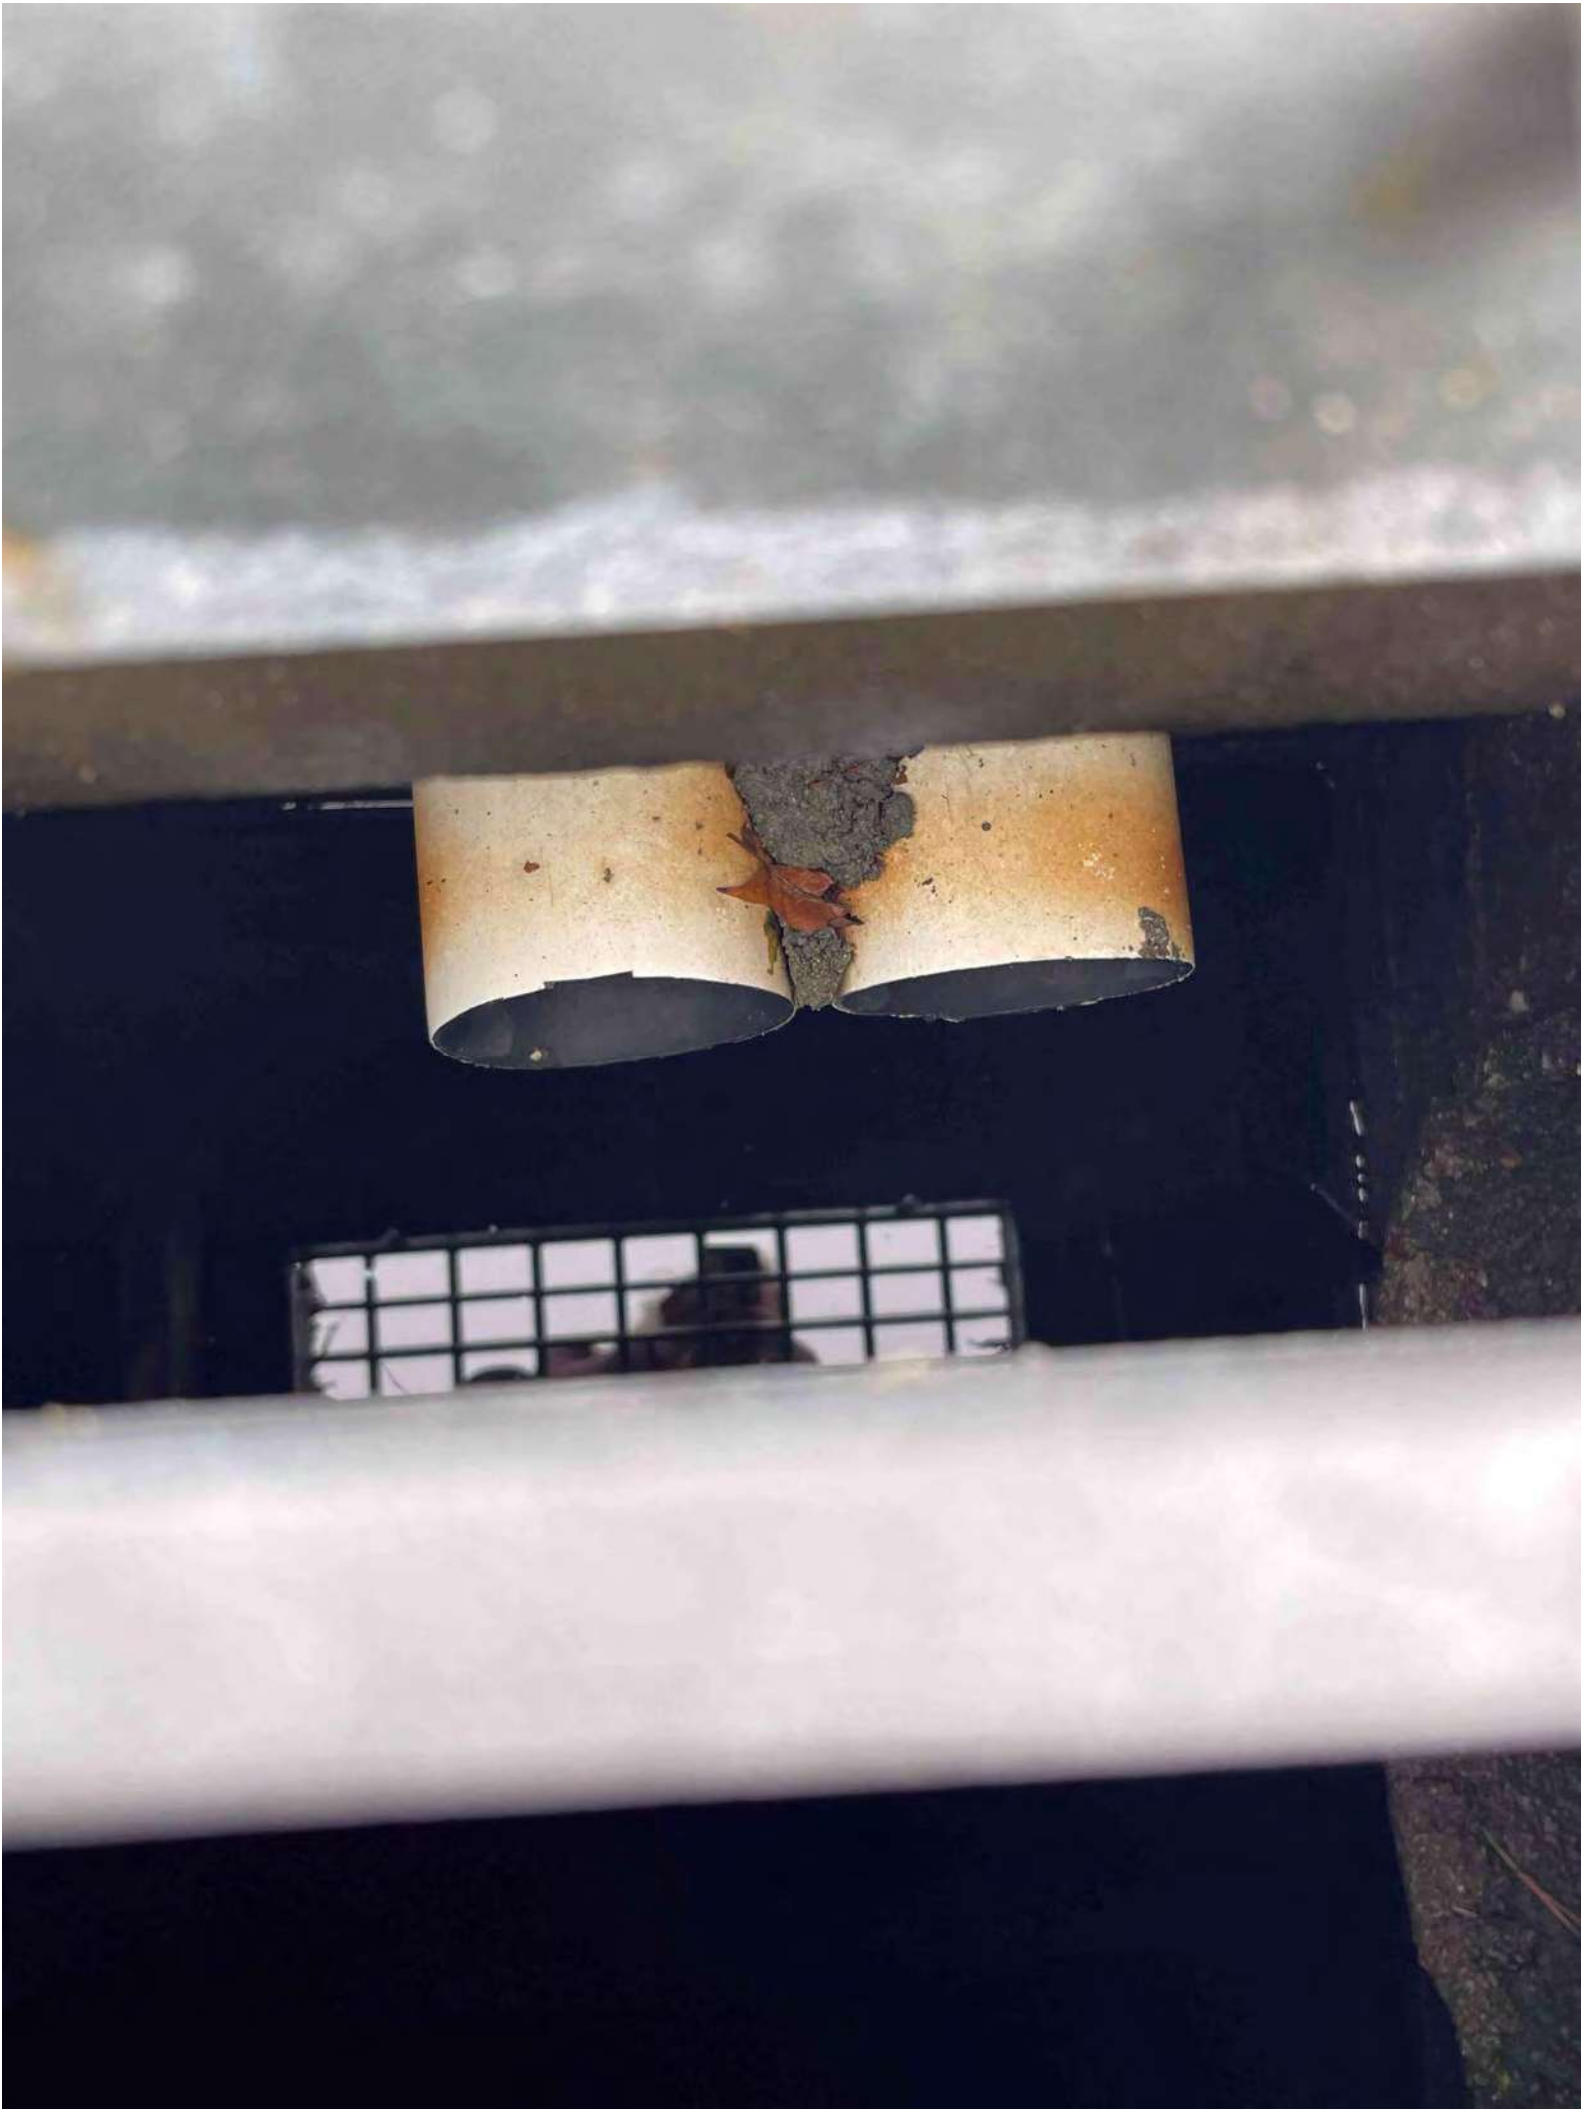
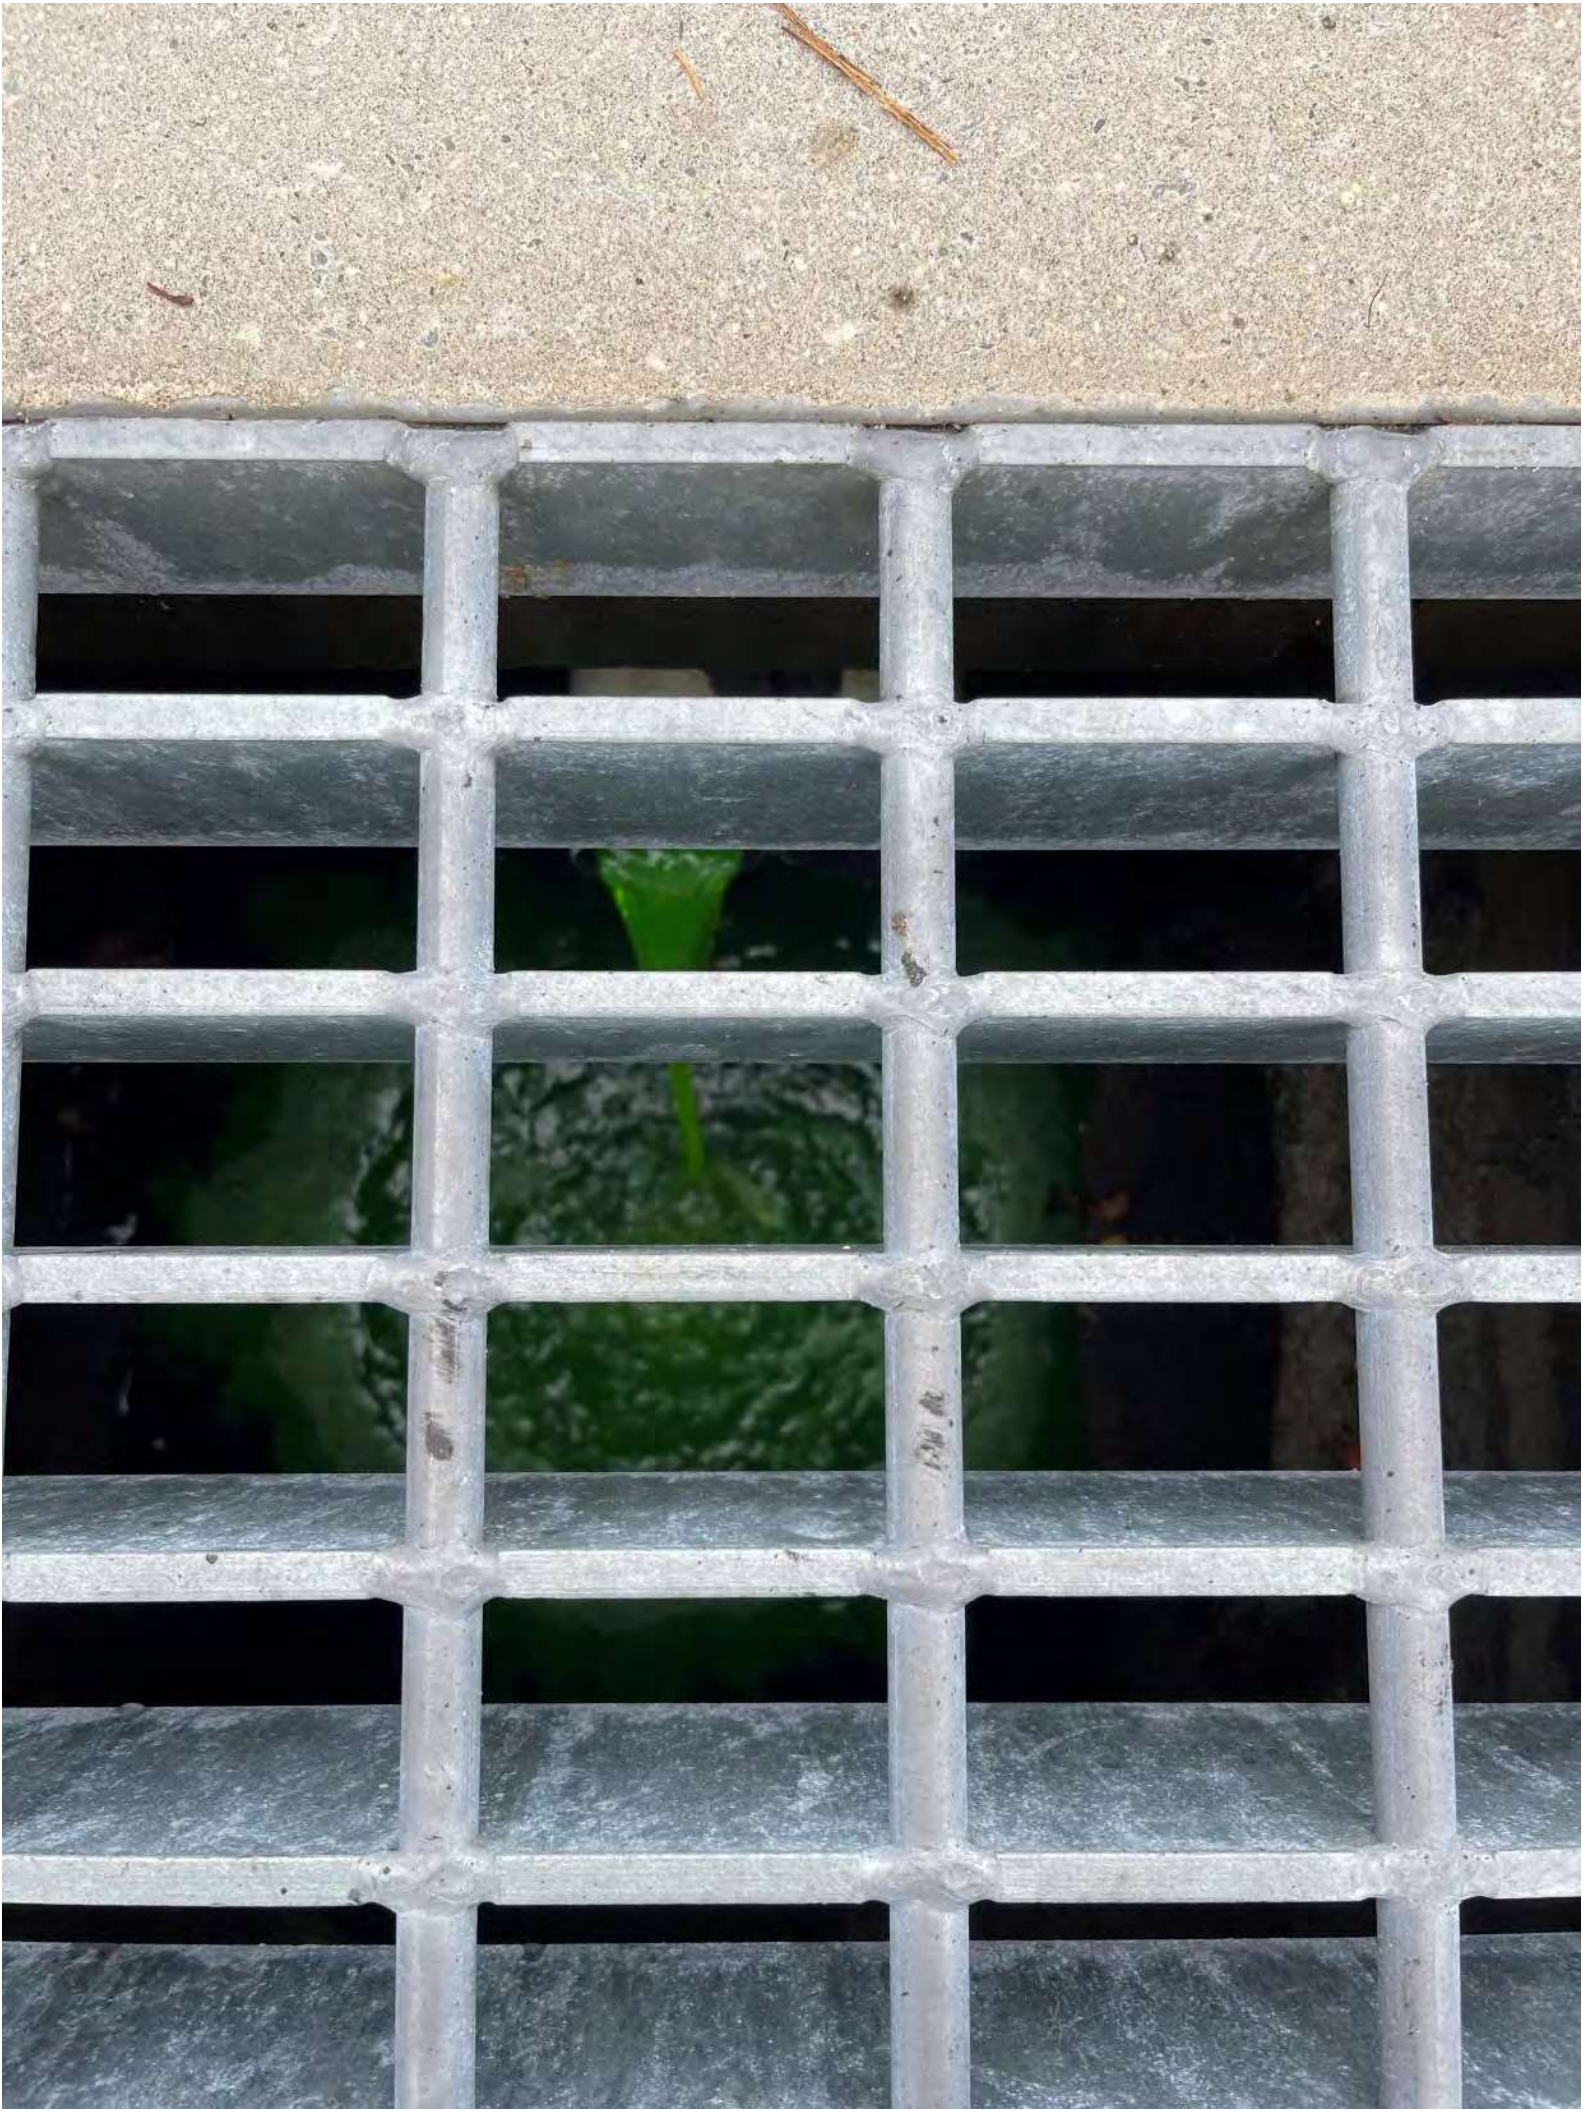
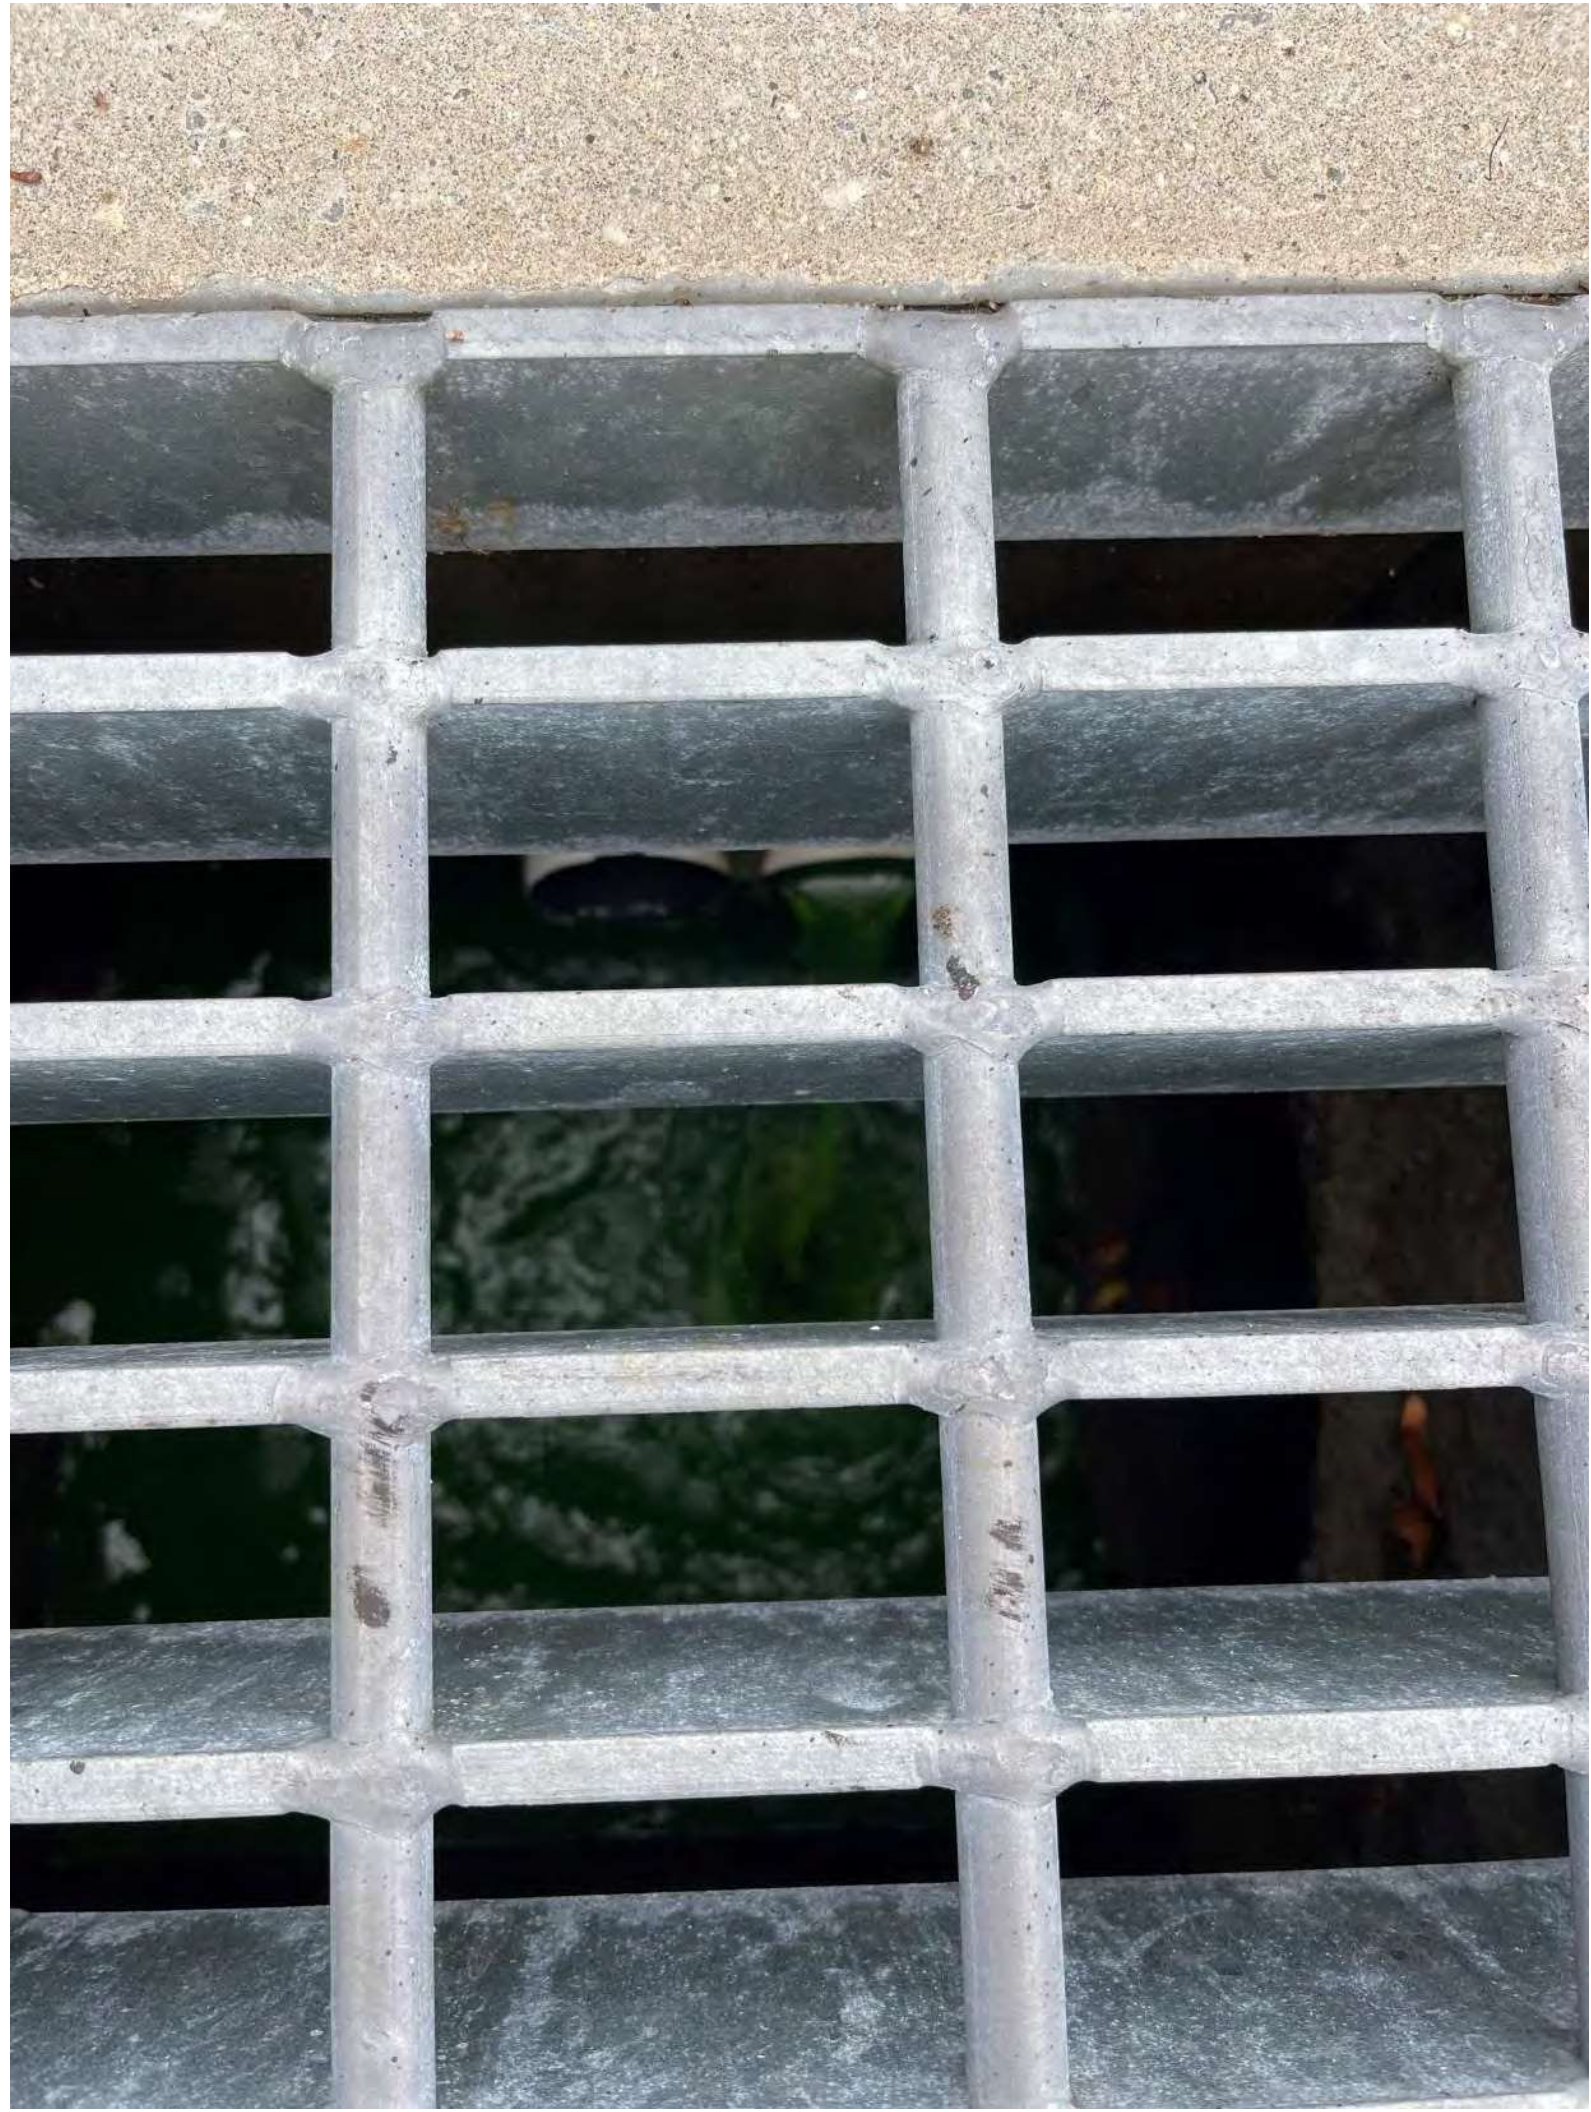
21 N. Stonington Road

- \* 8 total roof leaders, 6 into ground
- \* Truck bay drains connect to OWS in front of fire station as intended. OWS connects to sanitary sewer as it should.
- \* All (6) roof leaders go into ground and connect to storm drainage system. They drain into CB in front of fire station
- \* Stonington WPCA was present for testing
- \* Dan from WPCA confirmed that fire station was redone/upgraded ~20 years ago and truck bay drains were connected to sanitary
