### Mystic Area Dye Water Testing Results

# DYED-WATER FLOODING

STONINGTON, CONNECTICUT 06355

OCTOBER 2022  
MCA PROJECT NO.: 2021-335

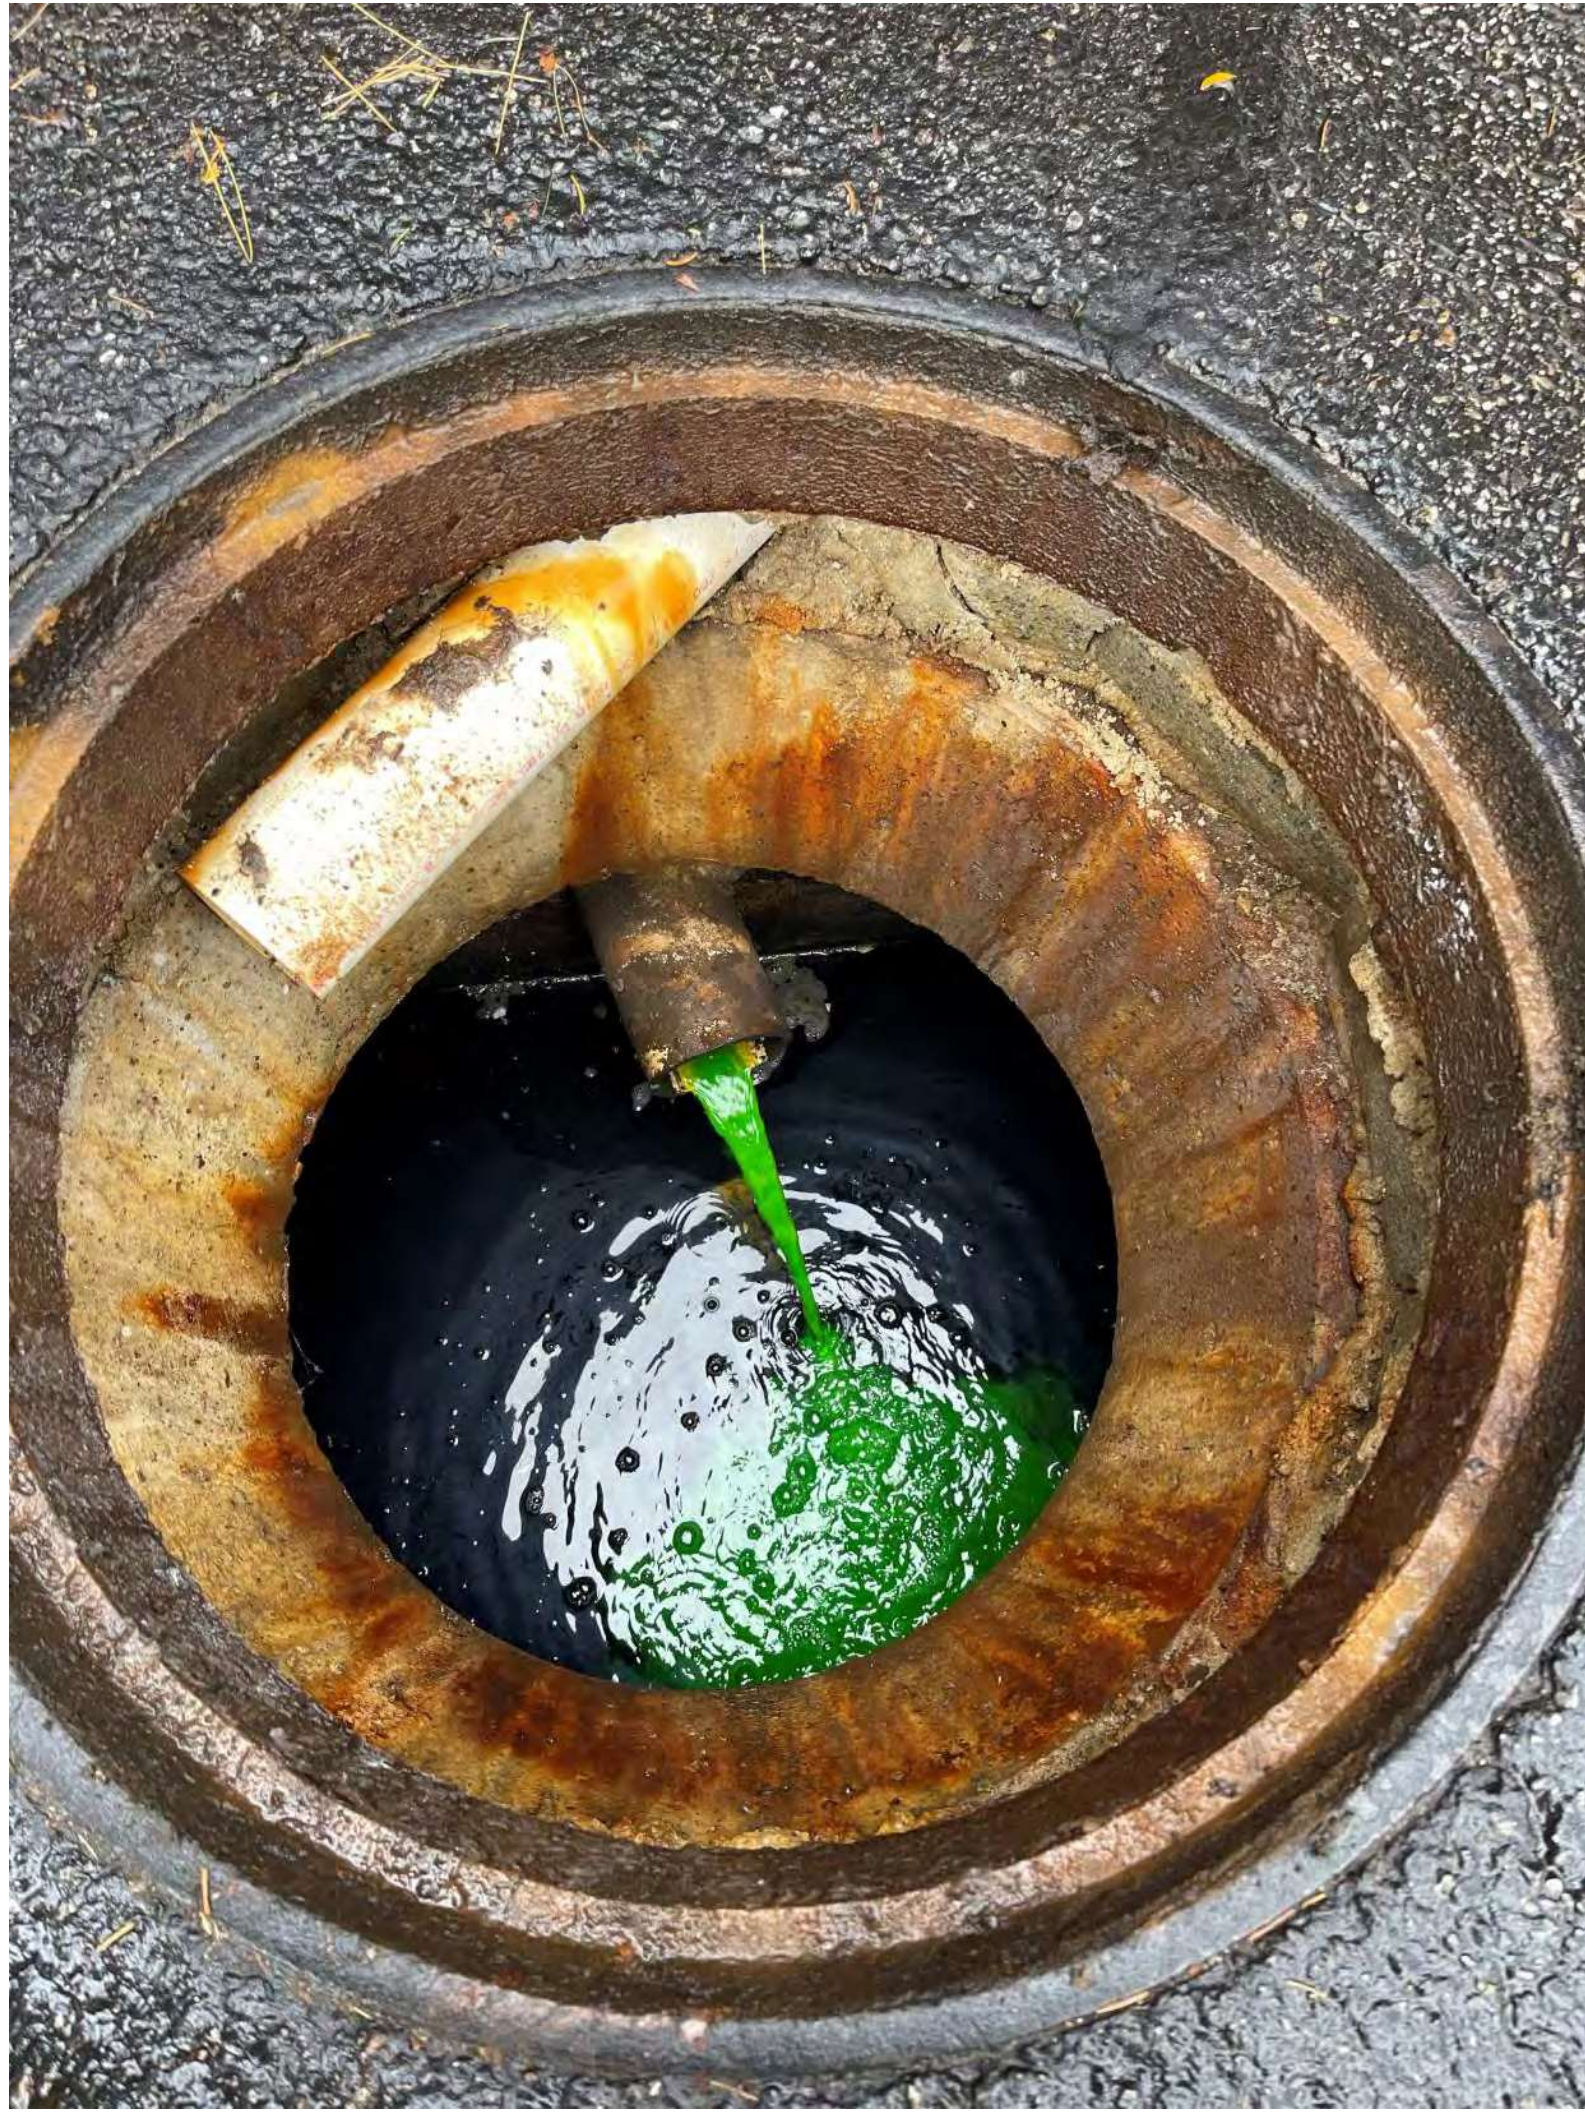
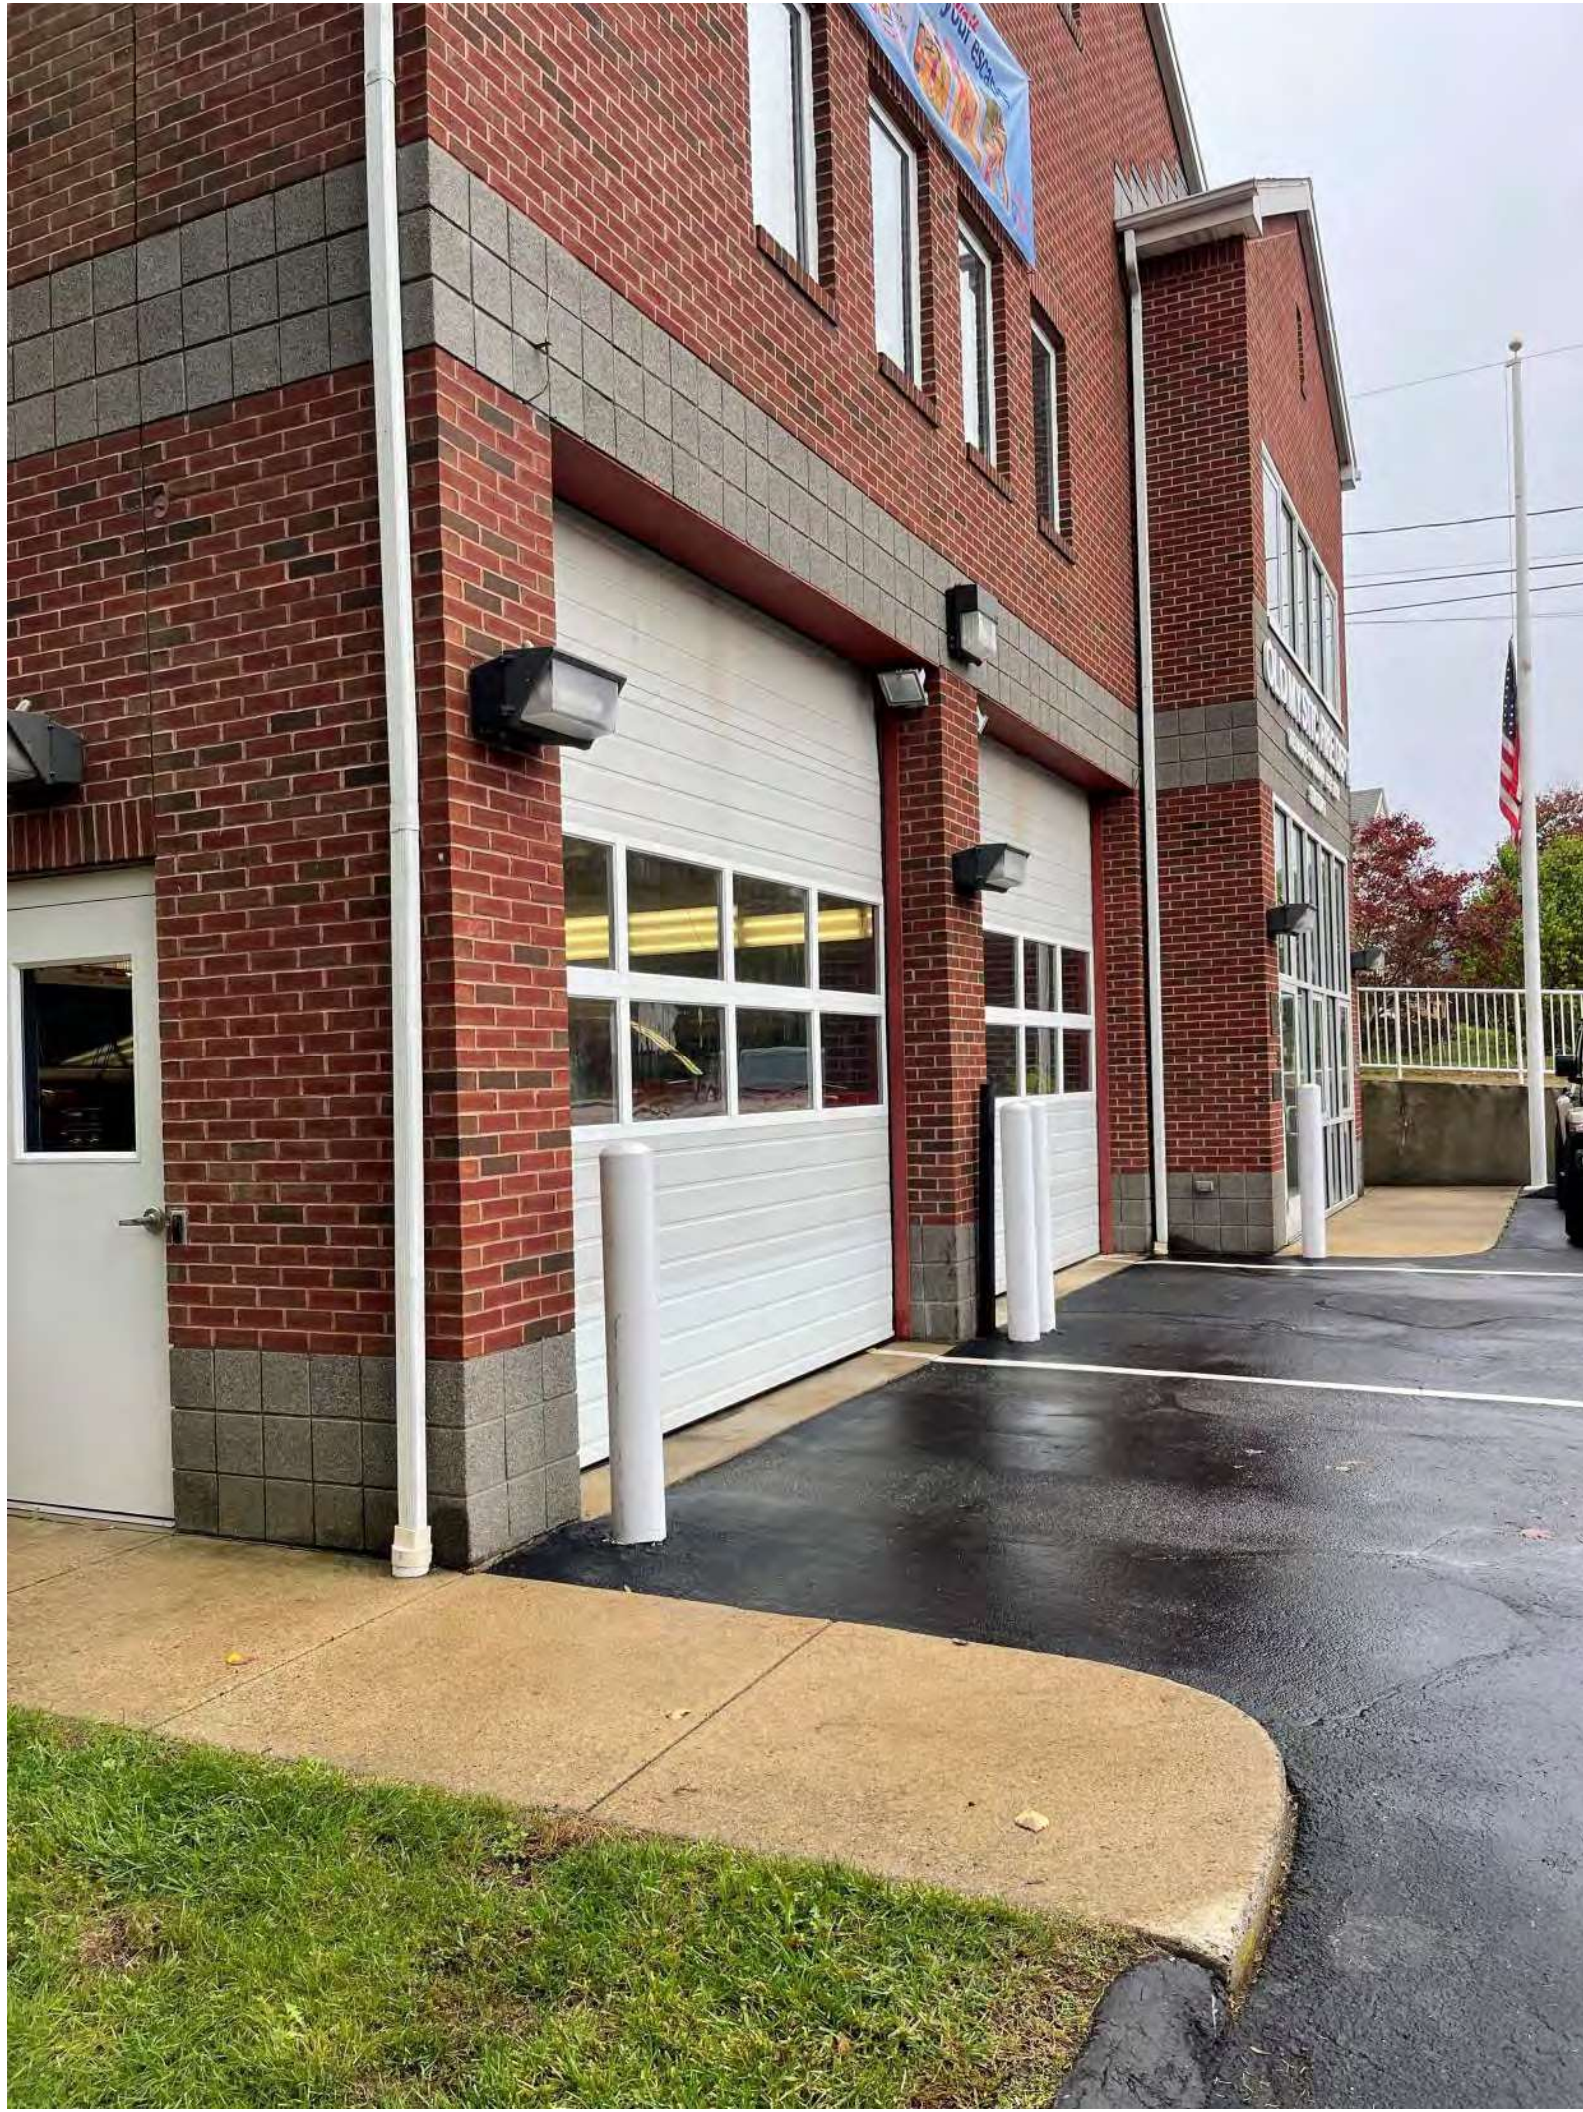
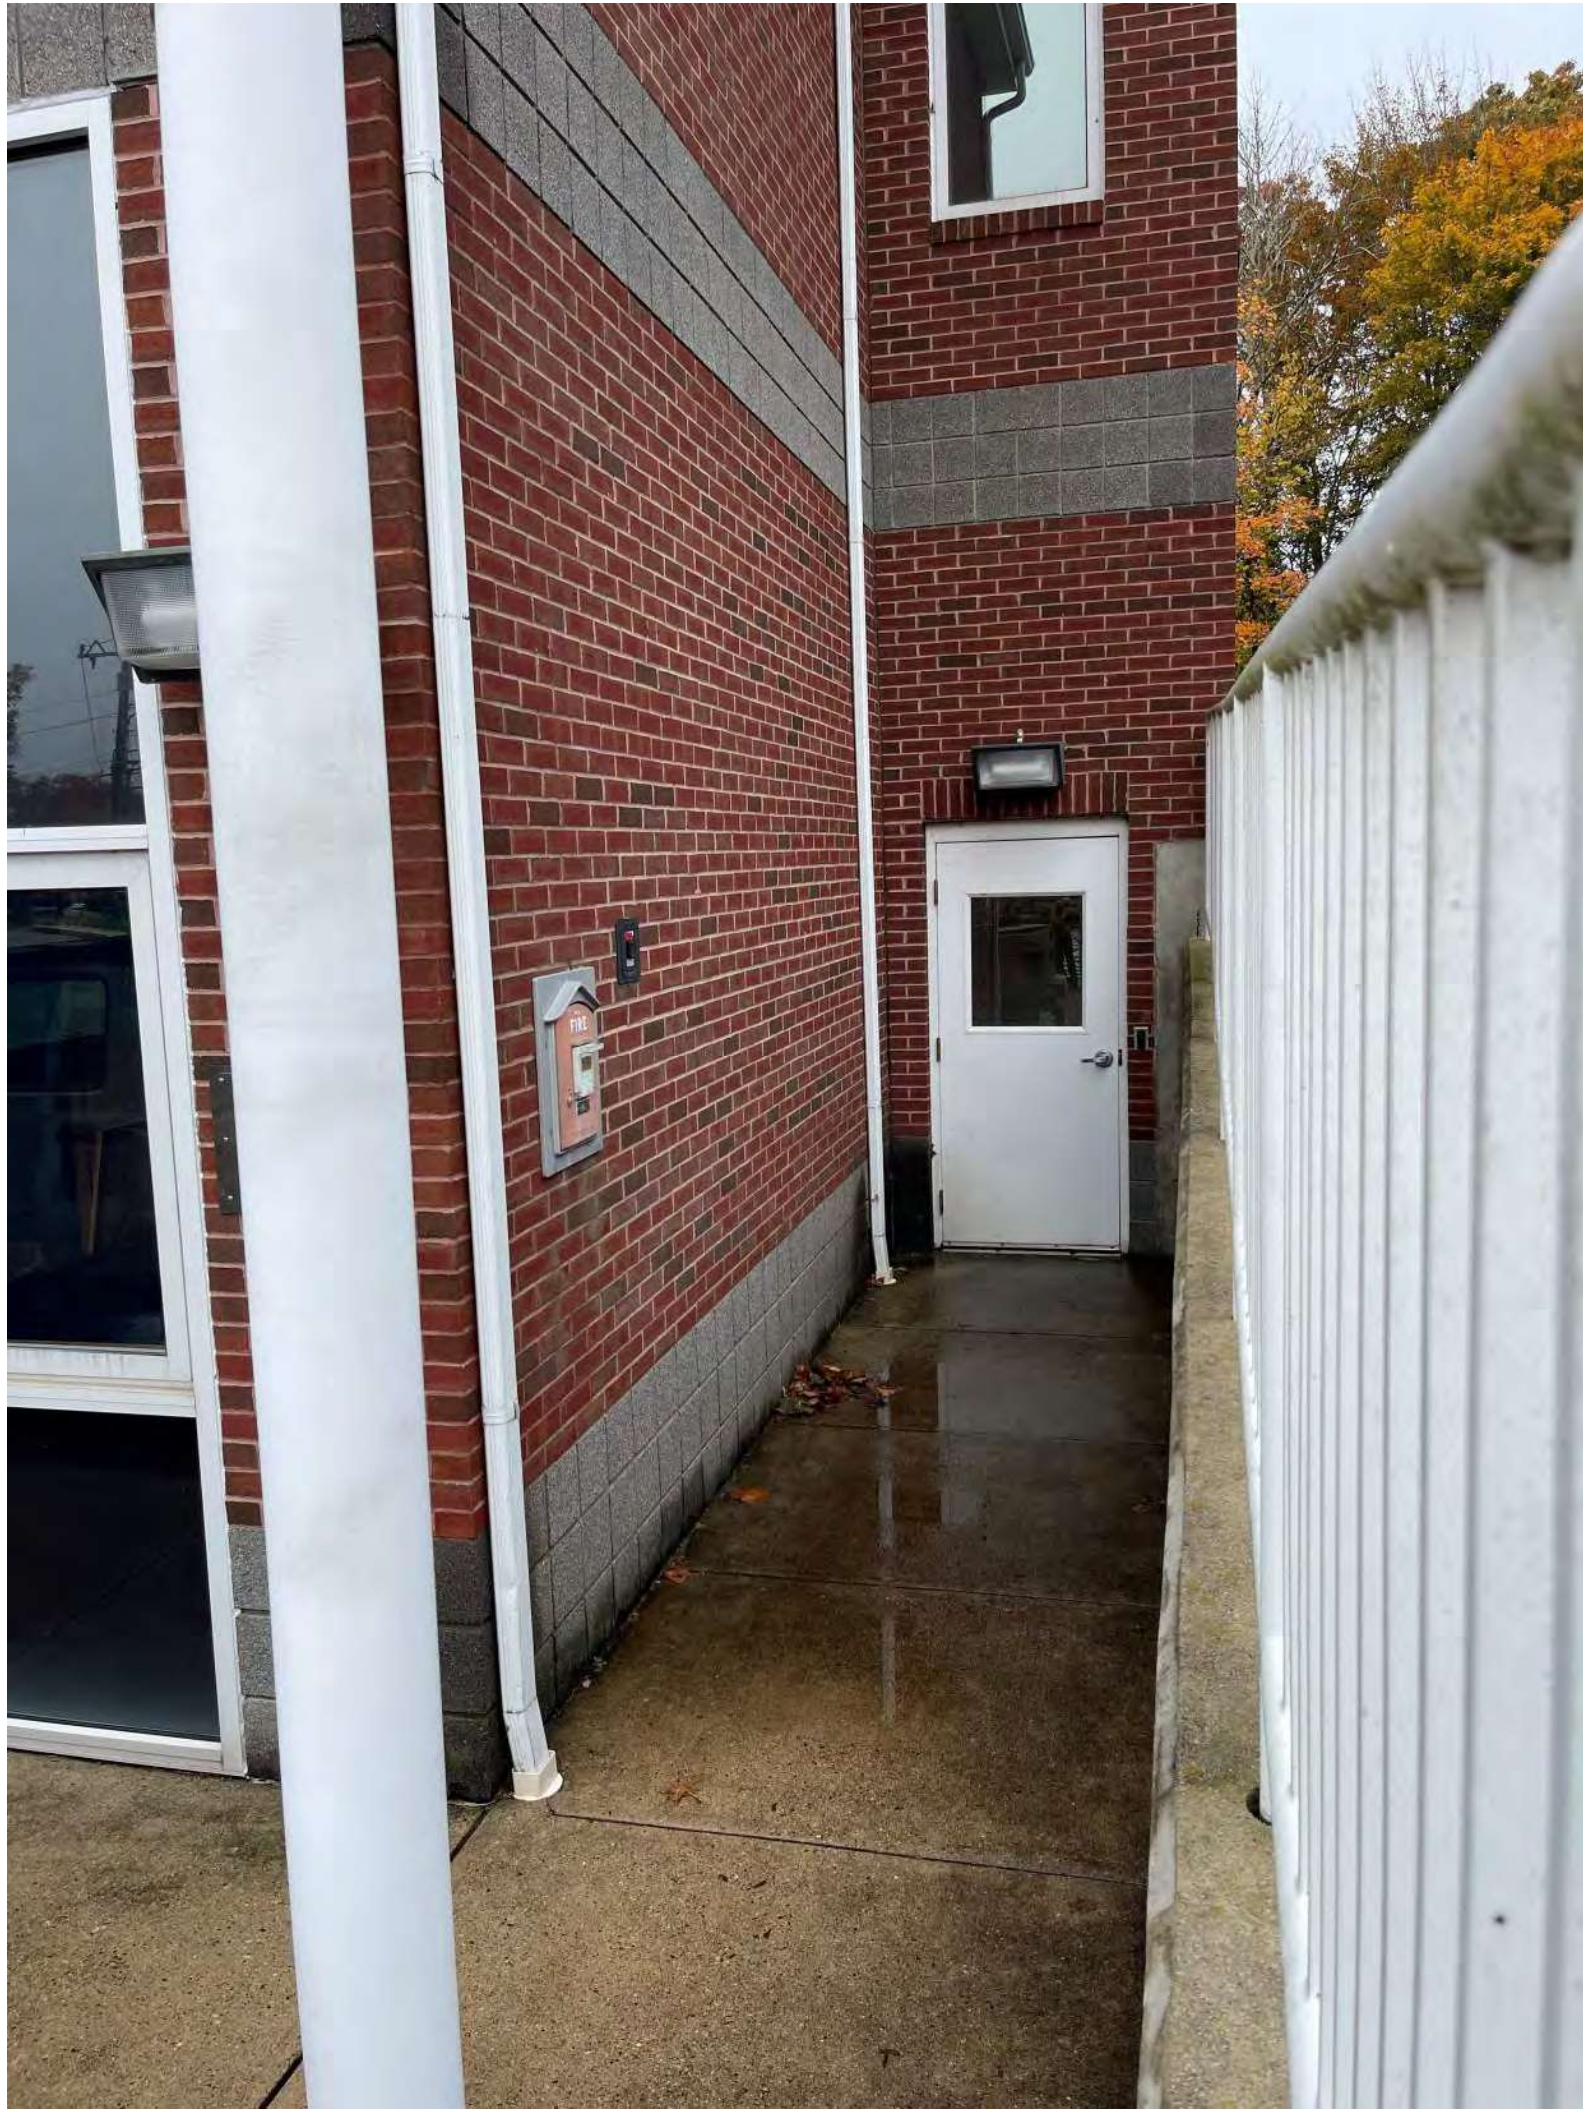
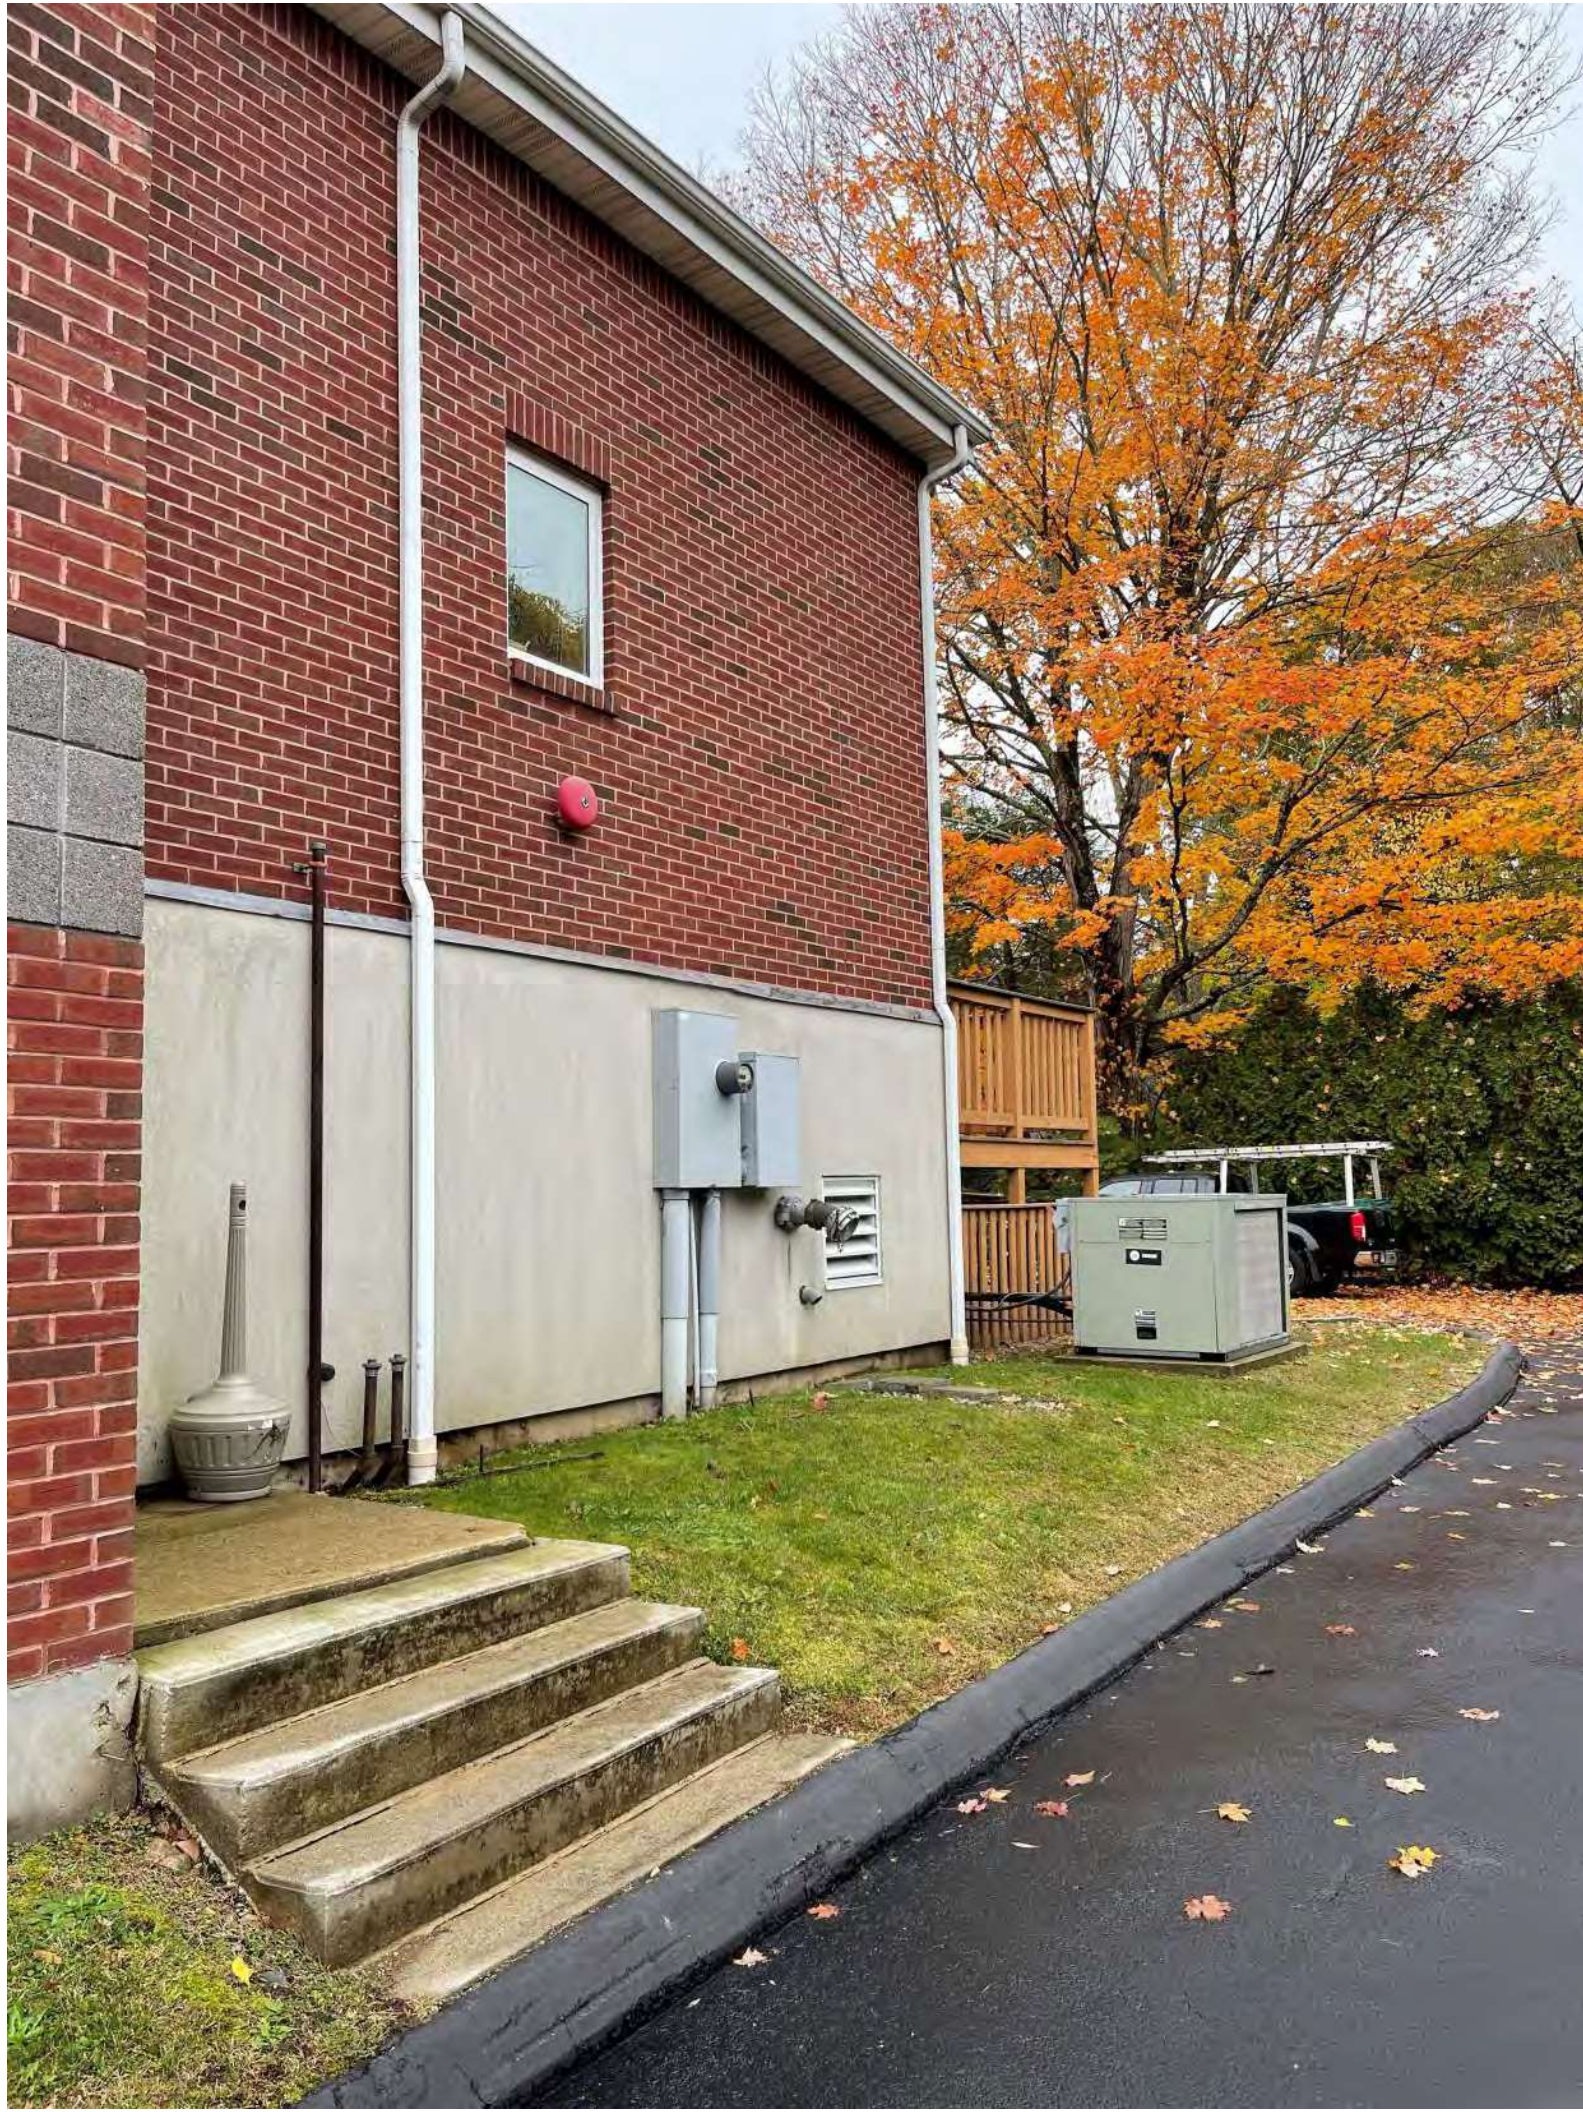
**Oil Water Separator**

- \* 8 total roof leaders, 6 into ground
- \* Truck bay drains connect to OWS in front of fire station as intended. OWS connects to sanitary sewer as it should.
- \* All (6) roof leaders go into ground and connect to storm drainage system. They drain into CB in front of fire station
- \* Stonington WPCA was present for testing
- \* Dan from WPCA confirmed that fire station was redone/upgraded ~20 years ago and truck bay drains were connected to sanitary
