### Mystic Area Dye Water Testing Results

# DYED-WATER FLOODING

STONINGTON, CONNECTICUT 06355

OCTOBER 2022  
MCA PROJECT NO.: 2021-335

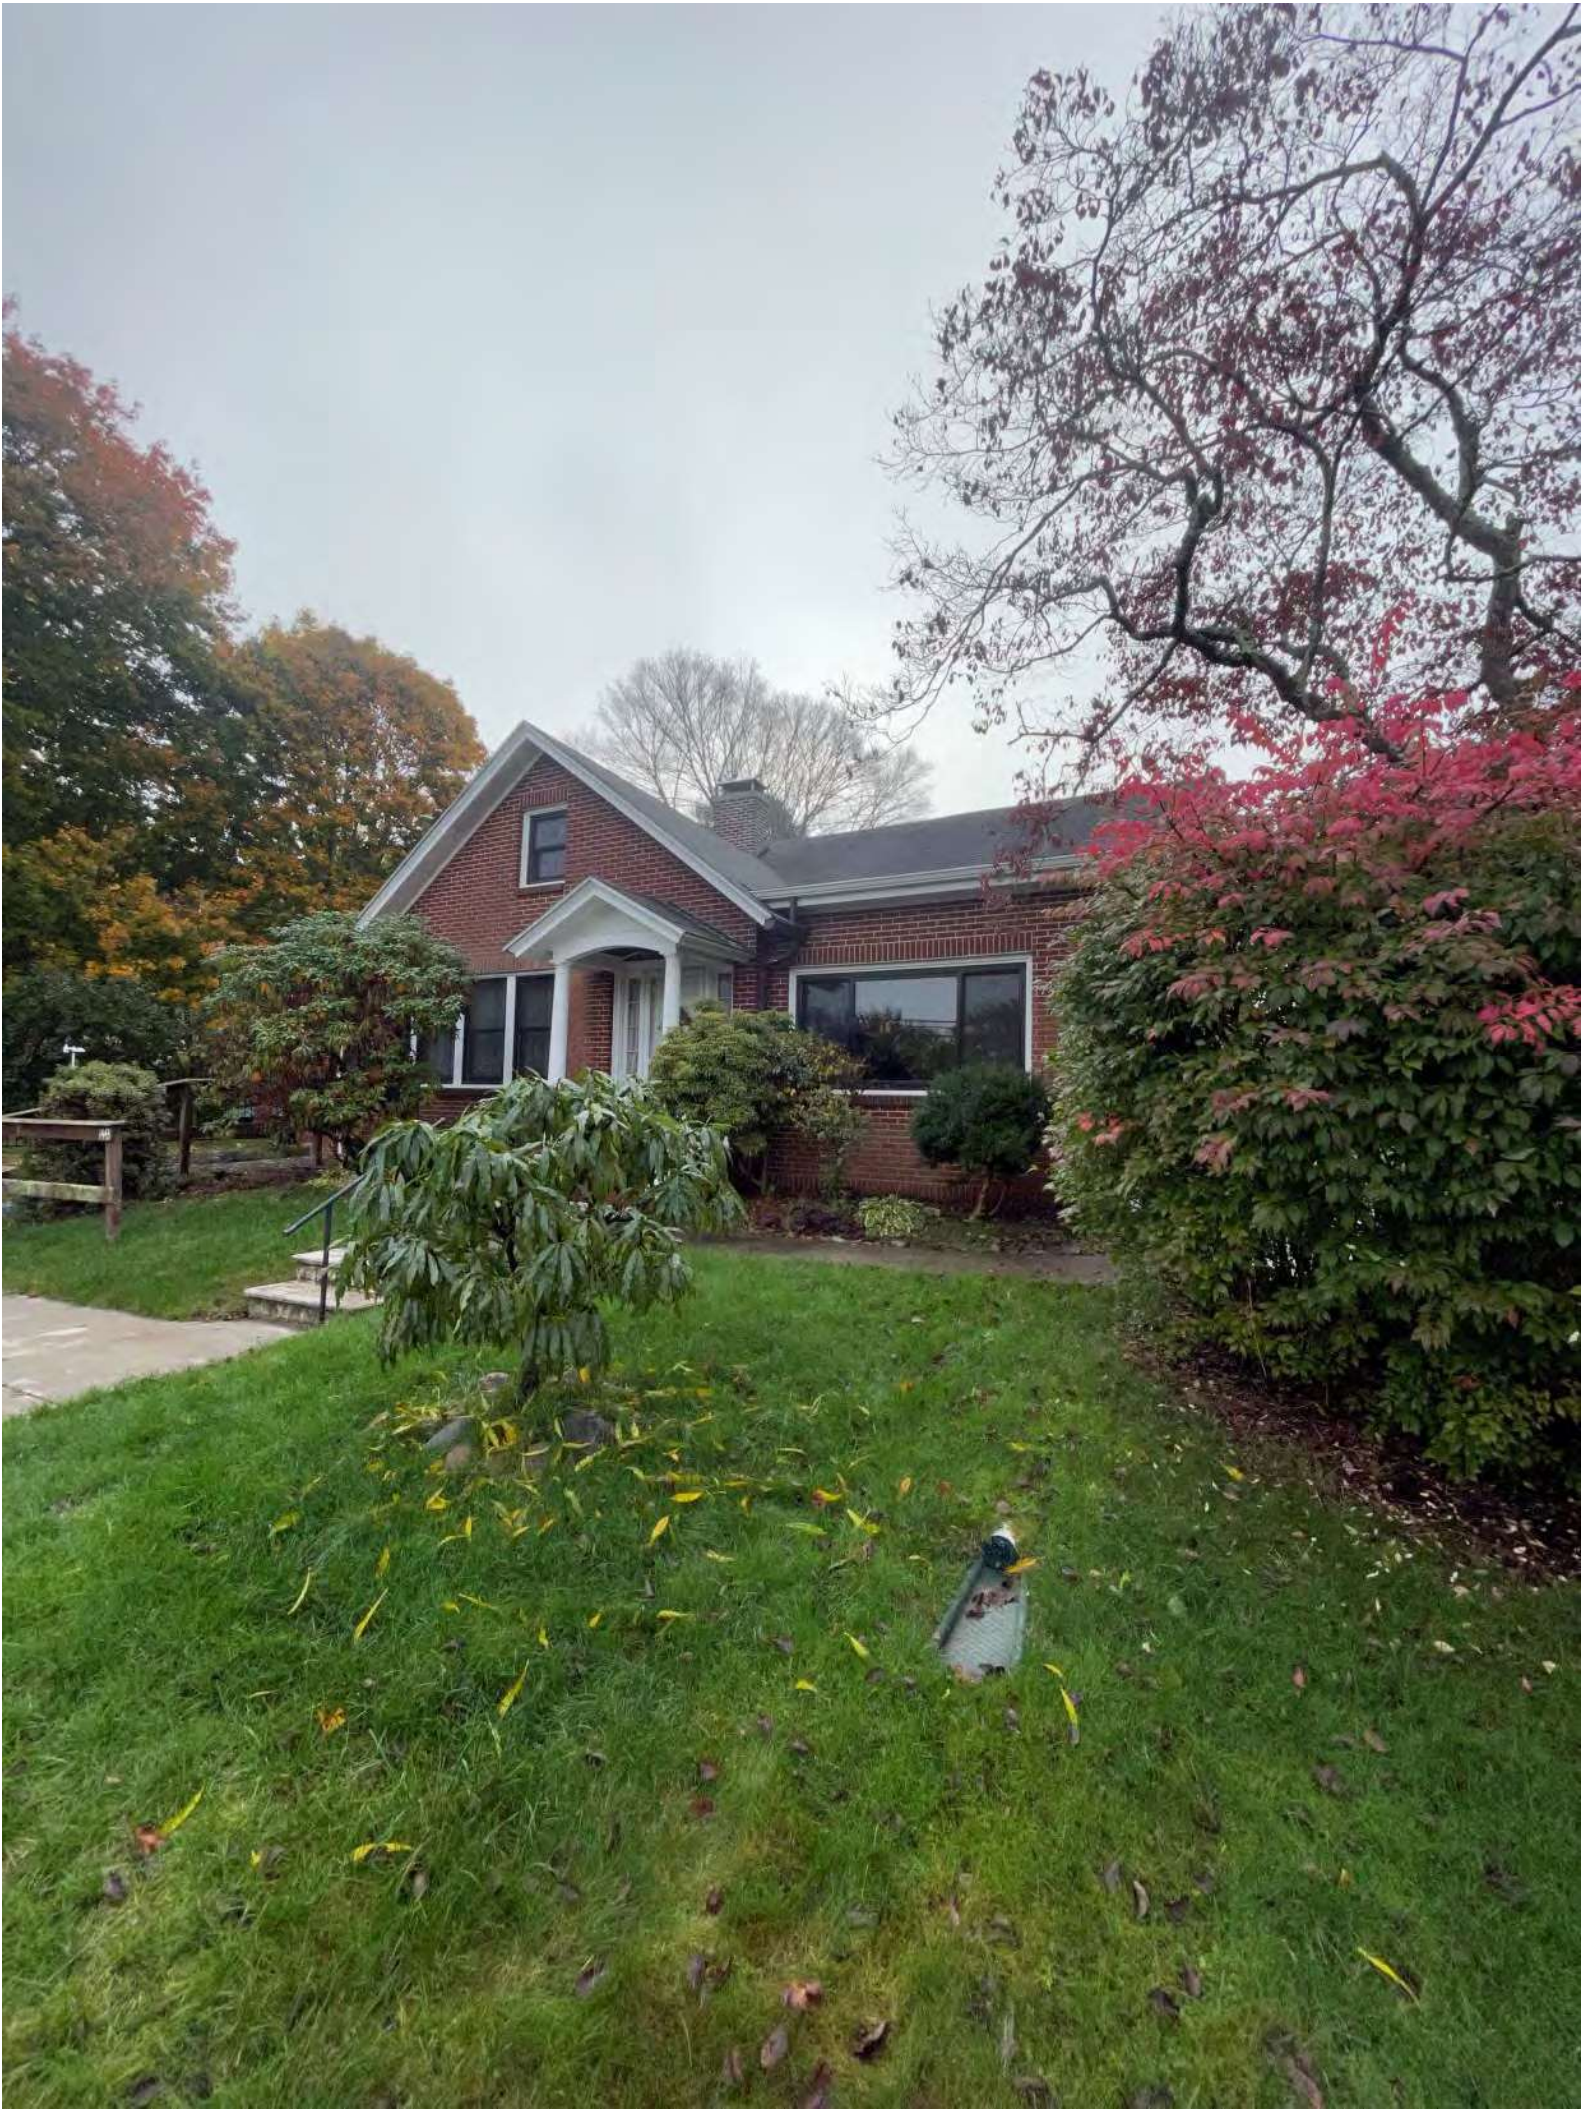
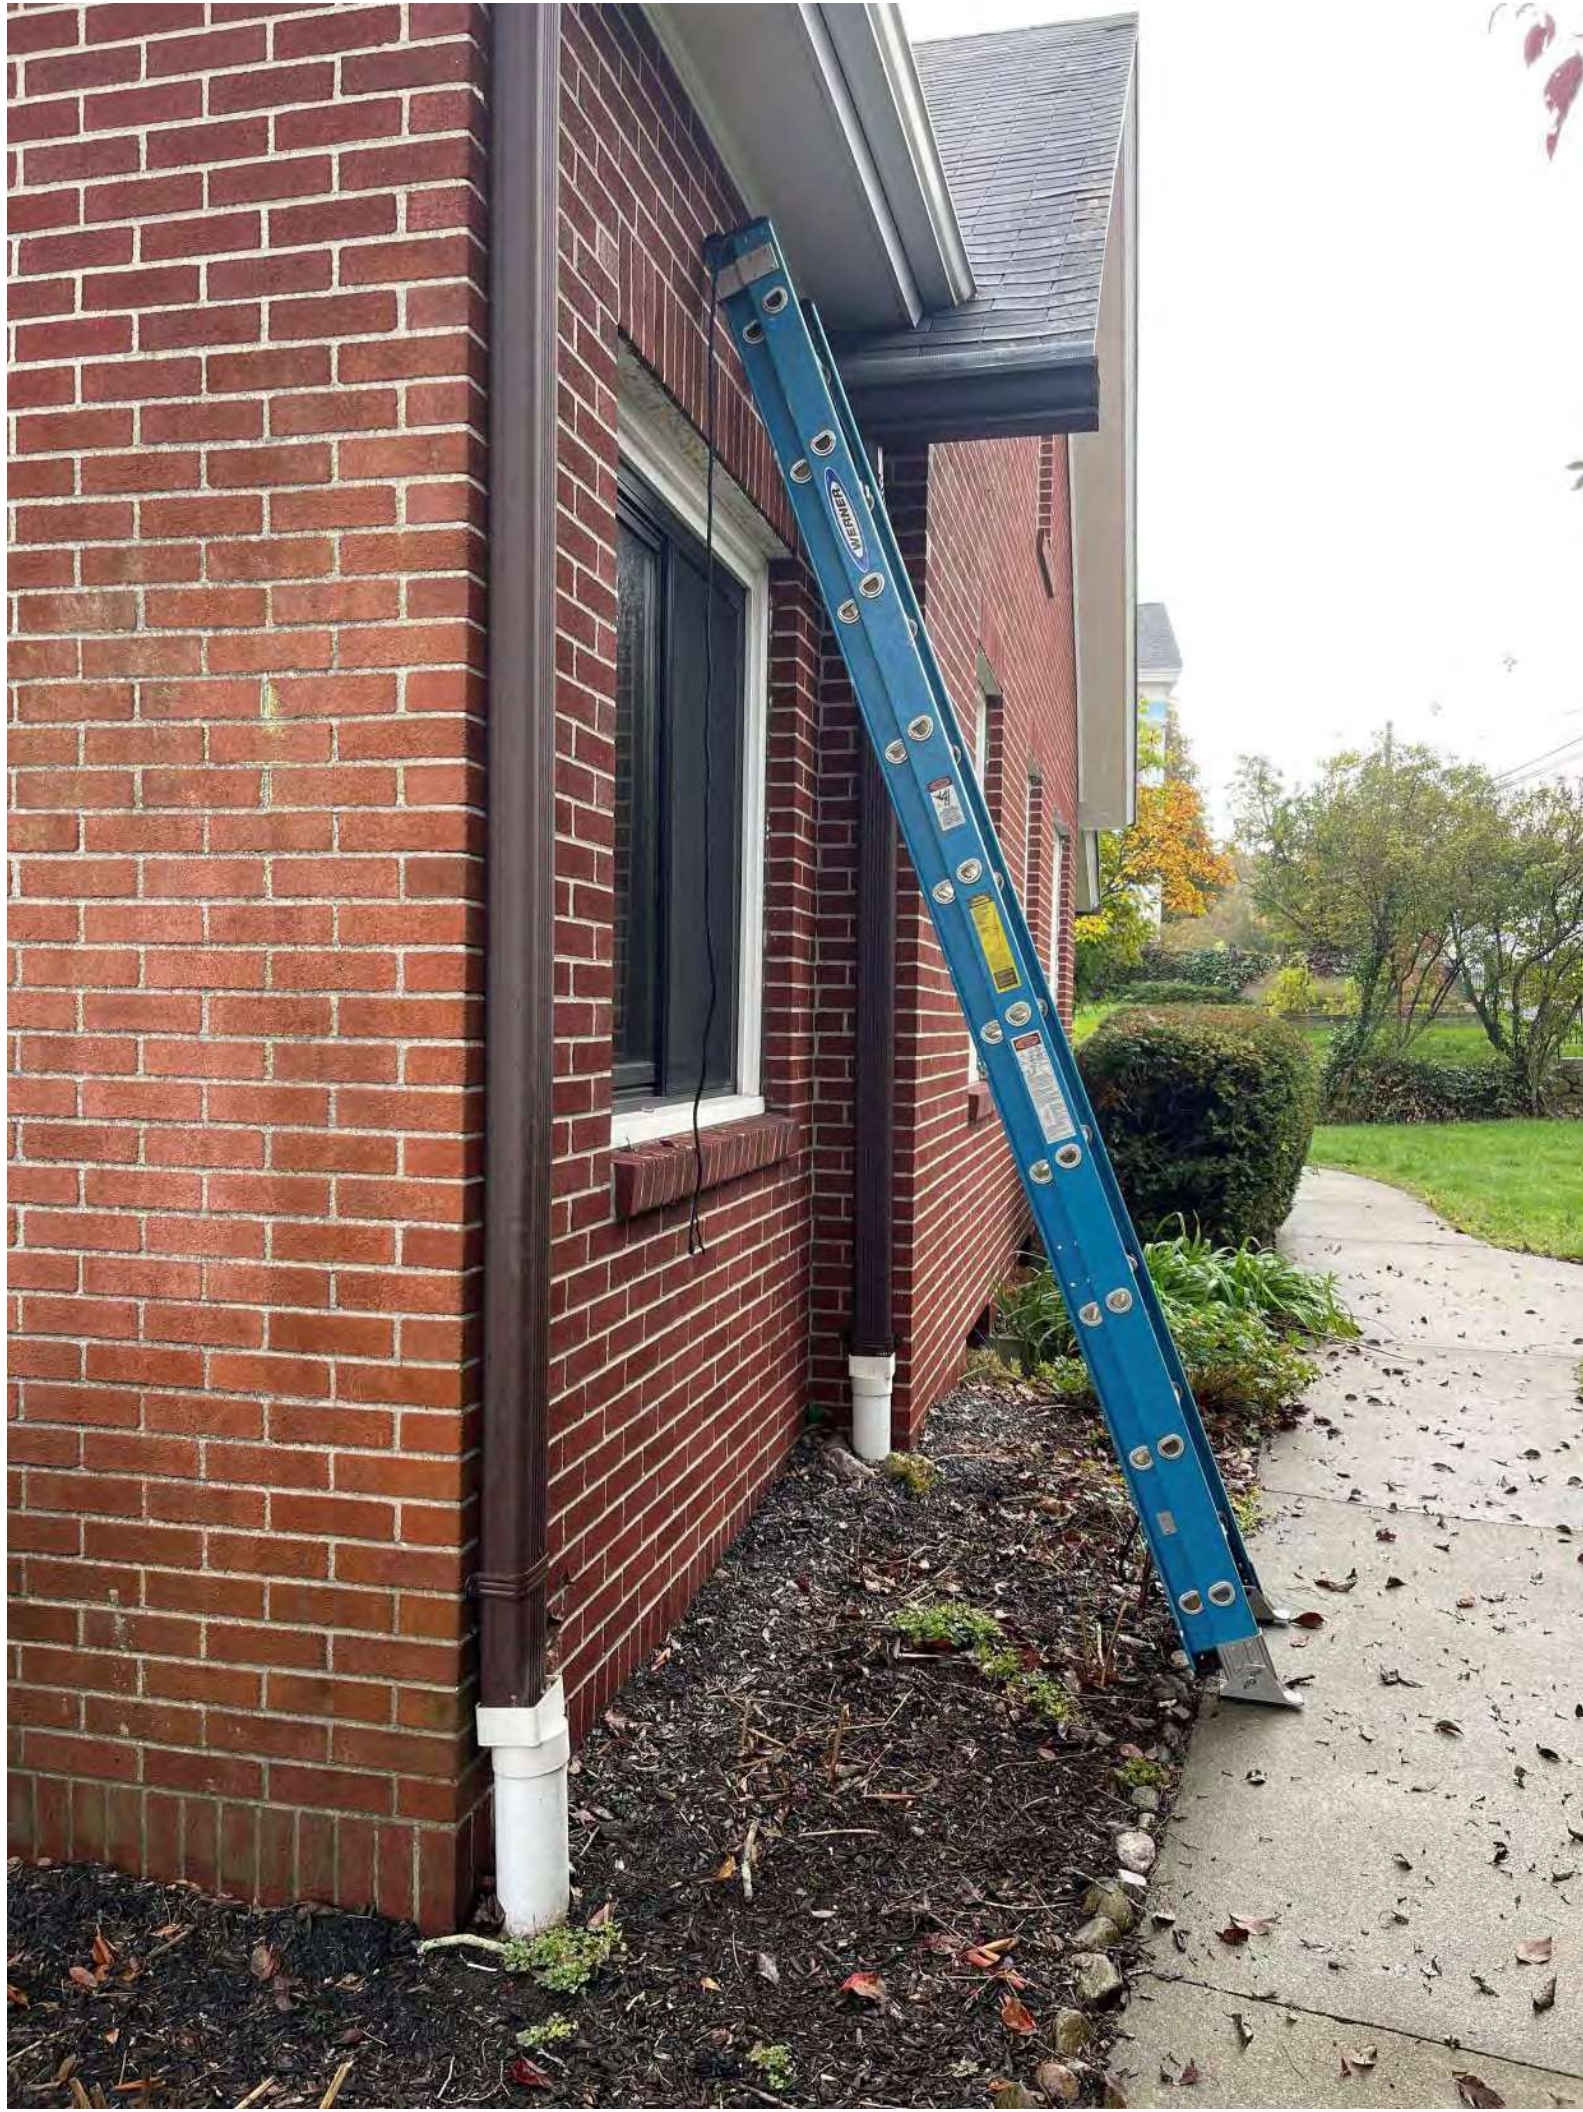
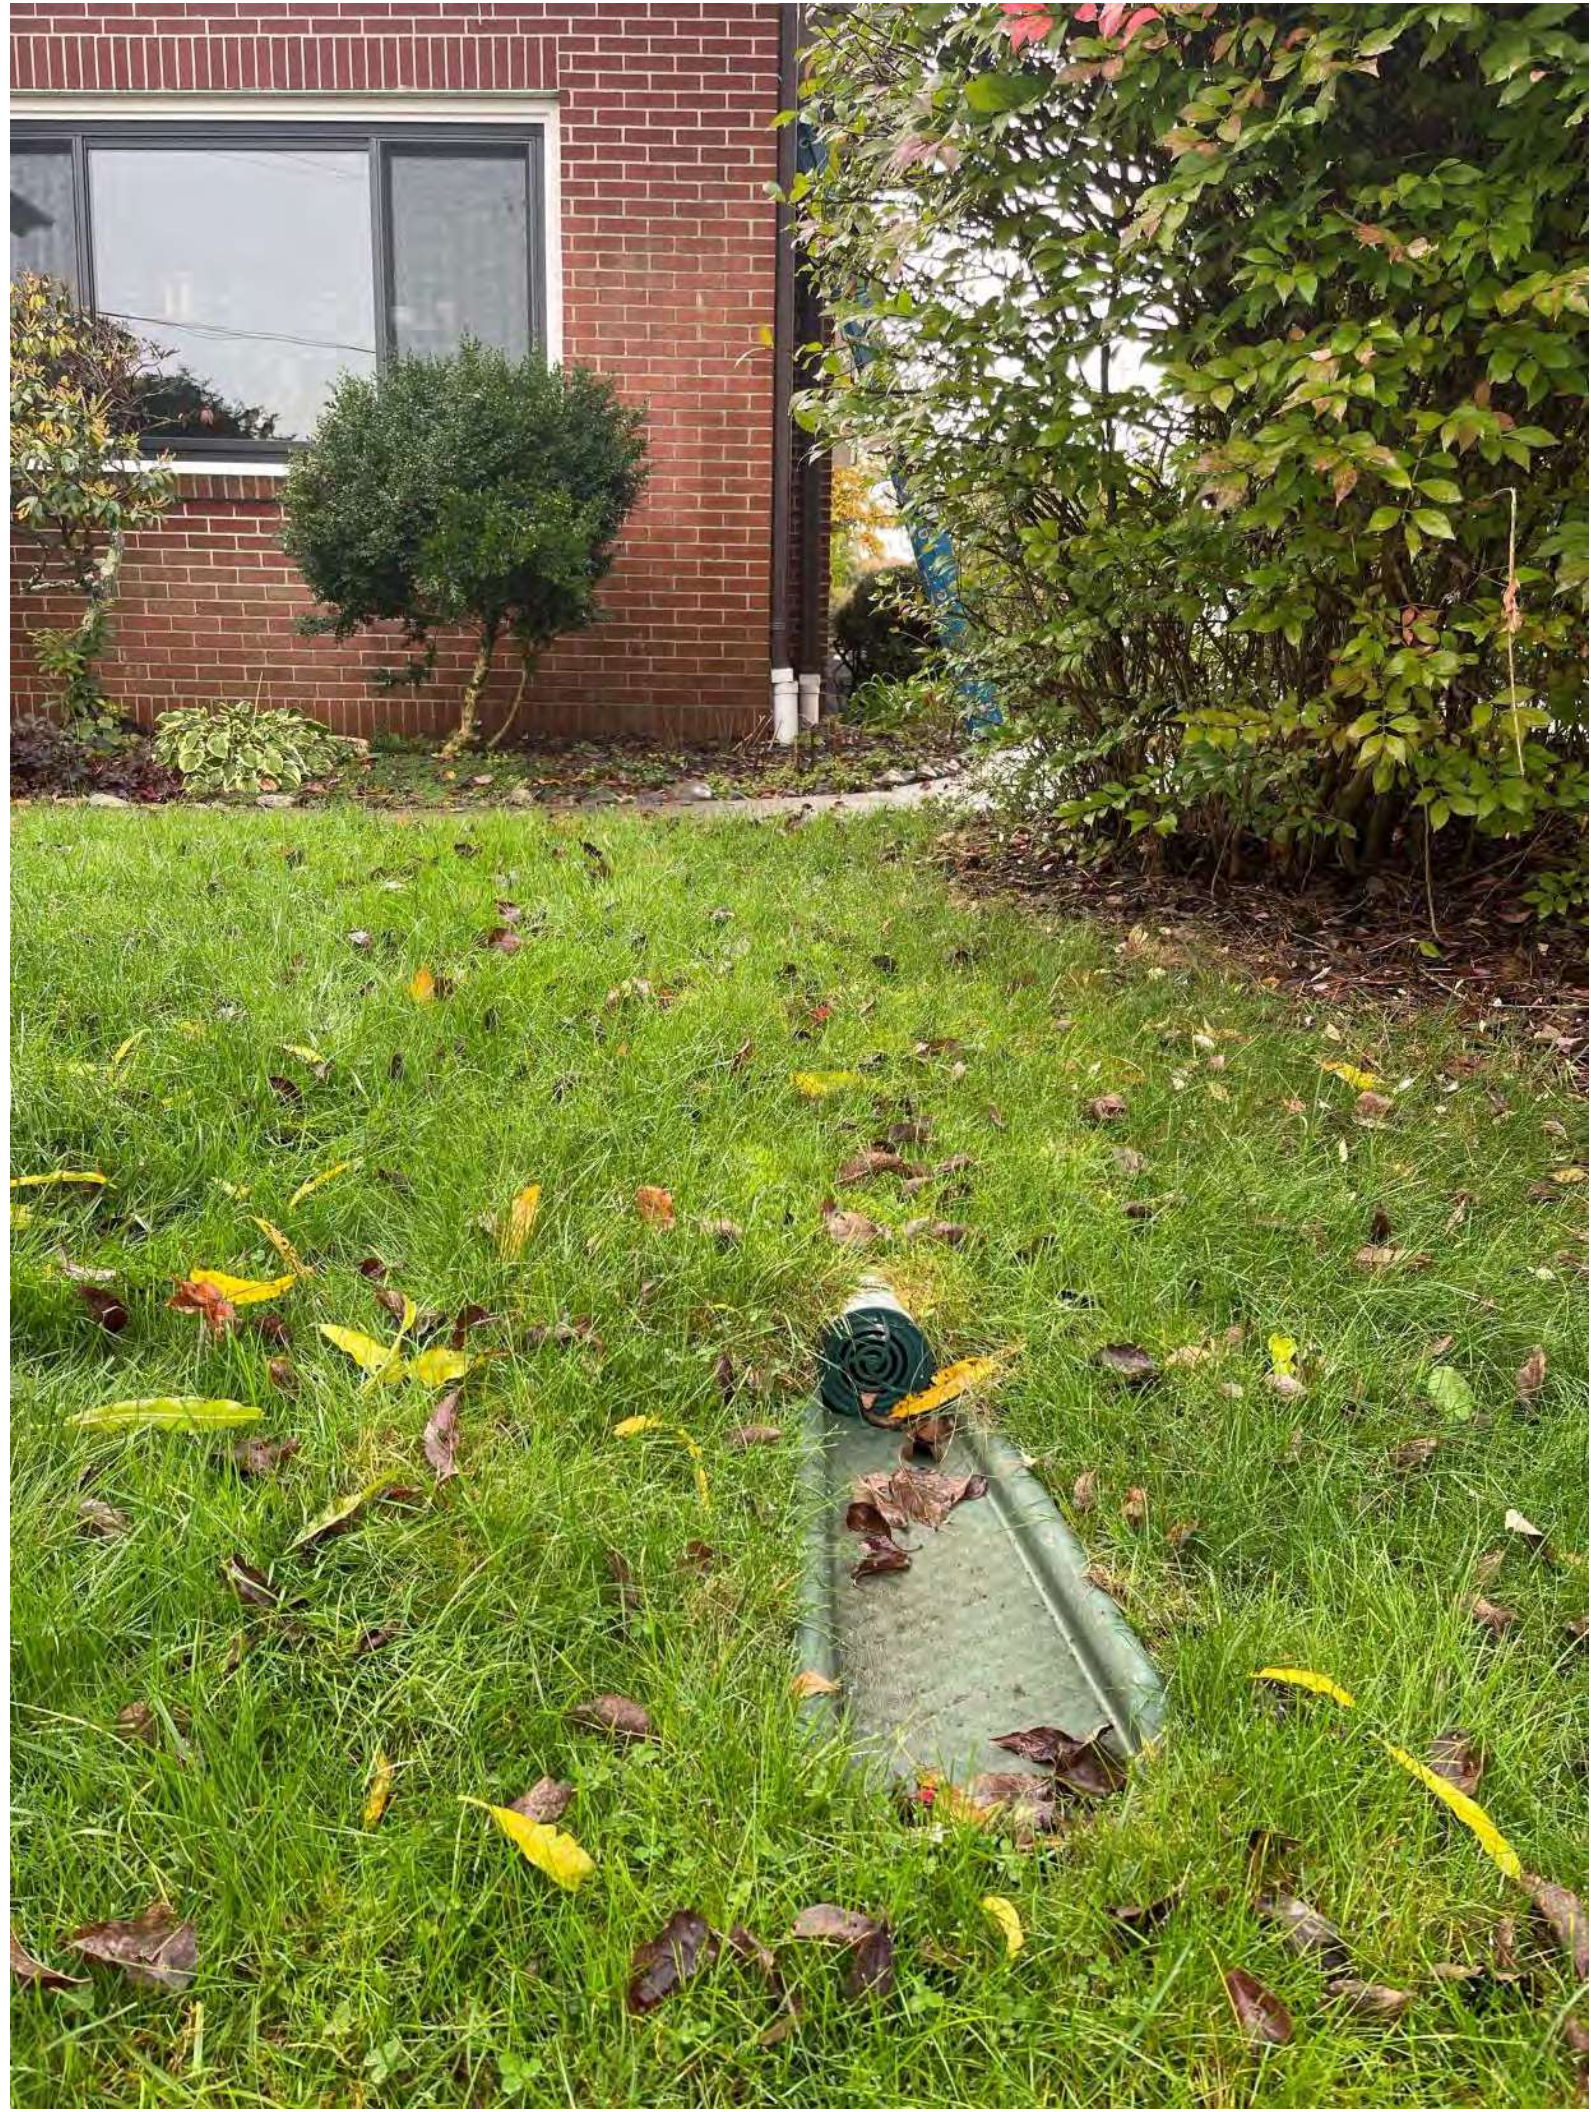
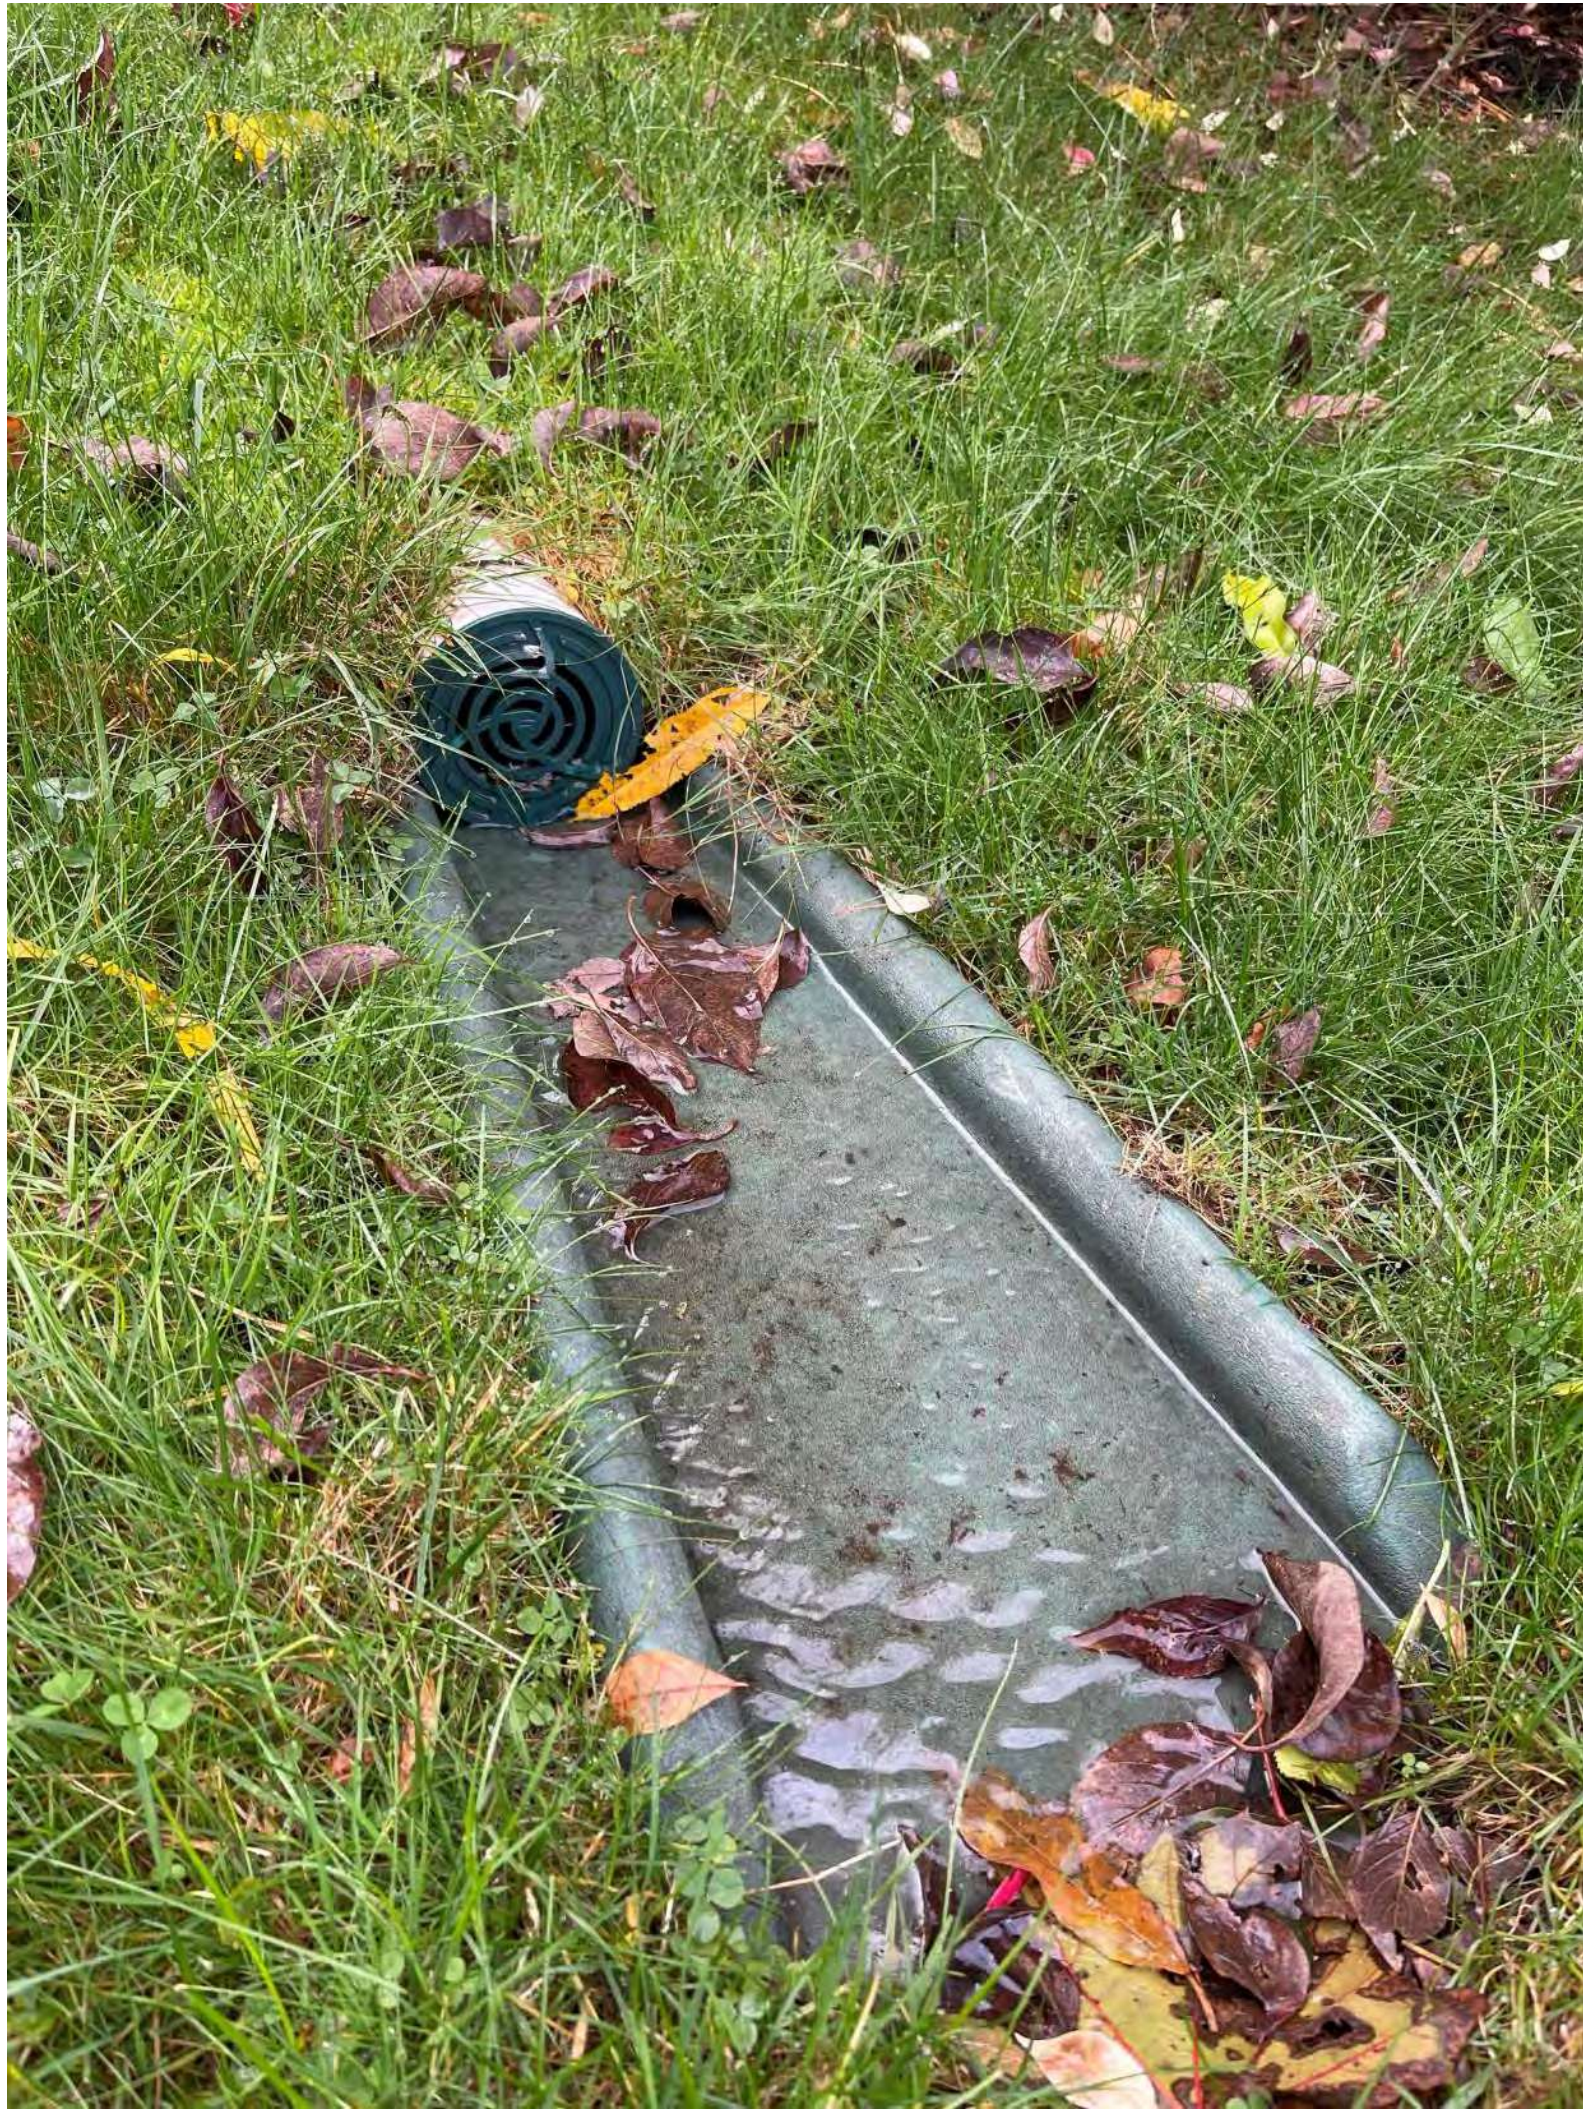
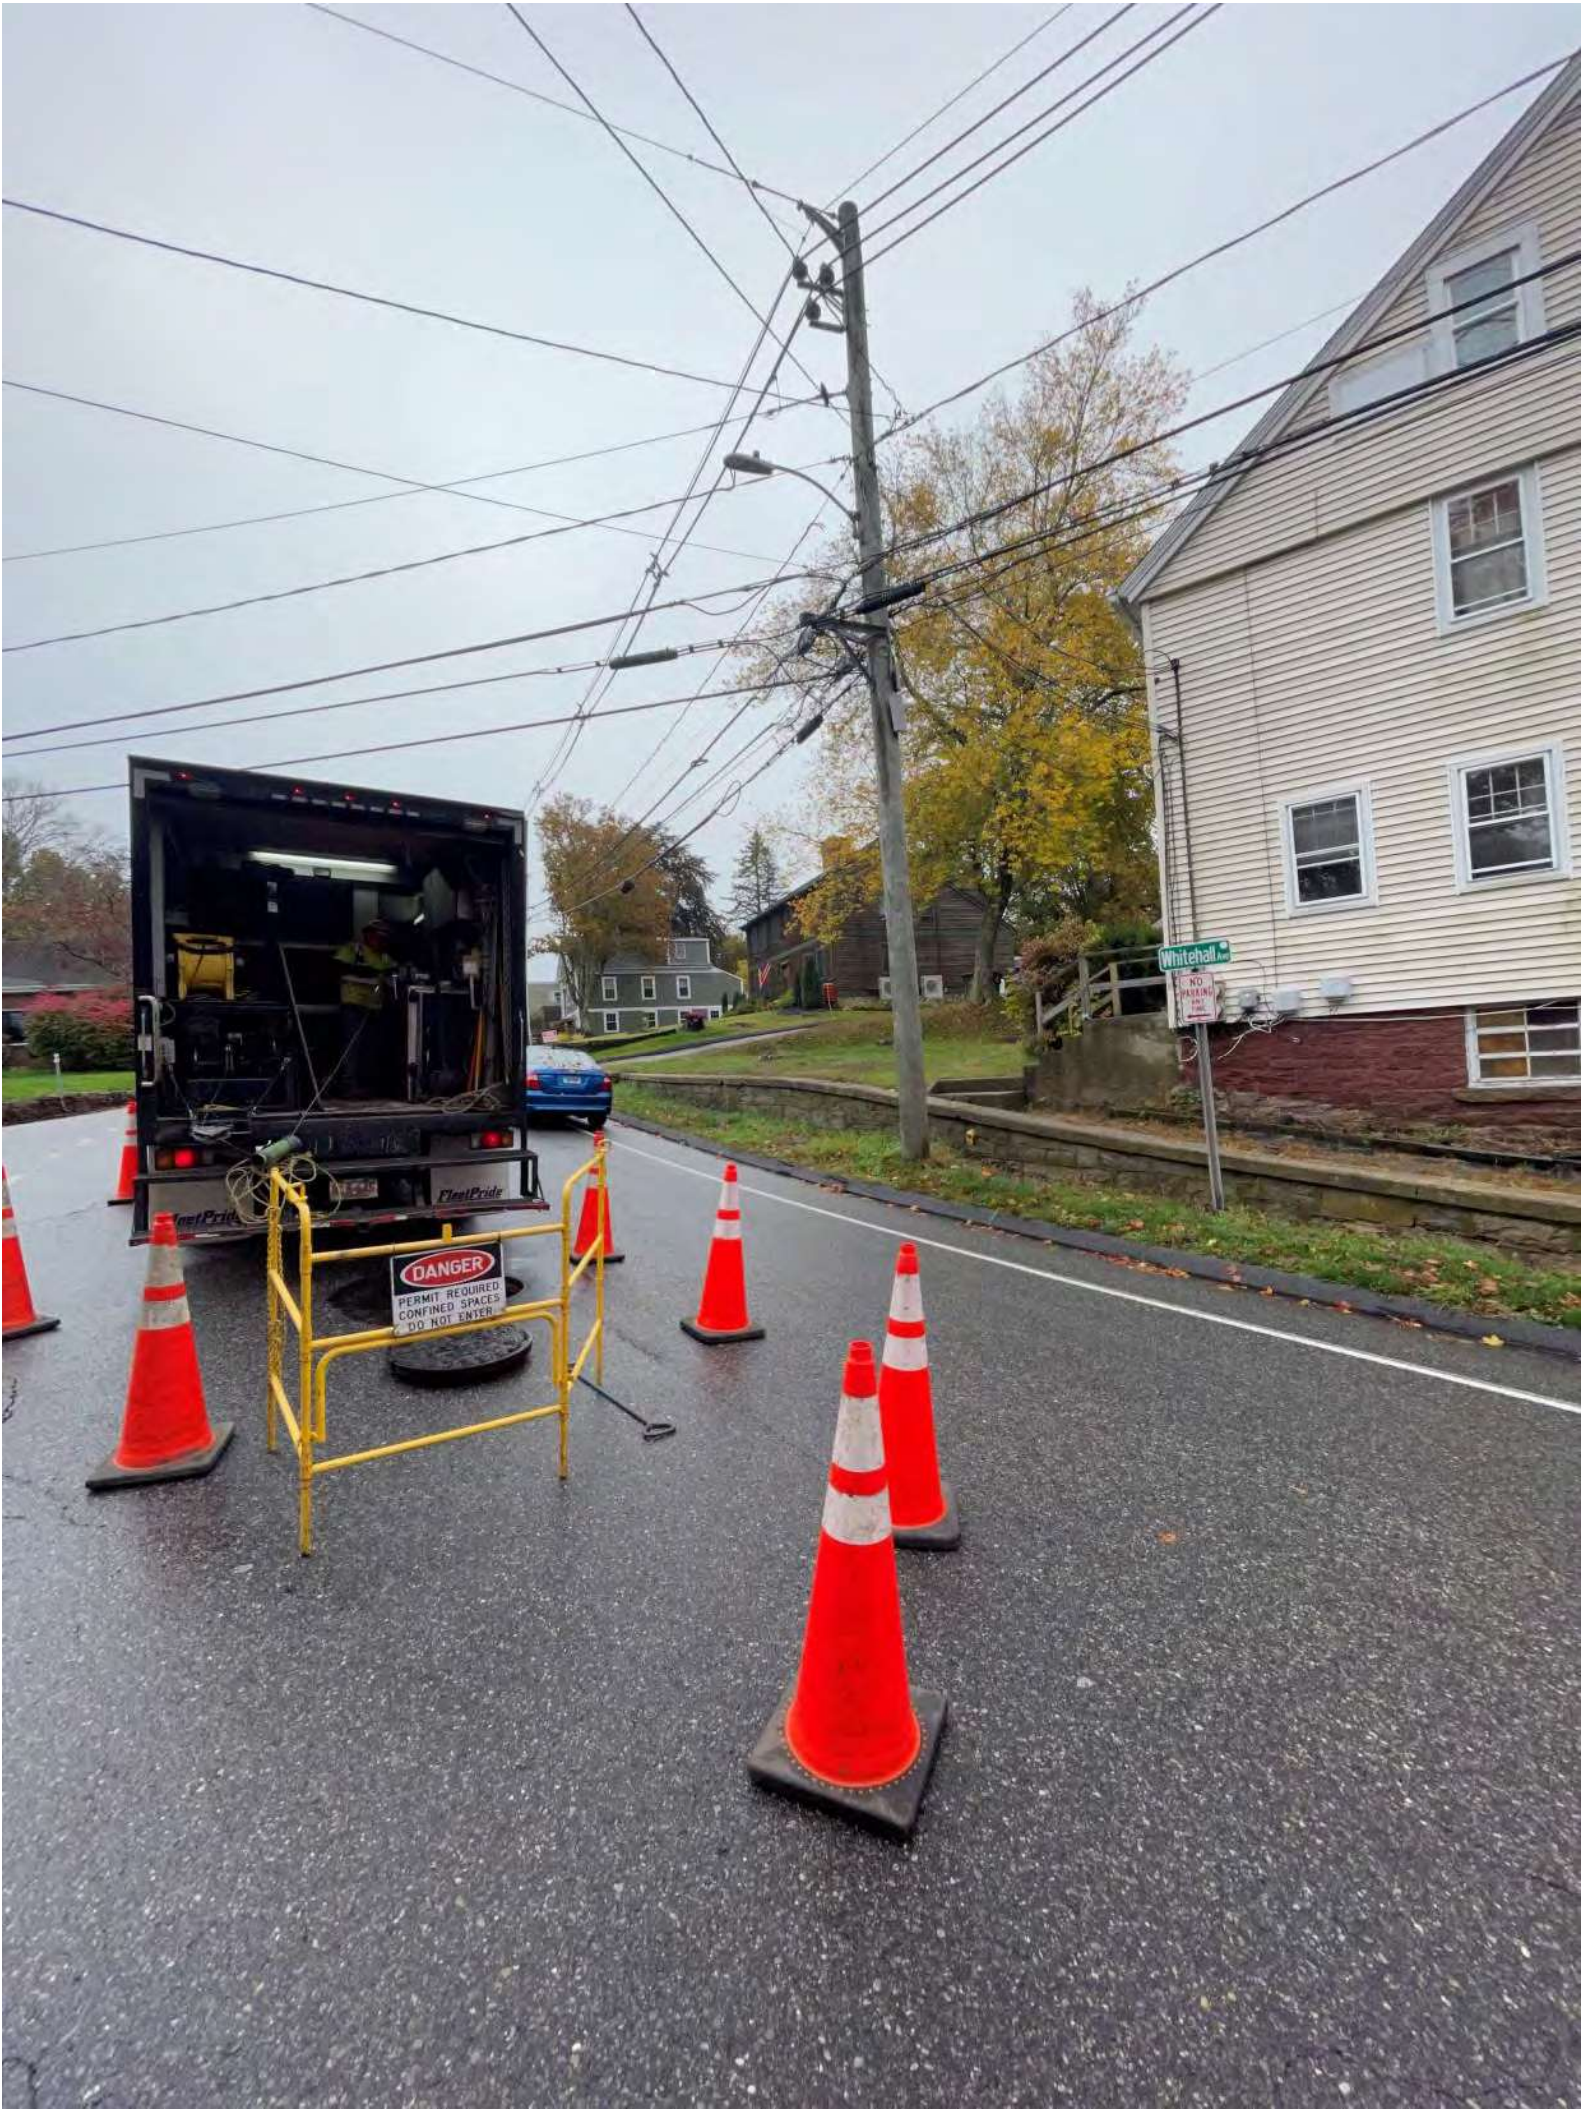
1443 Peguot Trail

\* 3 Roof leaders on West side of house connect and exit in grass of front yard through roof leader piping. See photos

\* Filled garage floor drain with green dye and several gallons of water. Did not observe any dye in setup MH 1-212 or throughout the line heading towards MH 1-215. No dye visible in any CB's or in sanitary lateral or driveway. CB's filled with water and debris at time of testing. Floor drain continued to drain throughout testing, no back ups.
