### Mystic Area Dye Water Testing Results

# DYED-WATER FLOODING

STONINGTON, CONNECTICUT 06355

OCTOBER 2022  
MCA PROJECT NO.: 2021-335

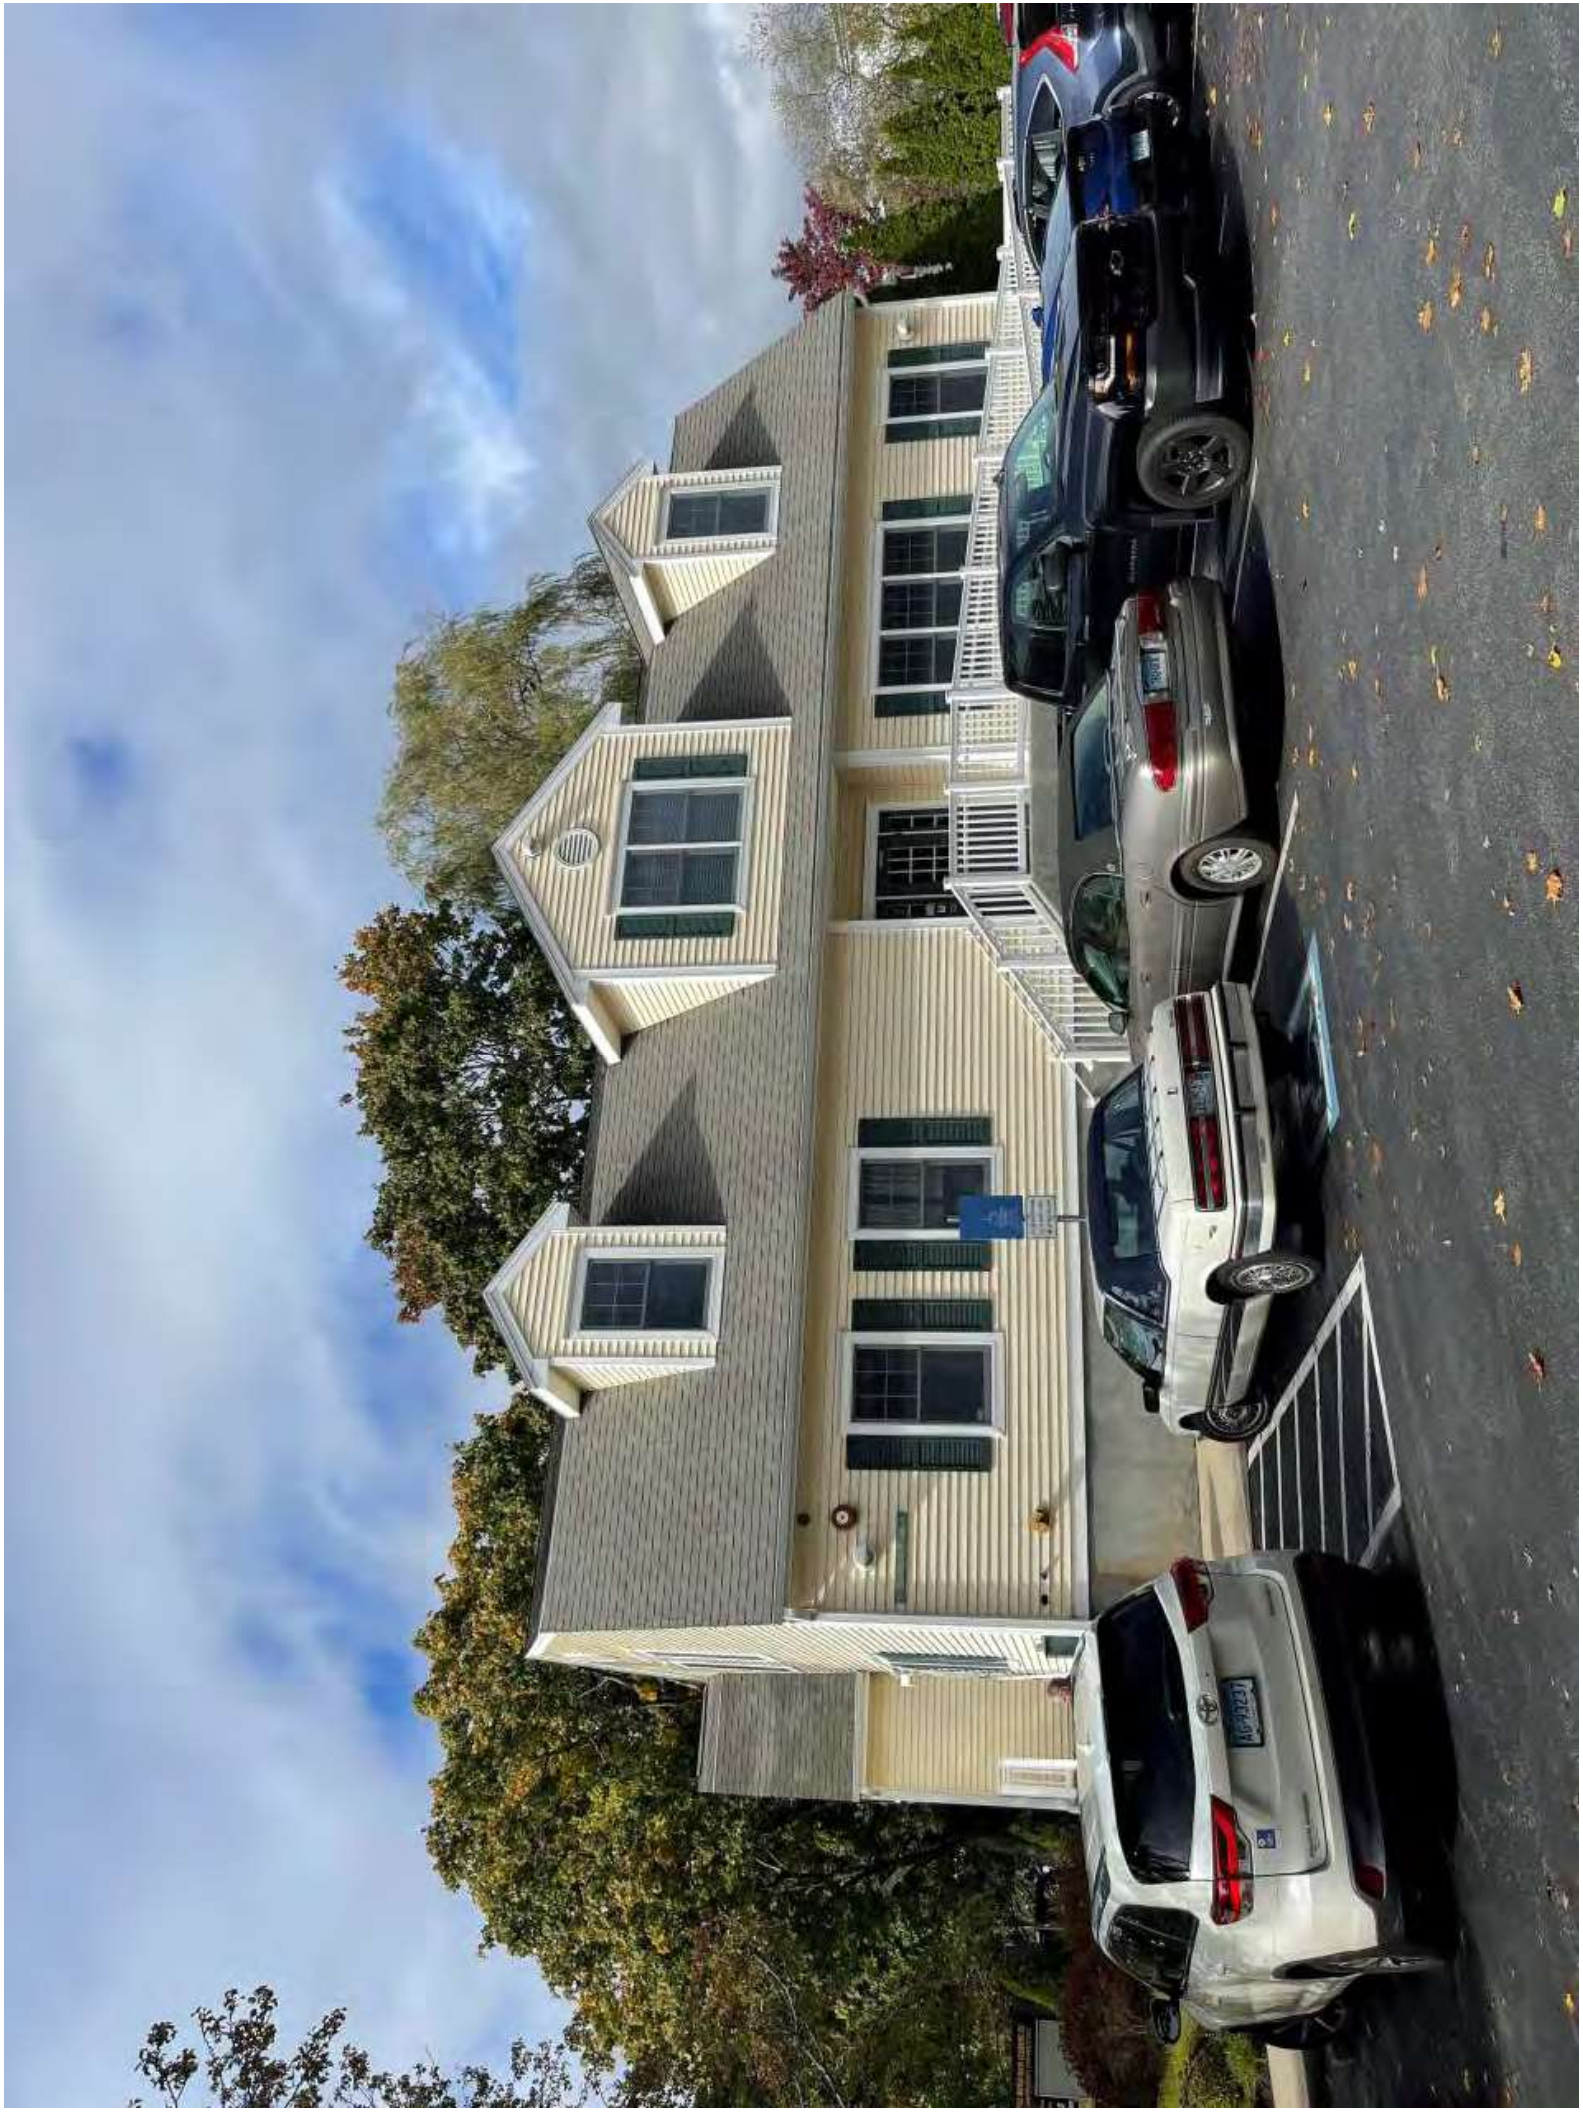
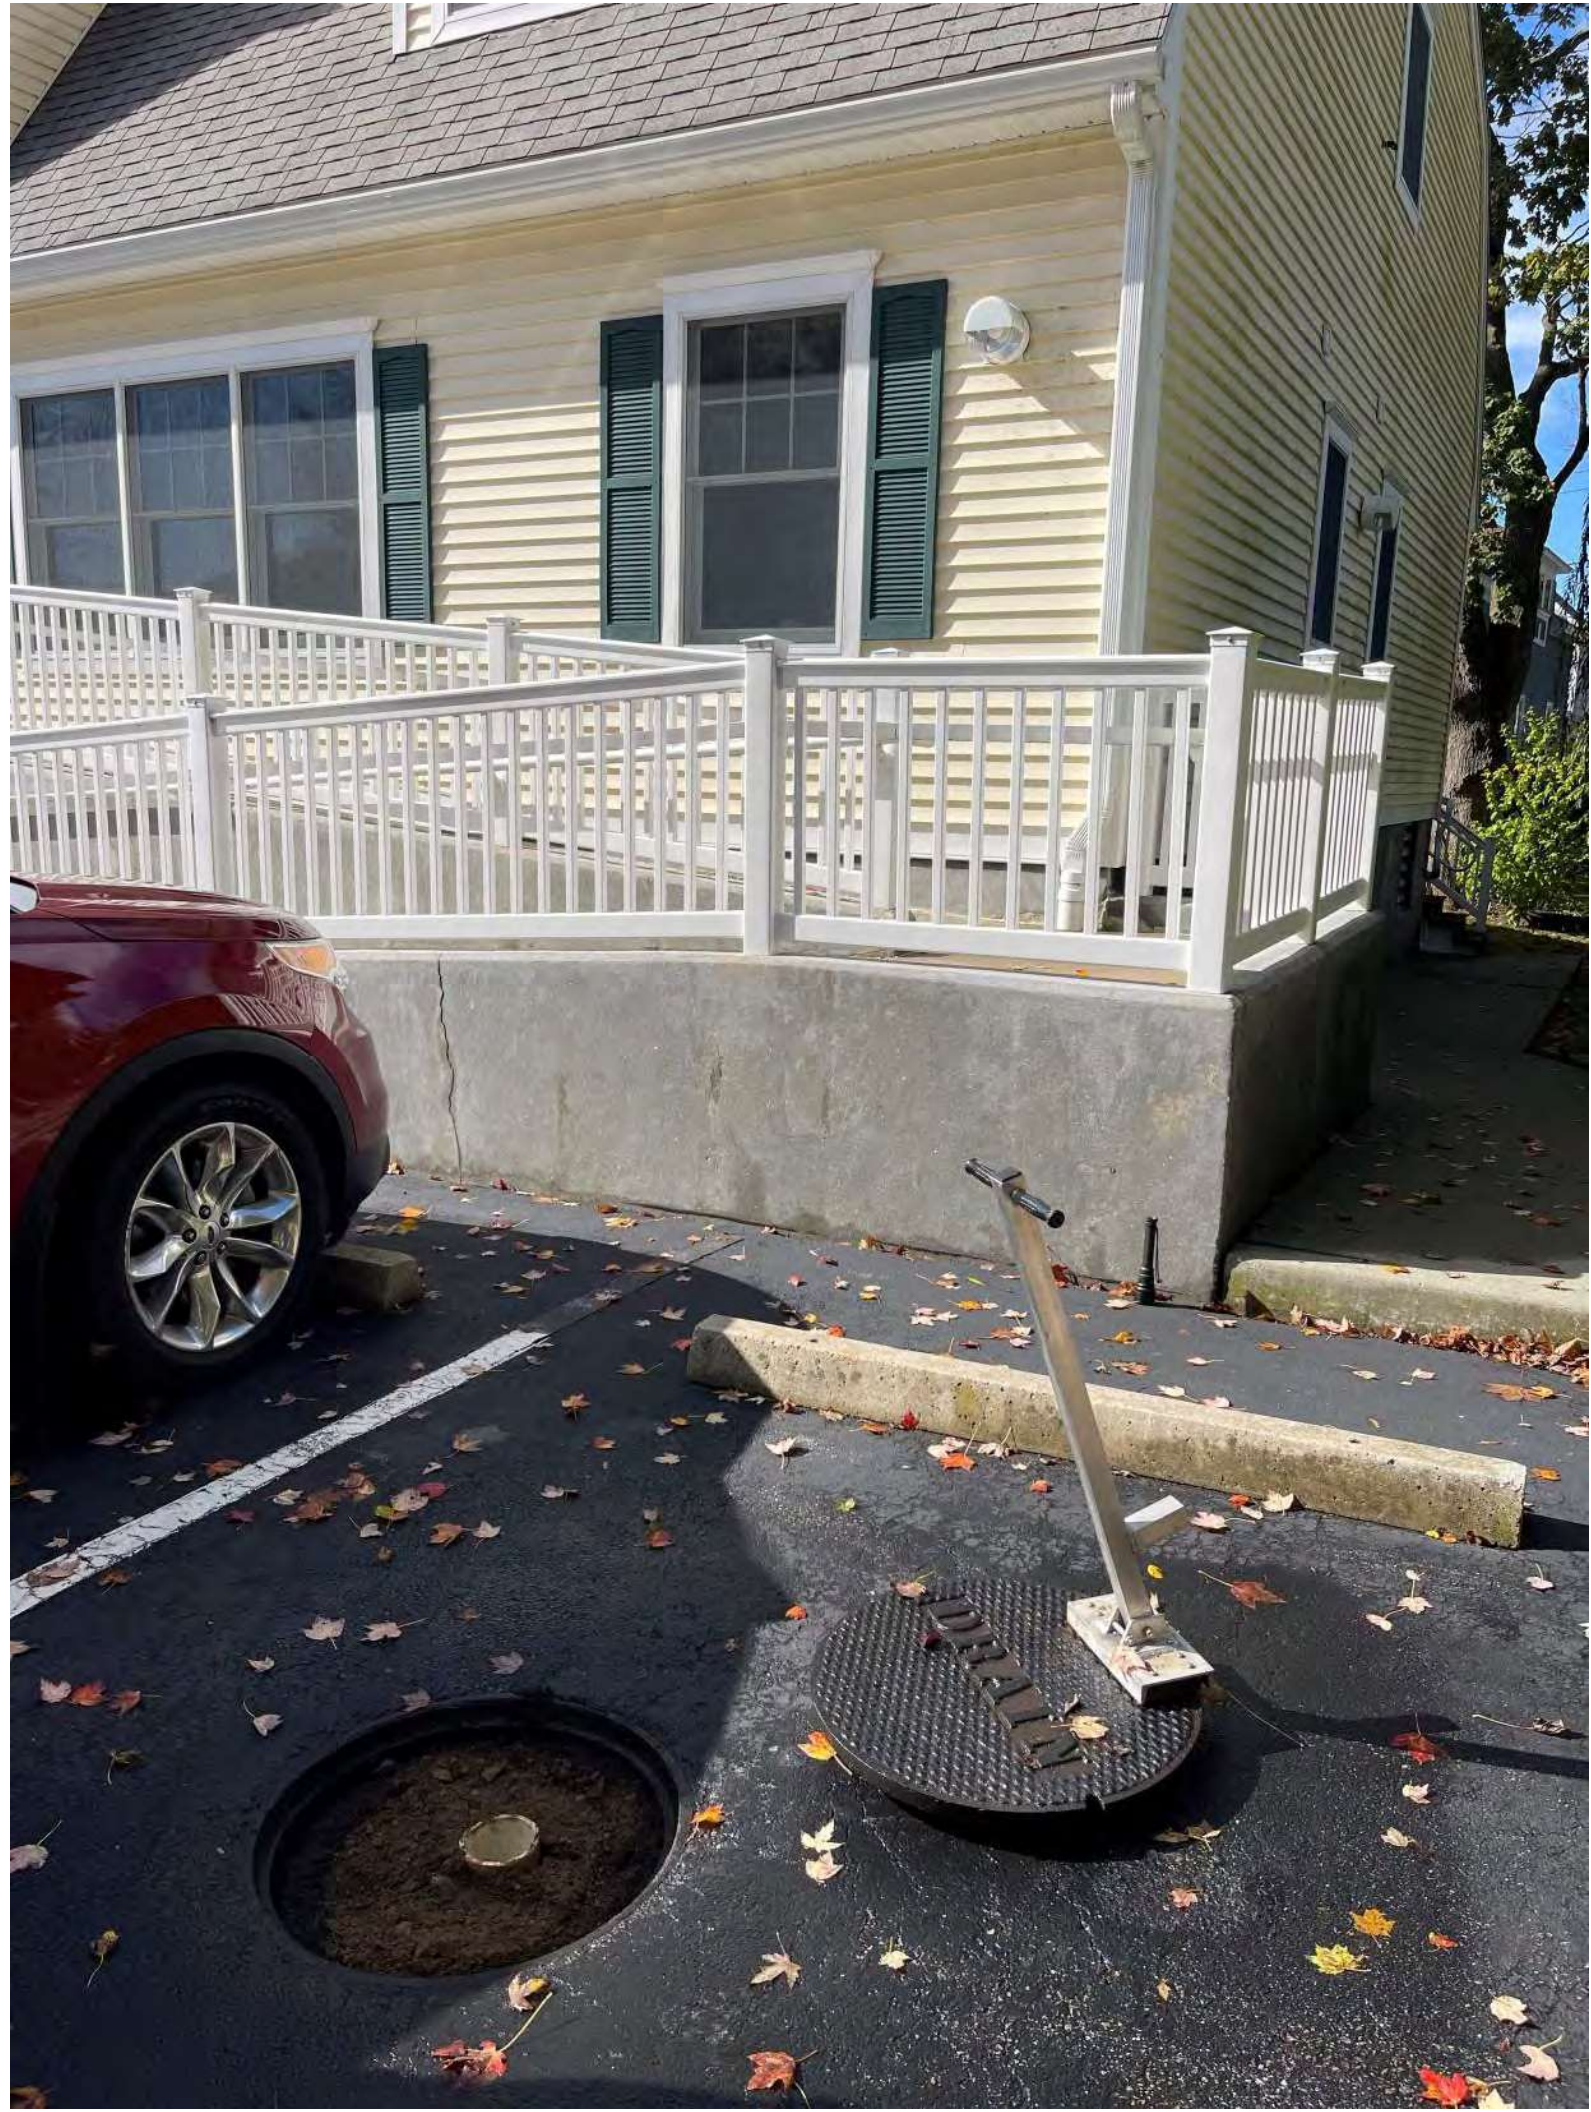
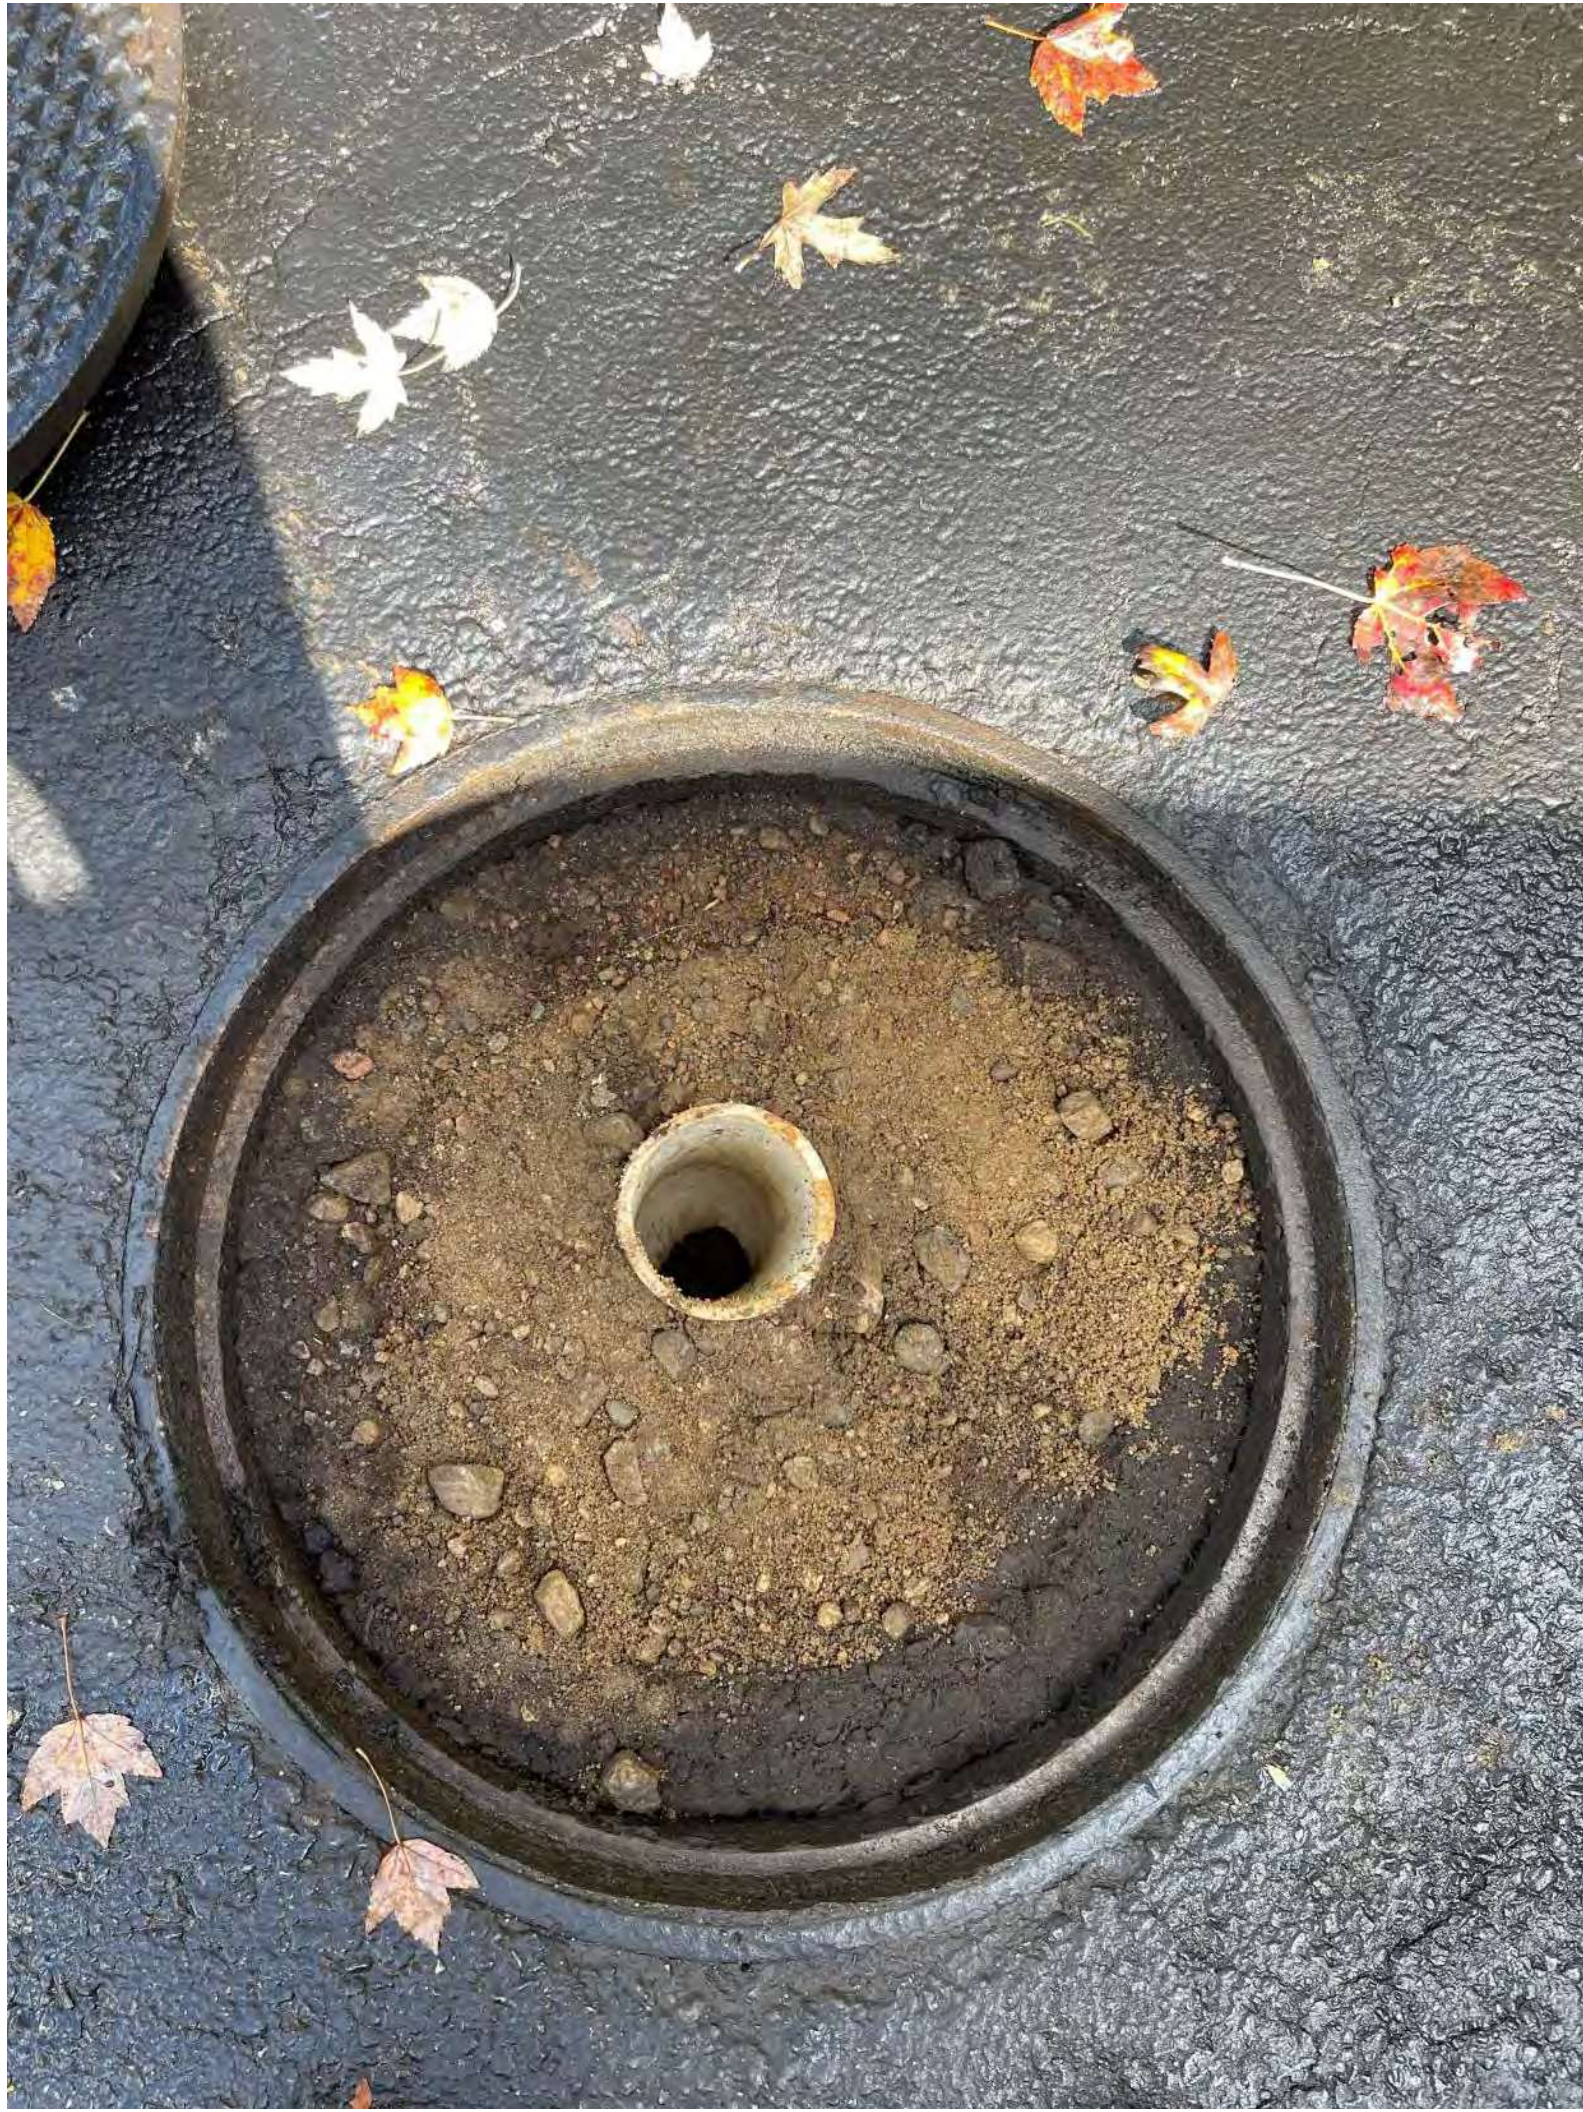
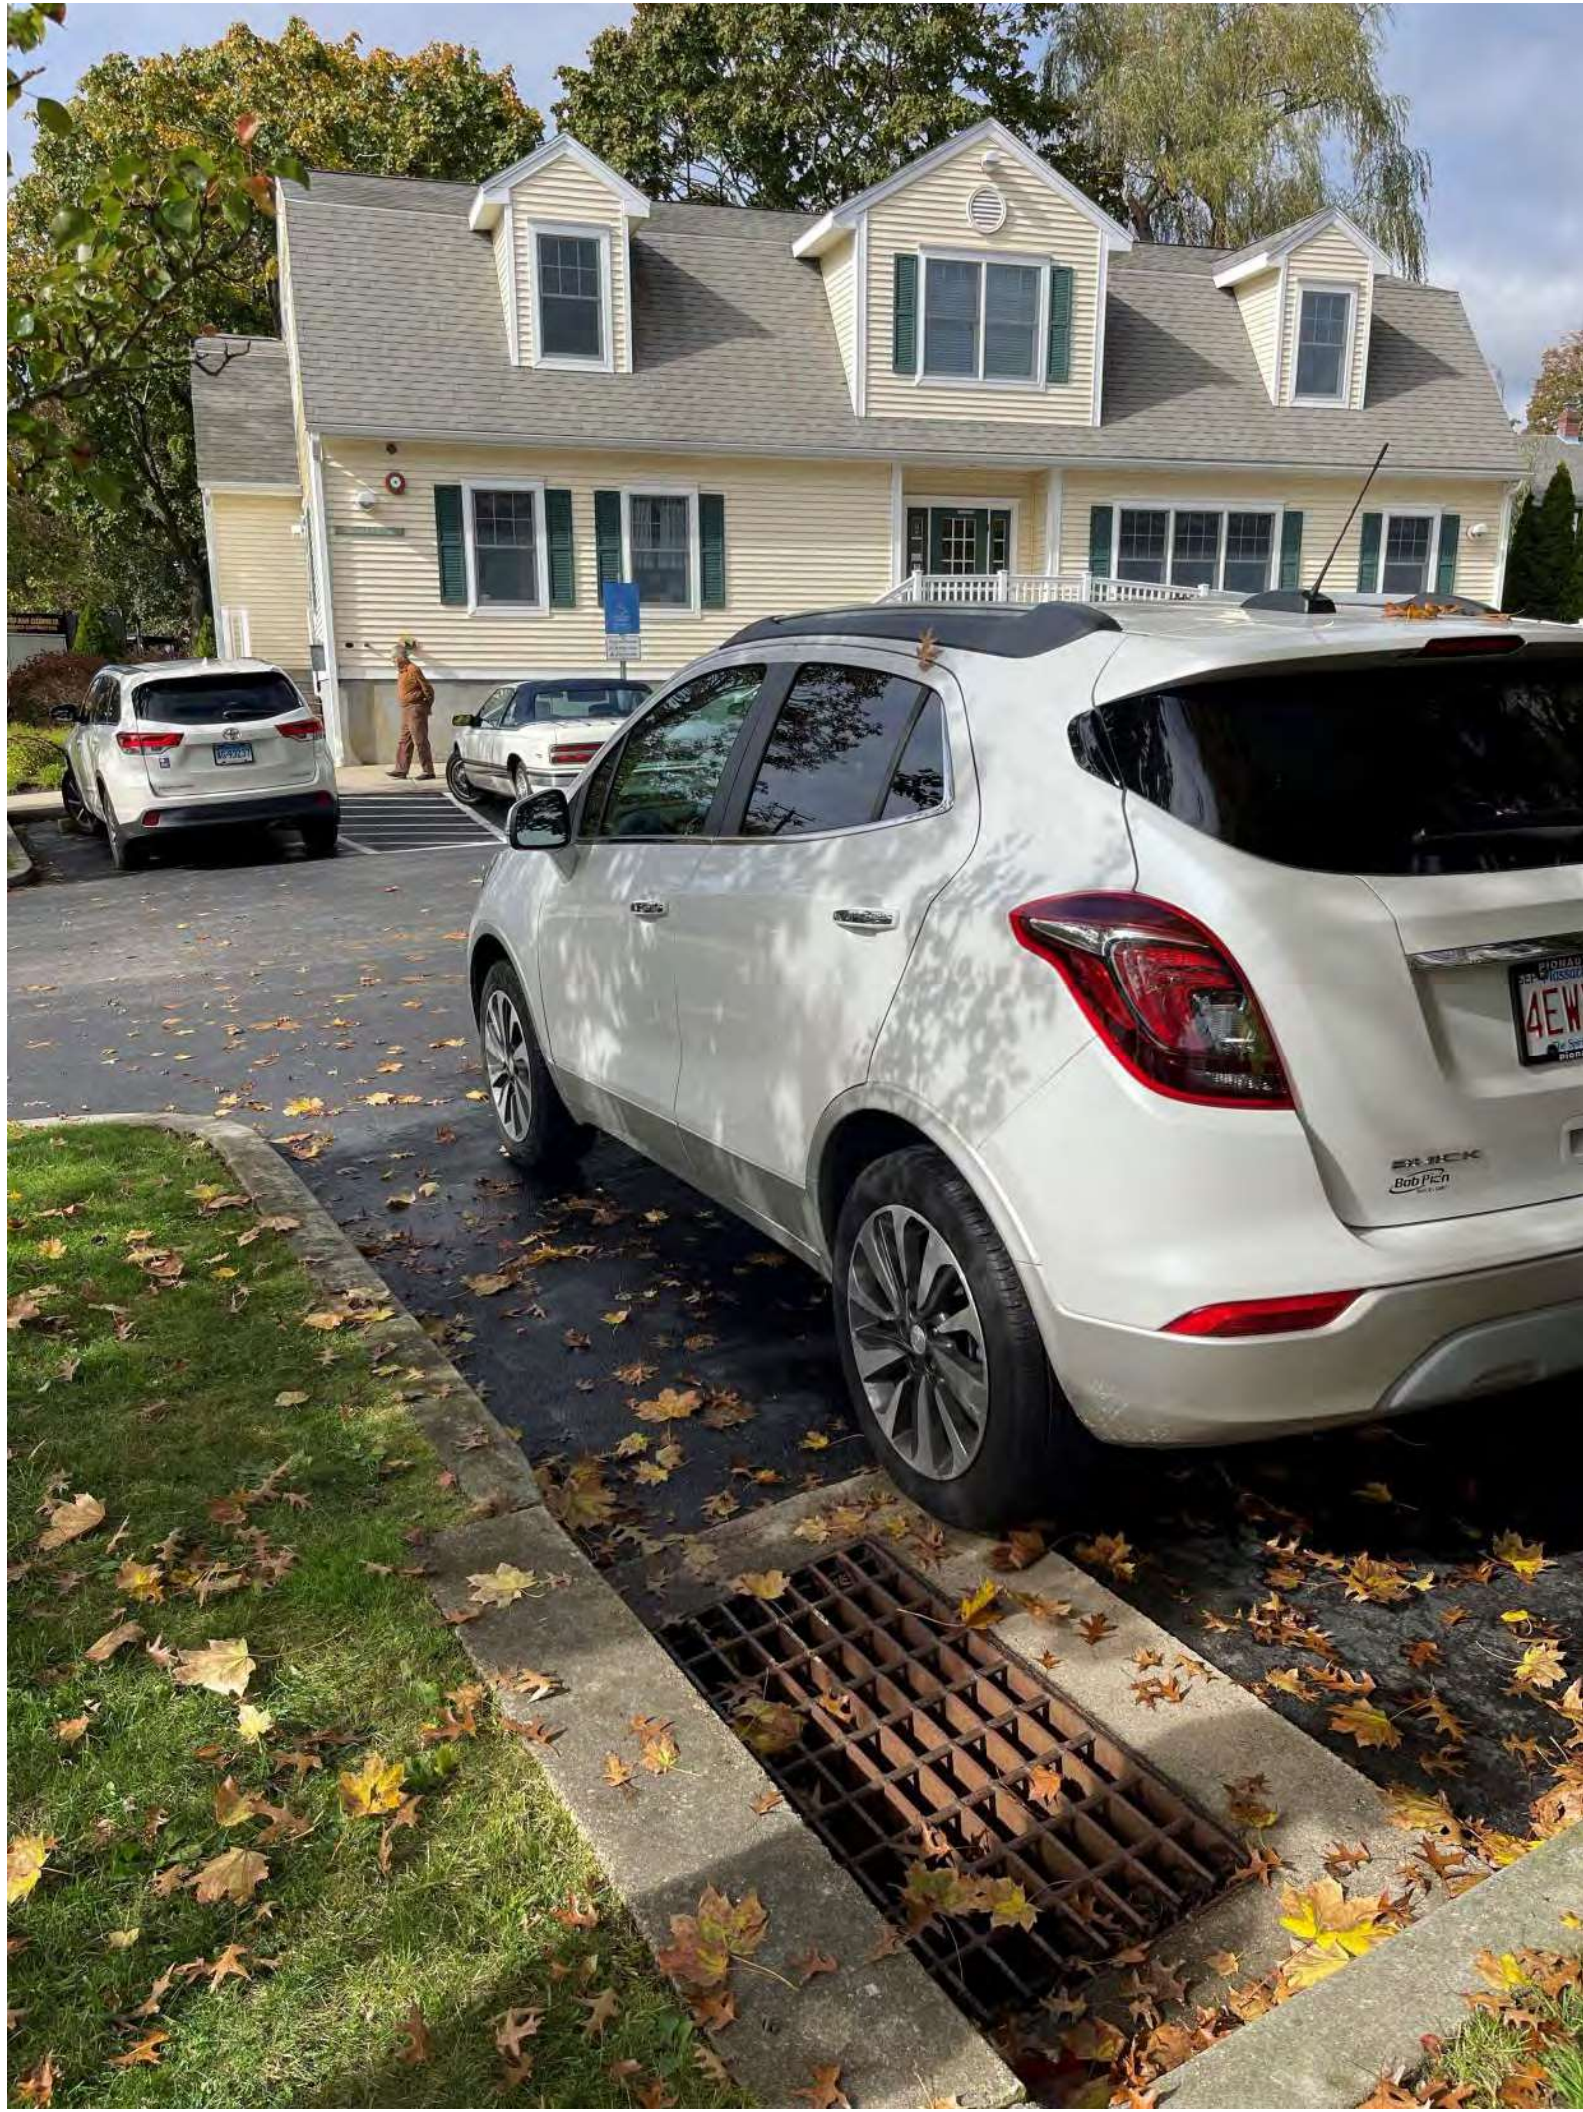
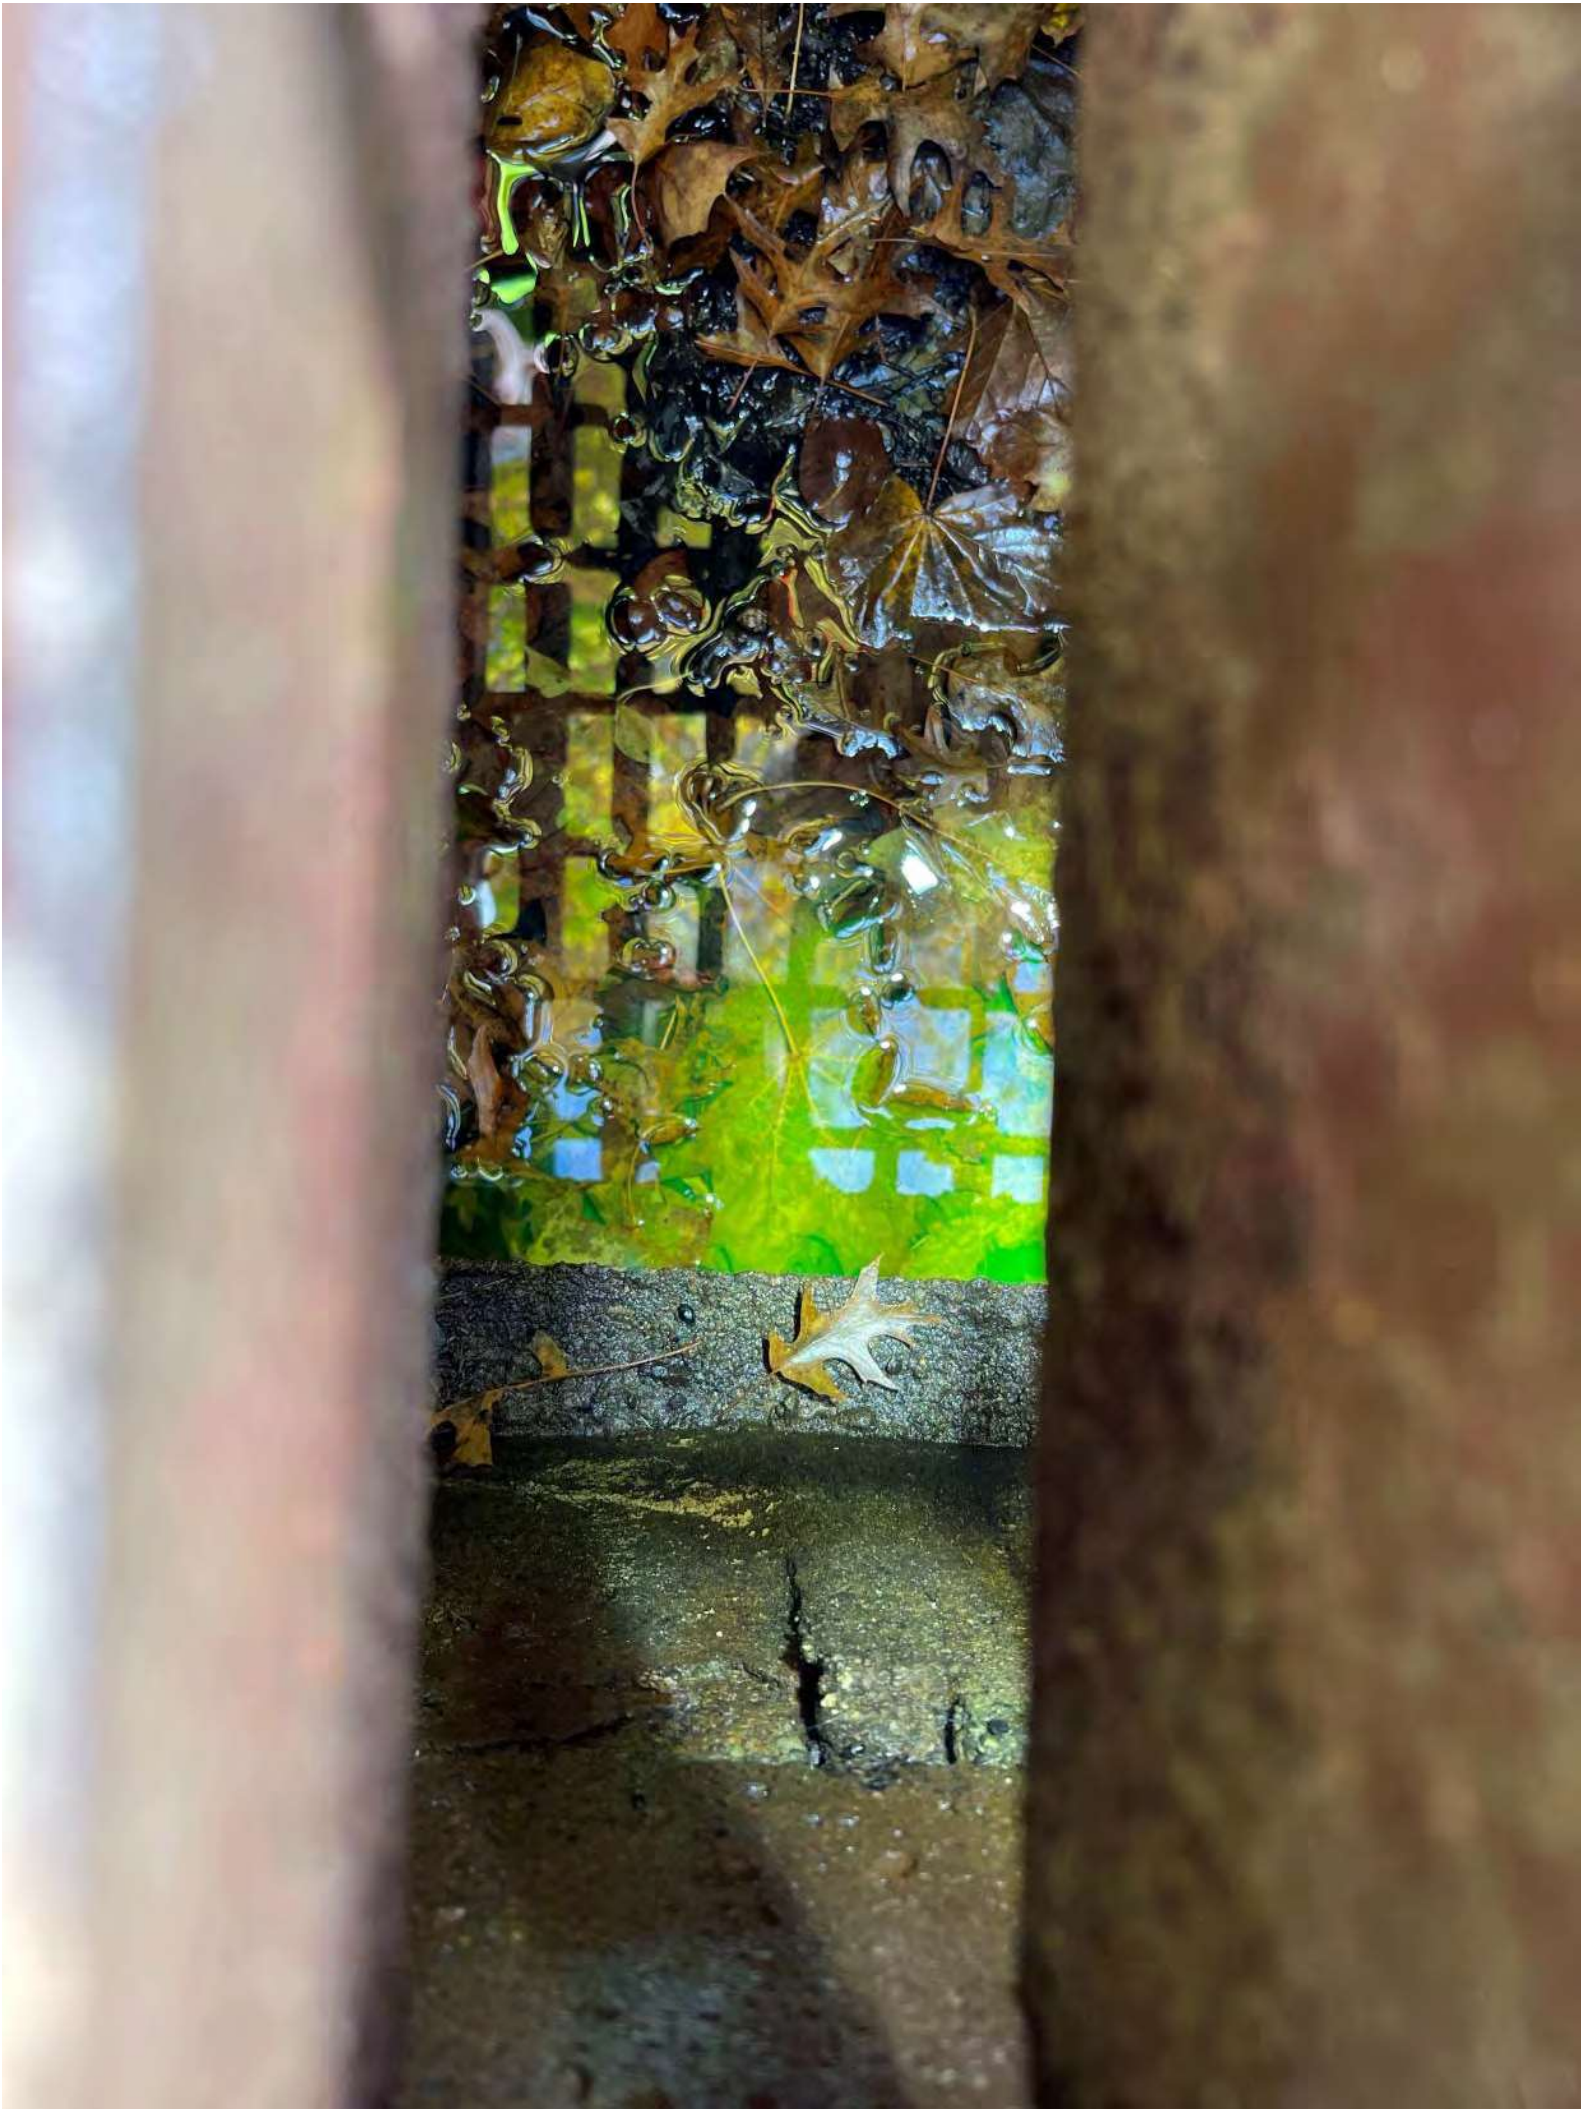
- \* All roof leaders(5) go into ground and connect to storm drainage system. Building owner confirmed that all roof leaders connect to drainage lamp hole manhole in parking lot, which leads to CB in Southeastern corner of parking lot. CB drains to CB in street.
- \* Yard drain in back yard of property connects to CB with check valve in street. The town required the building owner to route all roof leaders to storm drains.
- \* Stonington WPCA was present for testing
- \* Dan from WPCA informed that CB's in street are full due to the tidal flows. The water backs up from the waterways during tidal events. All were full during time of testing
