### Mystic Area Dye Water Testing Results

# DYED-WATER FLOODING

STONINGTON, CONNECTICUT 06355

OCTOBER 2022  
MCA PROJECT NO.: 2021-335

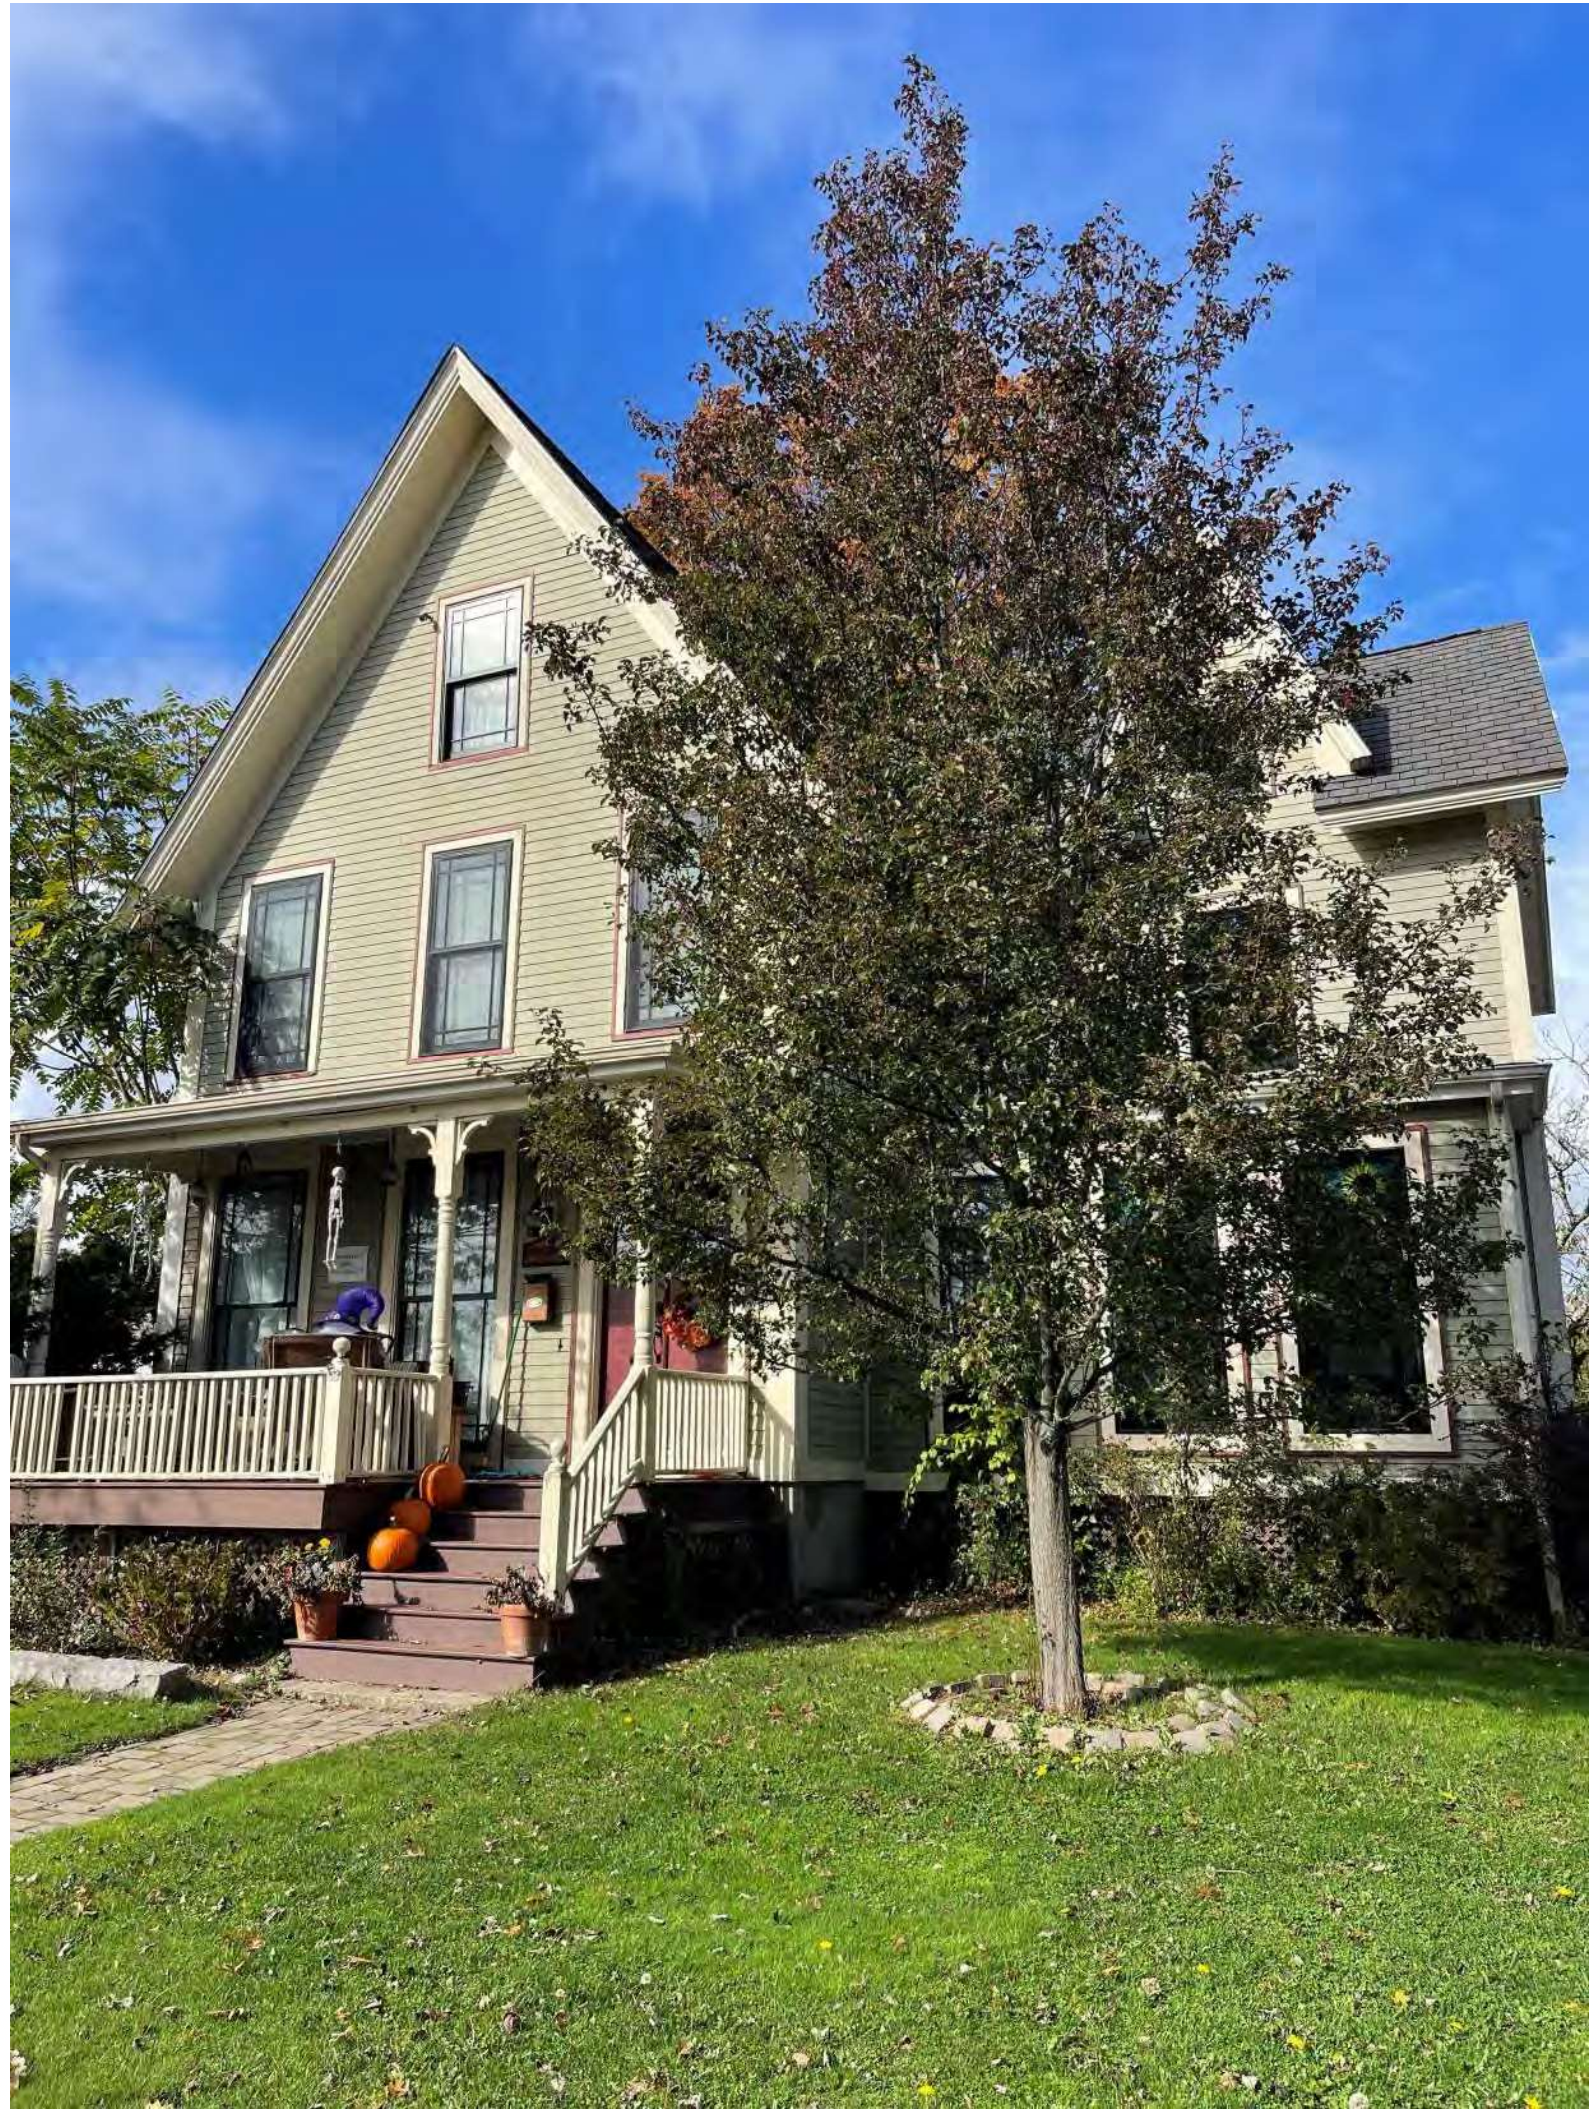
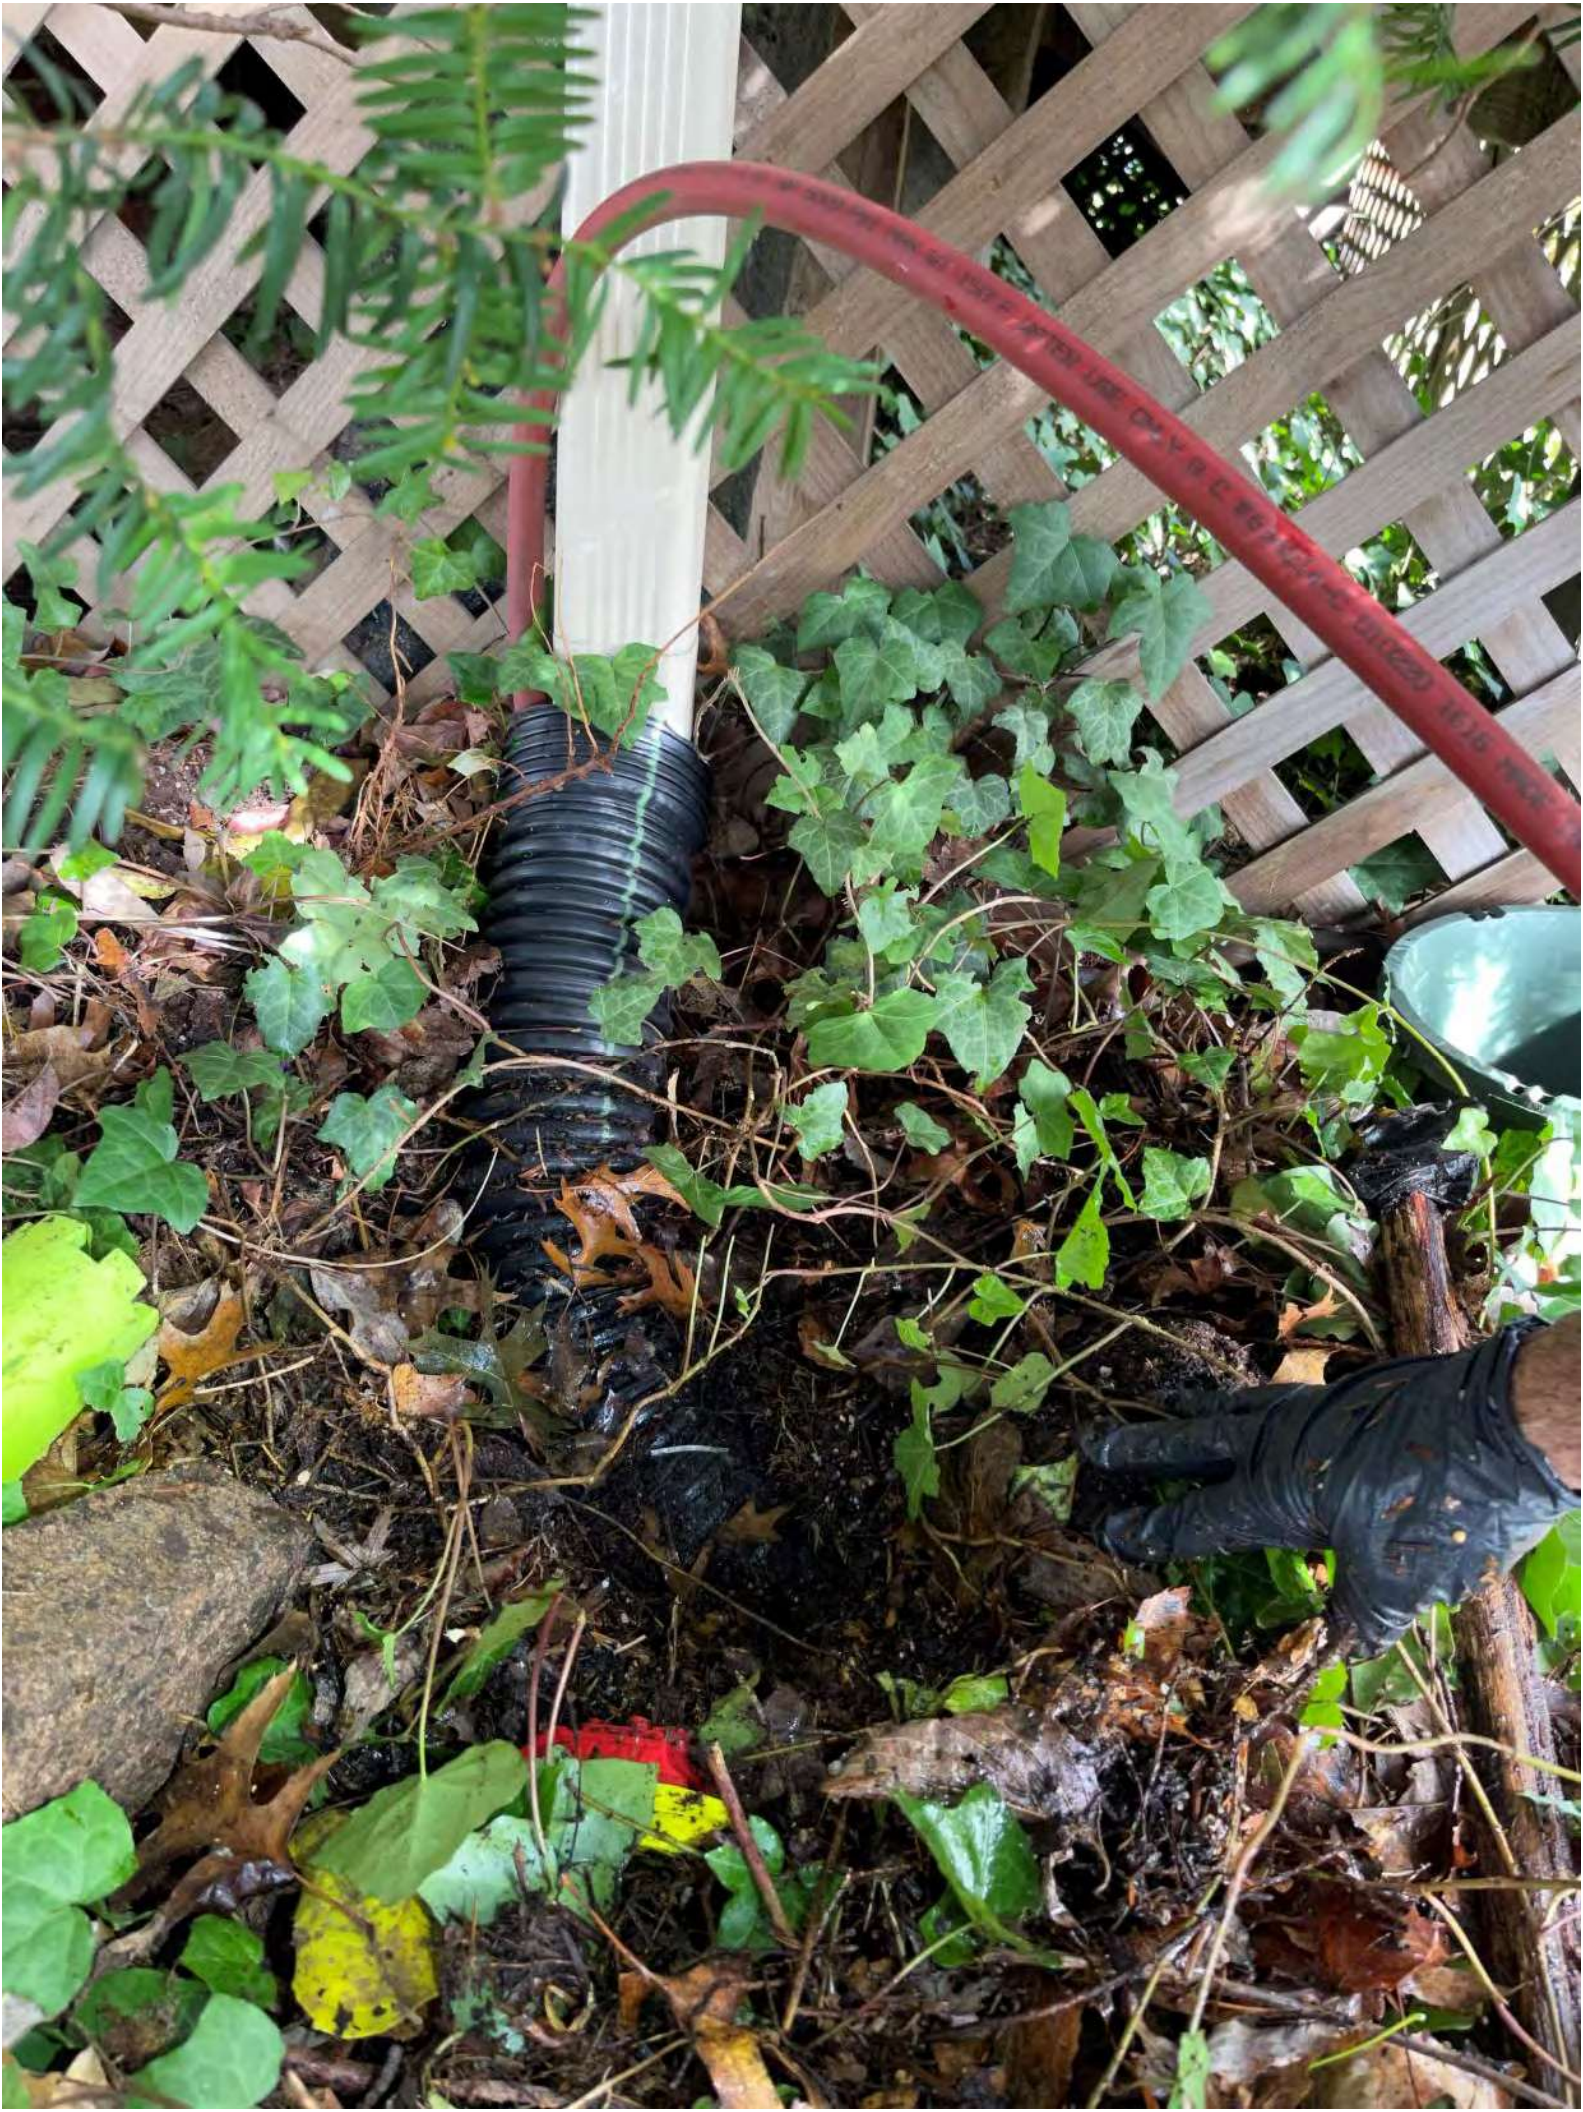
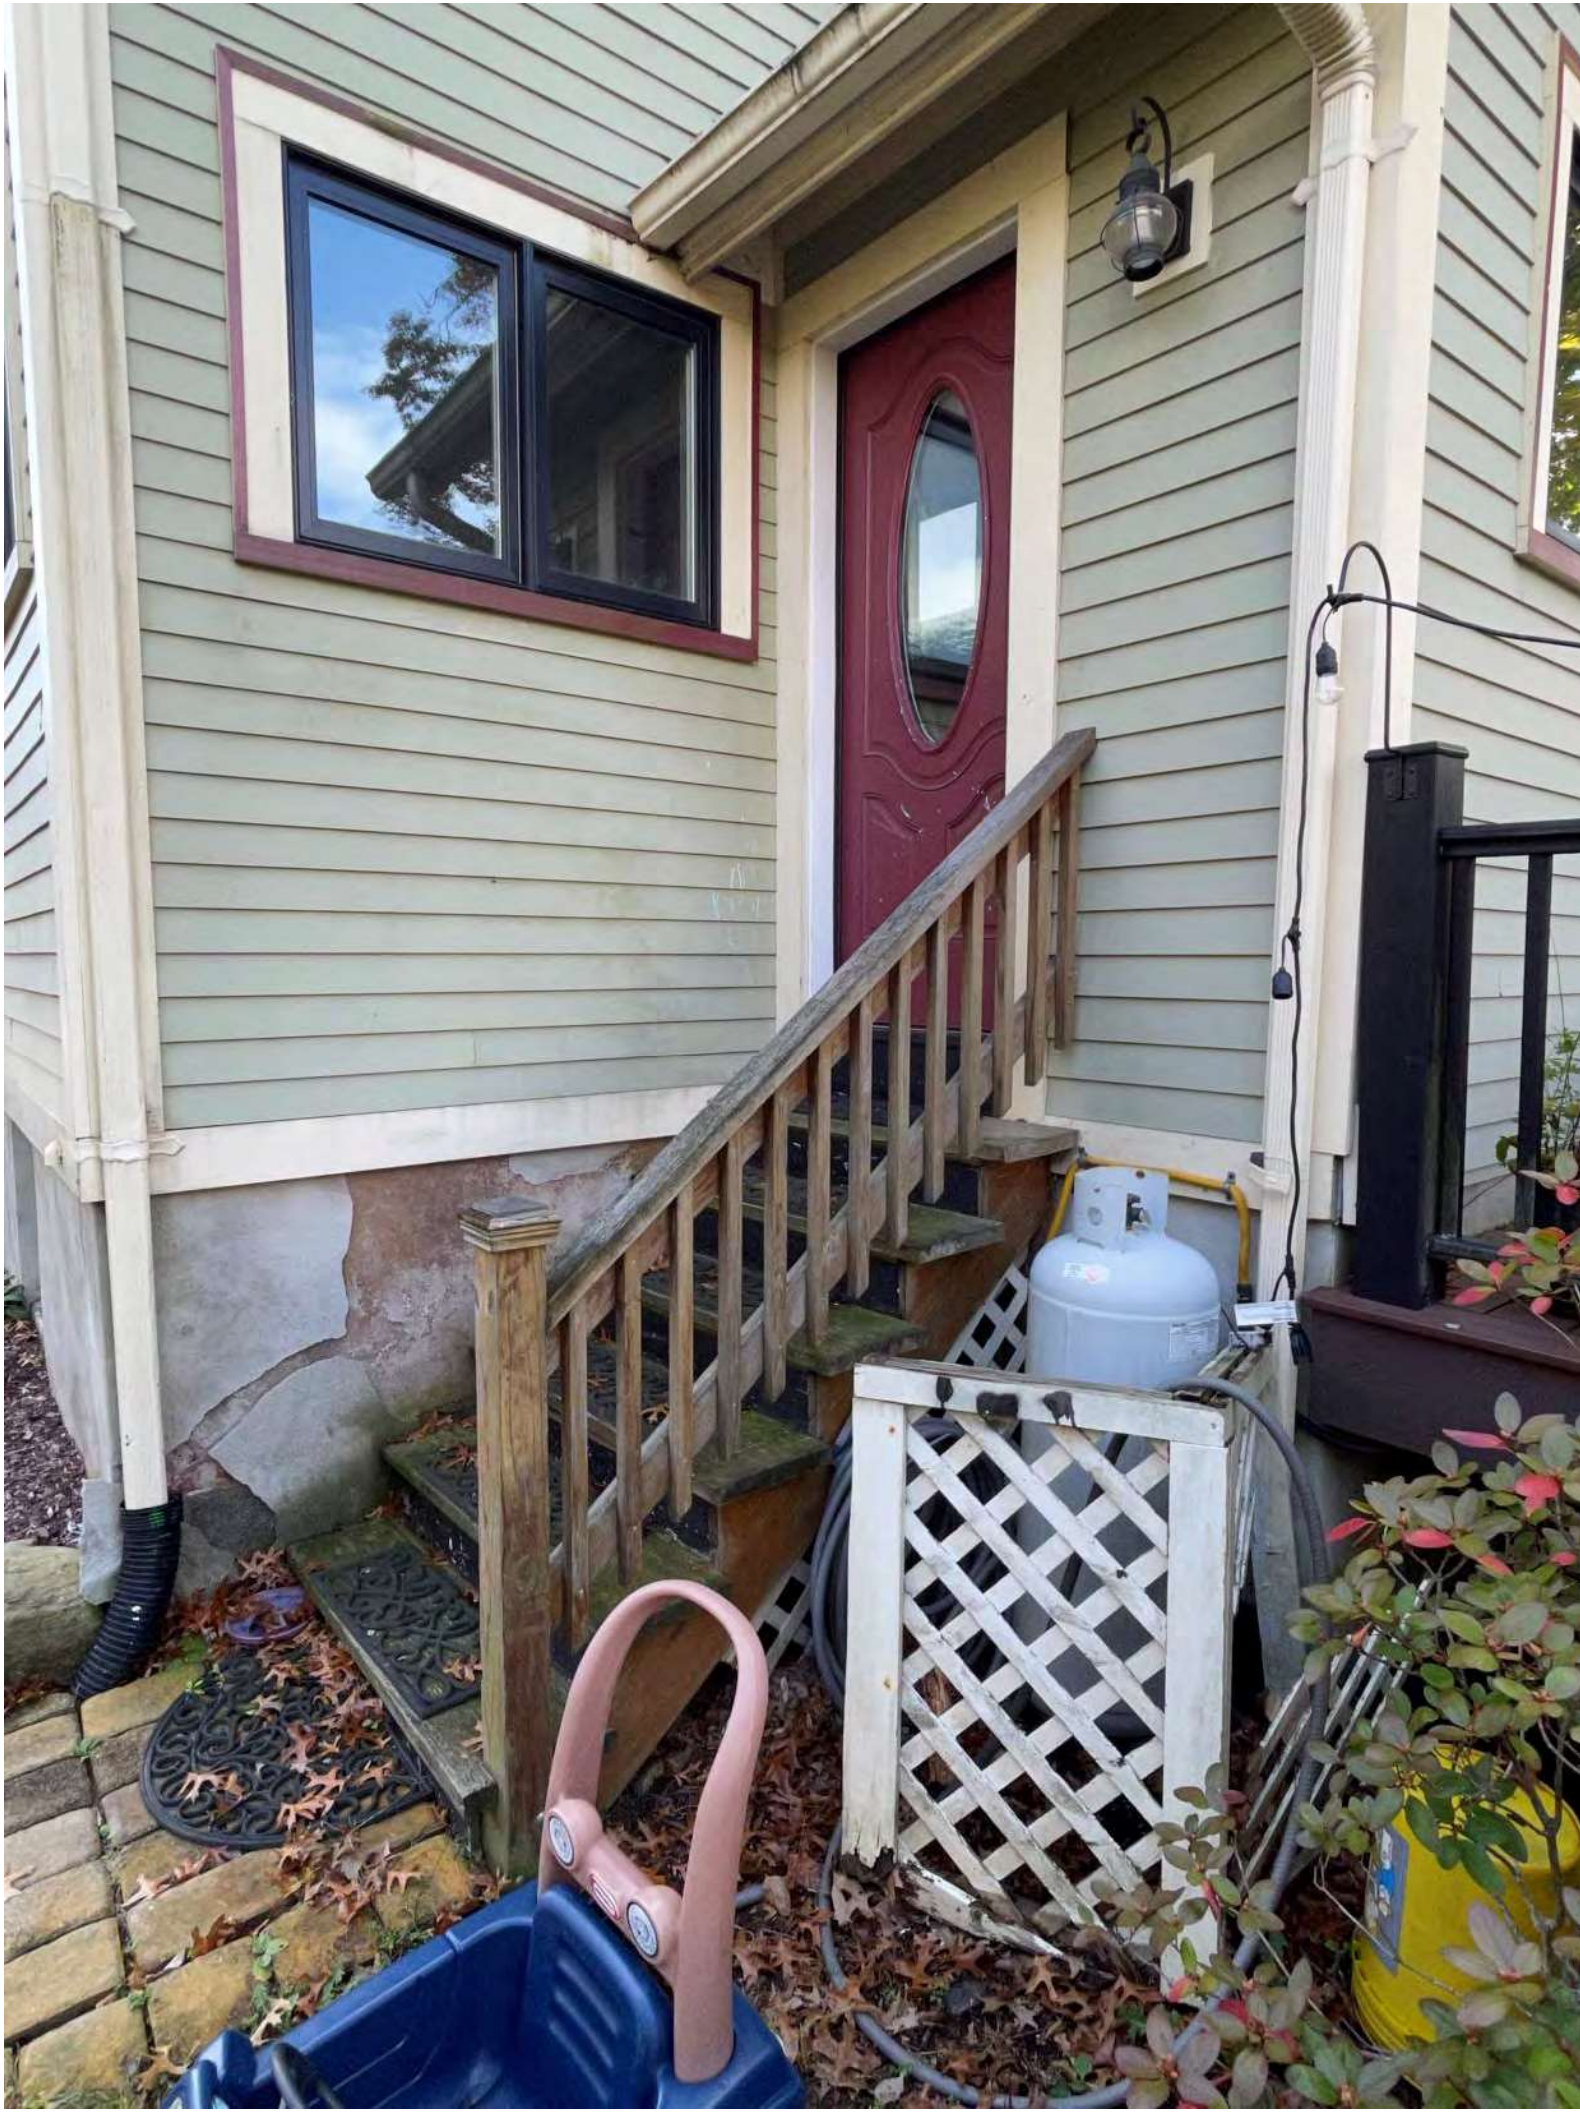
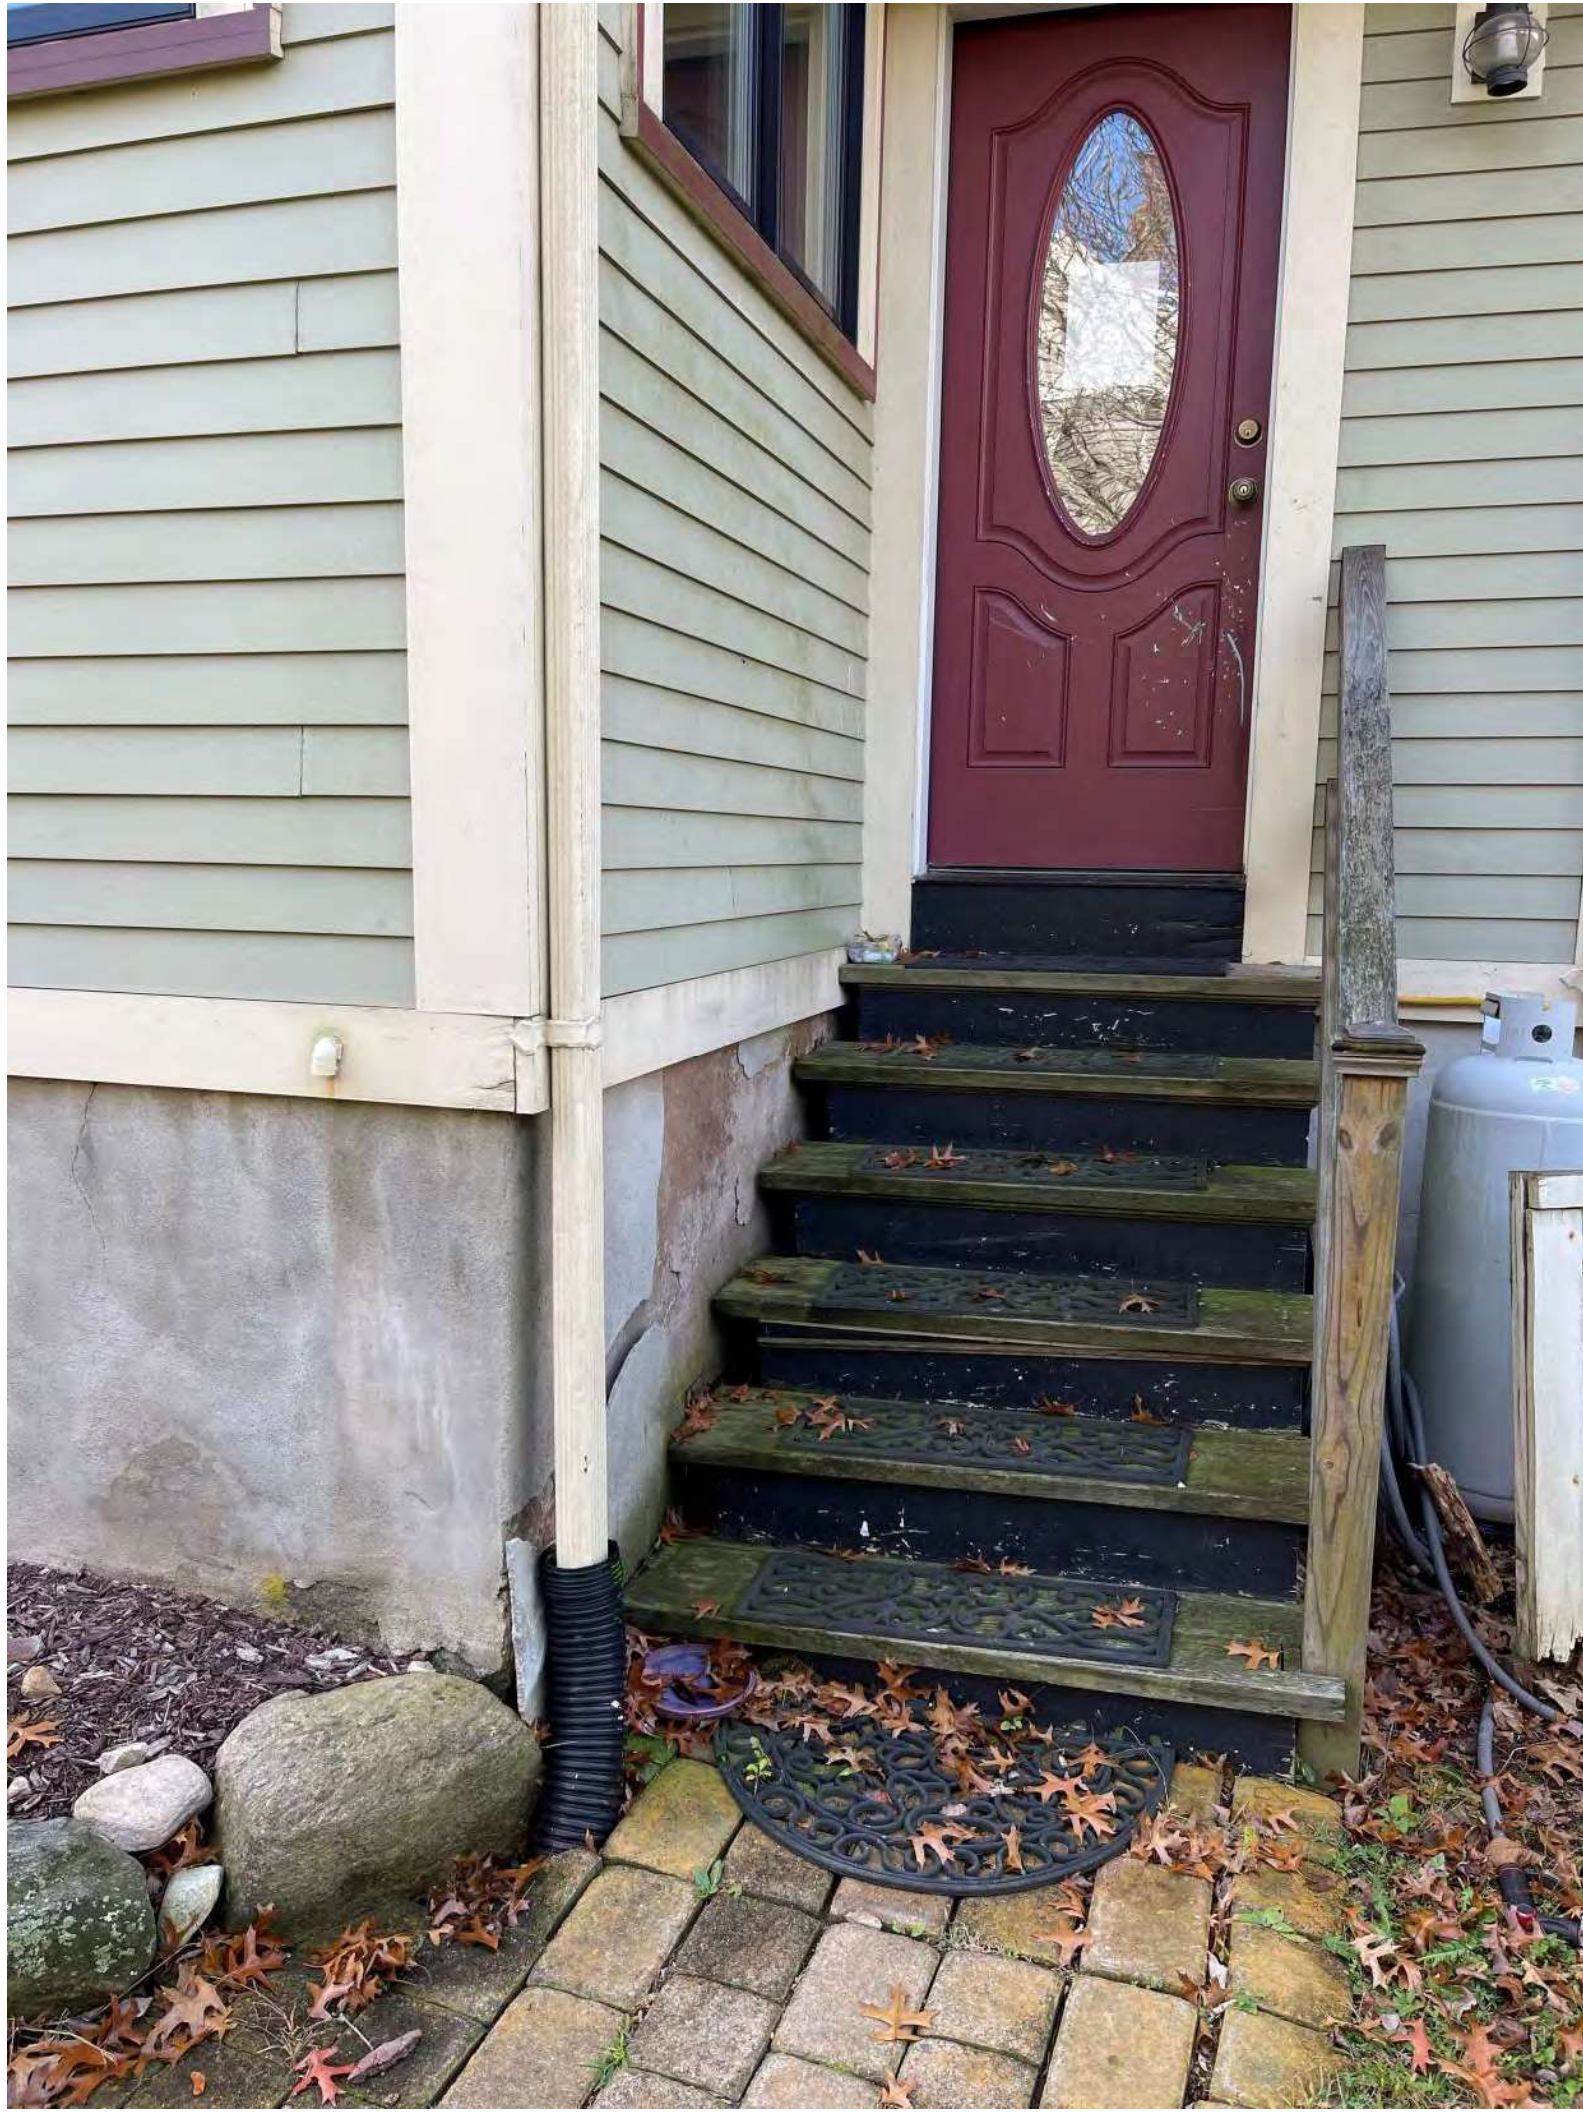
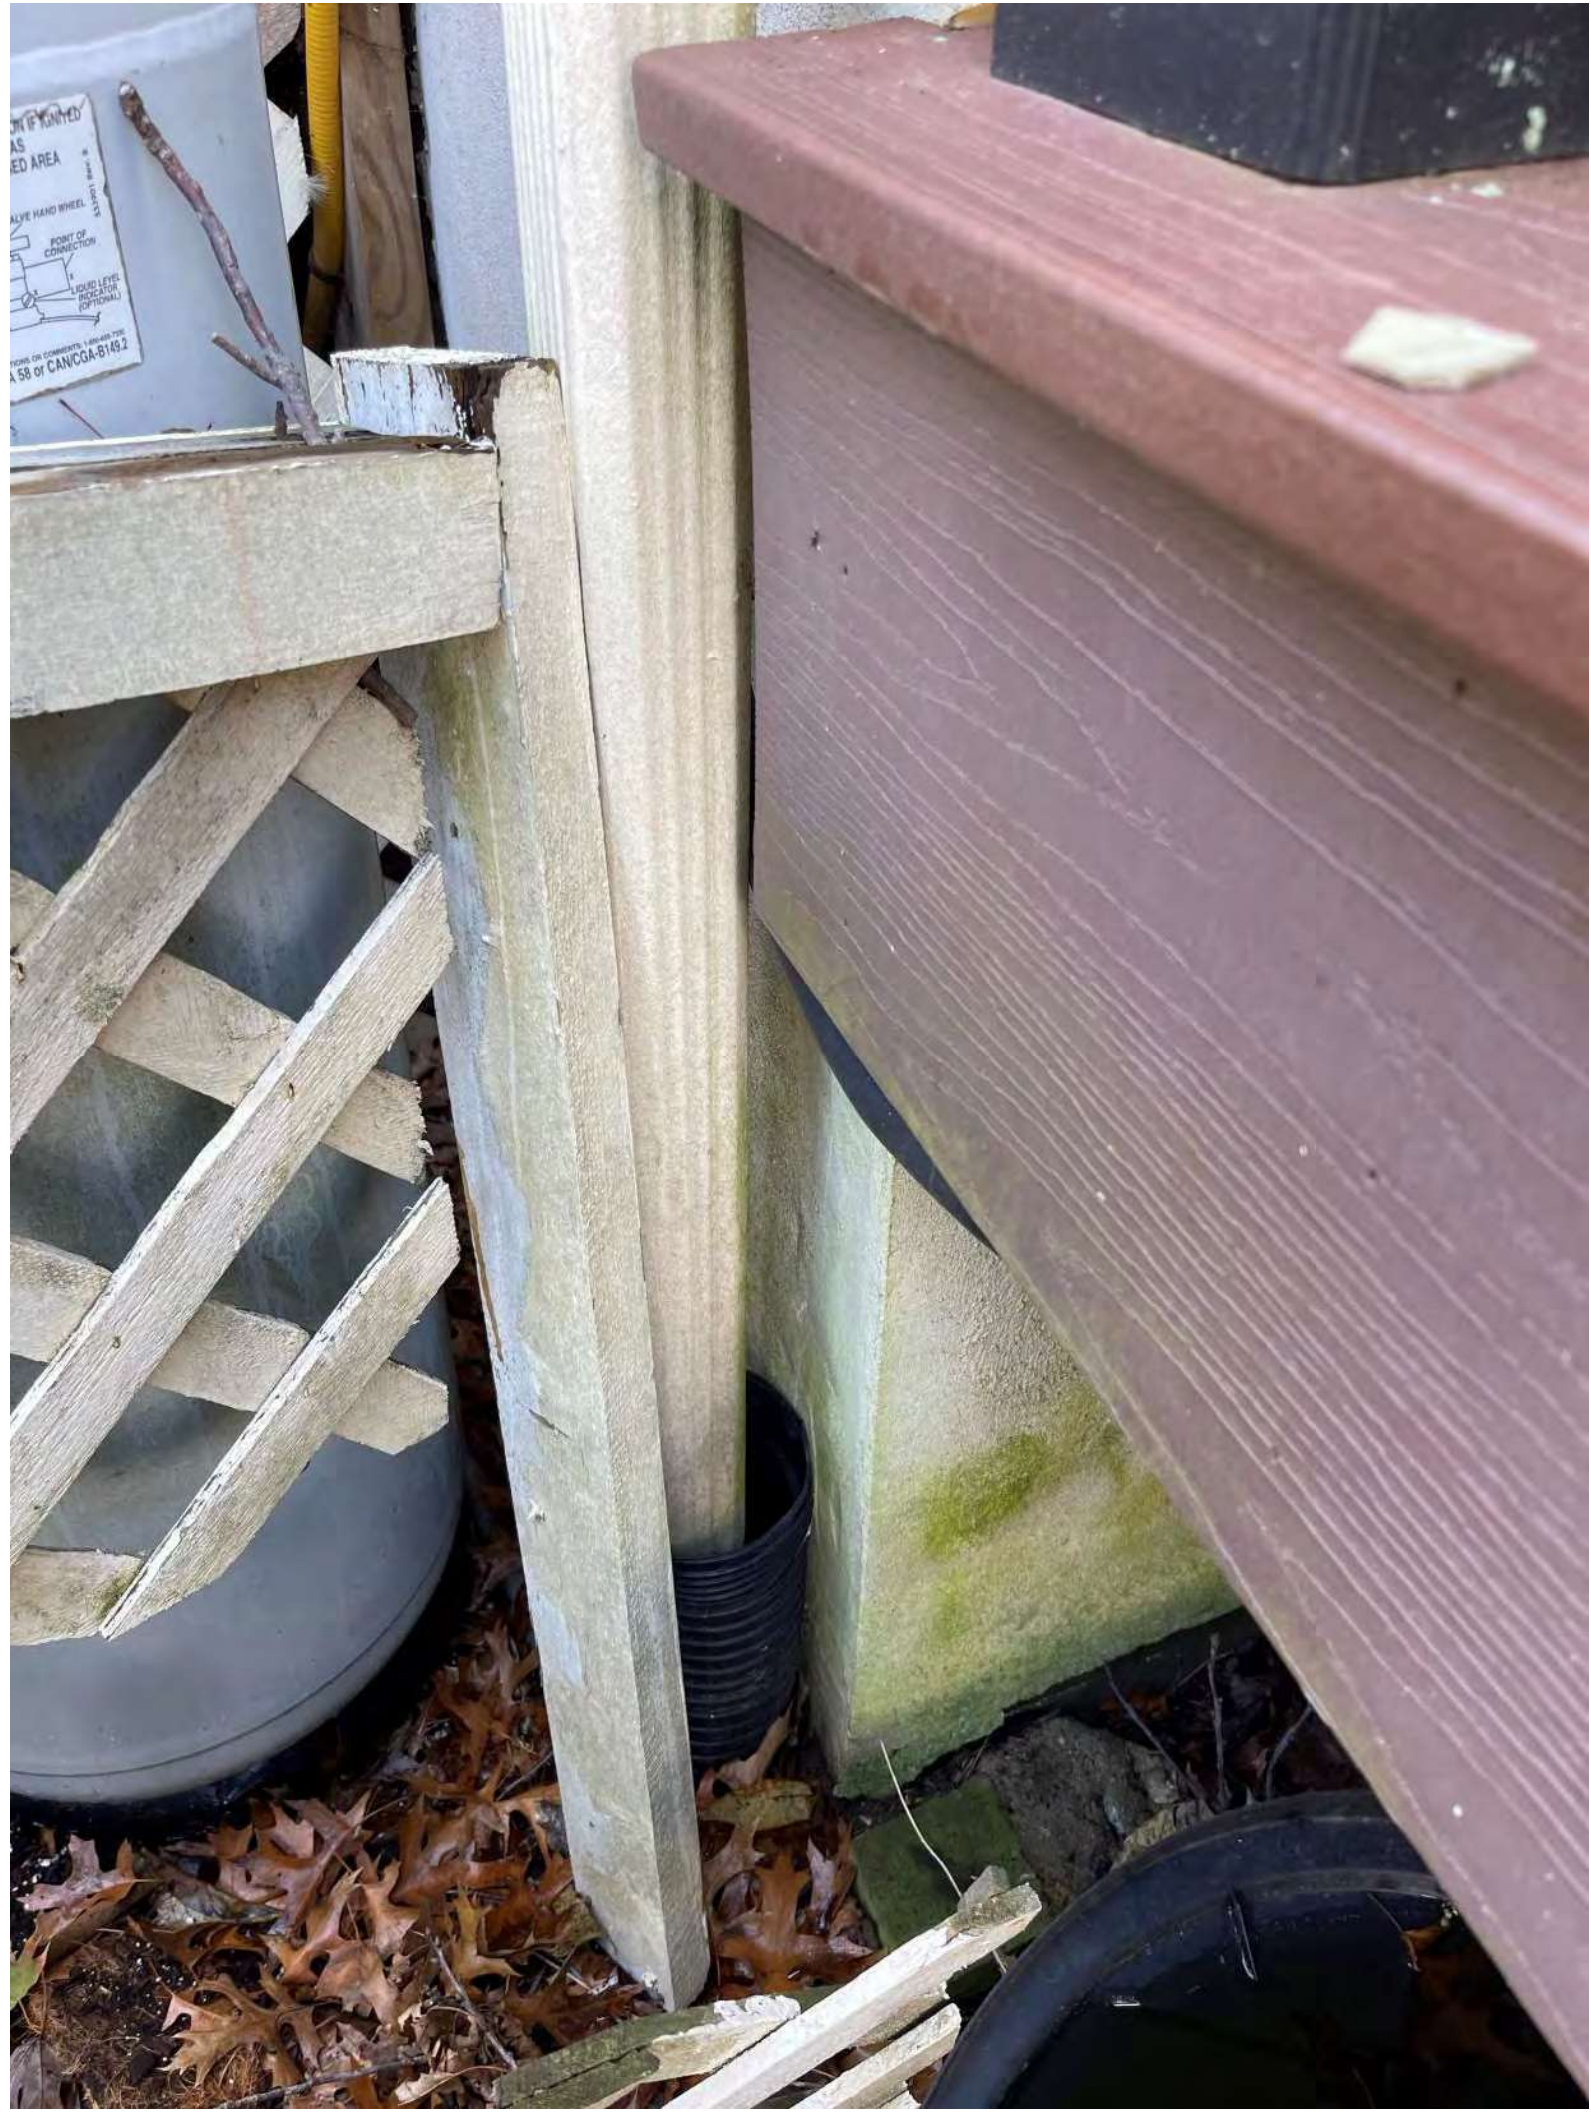
51 Washington Street

No dye visible in observation manhole. flex pipes at ends of roof leaders disperse into ground in front and back yard. we stuck the hose down the pipes about 1 ft - 1.5 ft before hitting dirt.
