### Mystic Area Dye Water Testing Results

# DYED-WATER FLOODING

STONINGTON, CONNECTICUT 06355

OCTOBER 2022  
MCA PROJECT NO.: 2021-335

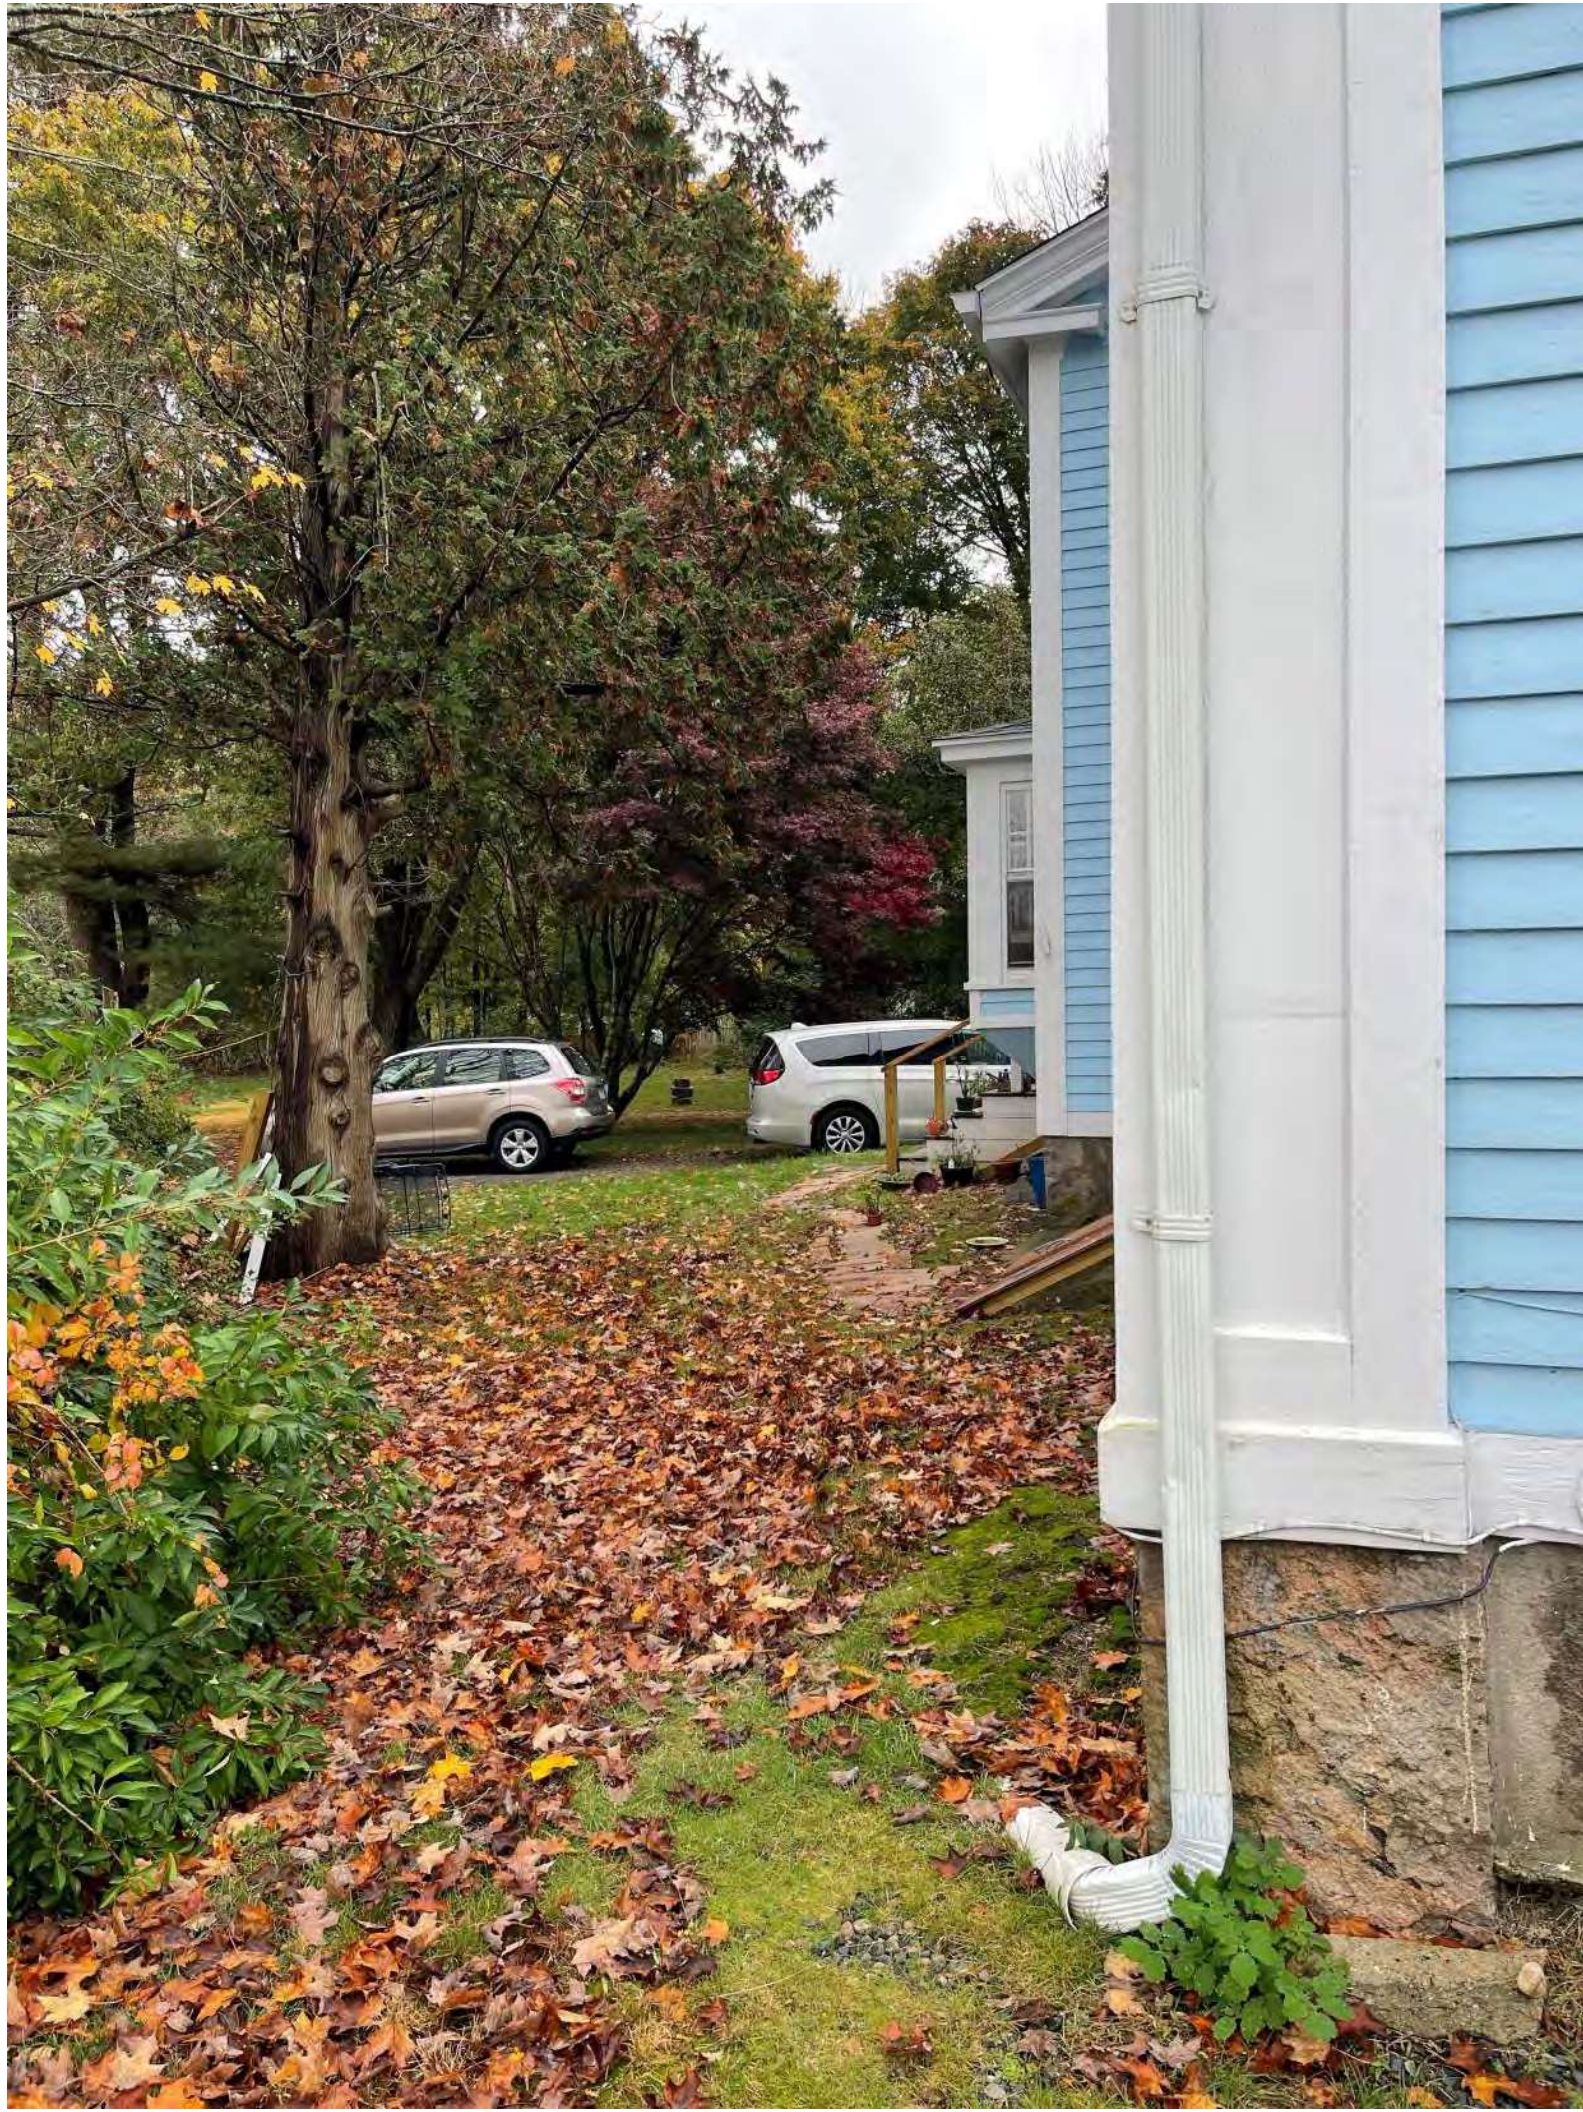
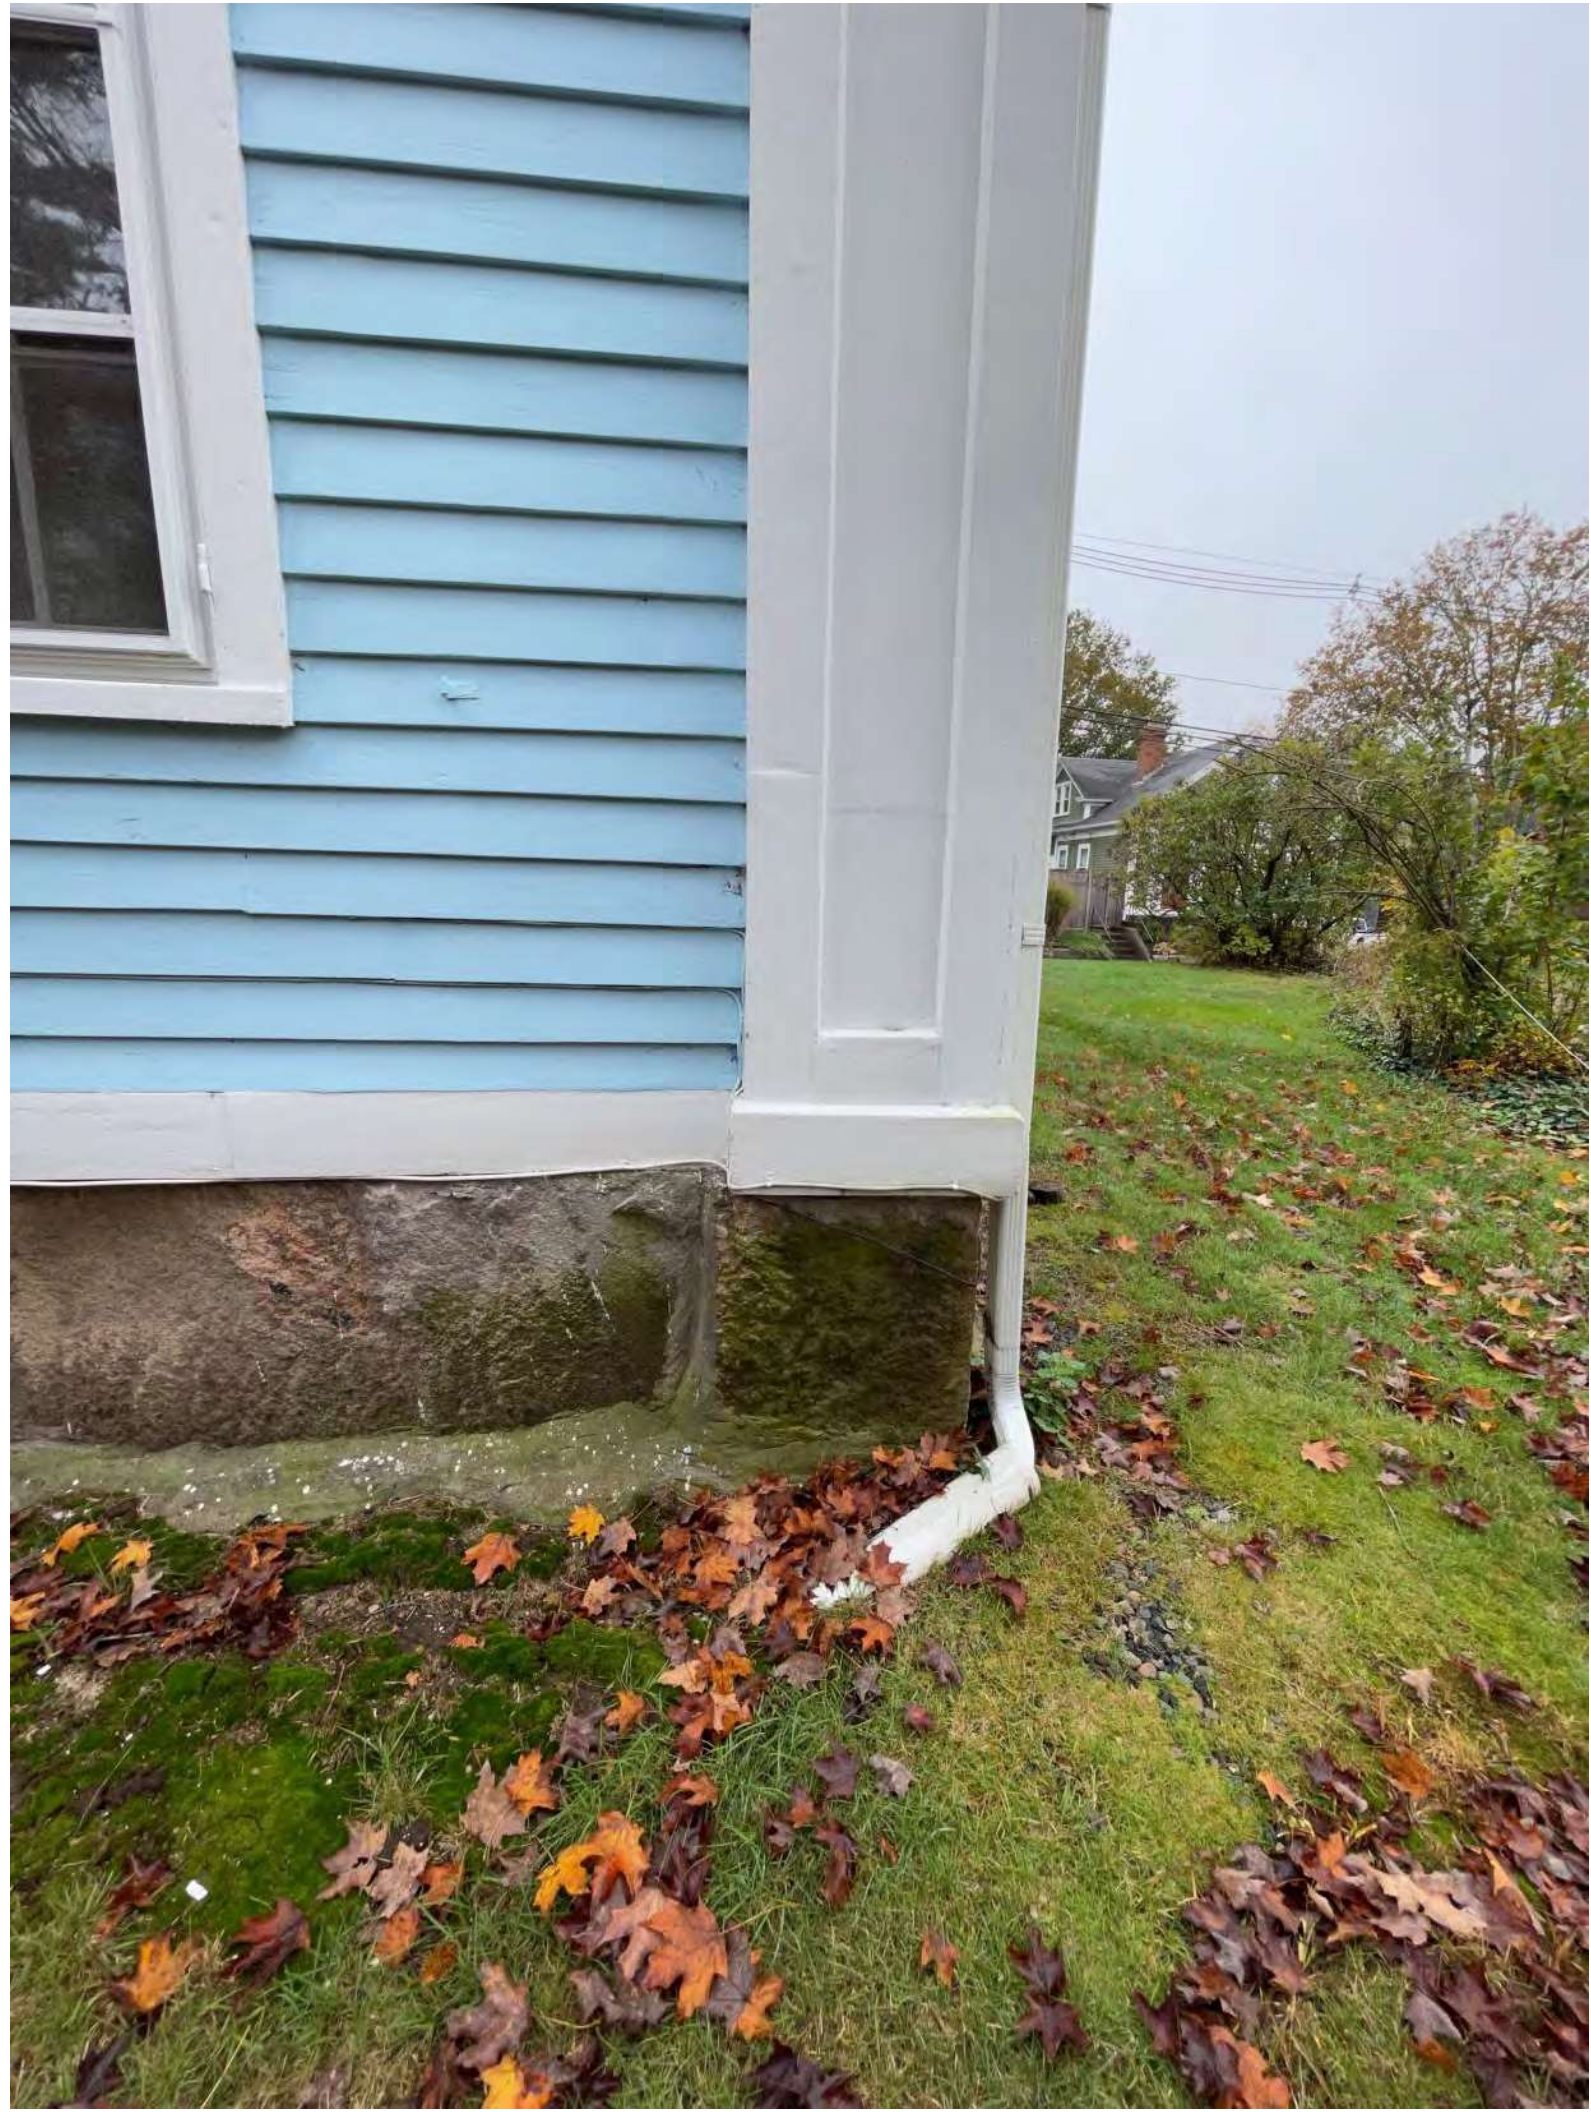
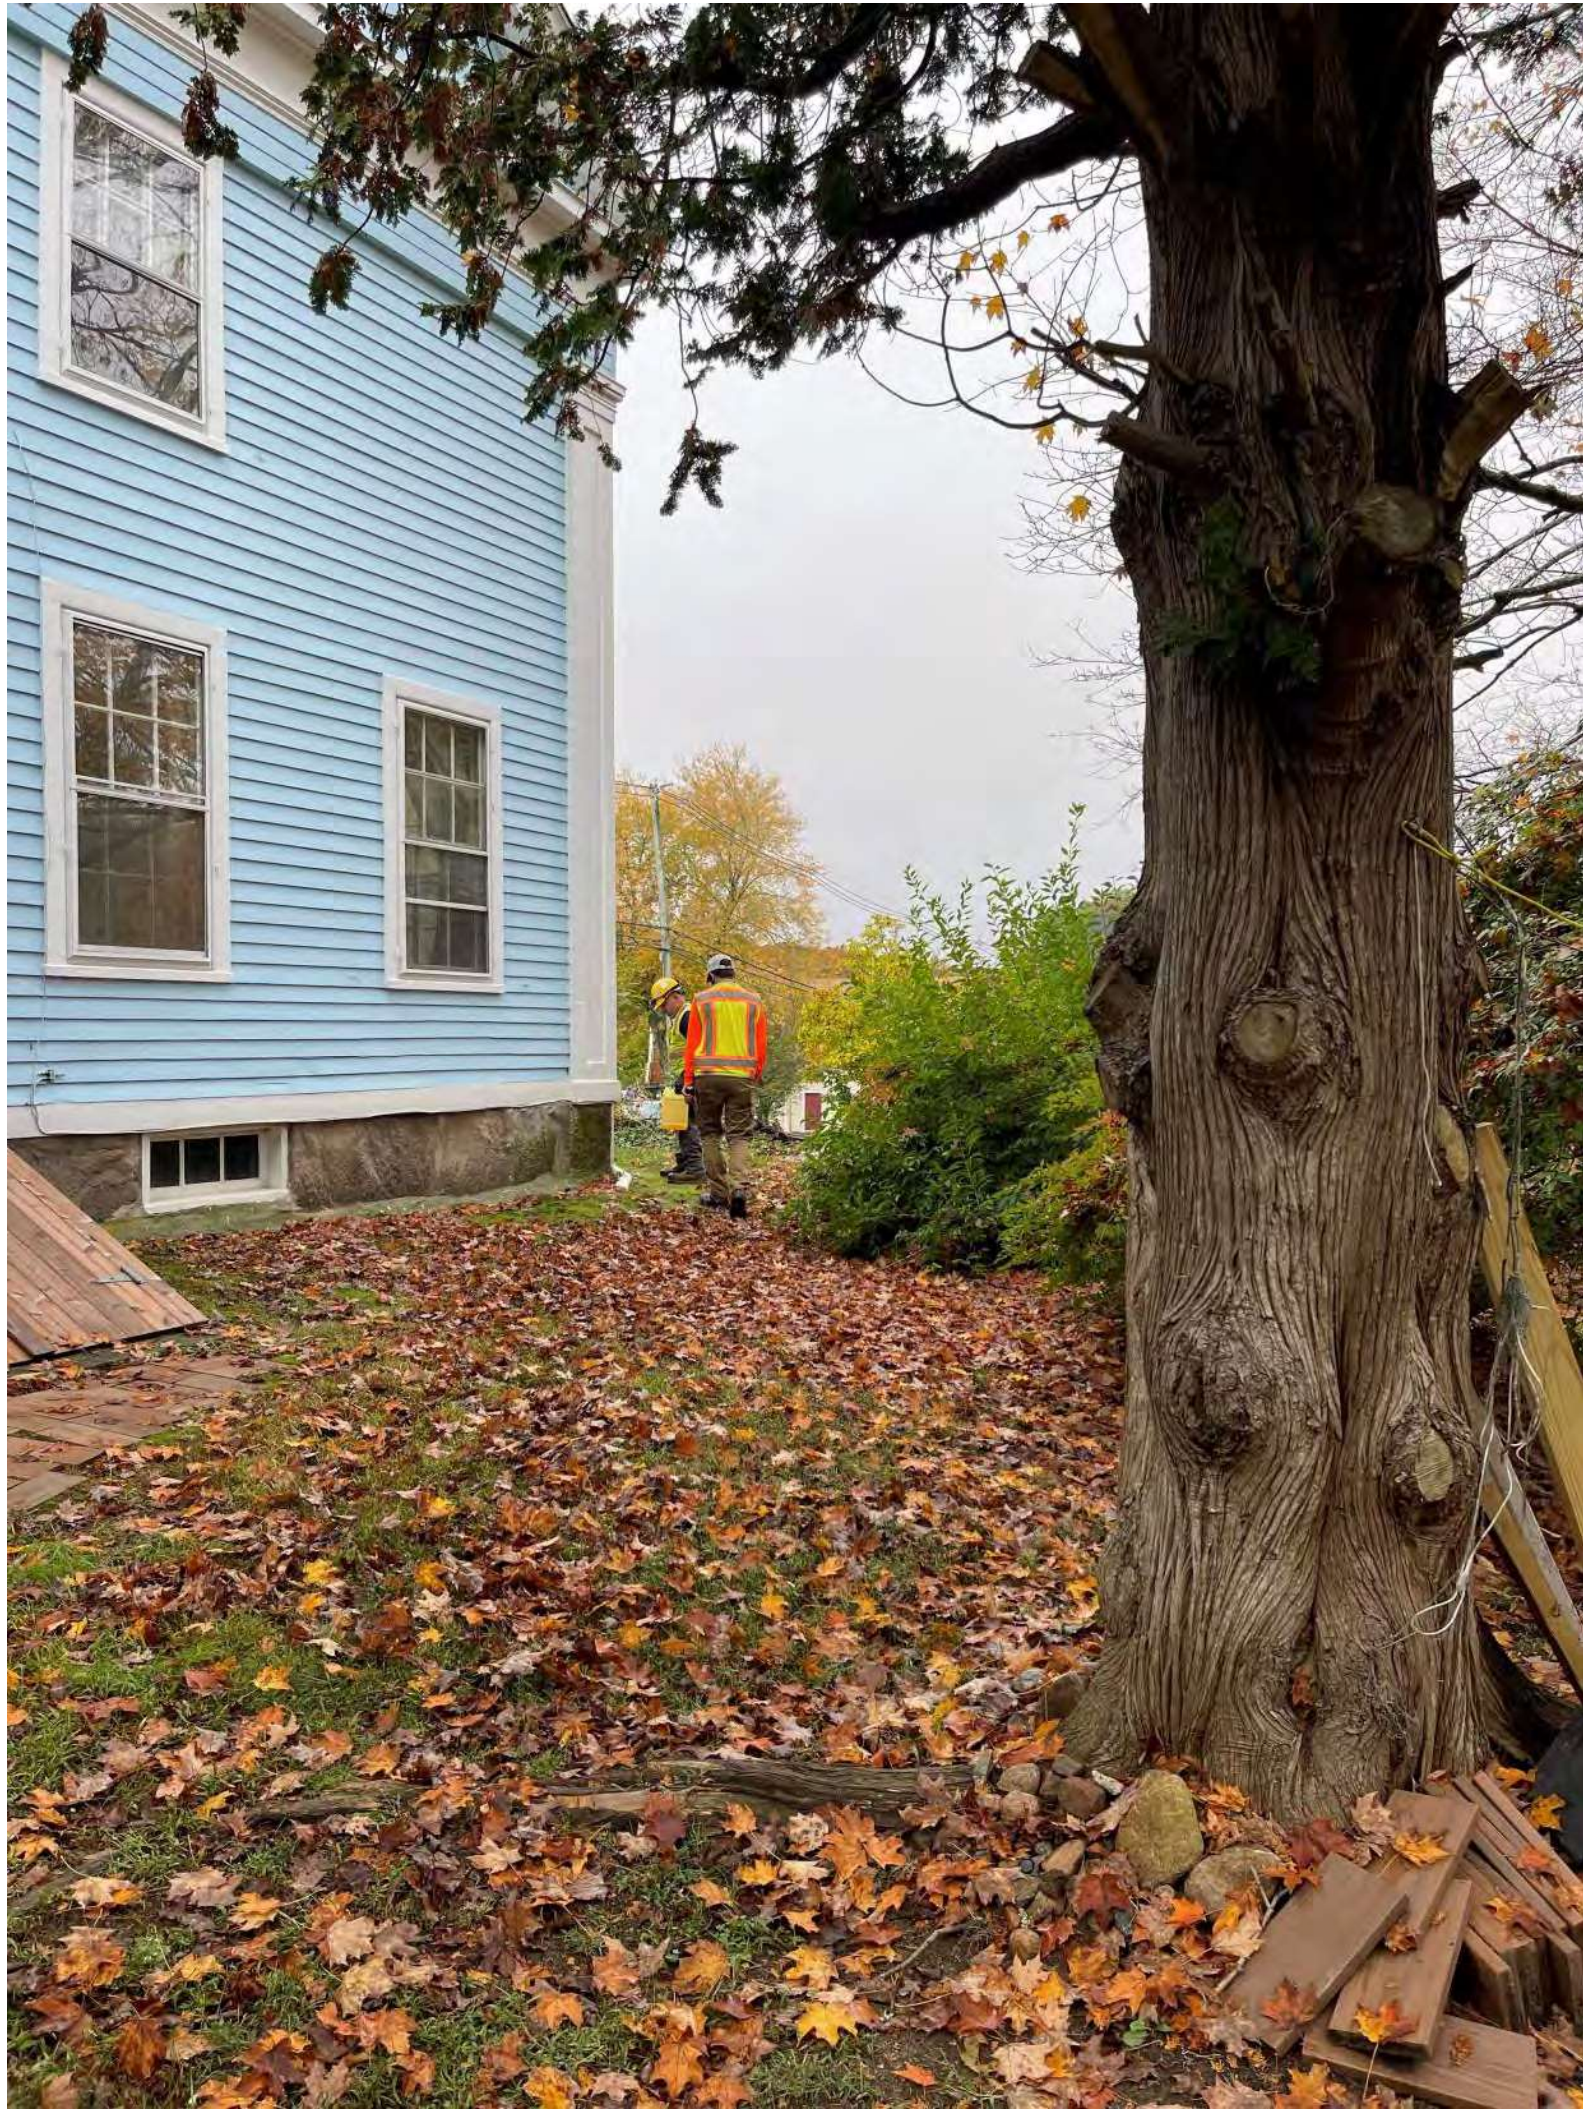
196 Whitehall Avenue

\* No yard drain on property

\* Roof leader goes into ground to perforated pipe and disperses in the yard by a tree. Homeowner confirmed

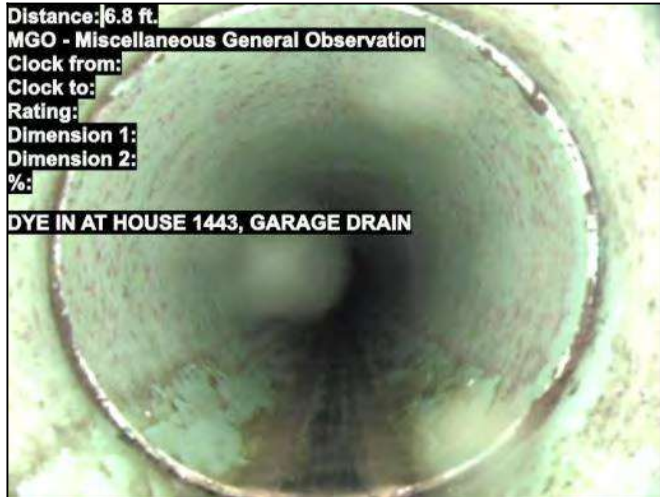
Photo: 1-215-1-212-20221025-091723-092446.JPG  
At: 6.805 ft. MGO - Miscellaneous General Observation  
Joint: No DYE IN AT HOUSE 1443, GARAGE DRAIN

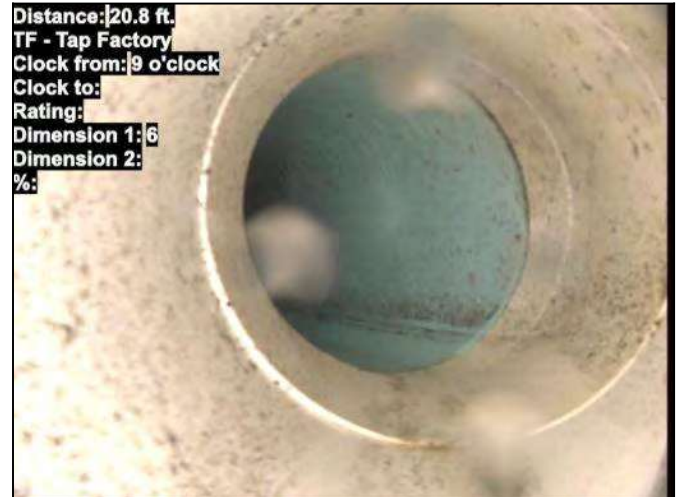
Photo: 1-215-1-212-20221025-091723-092702.JPG  
At: 20.816 ft. 9/. TF - Tap Factory  
Joint: No

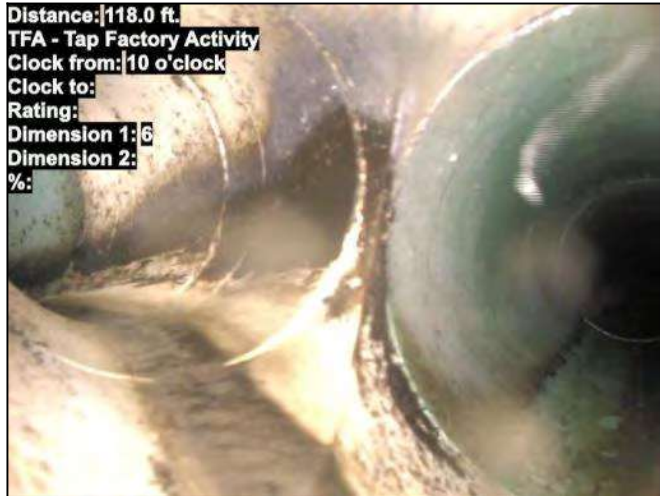
Photo: 1-215-1-212-20221025-091723-093051.JPG  
At: 117.99 ft. TFA - Tap Factory Activity  
10/.  
Joint: No

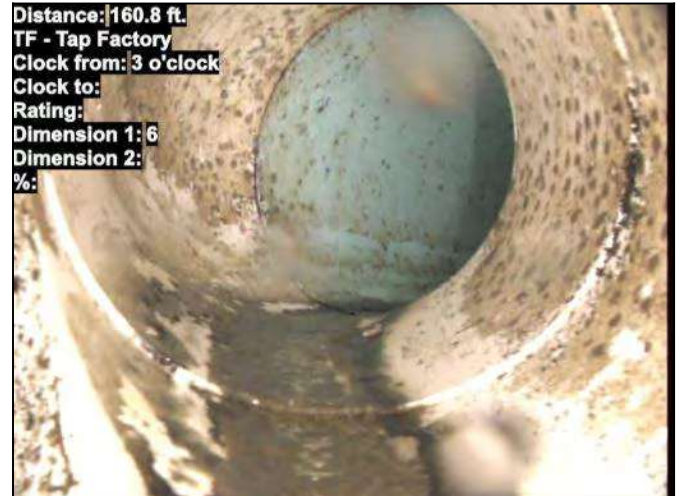
Photo: 1-215-1-212-20221025-091723-093259.JPG  
At: 160.823 ft. TF - Tap Factory  
3/.  
Joint: No

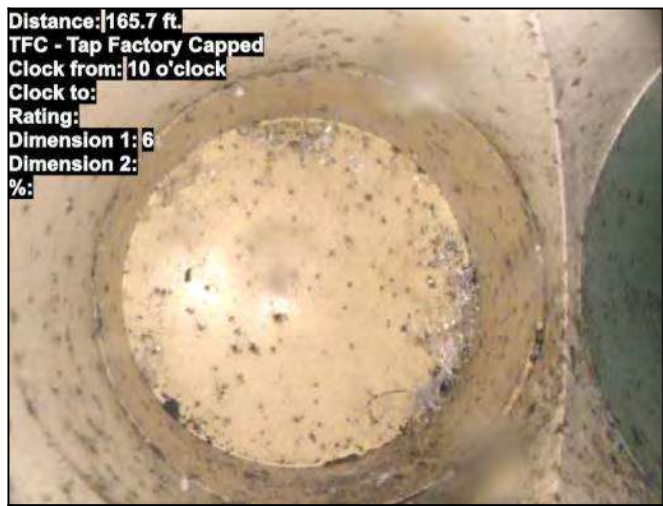
Distance: 165.7 ft.  
TFC - Tap Factory Capped  
Clock from: 10 o'clock  
Clock to:  
Rating:  
Dimension 1: 6  
Dimension 2:  
%:  
Photo: 1-215-1-212-20221025-091723-093331.JPG  
At: 165.727 ft. TFC - Tap Factory Capped  
10/.  
Joint: No

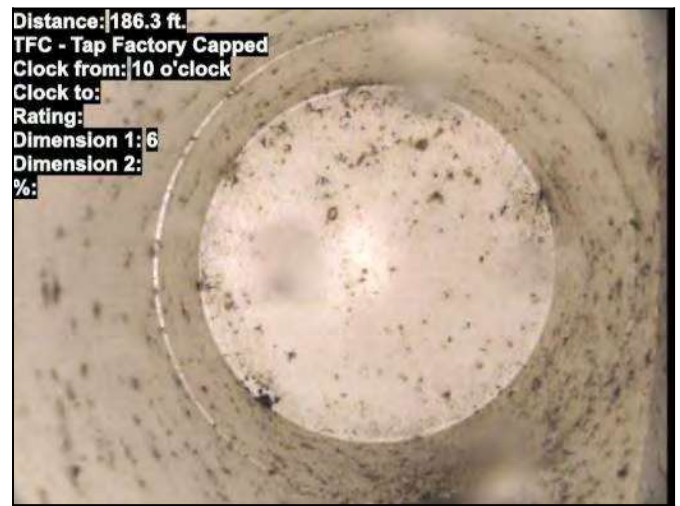
Distance: 186.3 ft.  
TFC - Tap Factory Capped  
Clock from: 10 o'clock  
Clock to:  
Rating:  
Dimension 1: 6  
Dimension 2:  
%:  
Photo: 1-215-1-212-20221025-091723-093424.JPG  
At: 186.343 ft. TFC - Tap Factory Capped  
10/.  
Joint: No

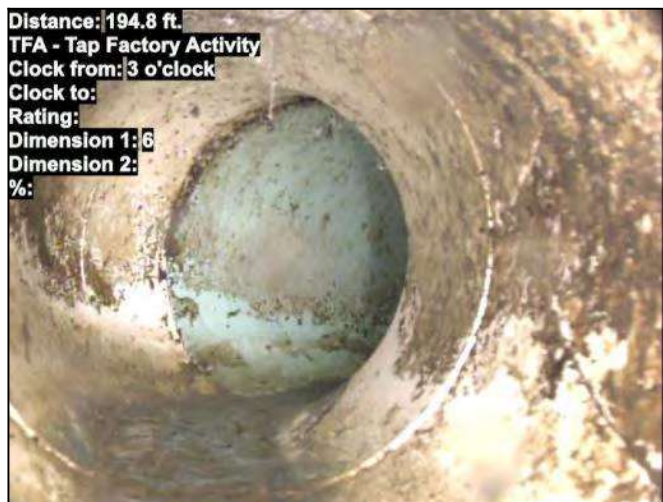
Distance: 194.8 ft.  
TFA - Tap Factory Activity  
Clock from: 3 o'clock  
Clock to:  
Rating:  
Dimension 1: 6  
Dimension 2:  
%:  
Photo: 1-215-1-212-20221025-091723-093453.JPG  
At: 194.849 ft. TFA - Tap Factory Activity  
3/.  
Joint: No

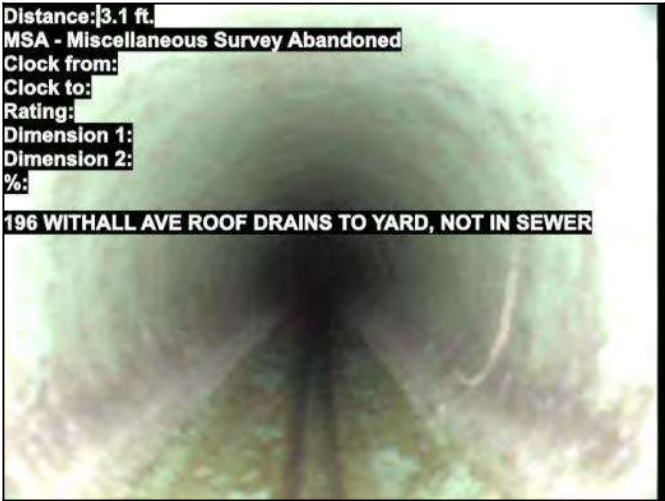
Photo: 1-214-1-213-20221025-095537-100600.JPG  
At: 3.102 ft. MSA - Miscellaneous Survey Abandoned  
Joint: No 196 WITHALL AVE ROOF DRAINS TO YARD,  
NOT IN SEWER

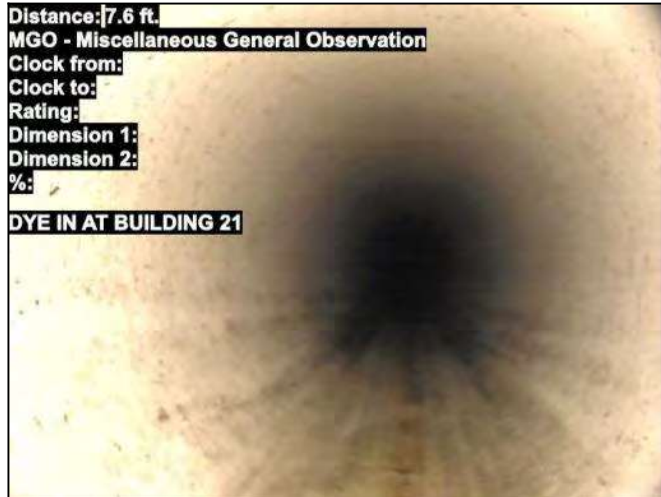
Photo: 1-229-1-228-20221025-102314-103519.JPG

Joint: No DYE IN AT BUILDING 21

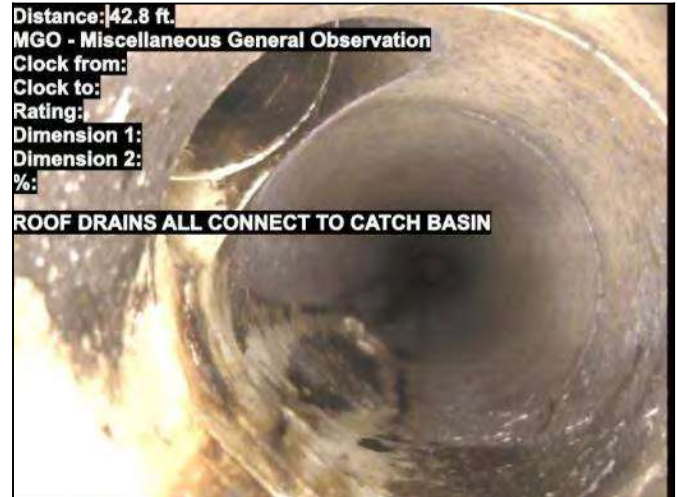
Photo: 1-229-1-228-20221025-102314-105845.JPG

Joint: No ROOF DRAINS ALL CONNECT TO CATCH BASIN

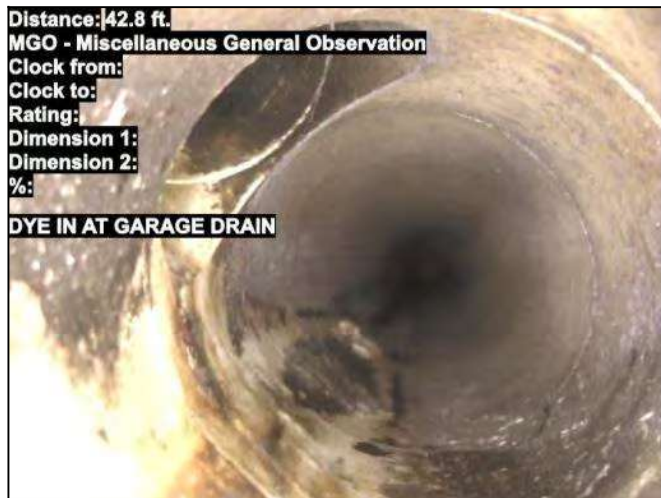
Photo: 1-229-1-228-20221025-102314-105812.JPG

Joint: No DYE IN AT GARAGE DRAIN

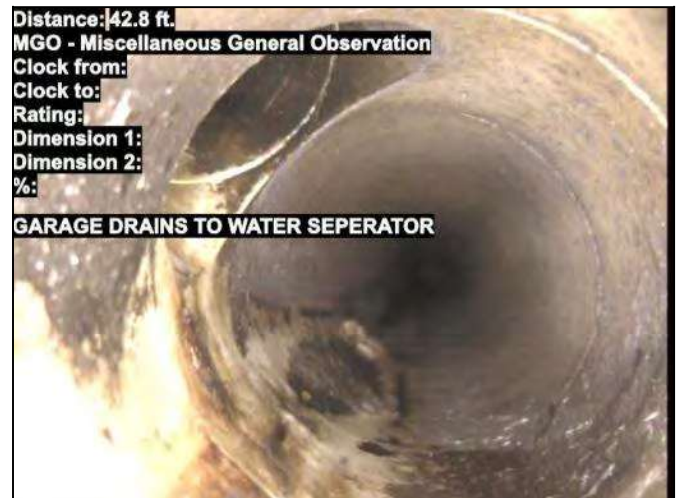
Photo: 1-229-1-228-20221025-102314-110313.JPG

Joint: No GARAGE DRAINS TO WATER SEPERATOR

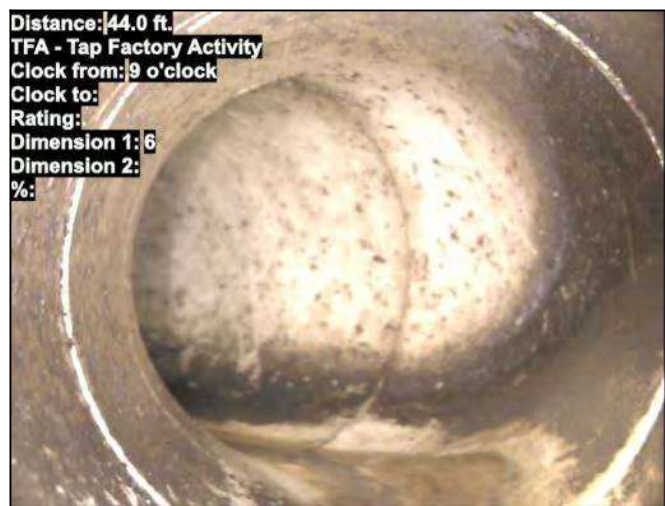
Photo: 1-229-1-228-20221025-102314-103635.JPG  
At: 44.034 ft. 9/. TFA - Tap Factory Activity  
Joint: No

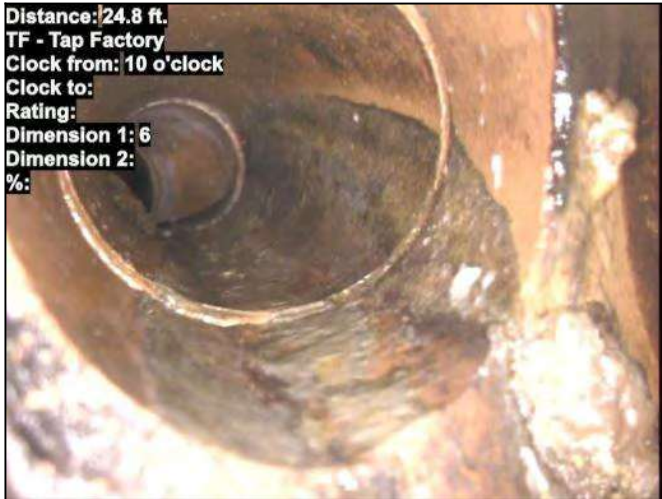
Photo: 1-65-1-64-20221025-121347-121659.JPG

Distance: 24.8 ft.  
TF - Tap Factory  
Clock from: 10 o'clock  
Clock to:  
Rating:  
Dimension 1: 6  
Dimension 2:  
%:

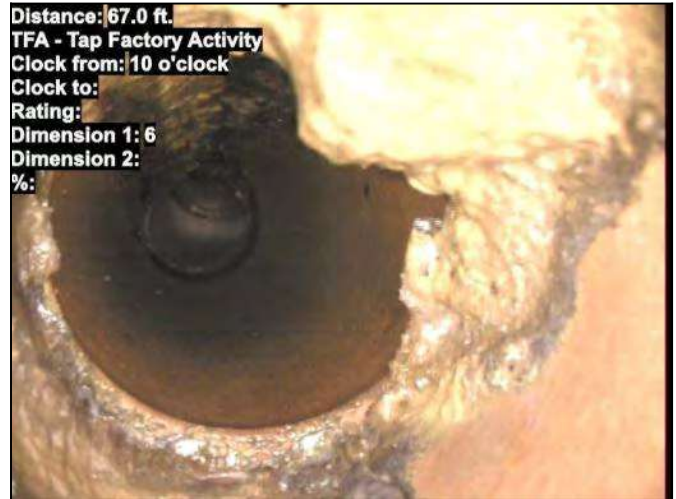
Photo: 1-65-1-64-20221025-121347-121812.JPG

Distance: 67.0 ft.  
TFA - Tap Factory Activity  
Clock from: 10 o'clock  
Clock to:  
Rating:  
Dimension 1: 6  
Dimension 2:  
%:
