## Appendix A

### Mystic Area CCTV Inspection Logs

## NWMCC INSPECTION REPORT

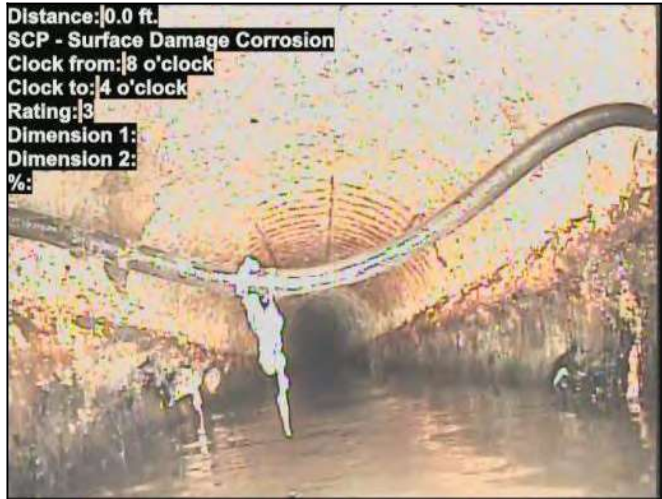
Photo: MH 1-40A-MH 1-40-20220822-115203.JPG

At: 0 ft. 8/4 SCP - Surface Damage Corrosion

Joint: Yes

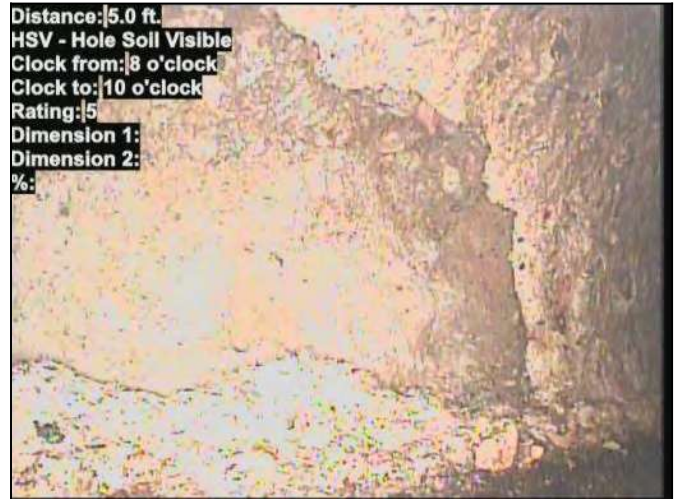
Photo: MH 1-40A-MH 1-40-20220822-115422.JPG

At: 5 ft. 8/10 HSV - Hole Soil Visible

Joint: Yes

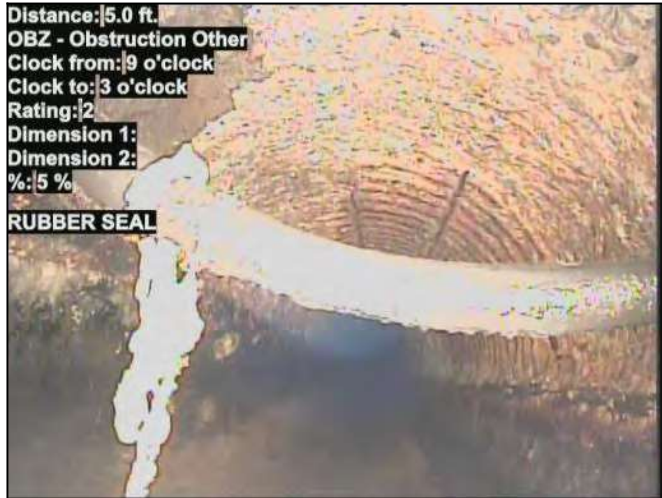
Photo: MH 1-40A-MH 1-40-20220822-115253.JPG

At: 5 ft. 9/3 OBZ - Obstruction Other

Joint: No 5 % RUBBER SEAL

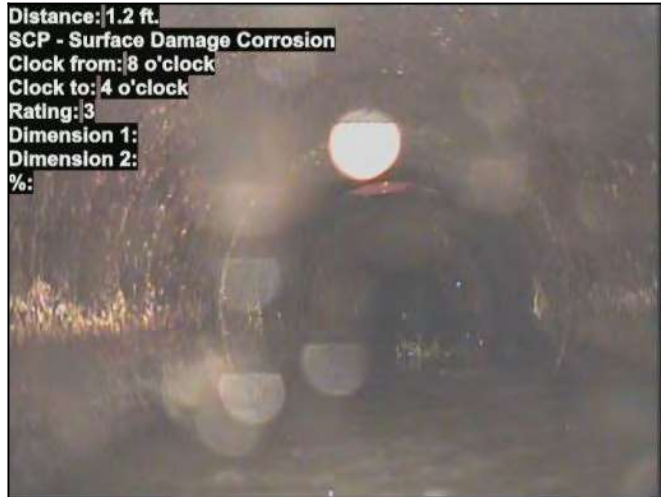
Photo: MH 1-40-MH 1-39-20220822-125611.JPG

At: 1.2 ft. 8/4 SCP - Surface Damage Corrosion

Joint: Yes

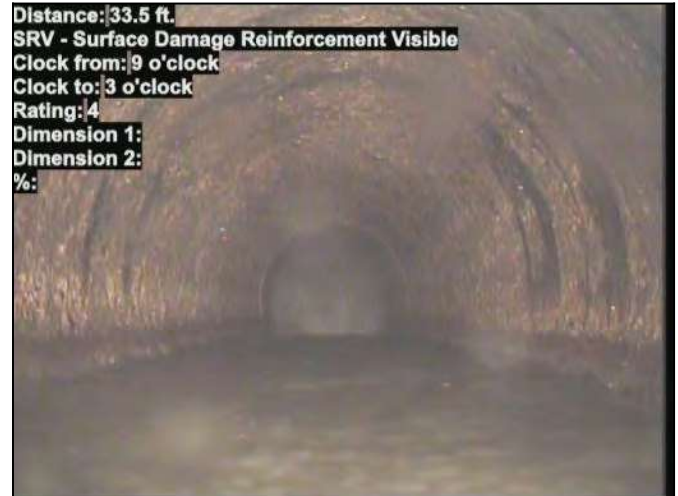
Photo: MH 1-40-MH 1-39-20220822-132024.JPG

At: 33.5 ft. 9/3 SRV - Surface Damage Reinforcement Visible

Joint: Yes

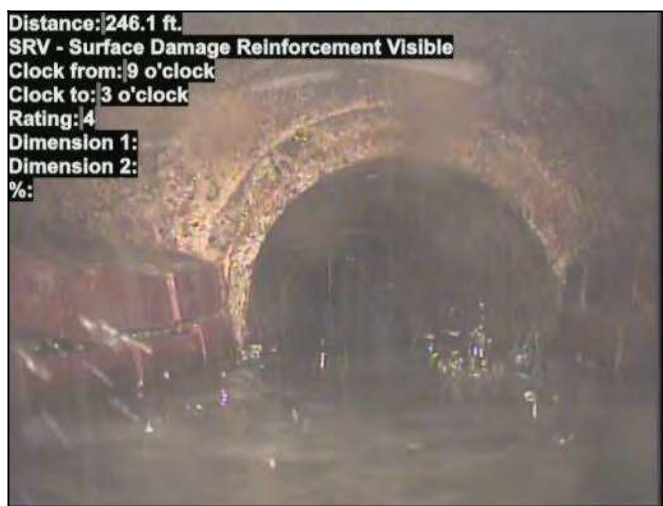
Photo: MH 1-40-MH 1-39-20220822-133603.JPG

Distance: 246.1 ft.  
 SRV - Surface Damage Reinforcement Visible  
 Clock from: 9 o'clock  
 Clock to: 3 o'clock  
 Rating: 4  
 Dimension 1:  
 Dimension 2:  
 %:

At: 246.1 ft. 9/3 SRV - Surface Damage Reinforcement Visible

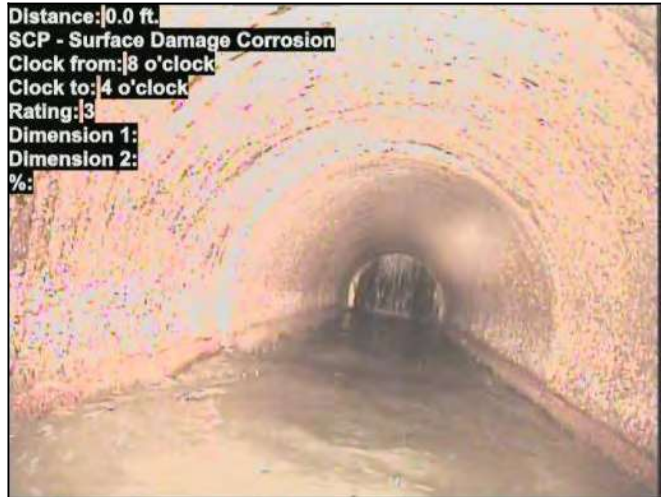
Photo: MH 1-39-MH 1-38-20220823-090930.JPG

At: 0 ft. 8/4 SCP - Surface Damage Corrosion

Joint: Yes

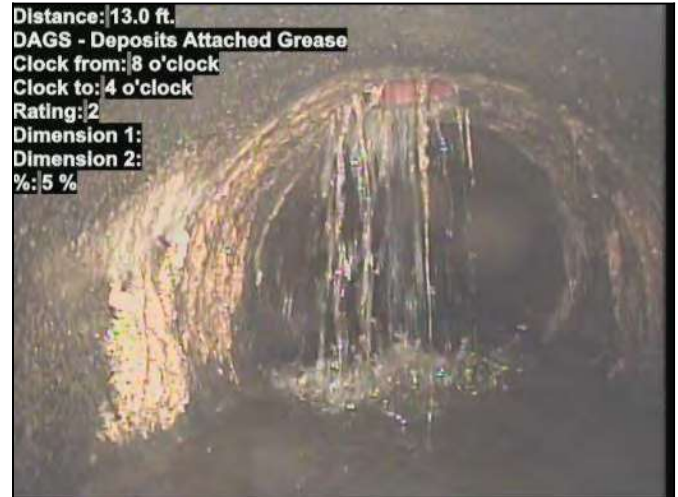
Photo: MH 1-39-MH 1-38-20220823-091218.JPG

At: 13 ft. 8/4 DAGS - Deposits Attached Grease

Joint: Yes 5 %

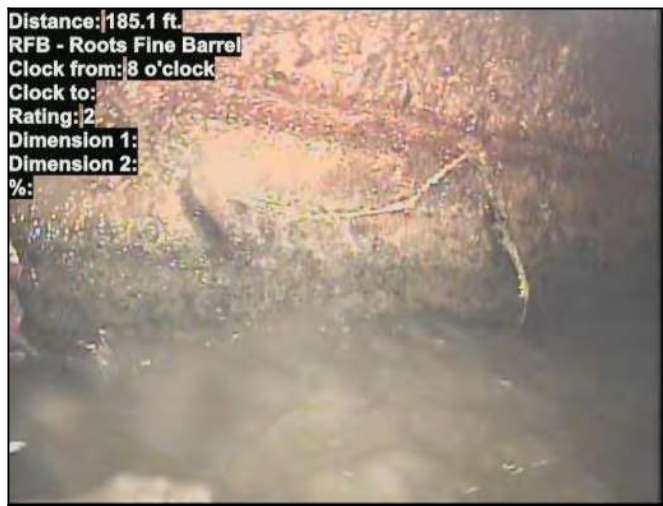
Photo: MH 1-39-MH 1-38-20220823-092057\_1.JPG

At: 185.1 ft. 8/. RFB - Roots Fine Barrel

Joint: No

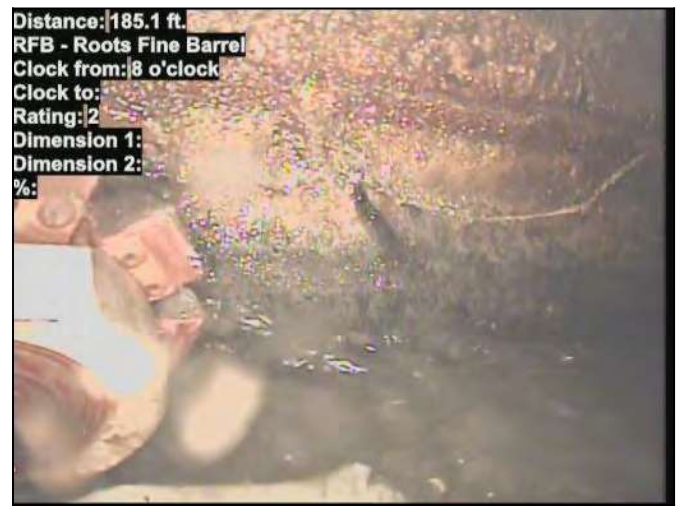
Photo: MH 1-39-MH 1-38-20220823-092057.JPG

At: 185.1 ft. 8/. RFB - Roots Fine Barrel

Joint: No

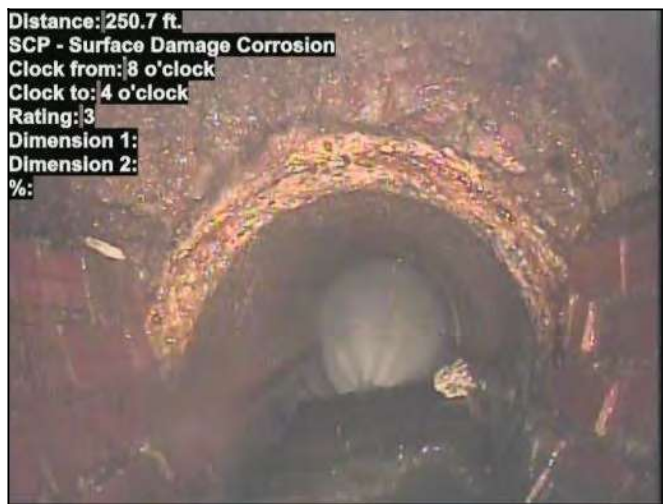
Photo: MH 1-39-MH 1-38-20220823-092549.JPG

At: 250.7 ft. 8/4 SCP - Surface Damage Corrosion

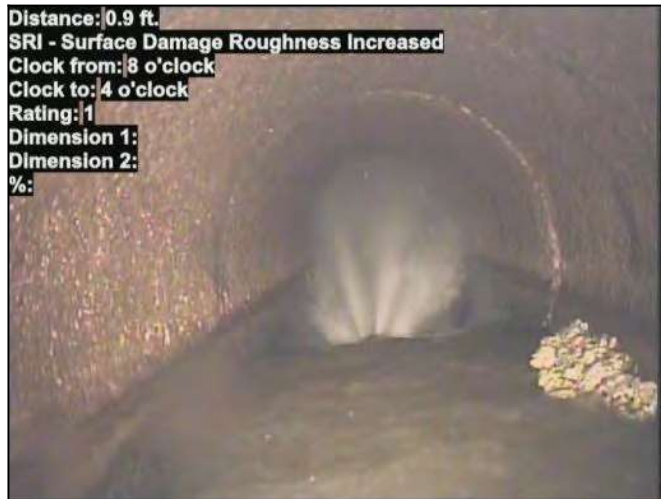
Photo: MH 1-38-MH 1-37-20220823-093446.JPG

At: 0.9 ft. 8/4 SRI - Surface Damage Roughness Increased

Joint: Yes

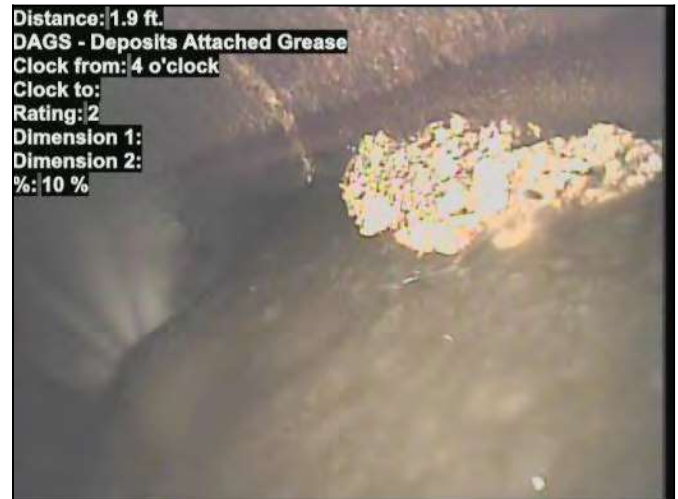
Photo: MH 1-38-MH 1-37-20220823-093544.JPG

At: 1.9 ft. 4/. DAGS - Deposits Attached Grease

Joint: No 10 %

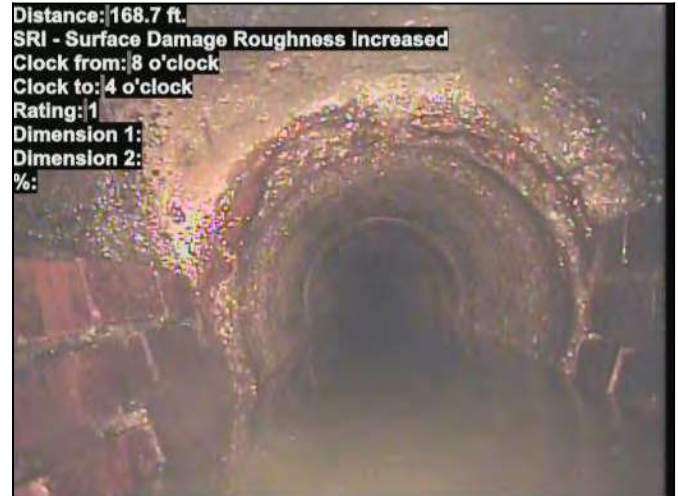
Photo: MH 1-38-MH 1-37-20220823-094255.JPG

At: 168.7 ft. 8/4 SRI - Surface Damage Roughness Increased

Joint: Yes

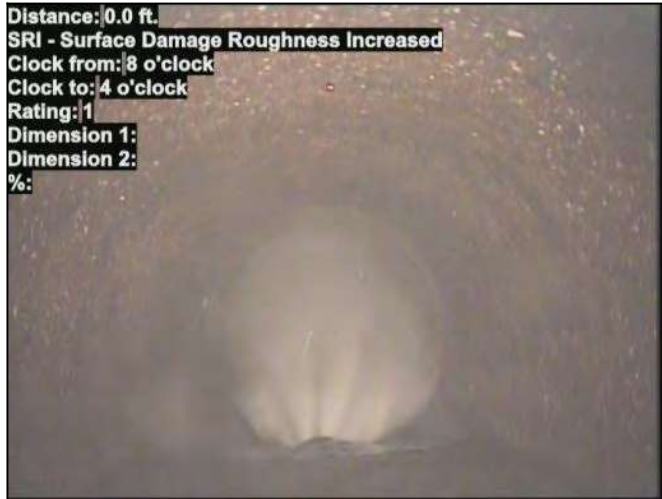
Distance: 0.0 ft.  
SRI - Surface Damage Roughness Increased  
Clock from: 8 o'clock  
Clock to: 4 o'clock  
Rating: 1  
Dimension 1:  
Dimension 2:  
%:

Photo: MH 1-37-MH 1-36-20220823-094656.JPG  
At: 0 ft. 8/4 SRI - Surface Damage Roughness Increased  
Joint: Yes

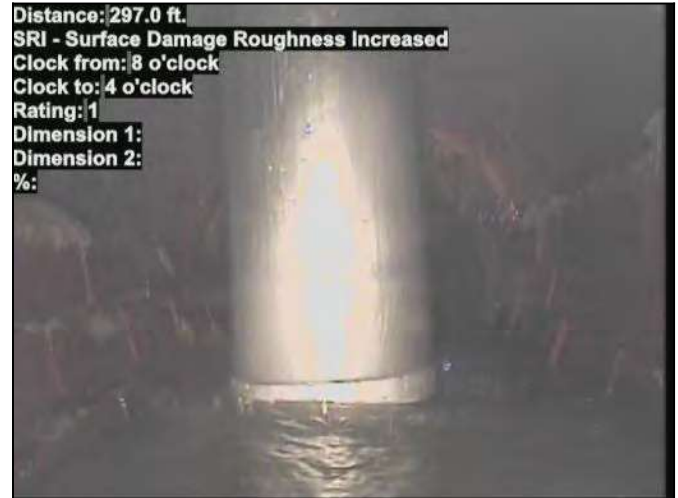
Distance: 297.0 ft.  
SRI - Surface Damage Roughness Increased  
Clock from: 8 o'clock  
Clock to: 4 o'clock  
Rating: 1  
Dimension 1:  
Dimension 2:  
%:

Photo: MH 1-37-MH 1-36-20220823-100449.JPG  
At: 297 ft. 8/4 SRI - Surface Damage Roughness Increased  
Joint: Yes

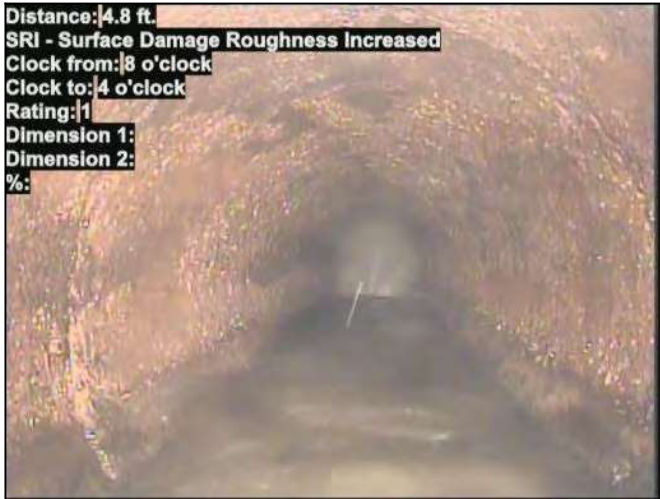
Photo: MH 1-36-MH 1-35-20220823-110922.JPG  
At: 4.8 ft. 8/4 SRI - Surface Damage Roughness Increased  
Joint: Yes

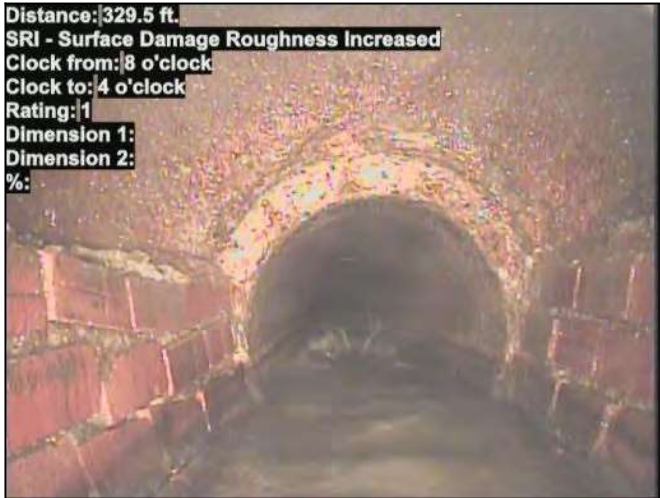
Photo: MH 1-36-MH 1-35-20220823-112226.JPG  
At: 329.5 ft. 8/4 SRI - Surface Damage Roughness Increased  
Joint: Yes

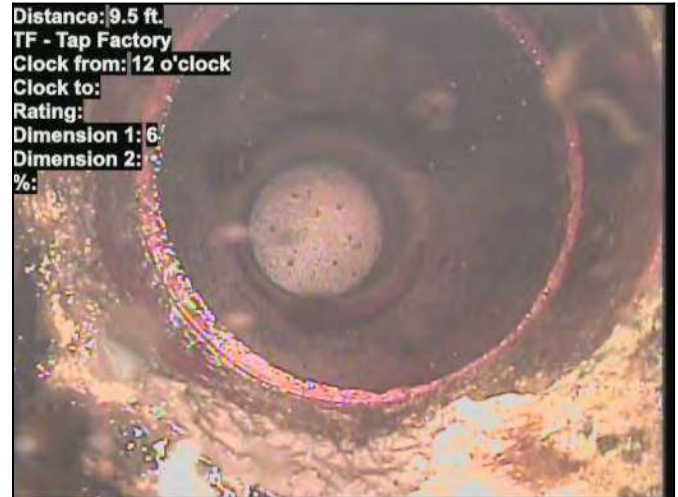
Photo: MH 1-35-MH 1-34-20220823-113000.JPG  
At: 9.5 ft. 12/ TF - Tap Factory  
Joint: No

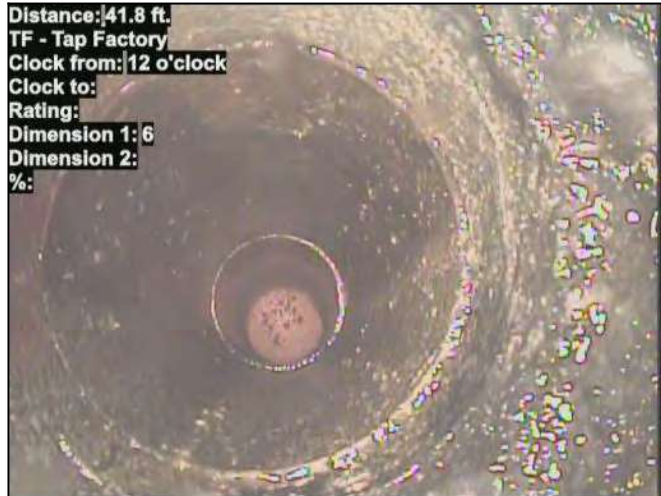
Photo: MH 1-35-MH 1-34-20220823-113212.JPG  
At: 41.8 ft. 12/ TF - Tap Factory  
Joint: No

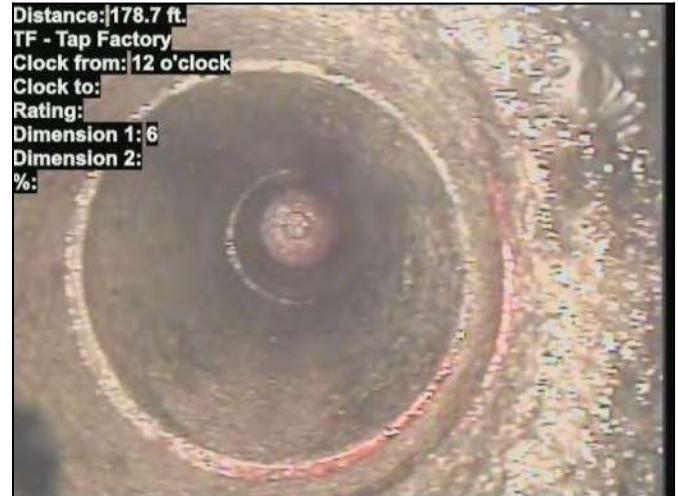
Photo: MH 1-35-MH 1-34-20220823-113907.JPG  
At: 178.7 ft. 12/ TF - Tap Factory  
Joint: No

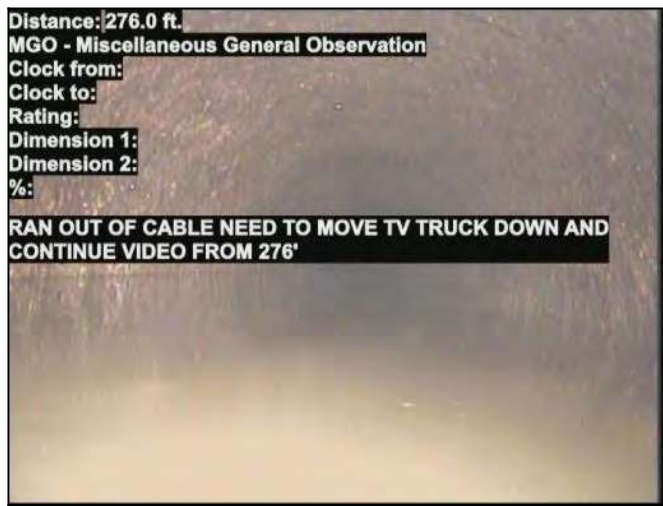
Photo: MH 1-35-MH 1-34-20220823-114713.JPG  
At: 276 ft. MGO - Miscellaneous General Observation  
Joint: No RAN OUT OF CABLE NEED TO MOVE TV TRUCK DOWN AND CONTINUE VIDEO FROM 276'

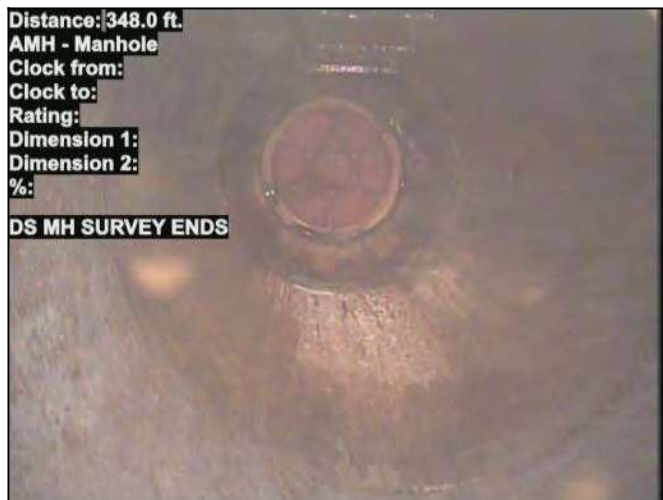
Photo: MH 1-35-MH 1-34-20220823-133723.JPG  
At: 348 ft. AMH - Manhole  
Joint: No DS MH SURVEY ENDS

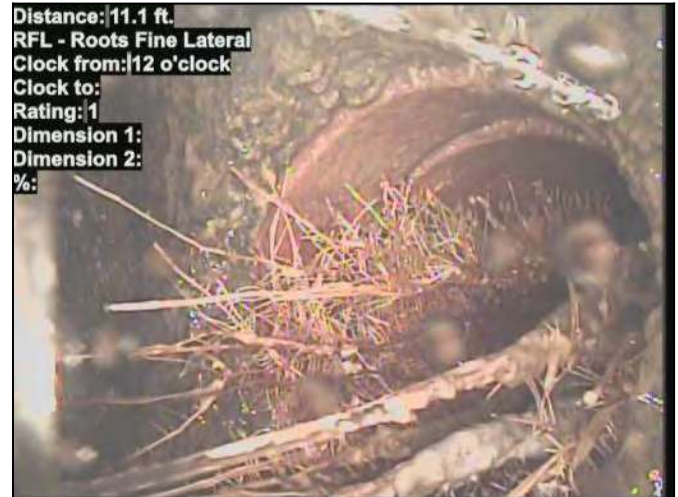
Photo: MH 1-34-MH 1-33-20220823-134254.JPG  
At: 11.1 ft. 12/. RFL - Roots Fine Lateral  
Joint: No

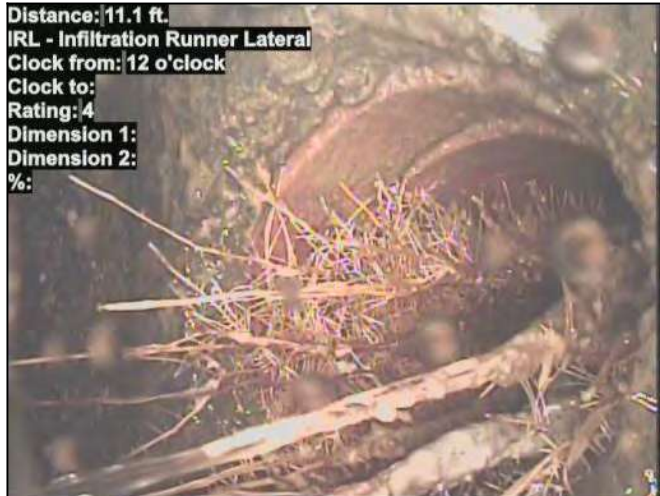
Photo: MH 1-34-MH 1-33-20220823-134319.JPG  
At: 11.1 ft. 12/. IRL - Infiltration Runner Lateral  
Joint: No

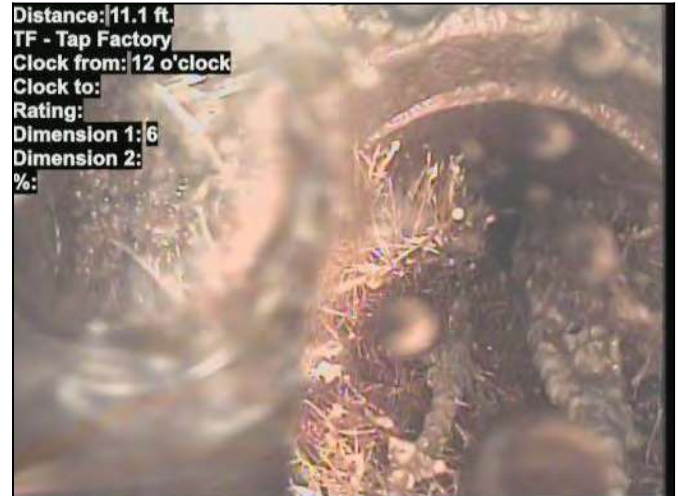
Photo: MH 1-34-MH 1-33-20220823-134232.JPG  
At: 11.1 ft. 12/. TF - Tap Factory  
Joint: No

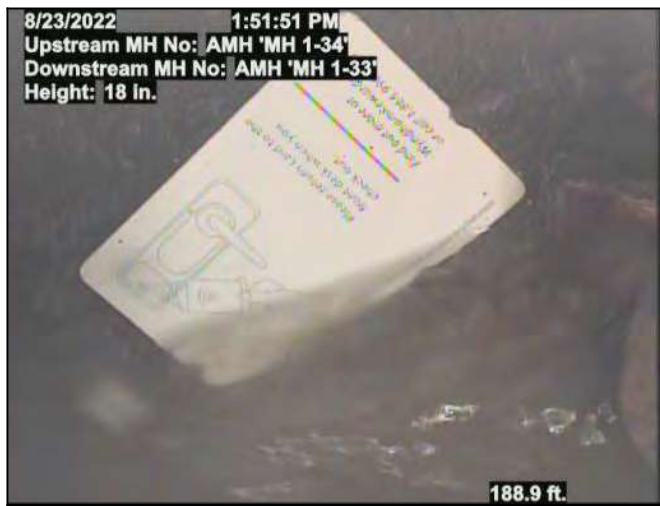
Photo: MH 1-34-MH 1-33-20220823-135005\_1.JPG

At: 163.8 ft. 10/. TF - Tap Factory

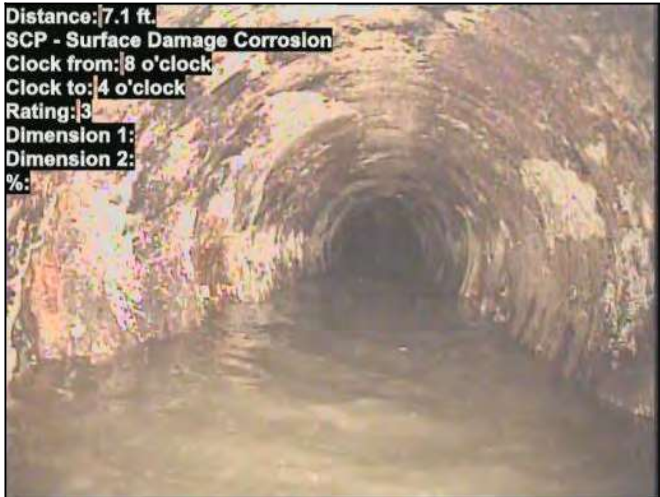
Photo: MH 1-33-MH 1-32A-20220824-085141.JPG  
At: 7.1 ft. 8/4 SCP - Surface Damage Corrosion  
Joint: Yes

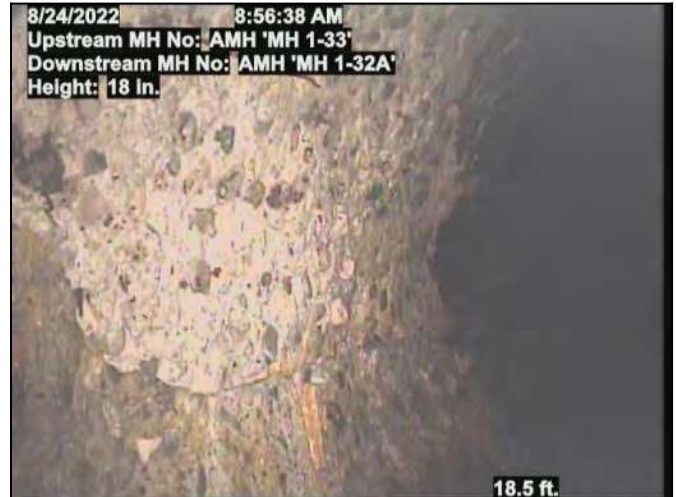
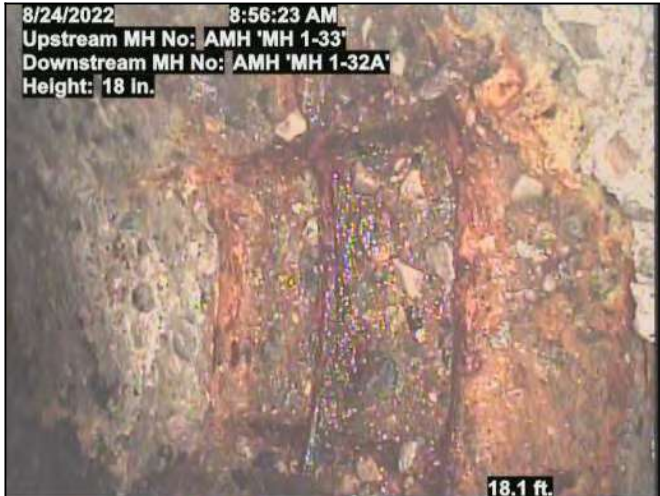
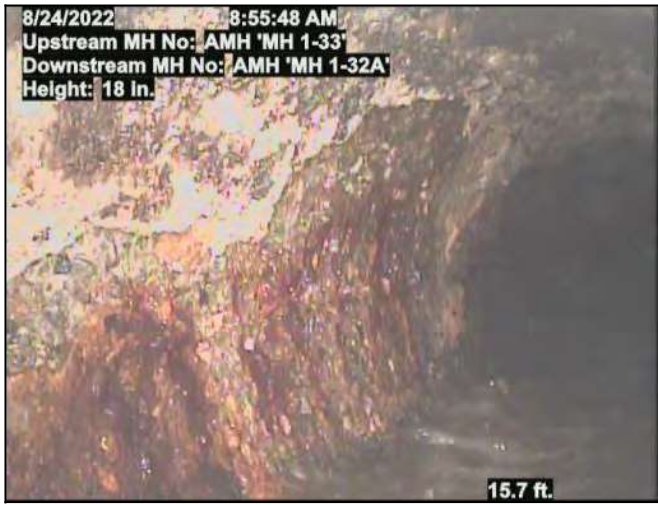
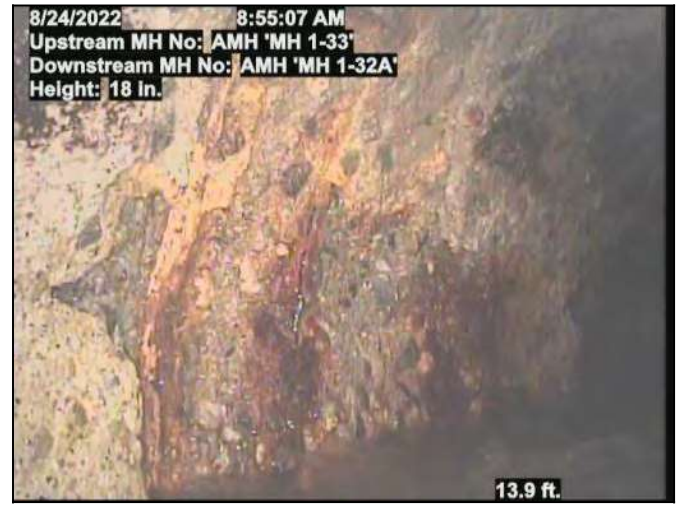
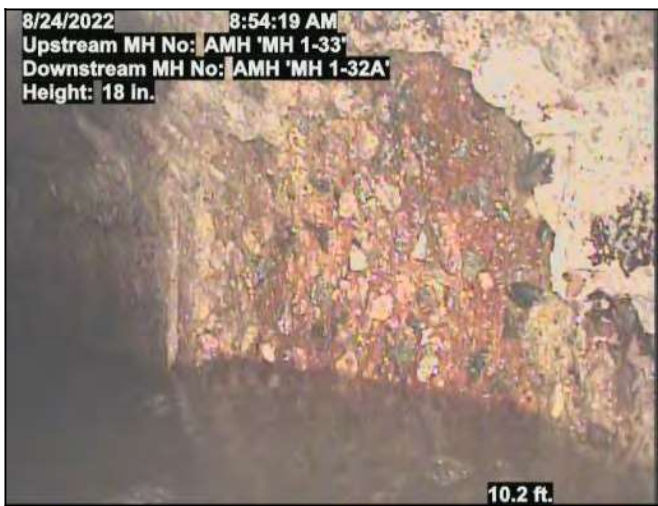
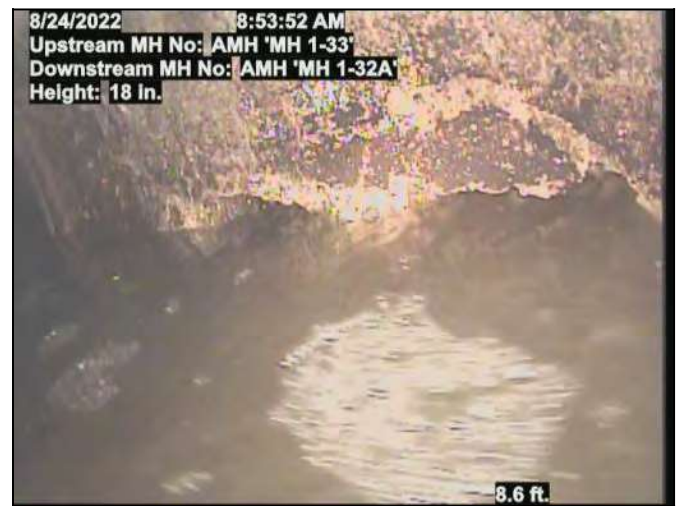
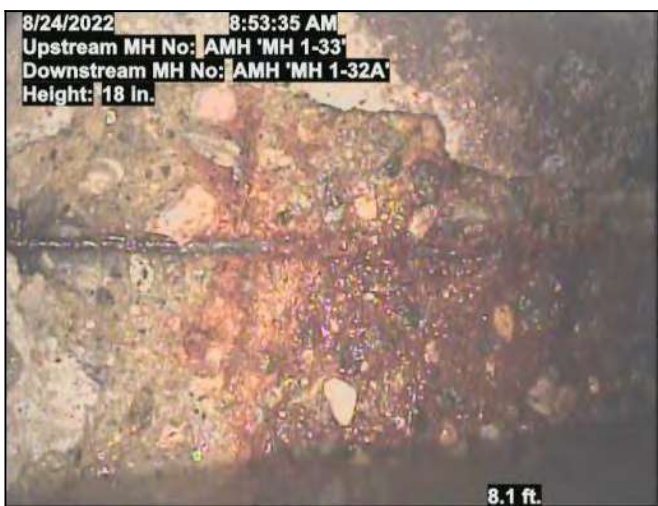
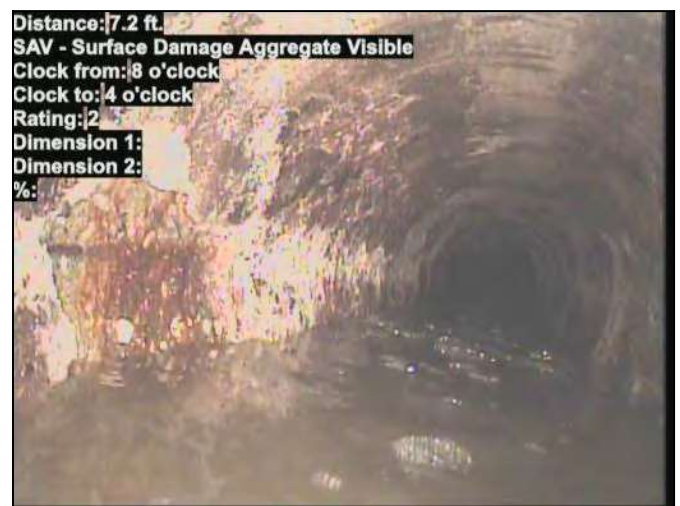
Photo: MH 1-33-MH 1-32A-20220824-085304\_8.JPG  
At: 7.2 ft. 8/4 SAV - Surface Damage Aggregate Visible  
Joint: Yes

Photo: MH 1-33-MH 1-32A-20220824-085304\_7.JPG  
At: 7.2 ft. 8/4 SAV - Surface Damage Aggregate Visible  
Joint: Yes

Photo: MH 1-33-MH 1-32A-20220824-085304\_6.JPG  
At: 7.2 ft. 8/4 SAV - Surface Damage Aggregate Visible  
Joint: Yes

Photo: MH 1-33-MH 1-32A-20220824-085304\_5.JPG  
 At: 7.2 ft. 8/4 SAV - Surface Damage Aggregate Visible  
 Joint: Yes

Photo: MH 1-33-MH 1-32A-20220824-085304\_4.JPG  
 At: 7.2 ft. 8/4 SAV - Surface Damage Aggregate Visible  
 Joint: Yes

Photo: MH 1-33-MH 1-32A-20220824-085304\_3.JPG  
 At: 7.2 ft. 8/4 SAV - Surface Damage Aggregate Visible  
 Joint: Yes

Photo: MH 1-33-MH 1-32A-20220824-085304\_2.JPG  
 At: 7.2 ft. 8/4 SAV - Surface Damage Aggregate Visible  
 Joint: Yes

Photo: MH 1-33-MH 1-32A-20220824-085304\_1.JPG  
 At: 7.2 ft. 8/4 SAV - Surface Damage Aggregate Visible  
 Joint: Yes

Photo: MH 1-33-MH 1-32A-20220824-085304.JPG  
 At: 7.2 ft. 8/4 SAV - Surface Damage Aggregate Visible  
 Joint: Yes

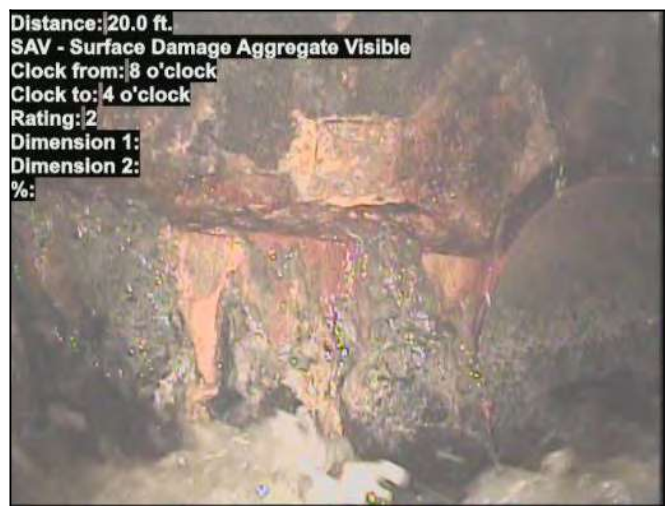
Distance: 20.0 ft.  
 SAV - Surface Damage Aggregate Visible  
 Clock from: 8 o'clock  
 Clock to: 4 o'clock  
 Rating: 2  
 Dimension 1:  
 Dimension 2:  
 %:  
 Photo: MH 1-33-MH 1-32A-20220824-085658.JPG  
 At: 20 ft. 8/4 SAV - Surface Damage Aggregate Visible  
 Joint: Yes

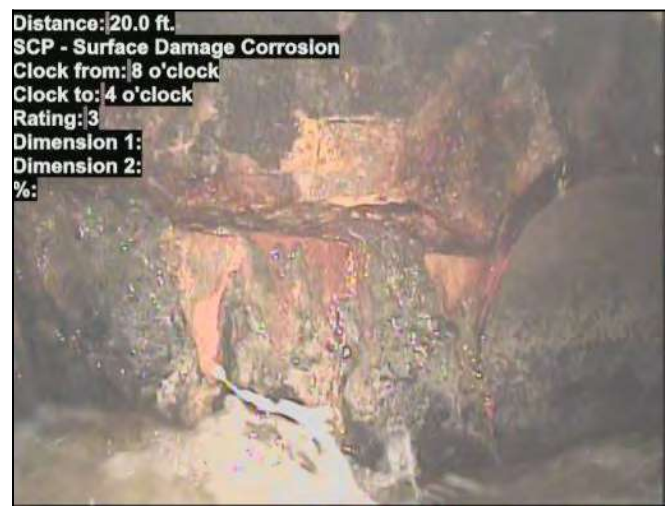
Distance: 20.0 ft.  
 SCP - Surface Damage Corrosion  
 Clock from: 8 o'clock  
 Clock to: 4 o'clock  
 Rating: 3  
 Dimension 1:  
 Dimension 2:  
 %:  
 Photo: MH 1-33-MH 1-32A-20220824-085655.JPG  
 At: 20 ft. 8/4 SCP - Surface Damage Corrosion  
 Joint: Yes

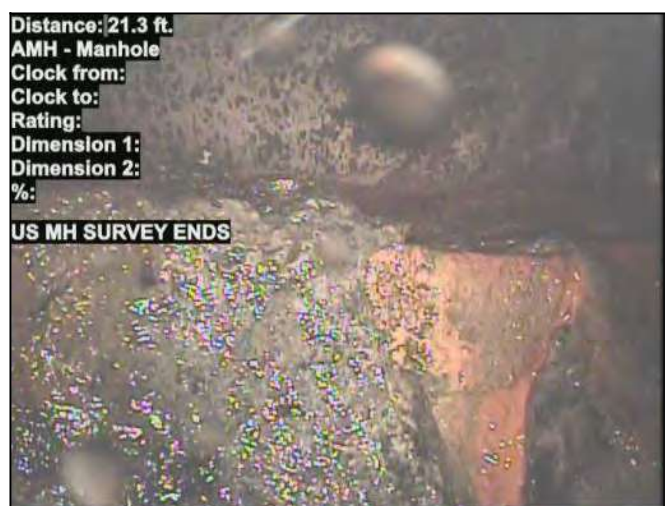
Distance: 21.3 ft.  
 AMH - Manhole  
 Clock from:  
 Clock to:  
 Rating:  
 Dimension 1:  
 Dimension 2:  
 %:  
 US MH SURVEY ENDS  
 Photo: MH 1-33-MH 1-32A-20220824-085742.JPG  
 At: 21.3 ft. AMH - Manhole  
 Joint: No US MH SURVEY ENDS

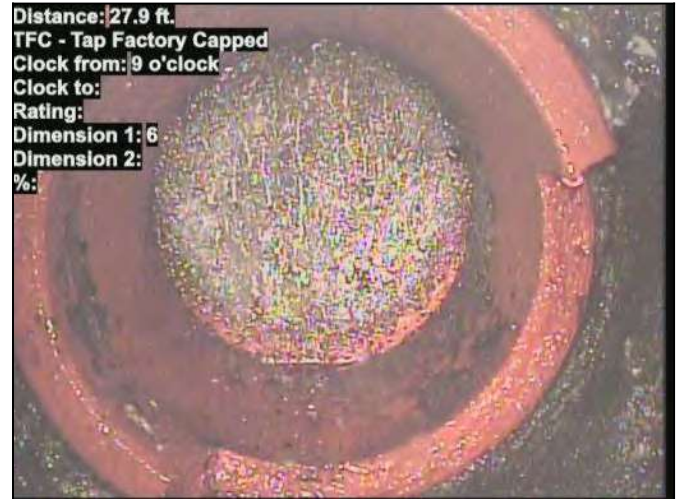
Photo: MH 1-32A-MH 1-32-20220824-090810.JPG

At: 27.9 ft. 9/ TFC - Tap Factory Capped

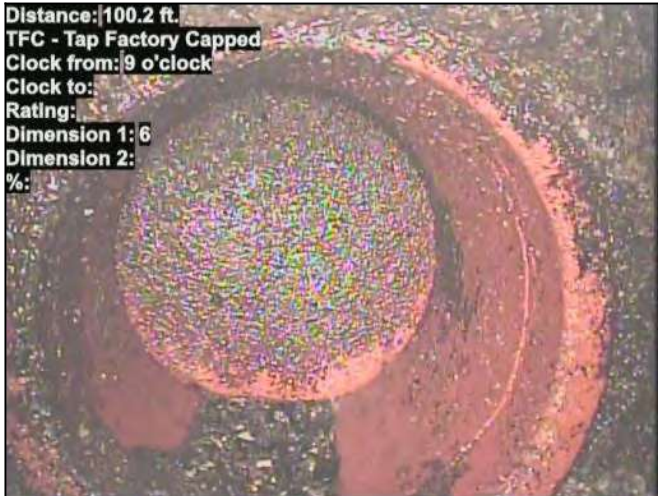
Photo: MH 1-32A-MH 1-32-20220824-091133.JPG

At: 100.2 ft. 9/ TFC - Tap Factory Capped

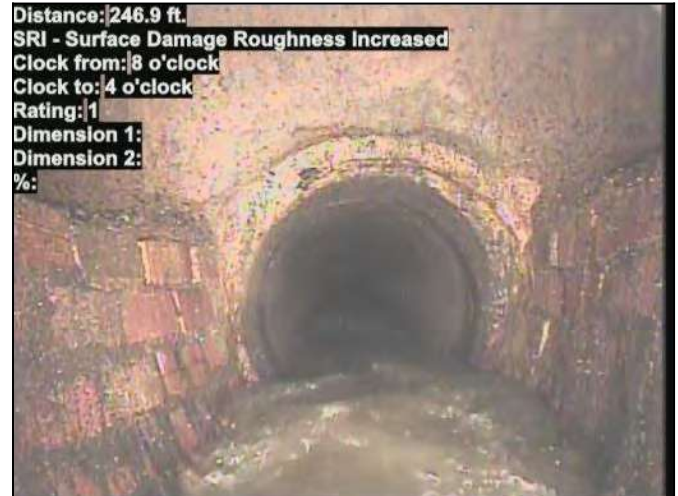
Photo: MH 1-32A-MH 1-32-20220824-091700.JPG

At: 246.9 ft. 8/4 SRI - Surface Damage Roughness Increased

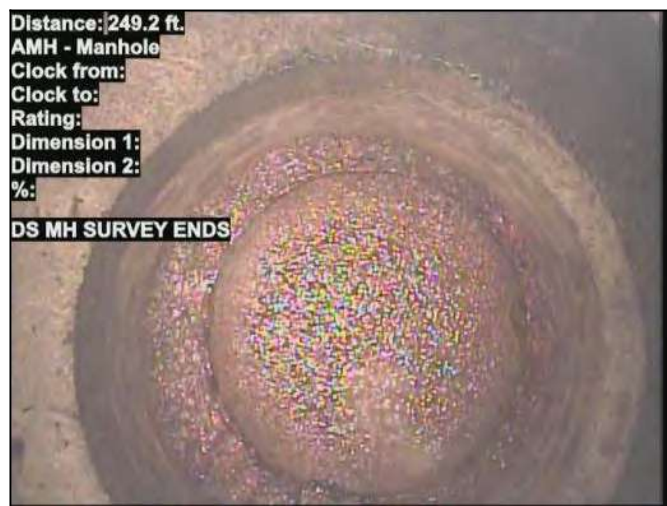
Photo: MH 1-32A-MH 1-32-20220824-091735.JPG

At: 249.2 ft. AMH - Manhole

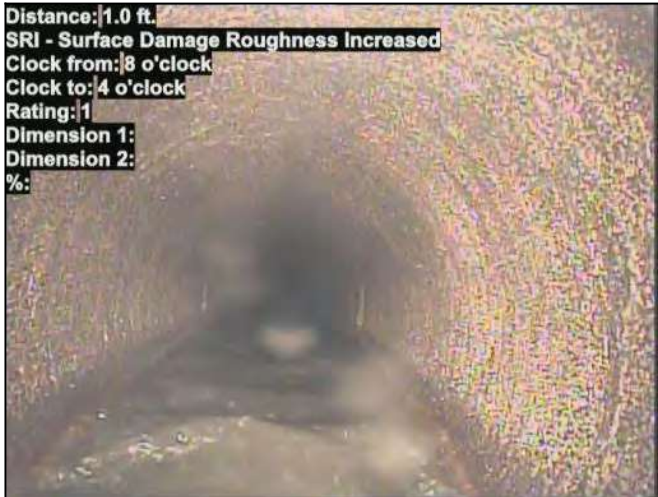
Photo: MH 1-32-MH 1-31-20220824-092325.JPG

At: 1 ft. 8/4 SRI - Surface Damage Roughness Increased

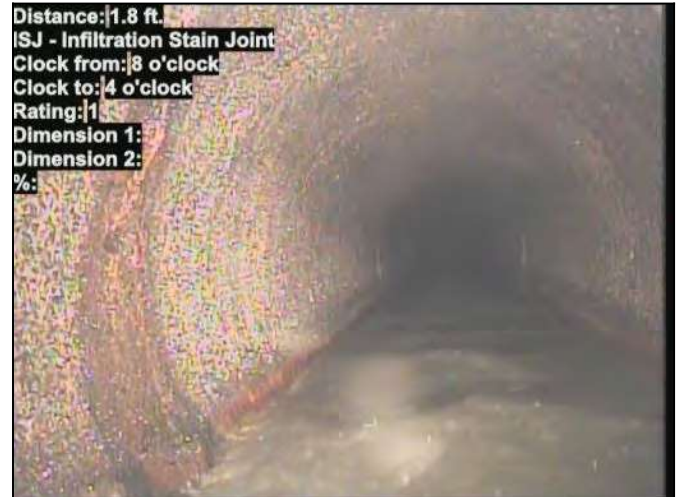
Photo: MH 1-32-MH 1-31-20220824-092428\_1.JPG

At: 1.8 ft. 8/4 ISJ - Infiltration Stain Joint

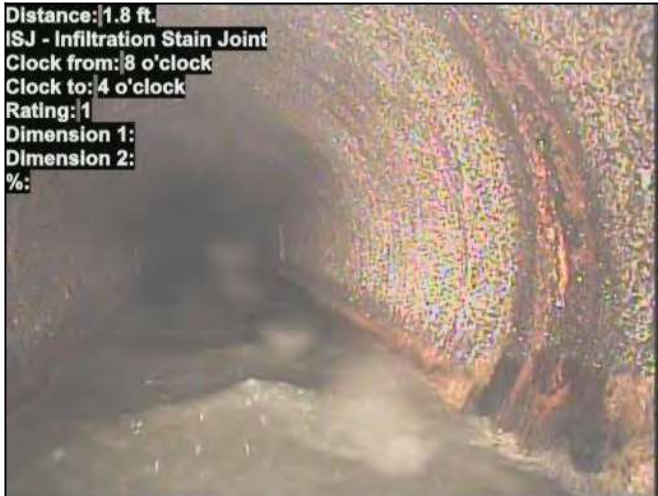
Photo: MH 1-32-MH 1-31-20220824-092428.JPG

At: 1.8 ft. 8/4 ISJ - Infiltration Stain Joint

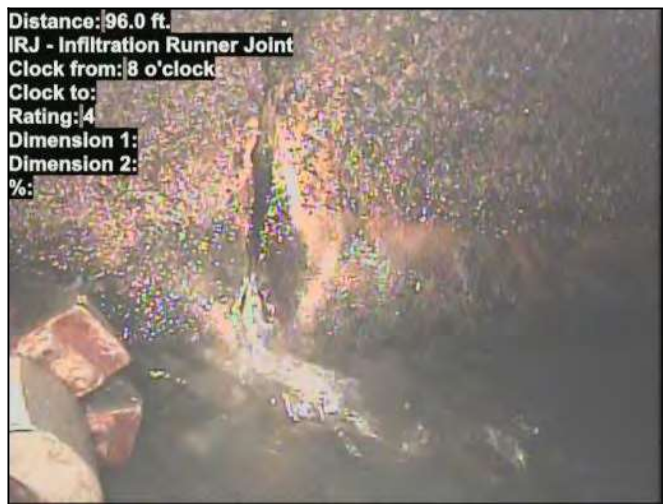
Photo: MH 1-32-MH 1-31-20220824-092825.JPG  
 At: 96 ft. 8/. IRJ - Infiltration Runner Joint  
 Joint: Yes

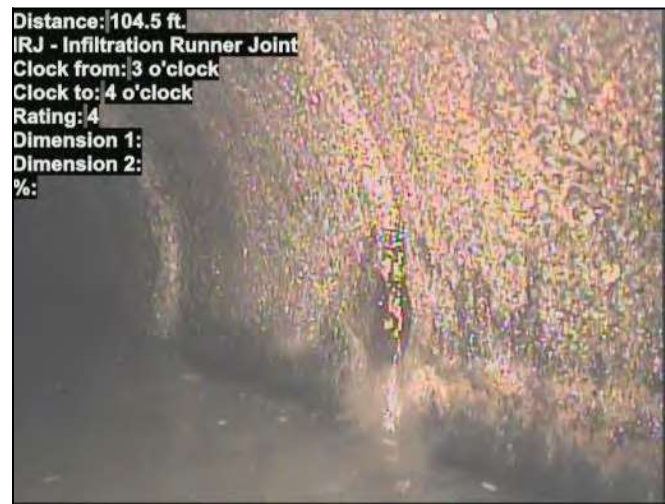
Photo: MH 1-32-MH 1-31-20220824-093143\_1.JPG  
 At: 104.5 ft. 3/4 IRJ - Infiltration Runner Joint  
 Joint: Yes

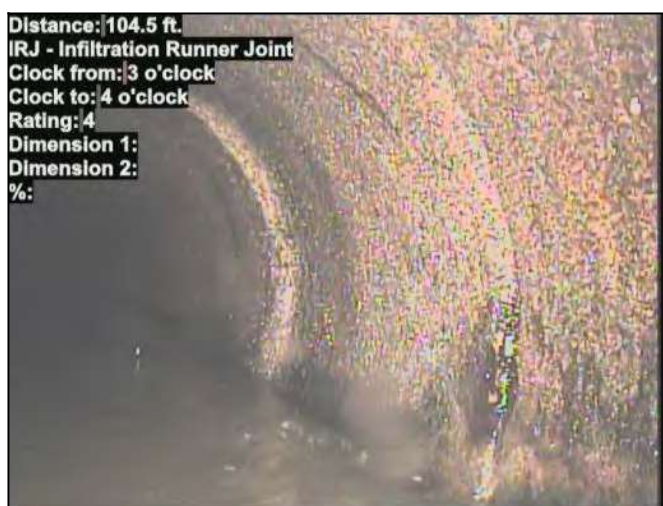
Photo: MH 1-32-MH 1-31-20220824-093143.JPG  
 At: 104.5 ft. 3/4 IRJ - Infiltration Runner Joint  
 Joint: Yes

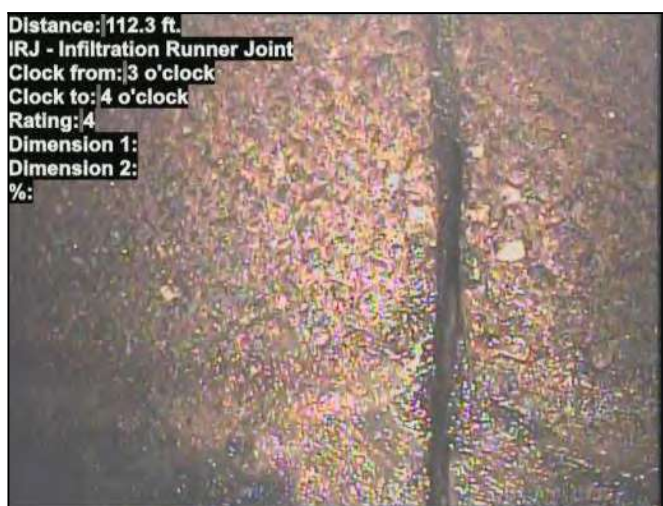
Photo: MH 1-32-MH 1-31-20220824-093531.JPG  
 At: 112.3 ft. 3/4 IRJ - Infiltration Runner Joint  
 Joint: Yes

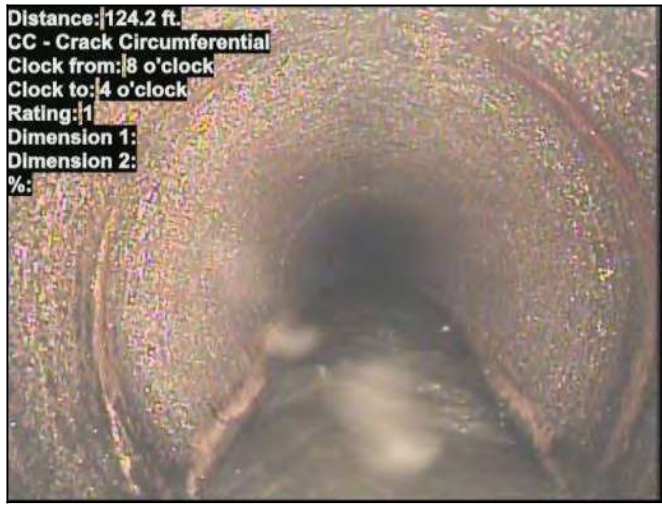
Distance: 124.2 ft.  
 CC - Crack Circumferential  
 Clock from: 8 o'clock  
 Clock to: 4 o'clock  
 Rating: 1  
 Dimension 1:  
 Dimension 2:  
 %:  
 Photo: MH 1-32-MH 1-31-20220824-093849.JPG  
 At: 124.2 ft. 8/4 CC - Crack Circumferential  
 Joint: No

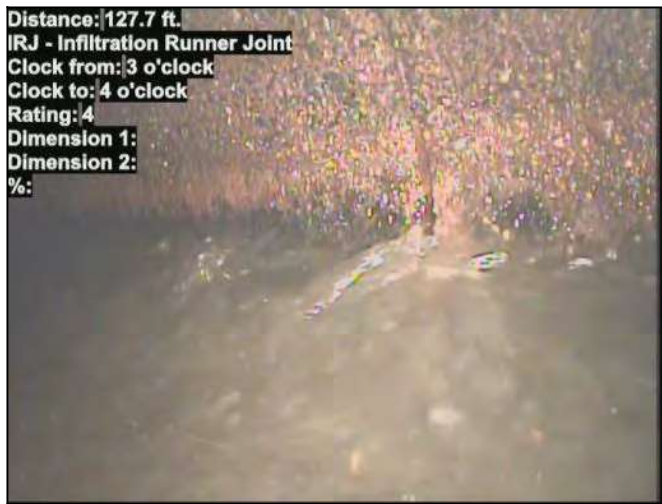
Distance: 127.7 ft.  
 IRJ - Infiltration Runner Joint  
 Clock from: 3 o'clock  
 Clock to: 4 o'clock  
 Rating: 4  
 Dimension 1:  
 Dimension 2:  
 %:  
 Photo: MH 1-32-MH 1-31-20220824-093952.JPG  
 At: 127.7 ft. 3/4 IRJ - Infiltration Runner Joint  
 Joint: Yes

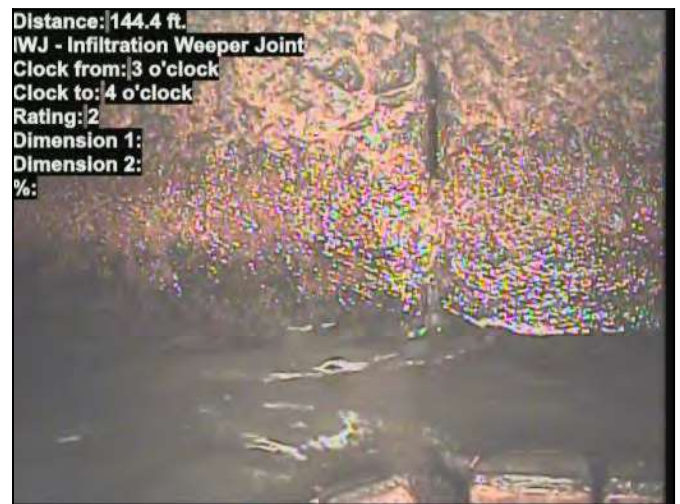
Distance: 144.4 ft.  
 IWJ - Infiltration Weeper Joint  
 Clock from: 3 o'clock  
 Clock to: 4 o'clock  
 Rating: 2  
 Dimension 1:  
 Dimension 2:  
 %:  
 Photo: MH 1-32-MH 1-31-20220824-094157.JPG  
 At: 144.4 ft. 3/4 IWJ - Infiltration Weeper Joint  
 Joint: Yes

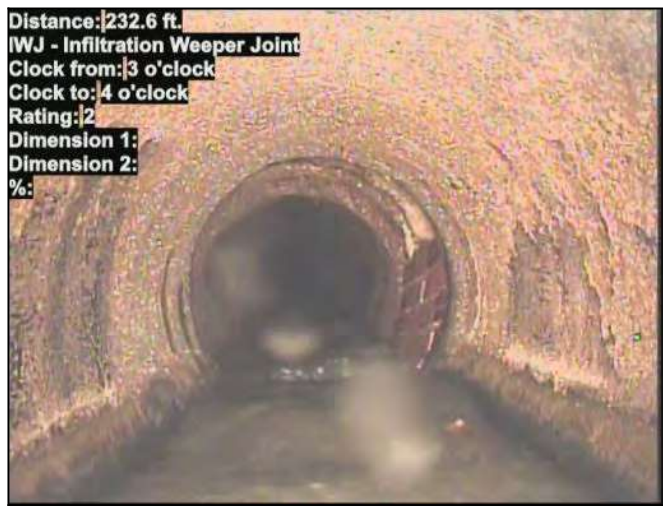
Photo: MH 1-32-MH 1-31-20220824-094600.JPG  
 At: 232.6 ft. 3/4 IWJ - Infiltration Weeper Joint  
 Joint: Yes

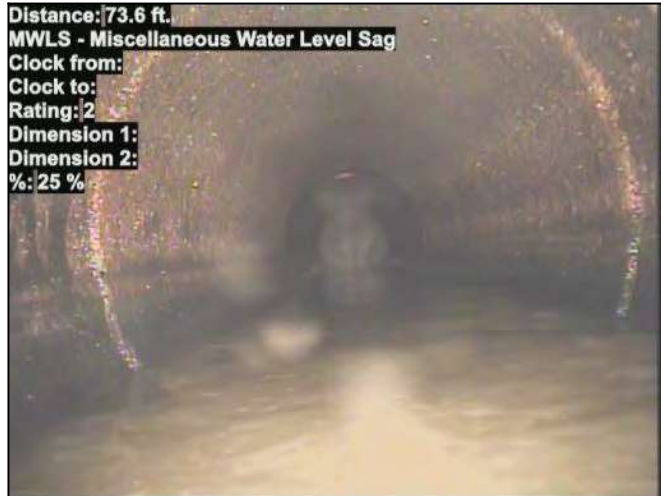
Photo: MH 1-31-MH 1-30-20220824-102653.JPG  
At: 73.6 ft. MWLS - Miscellaneous Water Level Sag  
Joint: No 25 %

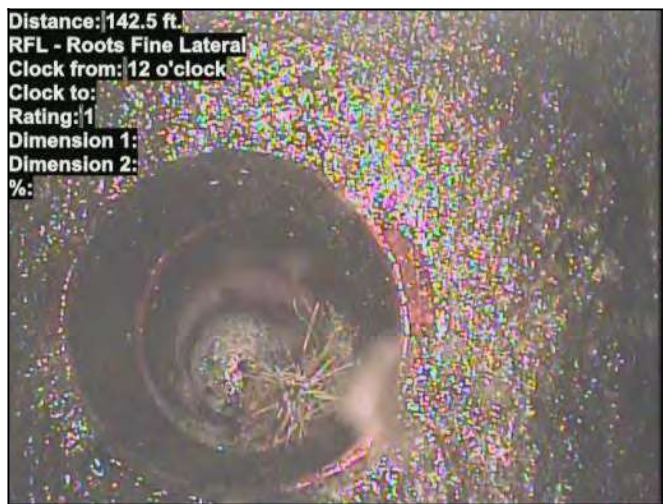
Distance: 142.5 ft.  
RFL - Roots Fine Lateral  
Clock from: 12 o'clock  
Clock to:  
Rating: 1  
Dimension 1:  
Dimension 2:  
%:  
Photo: MH 1-31-MH 1-30-20220824-103142.JPG  
At: 142.5 ft. 12/. RFL - Roots Fine Lateral  
Joint: No

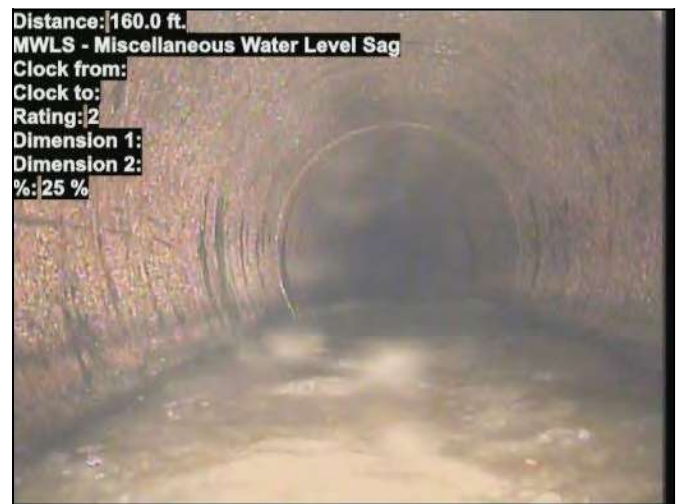
Distance: 160.0 ft.  
MWLS - Miscellaneous Water Level Sag  
Clock from:  
Clock to:  
Rating: 2  
Dimension 1:  
Dimension 2:  
%: 25 %  
Photo: MH 1-31-MH 1-30-20220824-103415.JPG  
At: 160 ft. MWLS - Miscellaneous Water Level Sag  
Joint: No 25 %

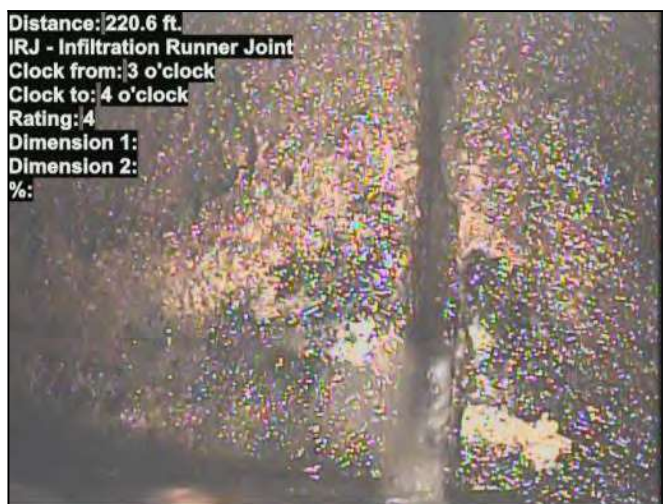
Distance: 220.6 ft.  
IRJ - Infiltration Runner Joint  
Clock from: 3 o'clock  
Clock to: 4 o'clock  
Rating: 4  
Dimension 1:  
Dimension 2:  
%:  
Photo: MH 1-31-MH 1-30-20220824-103713.JPG  
At: 220.6 ft. 3/4 IRJ - Infiltration Runner Joint  
Joint: Yes

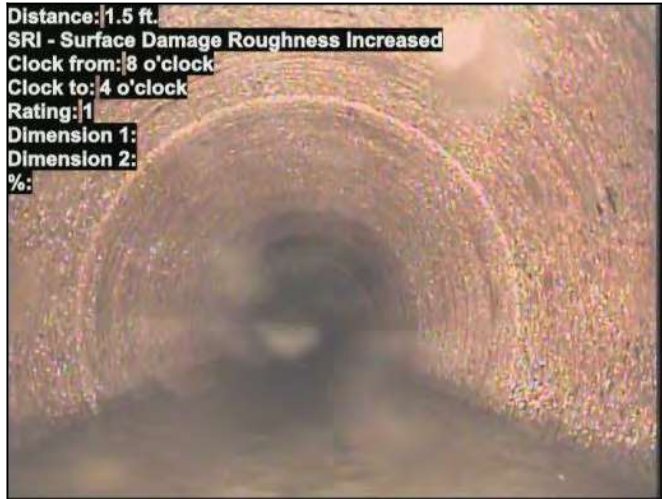
Photo: MH 1-30-MH 1-29-20220824-104433.JPG  
At: 1.5 ft. 8/4 SRI - Surface Damage Roughness Increased  
Joint: Yes

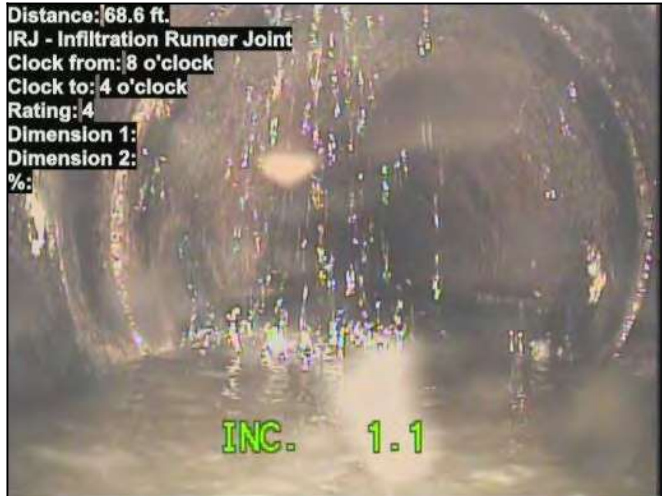
Photo: MH 1-30-MH 1-29-20220824-110302.JPG  
At: 68.6 ft. 8/4 IRJ - Infiltration Runner Joint  
Joint: Yes

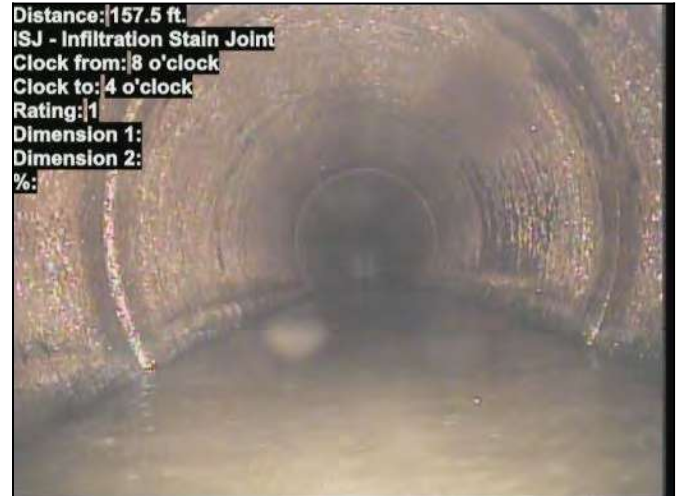
Photo: MH 1-30-MH 1-29-20220824-110741.JPG  
At: 157.5 ft. 8/4 ISJ - Infiltration Stain Joint  
Joint: Yes

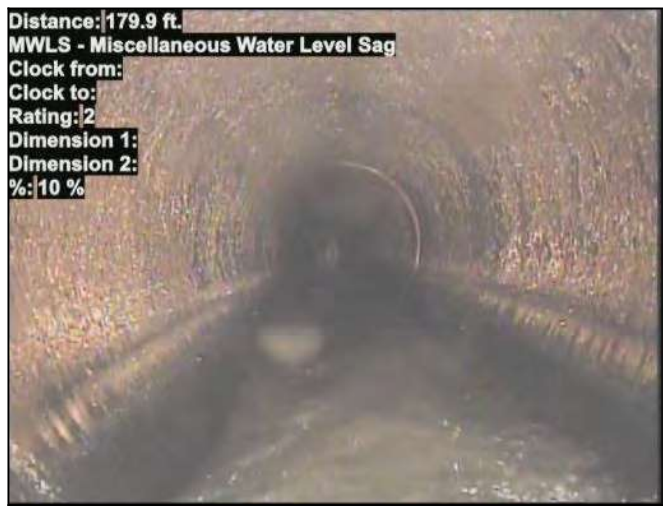
Distance: 179.9 ft.  
MWLS - Miscellaneous Water Level Sag  
Clock from:  
Clock to:  
Rating: 2  
Dimension 1:  
Dimension 2:  
%: 10 %

Photo: MH 1-30-MH 1-29-20220824-110834.JPG  
At: 179.9 ft. MWLS - Miscellaneous Water Level Sag  
Joint: No 10 %
