## Appendix A

### Mystic Area CCTV Inspection Logs

## NWMCC INSPECTION REPORT

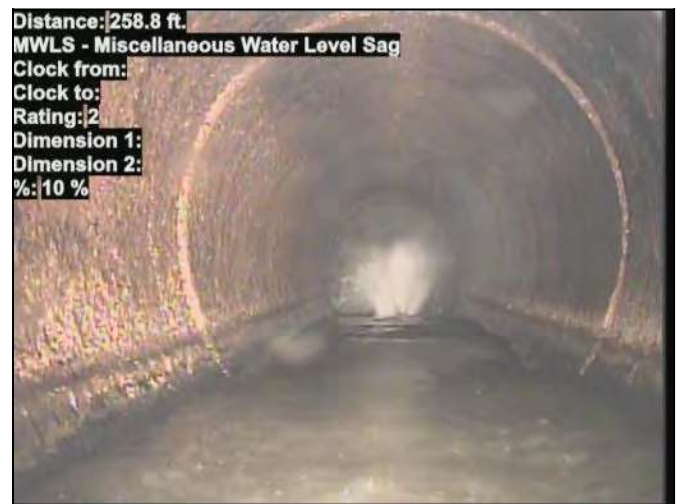
Distance: 258.8 ft.  
MWLS - Miscellaneous Water Level Sag  
Clock from:  
Clock to:  
Rating: 2  
Dimension 1:  
Dimension 2:  
%: 10 %

Photo: MH 1-30-MH 1-29-20220824-111742.JPG  
At: 258.8 ft. MWLS - Miscellaneous Water Level Sag  
Joint: No 10 %

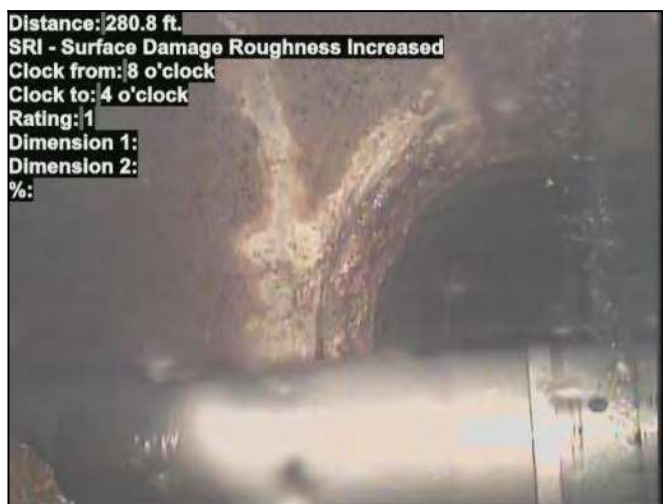
Distance: 280.8 ft.  
SRI - Surface Damage Roughness Increased  
Clock from: 8 o'clock  
Clock to: 4 o'clock  
Rating: 1  
Dimension 1:  
Dimension 2:  
%:

Photo: MH 1-30-MH 1-29-20220824-112033.JPG  
At: 280.8 ft. 8/4 SRI - Surface Damage Roughness Increased  
Joint: Yes

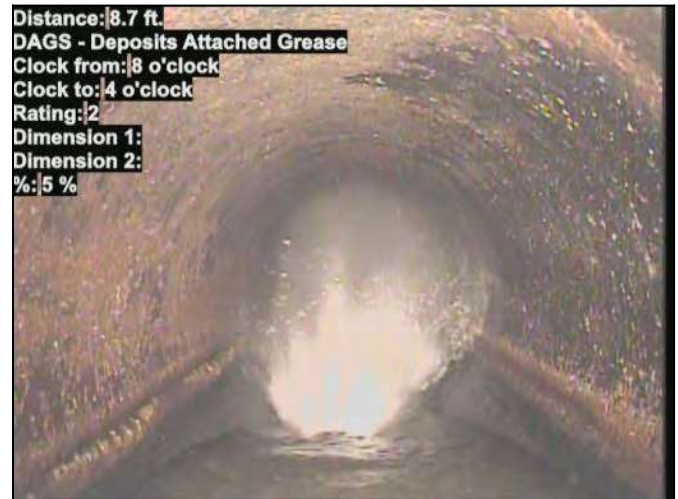
Photo: MH 1-29-MH 1-28-20220824-130928.JPG

At: 8.7 ft. 8/4 DAGS - Deposits Attached Grease

Joint: Yes 5 %

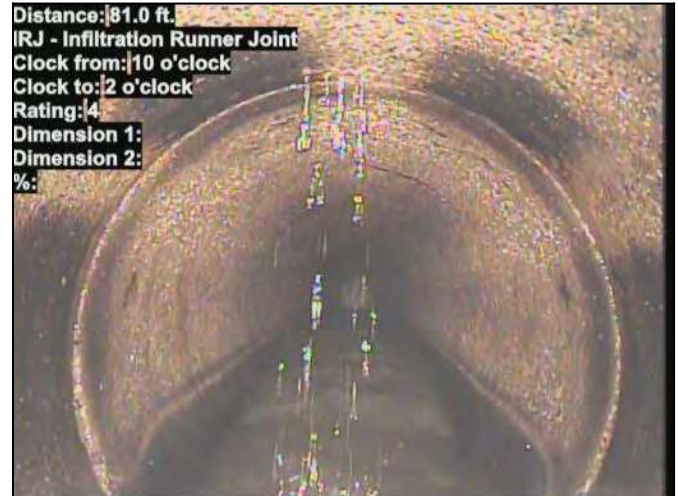
Photo: MH 1-29-MH 1-28-20220824-131259.JPG

At: 81 ft. 10/2 IRJ - Infiltration Runner Joint

Joint: Yes

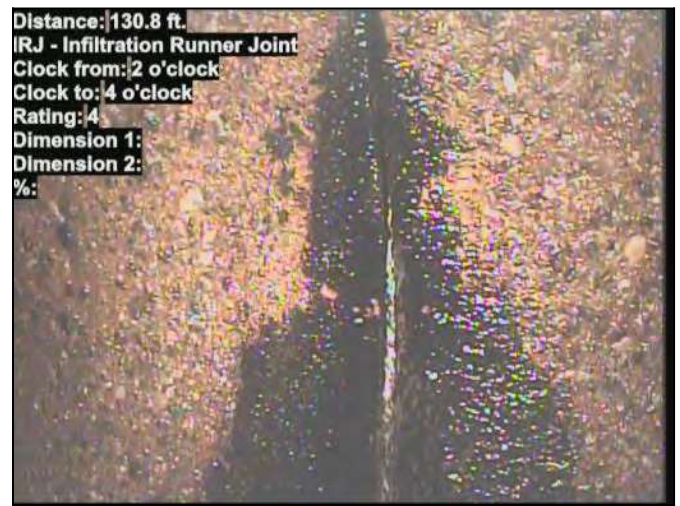
Photo: MH 1-29-MH 1-28-20220824-131538.JPG  
 At: 130.8 ft. 2/4 IRJ - Infiltration Runner Joint  
 Joint: Yes

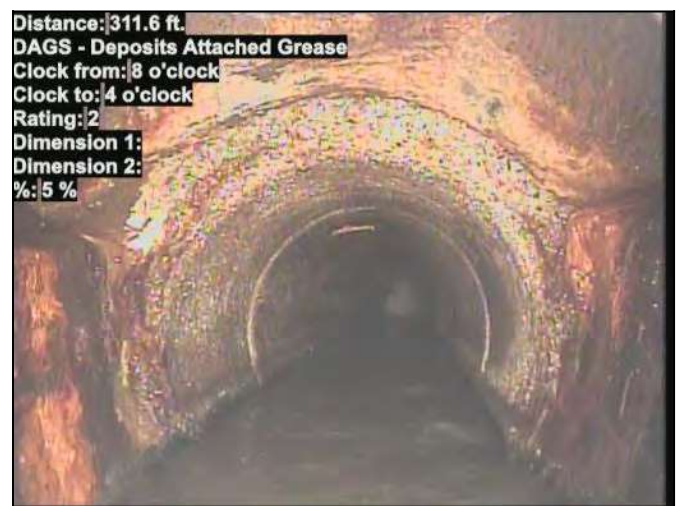
Photo: MH 1-29-MH 1-28-20220824-132349.JPG  
 At: 311.6 ft. 8/4 DAGS - Deposits Attached Grease  
 Joint: Yes 5 %

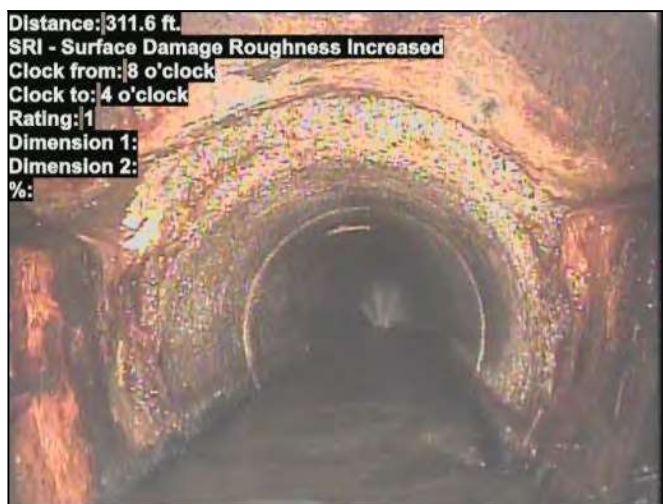
Photo: MH 1-29-MH 1-28-20220824-132335.JPG  
 At: 311.6 ft. 8/4 SRI - Surface Damage Roughness Increased  
 Joint: Yes

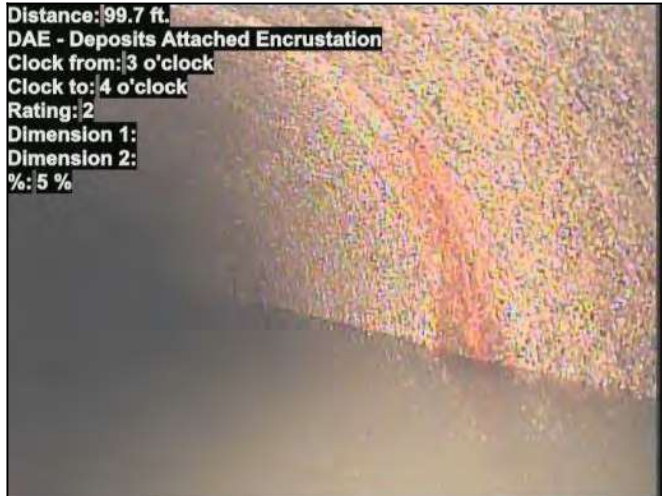
Photo: MH 1-28-MH 1-27-20220824-133321.JPG

At: 99.7 ft. 3/4 DAE - Deposits Attached Encrustation

Joint: Yes 5 %

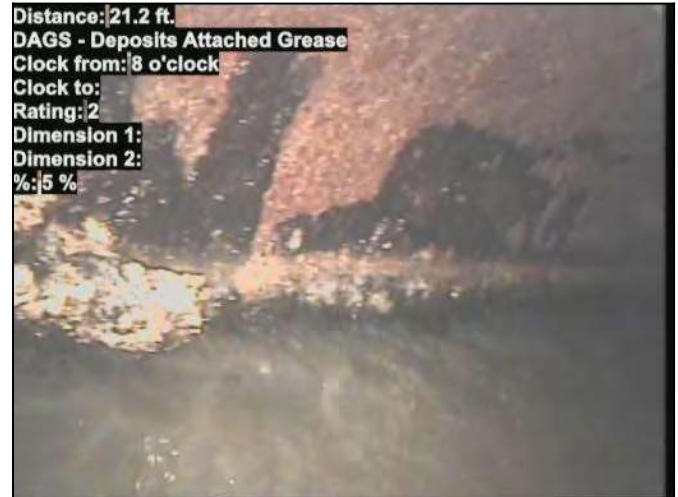
Photo: MH 1-27-MH 1-26-20220824-142210.JPG

At: 21.2 ft. 8/. DAGS - Deposits Attached Grease

Joint: No 5 %

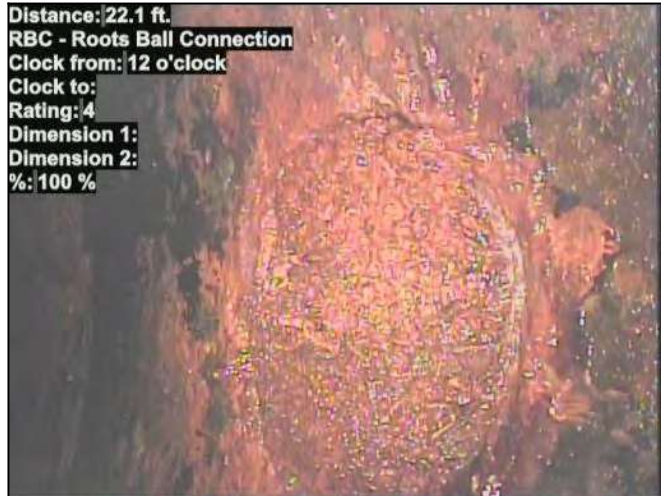
Photo: MH 1-27-MH 1-26-20220824-142255.JPG

At: 22.1 ft. 12/. RBC - Roots Ball Connection

Joint: No 100 %

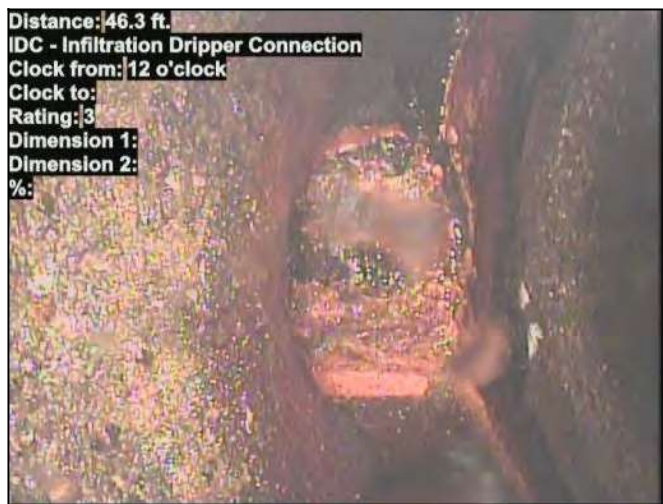
Distance: 46.3 ft.  
IDC - Infiltration Dripper Connection  
Clock from: 12 o'clock  
Clock to:  
Rating: 3  
Dimension 1:  
Dimension 2:  
%:  
Photo: MH 1-27-MH 1-26-20220824-142450.JPG  
At: 46.3 ft. 12/. IDC - Infiltration Dripper Connection  
Joint: No

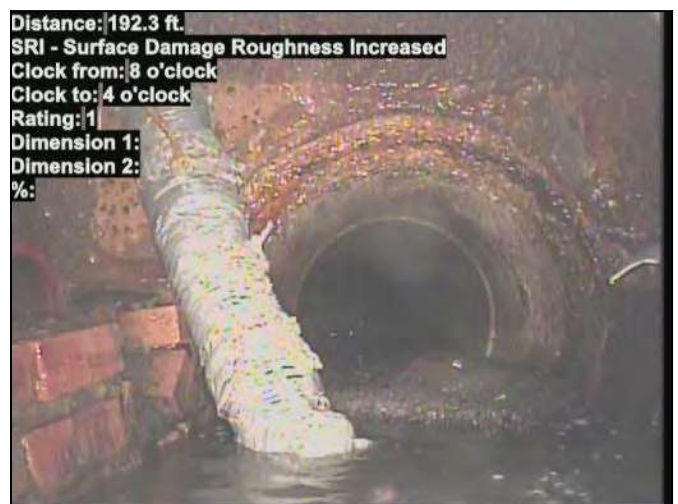
Distance: 192.3 ft.  
SRI - Surface Damage Roughness Increased  
Clock from: 8 o'clock  
Clock to: 4 o'clock  
Rating: 1  
Dimension 1:  
Dimension 2:  
%:  
Photo: MH 1-27-MH 1-26-20220824-143236.JPG  
At: 192.3 ft. 8/4 SRI - Surface Damage Roughness Increased  
Joint: Yes

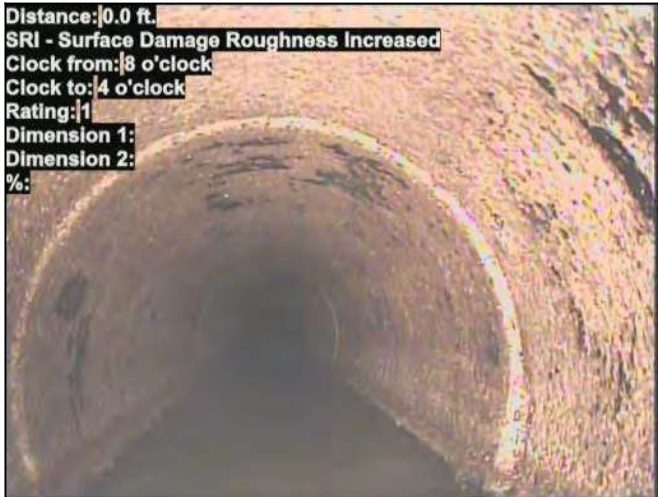
Photo: MH 1-26-MH 1-25-20220825-090036.JPG

At: 0 ft. 8/4 SRI - Surface Damage Roughness Increased

Joint: Yes

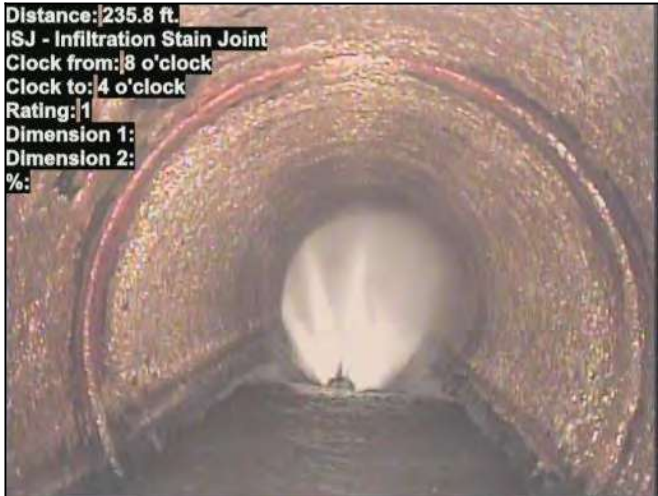
Photo: MH 1-26-MH 1-25-20220825-093006.JPG

At: 235.8 ft. 8/4 ISJ - Infiltration Stain Joint

Joint: Yes

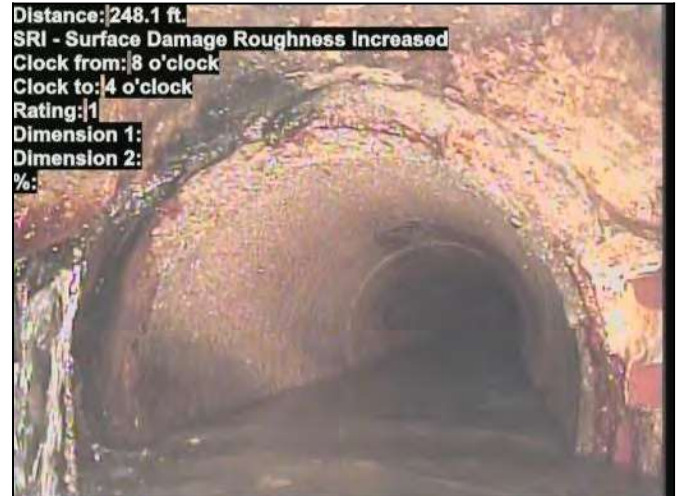
Photo: MH 1-26-MH 1-25-20220825-100646.JPG

At: 248.1 ft. 8/4 SRI - Surface Damage Roughness Increased

Joint: Yes

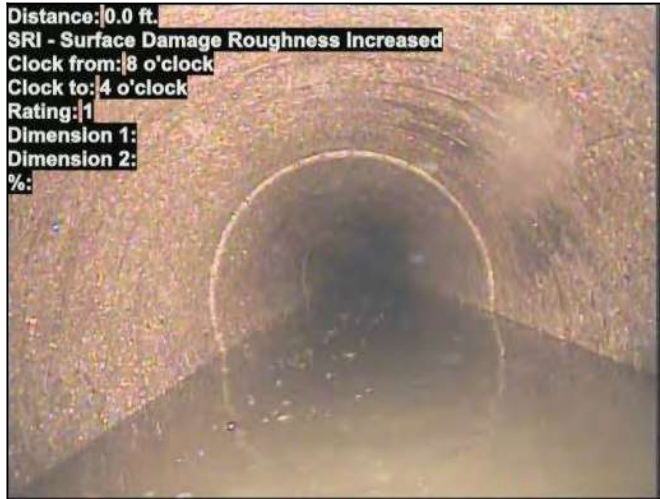
Distance: 0.0 ft.  
SRI - Surface Damage Roughness Increased  
Clock from: 8 o'clock  
Clock to: 4 o'clock  
Rating: 1  
Dimension 1:  
Dimension 2:  
%:

Photo: MH 1-25-MH 1-24-20220825-111257.JPG  
At: 0 ft. 8/4 SRI - Surface Damage Roughness Increased  
Joint: Yes

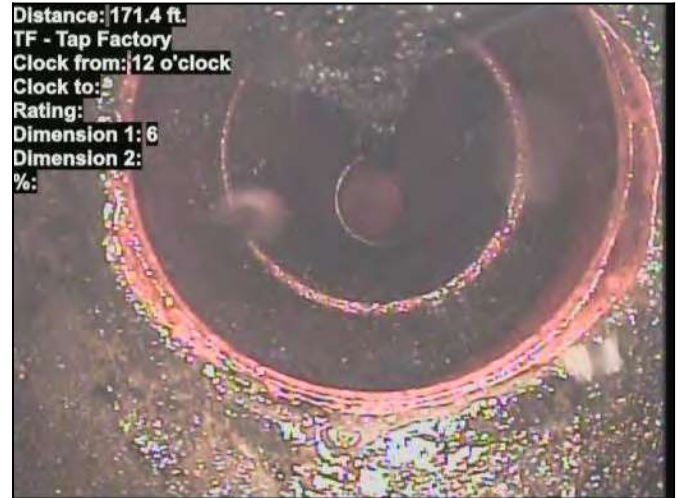
Distance: 155.5 ft.  
TF - Tap Factory  
Clock from: 12 o'clock  
Clock to:  
Rating:  
Dimension 1: 6  
Dimension 2:  
%:

Photo: MH 1-25-MH 1-24-20220825-123703.JPG  
At: 155.5 ft. 12/. TF - Tap Factory  
Joint: No

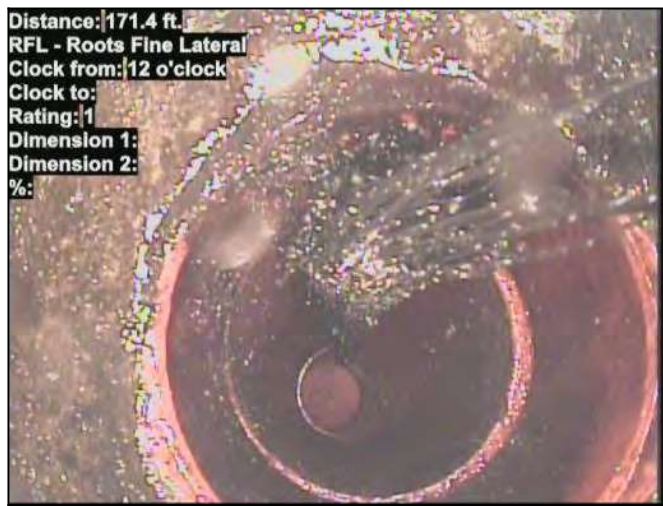
Distance: 171.4 ft.  
TF - Tap Factory  
Clock from: 12 o'clock  
Clock to:  
Rating:  
Dimension 1: 6  
Dimension 2:  
%:

Photo: MH 1-25-MH 1-24-20220825-123803.JPG  
At: 171.4 ft. 12/. TF - Tap Factory  
Joint: No

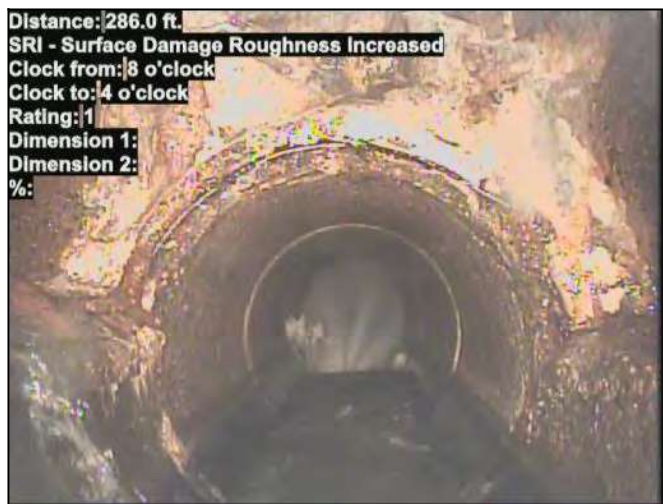
Photo: MH 1-25-MH 1-24-20220825-131921.JPG

At: 286 ft. 8/4 SRI - Surface Damage Roughness Increased

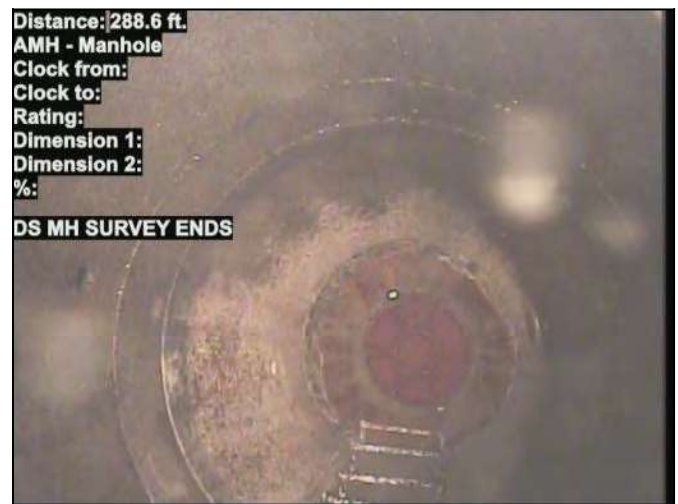
Photo: MH 1-25-MH 1-24-20220825-132018.JPG

At: 288.6 ft. AMH - Manhole

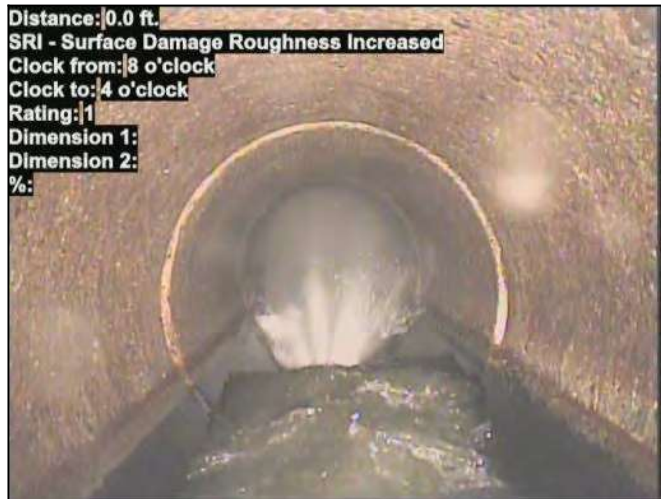
Photo: MH 1-24-MH 1-23A-20220825-132452.JPG

At: 0 ft. 8/4 SRI - Surface Damage Roughness Increased

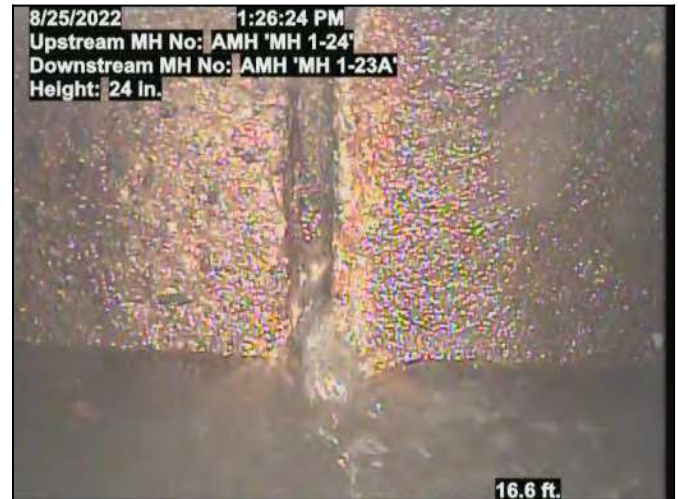
Photo: MH 1-24-MH 1-23A-20220825-132605\_1.JPG

At: 16.3 ft. 8/9 IGJ - Infiltration Gusher Joint

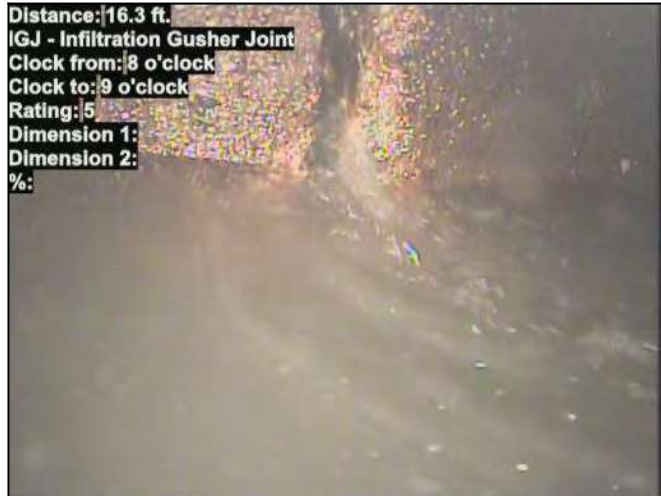
Photo: MH 1-24-MH 1-23A-20220825-132605.JPG

At: 16.3 ft. 8/9 IGJ - Infiltration Gusher Joint

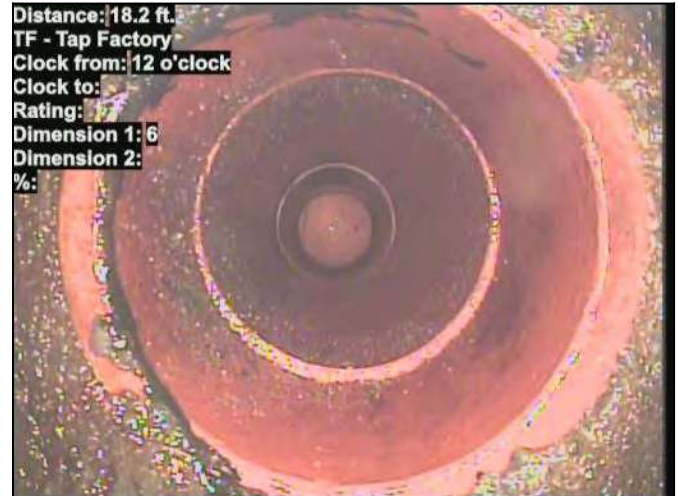
Photo: MH 1-24-MH 1-23A-20220825-132643.JPG

At: 18.2 ft. 12/ TF - Tap Factory

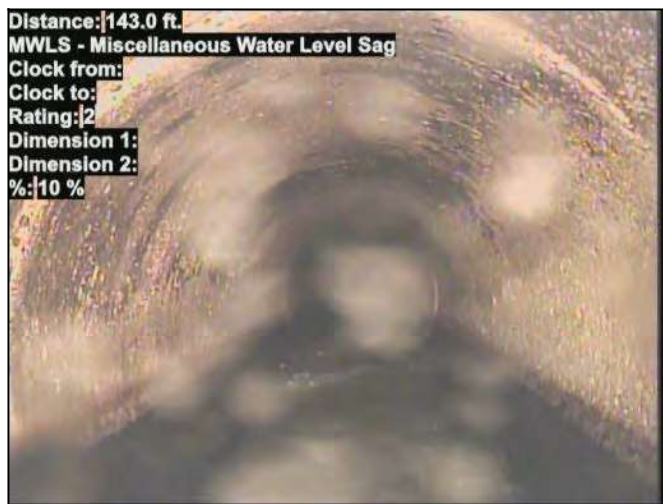
Distance: 143.0 ft.  
MWLS - Miscellaneous Water Level Sag  
Clock from:  
Clock to:  
Rating: 2  
Dimension 1:  
Dimension 2:  
%: 10 %

Photo: MH 1-24-MH 1-23A-20220825-141651.JPG

At: 143 ft. MWLS - Miscellaneous Water Level Sag

Joint: No 10 %

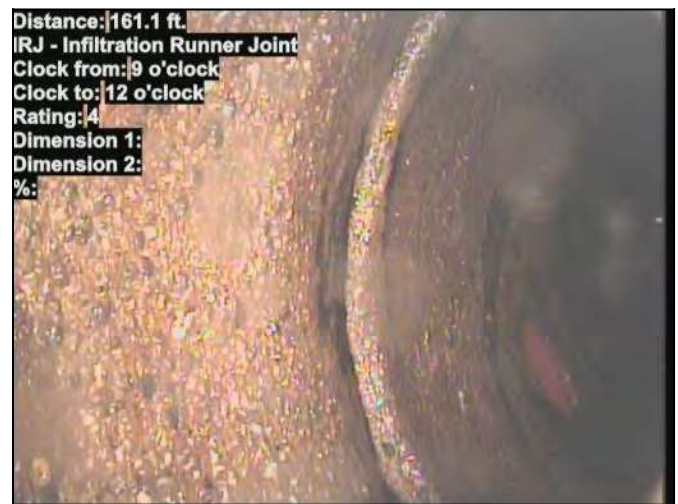
Distance: 161.1 ft.  
IRJ - Infiltration Runner Joint  
Clock from: 9 o'clock  
Clock to: 12 o'clock  
Rating: 4  
Dimension 1:  
Dimension 2:  
%:

Photo: MH 1-24-MH 1-23A-20220825-142556.JPG

At: 161.1 ft. IRJ - Infiltration Runner Joint

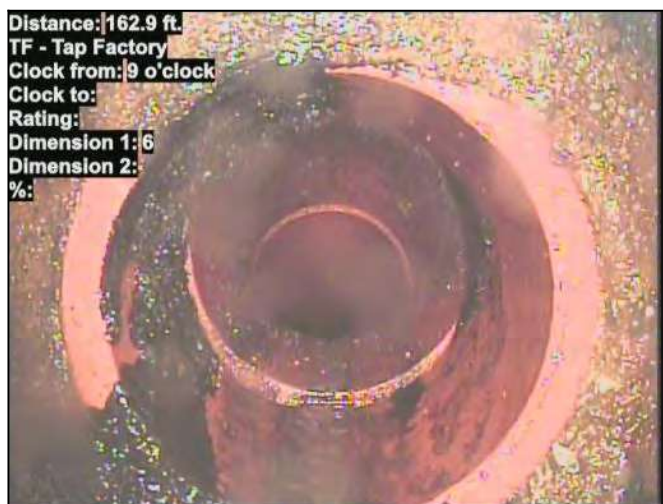
Distance: 162.9 ft.  
TF - Tap Factory  
Clock from: 9 o'clock  
Clock to:  
Rating:  
Dimension 1: 6  
Dimension 2:  
%:

Photo: MH 1-24-MH 1-23A-20220825-142636.JPG

At: 162.9 ft. 9/. TF - Tap Factory

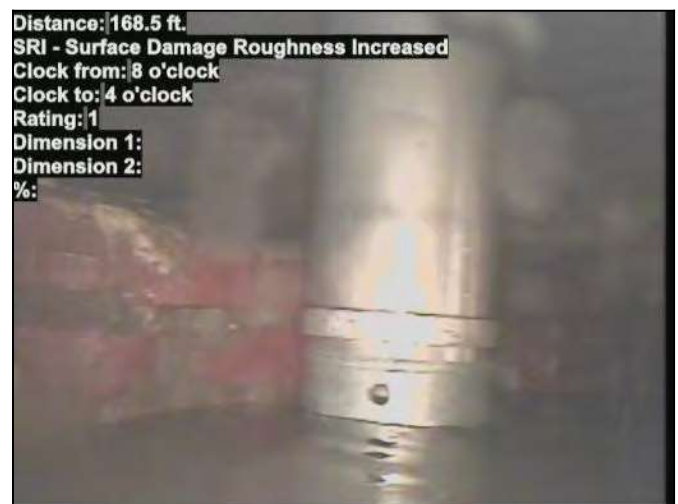
Distance: 168.5 ft.  
SRI - Surface Damage Roughness Increased  
Clock from: 8 o'clock  
Clock to: 4 o'clock  
Rating: 1  
Dimension 1:  
Dimension 2:  
%:

Photo: MH 1-24-MH 1-23A-20220825-142731.JPG

At: 168.5 ft. 8/4 SRI - Surface Damage Roughness Increased

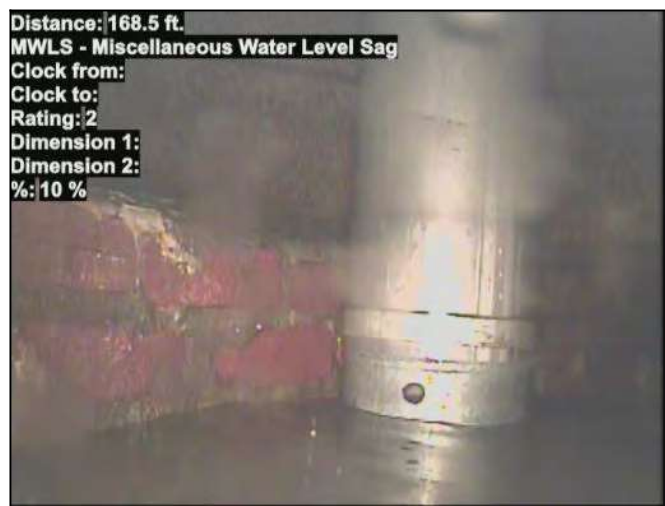
Photo: MH 1-24-MH 1-23A-20220825-142721.JPG  
At: 168.5 ft. MWLS - Miscellaneous Water Level Sag  
Joint: No 10 %

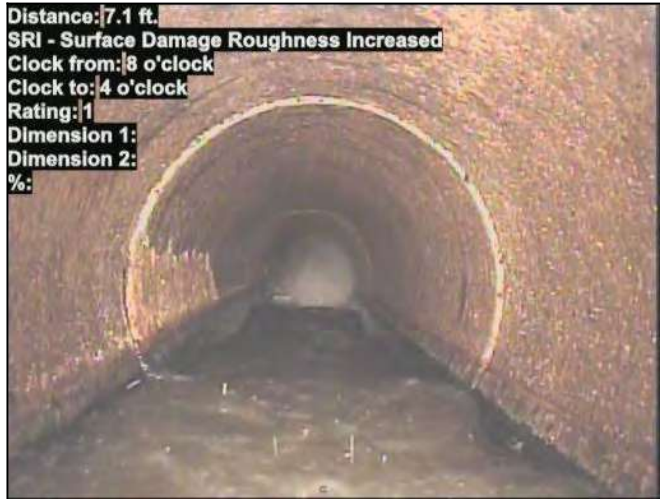
Photo: MH 1-23-MH 1-22-20220829-093514.JPG

At: 7.1 ft. 8/4 SRI - Surface Damage Roughness Increased

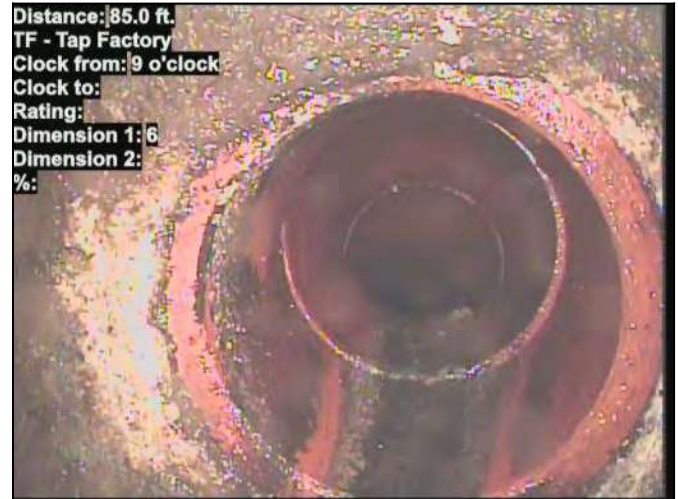
Photo: MH 1-23-MH 1-22-20220829-105206.JPG

At: 85 ft. 9/. TF - Tap Factory

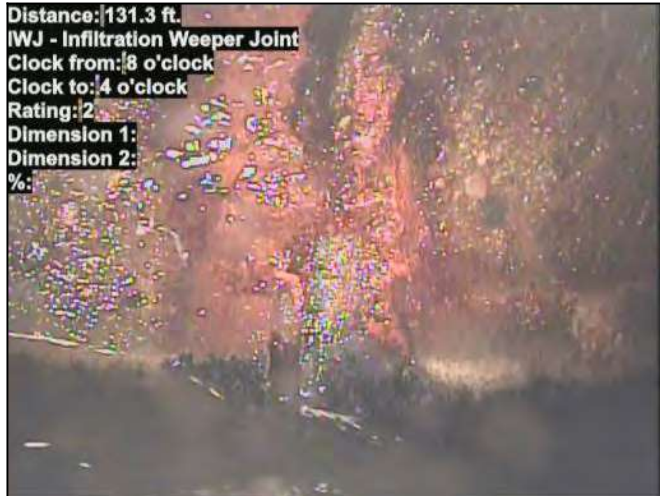
Photo: MH 1-23-MH 1-22-20220829-111040.JPG

At: 131.3 ft. 8/4 IWJ - Infiltration Weeper Joint

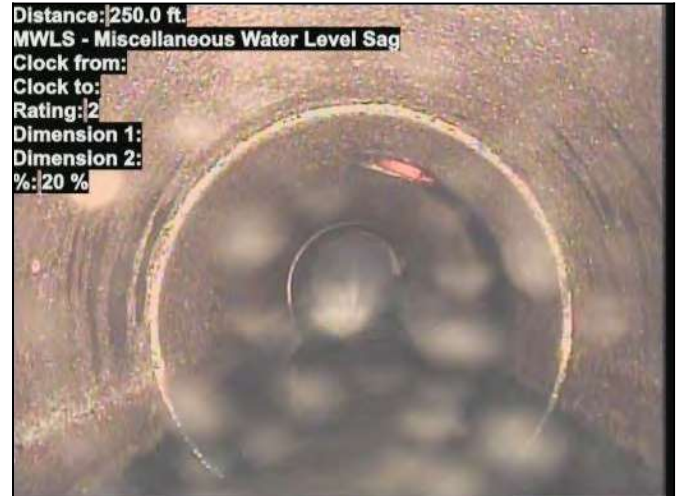
Photo: MH 1-23-MH 1-22-20220829-114957.JPG

At: 250 ft. MWLS - Miscellaneous Water Level Sag

Joint: No 20 %

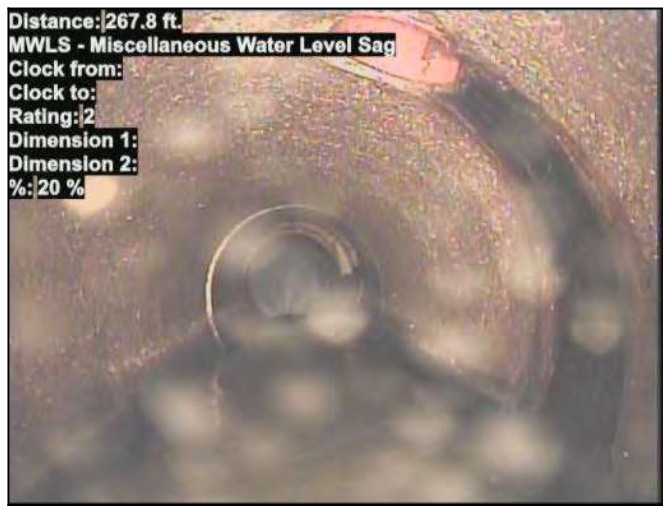
Distance: 267.8 ft.  
 MWLS - Miscellaneous Water Level Sag  
 Clock from:  
 Clock to:  
 Rating: 2  
 Dimension 1:  
 Dimension 2:  
 %: 20 %

Photo: MH 1-23-MH 1-22-20220829-115030.JPG  
 At: 267.8 ft. MWLS - Miscellaneous Water Level Sag  
 Joint: No 20 %

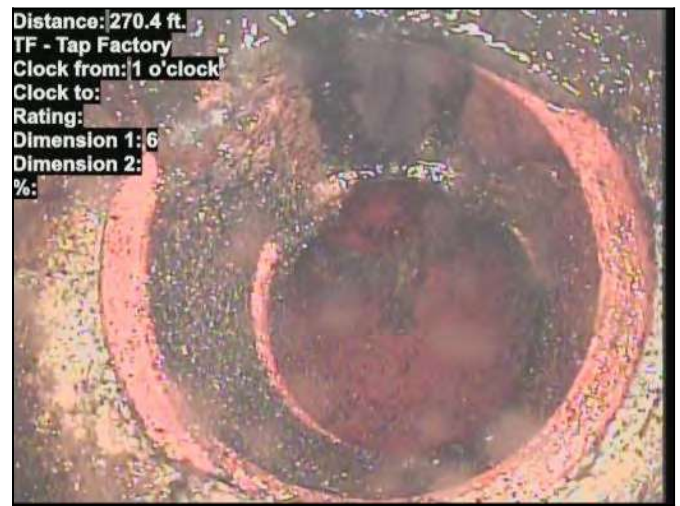
Distance: 270.4 ft.  
 TF - Tap Factory  
 Clock from: 1 o'clock  
 Clock to:  
 Rating:  
 Dimension 1: 6  
 Dimension 2:  
 %:

Photo: MH 1-23-MH 1-22-20220829-115047.JPG  
 At: 270.4 ft. 1/. TF - Tap Factory  
 Joint: No

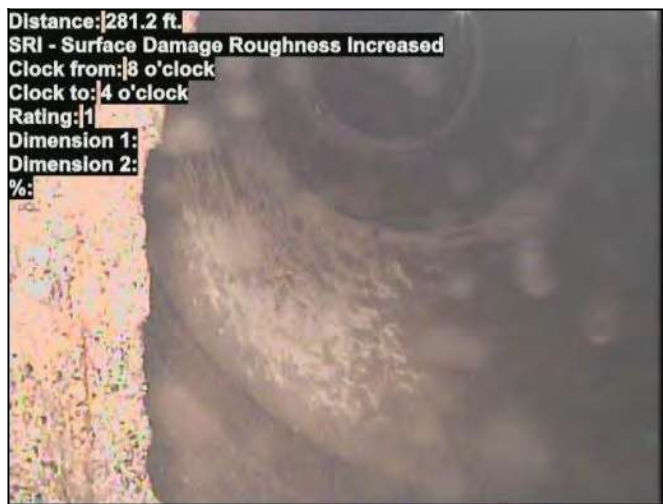
Distance: 281.2 ft.  
 SRI - Surface Damage Roughness Increased  
 Clock from: 8 o'clock  
 Clock to: 4 o'clock  
 Rating: 1  
 Dimension 1:  
 Dimension 2:  
 %:

Photo: MH 1-23-MH 1-22-20220829-115151.JPG  
 At: 281.2 ft. 8/4 SRI - Surface Damage Roughness Increased  
 Joint: Yes

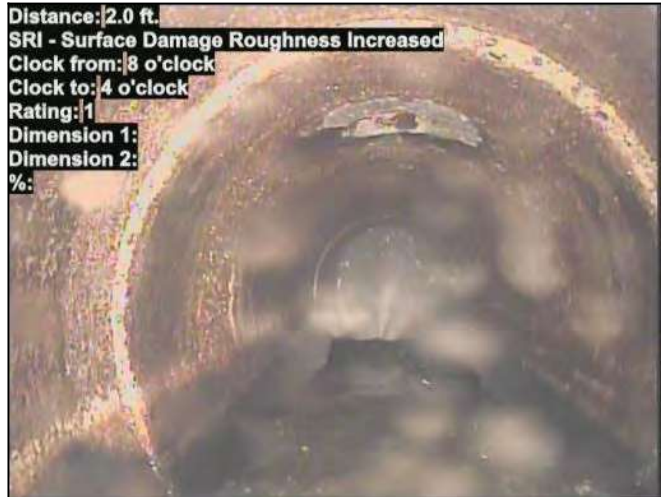
Photo: MH 1-22-MH 1-21-20220829-115540.JPG

At: 2 ft. 8/4 SRI - Surface Damage Roughness Increased

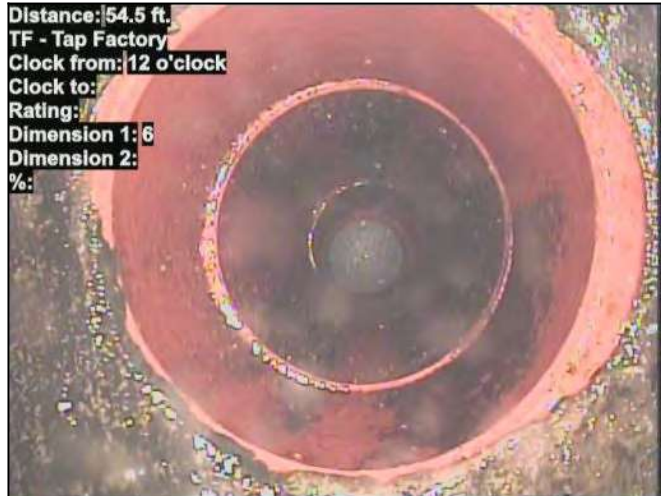
Photo: MH 1-22-MH 1-21-20220829-120227.JPG

At: 54.5 ft. 12/ TF - Tap Factory

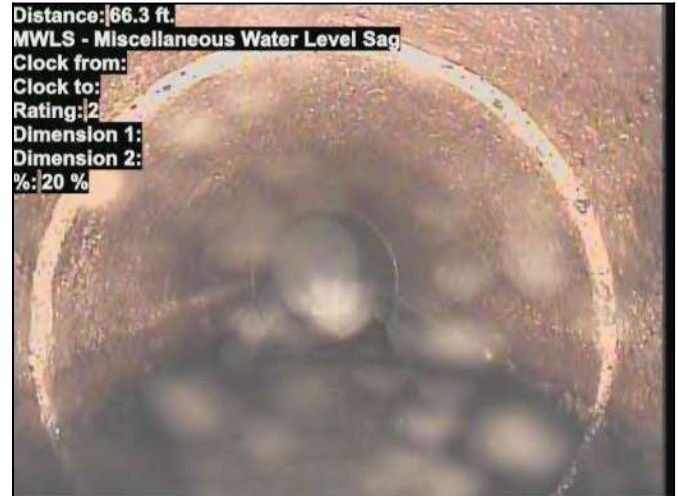
Photo: MH 1-22-MH 1-21-20220829-120259.JPG

At: 66.3 ft. MWLS - Miscellaneous Water Level Sag

Joint: No 20 %

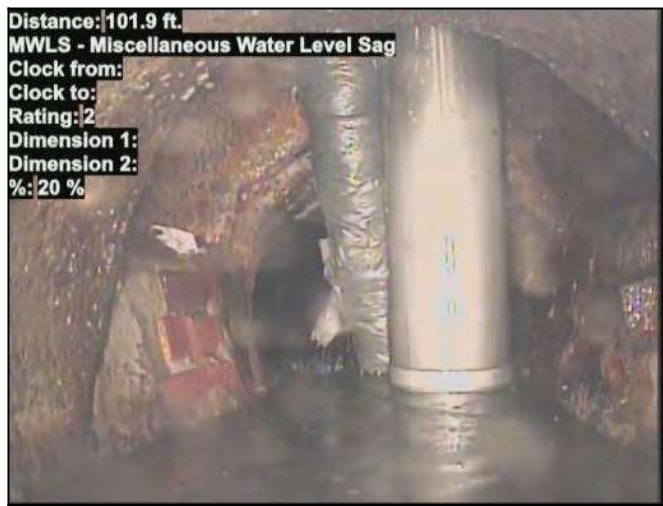
Photo: MH 1-22-MH 1-21-20220829-120633.JPG  
 At: 101.9 ft. MWLS - Miscellaneous Water Level Sag  
 Joint: No 20 %

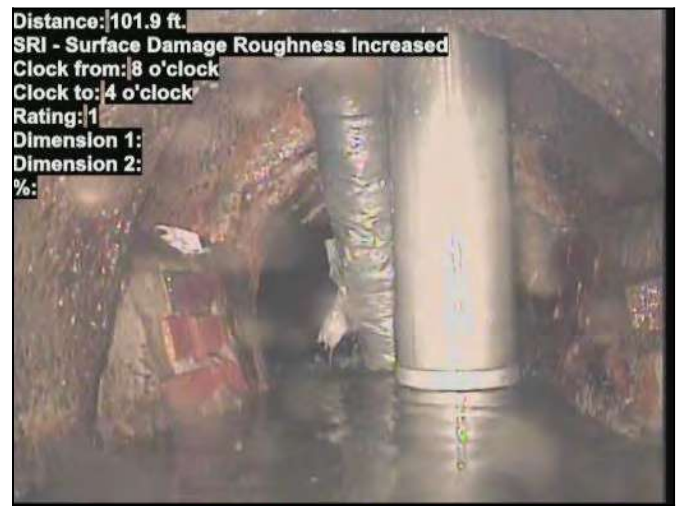
Photo: MH 1-22-MH 1-21-20220829-120642.JPG  
 At: 101.9 ft. 8/4 SRI - Surface Damage Roughness Increased  
 Joint: Yes

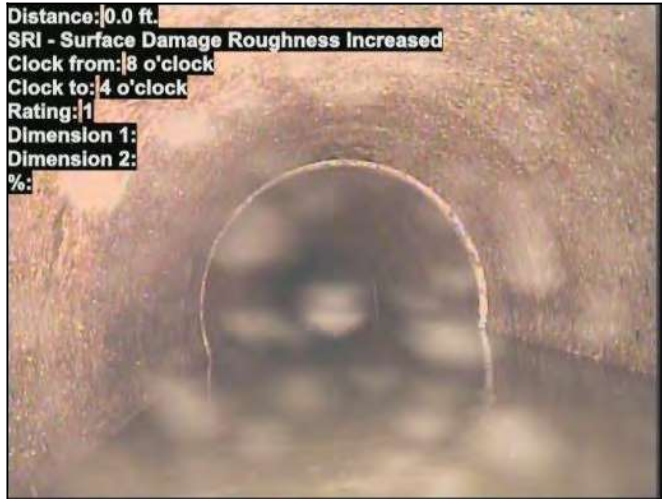
Photo: MH 1-21-MH 1-20-20220829-125158.JPG  
At: 0 ft. 8/4 SRI - Surface Damage Roughness Increased  
Joint: Yes

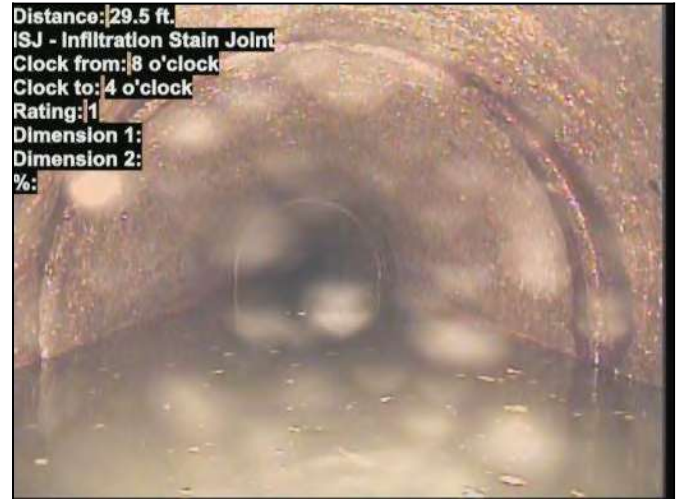
Photo: MH 1-21-MH 1-20-20220829-131435.JPG  
At: 29.5 ft. 8/4 ISJ - Infiltration Stain Joint  
Joint: Yes

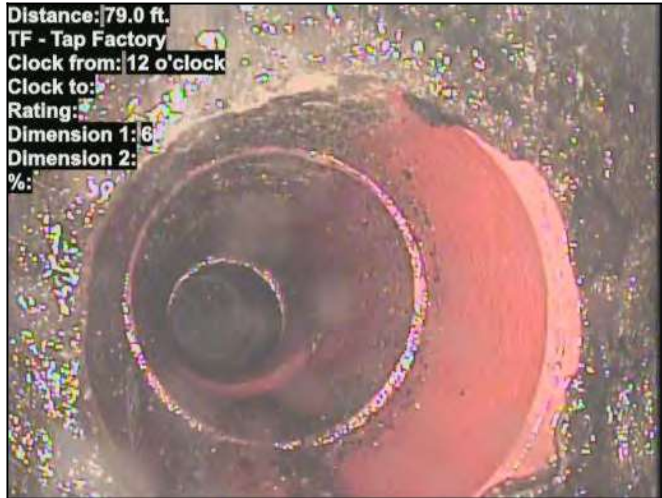
Photo: MH 1-21-MH 1-20-20220829-133636.JPG  
At: 79 ft. 12/. TF - Tap Factory  
Joint: No

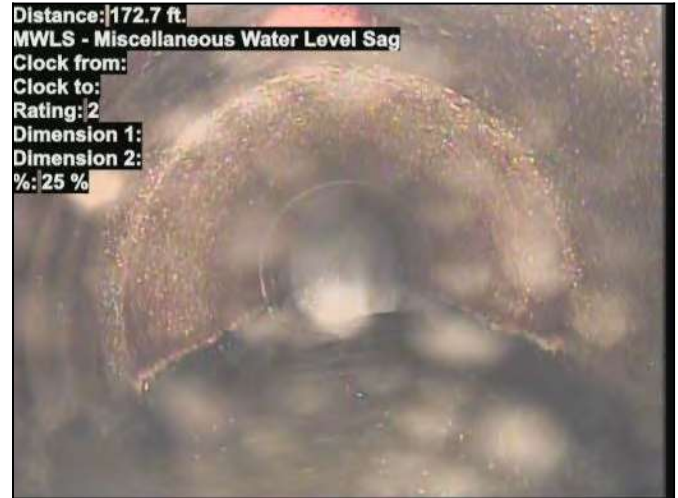
Photo: MH 1-21-MH 1-20-20220829-135630.JPG  
At: 172.7 ft. MWLS - Miscellaneous Water Level Sag  
Joint: No 25 %

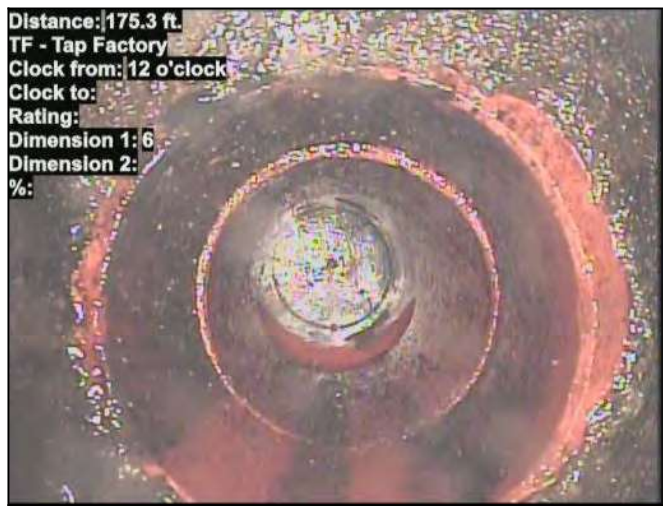
Photo: MH 1-21-MH 1-20-20220829-135617.JPG

At: 175.3 ft. 12/. TF - Tap Factory

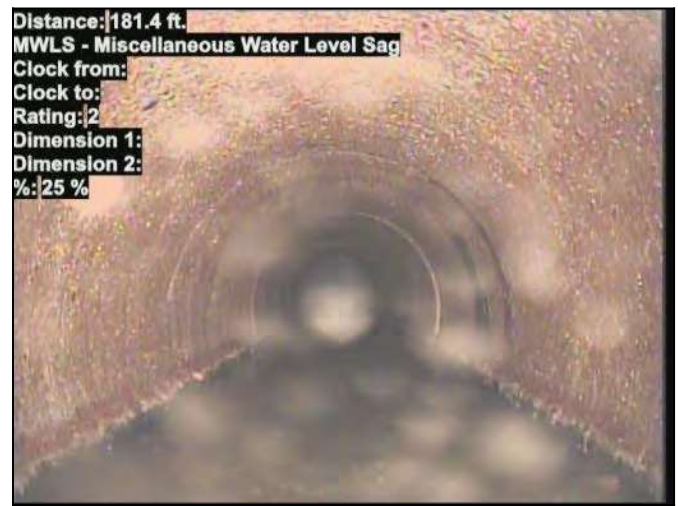
Photo: MH 1-21-MH 1-20-20220829-135646.JPG

At: 181.4 ft. MWLS - Miscellaneous Water Level Sag

Joint: No 25 %

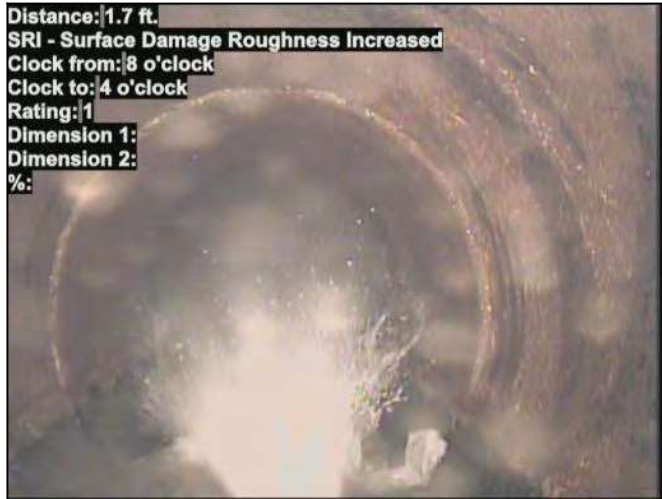
Photo: MH 1-20-MH 1-19-20220829-142506.JPG

At: 1.7 ft. 8/4 SRI - Surface Damage Roughness Increased

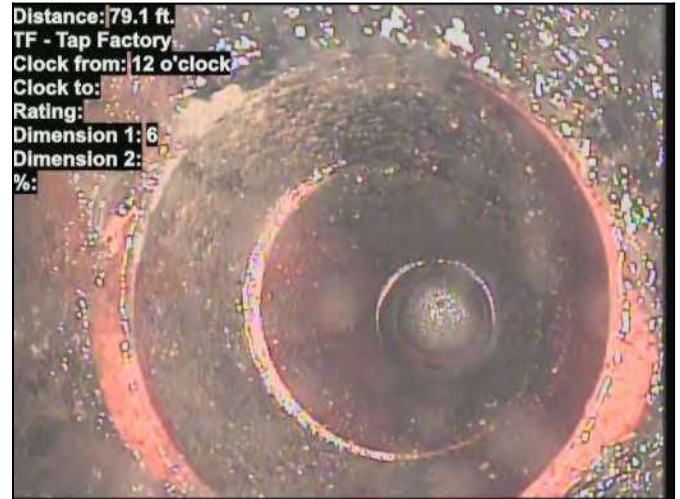
Photo: MH 1-20-MH 1-19-20220829-143828.JPG

At: 79.1 ft. 12/. TF - Tap Factory

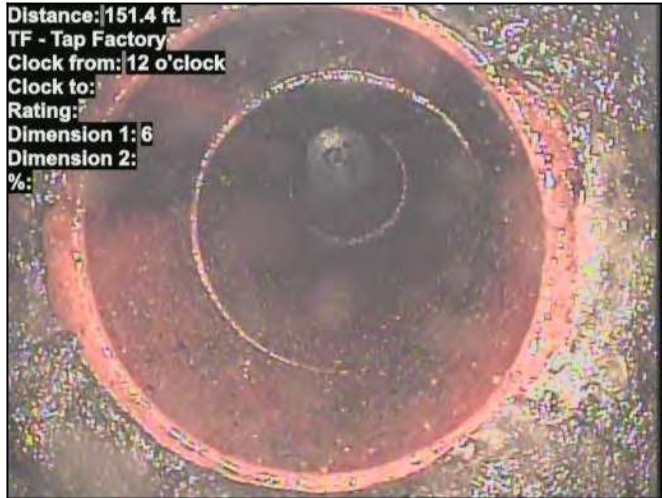
Photo: MH 1-20-MH 1-19-20220829-144210.JPG

At: 151.4 ft. 12/. TF - Tap Factory

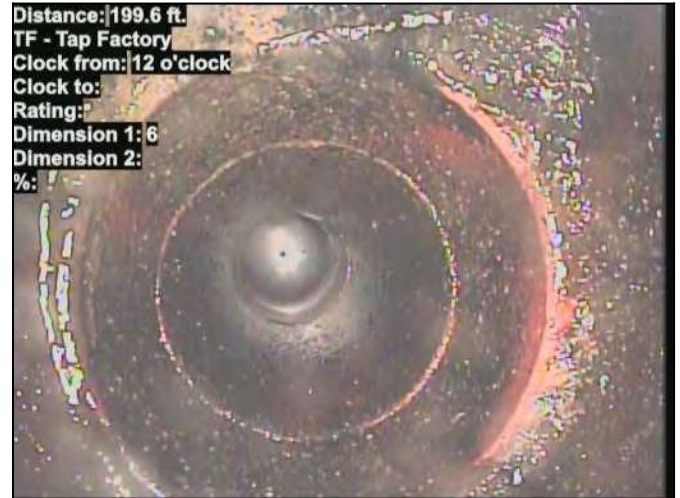
Photo: MH 1-20-MH 1-19-20220829-144446.JPG

At: 199.6 ft. 12/. TF - Tap Factory

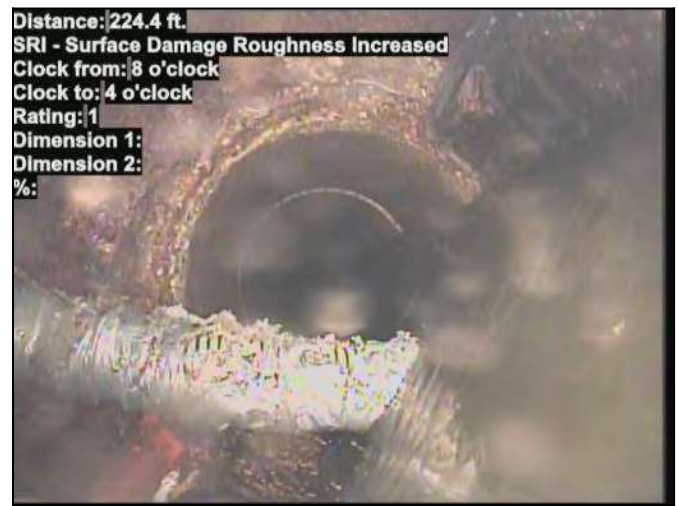
Photo: MH 1-20-MH 1-19-20220829-144902.JPG  
At: 224.4 ft. 8/4 SRI - Surface Damage Roughness Increased  
Joint: Yes

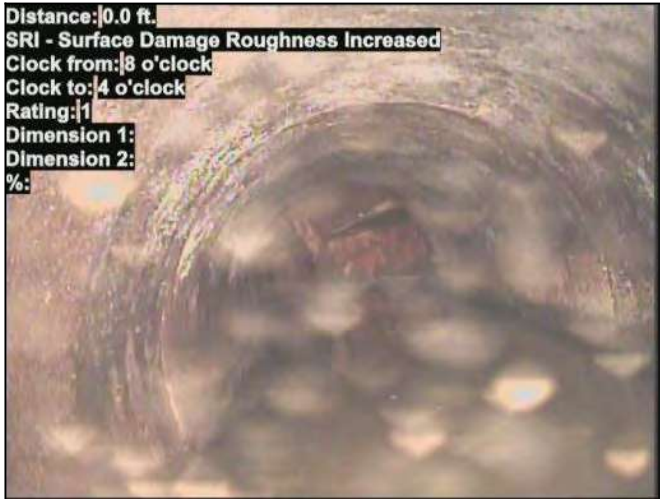
Photo: MH 1-23A-MH 1-23-20220829-152620.JPG  
At: 0 ft. 8/4 SRI - Surface Damage Roughness Increased  
Joint: Yes

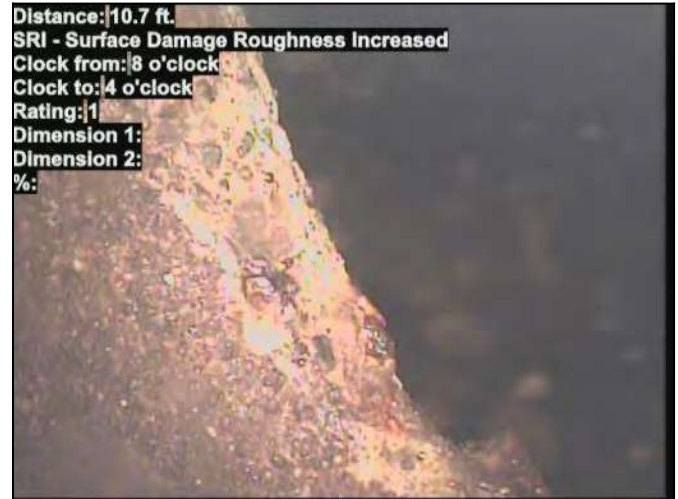
Photo: MH 1-23A-MH 1-23-20220829-152714.JPG  
At: 10.7 ft. 8/4 SRI - Surface Damage Roughness Increased  
Joint: Yes

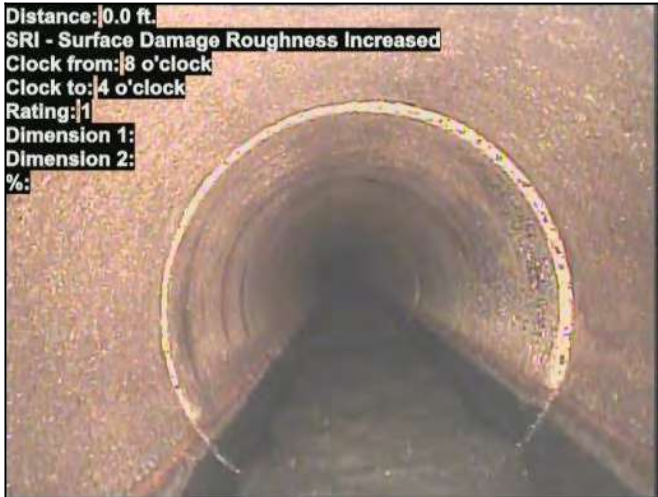
Photo: MH 1-19-MH 1-18-20220830-090743.JPG

At: 0 ft. 8/4 SRI - Surface Damage Roughness Increased

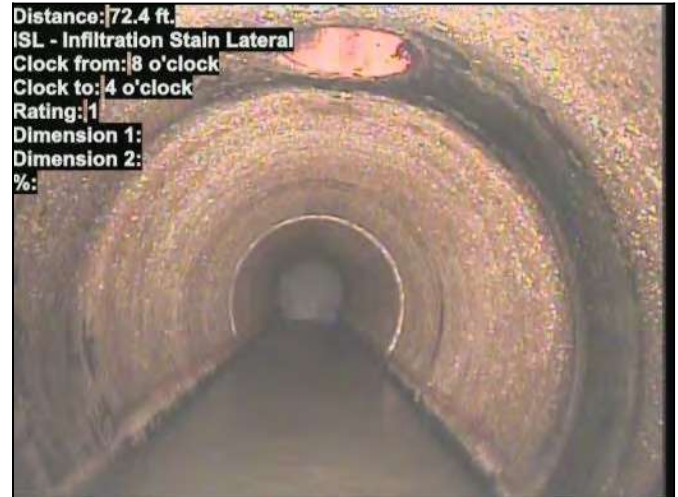
Photo: MH 1-19-MH 1-18-20220830-091322.JPG

At: 72.4 ft. 8/4 ISL - Infiltration Stain Lateral

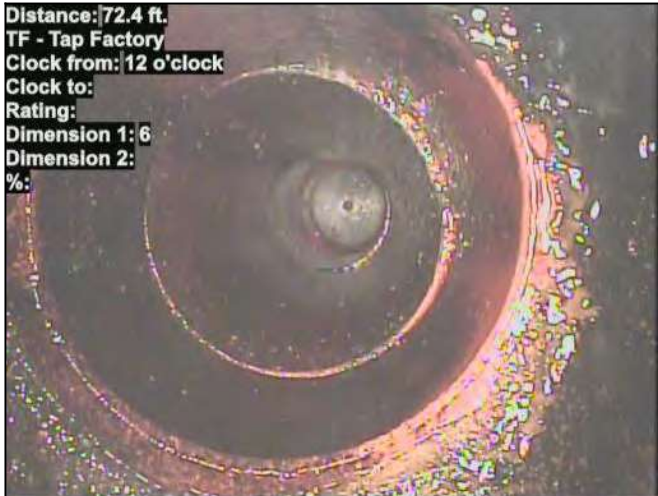
Photo: MH 1-19-MH 1-18-20220830-091253.JPG

At: 72.4 ft. 12/ TF - Tap Factory

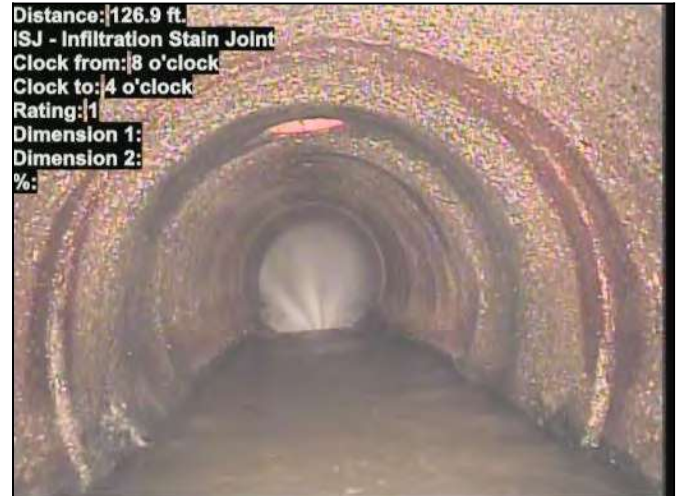
Photo: MH 1-19-MH 1-18-20220830-091559.JPG

At: 126.9 ft. 8/4 ISJ - Infiltration Stain Joint

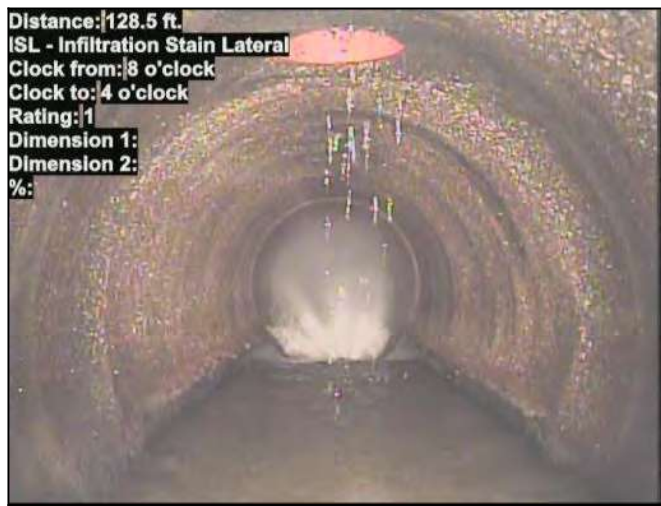
Distance: 128.5 ft.  
ISL - Infiltration Stain Lateral  
Clock from: 8 o'clock  
Clock to: 4 o'clock  
Rating: 1  
Dimension 1:  
Dimension 2:  
%:  
Photo: MH 1-19-MH 1-18-20220830-091748.JPG  
At: 128.5 ft. 8/4 ISL - Infiltration Stain Lateral  
Joint: Yes

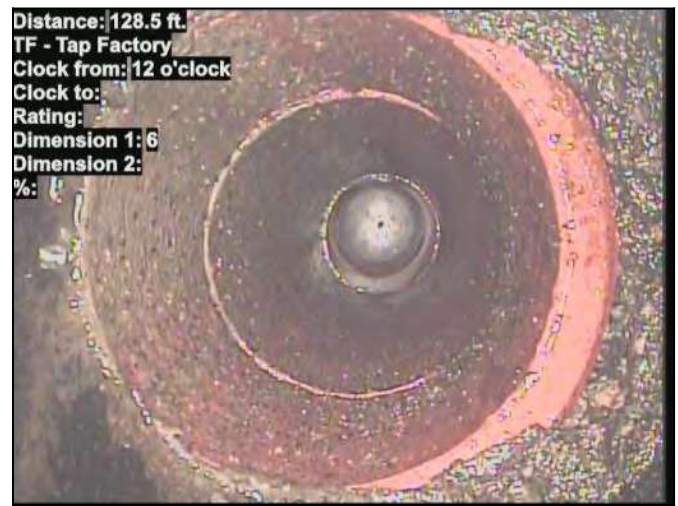
Distance: 128.5 ft.  
TF - Tap Factory  
Clock from: 12 o'clock  
Clock to:  
Rating:  
Dimension 1: 6  
Dimension 2:  
%:  
Photo: MH 1-19-MH 1-18-20220830-091733.JPG  
At: 128.5 ft. 12/. TF - Tap Factory  
Joint: No

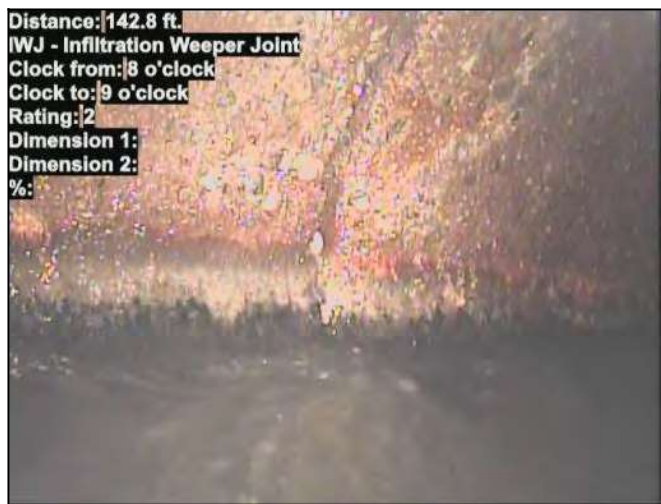
Distance: 142.8 ft.  
IWJ - Infiltration Weeper Joint  
Clock from: 8 o'clock  
Clock to: 9 o'clock  
Rating: 2  
Dimension 1:  
Dimension 2:  
%:  
Photo: MH 1-19-MH 1-18-20220830-091907.JPG  
At: 142.8 ft. 8/9 IWJ - Infiltration Weeper Joint  
Joint: Yes
