## Appendix A

### Mystic Area CCTV Inspection Logs

## NWMCC INSPECTION REPORT

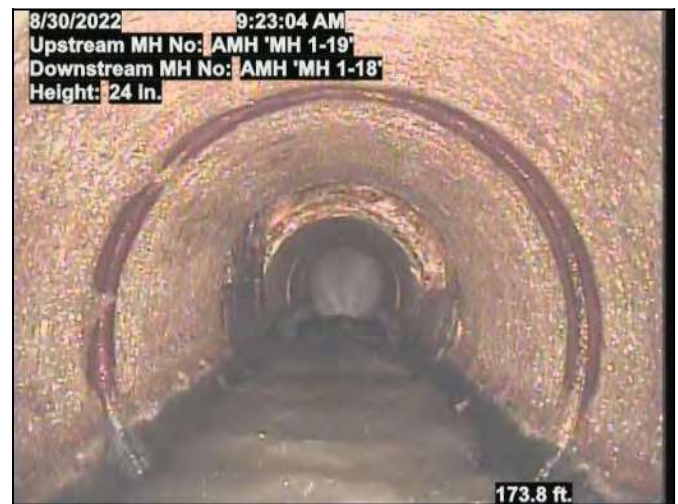
8/30/2022 9:23:04 AM  
Upstream MH No: AMH 'MH 1-19'  
Downstream MH No: AMH 'MH 1-18'  
Height: 24 In.  
173.8 ft.  
Photo: MH 1-19-MH 1-18-20220830-092042\_1.JPG  
At: 150.8 ft. 1/4 IWJ - Infiltration Weeper Joint  
Joint: Yes

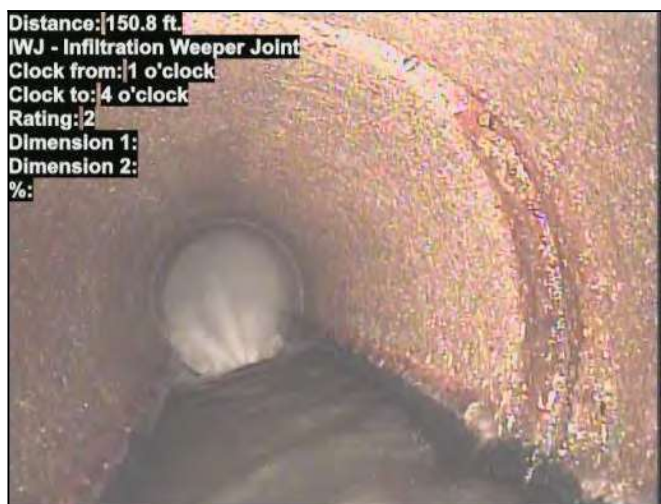
Distance: 150.8 ft.  
IWJ - Infiltration Weeper Joint  
Clock from: 1 o'clock  
Clock to: 4 o'clock  
Rating: 2  
Dimension 1:  
Dimension 2:  
%:  
Photo: MH 1-19-MH 1-18-20220830-092042.JPG  
At: 150.8 ft. 1/4 IWJ - Infiltration Weeper Joint  
Joint: Yes

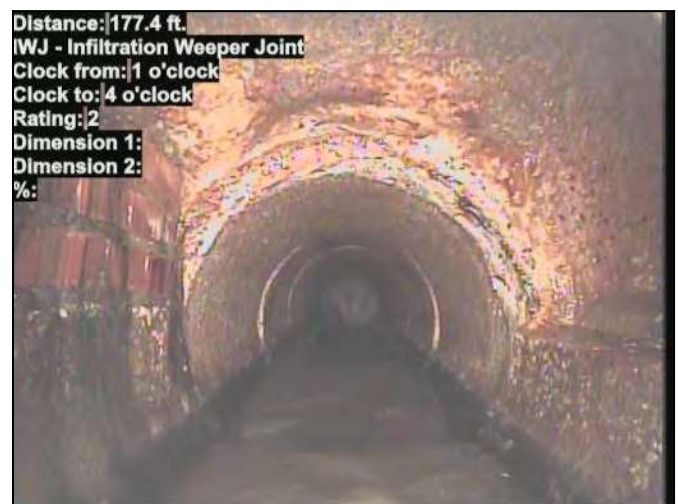
Distance: 177.4 ft.  
IWJ - Infiltration Weeper Joint  
Clock from: 1 o'clock  
Clock to: 4 o'clock  
Rating: 2  
Dimension 1:  
Dimension 2:  
%:  
Photo: MH 1-19-MH 1-18-20220830-092332.JPG  
At: 177.4 ft. 1/4 IWJ - Infiltration Weeper Joint  
Joint: Yes

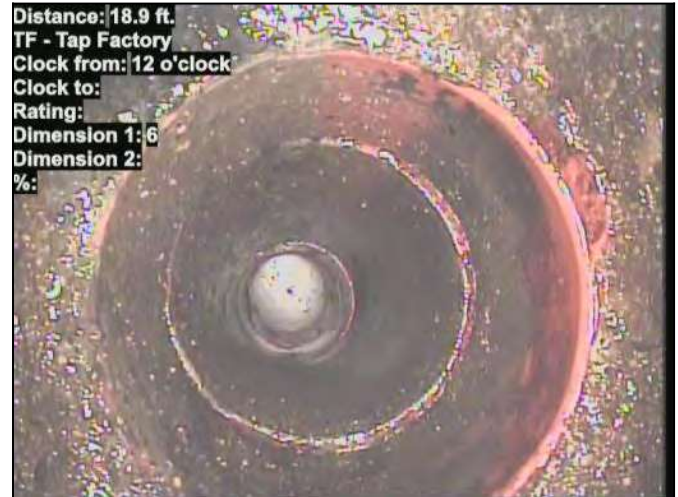
Photo: MH 1-18-MH 1-17-20220830-093036.JPG

At: 18.9 ft. 12/. TF - Tap Factory

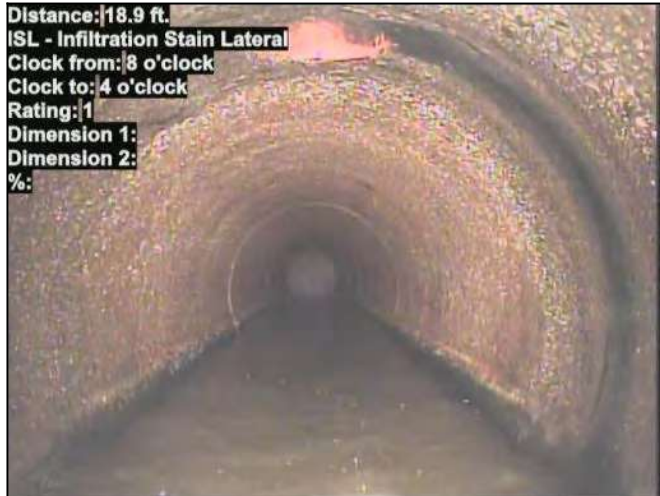
Photo: MH 1-18-MH 1-17-20220830-093055.JPG

At: 18.9 ft. 8/4 ISL - Infiltration Stain Lateral

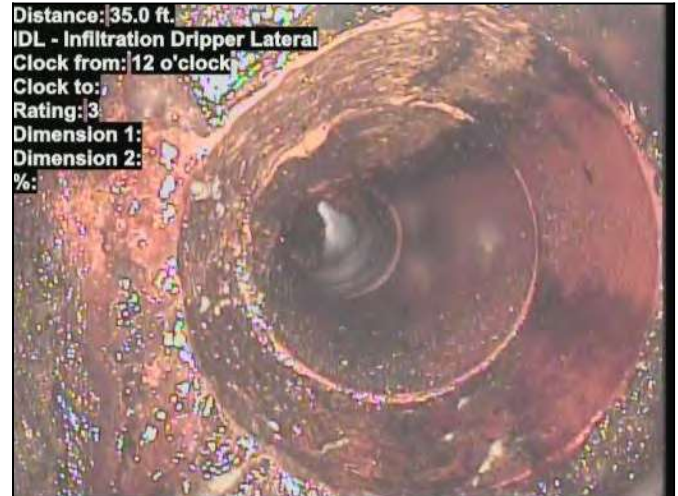
Photo: MH 1-18-MH 1-17-20220830-093215.JPG

At: 35 ft. 12/. IDL - Infiltration Dripper Lateral

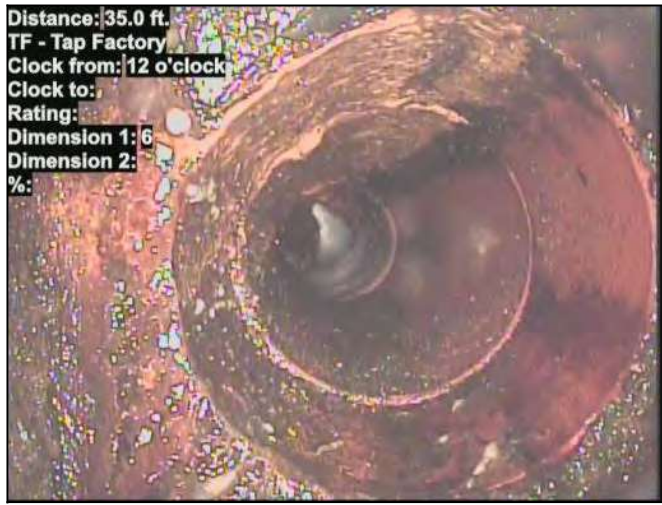
Distance: 35.0 ft.  
TF - Tap Factory  
Clock from: 12 o'clock  
Clock to:  
Rating:  
Dimension 1: 6  
Dimension 2:  
%:  
Photo: MH 1-18-MH 1-17-20220830-093210.JPG  
At: 35 ft. 12/. TF - Tap Factory  
Joint: No

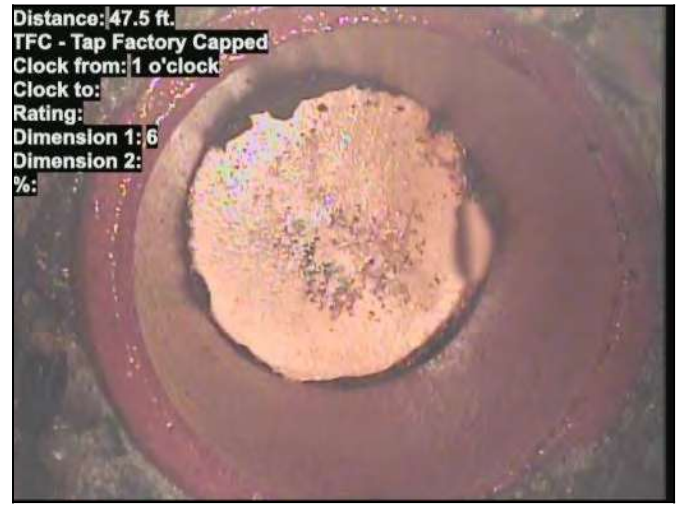
Distance: 47.5 ft.  
TFC - Tap Factory Capped  
Clock from: 1 o'clock  
Clock to:  
Rating:  
Dimension 1: 6  
Dimension 2:  
%:  
Photo: MH 1-18-MH 1-17-20220830-093314.JPG  
At: 47.5 ft. 1/. TFC - Tap Factory Capped  
Joint: Yes

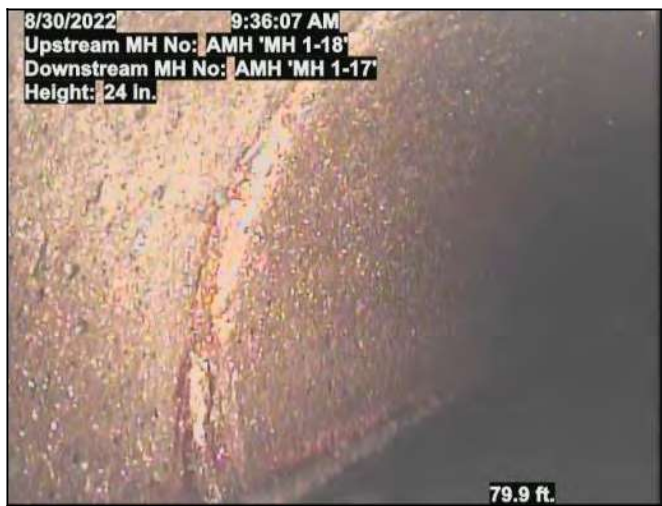
8/30/2022 9:36:07 AM  
Upstream MH No: AMH 'MH 1-18'  
Downstream MH No: AMH 'MH 1-17'  
Height: 24 in.  
Photo: MH 1-18-MH 1-17-20220830-093456\_3.JPG  
At: 49.3 ft. 8/4 ISJ - Infiltration Stain Joint  
Joint: Yes

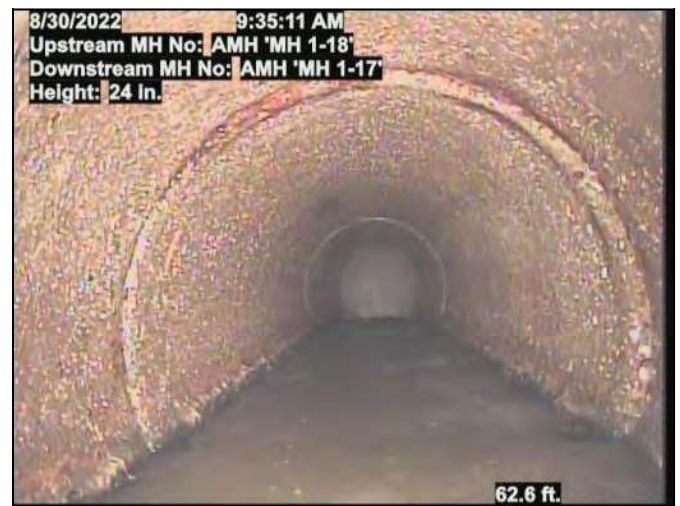
8/30/2022 9:35:11 AM  
Upstream MH No: AMH 'MH 1-18'  
Downstream MH No: AMH 'MH 1-17'  
Height: 24 in.  
Photo: MH 1-18-MH 1-17-20220830-093456\_2.JPG  
At: 49.3 ft. 8/4 ISJ - Infiltration Stain Joint  
Joint: Yes

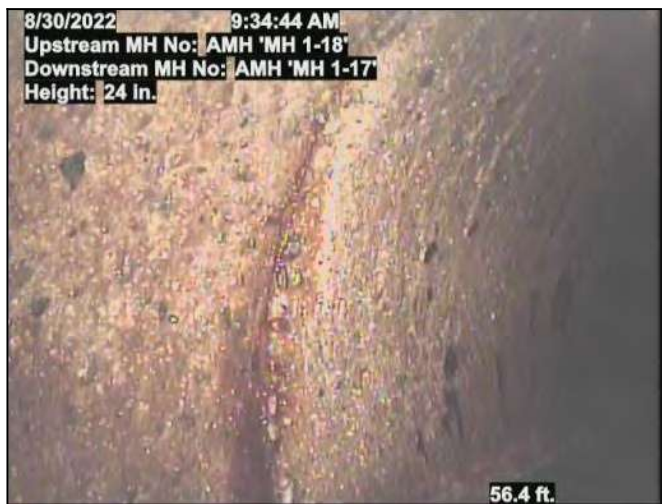
8/30/2022 9:34:44 AM  
Upstream MH No: AMH 'MH 1-18'  
Downstream MH No: AMH 'MH 1-17'  
Height: 24 in.  
Photo: MH 1-18-MH 1-17-20220830-093456\_1.JPG  
At: 49.3 ft. 8/4 ISJ - Infiltration Stain Joint  
Joint: Yes

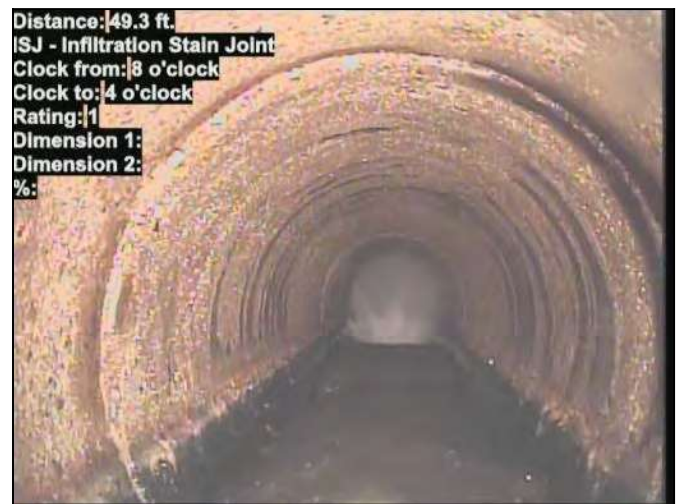
Distance: 49.3 ft.  
ISJ - Infiltration Stain Joint  
Clock from: 8 o'clock  
Clock to: 4 o'clock  
Rating: 1  
Dimension 1:  
Dimension 2:  
%:  
Photo: MH 1-18-MH 1-17-20220830-093456.JPG  
At: 49.3 ft. 8/4 ISJ - Infiltration Stain Joint  
Joint: Yes

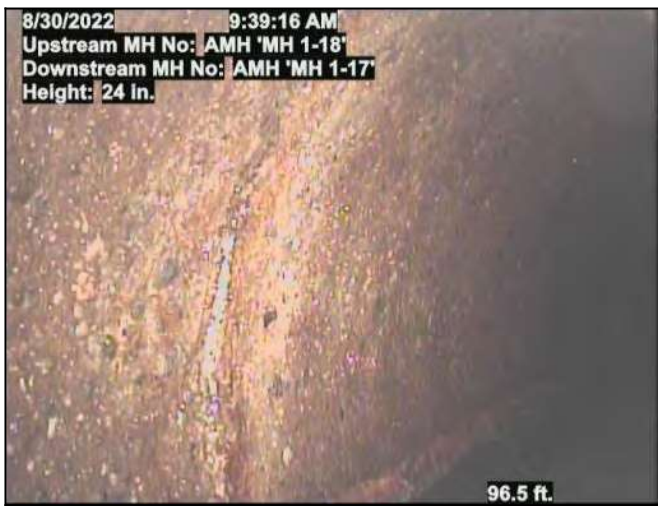
Photo: MH 1-18-MH 1-17-20220830-093656\_3.JPG  
 At: 89.2 ft. 4/8 DSC - Deposits Settled Hard/Compacted  
 Joint: Yes 10 %

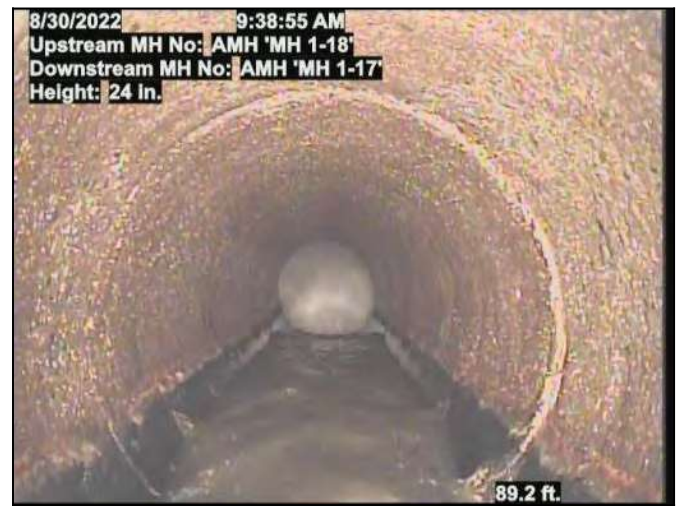
Photo: MH 1-18-MH 1-17-20220830-093656\_2.JPG  
 At: 89.2 ft. 4/8 DSC - Deposits Settled Hard/Compacted  
 Joint: Yes 10 %

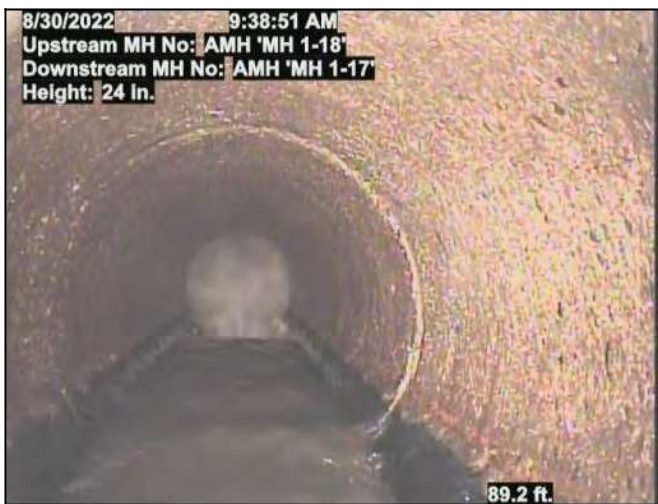
Photo: MH 1-18-MH 1-17-20220830-093656\_1.JPG  
 At: 89.2 ft. 4/8 DSC - Deposits Settled Hard/Compacted  
 Joint: Yes 10 %

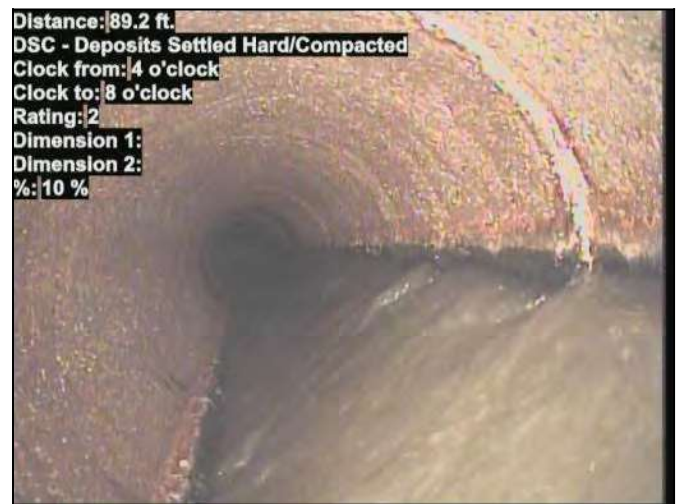
Photo: MH 1-18-MH 1-17-20220830-093656.JPG  
 At: 89.2 ft. 4/8 DSC - Deposits Settled Hard/Compacted  
 Joint: Yes 10 %

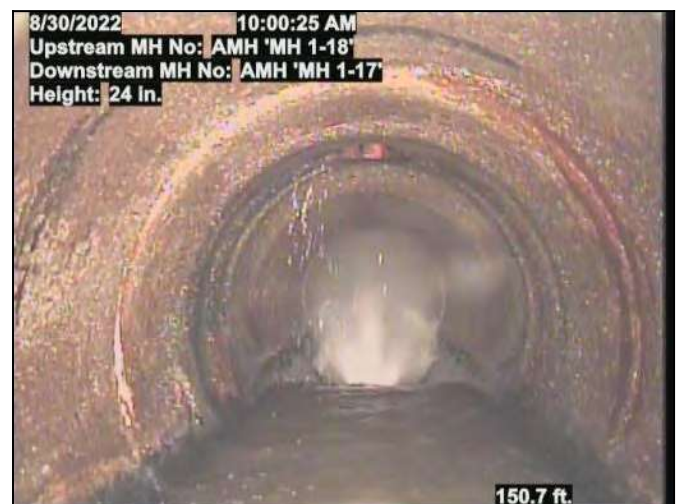
Photo: MH 1-18-MH 1-17-20220830-094013\_5.JPG  
 At: 103.6 ft. 8/4 ISL - Infiltration Stain Lateral  
 Joint: Yes

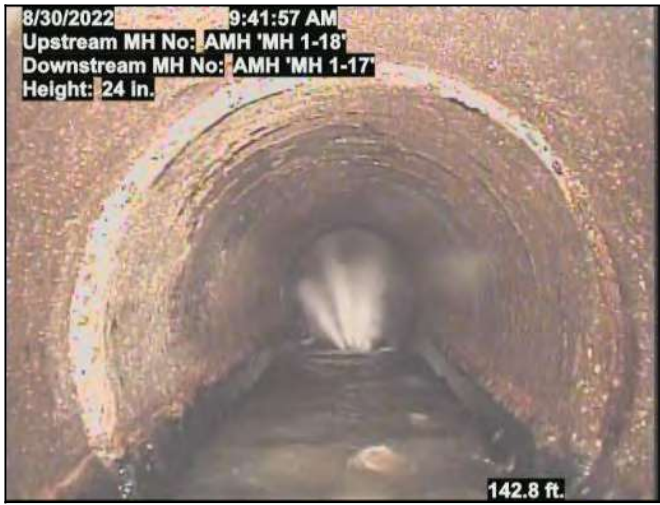
Photo: MH 1-18-MH 1-17-20220830-094013\_4.JPG  
 At: 103.6 ft. 8/4 ISL - Infiltration Stain Lateral  
 Joint: Yes

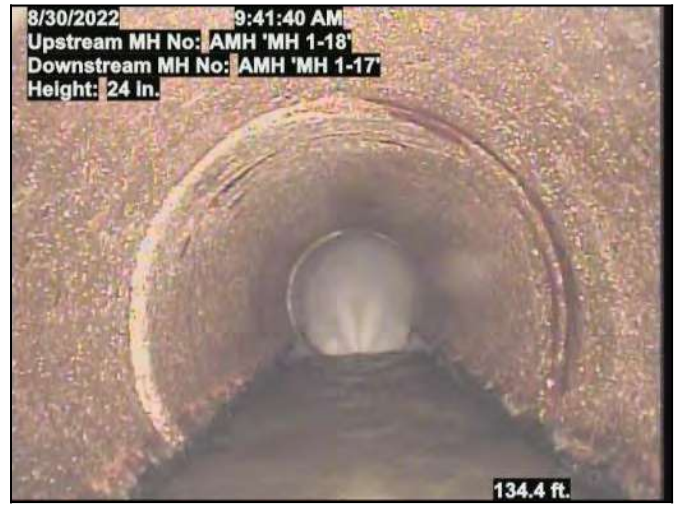
Photo: MH 1-18-MH 1-17-20220830-094013\_3.JPG  
 At: 103.6 ft. 8/4 ISL - Infiltration Stain Lateral  
 Joint: Yes

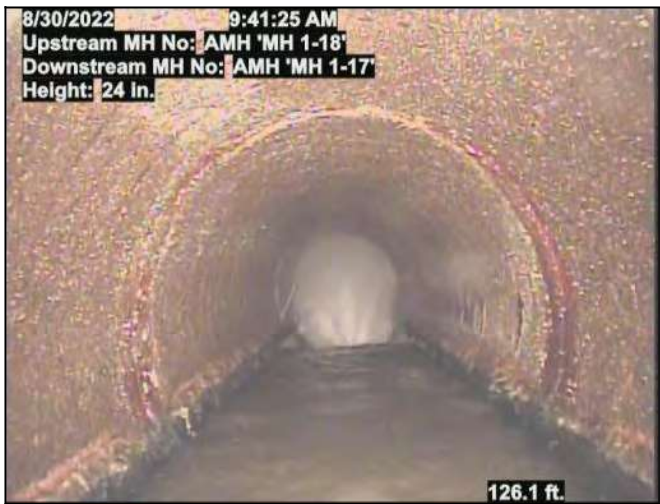
Photo: MH 1-18-MH 1-17-20220830-094013\_2.JPG  
 At: 103.6 ft. 8/4 ISL - Infiltration Stain Lateral  
 Joint: Yes

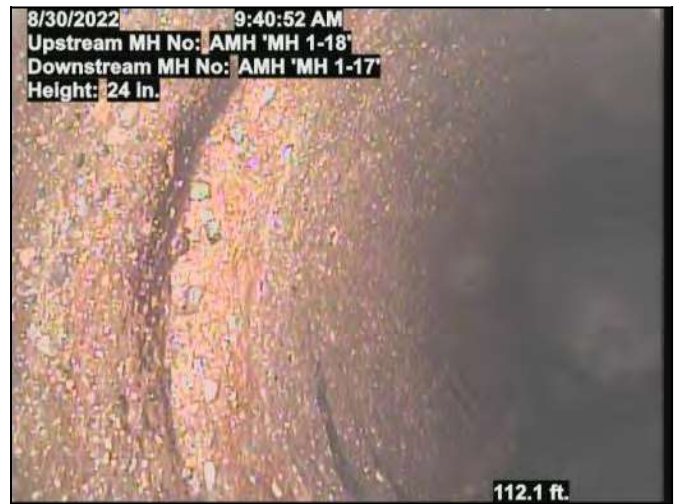
Photo: MH 1-18-MH 1-17-20220830-094013\_1.JPG  
 At: 103.6 ft. 8/4 ISL - Infiltration Stain Lateral  
 Joint: Yes

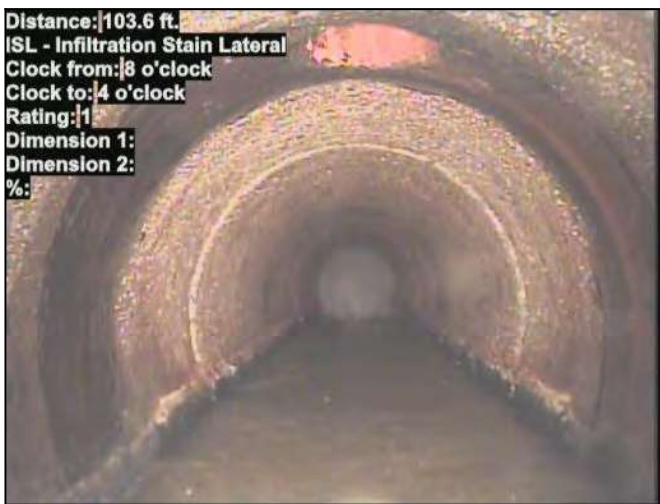
Photo: MH 1-18-MH 1-17-20220830-094013.JPG  
 At: 103.6 ft. 8/4 ISL - Infiltration Stain Lateral  
 Joint: Yes

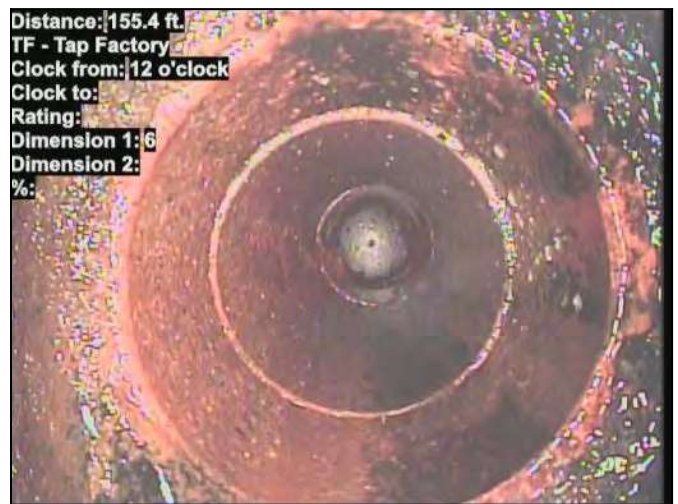
Photo: MH 1-18-MH 1-17-20220830-100047.JPG  
 At: 155.4 ft. 12/. TF - Tap Factory  
 Joint: No

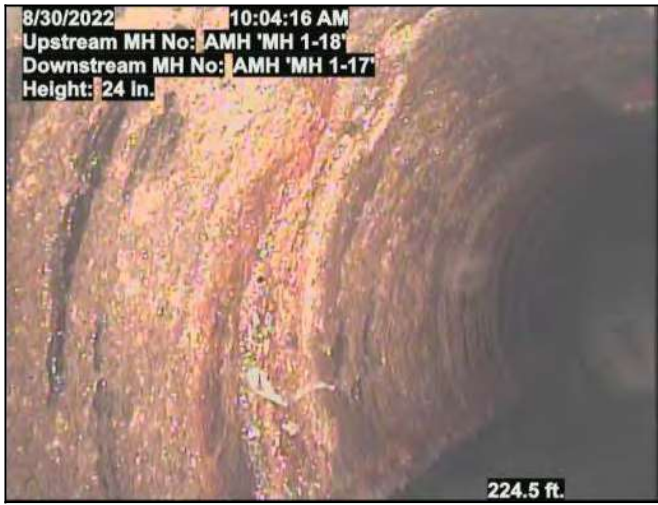
Photo: MH 1-18-MH 1-17-20220830-100052\_4.JPG  
 At: 155.5 ft. 12/. IRL - Infiltration Runner Lateral  
 Joint: Yes

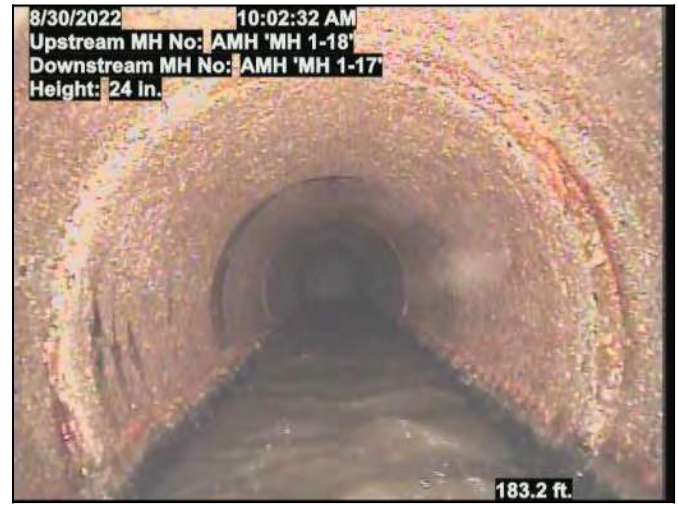
Photo: MH 1-18-MH 1-17-20220830-100052\_3.JPG  
 At: 155.5 ft. 12/. IRL - Infiltration Runner Lateral  
 Joint: Yes

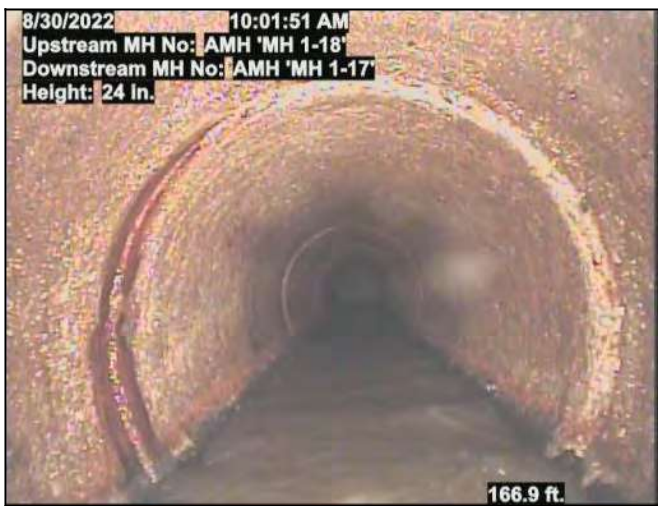
Photo: MH 1-18-MH 1-17-20220830-100052\_2.JPG  
 At: 155.5 ft. 12/. IRL - Infiltration Runner Lateral  
 Joint: Yes

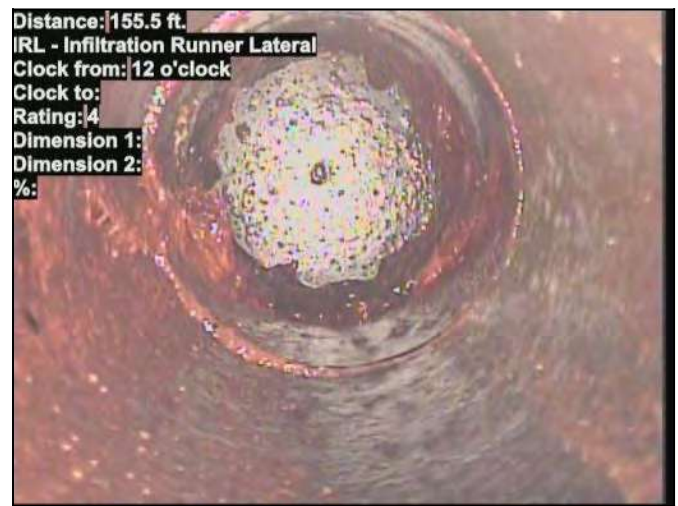
Photo: MH 1-18-MH 1-17-20220830-100052\_1.JPG  
 At: 155.5 ft. 12/. IRL - Infiltration Runner Lateral  
 Joint: Yes

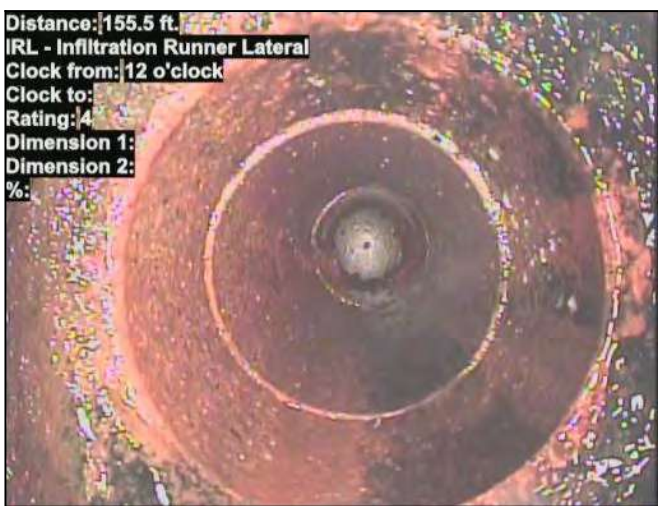
Photo: MH 1-18-MH 1-17-20220830-100052.JPG  
 At: 155.5 ft. 12/. IRL - Infiltration Runner Lateral  
 Joint: Yes

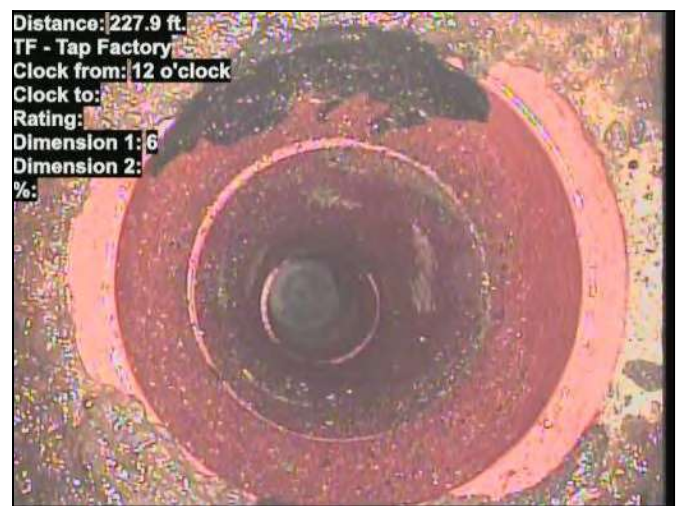
Photo: MH 1-18-MH 1-17-20220830-100437.JPG  
 At: 227.9 ft. 12/. TF - Tap Factory  
 Joint: No

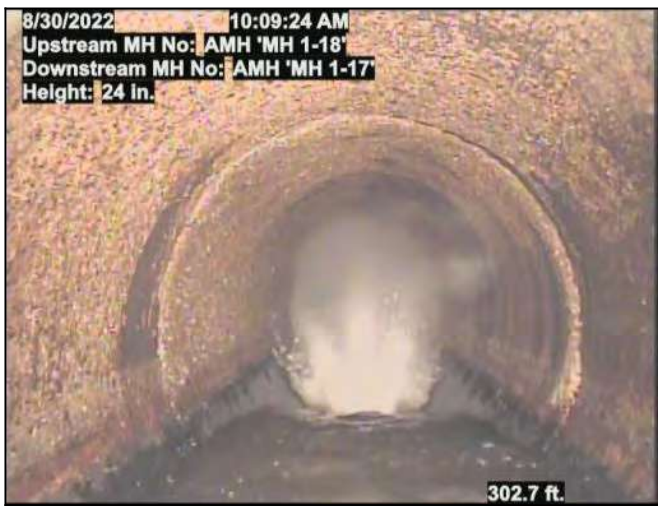
Photo: MH 1-18-MH 1-17-20220830-100821\_1.JPG  
At: 292.3 ft. 12/. IDL - Infiltration Dripper Lateral  
Joint: Yes

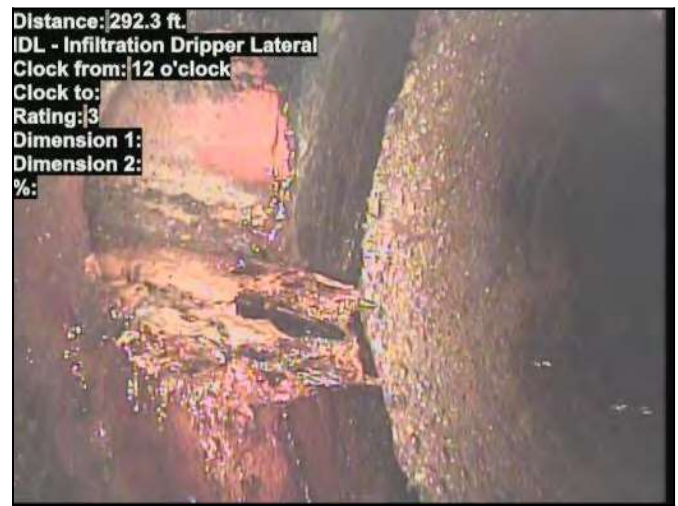
Photo: MH 1-18-MH 1-17-20220830-100821.JPG  
At: 292.3 ft. 12/. IDL - Infiltration Dripper Lateral  
Joint: Yes

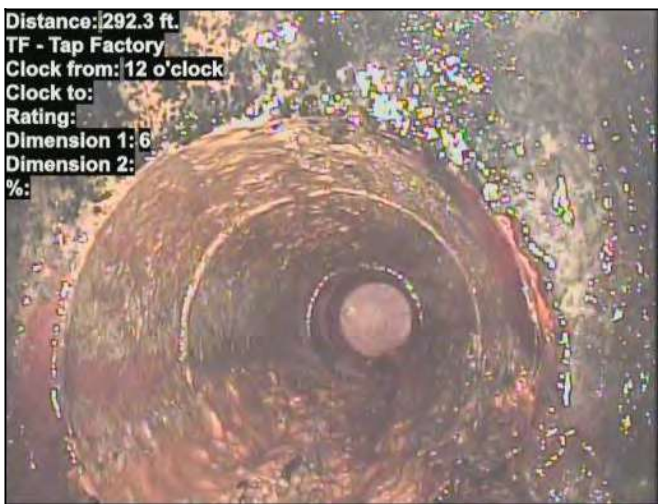
Photo: MH 1-18-MH 1-17-20220830-100725.JPG  
At: 292.3 ft. 12/. TF - Tap Factory  
Joint: No

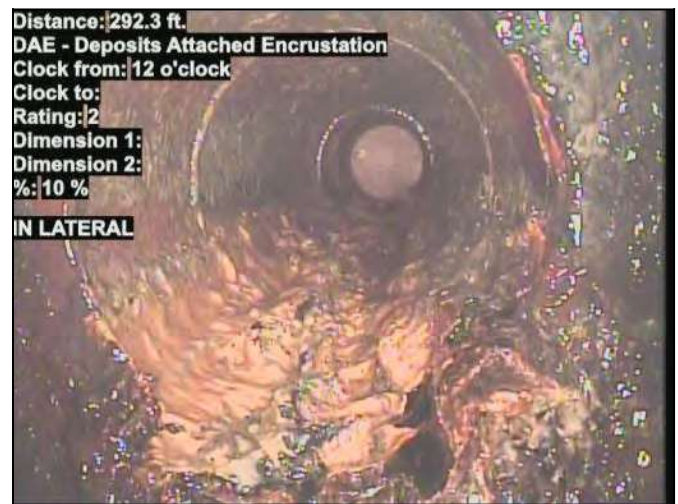
Photo: MH 1-18-MH 1-17-20220830-100737.JPG  
At: 292.3 ft. 12/. DAE - Deposits Attached Encrustation  
Joint: No 10 % IN LATERAL

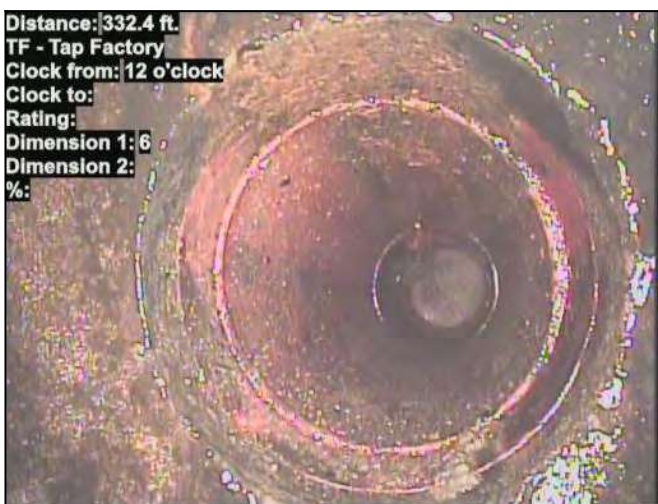
Photo: MH 1-18-MH 1-17-20220830-101055.JPG  
At: 332.4 ft. 12/. TF - Tap Factory  
Joint: No

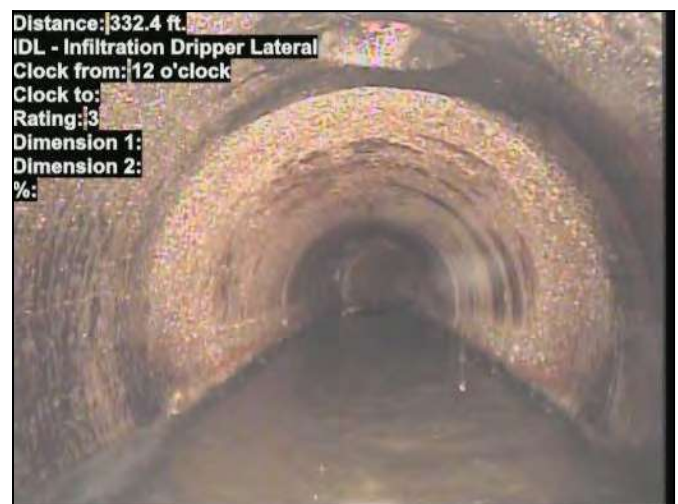
Photo: MH 1-18-MH 1-17-20220830-101132.JPG  
At: 332.4 ft. 12/. IDL - Infiltration Dripper Lateral  
Joint: Yes

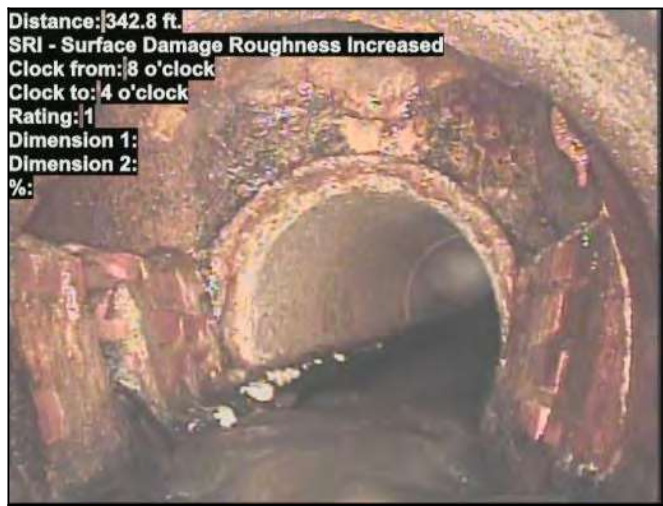
Photo: MH 1-18-MH 1-17-20220830-101206.JPG  
 At: 342.8 ft. 8/4 SRI - Surface Damage Roughness Increased  
 Joint: Yes

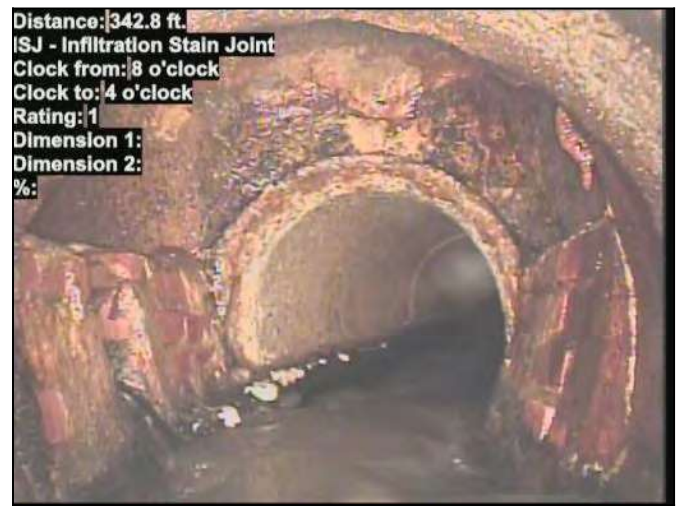
Photo: MH 1-18-MH 1-17-20220830-101217.JPG  
 At: 342.8 ft. 8/4 ISJ - Infiltration Stain Joint  
 Joint: Yes

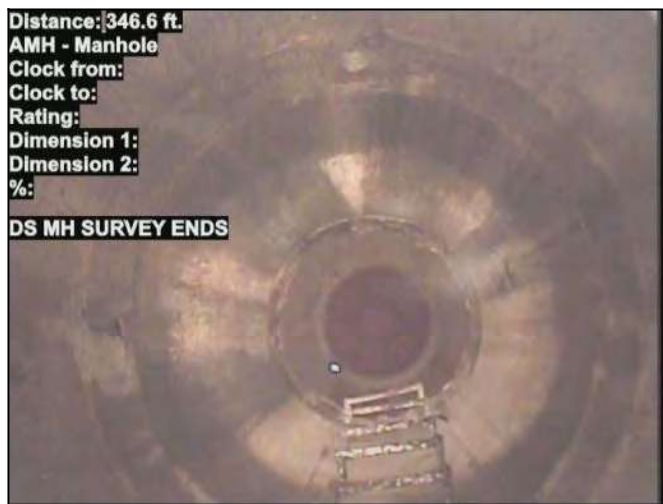
Photo: MH 1-18-MH 1-17-20220830-101248.JPG  
 At: 346.6 ft. AMH - Manhole  
 Joint: No DS MH SURVEY ENDS

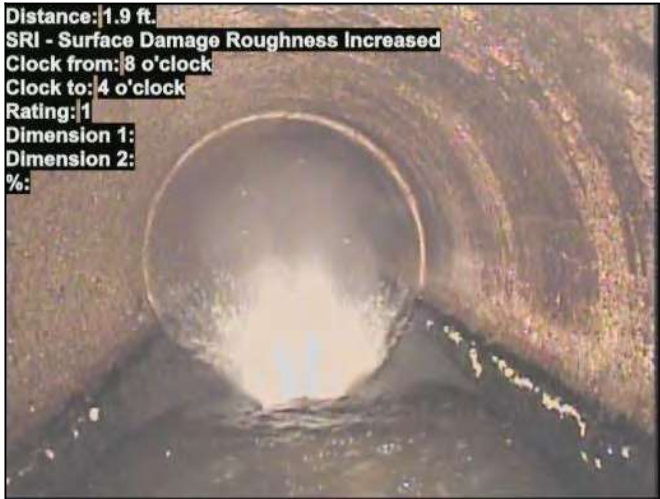
Photo: MH 1-17-MH 1-16-20220830-101532.JPG  
At: 1.9 ft. 8/4 SRI - Surface Damage Roughness Increased  
Joint: Yes

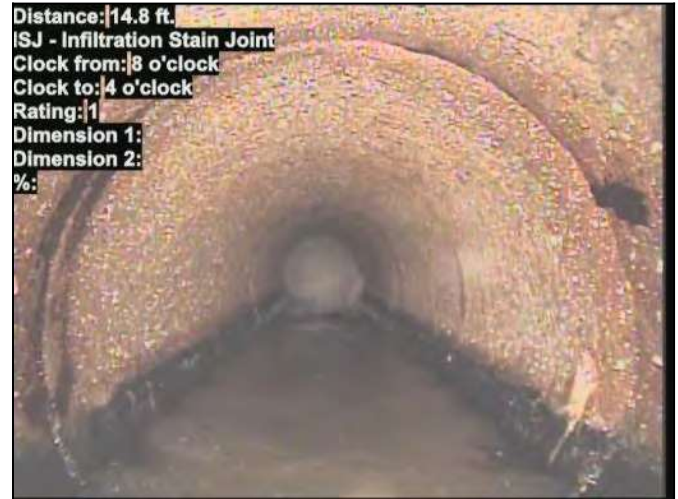
Photo: MH 1-17-MH 1-16-20220830-101640.JPG  
At: 14.8 ft. 8/4 ISJ - Infiltration Stain Joint  
Joint: Yes

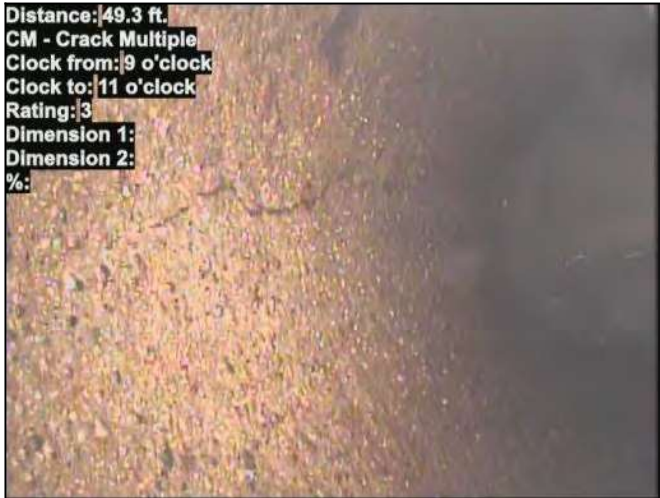
Photo: MH 1-17-MH 1-16-20220830-102008\_1.JPG  
At: 49.3 ft. 9/11 CM - Crack Multiple  
Joint: Yes

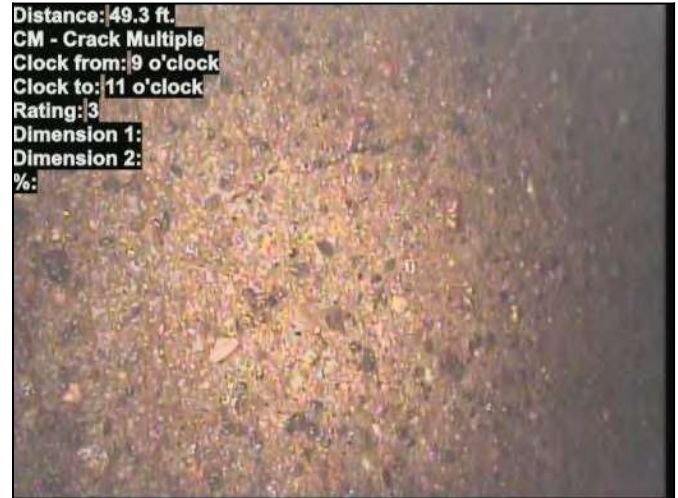
Photo: MH 1-17-MH 1-16-20220830-102008.JPG  
At: 49.3 ft. 9/11 CM - Crack Multiple  
Joint: Yes

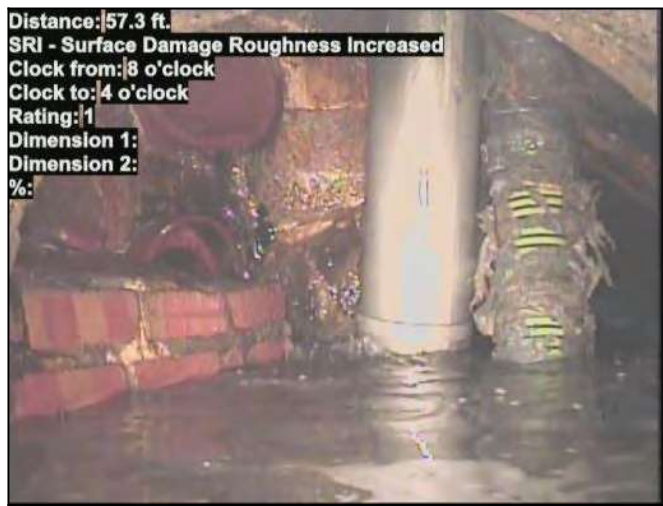
Photo: MH 1-17-MH 1-16-20220830-102142.JPG  
 At: 57.3 ft. 8/4 SRI - Surface Damage Roughness Increased  
 Joint: Yes

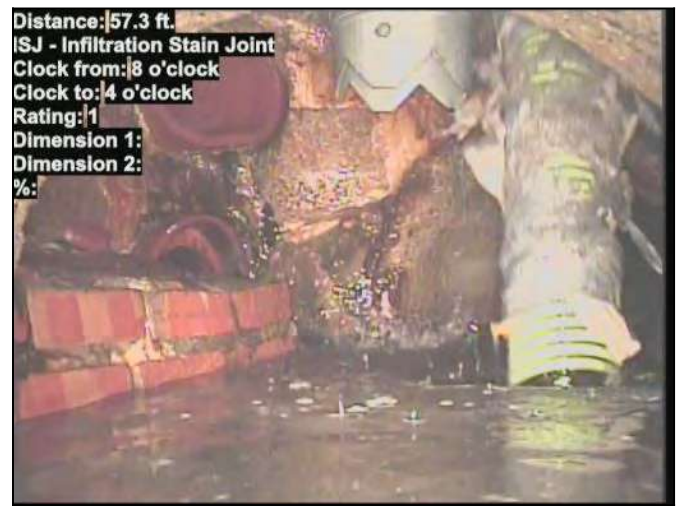
Photo: MH 1-17-MH 1-16-20220830-102155.JPG  
 At: 57.3 ft. 8/4 ISJ - Infiltration Stain Joint  
 Joint: Yes

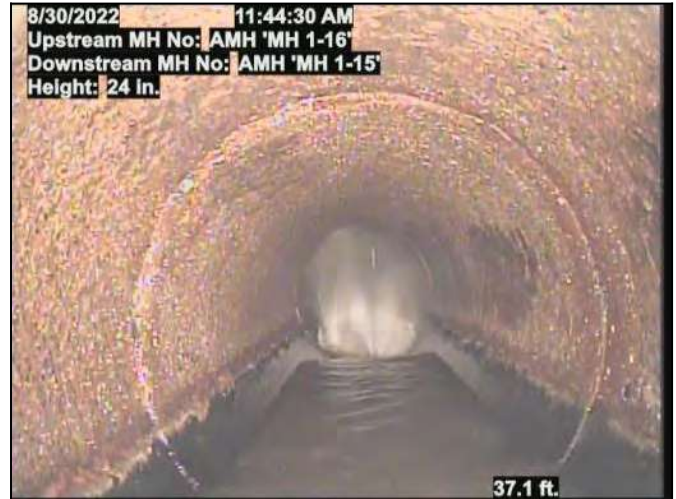
Photo: MH 1-16-MH 1-15-20220830-114258\_2.JPG  
At: 8.4 ft. 8/4 ISJ - Infiltration Stain Joint  
Joint: Yes

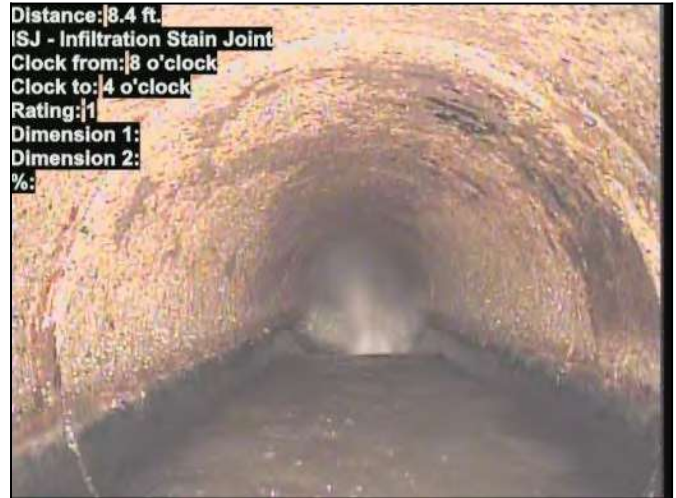
Photo: MH 1-16-MH 1-15-20220830-114258\_1.JPG  
At: 8.4 ft. 8/4 ISJ - Infiltration Stain Joint  
Joint: Yes

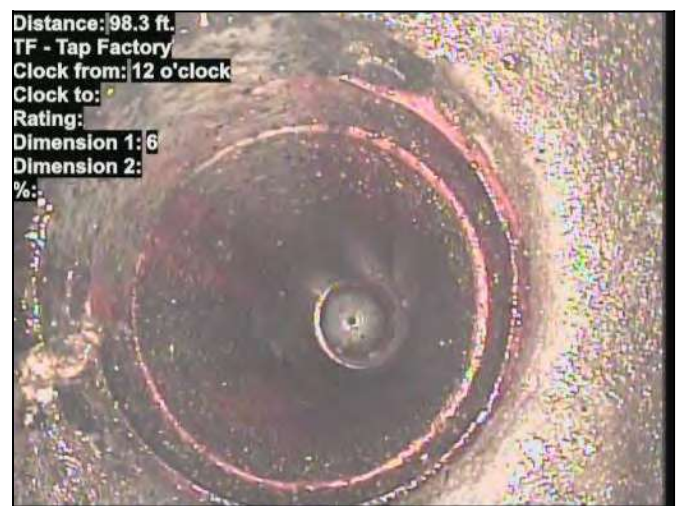
Photo: MH 1-16-MH 1-15-20220830-114831\_1.JPG  
 At: 98.3 ft. 12/. TF - Tap Factory  
 Joint: No

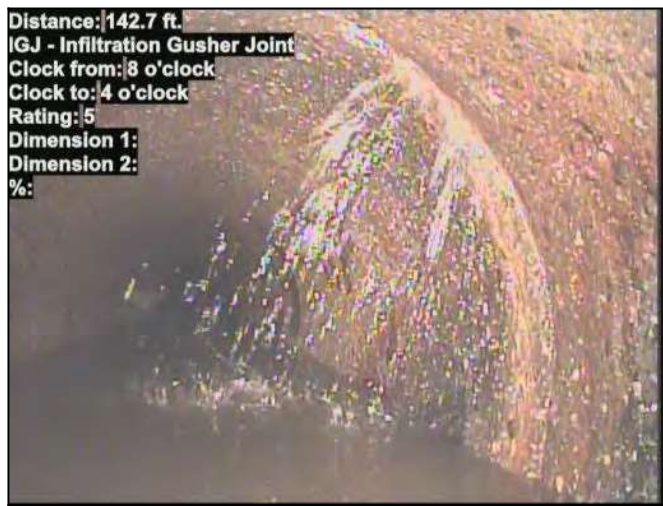
Photo: MH 1-16-MH 1-15-20220830-115110\_1.JPG  
 At: 142.7 ft. 8/4 IGJ - Infiltration Gusher Joint  
 Joint: Yes

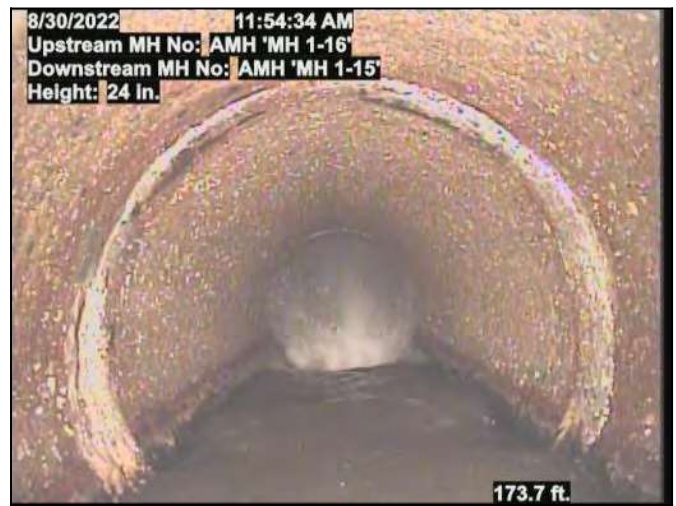
Distance: 142.7 ft.  
IGJ - Infiltration Gusher Joint  
Clock from: 8 o'clock  
Clock to: 4 o'clock  
Rating: 5  
Dimension 1:  
Dimension 2:  
%:  
Photo: MH 1-16-MH 1-15-20220830-115110.JPG  
At: 142.7 ft. 8/4 IGJ - Infiltration Gusher Joint  
Joint: Yes

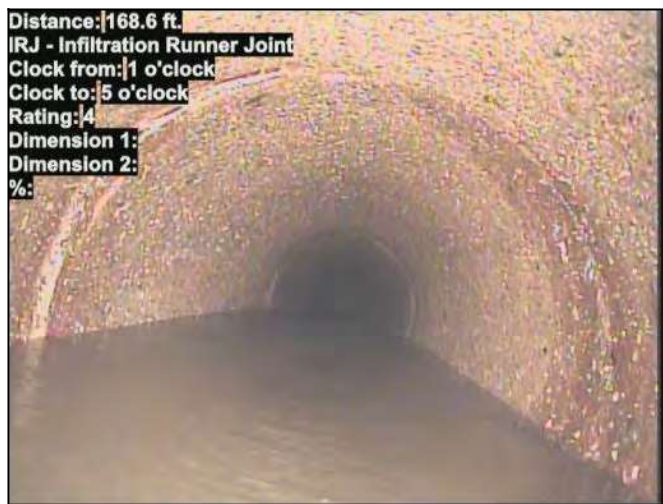
8/30/2022 11:54:34 AM  
Upstream MH No: AMH 'MH 1-16'  
Downstream MH No: AMH 'MH 1-15'  
Height: 24 In.  
173.7 ft.  
Photo: MH 1-16-MH 1-15-20220830-115308\_1.JPG  
At: 168.6 ft. 1/5 IRJ - Infiltration Runner Joint  
Joint: Yes

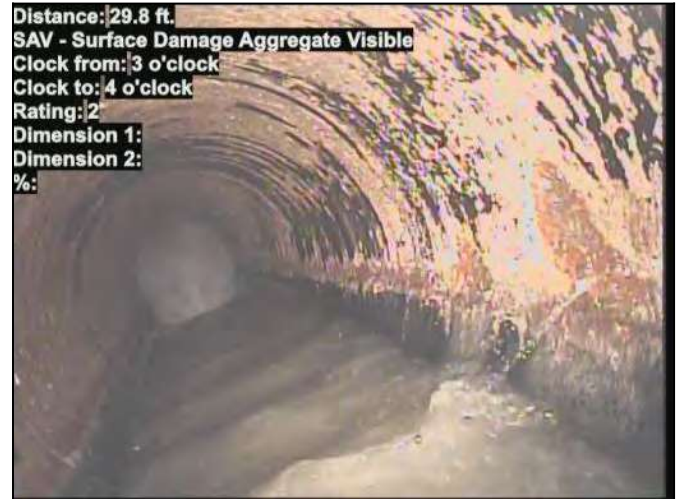
Photo: MH 1-15-MH 1-14-20220830-130845.JPG  
At: 29.8 ft. 3/4 SAV - Surface Damage Aggregate Visible  
Joint: No

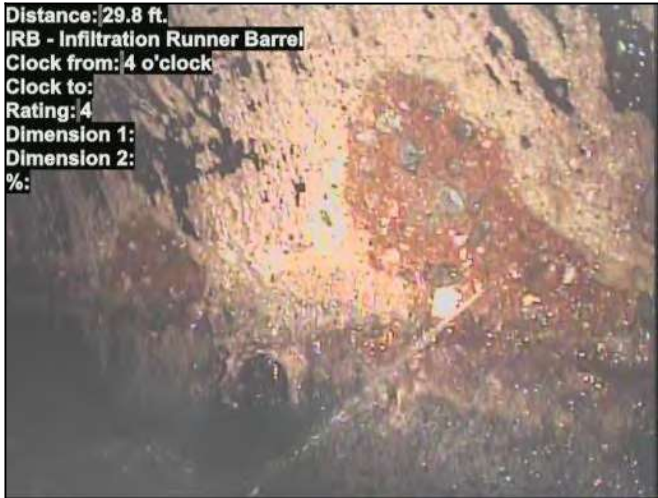
Photo: MH 1-15-MH 1-14-20220830-130903\_1.JPG  
At: 29.8 ft. 4/. IRB - Infiltration Runner Barrel  
Joint: No

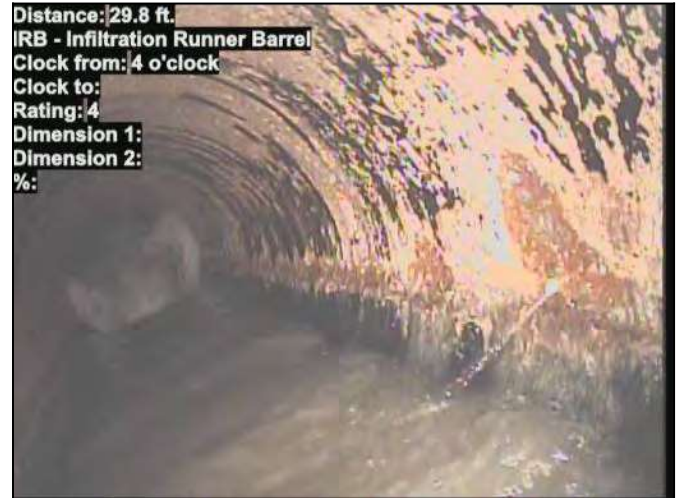
Photo: MH 1-15-MH 1-14-20220830-130903.JPG  
At: 29.8 ft. 4/. IRB - Infiltration Runner Barrel  
Joint: No

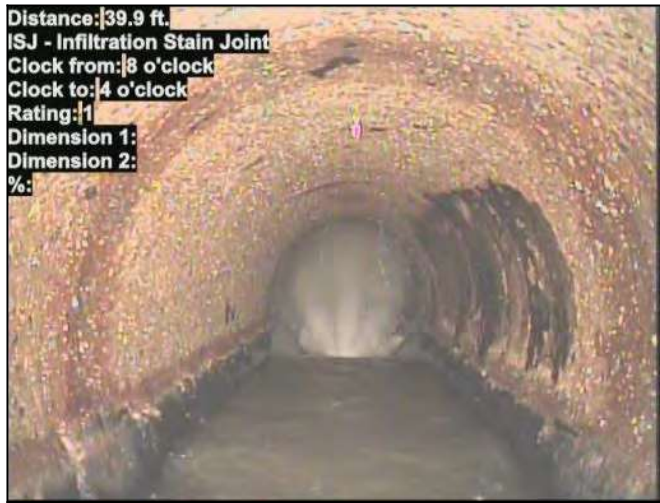
Distance: 39.9 ft.  
ISJ - Infiltration Stain Joint  
Clock from: 8 o'clock  
Clock to: 4 o'clock  
Rating: 1  
Dimension 1:  
Dimension 2:  
%:  
Photo: MH 1-15-MH 1-14-20220830-131049.JPG  
At: 39.9 ft. 8/4 ISJ - Infiltration Stain Joint  
Joint: Yes

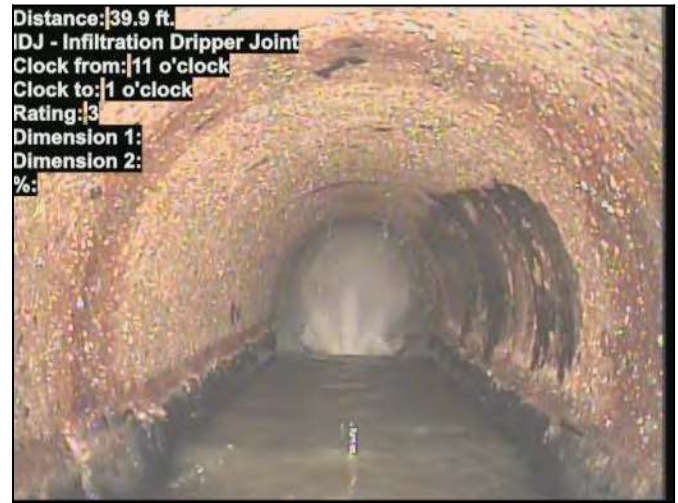
Distance: 39.9 ft.  
IDJ - Infiltration Dripper Joint  
Clock from: 11 o'clock  
Clock to: 1 o'clock  
Rating: 3  
Dimension 1:  
Dimension 2:  
%:  
Photo: MH 1-15-MH 1-14-20220830-131030.JPG  
At: 39.9 ft. 11/1 IDJ - Infiltration Dripper Joint  
Joint: Yes

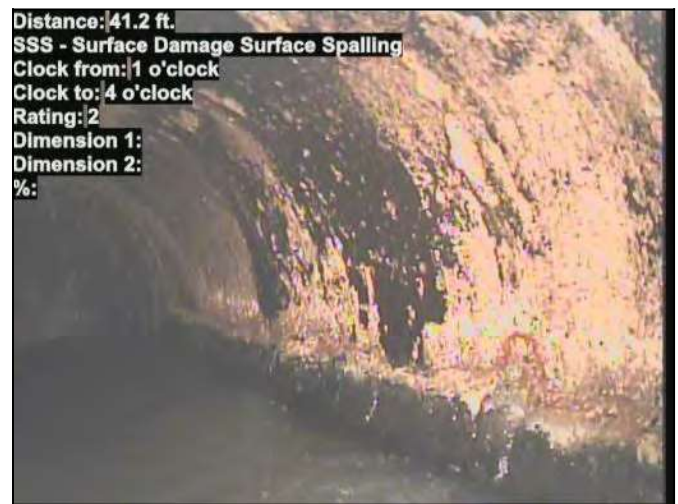
Distance: 41.2 ft.  
SSS - Surface Damage Surface Spalling  
Clock from: 1 o'clock  
Clock to: 4 o'clock  
Rating: 2  
Dimension 1:  
Dimension 2:  
%:  
Photo: MH 1-15-MH 1-14-20220830-131138.JPG  
At: 41.2 ft. 1/4 SSS - Surface Damage Surface Spalling  
Joint: Yes

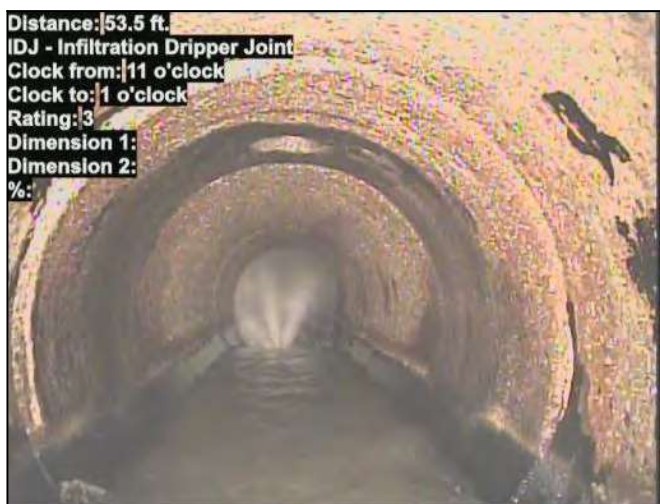
Distance: 53.5 ft.  
IDJ - Infiltration Dripper Joint  
Clock from: 11 o'clock  
Clock to: 1 o'clock  
Rating: 3  
Dimension 1:  
Dimension 2:  
%:  
Photo: MH 1-15-MH 1-14-20220830-131344.JPG  
At: 53.5 ft. 11/1 IDJ - Infiltration Dripper Joint  
Joint: Yes

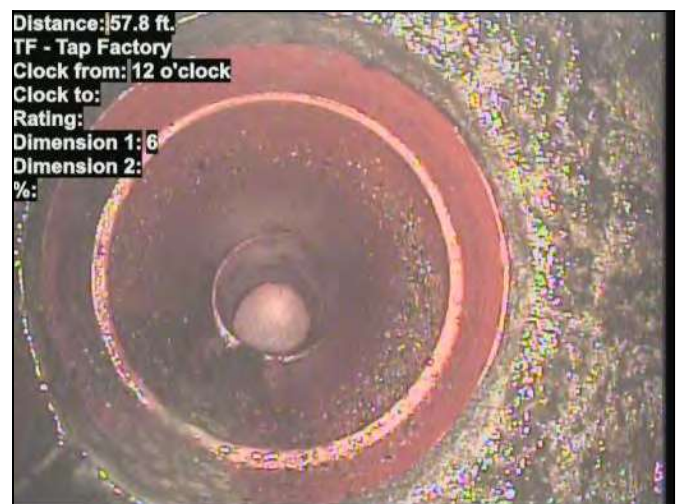
Distance: 57.8 ft.  
TF - Tap Factory  
Clock from: 12 o'clock  
Clock to:  
Rating:  
Dimension 1: 6  
Dimension 2:  
%:  
Photo: MH 1-15-MH 1-14-20220830-131405.JPG  
At: 57.8 ft. 12/ TF - Tap Factory  
Joint: No

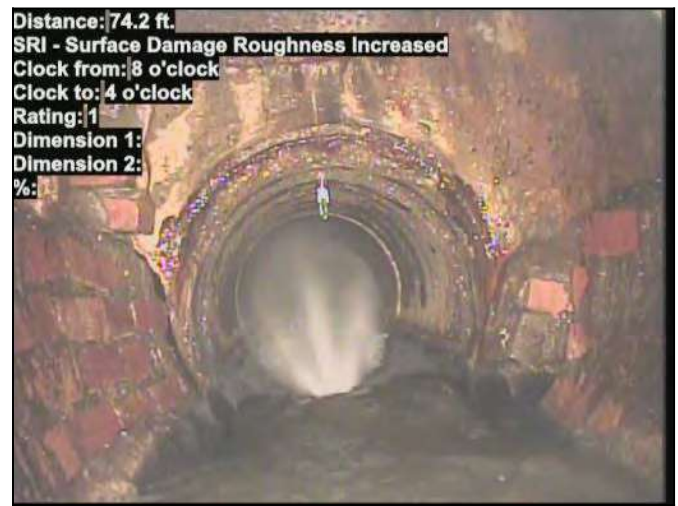
Photo: MH 1-15-MH 1-14-20220830-132738.JPG  
At: 74.2 ft. 8/4 SRI - Surface Damage Roughness Increased  
Joint: Yes

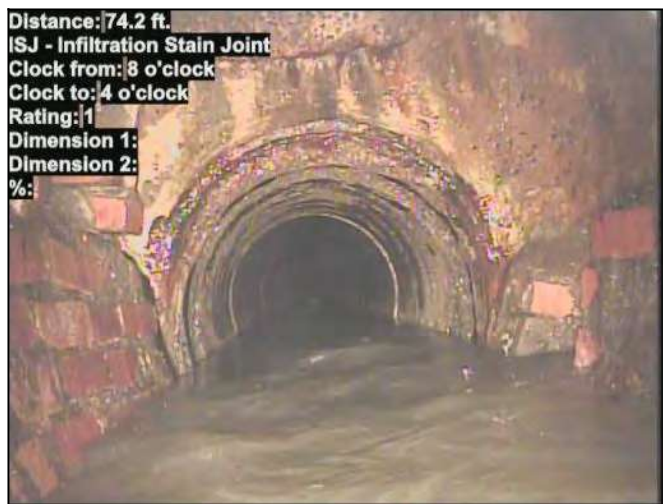
Photo: MH 1-15-MH 1-14-20220830-132749.JPG  
At: 74.2 ft. 8/4 ISJ - Infiltration Stain Joint  
Joint: Yes

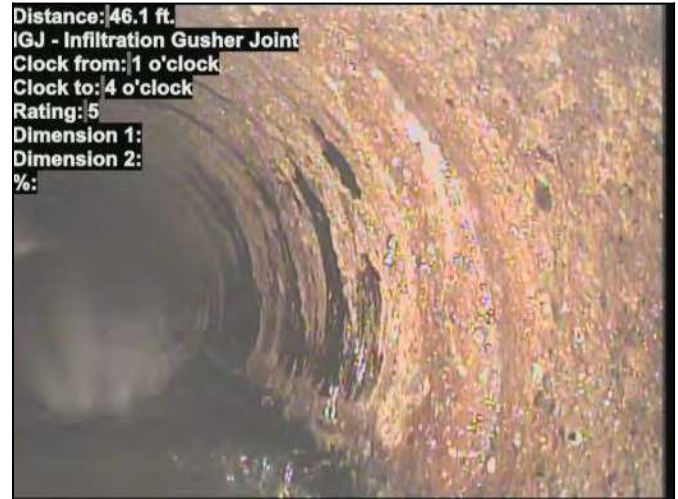
Photo: MH 1-14-MH 1-13-20220830-134653.JPG

At: 46.1 ft. 1/4 IGJ - Infiltration Gusher Joint
