## Appendix A

### Mystic Area CCTV Inspection Logs

## NWMCC INSPECTION REPORT

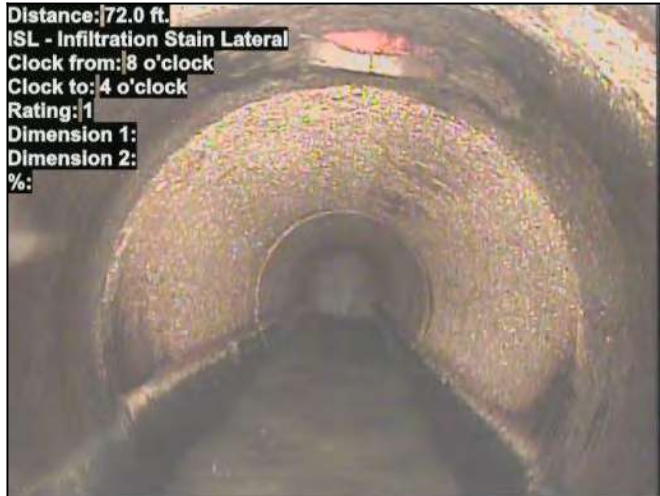
Photo: MH 1-14-MH 1-13-20220830-134905.JPG

At: 72 ft. 8/4 ISL - Infiltration Stain Lateral

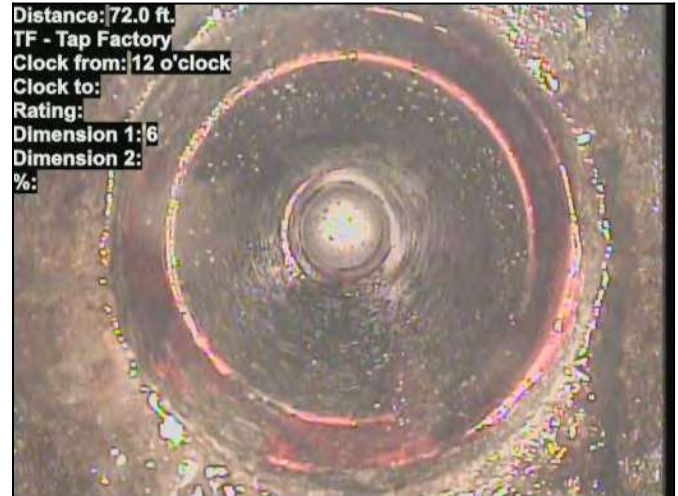
Photo: MH 1-14-MH 1-13-20220830-134853.JPG

At: 72 ft. 12/ TF - Tap Factory

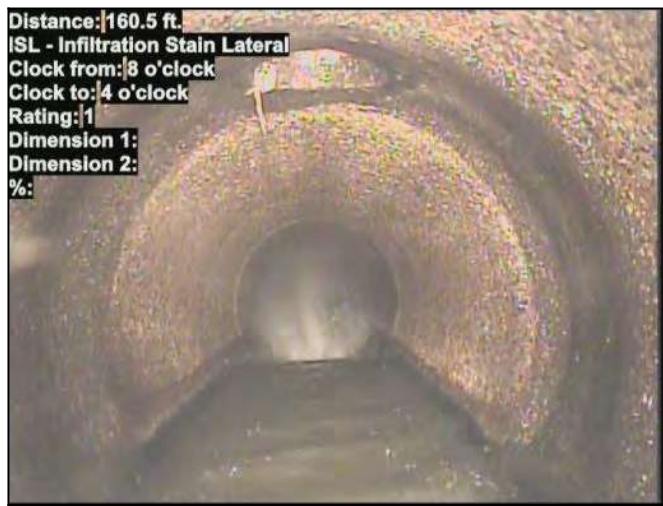
Photo: MH 1-14-MH 1-13-20220830-141346.JPG  
 At: 160.5 ft. 8/4 ISL - Infiltration Stain Lateral  
 Joint: Yes

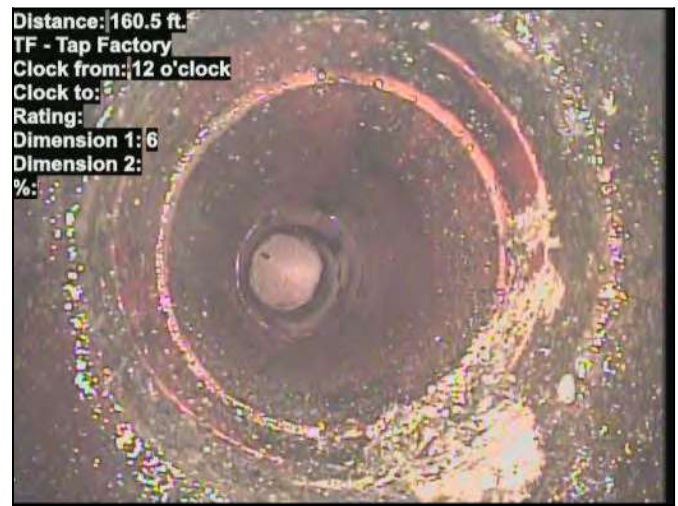
Photo: MH 1-14-MH 1-13-20220830-141334.JPG  
 At: 160.5 ft. 12/. TF - Tap Factory  
 Joint: No

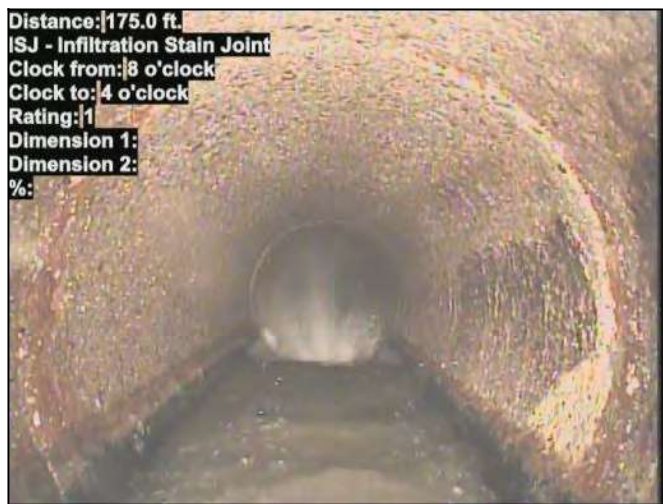
Photo: MH 1-14-MH 1-13-20220830-141448.JPG  
 At: 175 ft. 8/4 ISJ - Infiltration Stain Joint  
 Joint: Yes

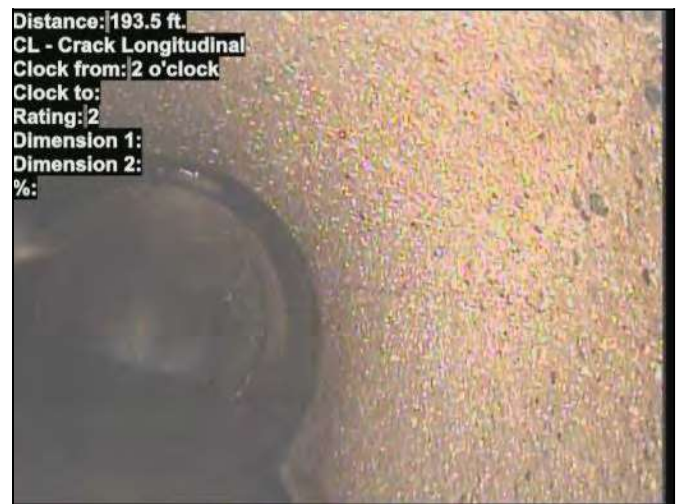
Photo: MH 1-14-MH 1-13-20220830-141615.JPG  
 At: 193.5 ft. 2/. CL - Crack Longitudinal  
 Joint: Yes

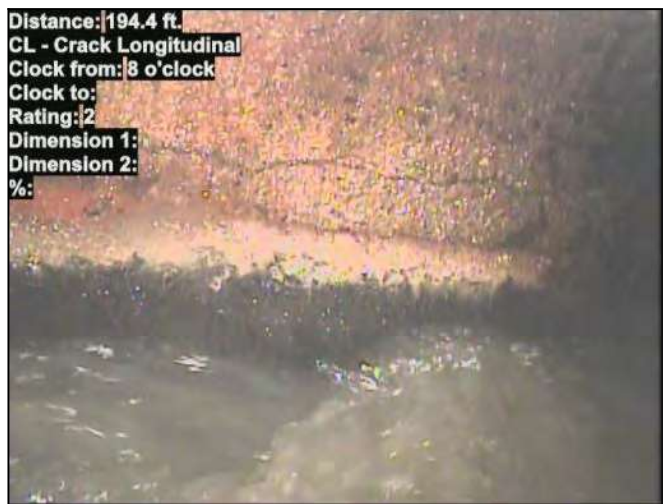
Photo: MH 1-14-MH 1-13-20220830-141641.JPG  
 At: 194.4 ft. 8/. CL - Crack Longitudinal  
 Joint: Yes

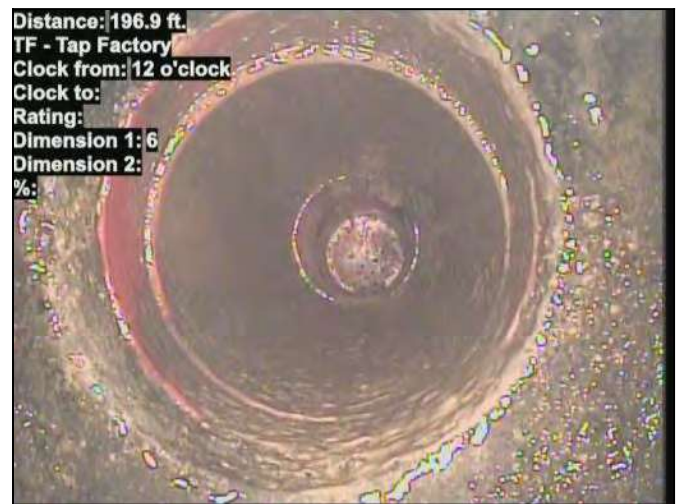
Photo: MH 1-14-MH 1-13-20220830-141708.JPG  
 At: 196.9 ft. 12/. TF - Tap Factory  
 Joint: No

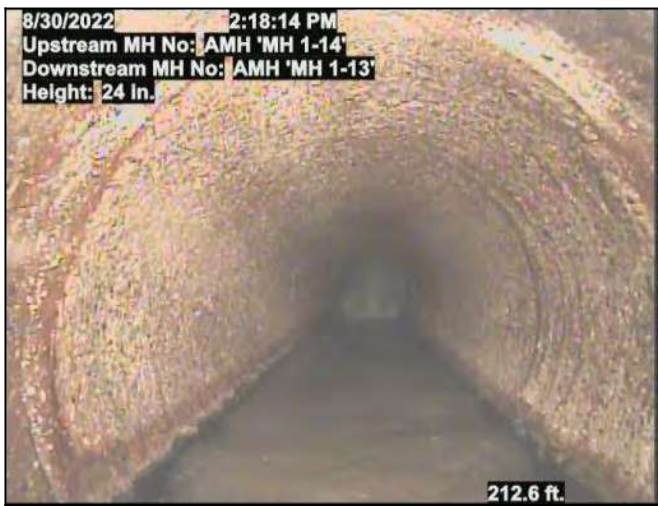
Photo: MH 1-14-MH 1-13-20220830-141729\_1.JPG  
 At: 198.6 ft. 1/4 IRJ - Infiltration Runner Joint  
 Joint: Yes

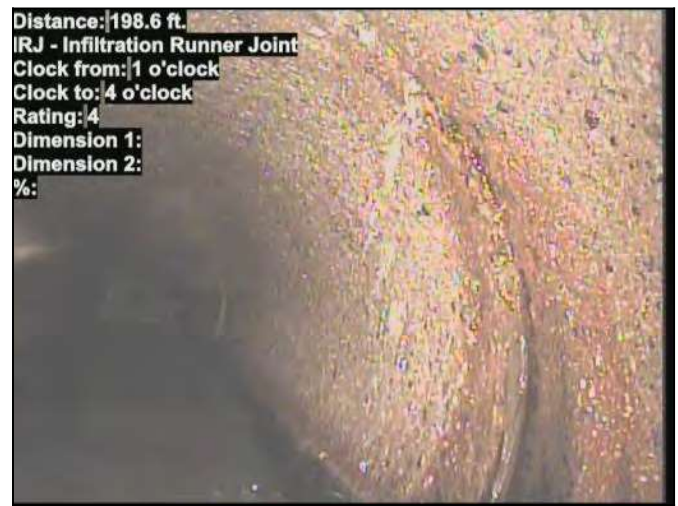
Photo: MH 1-14-MH 1-13-20220830-141729.JPG  
 At: 198.6 ft. 1/4 IRJ - Infiltration Runner Joint  
 Joint: Yes

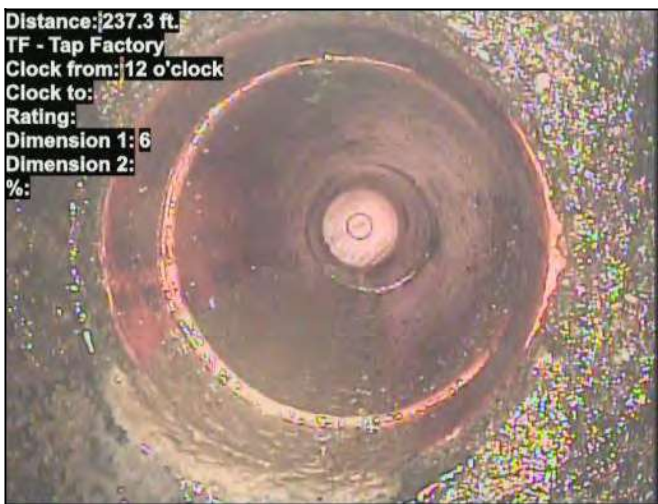
Photo: MH 1-14-MH 1-13-20220830-141907.JPG  
 At: 237.3 ft. 12/ TF - Tap Factory  
 Joint: No

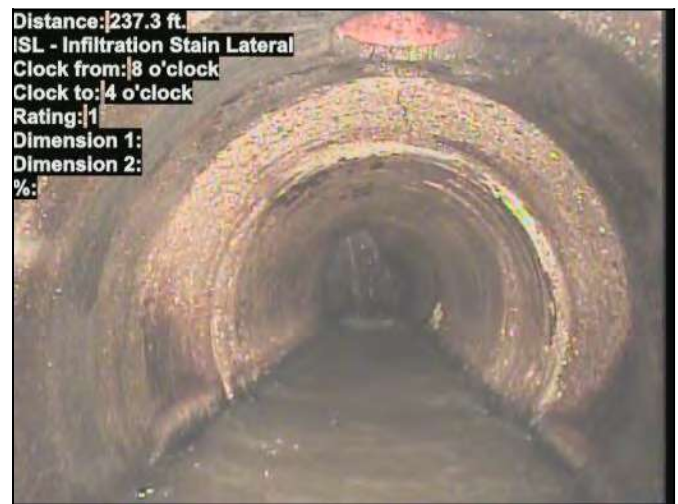
Photo: MH 1-14-MH 1-13-20220830-141925.JPG  
 At: 237.3 ft. 8/4 ISL - Infiltration Stain Lateral  
 Joint: Yes

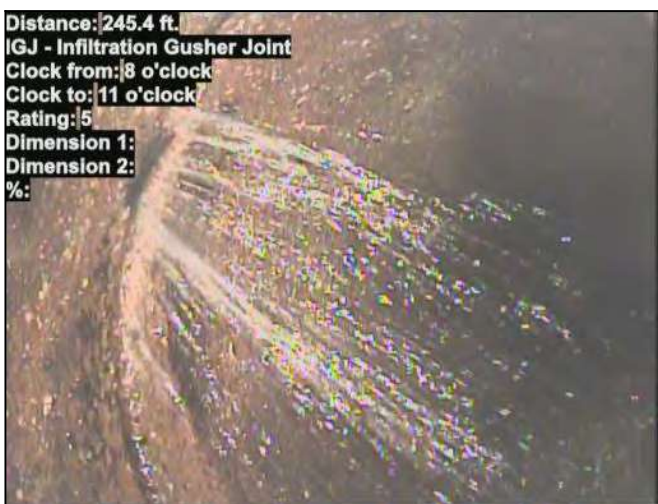
Photo: MH 1-14-MH 1-13-20220830-142029.JPG  
 At: 245.4 ft. IGJ - Infiltration Gusher Joint  
 8/11  
 Joint: Yes

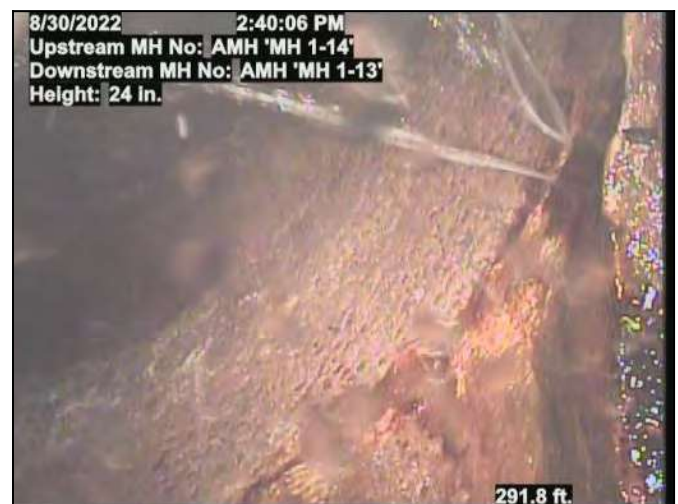
Photo: MH 1-14-MH 1-13-20220830-142321\_1.JPG  
 At: 288.2 ft. 8/4 ISJ - Infiltration Stain Joint  
 Joint: Yes

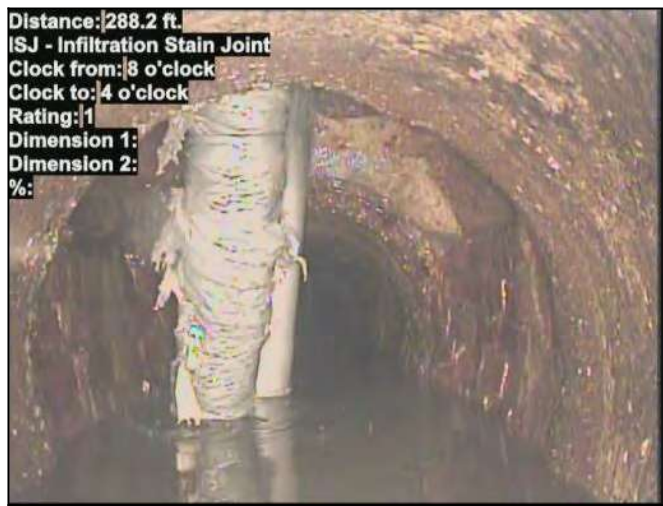
Photo: MH 1-14-MH 1-13-20220830-142321.JPG  
 At: 288.2 ft. 8/4 ISJ - Infiltration Stain Joint  
 Joint: Yes

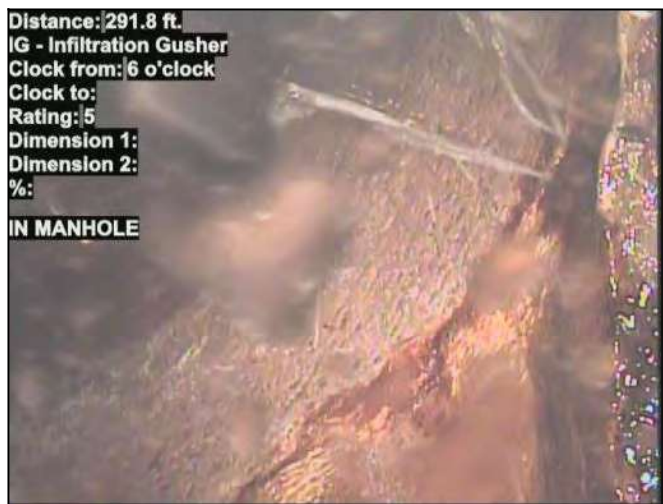
Photo: MH 1-14-MH 1-13-20220830-144008.JPG  
 At: 291.8 ft. 6/. IG - Infiltration Gusher  
 Joint: No IN MANHOLE

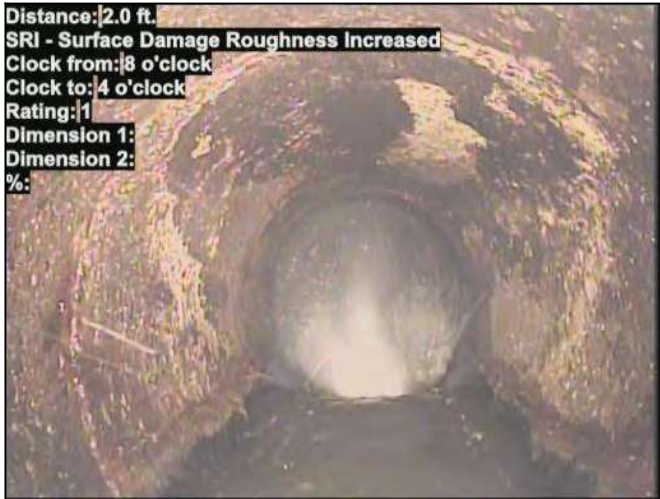
Photo: MH 1-13-MH 1-12-20220830-152236.JPG  
At: 2 ft. 8/4 SRI - Surface Damage Roughness Increased  
Joint: Yes

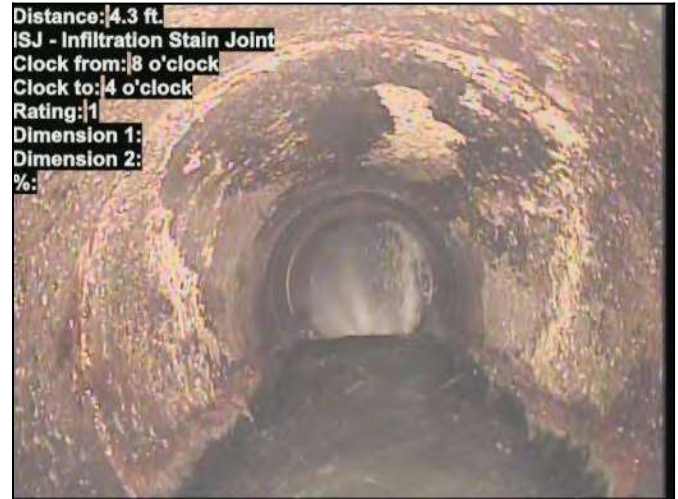
Photo: MH 1-13-MH 1-12-20220830-152318.JPG  
At: 4.3 ft. 8/4 ISJ - Infiltration Stain Joint  
Joint: Yes

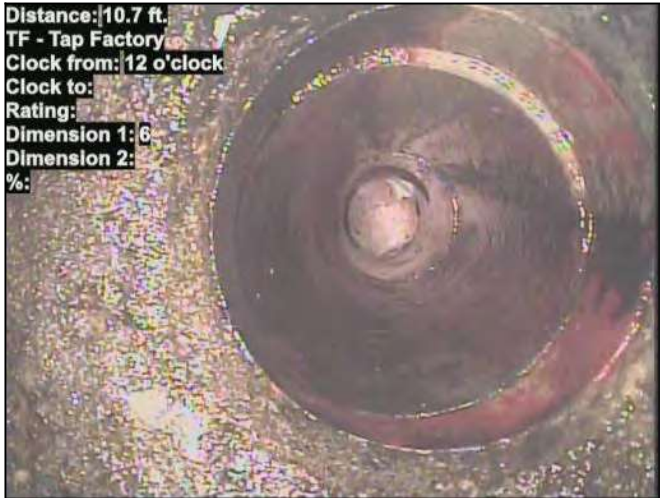
Photo: MH 1-13-MH 1-12-20220830-152401.JPG  
At: 10.7 ft. 12/. TF - Tap Factory  
Joint: No

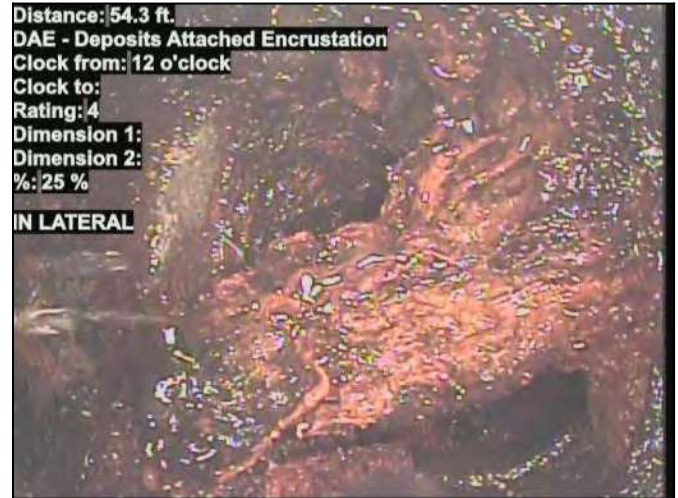
Photo: MH 1-13-MH 1-12-20220830-152609.JPG  
At: 54.3 ft. 12/. DAE - Deposits Attached Encrustation  
Joint: No 25 % IN LATERAL

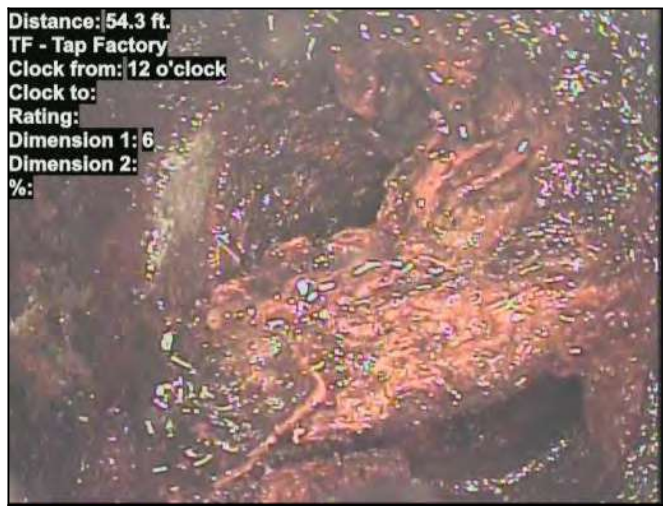
Photo: MH 1-13-MH 1-12-20220830-152604.JPG

At: 54.3 ft. 12/. TF - Tap Factory

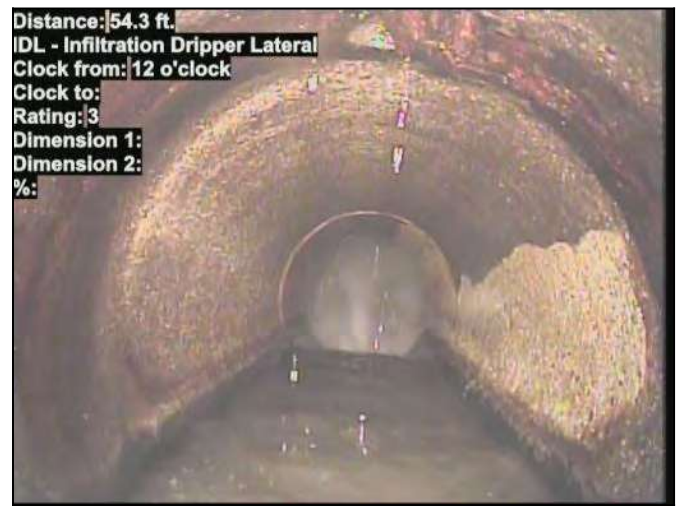
Photo: MH 1-13-MH 1-12-20220830-152642\_1.JPG

At: 54.3 ft. 12/. IDL - Infiltration Dripper Lateral

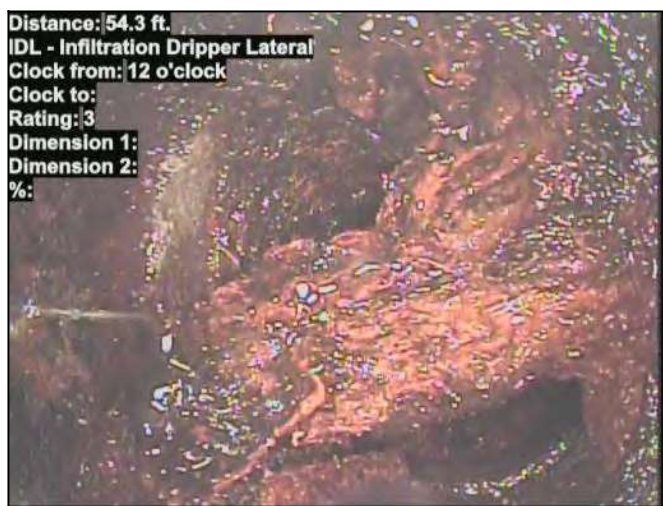
Photo: MH 1-13-MH 1-12-20220830-152642.JPG

At: 54.3 ft. 12/. IDL - Infiltration Dripper Lateral

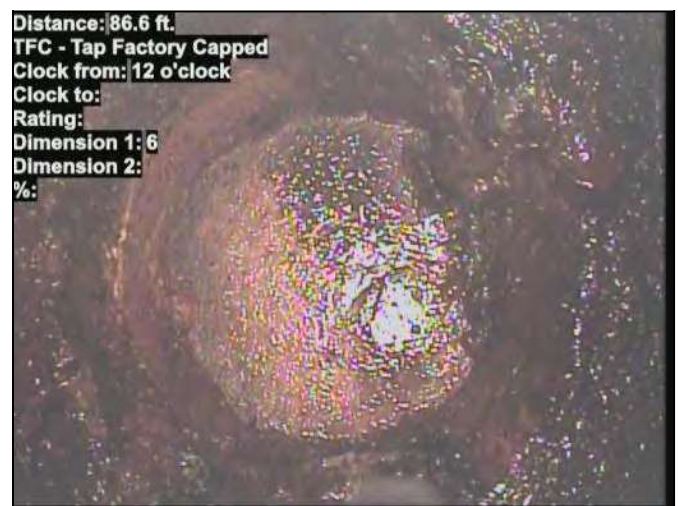
Photo: MH 1-13-MH 1-12-20220830-152858.JPG

At: 86.6 ft. 12/. TFC - Tap Factory Capped

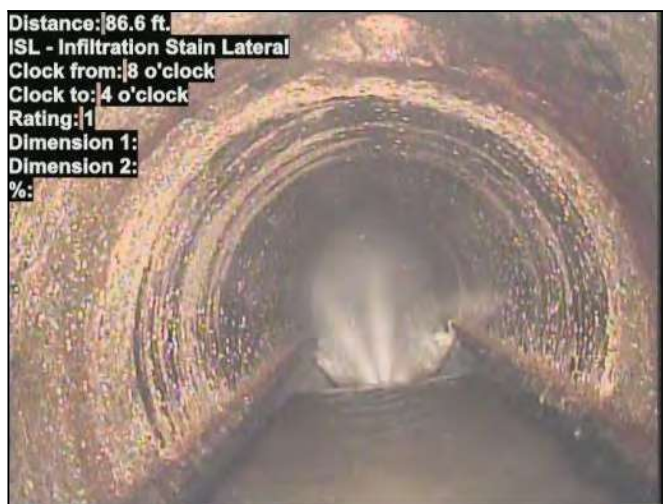
Photo: MH 1-13-MH 1-12-20220830-152927.JPG

At: 86.6 ft. 8/4 ISL - Infiltration Stain Lateral

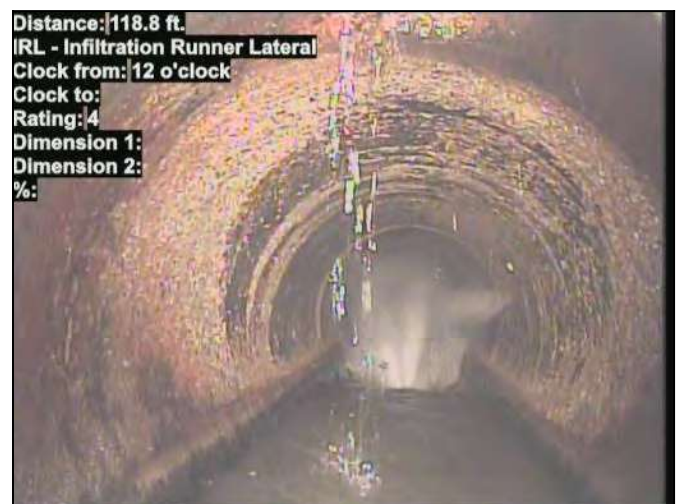
Photo: MH 1-13-MH 1-12-20220830-154213.JPG

At: 118.8 ft. 12/. IRL - Infiltration Runner Lateral

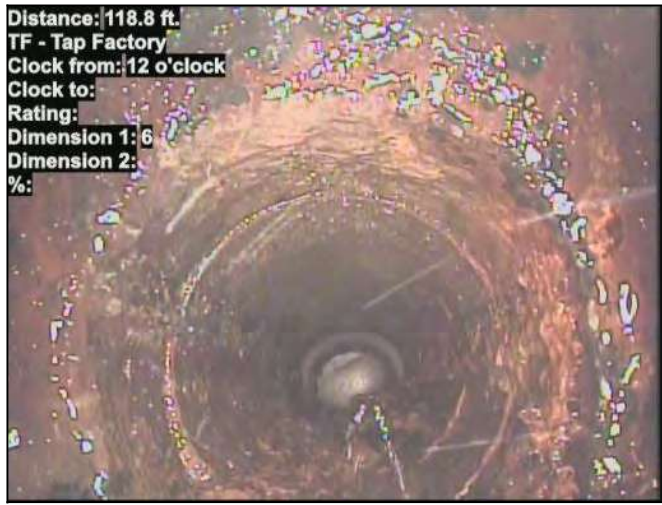
Photo: MH 1-13-MH 1-12-20220830-154158.JPG

At: 118.8 ft. 12/. TF - Tap Factory

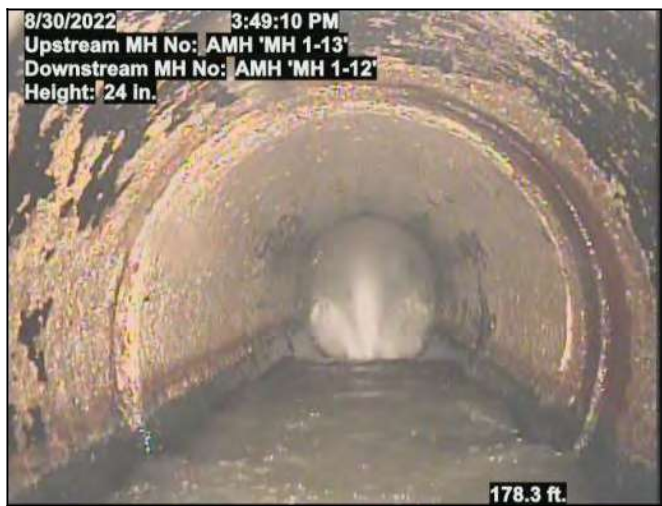
Photo: MH 1-13-MH 1-12-20220830-154500\_1.JPG

At: 167.4 ft. 12/. IDL - Infiltration Dripper Lateral

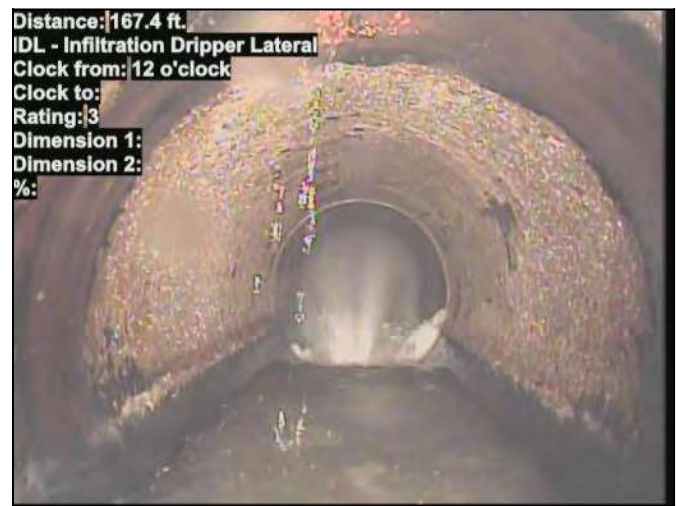
Photo: MH 1-13-MH 1-12-20220830-154500.JPG

At: 167.4 ft. 12/. IDL - Infiltration Dripper Lateral

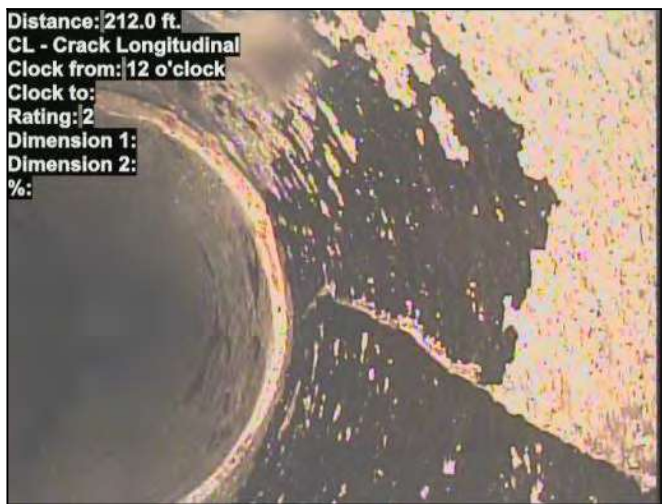
Photo: MH 1-13-MH 1-12-20220830-155115.JPG

At: 212 ft. 12/. CL - Crack Longitudinal

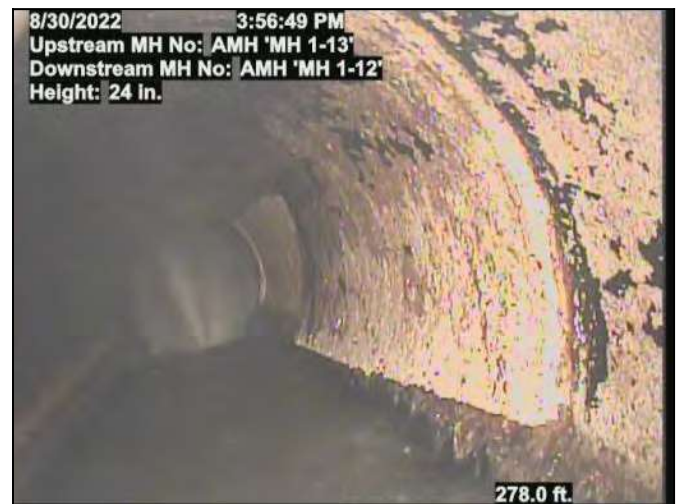
Photo: MH 1-13-MH 1-12-20220830-155235\_1.JPG

At: 231.6 ft. 12/. TF - Tap Factory

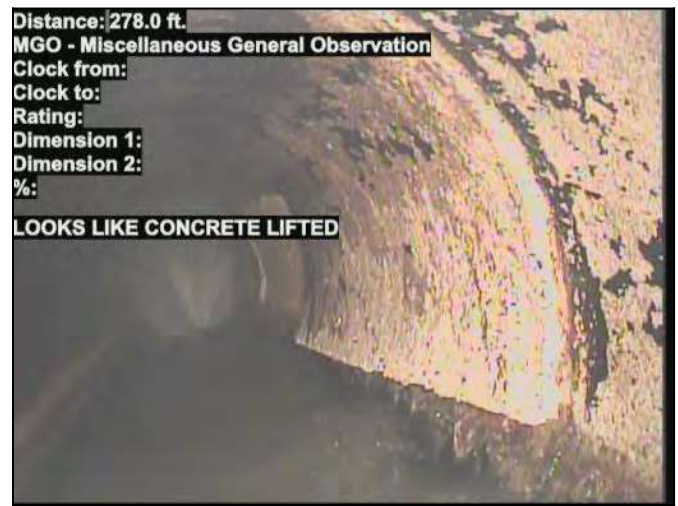
Distance: 278.0 ft.  
MGO - Miscellaneous General Observation  
Clock from:  
Clock to:  
Rating:  
Dimension 1:  
Dimension 2:  
%:  
LOOKS LIKE CONCRETE LIFTED  
Photo: MH 1-13-MH 1-12-20220830-155650.JPG  
At: 278 ft. MGO - Miscellaneous General Observation  
Joint: No LOOKS LIKE CONCRETE LIFTED

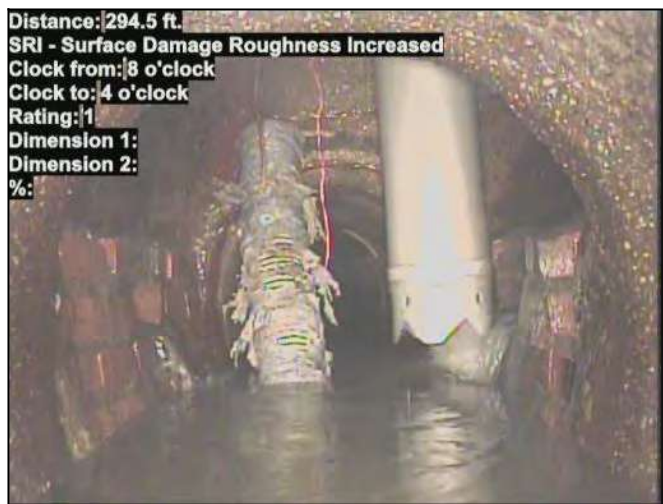
Distance: 294.5 ft.  
SRI - Surface Damage Roughness Increased  
Clock from: 8 o'clock  
Clock to: 4 o'clock  
Rating: 1  
Dimension 1:  
Dimension 2:  
%:  
Photo: MH 1-13-MH 1-12-20220830-155949.JPG  
At: 294.5 ft. 8/4 SRI - Surface Damage Roughness Increased  
Joint: Yes

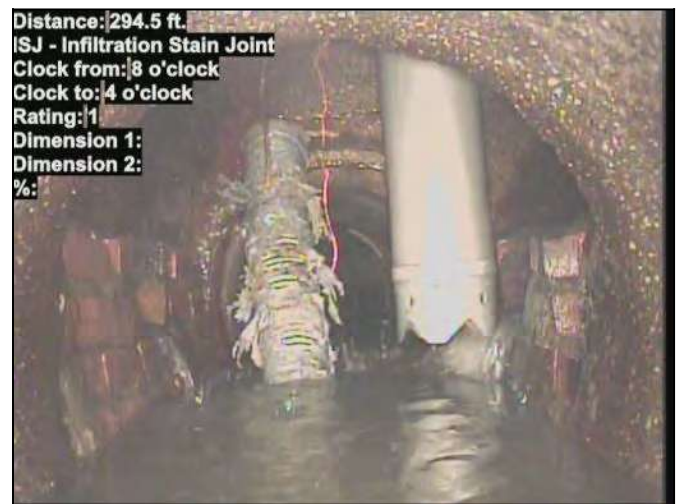
Distance: 294.5 ft.  
ISJ - Infiltration Stain Joint  
Clock from: 8 o'clock  
Clock to: 4 o'clock  
Rating: 1  
Dimension 1:  
Dimension 2:  
%:  
Photo: MH 1-13-MH 1-12-20220830-155935.JPG  
At: 294.5 ft. 8/4 ISJ - Infiltration Stain Joint  
Joint: Yes

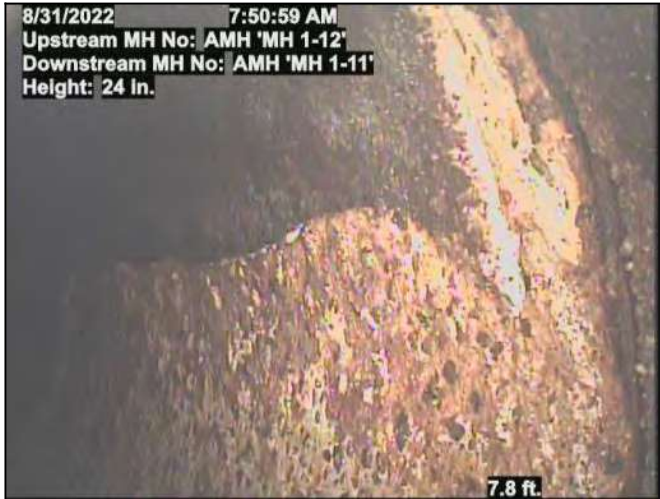
Photo: MH 1-12-MH 1-11-20220831-074235\_2.JPG  
At: 0 ft. 8/4 SSC - Surface Spalling of Damage Coating  
Joint: Yes

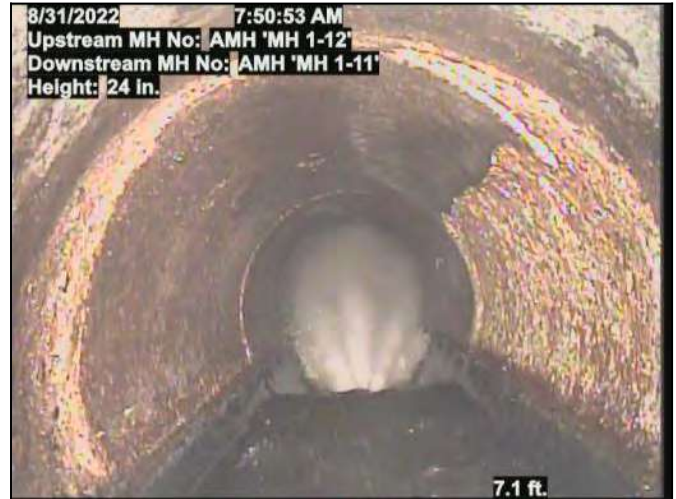
Photo: MH 1-12-MH 1-11-20220831-074235\_1.JPG  
At: 0 ft. 8/4 SSC - Surface Spalling of Damage Coating  
Joint: Yes

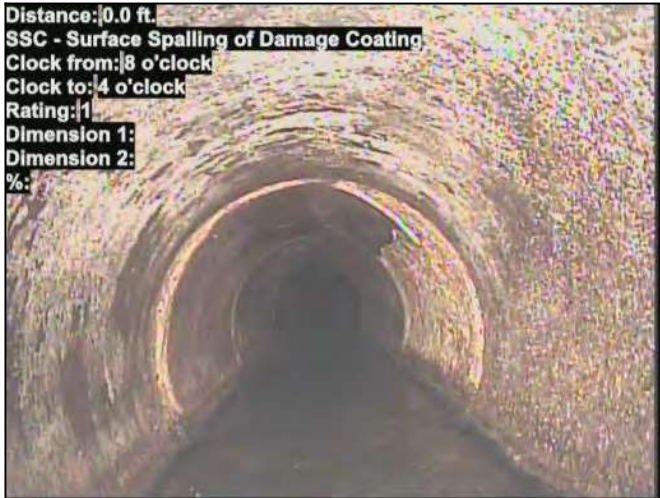
Photo: MH 1-12-MH 1-11-20220831-074235.JPG  
At: 0 ft. 8/4 SSC - Surface Spalling of Damage Coating  
Joint: Yes

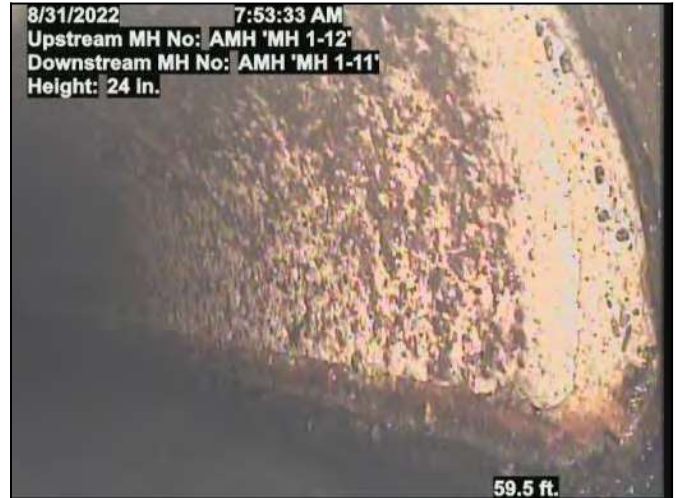
Photo: MH 1-12-MH 1-11-20220831-075257\_1.JPG  
At: 52.1 ft. 3/4 IRJ - Infiltration Runner Joint  
Joint: Yes

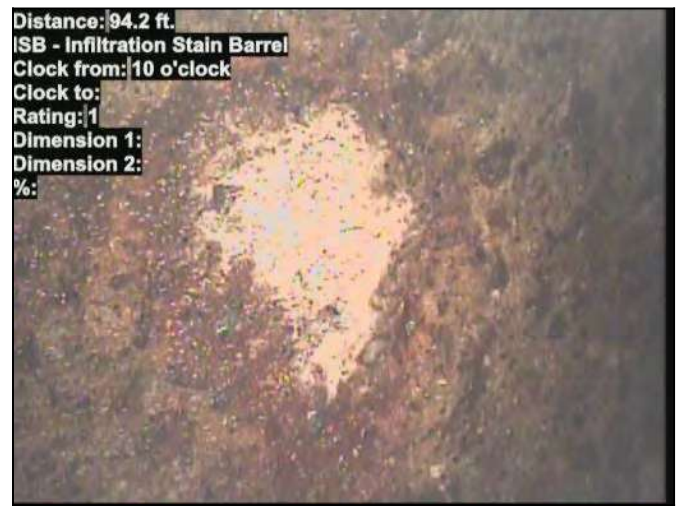
Distance: 94.2 ft.  
ISB - Infiltration Stain Barrel  
Clock from: 10 o'clock  
Clock to:  
Rating: 1  
Dimension 1:  
Dimension 2:  
%:  
Photo: MH 1-12-MH 1-11-20220831-075511.JPG  
At: 94.2 ft. 10/. ISB - Infiltration Stain Barrel  
Joint: No

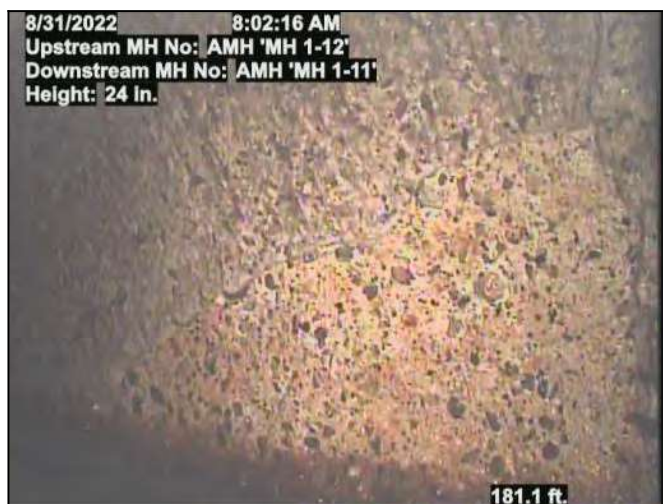
8/31/2022 8:02:16 AM  
Upstream MH No: AMH 'MH 1-12'  
Downstream MH No: AMH 'MH 1-11'  
Height: 24 in.  
181.1 ft.  
Photo: MH 1-12-MH 1-11-20220831-075835\_2.JPG  
At: 132.7 ft. 8/4 ISJ - Infiltration Stain Joint  
Joint: Yes

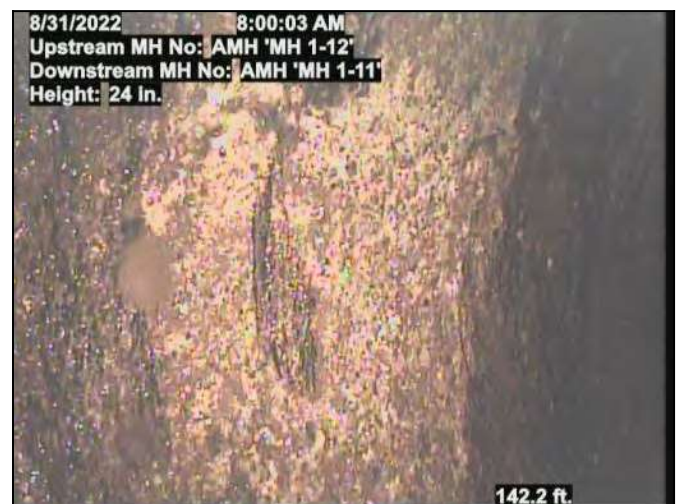
8/31/2022 8:00:03 AM  
Upstream MH No: AMH 'MH 1-12'  
Downstream MH No: AMH 'MH 1-11'  
Height: 24 in.  
142.2 ft.  
Photo: MH 1-12-MH 1-11-20220831-075835\_1.JPG  
At: 132.7 ft. 8/4 ISJ - Infiltration Stain Joint  
Joint: Yes

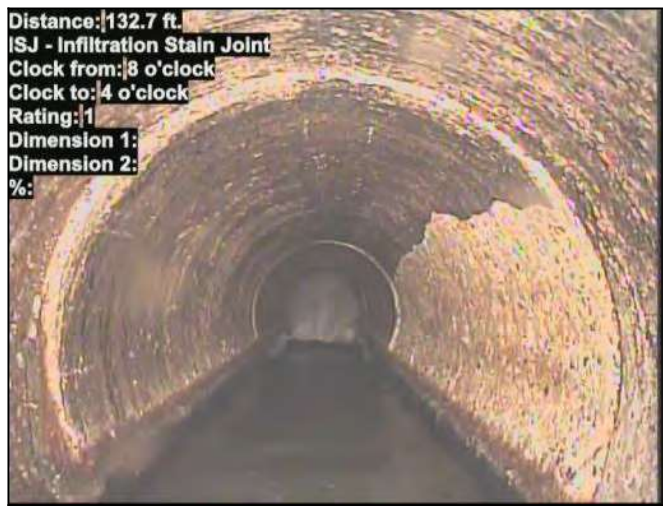
Distance: 132.7 ft.  
ISJ - Infiltration Stain Joint  
Clock from: 8 o'clock  
Clock to: 4 o'clock  
Rating: 1  
Dimension 1:  
Dimension 2:  
%:

Photo: MH 1-12-MH 1-11-20220831-075835.JPG  
At: 132.7 ft. 8/4 ISJ - Infiltration Stain Joint  
Joint: Yes

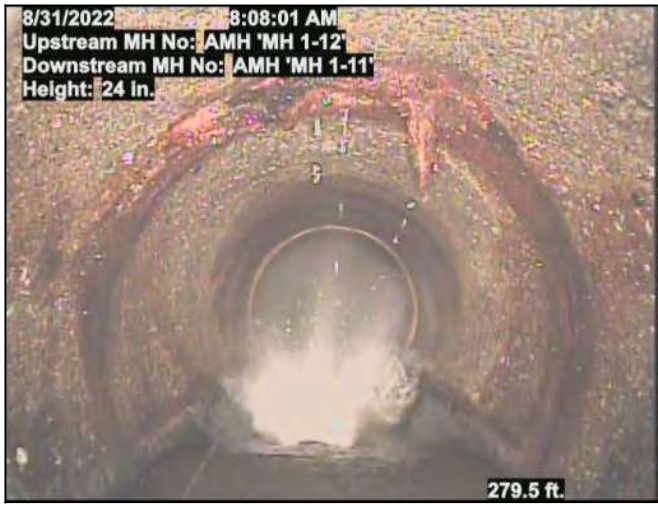
Photo: MH 1-12-MH 1-11-20220831-080715\_1.JPG  
At: 279.5 ft. 12/. DAE - Deposits Attached Encrustation  
Joint: Yes 10 % IN AND OUT OF LATERAL

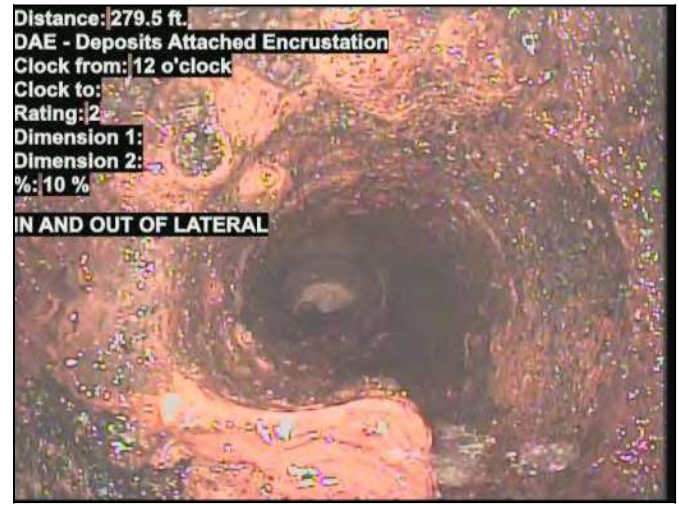
Photo: MH 1-12-MH 1-11-20220831-080715.JPG  
At: 279.5 ft. 12/. DAE - Deposits Attached Encrustation  
Joint: Yes 10 % IN AND OUT OF LATERAL

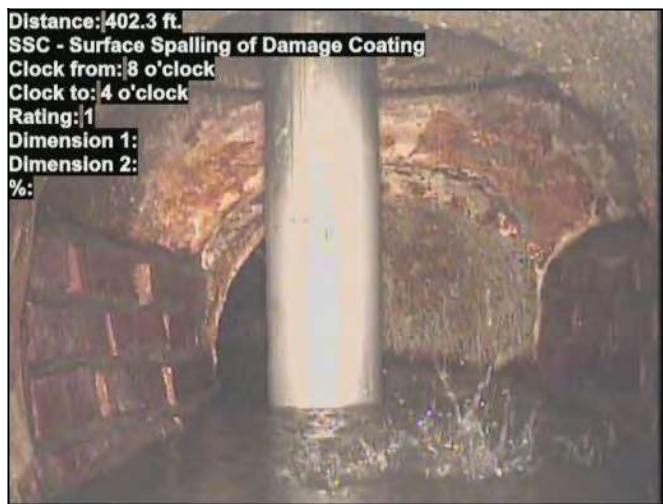
Photo: MH 1-12-MH 1-11-20220831-081944.JPG  
 At: 402.3 ft. 8/4 SSC - Surface Spalling of Damage Coating  
 Joint: Yes

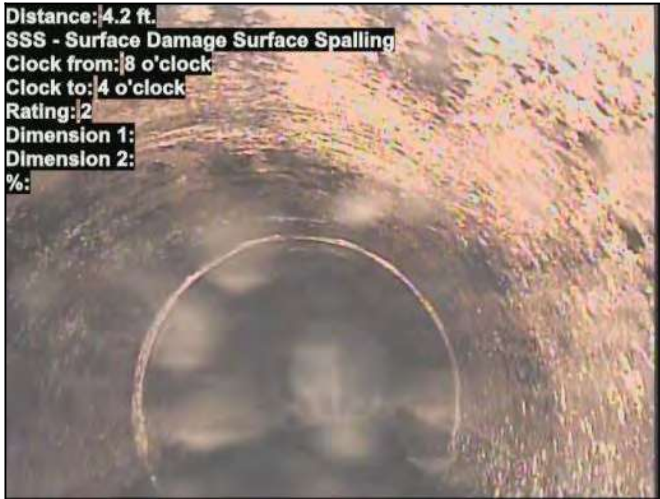
Photo: MH 1-11-MH 1-10-20220831-090839.JPG  
At: 4.2 ft. 8/4 SSS - Surface Damage Surface Spalling  
Joint: Yes

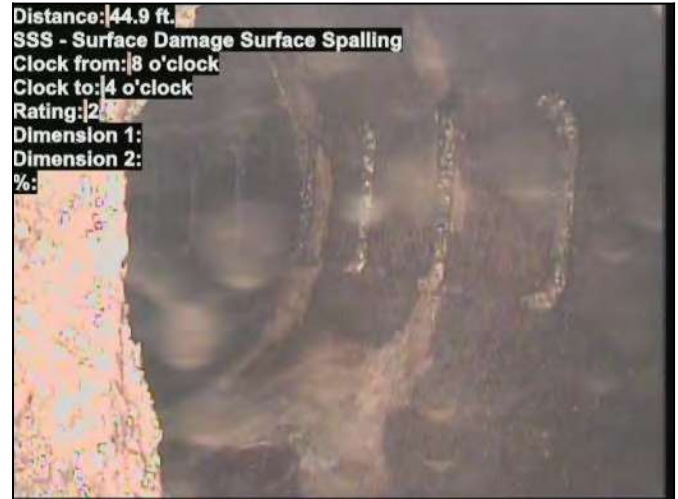
Photo: MH 1-11-MH 1-10-20220831-091049.JPG  
At: 44.9 ft. 8/4 SSS - Surface Damage Surface Spalling  
Joint: Yes

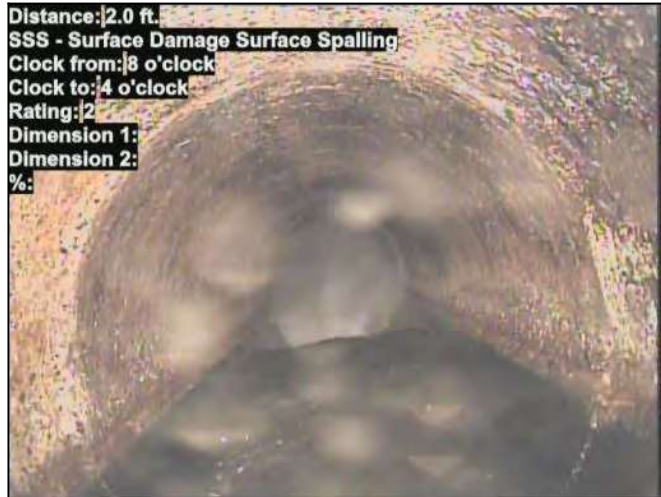
Photo: MH 1-10-MH 1-09-20220831-091434.JPG

At: 2 ft. 8/4 SSS - Surface Damage Surface Spalling

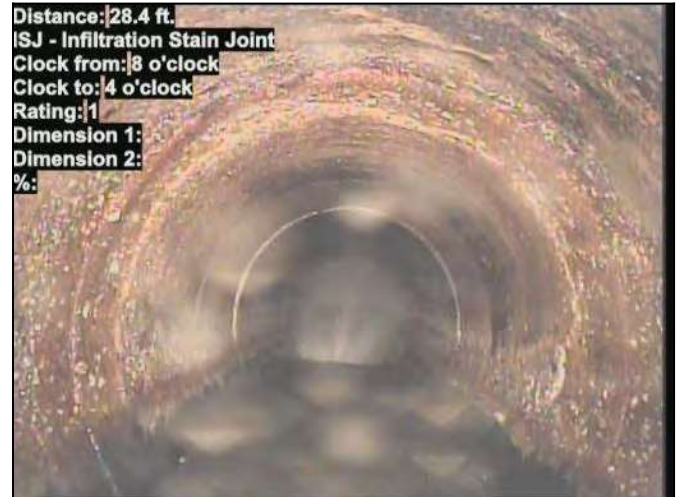
Photo: MH 1-10-MH 1-09-20220831-091613.JPG

At: 28.4 ft. 8/4 ISJ - Infiltration Stain Joint

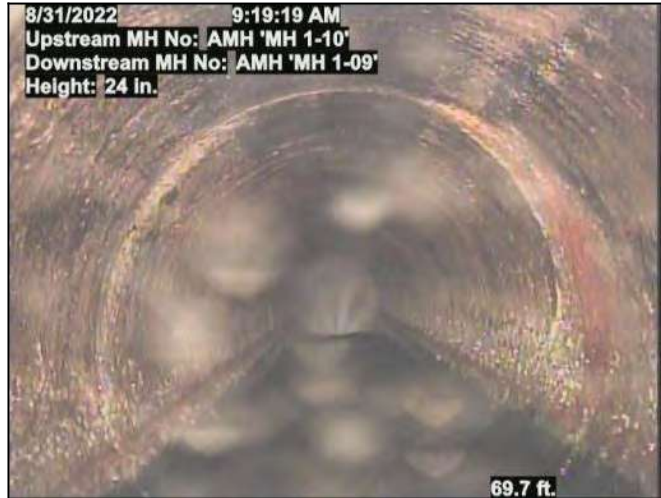
Photo: MH 1-10-MH 1-09-20220831-091859\_2.JPG

At: 48.9 ft. 8/4 ISJ - Infiltration Stain Joint

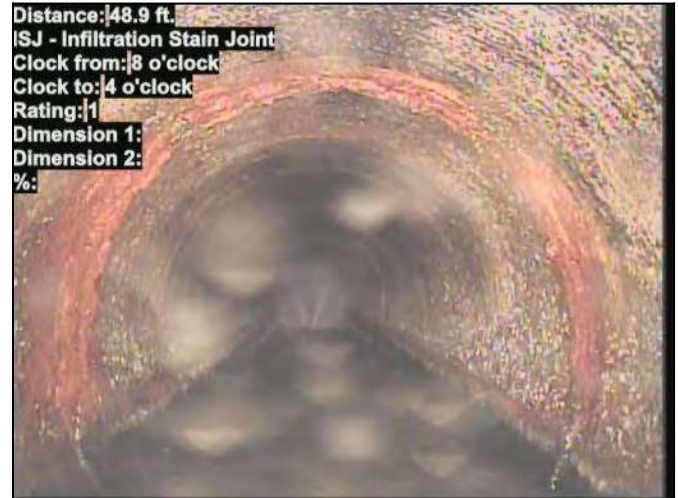
Photo: MH 1-10-MH 1-09-20220831-091859\_1.JPG

At: 48.9 ft. 8/4 ISJ - Infiltration Stain Joint

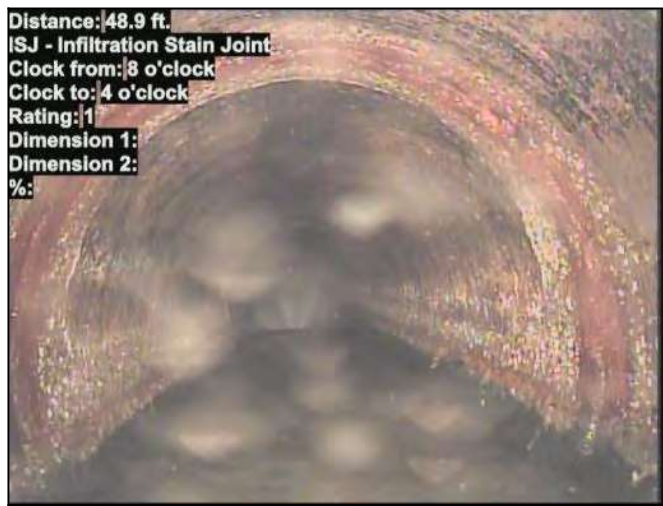
Photo: MH 1-10-MH 1-09-20220831-091859.JPG  
 At: 48.9 ft. 8/4 ISJ - Infiltration Stain Joint  
 Joint: Yes

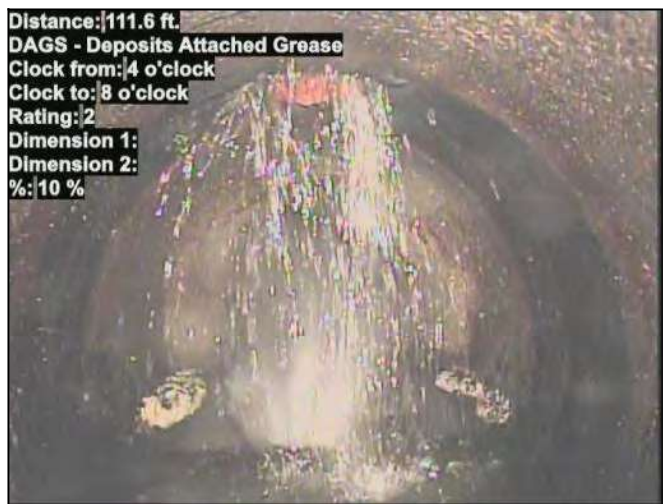
Photo: MH 1-10-MH 1-09-20220831-092455.JPG  
 At: 111.6 ft. 4/8 DAGS - Deposits Attached Grease  
 Joint: Yes 10 %

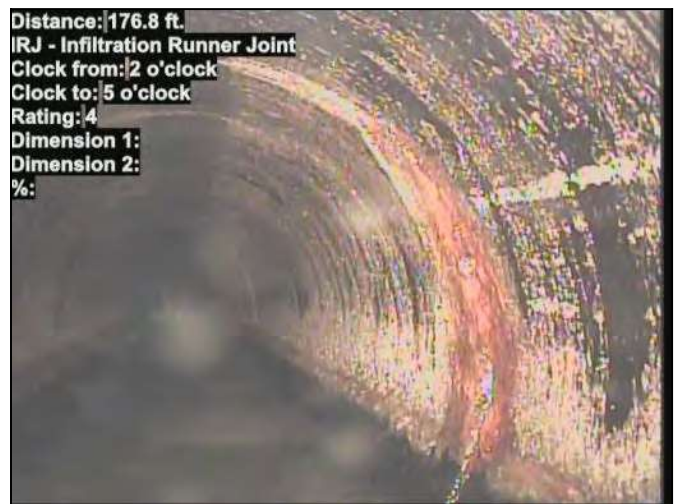
Photo: MH 1-10-MH 1-09-20220831-092900\_1.JPG  
 At: 176.8 ft. 2/5 IRJ - Infiltration Runner Joint  
 Joint: Yes

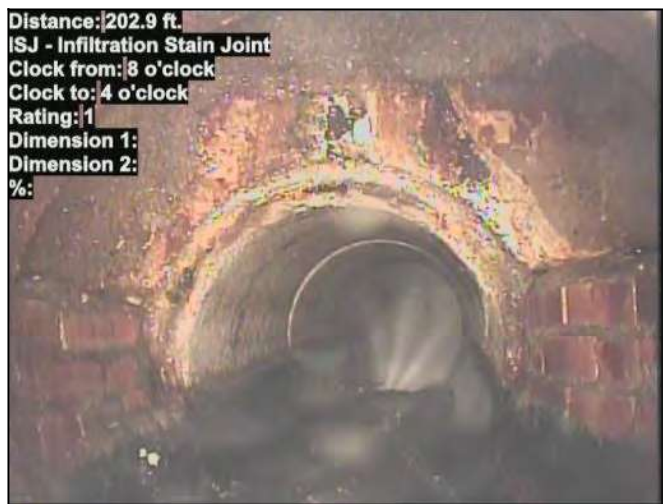
Distance: 202.9 ft.  
 SSS - Surface Damage Surface Spalling  
 Clock from: 8 o'clock  
 Clock to: 4 o'clock  
 Rating: 2  
 Dimension 1:  
 Dimension 2:  
 %:

Photo: MH 1-10-MH 1-09-20220831-093109.JPG  
 At: 202.9 ft. 8/4 SSS - Surface Damage Surface Spalling  
 Joint: Yes

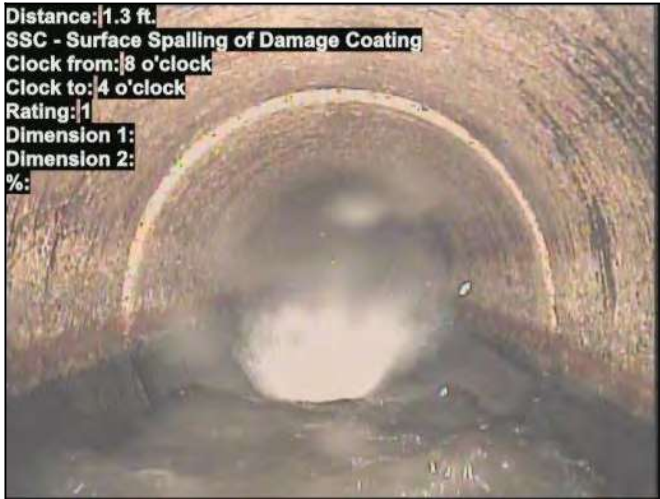
Photo: MH 1-09-MH 1-08-20220831-093912.JPG  
At: 1.3 ft. 8/4 SSC - Surface Spalling of Damage Coating  
Joint: Yes

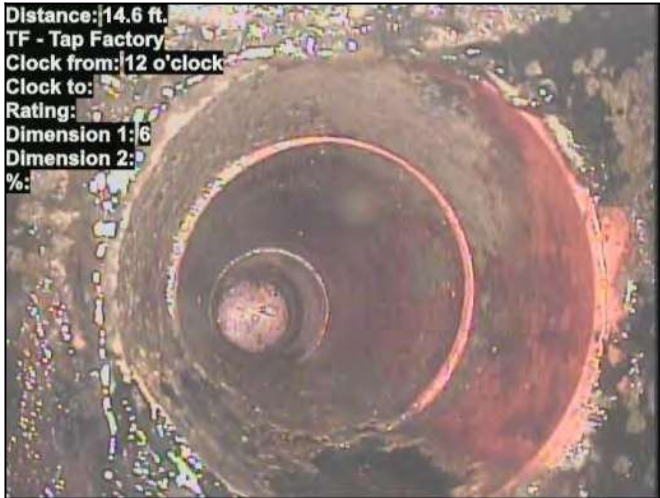
Photo: MH 1-09-MH 1-08-20220831-094023.JPG  
At: 14.6 ft. 12/ TF - Tap Factory  
Joint: No

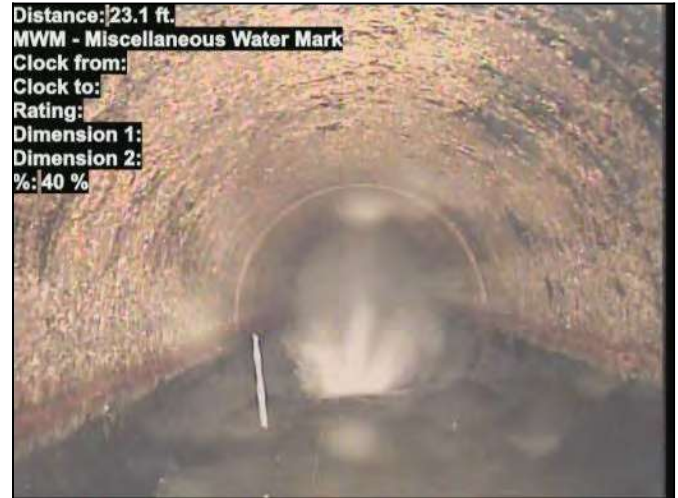
Photo: MH 1-09-MH 1-08-20220831-095307.JPG  
At: 23.1 ft. MWM - Miscellaneous Water Mark  
Joint: No 40 %

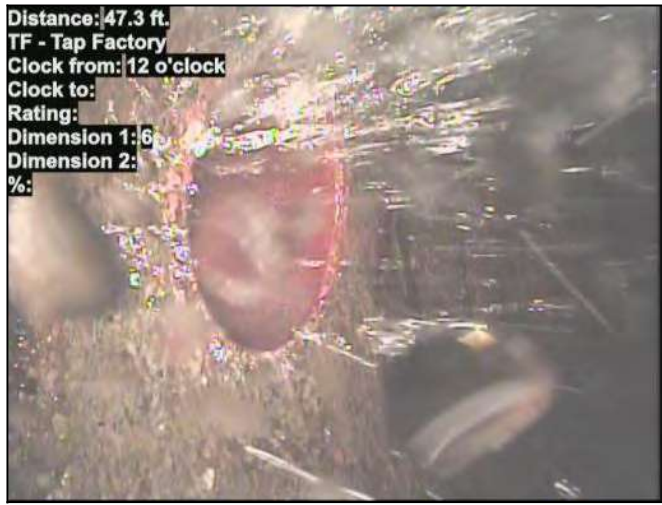
Photo: MH 1-09-MH 1-08-20220831-095442\_1.JPG

At: 47.3 ft. 12/. TF - Tap Factory

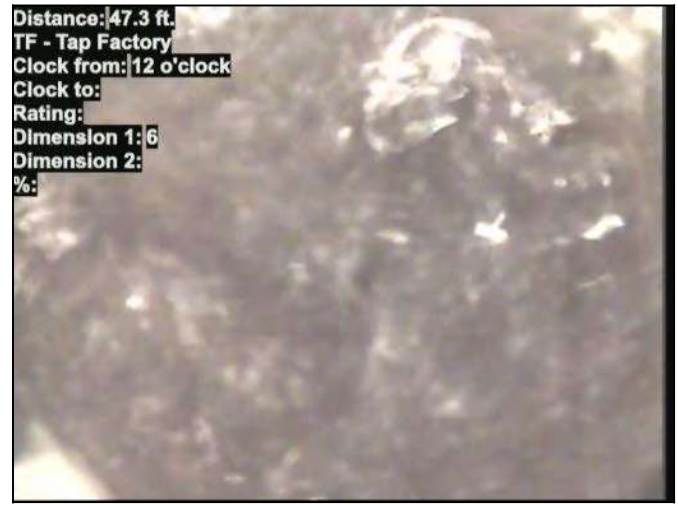
Photo: MH 1-09-MH 1-08-20220831-095442.JPG

At: 47.3 ft. 12/. TF - Tap Factory

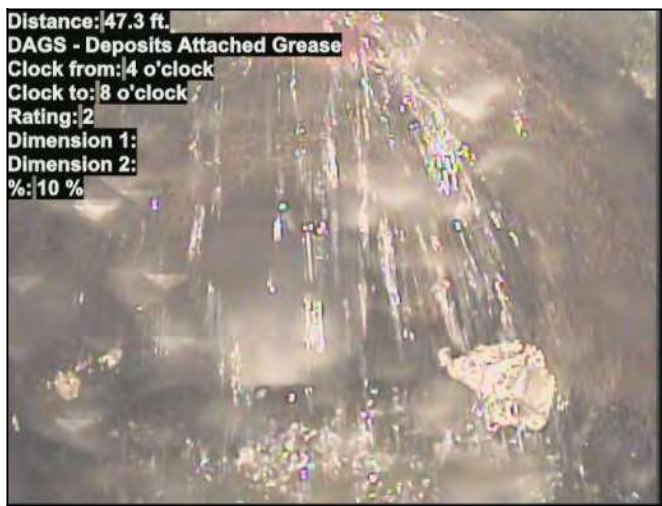
Photo: MH 1-09-MH 1-08-20220831-095529.JPG

At: 47.3 ft. 4/8 DAGS - Deposits Attached Grease

Joint: Yes 10 %

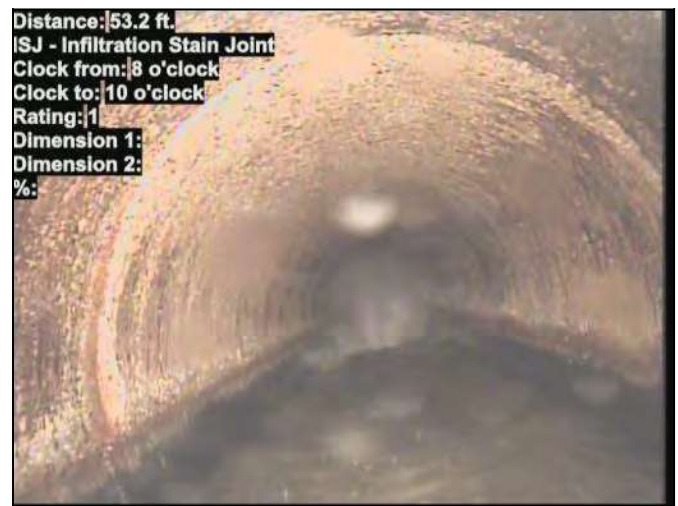
Photo: MH 1-09-MH 1-08-20220831-095645.JPG

At: 53.2 ft. 8/10 ISJ - Infiltration Stain Joint
