## Appendix A

### Mystic Area CCTV Inspection Logs

## NWMCC INSPECTION REPORT

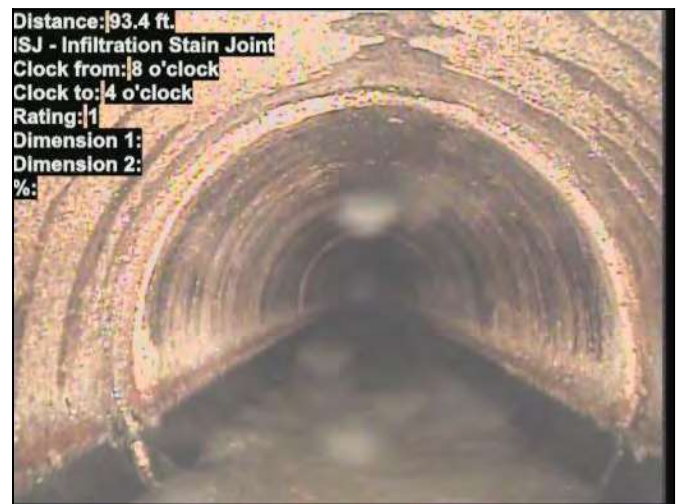
Photo: MH 1-09-MH 1-08-20220831-095920.JPG

At: 93.4 ft. 8/4 ISJ - Infiltration Stain Joint

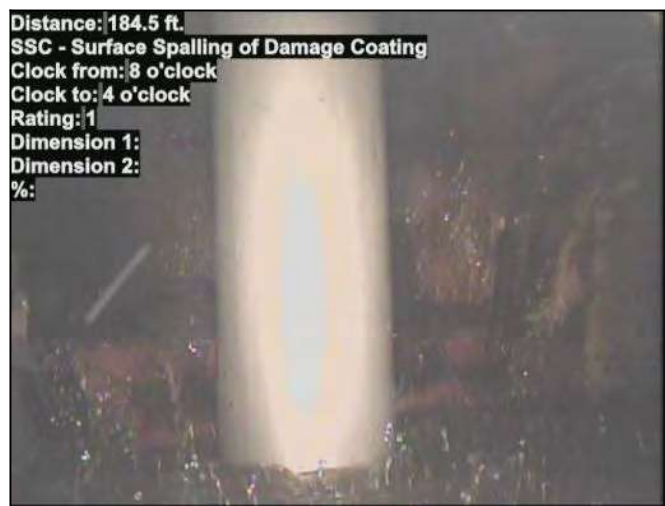
Photo: MH 1-09-MH 1-08-20220831-102126.JPG  
At: 184.5 ft. 8/4 SSC - Surface Spalling of Damage Coating  
Joint: Yes

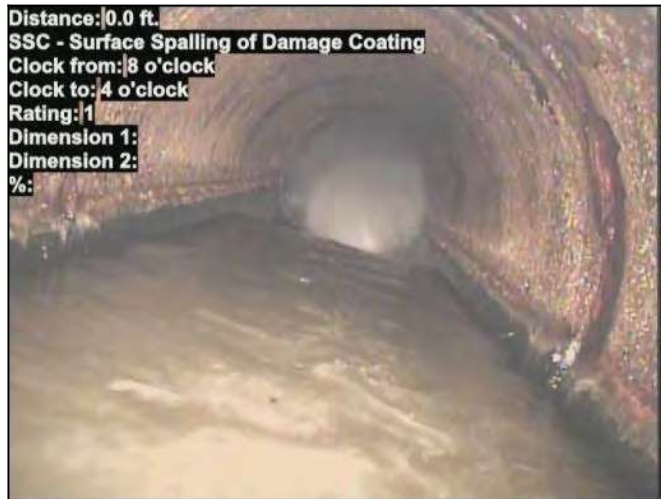
Photo: MH 1-08-MH 1-07-20220831-112434.JPG

At: 0 ft. 8/4 SSC - Surface Spalling of Damage Coating

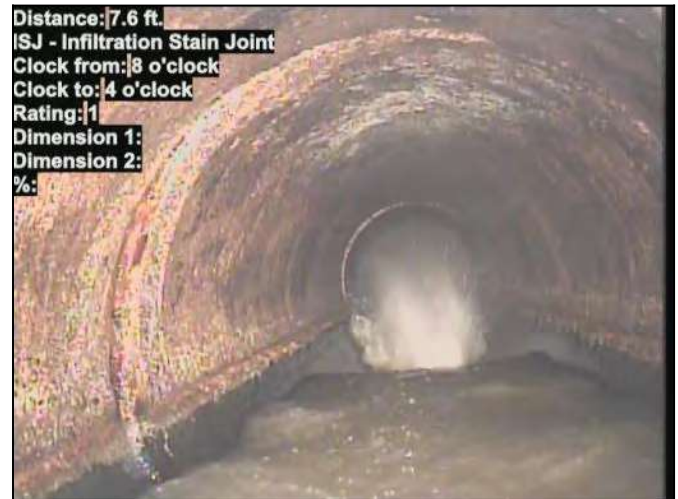
Photo: MH 1-08-MH 1-07-20220831-112701\_2.JPG

At: 7.6 ft. 8/4 ISJ - Infiltration Stain Joint

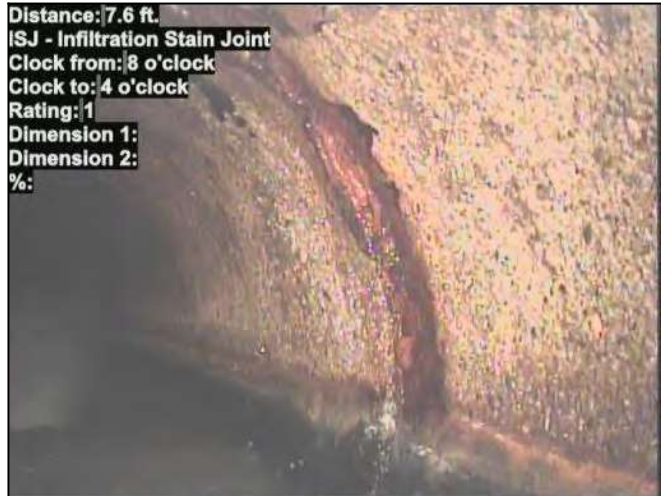
Photo: MH 1-08-MH 1-07-20220831-112701\_1.JPG

At: 7.6 ft. 8/4 ISJ - Infiltration Stain Joint

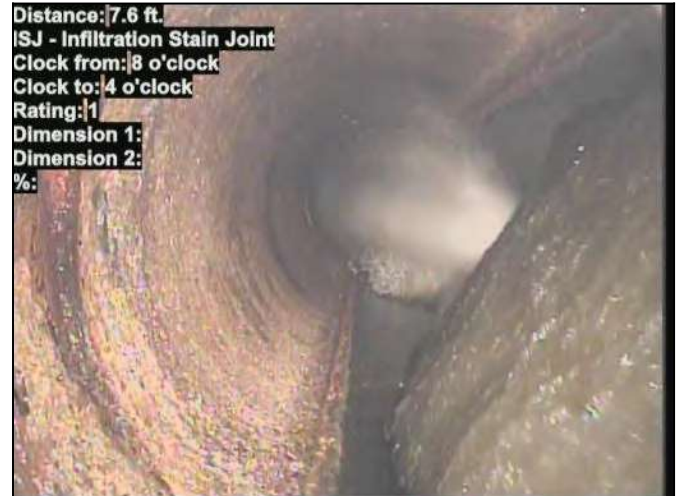
Photo: MH 1-08-MH 1-07-20220831-112701.JPG

At: 7.6 ft. 8/4 ISJ - Infiltration Stain Joint

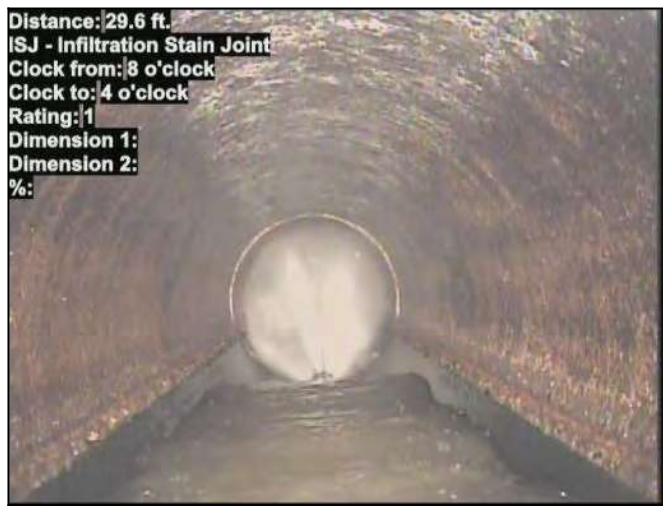
Photo: MH 1-08-MH 1-07-20220831-112809.JPG  
 At: 29.6 ft. 8/4 ISJ - Infiltration Stain Joint  
 Joint: Yes

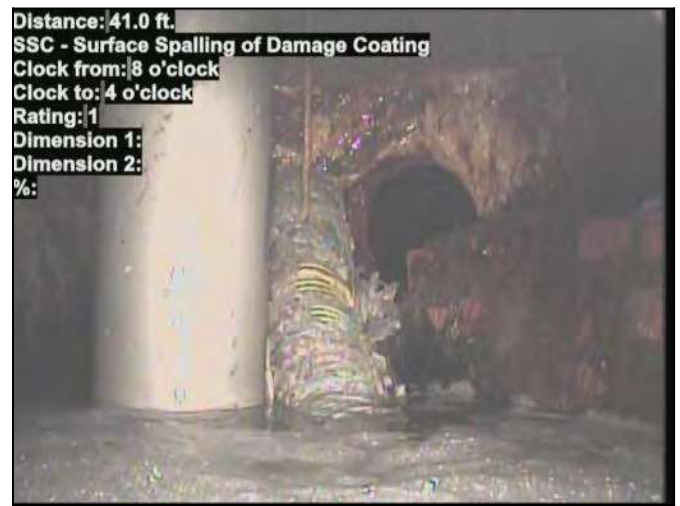
Photo: MH 1-08-MH 1-07-20220831-112900.JPG  
 At: 41 ft. 8/4 SSC - Surface Spalling of Damage Coating  
 Joint: Yes

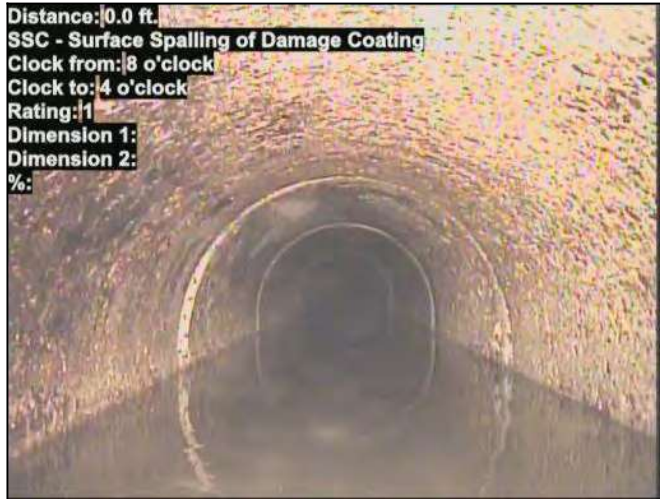
Photo: MH 1-07-MH 1-06-20220831-124859.JPG  
At: 0 ft. 8/4 SSC - Surface Spalling of Damage Coating  
Joint: Yes

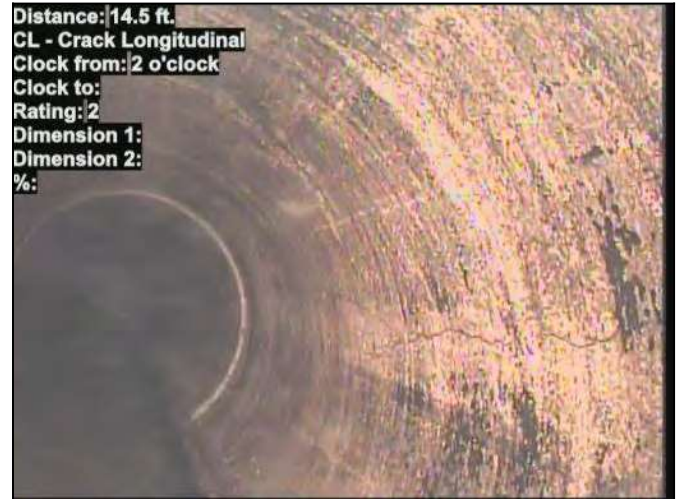
Photo: MH 1-07-MH 1-06-20220831-125032.JPG  
At: 14.5 ft. 2/ CL - Crack Longitudinal  
Joint: No

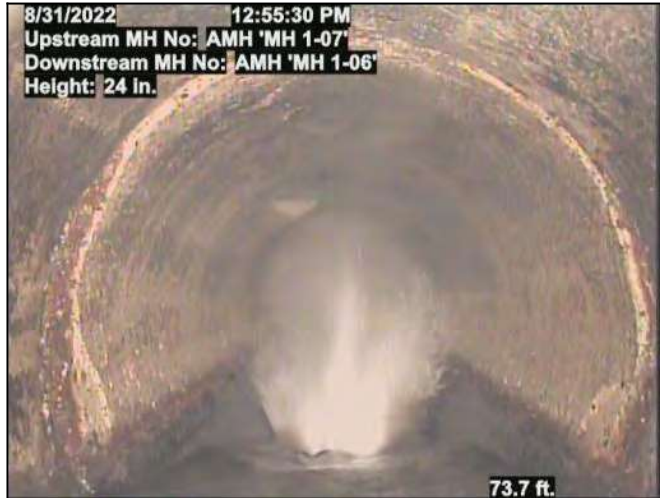
Photo: MH 1-07-MH 1-06-20220831-125339\_2.JPG  
At: 35.7 ft. 8/4 ISJ - Infiltration Stain Joint  
Joint: Yes

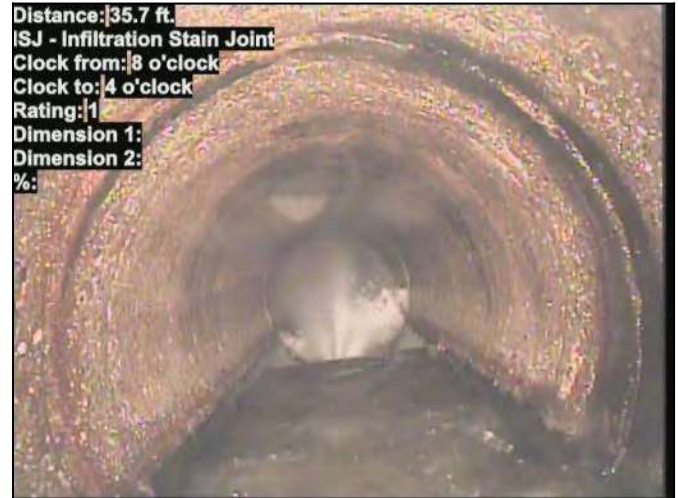
Photo: MH 1-07-MH 1-06-20220831-125339\_1.JPG  
At: 35.7 ft. 8/4 ISJ - Infiltration Stain Joint  
Joint: Yes

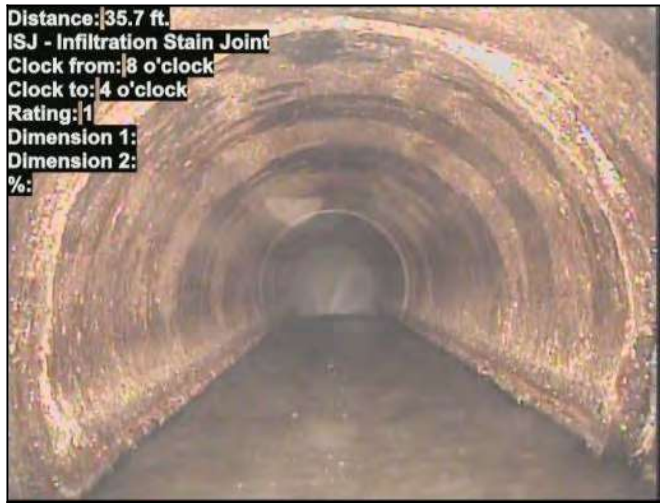
Distance: 35.7 ft.  
ISJ - Infiltration Stain Joint  
Clock from: 8 o'clock  
Clock to: 4 o'clock  
Rating: 1  
Dimension 1:  
Dimension 2:  
%:  
Photo: MH 1-07-MH 1-06-20220831-125339.JPG  
At: 35.7 ft. 8/4 ISJ - Infiltration Stain Joint  
Joint: Yes

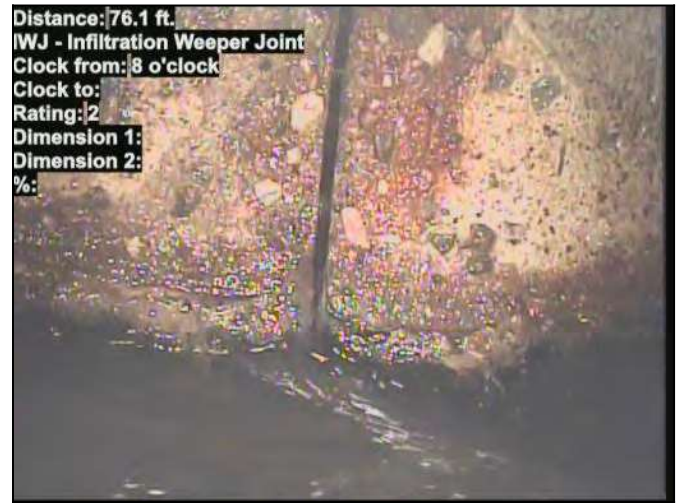
Distance: 76.1 ft.  
IWJ - Infiltration Weeper Joint  
Clock from: 8 o'clock  
Clock to:  
Rating: 2  
Dimension 1:  
Dimension 2:  
%:  
Photo: MH 1-07-MH 1-06-20220831-125615.JPG  
At: 76.1 ft. 8/. IWJ - Infiltration Weeper Joint  
Joint: Yes

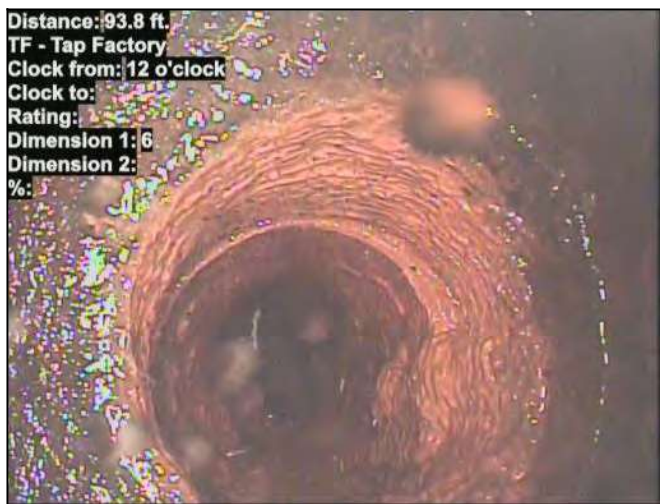
Distance: 93.8 ft.  
TF - Tap Factory  
Clock from: 12 o'clock  
Clock to:  
Rating:  
Dimension 1: 6  
Dimension 2:  
%:  
Photo: MH 1-07-MH 1-06-20220831-125720.JPG  
At: 93.8 ft. 12/. TF - Tap Factory  
Joint: No

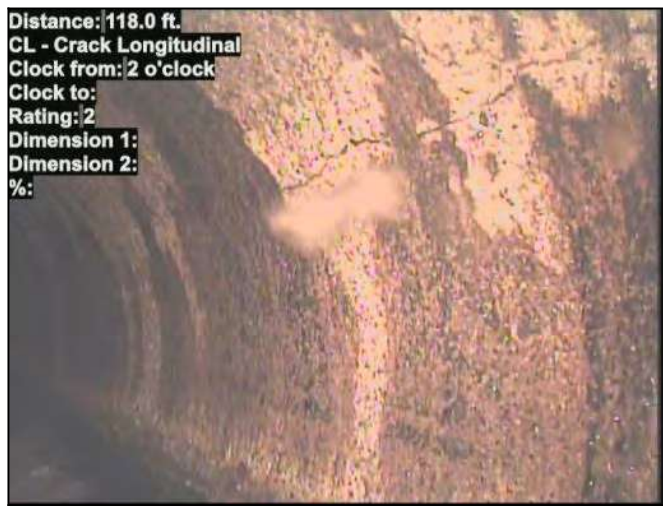
Photo: MH 1-07-MH 1-06-20220831-130548\_1.JPG

Distance: 118.0 ft.  
CL - Crack Longitudinal  
Clock from: 2 o'clock  
Clock to:  
Rating: 2  
Dimension 1:  
Dimension 2:  
%:

At: 118 ft. 2/. CL - Crack Longitudinal

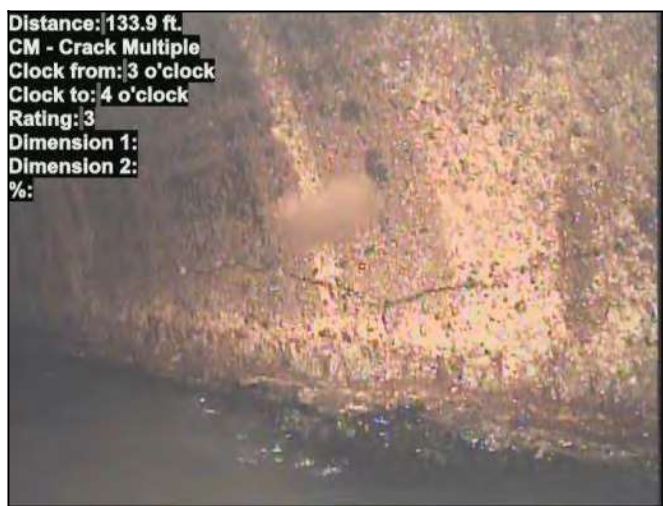
Photo: MH 1-07-MH 1-06-20220831-130738.JPG

Distance: 133.9 ft.  
CM - Crack Multiple  
Clock from: 3 o'clock  
Clock to: 4 o'clock  
Rating: 3  
Dimension 1:  
Dimension 2:  
%:

At: 133.9 ft. 3/4 CM - Crack Multiple

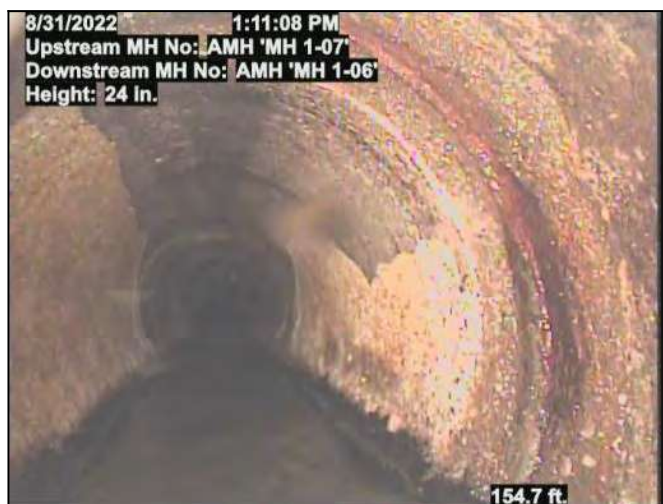
At: 137 ft. 9/. ISB - Infiltration Stain Barrel

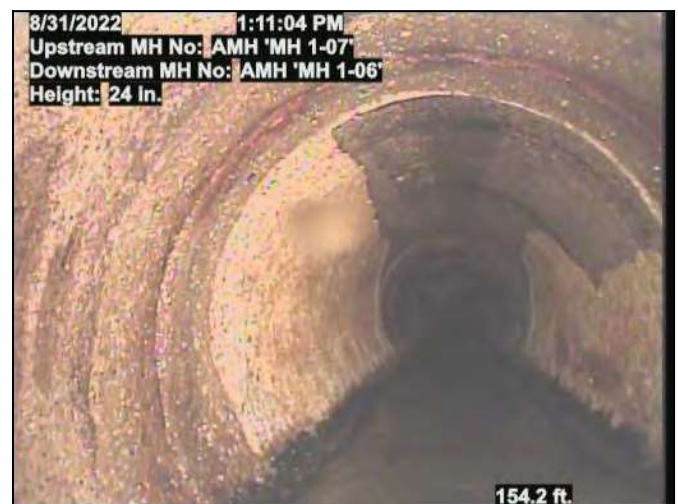
At: 137 ft. 9/. ISB - Infiltration Stain Barrel

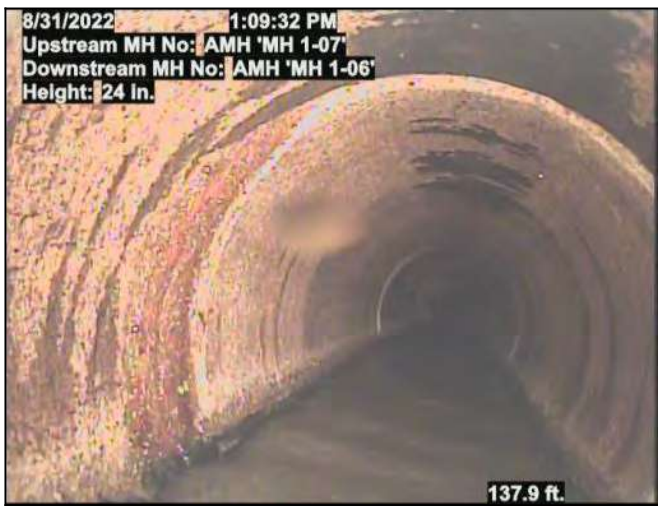
Photo: MH 1-07-MH 1-06-20220831-130914\_1.JPG  
 At: 137 ft. 9/. ISB - Infiltration Stain Barrel  
 Joint: No

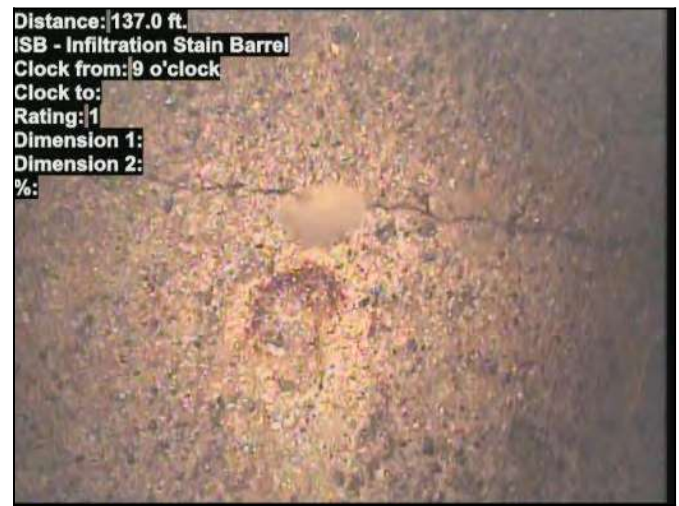
Photo: MH 1-07-MH 1-06-20220831-130914.JPG  
 At: 137 ft. 9/. ISB - Infiltration Stain Barrel  
 Joint: No

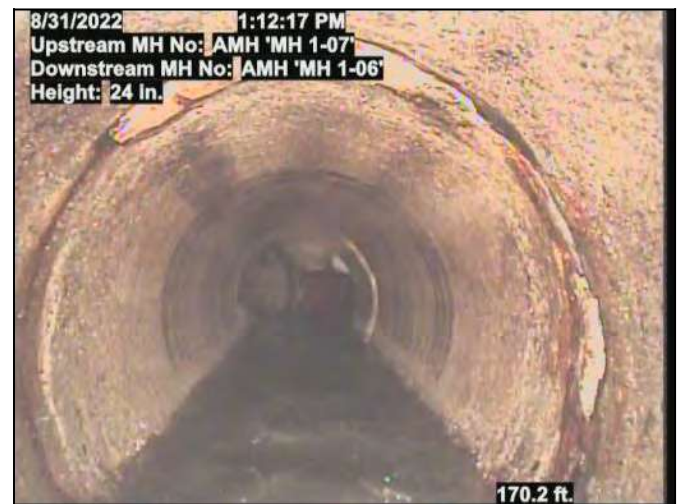
Photo: MH 1-07-MH 1-06-20220831-131157\_1.JPG  
 At: 166.6 ft. 12/. TF - Tap Factory  
 Joint: No

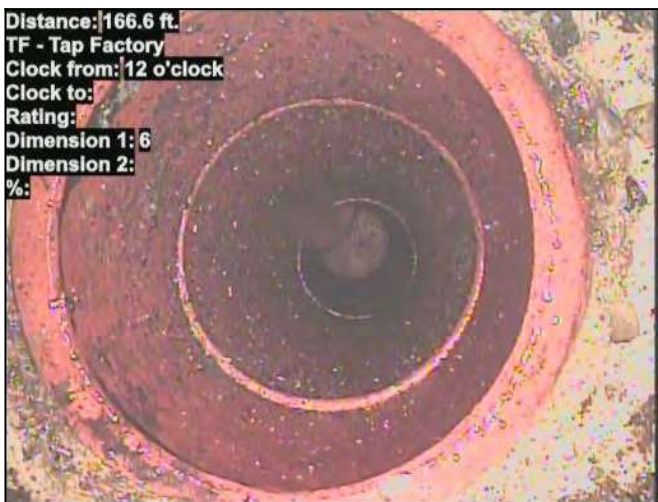
Photo: MH 1-07-MH 1-06-20220831-131157.JPG  
 At: 166.6 ft. 12/. TF - Tap Factory  
 Joint: No

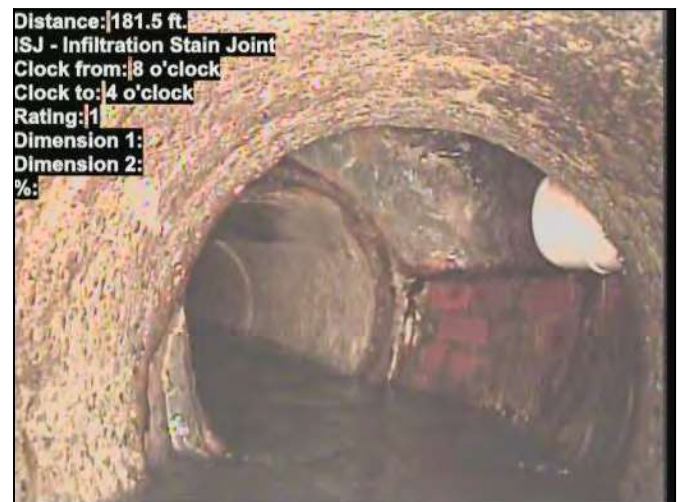
Photo: MH 1-07-MH 1-06-20220831-131333.JPG  
 At: 181.5 ft. 8/4 ISJ - Infiltration Stain Joint  
 Joint: Yes

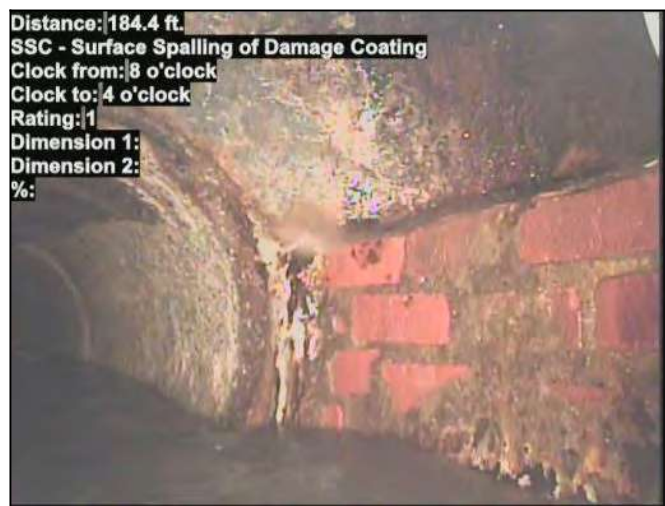
Photo: MH 1-07-MH 1-06-20220831-131346.JPG  
 At: 184.4 ft. 8/4 SSC - Surface Spalling of Damage Coating  
 Joint: Yes

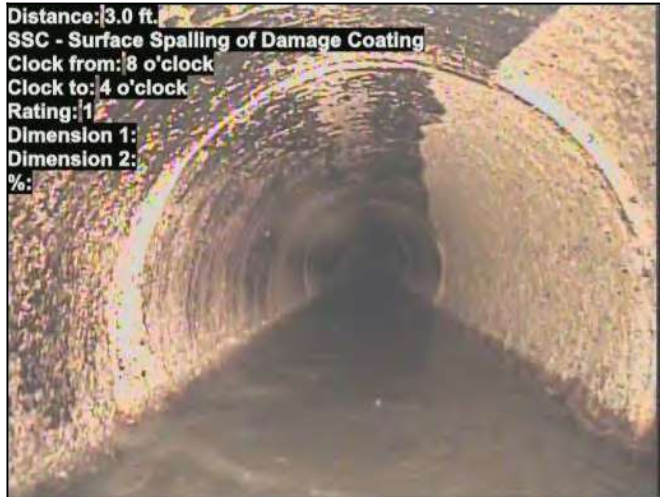
Photo: MH 1-06-MH 1-05-20220831-131817.JPG  
At: 3 ft. 8/4 SSC - Surface Spalling of Damage Coating  
Joint: Yes

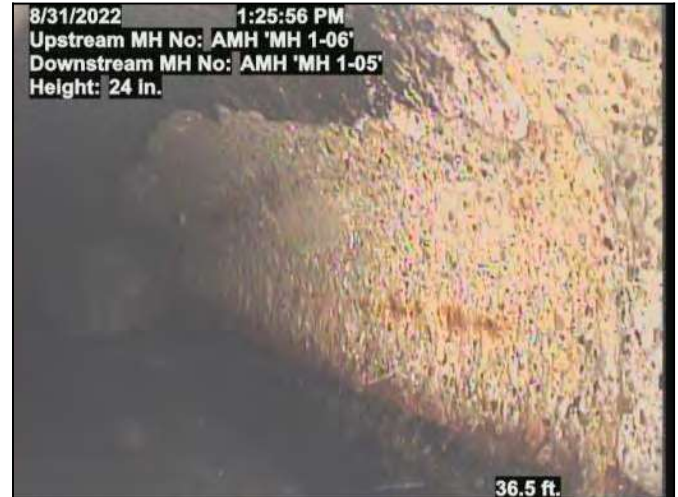
Photo: MH 1-06-MH 1-05-20220831-132421\_1.JPG  
At: 13.6 ft. 3/4 ISJ - Infiltration Stain Joint  
Joint: Yes

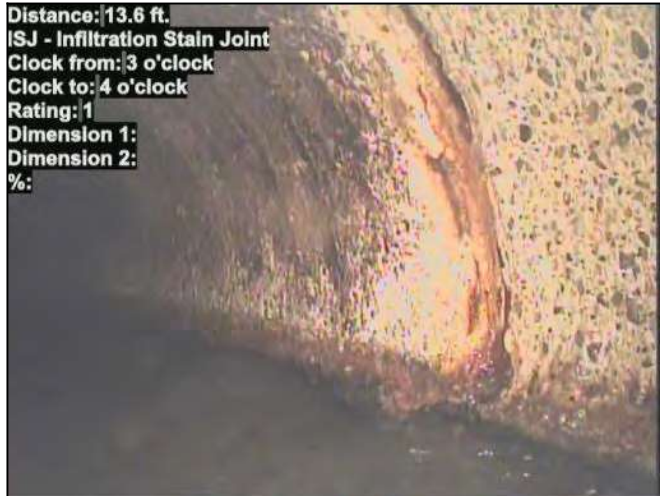
Photo: MH 1-06-MH 1-05-20220831-132421.JPG  
At: 13.6 ft. 3/4 ISJ - Infiltration Stain Joint  
Joint: Yes

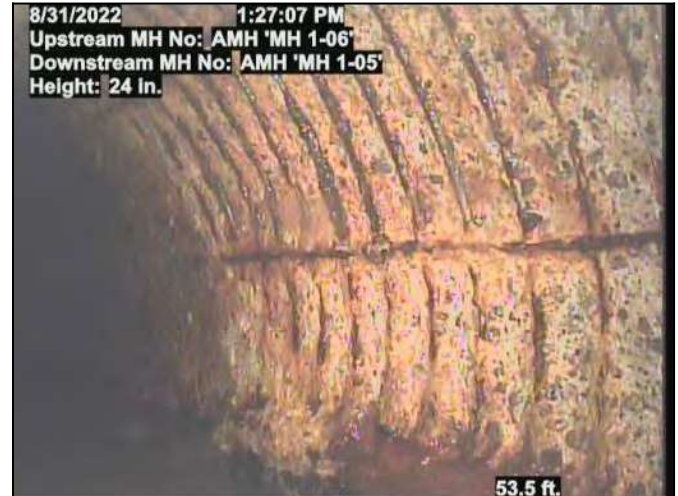
Photo: MH 1-06-MH 1-05-20220831-132642\_1.JPG  
At: 51.9 ft. 8/4 SRP - Surface Damage Reinforcement Projecting  
Joint: Yes

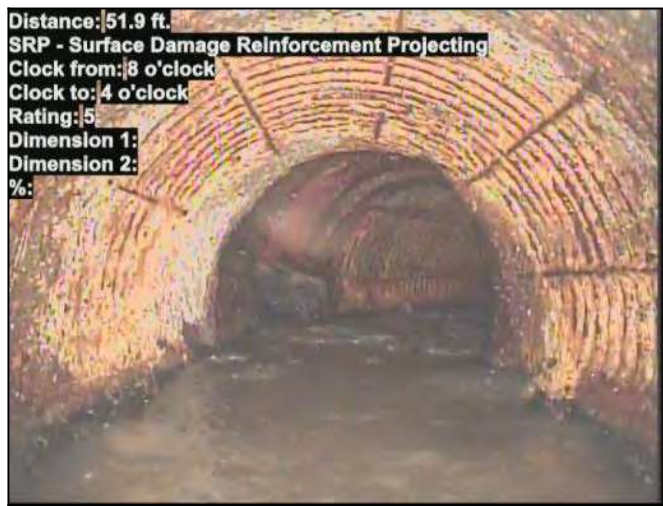
Photo: MH 1-06-MH 1-05-20220831-132642.JPG  
At: 51.9 ft. 8/4 SRP - Surface Damage Reinforcement Projecting  
Joint: Yes

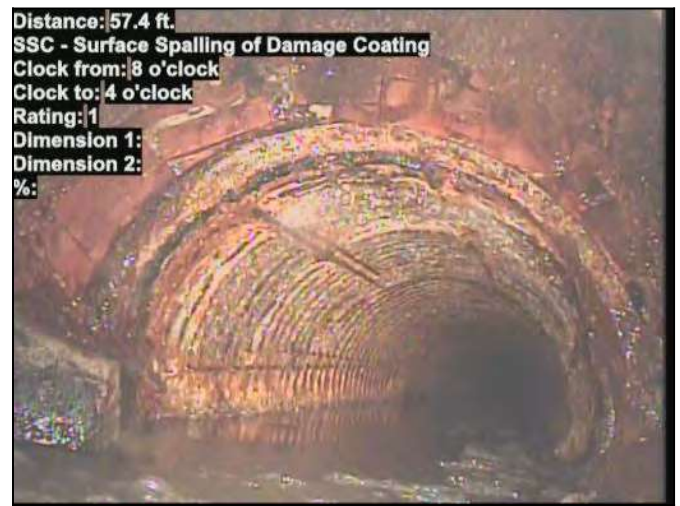
Photo: MH 1-06-MH 1-05-20220831-132739.JPG  
At: 57.4 ft. 8/4 SSC - Surface Spalling of Damage Coating  
Joint: Yes

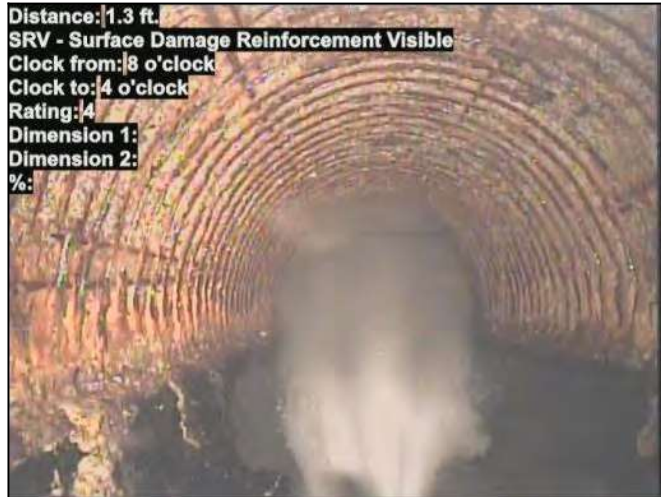
Photo: MH 1-05-MH 1-04-20220831-133415.JPG

At: 1.3 ft. 8/4 SRV - Surface Damage Reinforcement Visible

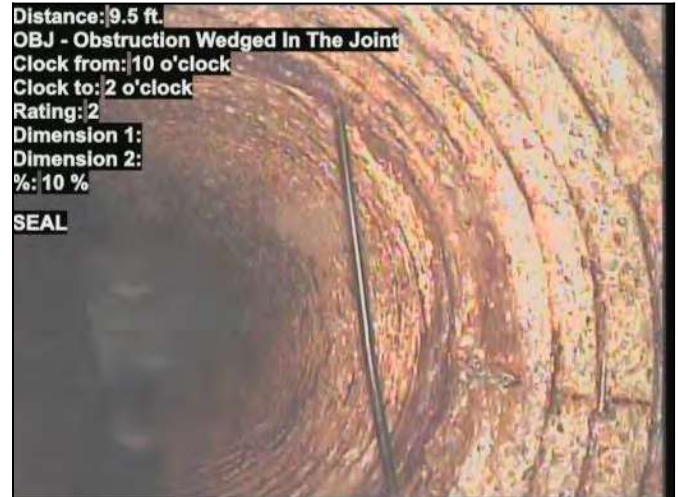
Photo: MH 1-05-MH 1-04-20220831-133618\_1.JPG

At: 9.5 ft. 10/2 OBJ - Obstruction Wedged In The Joint

Joint: Yes 10 % SEAL

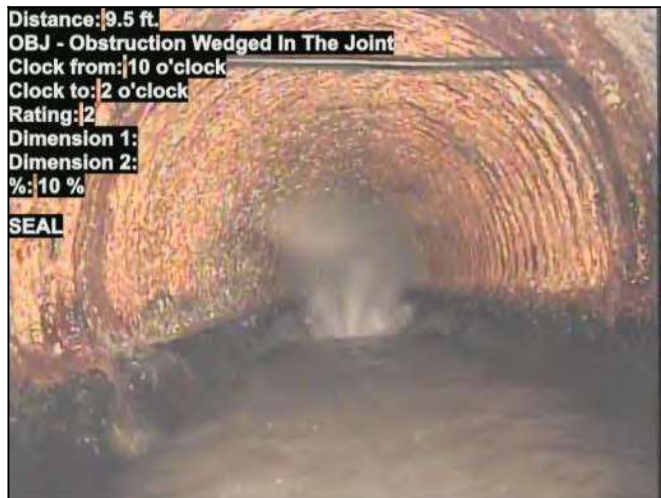
Photo: MH 1-05-MH 1-04-20220831-133618.JPG

At: 9.5 ft. 10/2 OBJ - Obstruction Wedged In The Joint

Joint: Yes 10 % SEAL

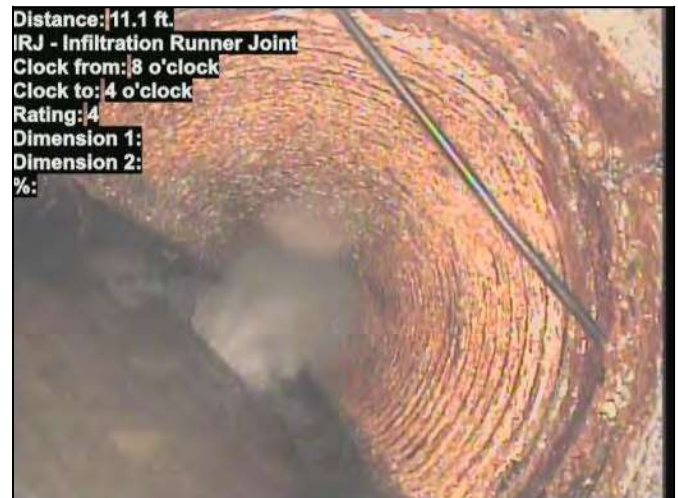
Photo: MH 1-05-MH 1-04-20220831-133823.JPG

At: 11.1 ft. 8/4 IRJ - Infiltration Runner Joint

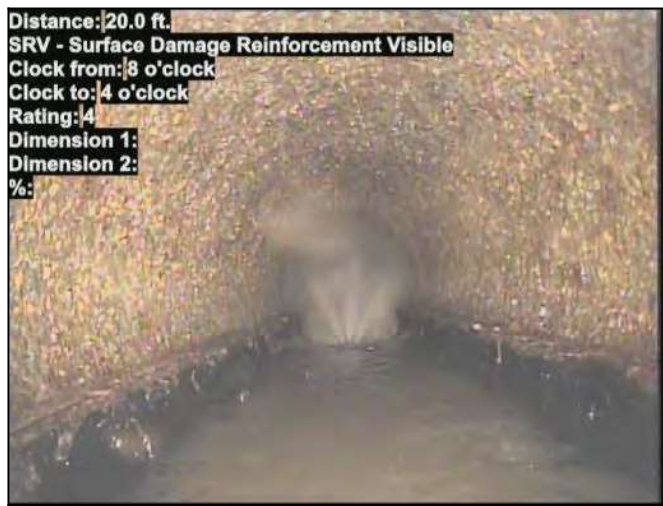
Photo: MH 1-05-MH 1-04-20220831-133912.JPG  
At: 20 ft. 8/4 SRV - Surface Damage Reinforcement Visible  
Joint: Yes

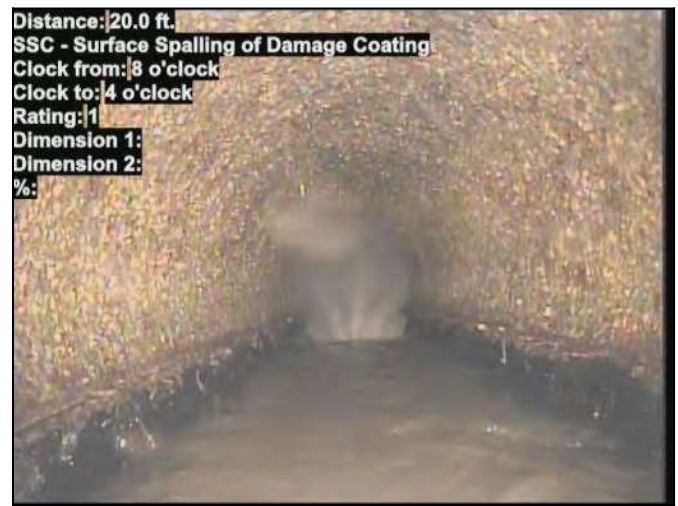
Photo: MH 1-05-MH 1-04-20220831-133924.JPG  
At: 20 ft. 8/4 SSC - Surface Spalling of Damage Coating  
Joint: Yes

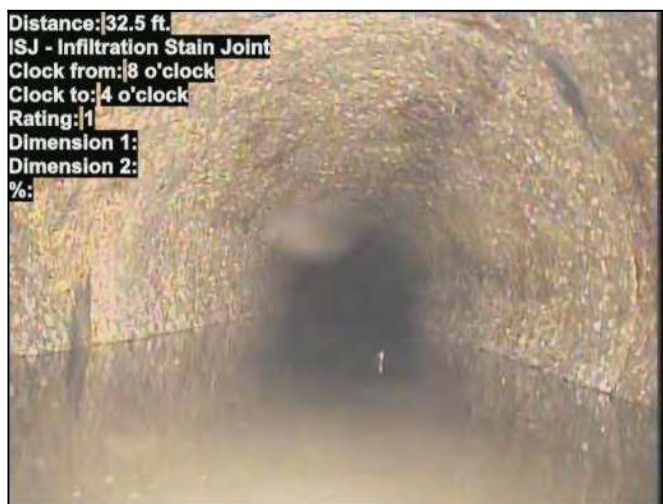
Photo: MH 1-05-MH 1-04-20220831-134111.JPG  
At: 32.5 ft. 8/4 ISJ - Infiltration Stain Joint  
Joint: Yes

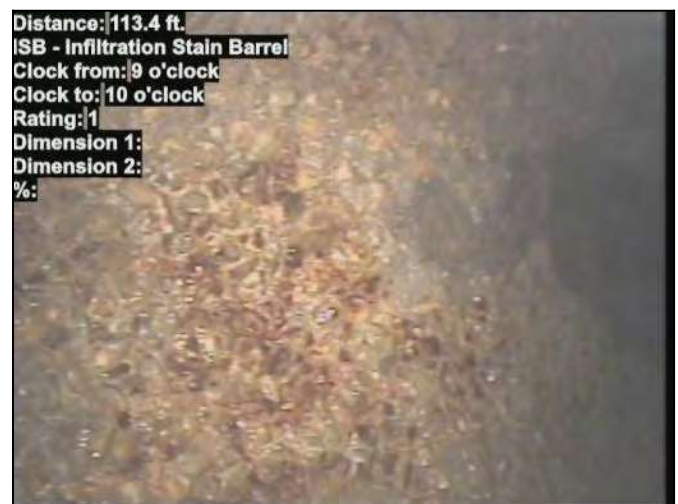
Photo: MH 1-05-MH 1-04-20220831-140949.JPG  
At: 113.4 ft. ISB - Infiltration Stain Barrel 9/10  
Joint: No

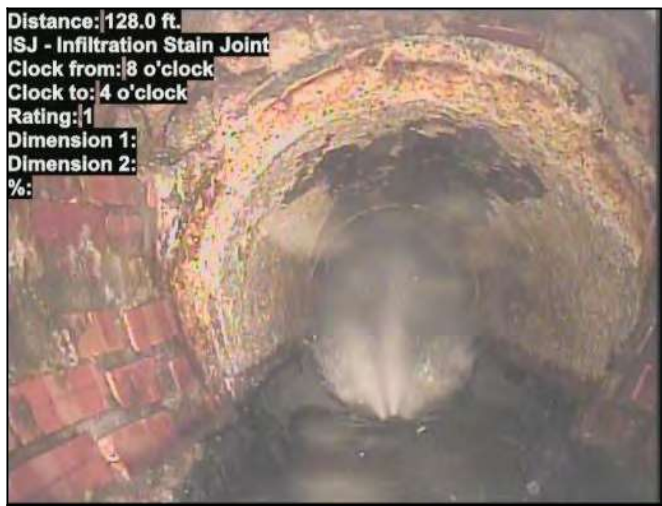
Distance: 128.0 ft.  
 ISJ - Infiltration Stain Joint  
 Clock from: 8 o'clock  
 Clock to: 4 o'clock  
 Rating: 1  
 Dimension 1:  
 Dimension 2:  
 %:  
 Photo: MH 1-05-MH 1-04-20220831-141101.JPG  
 At: 128 ft. 8/4 ISJ - Infiltration Stain Joint  
 Joint: Yes

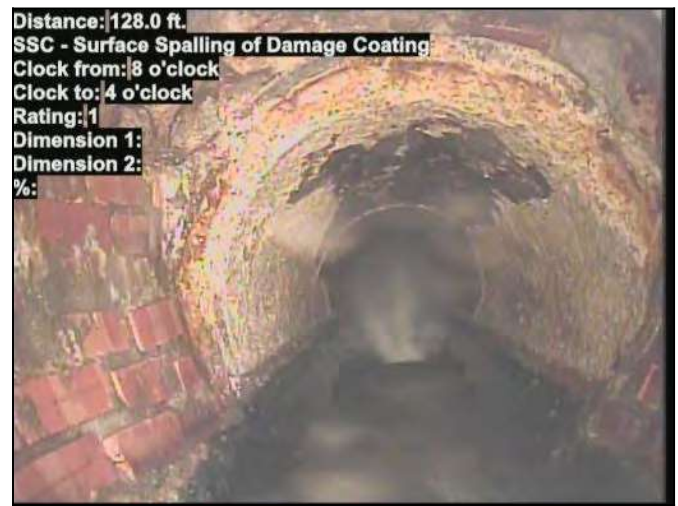
Distance: 128.0 ft.  
 SSC - Surface Spalling of Damage Coating  
 Clock from: 8 o'clock  
 Clock to: 4 o'clock  
 Rating: 1  
 Dimension 1:  
 Dimension 2:  
 %:  
 Photo: MH 1-05-MH 1-04-20220831-141114.JPG  
 At: 128 ft. 8/4 SSC - Surface Spalling of Damage Coating  
 Joint: Yes

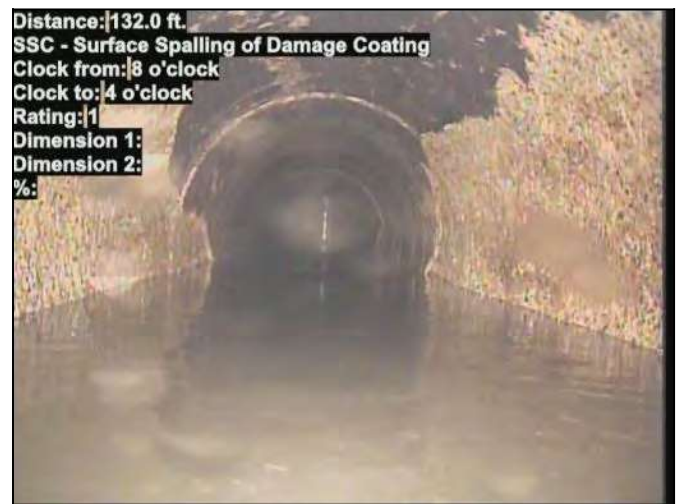
Distance: 132.0 ft.  
 SSC - Surface Spalling of Damage Coating  
 Clock from: 8 o'clock  
 Clock to: 4 o'clock  
 Rating: 1  
 Dimension 1:  
 Dimension 2:  
 %:  
 Photo: MH 1-05-MH 1-04-20220831-141338.JPG  
 At: 132 ft. 8/4 SSC - Surface Spalling of Damage Coating  
 Joint: Yes

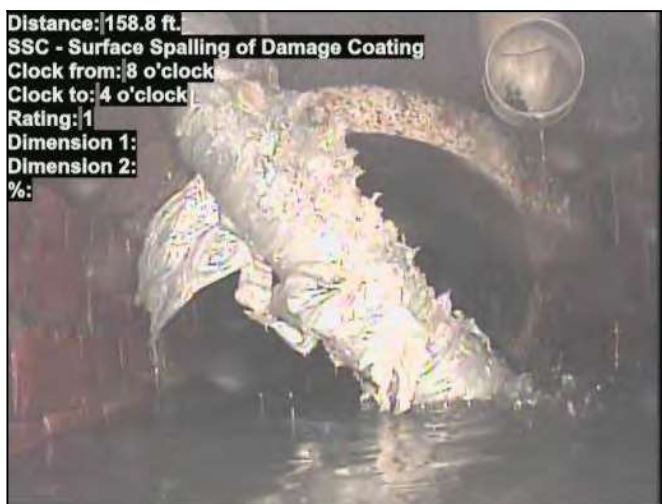
Distance: 158.8 ft.  
 SSC - Surface Spalling of Damage Coating  
 Clock from: 8 o'clock  
 Clock to: 4 o'clock  
 Rating: 1  
 Dimension 1:  
 Dimension 2:  
 %:  
 Photo: MH 1-05-MH 1-04-20220831-141547.JPG  
 At: 158.8 ft. 8/4 SSC - Surface Spalling of Damage Coating  
 Joint: Yes

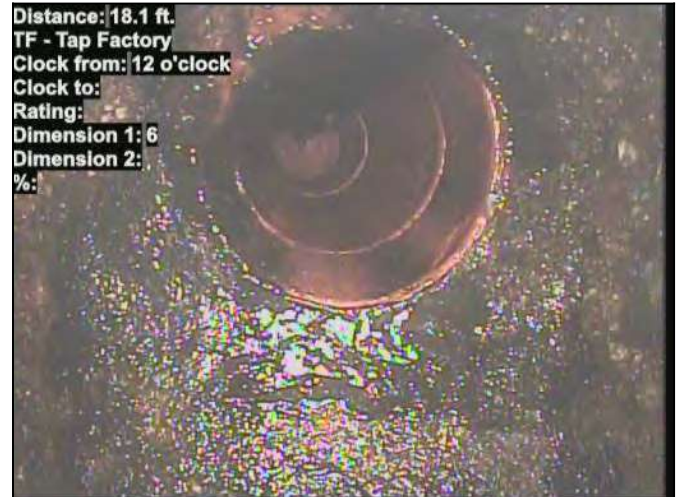
Photo: MH 1-04-MH 1-03-20220901-091855.JPG  
At: 18.1 ft. 12/. TF - Tap Factory  
Joint: No

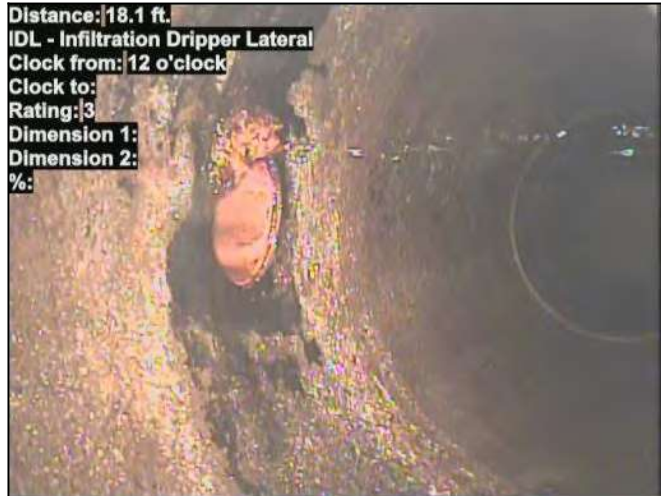
Photo: MH 1-04-MH 1-03-20220901-091911.JPG  
At: 18.1 ft. 12/. IDL - Infiltration Drinker Lateral  
Joint: No

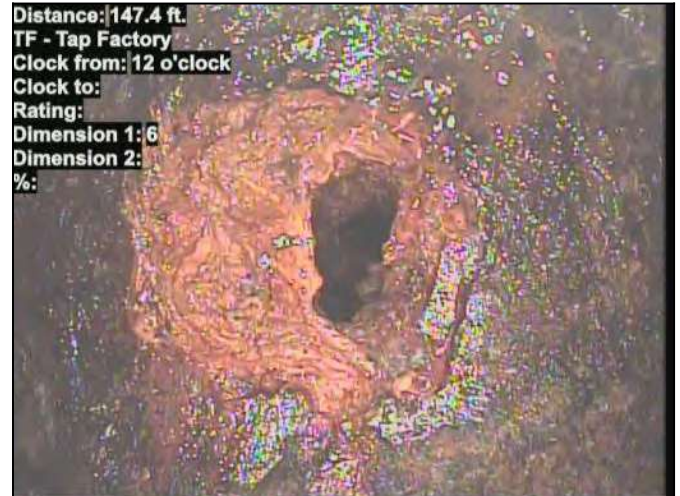
Photo: MH 1-04-MH 1-03-20220901-095727.JPG  
At: 147.4 ft. 12/. TF - Tap Factory  
Joint: No

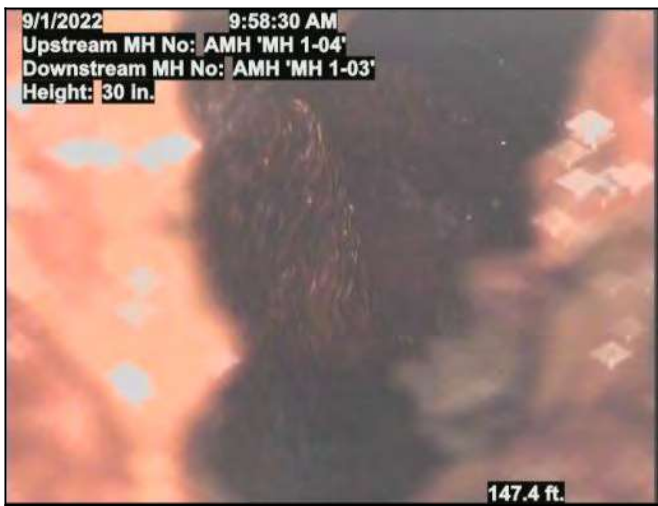
Photo: MH 1-04-MH 1-03-20220901-095751\_1.JPG  
At: 147.4 ft. 12/. DAE - Deposits Attached Encrustation  
Joint: No 30 % IN LATERAL

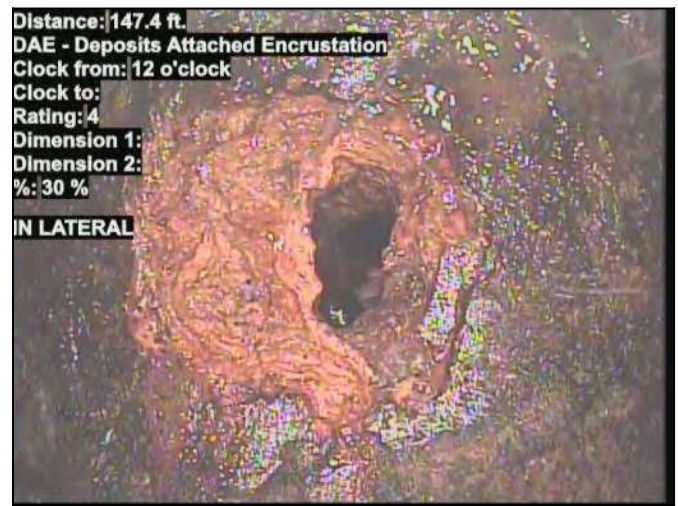
Photo: MH 1-04-MH 1-03-20220901-095751.JPG  
At: 147.4 ft. 12/. DAE - Deposits Attached Encrustation  
Joint: No 30 % IN LATERAL

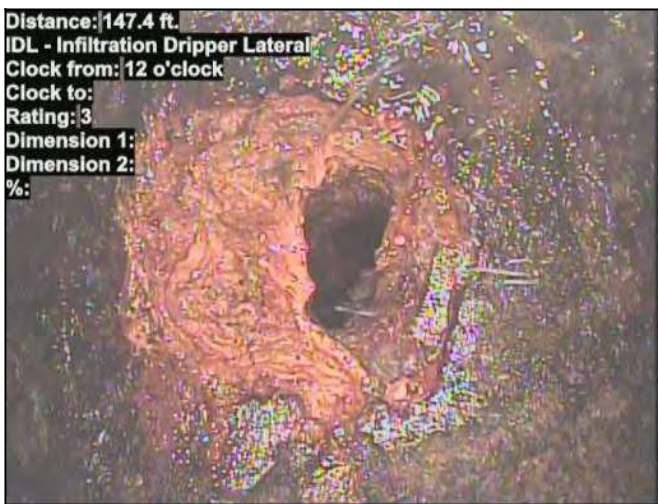
Photo: MH 1-04-MH 1-03-20220901-095736.JPG  
At: 147.4 ft. 12/. IDL - Infiltration Dripper Lateral  
Joint: No

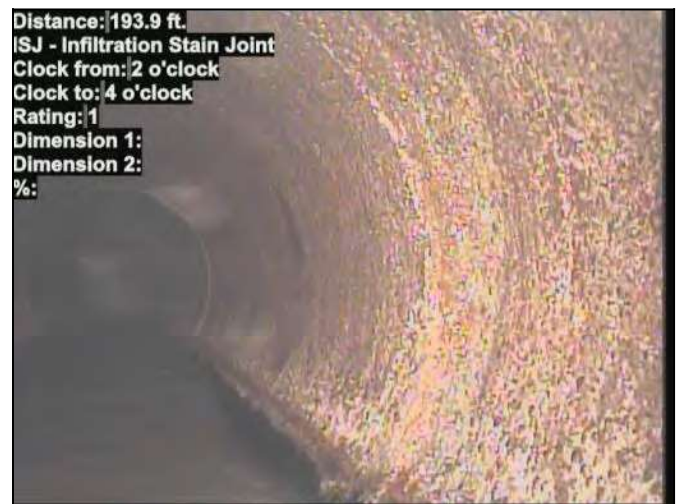
Photo: MH 1-04-MH 1-03-20220901-100109\_1.JPG  
At: 193.9 ft. 2/4 ISJ - Infiltration Stain Joint  
Joint: Yes

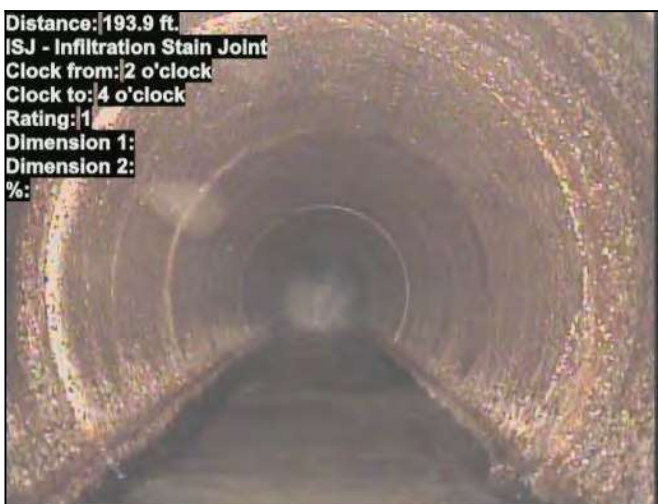
Photo: MH 1-04-MH 1-03-20220901-100109.JPG  
At: 193.9 ft. 2/4 ISJ - Infiltration Stain Joint  
Joint: Yes

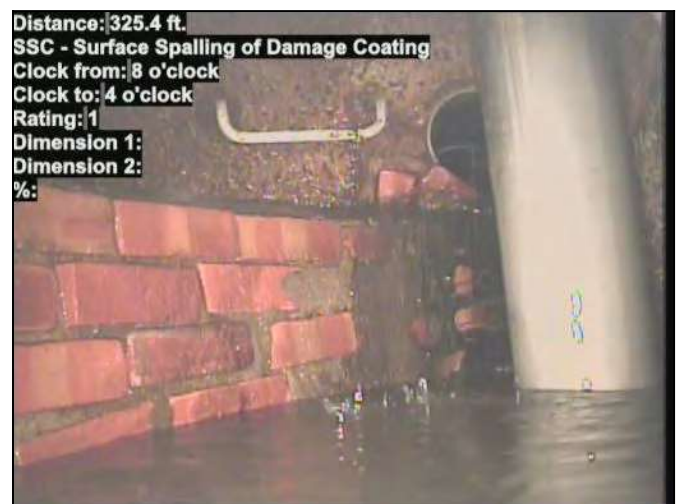
Photo: MH 1-04-MH 1-03-20220901-101659.JPG  
At: 325.4 ft. 8/4 SSC - Surface Spalling of Damage Coating  
Joint: Yes

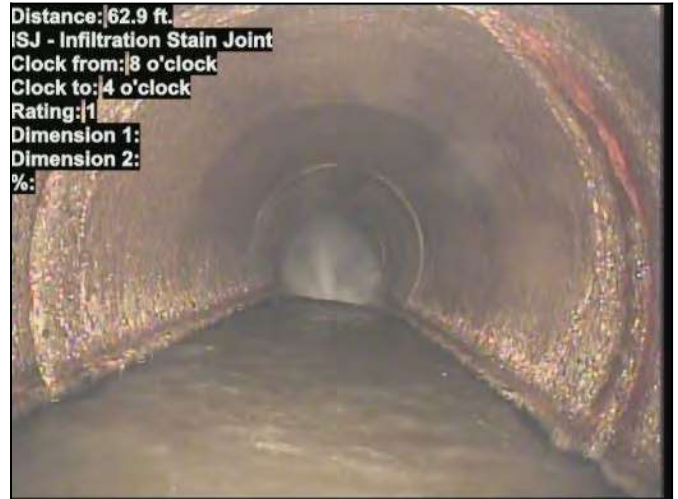
Photo: MH 1-03-MH 1-02-20220901-113859.JPG

At: 62.9 ft. 8/4 ISJ - Infiltration Stain Joint

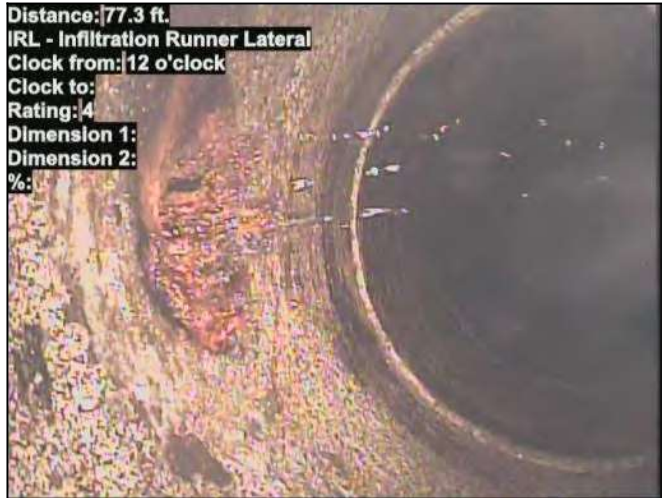
Photo: MH 1-03-MH 1-02-20220901-114026.JPG

At: 77.3 ft. 12/. IRL - Infiltration Runner Lateral

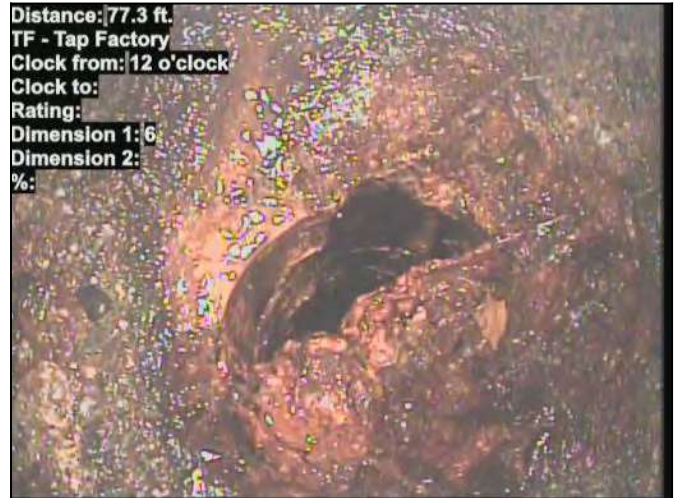
Photo: MH 1-03-MH 1-02-20220901-113955.JPG

At: 77.3 ft. 12/. TF - Tap Factory

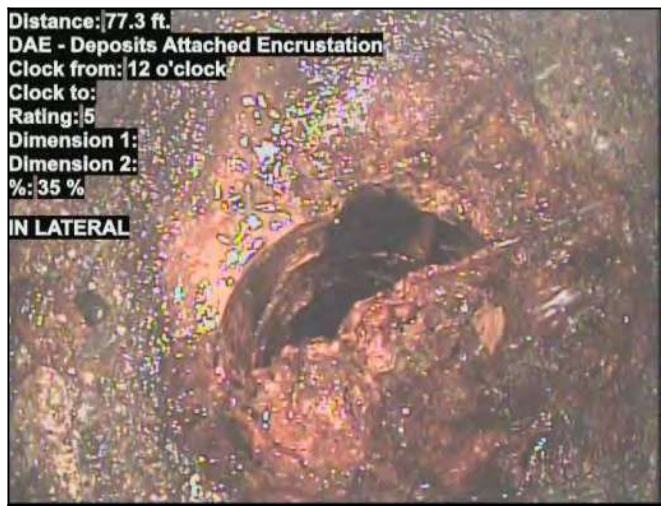
Distance: 77.3 ft.  
DAE - Deposits Attached Encrustation  
Clock from: 12 o'clock  
Clock to:  
Rating: 5  
Dimension 1:  
Dimension 2:  
%: 35 %  
IN LATERAL

Photo: MH 1-03-MH 1-02-20220901-114000.JPG  
At: 77.3 ft. 12/. DAE - Deposits Attached Encrustation  
Joint: No 35 % IN LATERAL

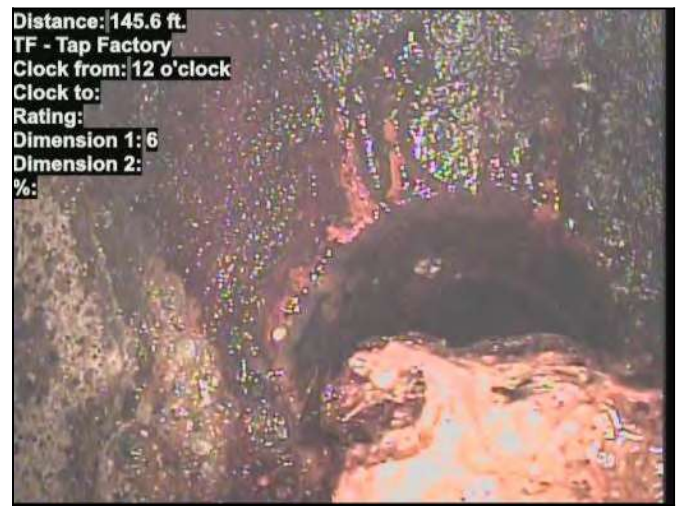
Distance: 145.6 ft.  
TF - Tap Factory  
Clock from: 12 o'clock  
Clock to:  
Rating:  
Dimension 1: 6  
Dimension 2:  
%:

Photo: MH 1-03-MH 1-02-20220901-114356.JPG  
At: 145.6 ft. 12/. TF - Tap Factory  
Joint: No

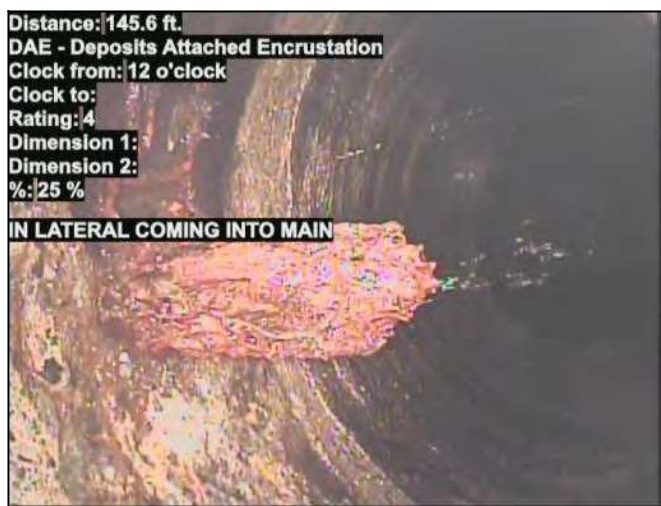
Distance: 145.6 ft.  
DAE - Deposits Attached Encrustation  
Clock from: 12 o'clock  
Clock to:  
Rating: 4  
Dimension 1:  
Dimension 2:  
%: 25 %  
IN LATERAL COMING INTO MAIN

Photo: MH 1-03-MH 1-02-20220901-114404.JPG  
At: 145.6 ft. 12/. DAE - Deposits Attached Encrustation  
Joint: No 25 % IN LATERAL COMING INTO MAIN

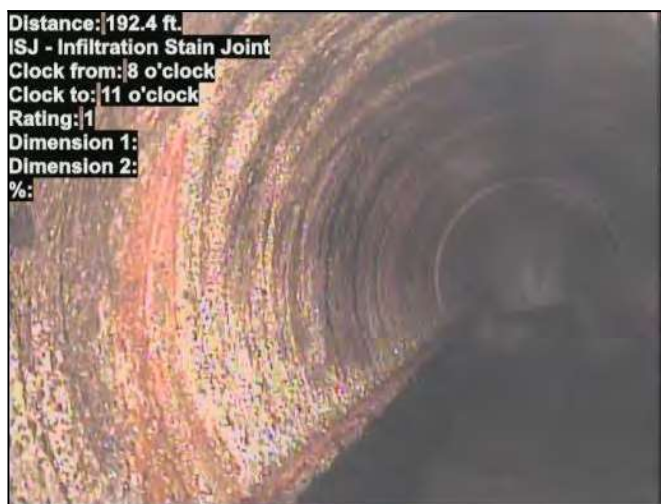
Distance: 192.4 ft.  
ISJ - Infiltration Stain Joint  
Clock from: 8 o'clock  
Clock to: 11 o'clock  
Rating: 1  
Dimension 1:  
Dimension 2:  
%:

Photo: MH 1-03-MH 1-02-20220901-114657.JPG  
At: 192.4 ft. ISJ - Infiltration Stain Joint  
8/11  
Joint: Yes

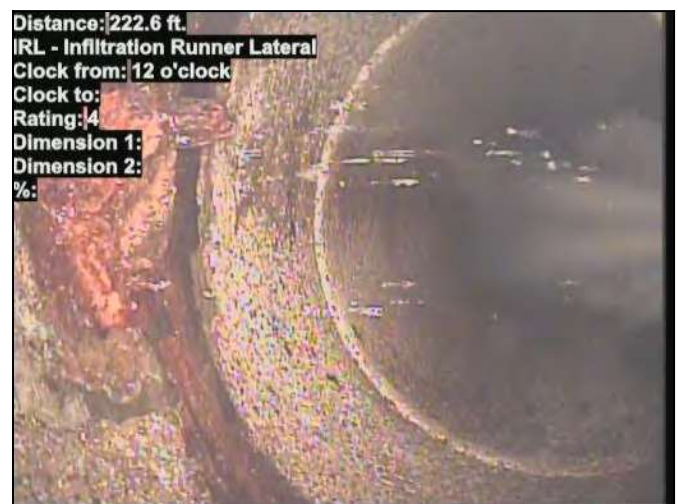
Distance: 222.6 ft.  
IRL - Infiltration Runner Lateral  
Clock from: 12 o'clock  
Clock to:  
Rating: 4  
Dimension 1:  
Dimension 2:  
%:

Photo: MH 1-03-MH 1-02-20220901-114912.JPG  
At: 222.6 ft. 12/. IRL - Infiltration Runner Lateral  
Joint: Yes

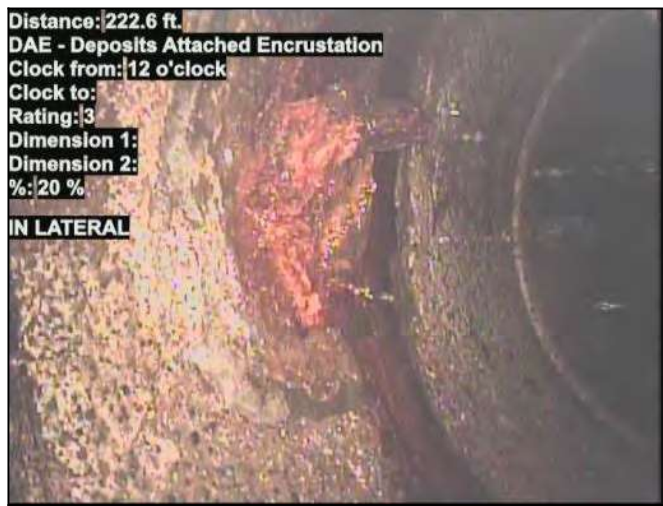
Distance: 222.6 ft.  
DAE - Deposits Attached Encrustation  
Clock from: 12 o'clock  
Clock to:  
Rating: 3  
Dimension 1:  
Dimension 2:  
%: 20 %  
IN LATERAL  
Photo: MH 1-03-MH 1-02-20220901-114850.JPG  
At: 222.6 ft. 12/. DAE - Deposits Attached Encrustation  
Joint: Yes 20 % IN LATERAL
