## Appendix A

### Mystic Area CCTV Inspection Logs

## NWMCC INSPECTION REPORT

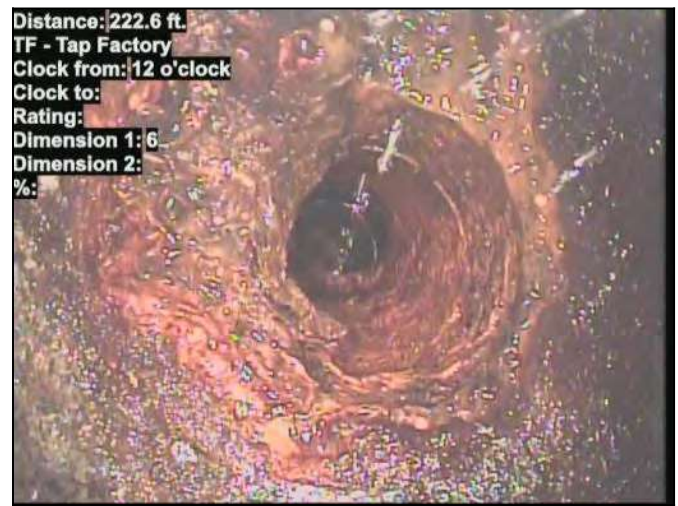
Distance: 222.6 ft.  
TF - Tap Factory  
Clock from: 12 o'clock  
Clock to:  
Rating:  
Dimension 1: 6  
Dimension 2:  
%:  
Photo: MH 1-03-MH 1-02-20220901-114837.JPG  
At: 222.6 ft. 12/. TF - Tap Factory  
Joint: No

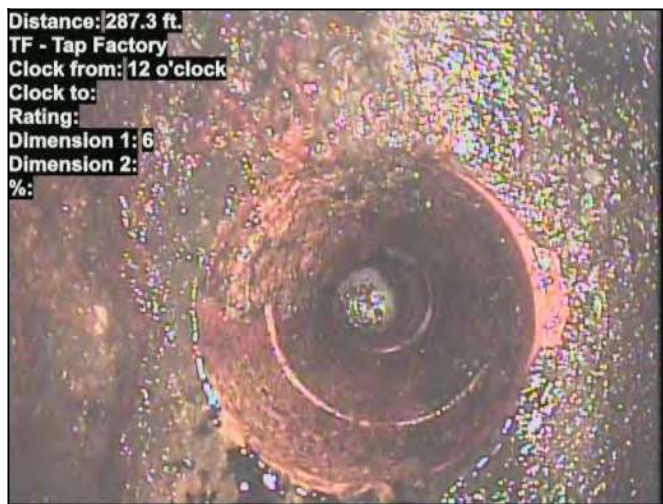
Distance: 287.3 ft.  
TF - Tap Factory  
Clock from: 12 o'clock  
Clock to:  
Rating:  
Dimension 1: 6  
Dimension 2:  
%:  
Photo: MH 1-03-MH 1-02-20220901-115209.JPG  
At: 287.3 ft. 12/. TF - Tap Factory  
Joint: No

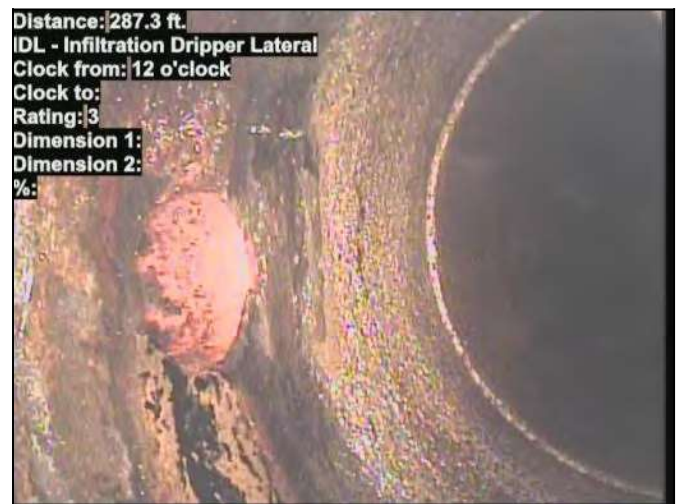
Distance: 287.3 ft.  
IDL - Infiltration Dripper Lateral  
Clock from: 12 o'clock  
Clock to:  
Rating: 3  
Dimension 1:  
Dimension 2:  
%:  
Photo: MH 1-03-MH 1-02-20220901-115218.JPG  
At: 287.3 ft. 12/. IDL - Infiltration Dripper Lateral  
Joint: Yes

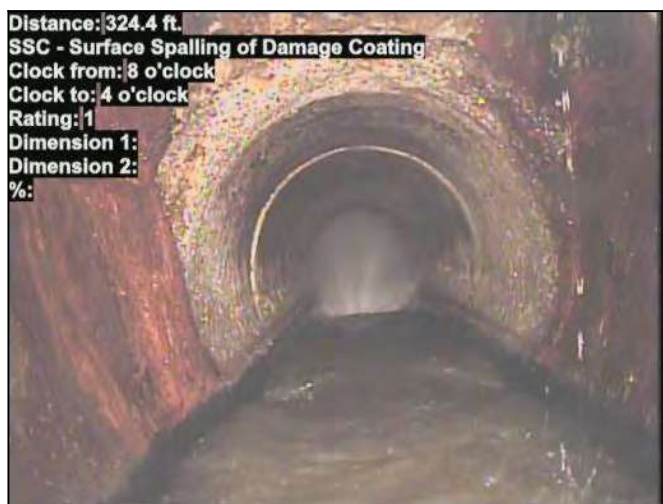
Distance: 324.4 ft.  
SSC - Surface Spalling of Damage Coating  
Clock from: 8 o'clock  
Clock to: 4 o'clock  
Rating: 1  
Dimension 1:  
Dimension 2:  
%:  
Photo: MH 1-03-MH 1-02-20220901-123014.JPG  
At: 324.4 ft. 8/4 SSC - Surface Spalling of Damage Coating  
Joint: Yes

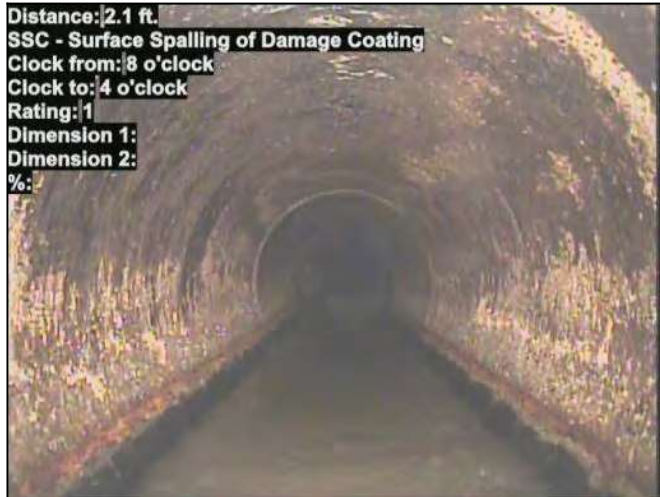
Photo: MH 1-02-MH 1-01-20220901-123532.JPG  
At: 2.1 ft. 8/4 SSC - Surface Spalling of Damage Coating  
Joint: Yes

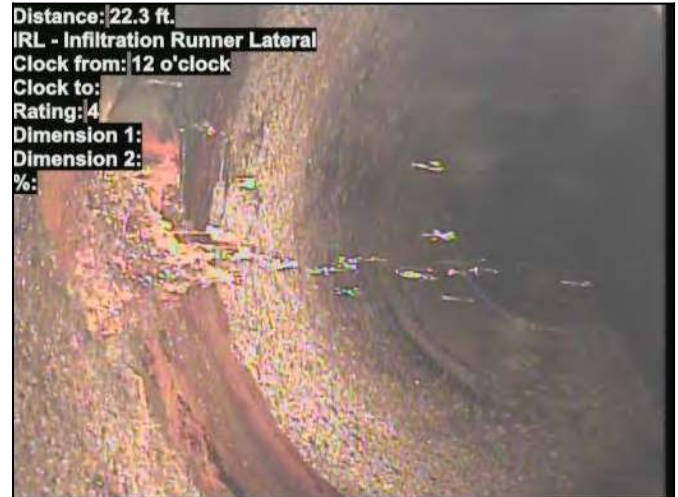
Photo: MH 1-02-MH 1-01-20220901-123747.JPG  
At: 22.3 ft. 12/. IRL - Infiltration Runner Lateral  
Joint: Yes

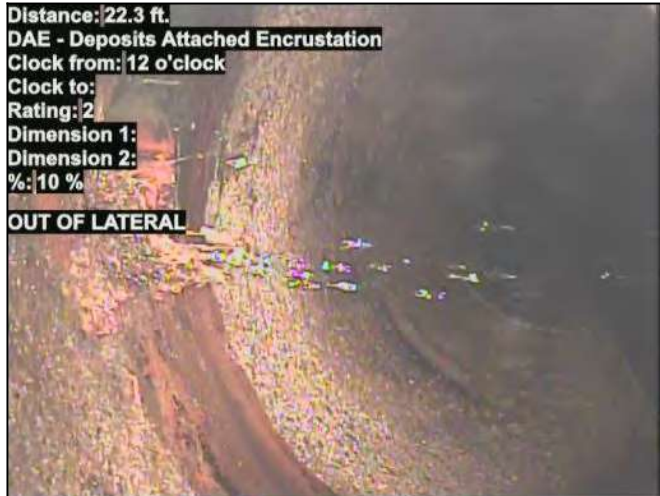
Photo: MH 1-02-MH 1-01-20220901-123718.JPG  
At: 22.3 ft. 12/. DAE - Deposits Attached Encrustation  
Joint: Yes 10 % OUT OF LATERAL

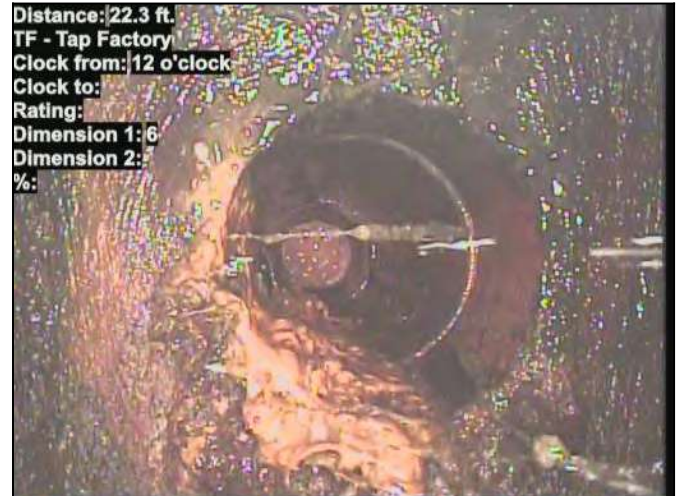
Photo: MH 1-02-MH 1-01-20220901-123707.JPG  
At: 22.3 ft. 12/. TF - Tap Factory  
Joint: No

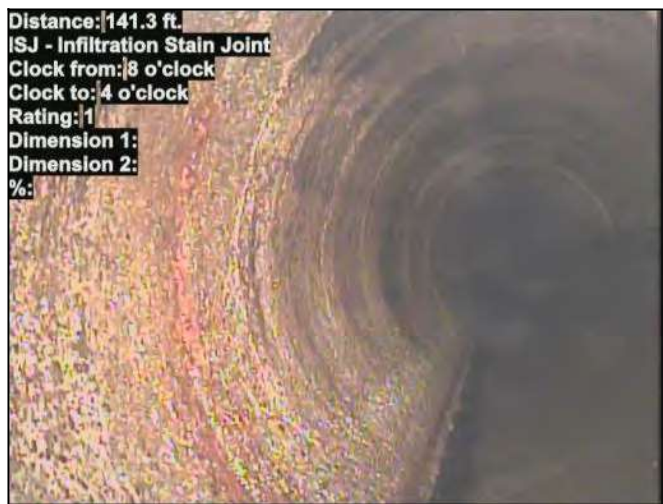
Distance: 141.3 ft.  
ISJ - Infiltration Stain Joint  
Clock from: 8 o'clock  
Clock to: 4 o'clock  
Rating: 1  
Dimension 1:  
Dimension 2:  
%:

Photo: MH 1-02-MH 1-01-20220901-124724.JPG  
At: 141.3 ft. 8/4 ISJ - Infiltration Stain Joint  
Joint: Yes

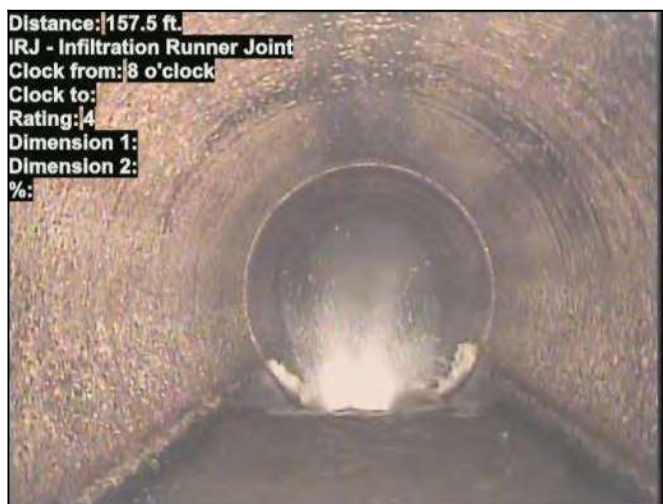
Distance: 157.5 ft.  
IRJ - Infiltration Runner Joint  
Clock from: 8 o'clock  
Clock to:  
Rating: 4  
Dimension 1:  
Dimension 2:  
%:

Photo: MH 1-02-MH 1-01-20220901-125340.JPG  
At: 157.5 ft. 8/. IRJ - Infiltration Runner Joint  
Joint: Yes

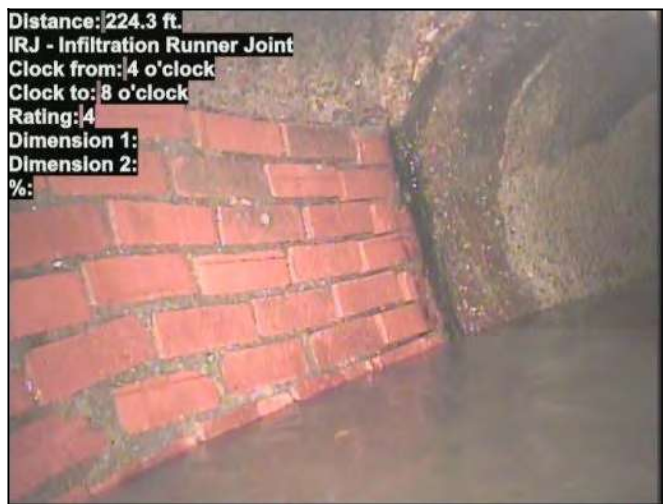
Photo: MH 1-02-MH 1-01-20220901-131508.JPG  
 At: 224.3 ft. 4/8 IRJ - Infiltration Runner Joint  
 Joint: Yes

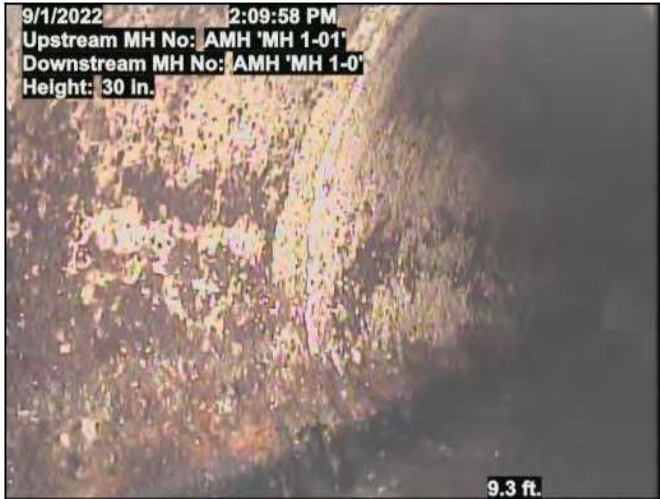
Photo: MH 1-01-MH 1-0-20220901-132140\_1.JPG  
At: 0 ft. 8/4 SSC - Surface Spalling of Damage Coating  
Joint: Yes

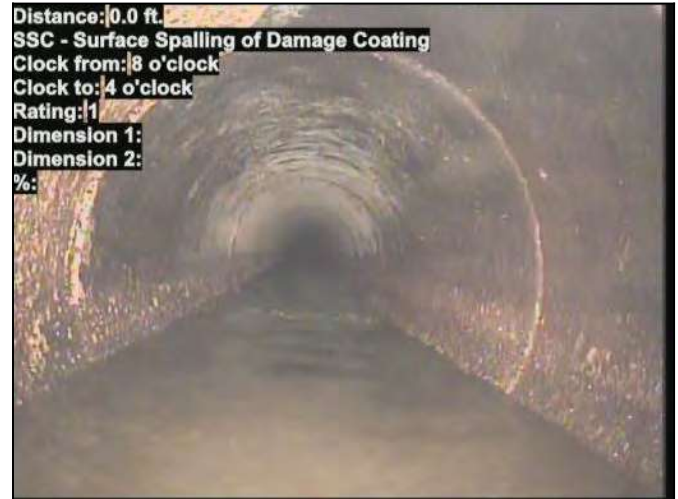
Photo: MH 1-01-MH 1-0-20220901-132140.JPG  
At: 0 ft. 8/4 SSC - Surface Spalling of Damage Coating  
Joint: Yes

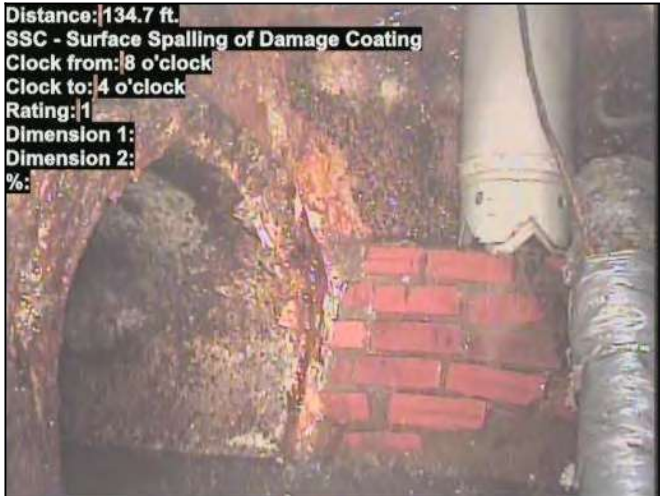
Photo: MH 1-01-MH 1-0-20220901-141458.JPG  
At: 134.7 ft. 8/4 SSC - Surface Spalling of Damage Coating  
Joint: Yes

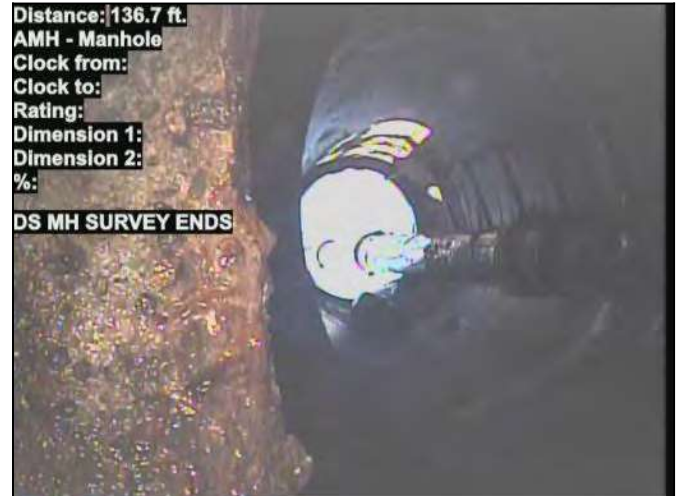
Photo: MH 1-01-MH 1-0-20220901-142901.JPG  
At: 136.7 ft. AMH - Manhole  
Joint: No DS MH SURVEY ENDS
